**BRITANNIA GATE
CHAMPION WAY
BEDFORD**

**ARCHAEOLOGICAL OBSERVATION,
INVESTIGATION, RECORDING,
ANALYSIS AND PUBLICATION**

Project: BG3480
Museum accession no.: BEDFM 2019.83
OASIS no.: albionar1-367679

Document: 2020/001
Version 1.1

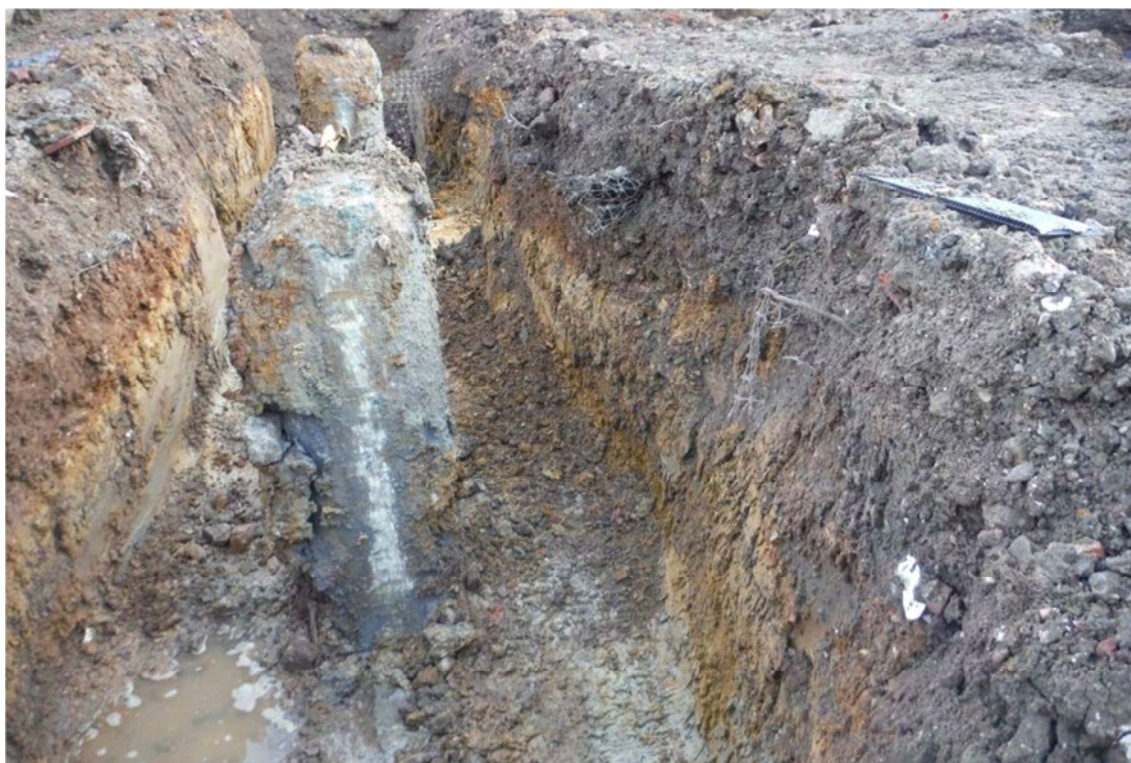
Photograph 1: South wing, beam trench with pile tops – natural sand and gravel surviving

Excavation of the ground beams revealed heavy truncation caused by former buildings within the PDA (Photographs 3, 4, 17 and 18). The majority of the site revealed modern truncation to a depth of at least 1m below the foundation level (i.e. below 27.05m AOD) (see Figures 5 and 7). Therefore, the potential for archaeological remains was restricted to a strip across the south corner of the area *c.*13m wide. Within this area natural deposits were reached at *c.*0.4m below the formation level (*c.*28.1m AOD) (Photographs 1, 2 and 5).

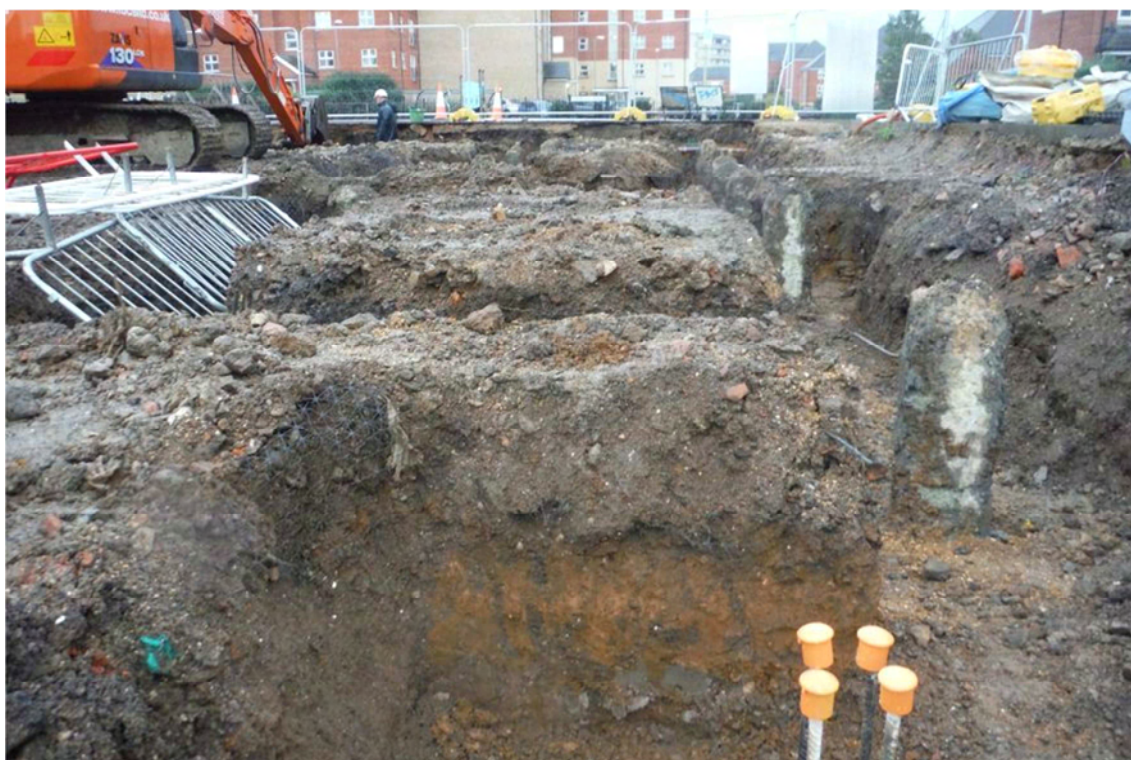
Photograph 2: South wing, looking along south-east side, some natural geology surviving at c.28.2m AOD (centre) but largely truncated to c.27.8m AOD (right)

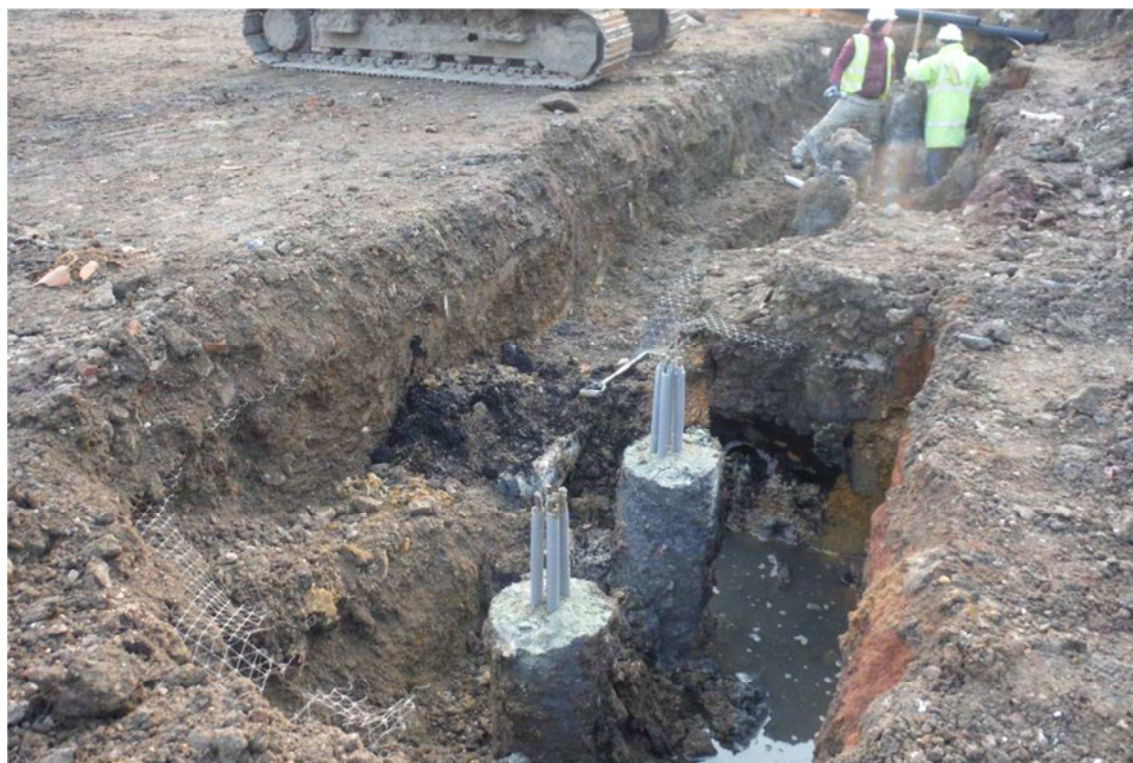
Photograph 3: South wing, south-west edge, heavily truncated by old service trench (black material)

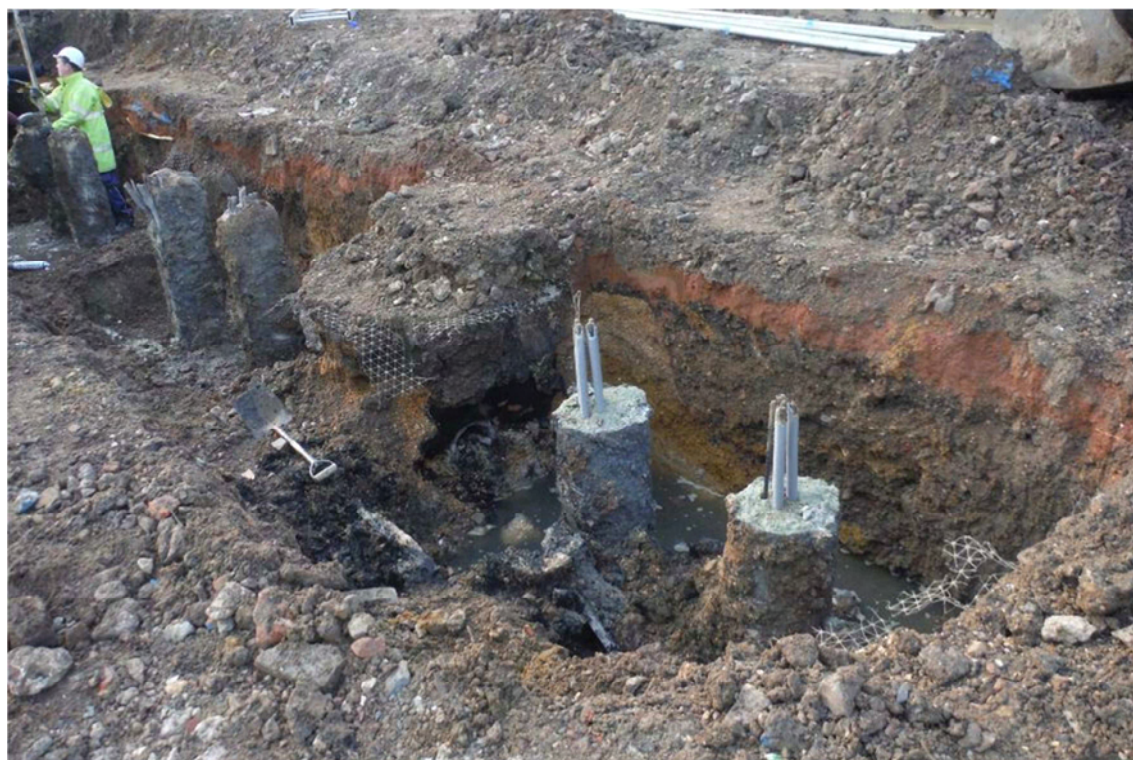
Photograph 4: South wing, south-west edge, heavily truncated by large modern feature and old service trench

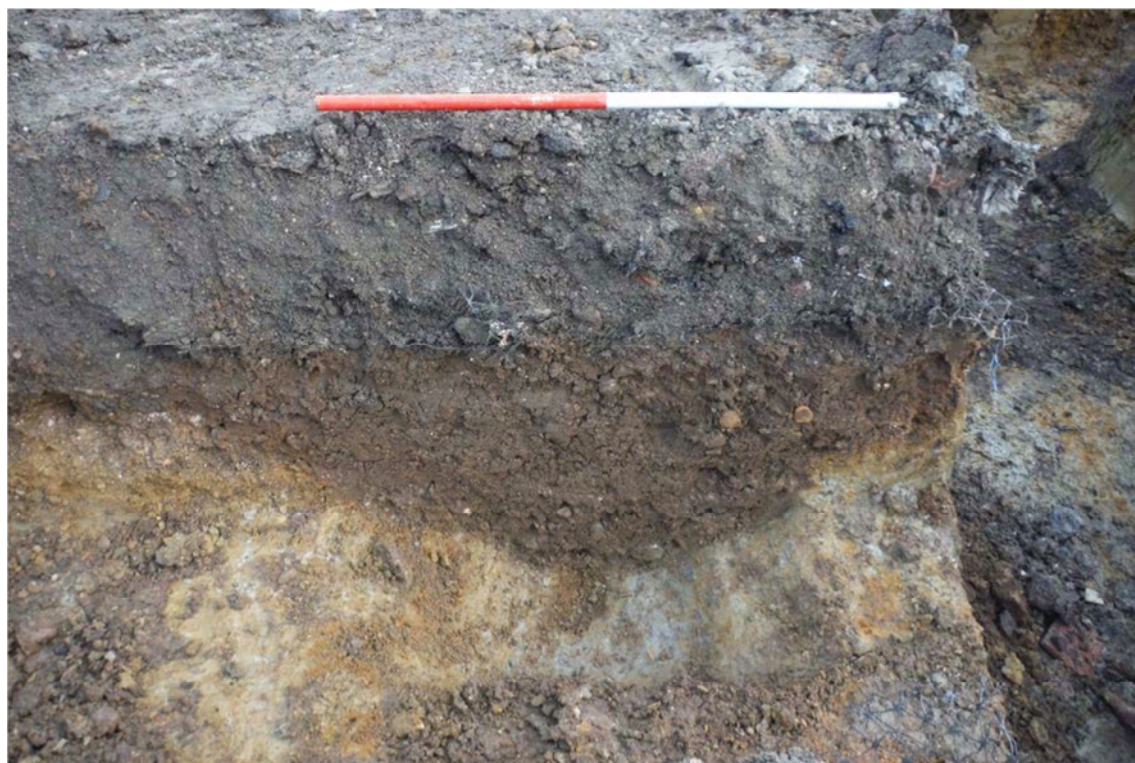
Observation revealed the remains of a ditch *c.*1.45m wide and 0.65m deep (Photograph 5). No dating evidence was recovered from the ditch. It must have terminated within a metre or so to the east, since it was not observed in the adjacent beam trench (its conjectured extent is proposed on Figures 5 and 6).

Photograph 5: Ditch cut into natural geology, south-west-facing section (top of archaeology at c.28.2m AOD)

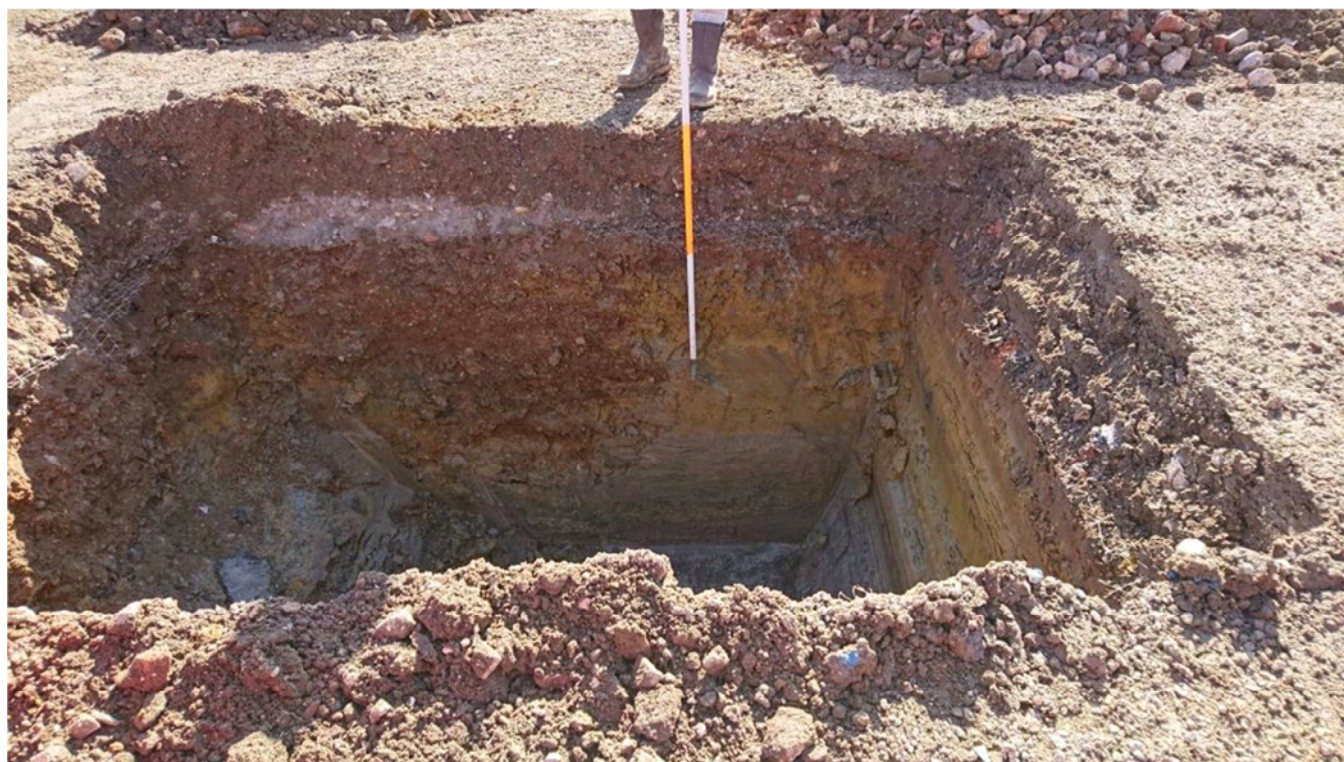
However, two test-pits in the south wing of the building revealed natural sands and gravels at a height of c.28.2m AOD (Photographs 6 and 7). These test-pits were accurately surveyed and shown on Figure 3. No archaeological features were observed, but the survival of natural deposits confirmed that this part of the site had not been basemented and retained potential for the survival of archaeological deposits.

Photograph 6: Test-pit 7, south wing (east of proposed lift pit), showing natural sand and gravel deposits surviving at c.28.2m AOD.

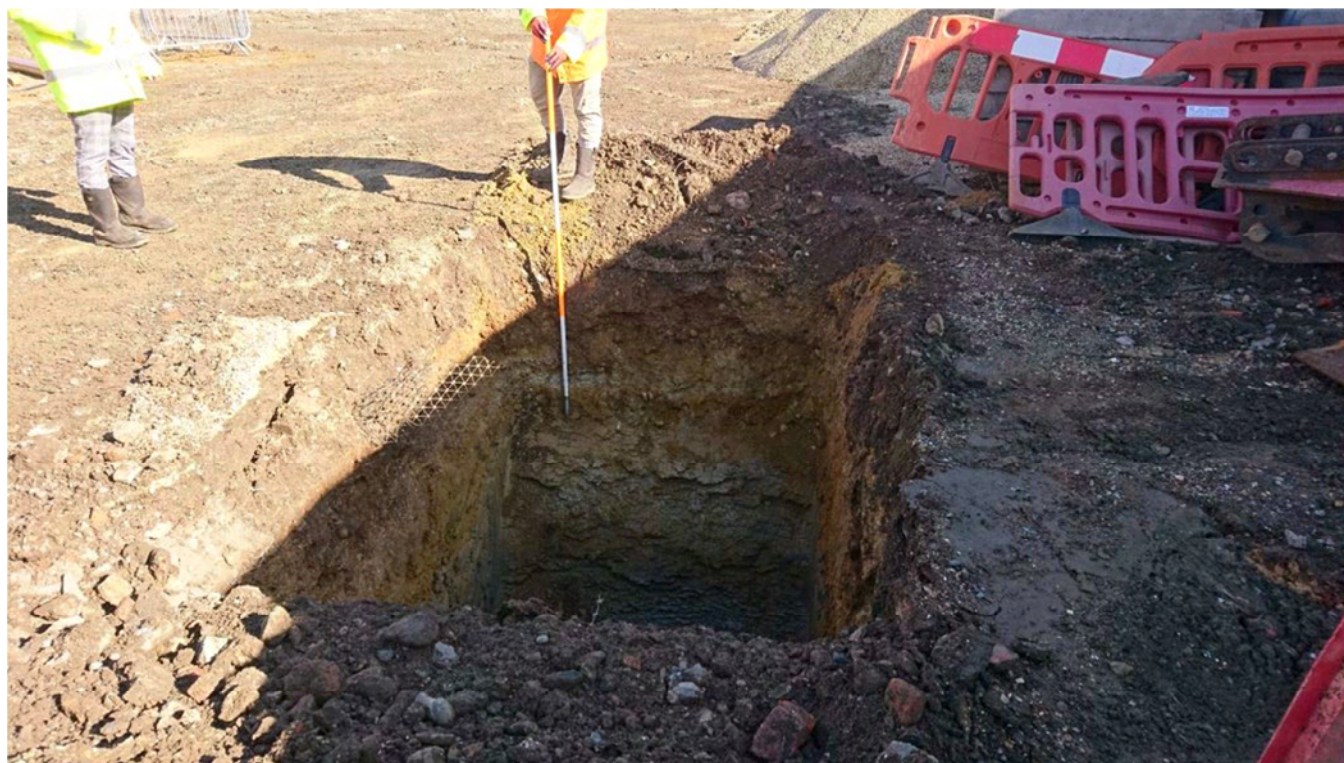
Photograph 7: Test-pit 8, south wing, showing natural sand and gravel deposits at c.28.2m AOD

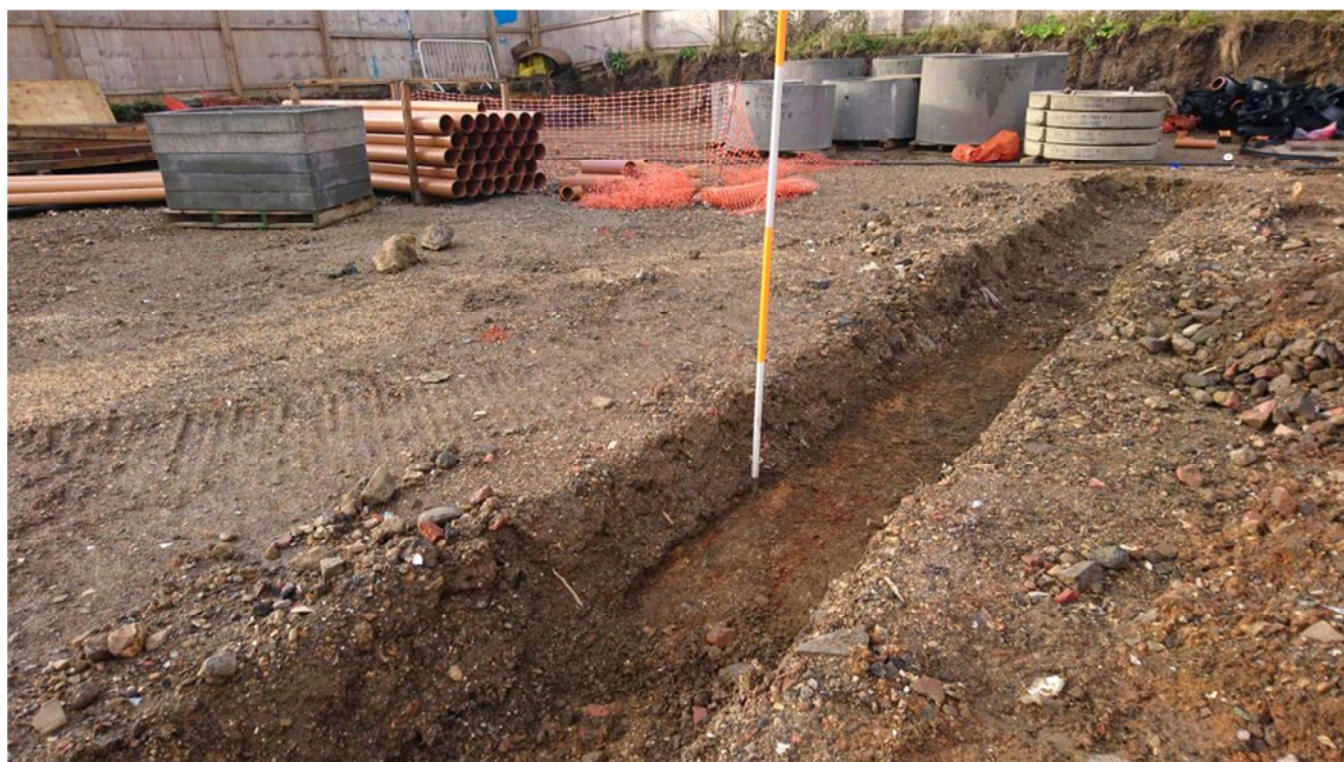
The service trenches around the central courtyard were mostly dug through the made ground backfilling the former basement (Figure 5; Photographs 10 and 11), but along the north side of the south wing natural gravel deposits survived to a height of *c.*28.1m AOD (Figures 5 and 6; Photographs 8 and 9). No archaeological remains were found.

Photograph 8: Service trench north of south wing, looking south-west; top of natural sand and gravel at c.28.2m AOD

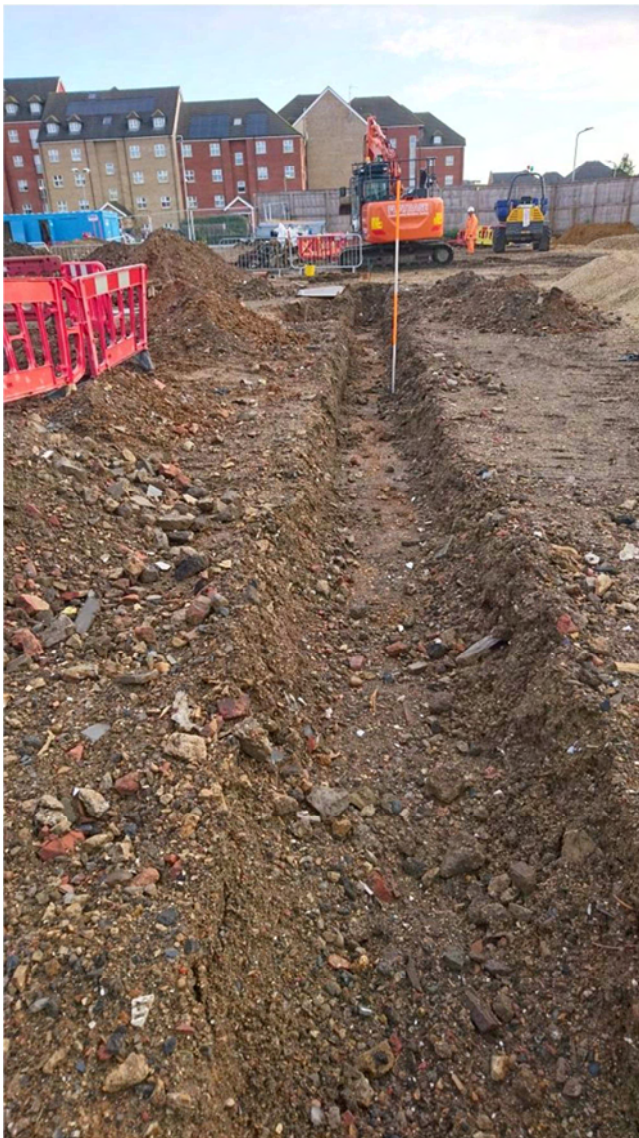
Photograph 9: Service trench, looking north-east.

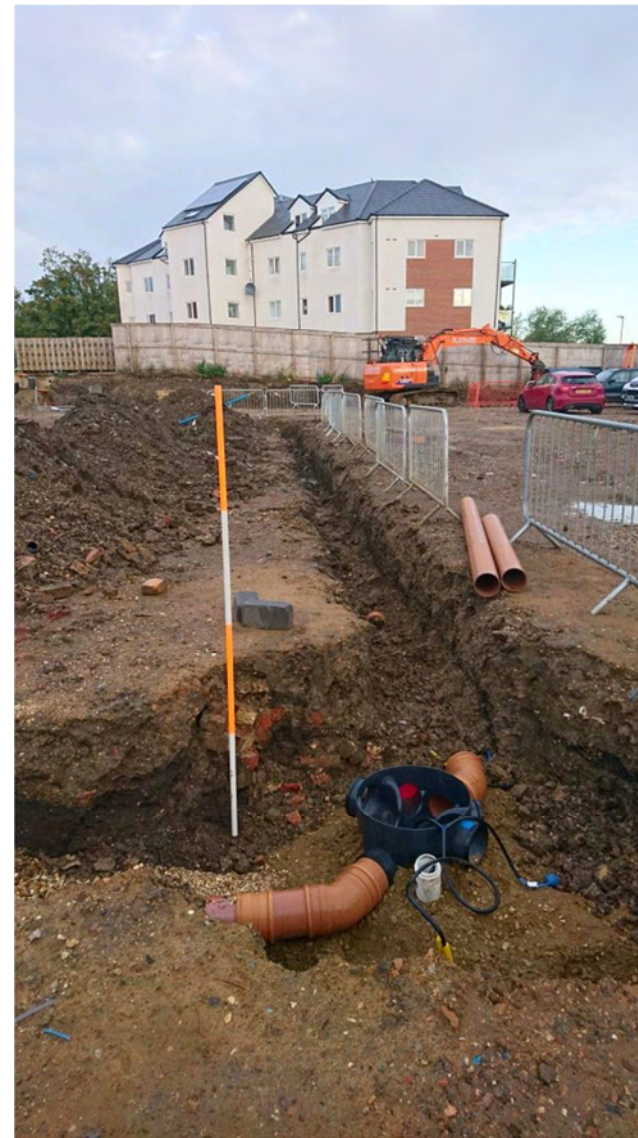
Photograph 10: Service trench in made ground, looking north-west

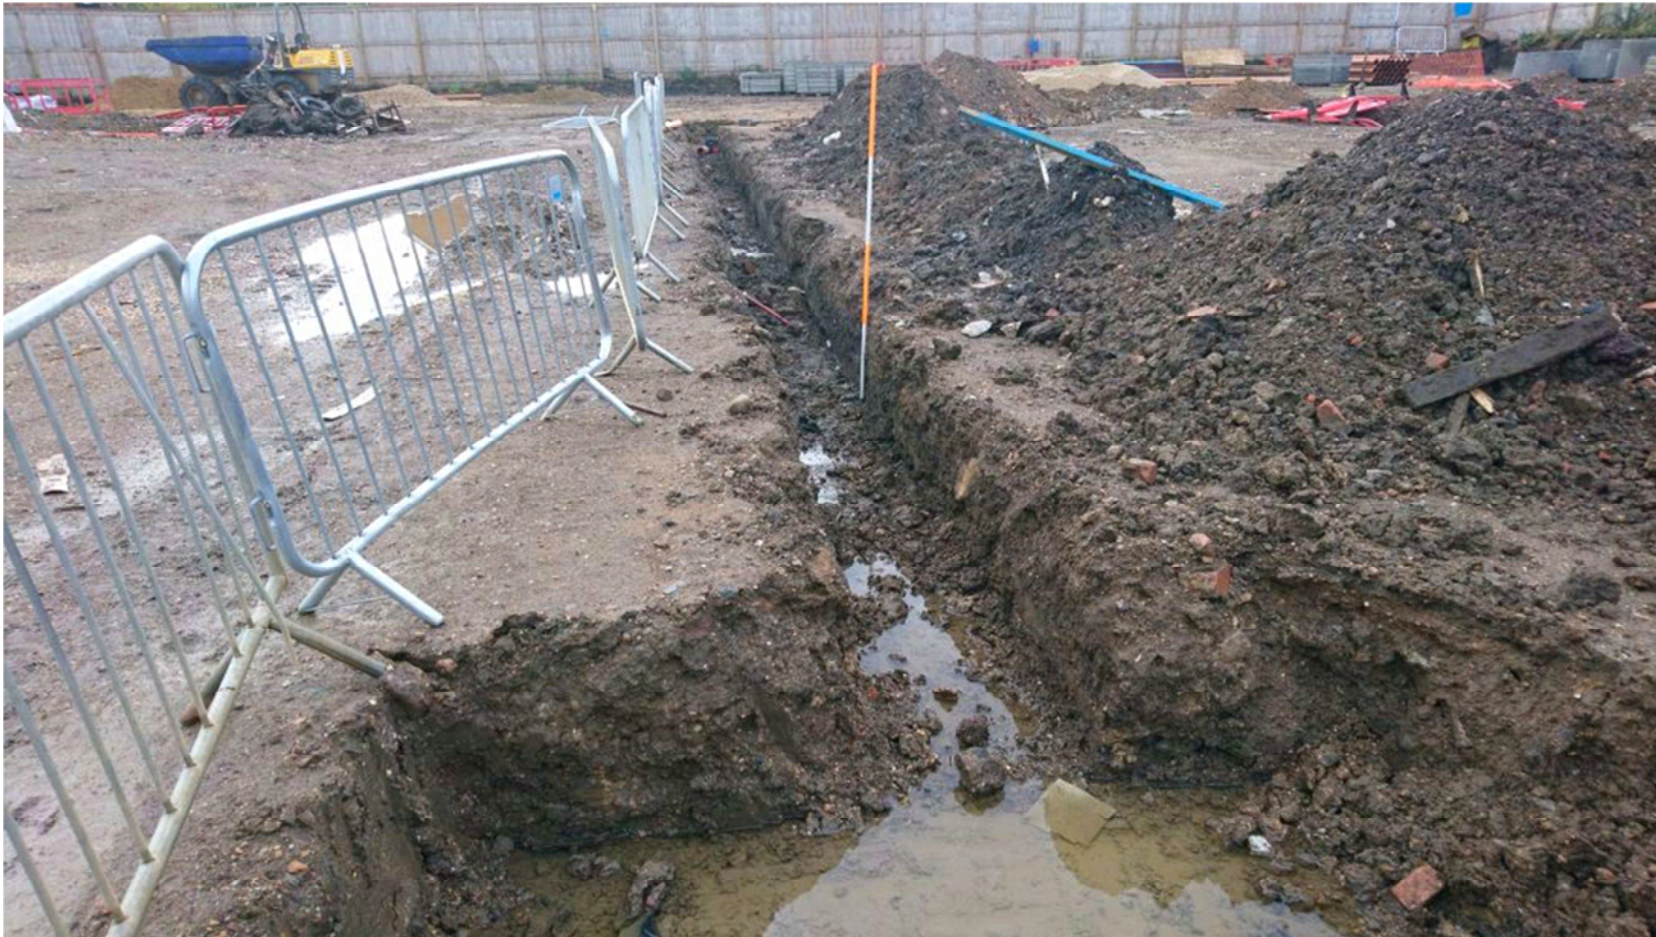
Photograph 11: Service trench on west side of the east wing; entirely excavated into made ground, looking south-east

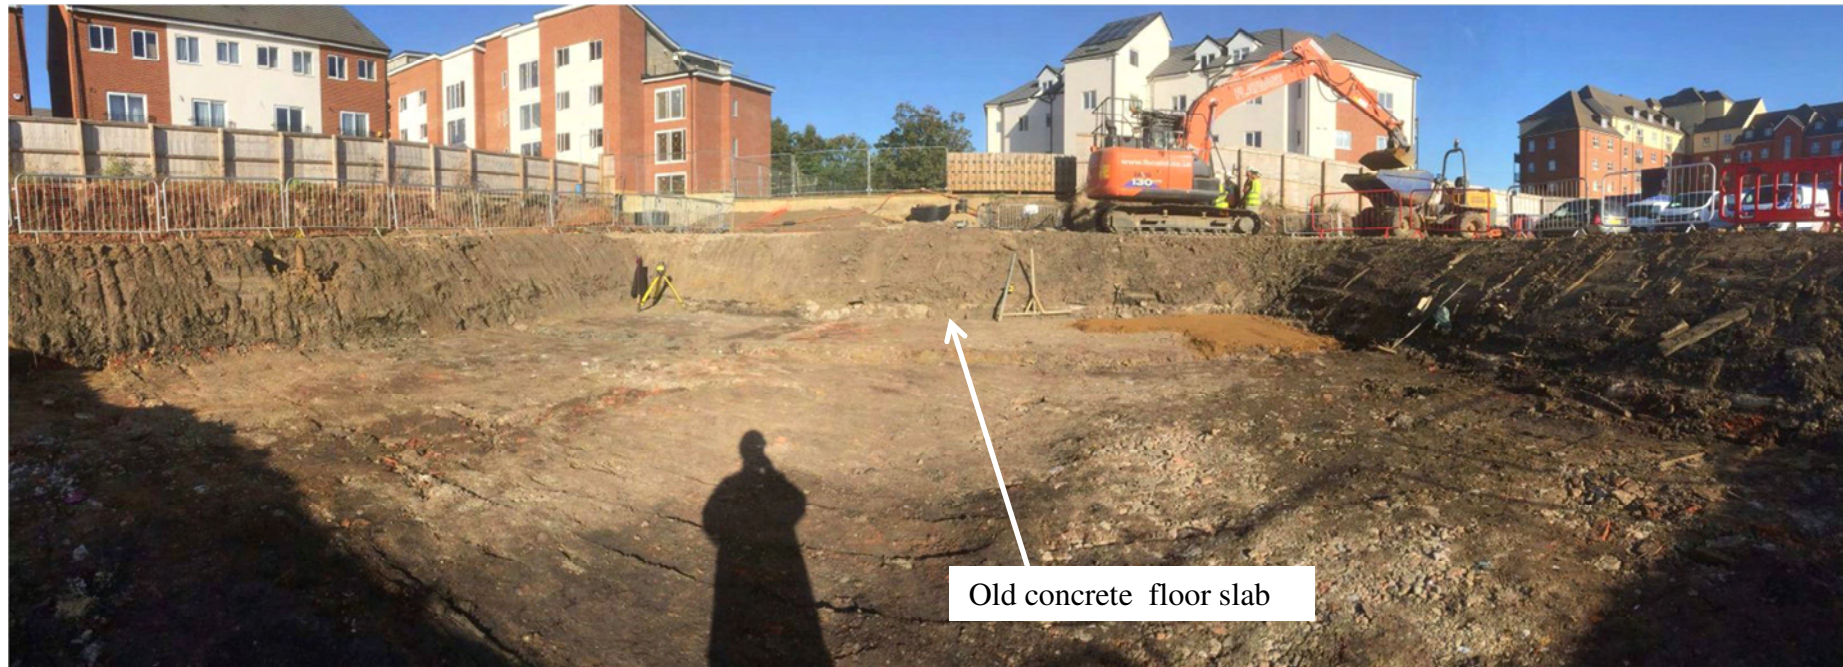
Although the attenuation tank had already been excavated by contractors without an archaeologist present, it was clear that no archaeological remains had been disturbed. The base of the excavation (c.26.3m AOD) revealed layers of subsoil and brick/concrete rubble that were clearly the remaining make-up layers for an old concrete floor slab that was visible in section (Photograph 12). A possibly natural, light yellow-brown gravel deposit was observed at the base of the excavation, in the south-west corner, but this underlay the old floor slab so might well have been imported ballast laid beneath the slab. A shallow drainage trench, <300mm deep and c.600mm wide, had been dug down the middle of the excavation. The base of this had exposed a yellow-brown sandy clay, which was almost certainly natural geology, but no archaeological features were visible.

The top of the old slab was recorded by the contractors at c.27.1m AOD. All the deposits seen in section above the slab were mixed dumps of very modern make-up containing rubble and plastic refuse.

The slab must have formed the basement floor of the former ironworks building.

Photograph 12: Attenuation tank, looking north-west; reduced to formation level (c.27.0m AOD), old floor slab visible in section at c.27.1m AOD

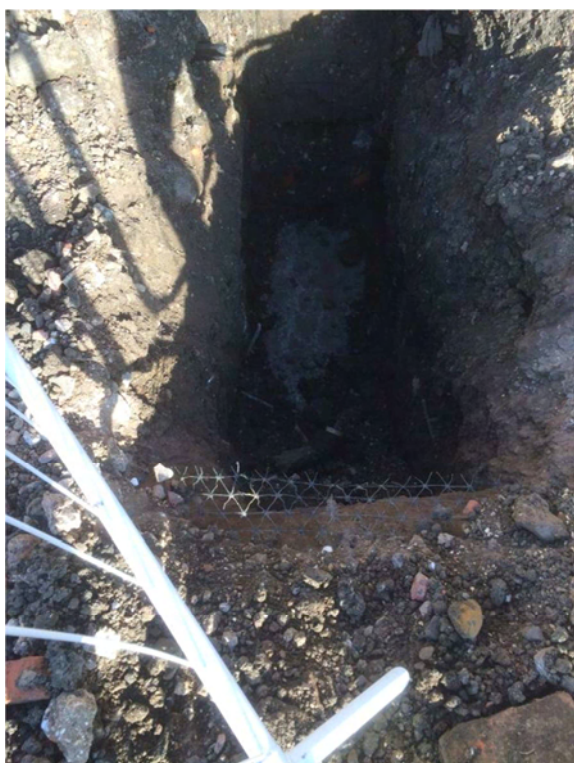
Eight test-pits were excavated by the contractors across the site to look for obstructions that might affect piling operations (Figure 5; Photographs 6 and 7, 13–16). Six of these were dug through layers of made ground similar to the deposits observed in the sides of the attenuation tank excavation and came down onto the top of a concrete slab at c.27.1m AOD. Test-pit 5 had a second slab at c.28.0m AOD. The locations of these test-pits were not surveyed accurately but they were between 600mm and 1.2m wide by 1–2m long.

Photograph 13: Test-pit 1, *in-situ* slab in base at c.27.1m AOD

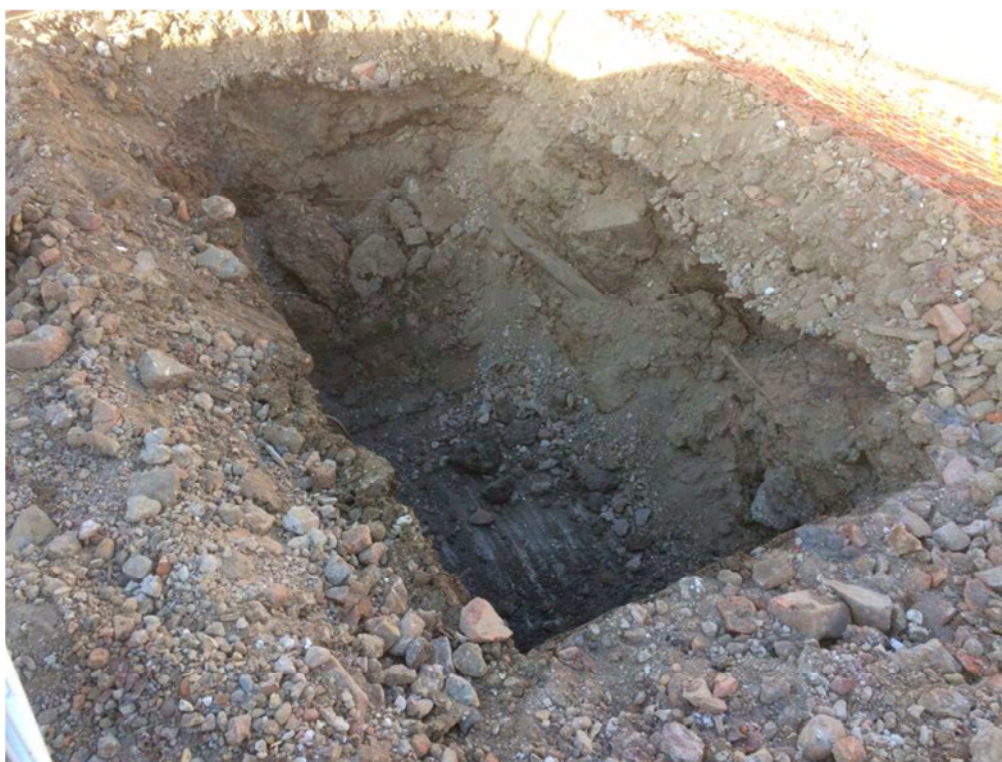
Photograph 14: Test-pit 2, *in-situ* slab in base at c.27.1m AOD

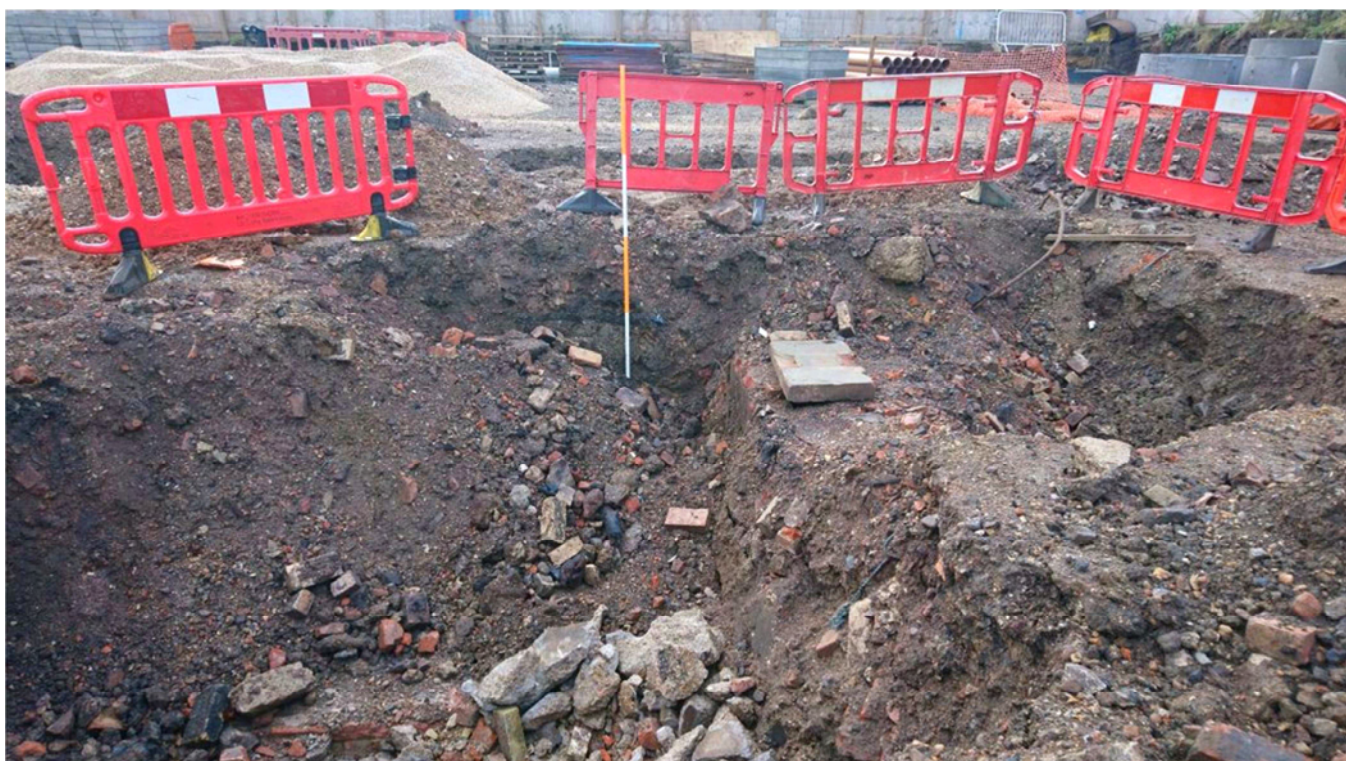
Photograph 15: Modern structures exposed by Test-pit 6

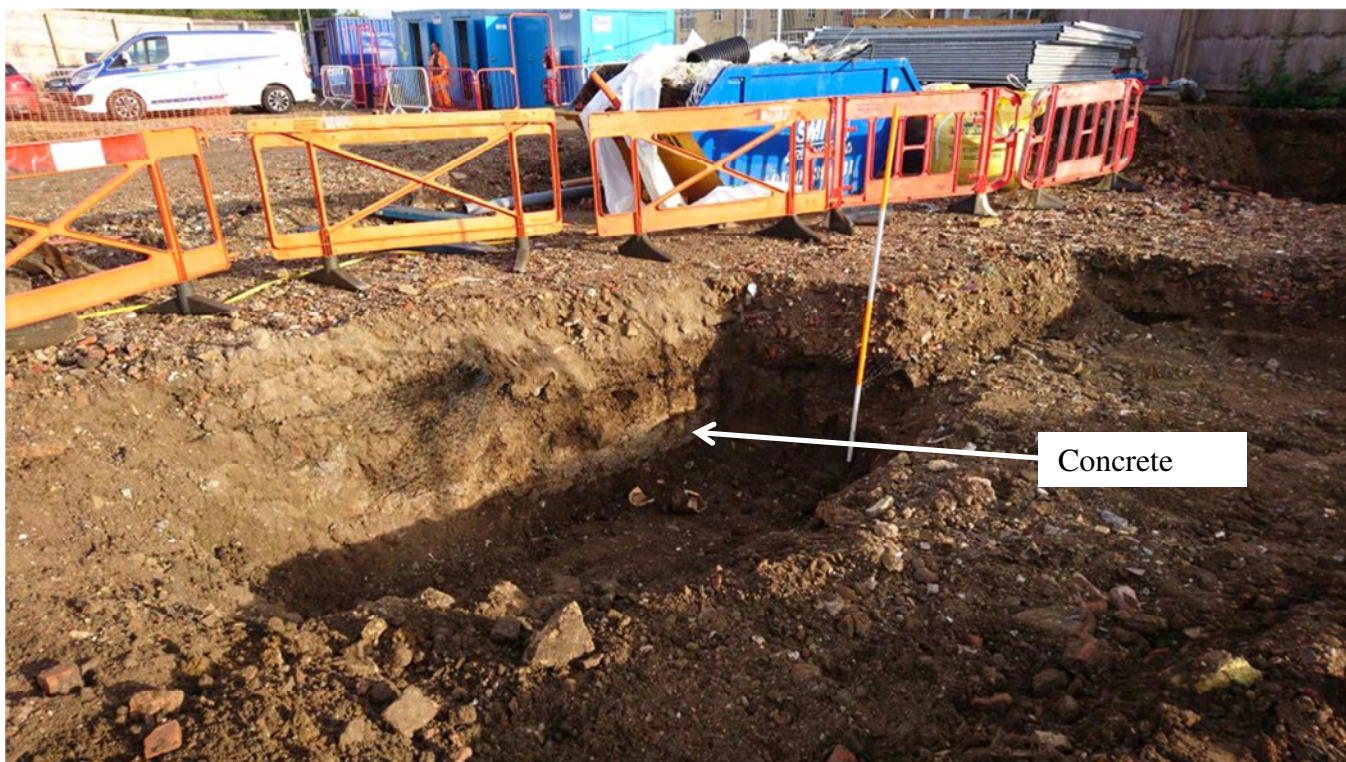
Photograph 16: Test-pit 5 with upper concrete slab in section, top at 28.0m AOD, made ground below

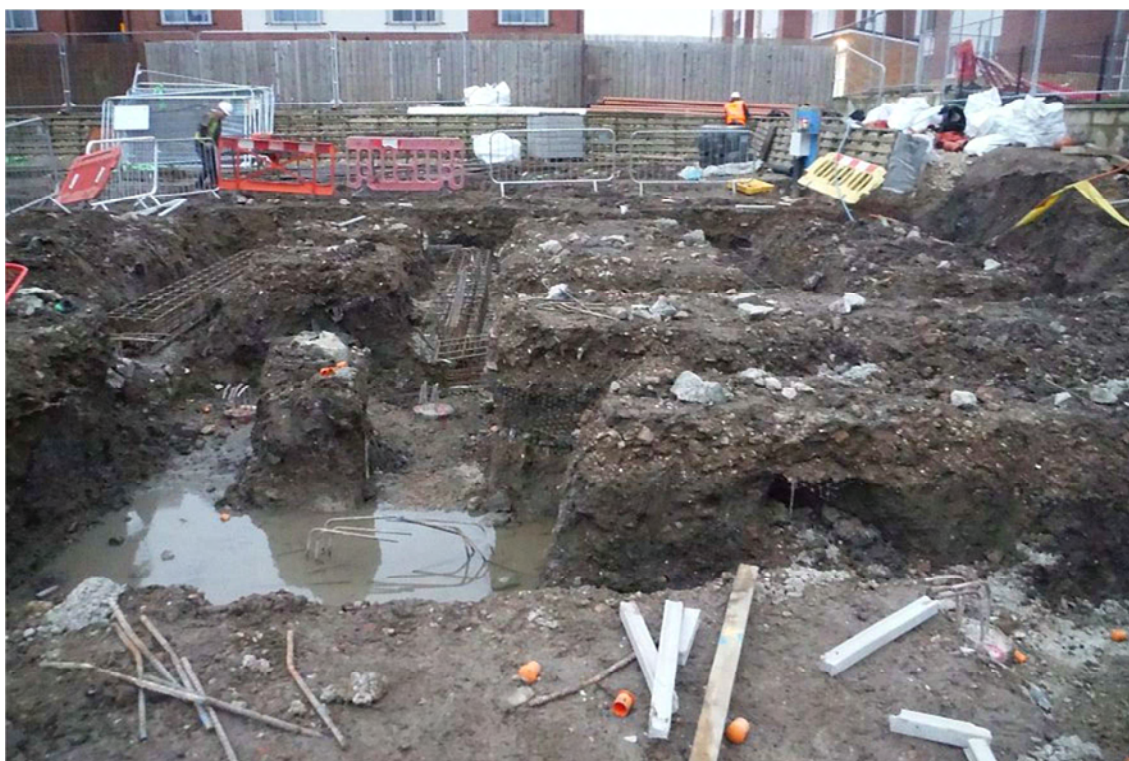
Photograph 17: Foundation trenches at the west end of the north wing, looking south-west; all exposed deposits comprise made ground, containing soil, brick rubble and other modern inclusions

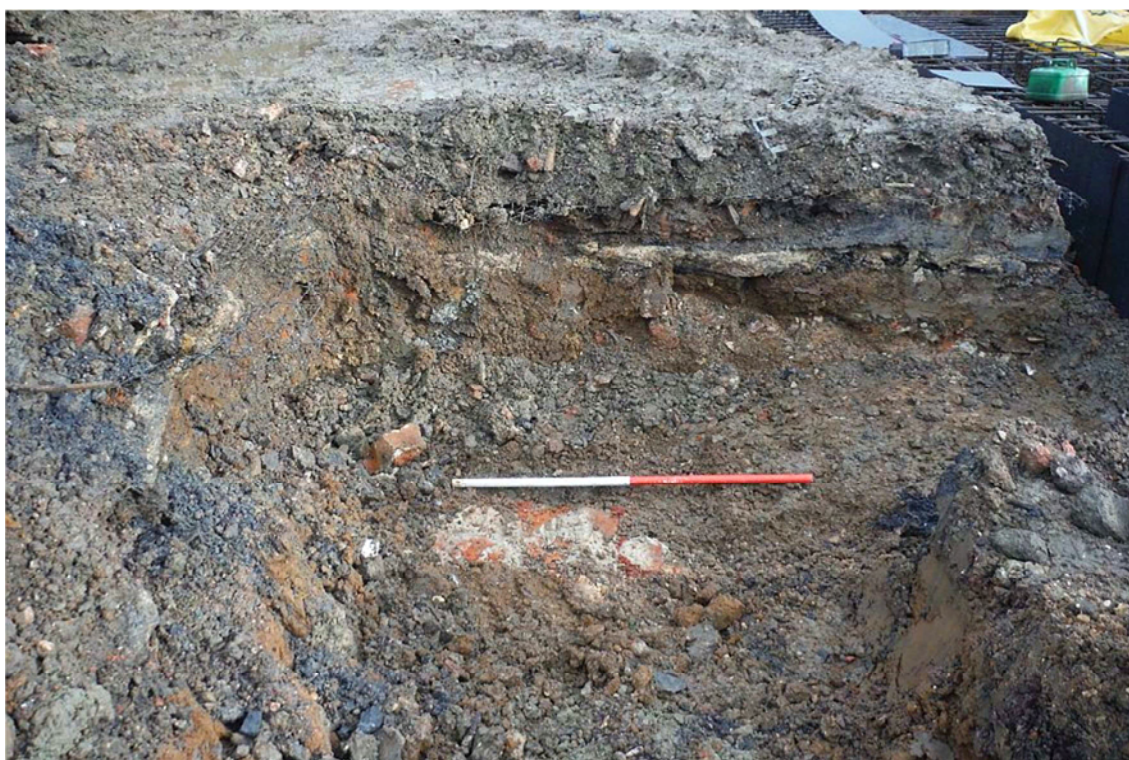
Photograph 18: Part of brick wall exposed at the base of foundation trench, looking north-east; all deposits are made ground, containing brick rubble and other modern inclusions

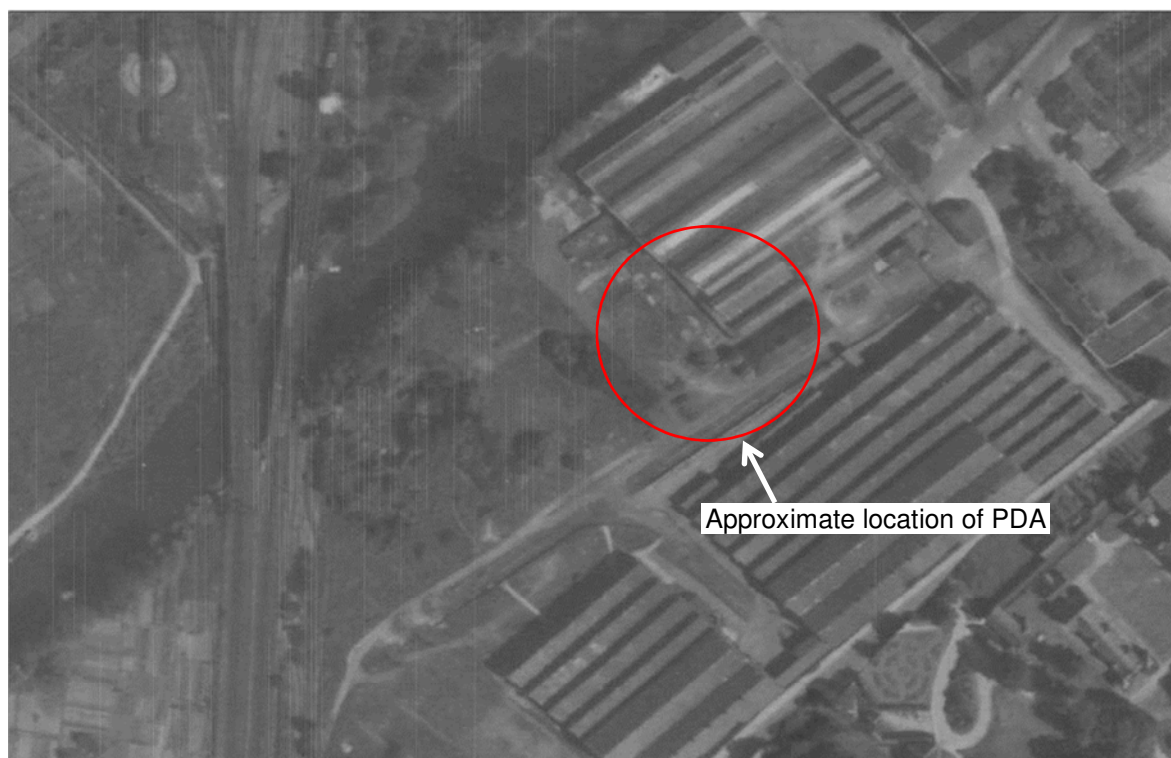
Photograph 19: RAF aerial photograph 1949–50 (BBC HER)
© Bedford Borough Council, reproduced with permission

With reference to old maps and aerial photographs from the HER (Figures 2 and 3; Photographs 19–22) it is possible to conclude that the north-east part of the PDA had been truncated to *c.*26.3m AOD by the construction of the basement of a single, large factory building. In Figure 7 the approximate footprint of this building is indicated in relation to the recent archaeological observations and earlier trial trenching. The south and west sides of the PDA were historically separate land parcels (Figure 2). As a result of this division, the subsequent development of the site resulted in differential survival of archaeological remains (Figure 7). Trial Trench 8 indicated that remains of Iron Age date survived on the western edge. Whilst the ditch observed during the recent works was undated, it is also likely to have dated from the Iron Age (although its alignment might also indicate that it was a much more recent boundary ditch).
