**ST PETER'S CHURCH
SHARNBROOK
BEDFORDSHIRE**

**ARCHAEOLOGICAL OBSERVATION,
INVESTIGATION, RECORDING, ANALYSIS AND
PUBLICATION**

Project Code: SP3569
Document: 2019/138
Version: 1.0

Produced for:
SC Builders (Thrapston) Ltd

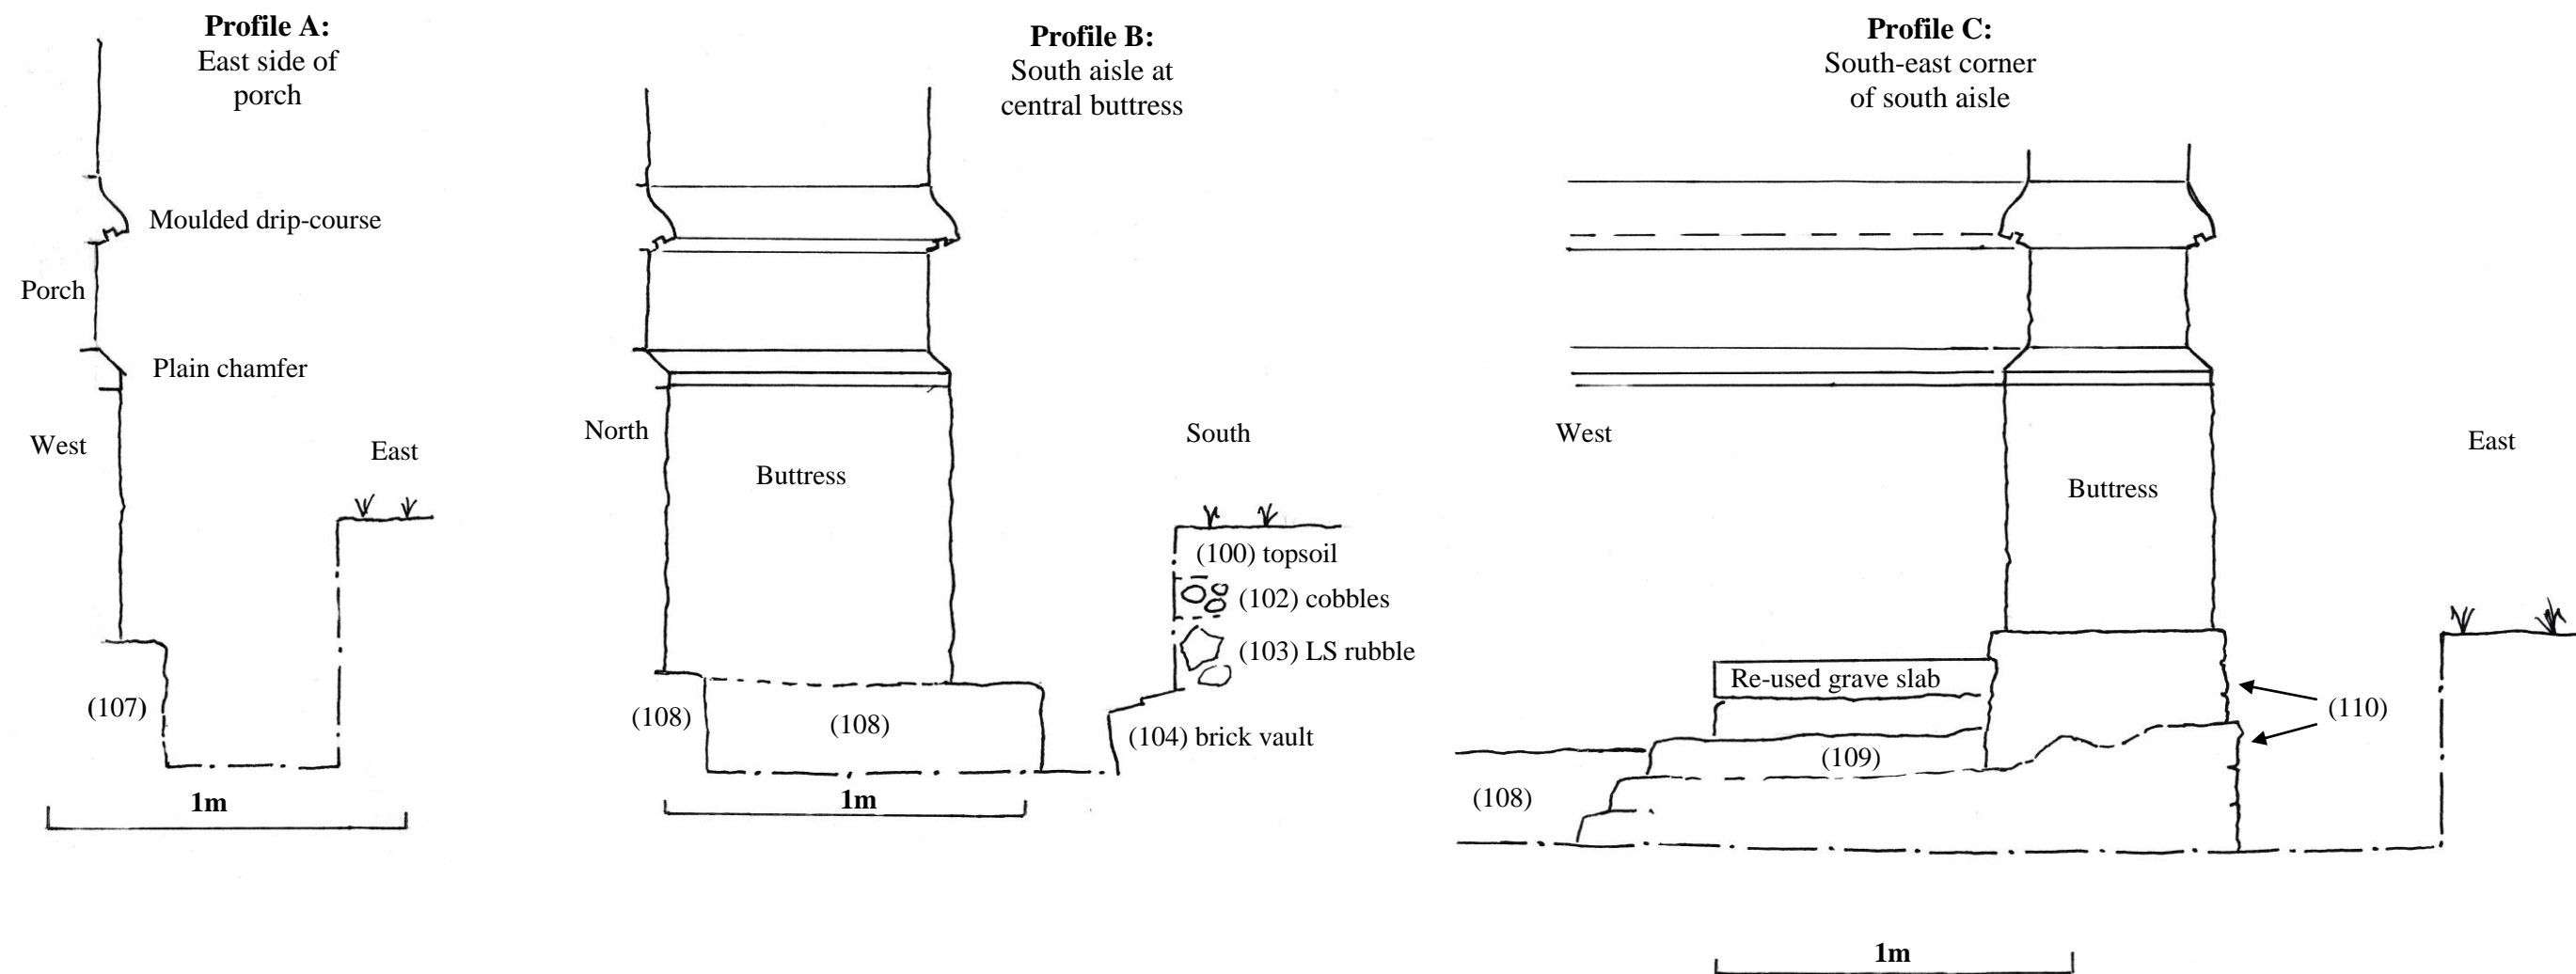
Figure 5: Trench profiles A to C

The masonry in the south porch and the south aisle is fairly consistent. Both have a similar offset rubble foundation, the masonry in the walls is similar with a plain chamfer and moulded drip course running through at the same height (Figure 5-A, Image 3). The masonry of the south porch abuts that of the south aisle and the uppermost course in the foundations of the porch extends over the foundation for the south aisle.

Construction of the central buttress in the south aisle appears to be integral with the wall (Figure 5-B, Images 6 and 7). The foundation of the wall and the foundation pad of the buttress are at the same level. Although it has been affected by later masonry repairs, there are indications, particularly on the east side of the buttress, that its construction is integral with the wall.

The foundations of the south aisle included a widened foundation pad at the east end of the south wall (Figure 5-C, Images 9 and 10). This widened foundation incorporates large flat slabs of stone, with at least one re-used 13th-century grave slab. It was not clear whether the expanded foundation formed

Drawings based on measured sketch records showing foundations and masonry in lower part of walls (Scale 1:50 at A3)

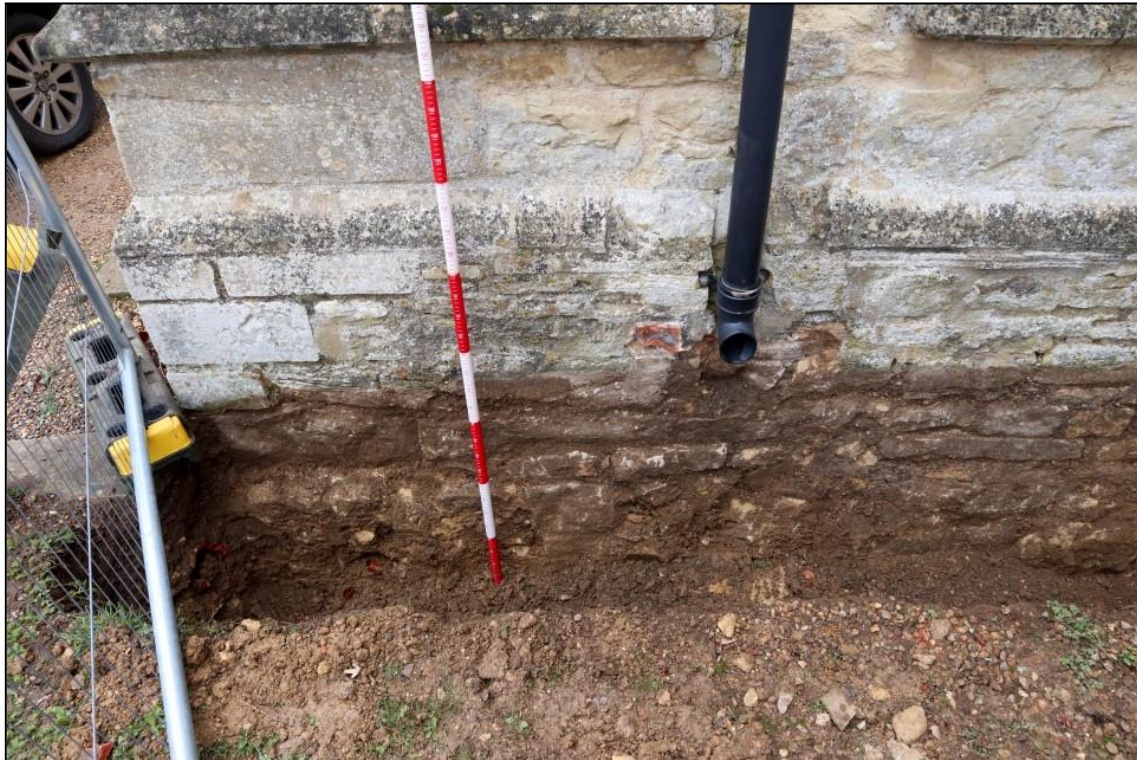
- **(107) South porch, east wall:**
This foundation consists of a plain offset, at a depth of 350mm below ground level (Images 2 and 3). It is constructed from roughly squared-off limestone blocks with at least three courses visible in the trench. The offset projects 100mm at the north end of the wall, 130mm at the south end and is flush with the wall in the central section. The foundation abuts the foundation of the south aisle, with the uppermost course of the offset extending over the foundation offset of the south aisle.

Image 2: Trench 1. East wall of south porch, left end
(Scale 200mm divisions)

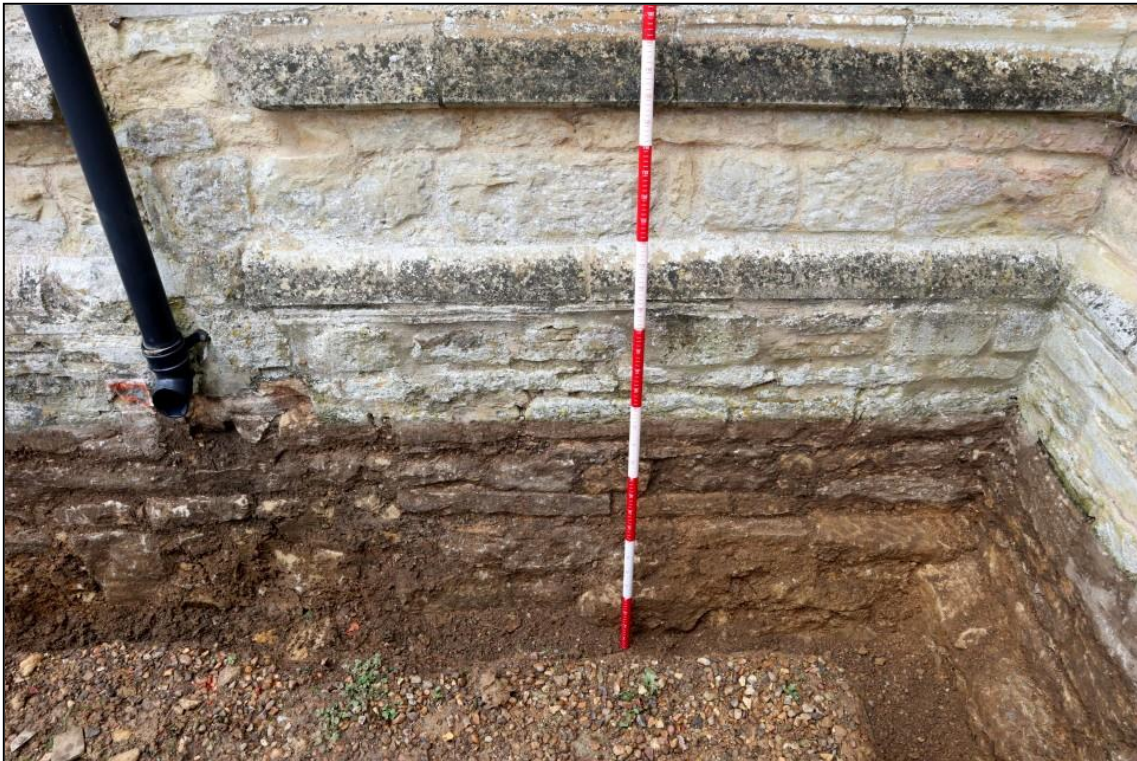
Image 3: Trench 1. East wall of south porch, right end
(Scale 200mm divisions)

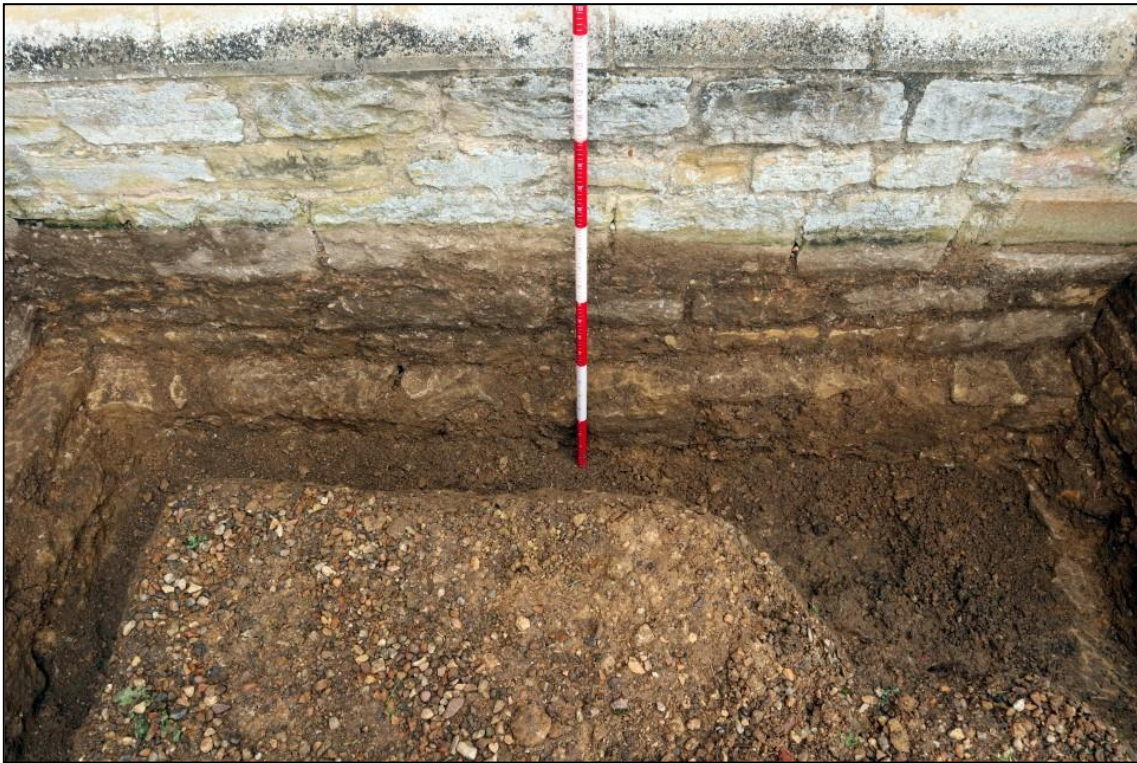
- **(108) South aisle, south wall:**
This foundation is a plain offset at a depth of 440mm below ground level (Images 5–8). The offset projects between 100mm and 200mm. It is fairly regular in appearance, made from unshaped and roughly squared limestone blocks with at least two courses visible. The central buttress appears to be integral with the wall; on the east side of the buttress where the foundations could be seen clearly these were tied in with construction of the wall foundations.

Image 5: Trench 1. South aisle between porch and central buttress
(Scale 200mm divisions)

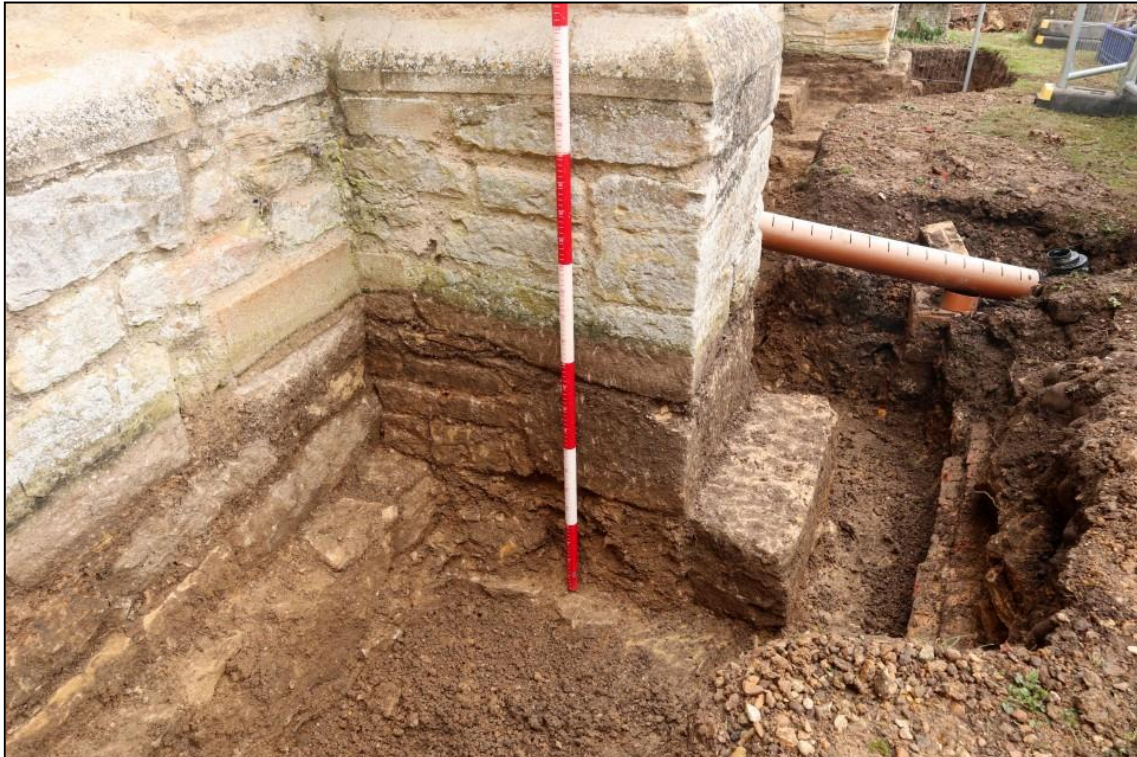
Image 6: Trench 1. South aisle, central buttress, looking north-east
Brick vault (104) visible in base of trench at right (Scale 200mm divisions)

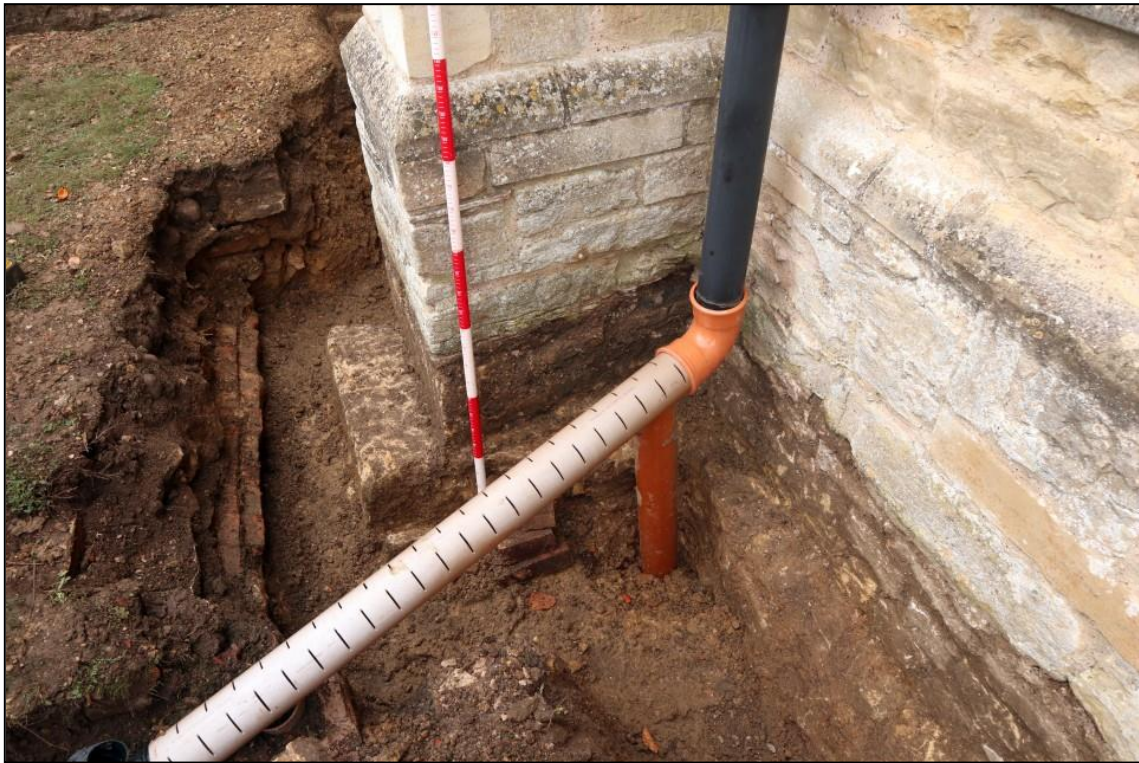
Image 7: Trench 1. South aisle, central buttress, looking north-west
Brick vault (104) visible in base of trench at left. (Scale 200mm divisions)

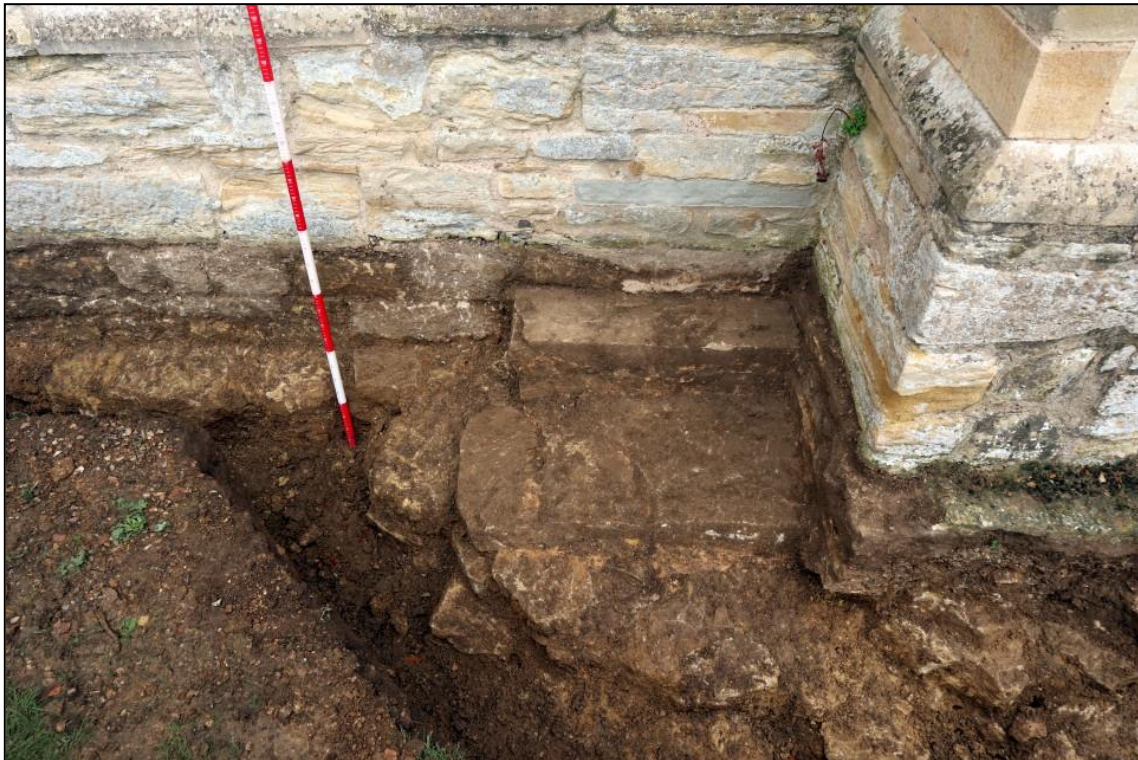
- **(109) South aisle, foundation pad at south-east corner:**
The buttress on the eastern end of the south aisle is supported by an expanded foundation pad (109). This is an irregular, stepped foundation which extends up to 900mm from the face of the wall (Images 8–10). The wider, lower part of the pad consists of unshaped limestone blocks. On the west side of the buttress, the upper part of the foundation is made of large flat limestone slabs. The uppermost slab appears to be a reused medieval grave cover (Image 10). This is a rectangular slab with finely dressed surfaces. It is partially embedded in the wall and buttress and has minimum dimensions of 780mm long by 225mm wide. The southern side of the stone is intact, while the west end has some damage but may be the original edge. Decoration on the visible part of the stone consists of a three-lobed terminal, extending up to the southern edge of the stone. This is likely to be one arm of a cross.

Image 9: Trench 1. South aisle, foundation pad at east end
(Scale 200mm divisions)

An expanded foundation slab at the south-east corner of the south aisle may have been part of later repair works. One of the slabs of stone in the foundation is a reused medieval grave cover. Carving on the grave slab consists of one terminal from what appears to be a simple cross design. The terminal is a three-lobed trefoil, of the type derived from stiff leaf ornament, suggesting a 13th-century date for the grave slab (Butler 1965, 135–41).

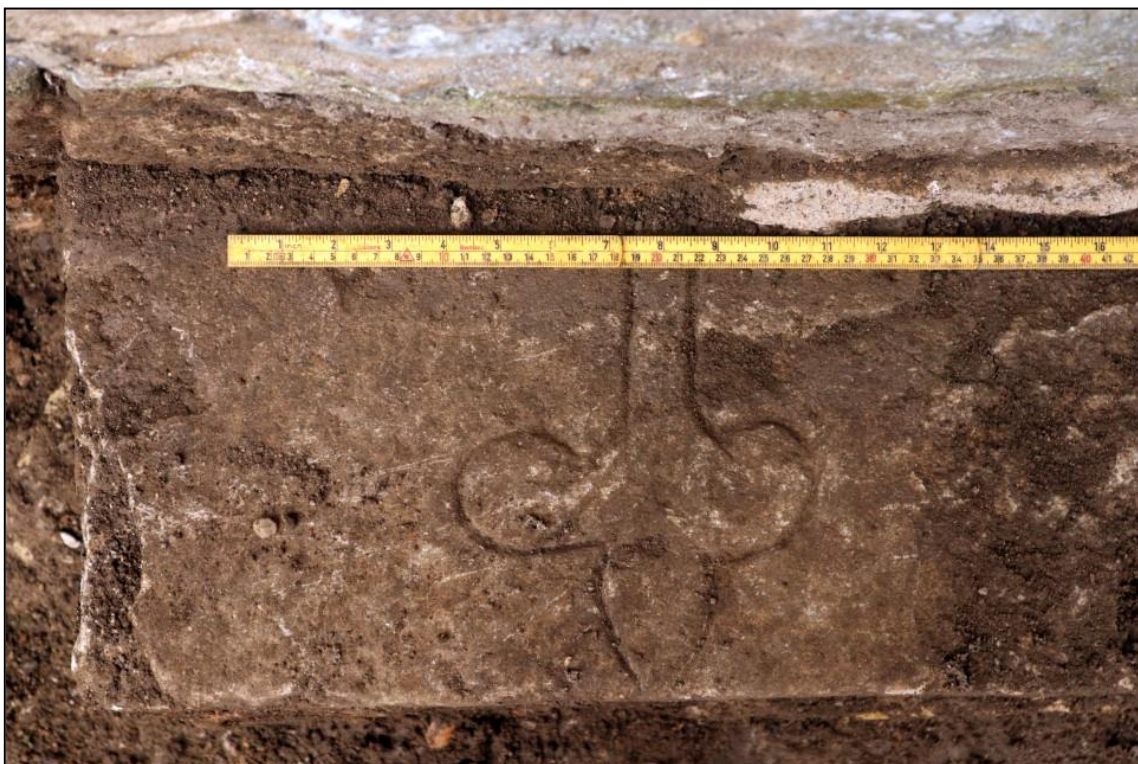
Image 10: Trench 1. Reused medieval grave slab
Shows western end of slab

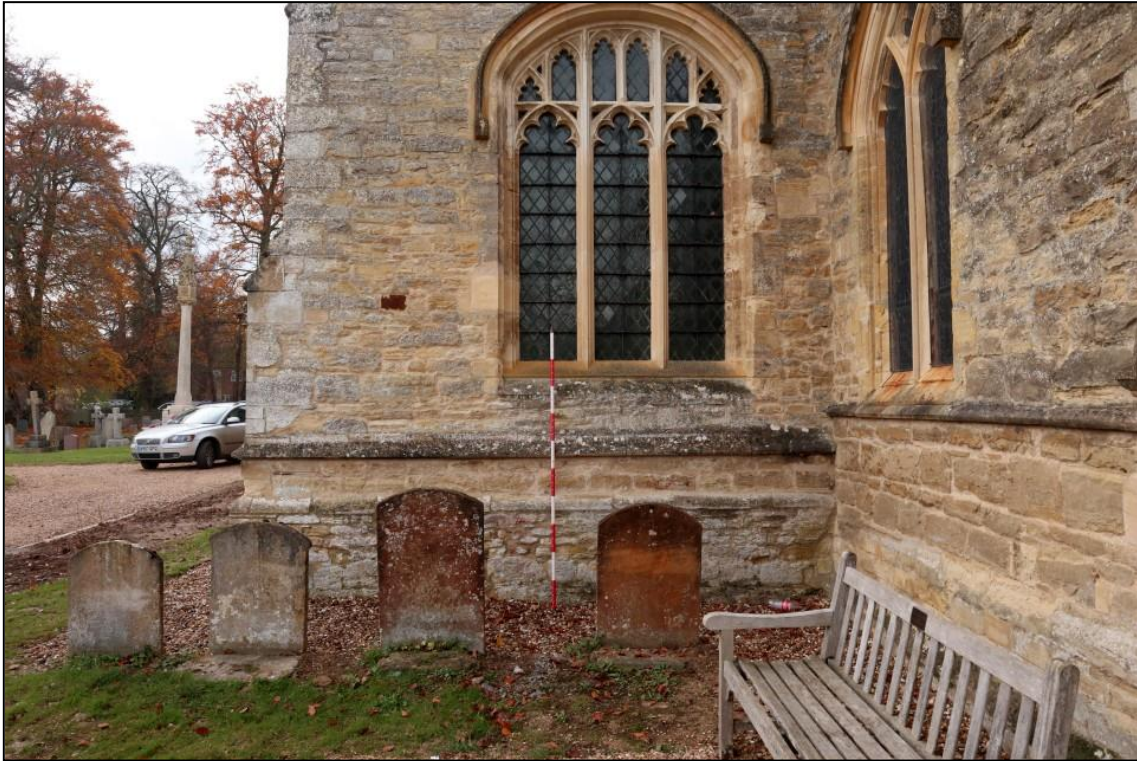
Image 11: East end of south aisle

Looking west, photographed following completion of French drain (Scale 2m)

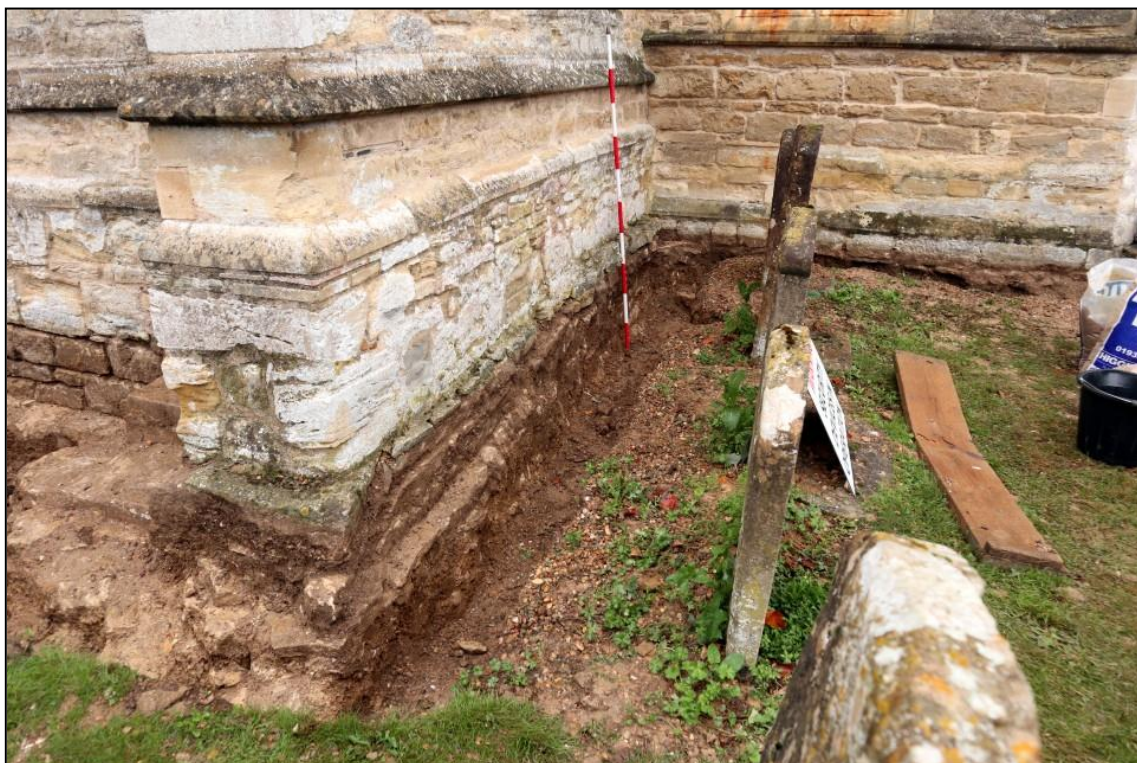
Image 12: Trench 1. South-east corner of south aisle

Looking north-east (Scale 20m)

- **(110) South aisle, east wall:**
The foundations for the east end of south aisle (110) are in coursed rubble limestone masonry, mostly thin slabs of stone (Images 12–14). There are two narrow offsets in the foundation: an upper offset at or just

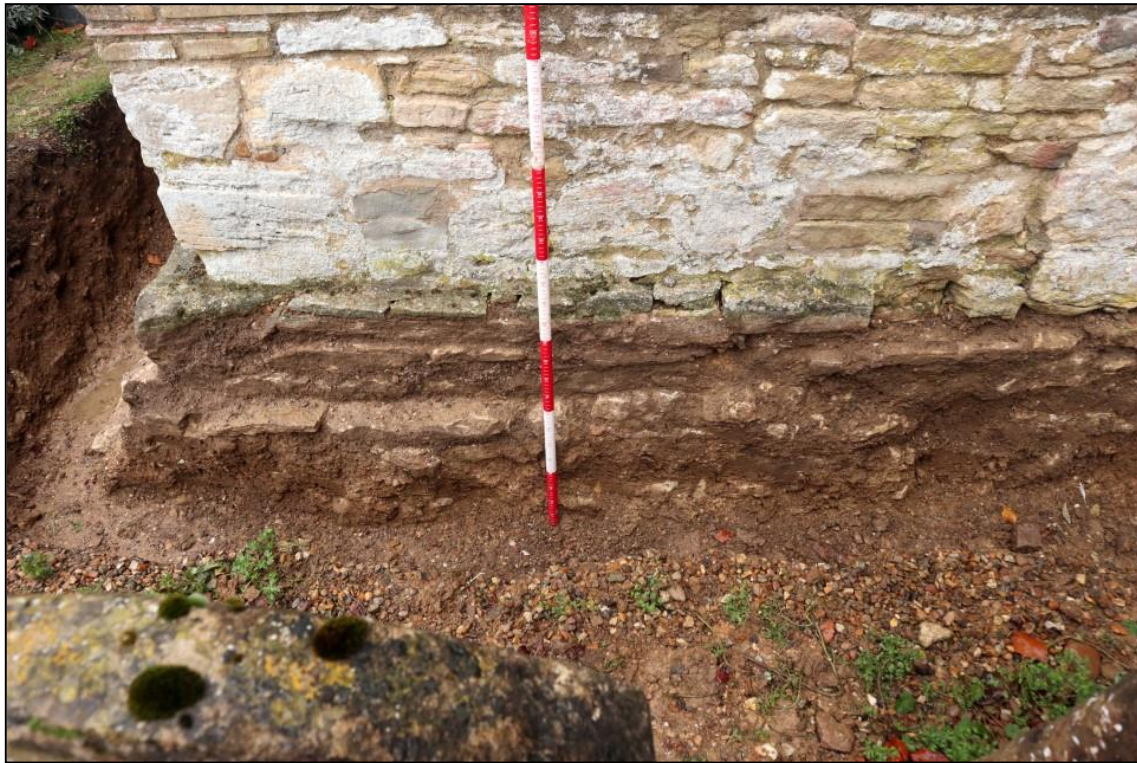
Image 13: Trench 1. East end of south aisle, left end
Shows two foundation offsets in rubble masonry (Scale 200mm divisions)

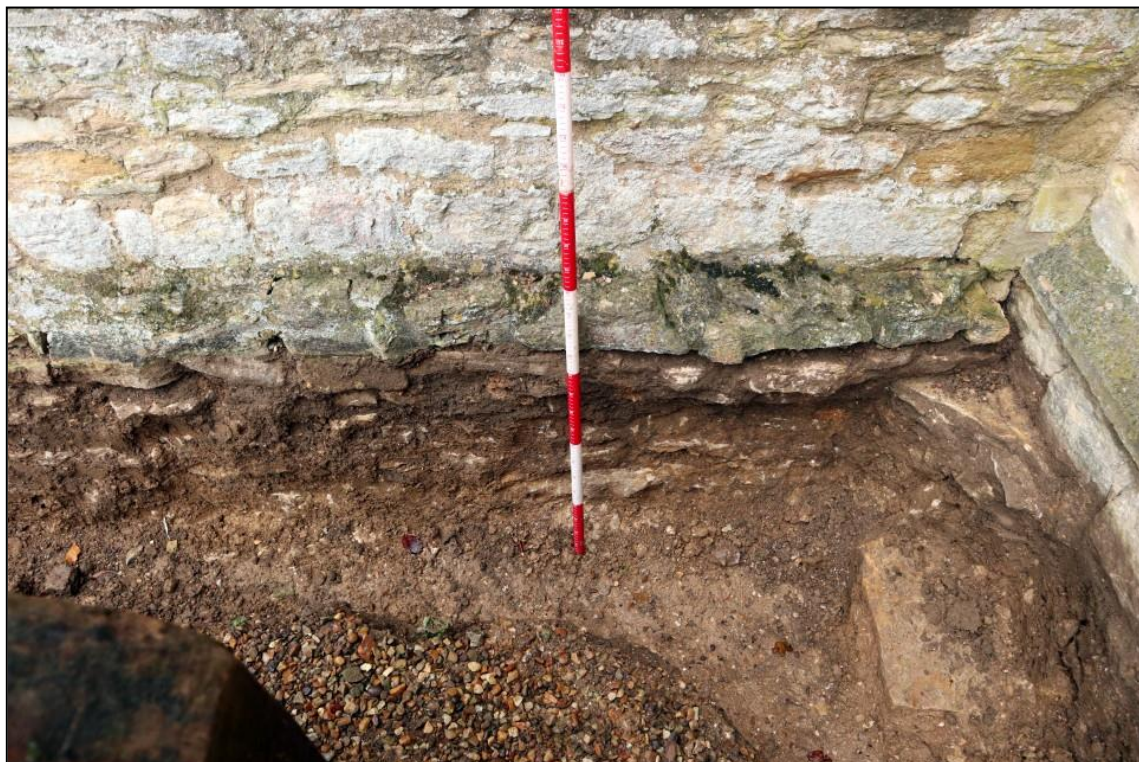
Image 14: Trench 1. East end of south aisle, right end
Shows foundation offset; chancel wall at right (Scale 200mm divisions)

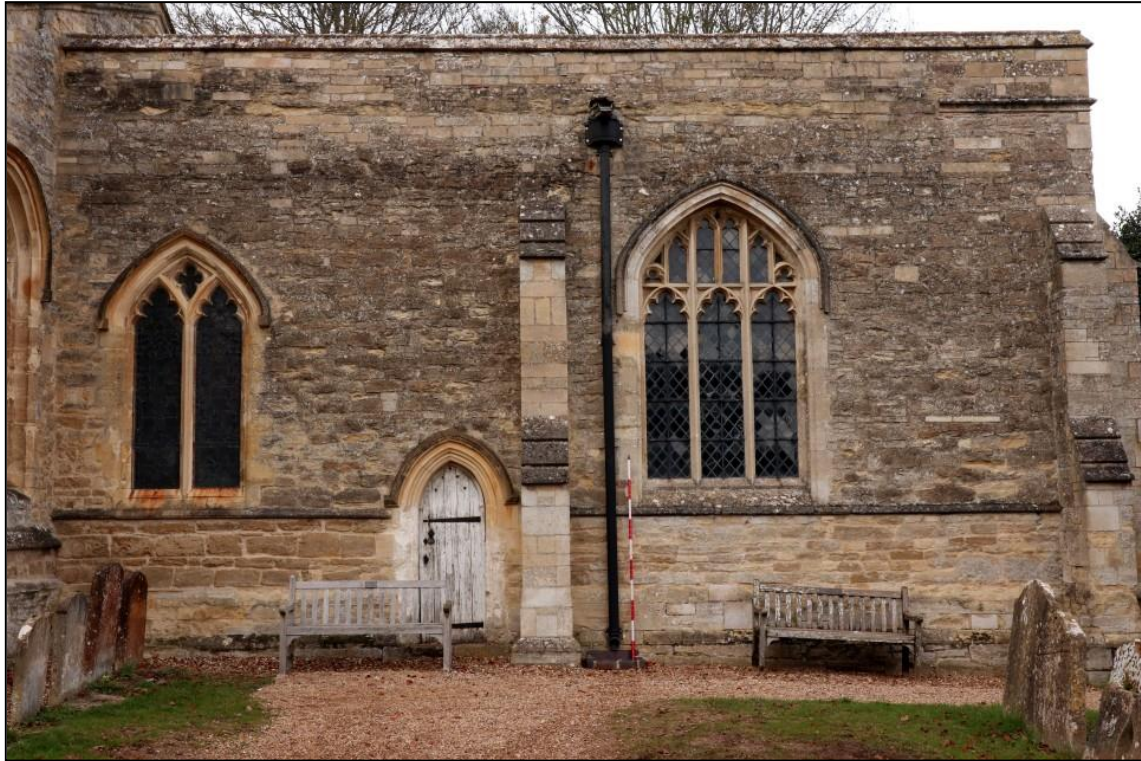
Image 15: South wall of chancel

Photographed following completion of French drain (Scale 2m)

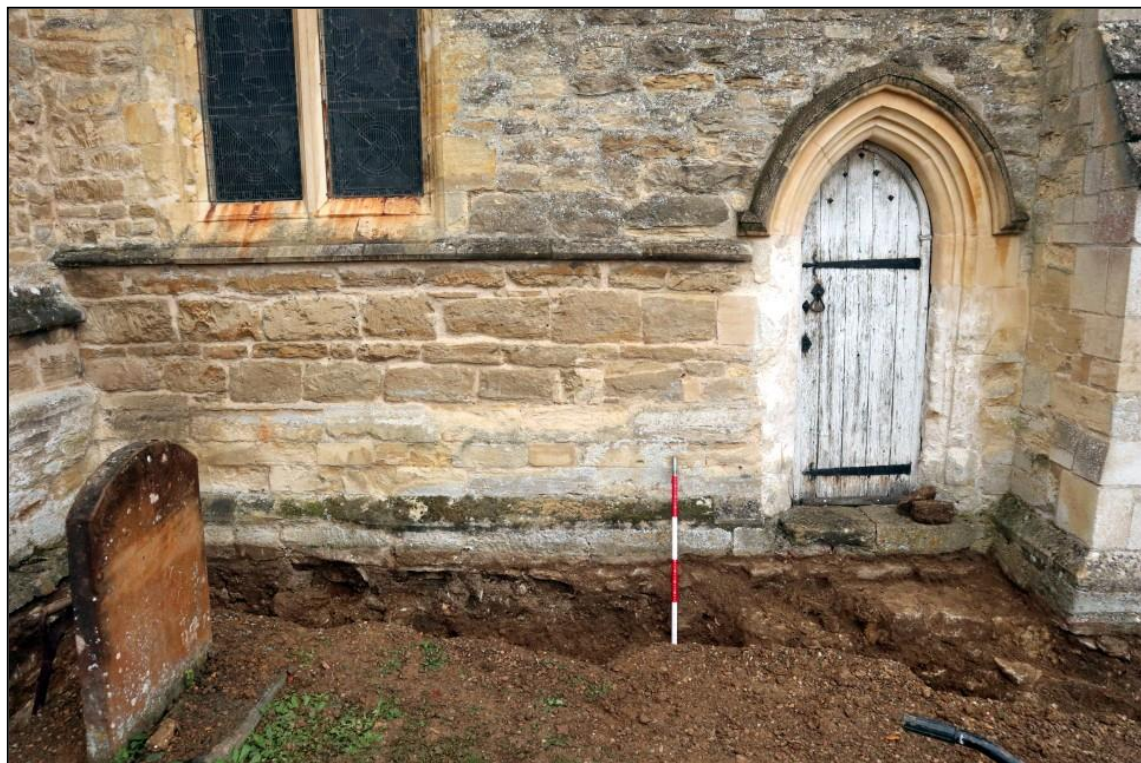
The stonework in the lower part of the chancel shows evidence of extensive restoration work (Figure 6-D and E, Images 16 and 17). Near the base of the wall is a plain chamfer course, that was renewed or added during restoration works judging from its condition. Above the plain chamfer are two courses of rectangular ashlar blocks, also part of restoration works. Above these is a badly weathered course of stone that appears to be the remains of a moulded drip course or plinth moulding. At its west end, where it has been subject to less weathering, it has the remains of a projecting bead moulding on its upper edge above a concave dressed surface. The lower half of the stones appear to have been cut back to make them flush with the face of the wall below, presumably during the later restoration works. Higher up the wall, level with the base of the windows, is a narrow projecting drip course. Its condition indicates it is part of the later restoration, but weathered stones remaining at its east and west ends show that it was a renewal of an existing moulding.

Image 16: Trench 1. Chancel, left end

The lower part of the chancel walls have been extensively repaired, probably as part of the mid-19th-century restoration works. A heavily weathered drip moulding or basement moulding appears to have been trimmed back level with the wall and the wall below the moulding refaced with new stone.

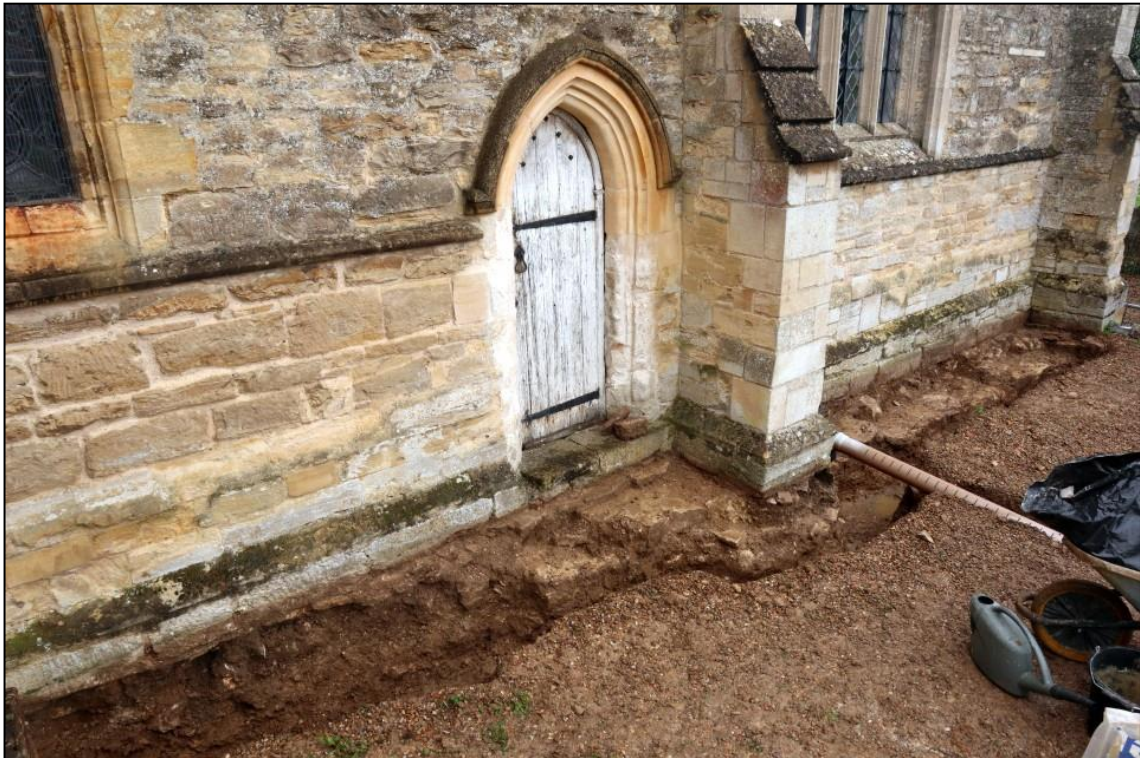
Image 17: Trench 1. Chancel, looking north-east

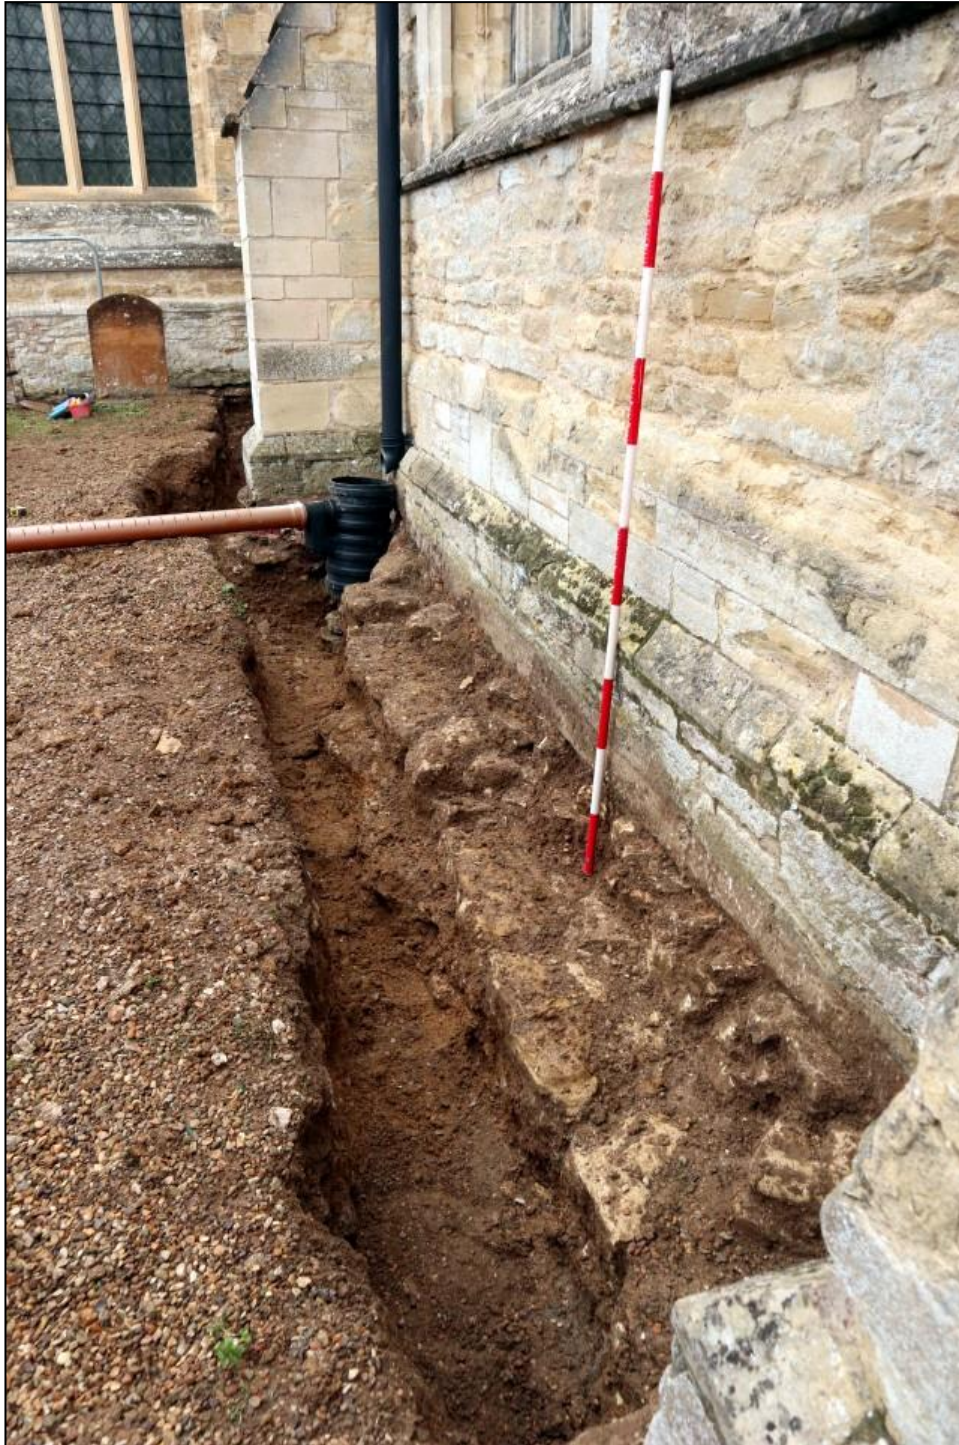
Image 19: Trench 1. Chancel, looking west

(Scale 2m)

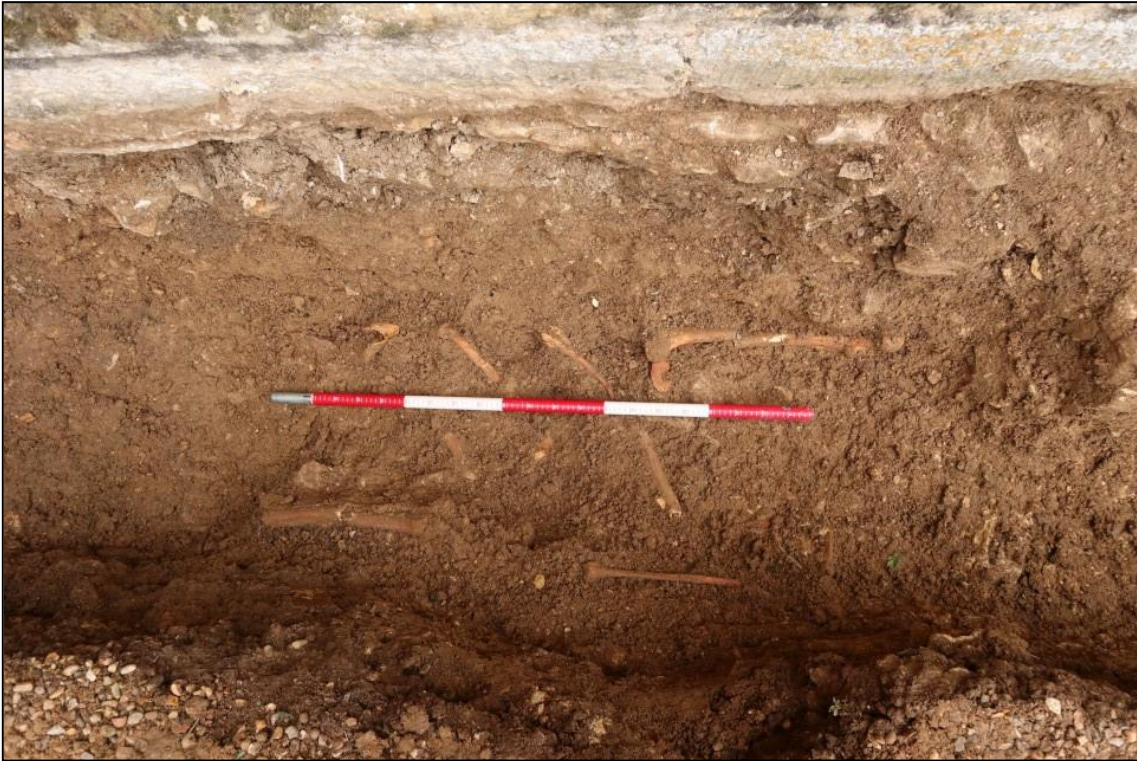
- A concentration of disarticulated human bone (105 and 106) in Trench 1 was found near the west end of the chancel (Image 20). The deposit comprised adult bones and coffin fittings (105) and a discrete cluster of neonate or infant bones (106). The identifiable adult bones comprised: humerus x2, femur x2, a scapula, some ribs and a single vertebra; they could represent elements from a single disturbed burial. Coffin fittings were represented by an iron coffin handle and a small number of copper alloy studs. The neonate bones, although forming a discrete cluster, appeared to be incomplete and disarticulated.

Image 20: Trench 1. Human bone (105)

Shows disarticulated human bone found adjacent to chancel (Scale 1m)

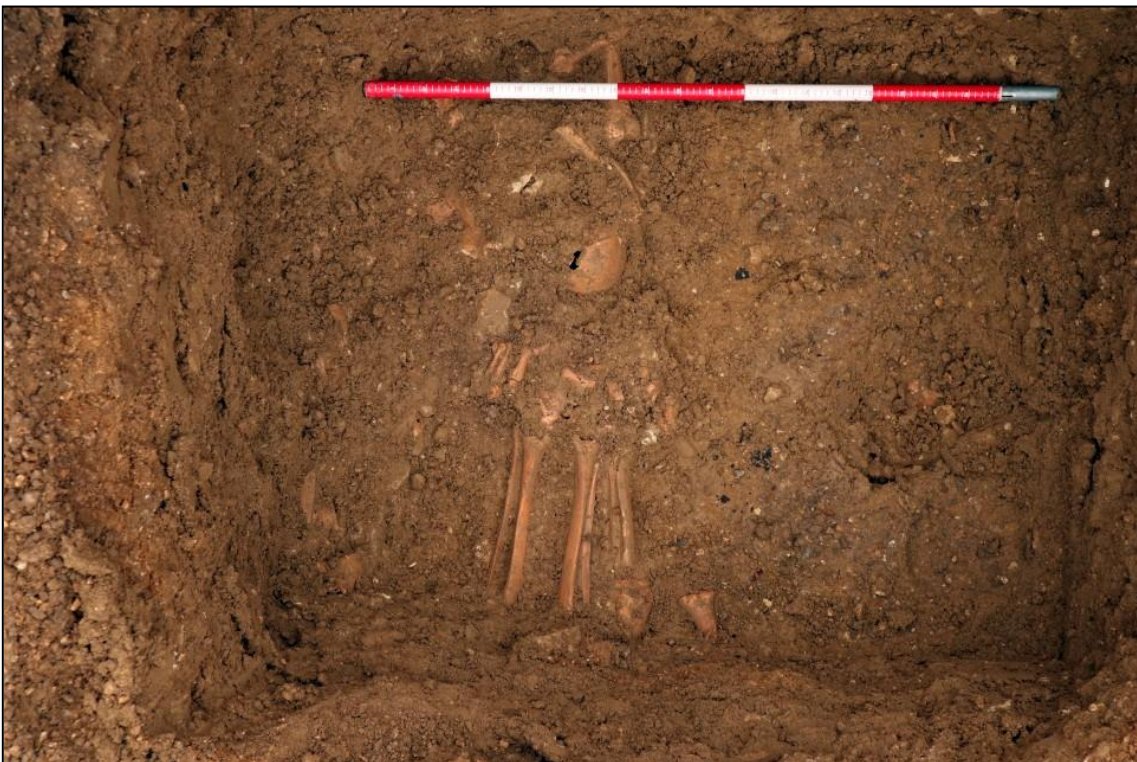
The uppermost burials in this trench were found at a depth of 740–800mm below the ground surface (Image 21). They consisted of the lower part of two burials (203 and 204) in the western half of the trench and the upper part of another (205) in the eastern half.

Image 21: Trench 2. Upper layer of burials (203), (204) and (205)

East at top of image; burials (203) and (204) in lower half of image; Skull of (205) and various disarticulated bones (charnel) in upper half (Scale 1m)

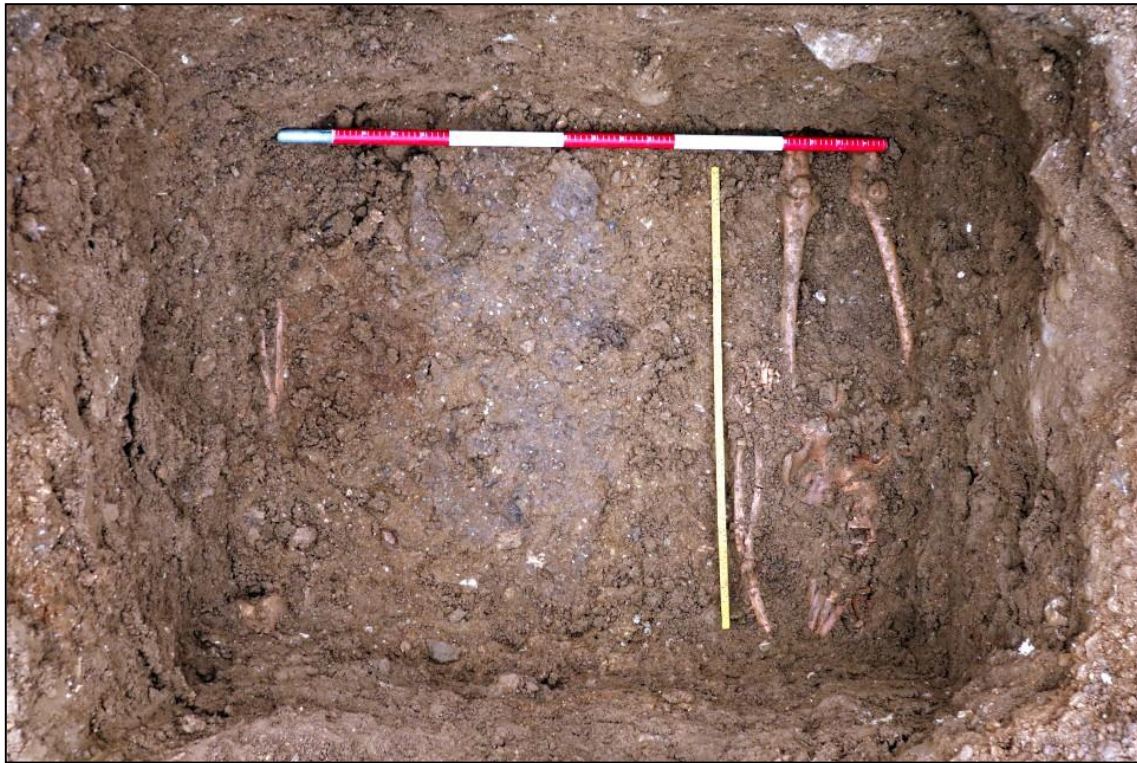
- Burial (206) was an adult skeleton located at a depth of 900mm next to the southern edge of the trench. The left arm, torso and upper legs were within the limits of the trench. The bones were in a good state of preservation. The left femur was 460mm long.
- Burial (207) consisted of a radius and ulna (lower arm) found at a depth of 940mm in the northern side of the trench, probably indicating an *in-situ* burial beyond the northern limit of the trench.

Image 22: Trench 2. Lower layer of burials (206) and (207)

East at top of image; burial (206) at right; lower arm of burial (207) at left (Scale 1m)

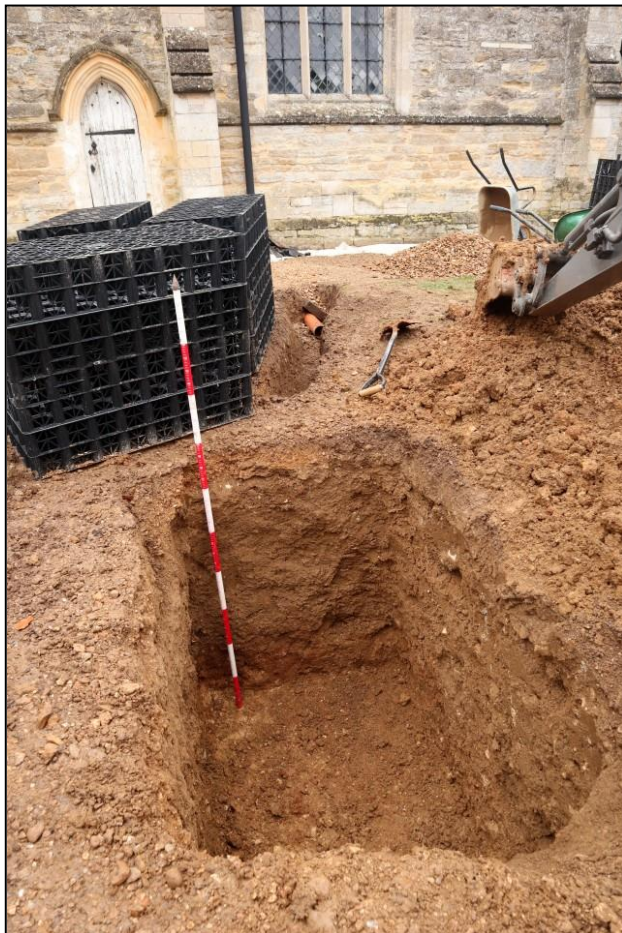
The uppermost layer (200) was a dark silt turf and topsoil layer, 100–150mm thick. Beneath the topsoil the soil consisted of a homogenous layer of mid-yellow-brown sandy silt (201), *c.* 1.1m thick. This is a ‘grave-earth’, soil that has been continuously reworked through the burial process over hundreds of years. The initial machine excavation of the trench was stopped when articulated human remains were observed and excavation continued by hand digging. A number of burials were identified (see below), but no individual grave cuts were identified in the grave earth.

Image 23: Trench 2. Fully excavated

Looking north, showing grave earth (201) above natural gravel deposit (202) in base of trench

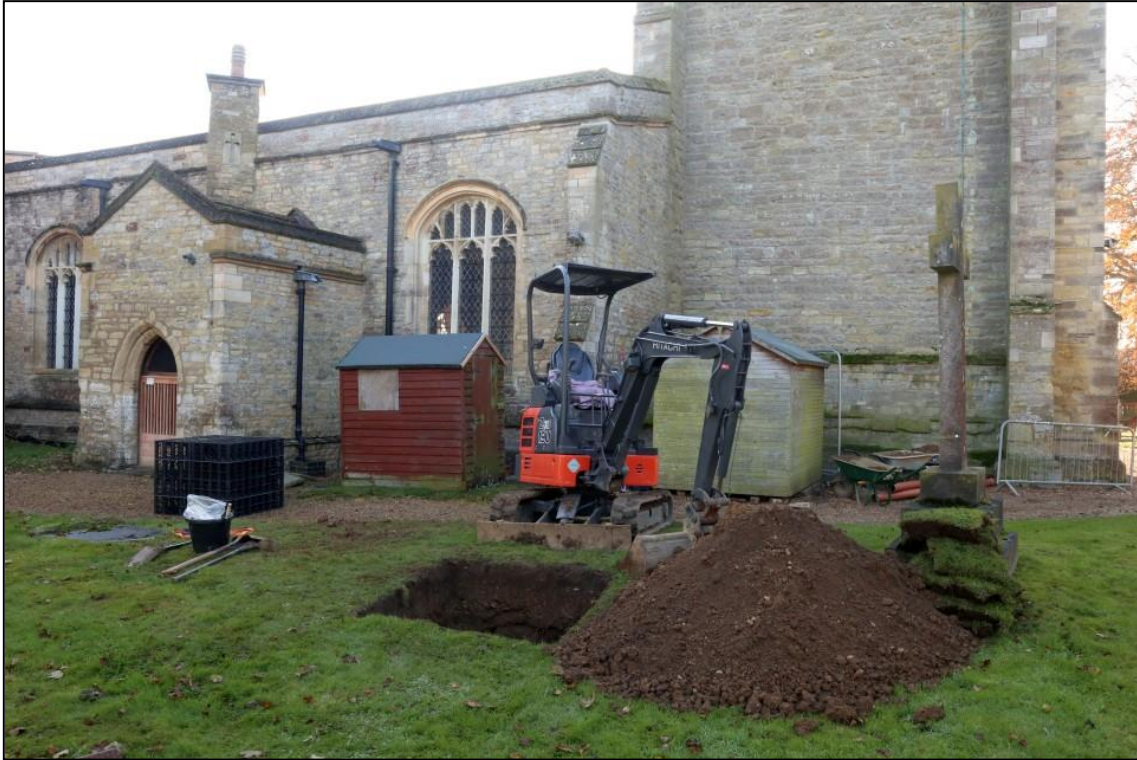
Image 24: Trench 3

Looking north-east, showing location of Trench 3

This trench was excavated for the installation of a plastic crate soakaway. It was located approximately 10m north of the tower (Image 24). See Figure 2 for location and Figure 4 for detailed plan of burials. The trench was 1.35 long by 1.2 m wide and 1.2m deep.
