**ST PETER'S CHURCH
SHARNBROOK
BEDFORDSHIRE**

**ARCHAEOLOGICAL OBSERVATION,
INVESTIGATION, RECORDING, ANALYSIS AND
PUBLICATION**

Project Code: SP3569
Document: 2019/138
Version: 1.0

Produced for:
SC Builders (Thrapston) Ltd

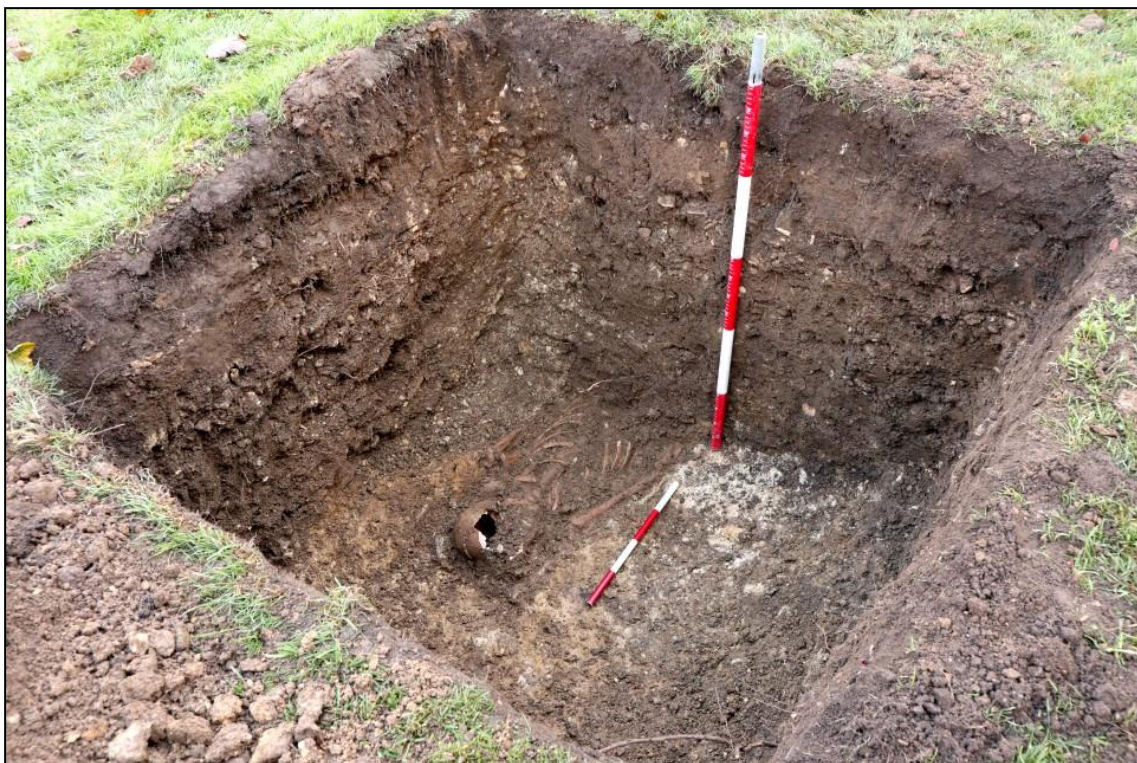
This trench contained comparatively few burials, with the southern half of the trench showing no evidence of burials. Two burials (304 and 307) were found at a depth of *c.*1m below the ground surface and a later grave cut [305] could be seen in the north-east corner of the trench (Images 25 and 26).

Image 25: Trench 3. Looking north-east

Shows burial (304), with later grave cut [305] visible as lighter area of soil in far corner of trench (Scale 1m)

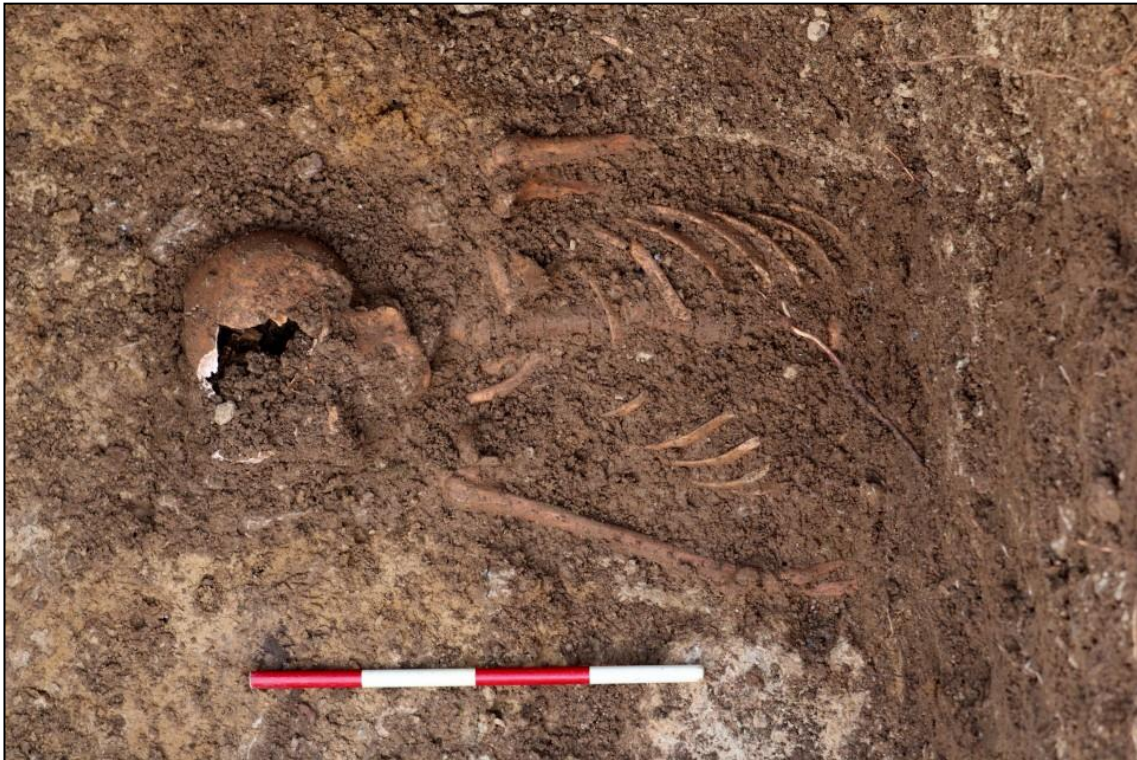
- Burial (304) in grave [303] was found at depth of 1.05m below the ground surface. The grave had been dug slightly into the underlying bedrock and appeared to extend around 500mm beyond the skull. The upper left arm of the burial had been partially truncated by the later grave cut [305]. The well-preserved skeleton comprised skull, upper arms and torso. The teeth were heavily worn. The right humerus was 312mm long. No nails were found around the head end of the grave; this together with the slightly irregular outline of the grave suggests that (304) was probably an un-coffined burial.

Image 26: Trench 3. Burial (304)

North at top; Left arm of burial (304) partially truncated by grave cut [305] at top of image
(Scale 40cm)

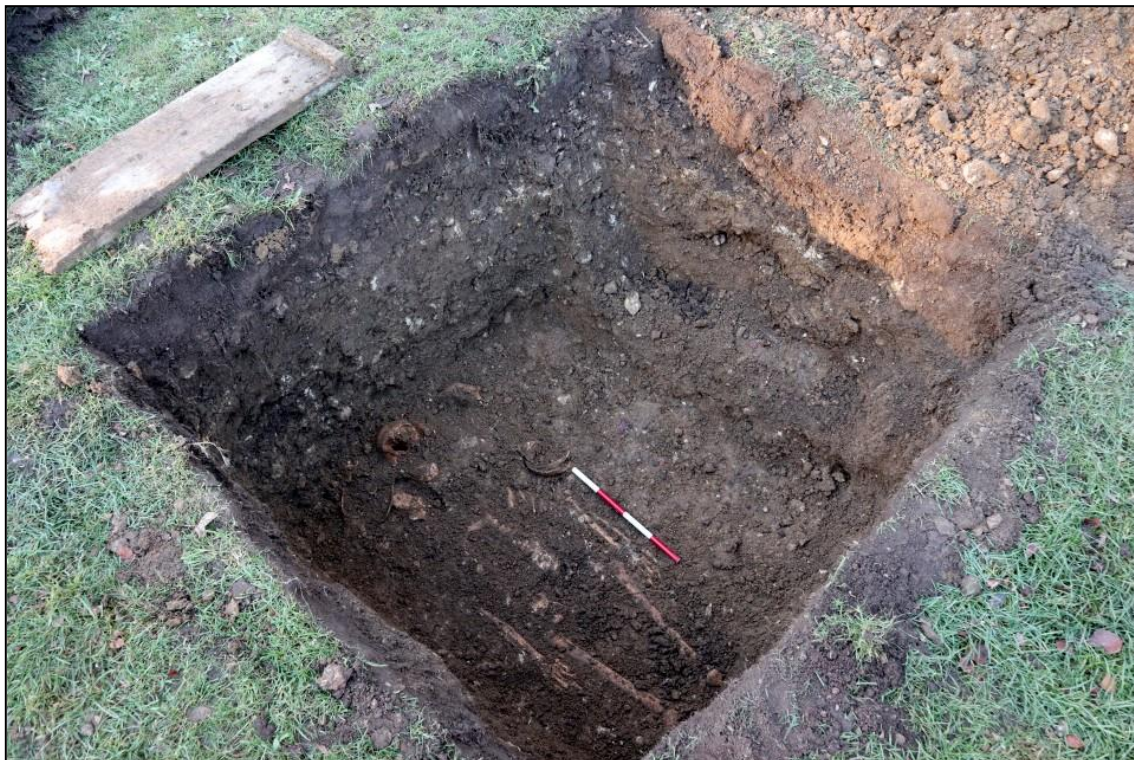
Image 28: Trench 4. Upper layer of burials

North-west at top; burial (403) with skull of burial (404) visible at furthest end of scale bar
(Scale 40cm)

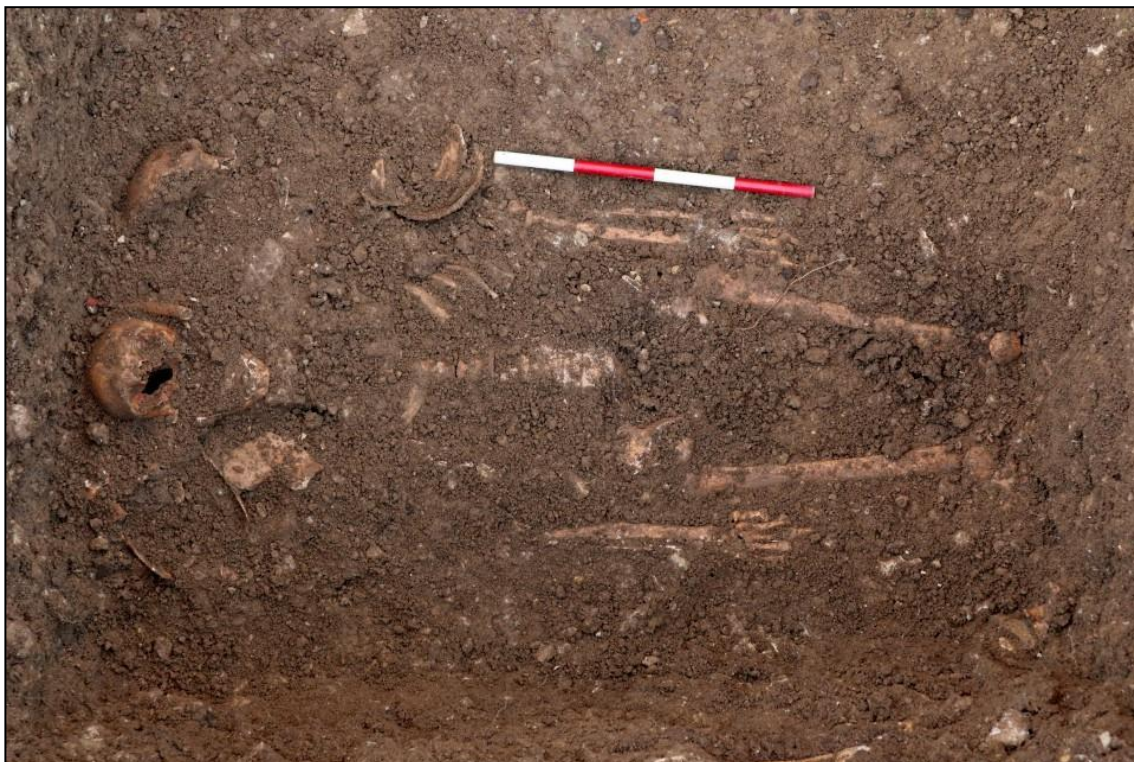
The uppermost burials were found at a depth of 750–850mm below ground level. They comprised: one intact adult burial (403); which had partially truncated an earlier juvenile burial (404); and various disarticulated charnel material.

Image 29: Trench 4. Upper layer of burials, (403) and (404)

North at top; burial (403) with skull of burial (404) at left end of scale bar
(Scale 40cm)

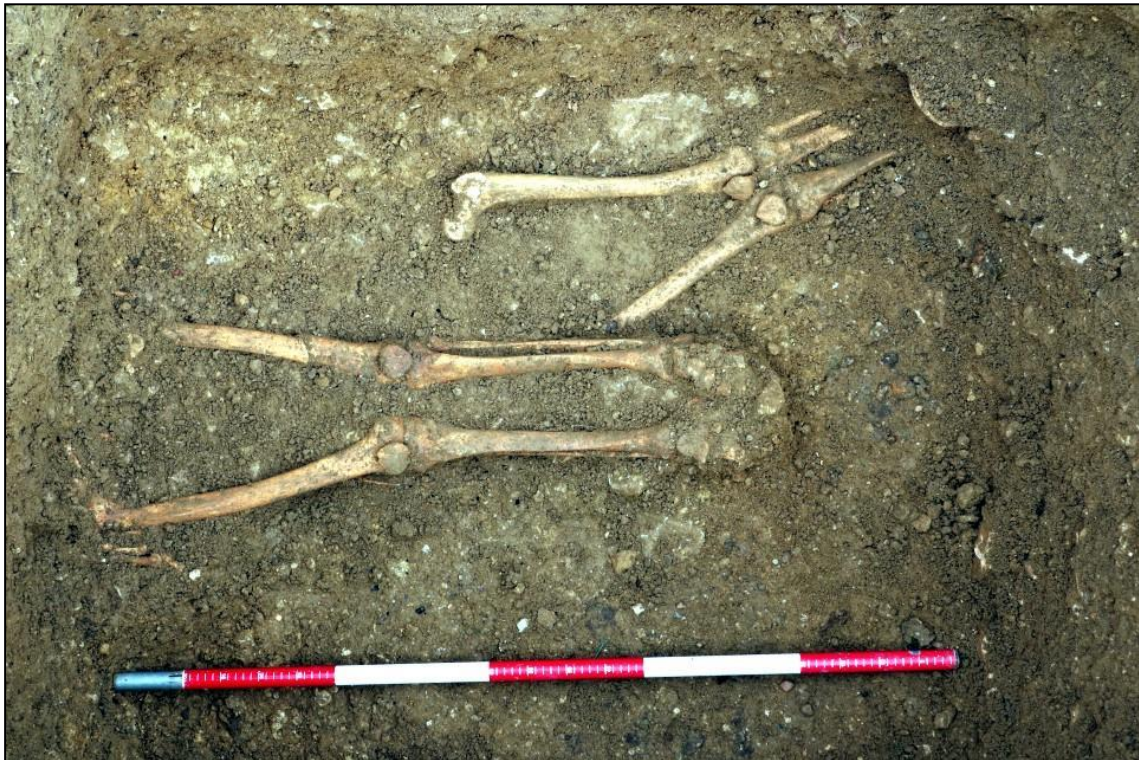
- Burial (405) was the lower half of an adult burial, with hands, legs and feet within the limits of the trench. The bones were well preserved. Dimensions: right femur 450mm, right tibia 355mm. No nails were found during excavation around the feet, suggesting it was probably an un-coffined burial. The partial remains of an earlier burial (406) appear to have been truncated by burial (405).
- Burial (406) consisted of the legs and left hand only of an adult skeleton, which had been partly truncated by a subsequent burial (405). The bones were well preserved. Dimensions: right femur 432mm. A vertical edge in the limestone bedrock along the north edge of the trench appears to be part of the grave cut for burial (406).
- Disarticulated charnel remains at this level consisted of a femur that was found in the south-east corner of the trench.

Image 30: Trench 4. Lower layer of burials, (405) and (406)

North at top; burial (405) overlying truncated lower half of burial (406)
(Scale 1m)
