**AUDLEY END HOUSE
SAFFRON WALDEN
ESSEX**

**ARCHAEOLOGICAL EVALUATION
PROPOSED NEW CAFÉ AND VISITOR RECEPTION
AREA**

Document: 2007/76.1
Project: 1281

31 July 2007

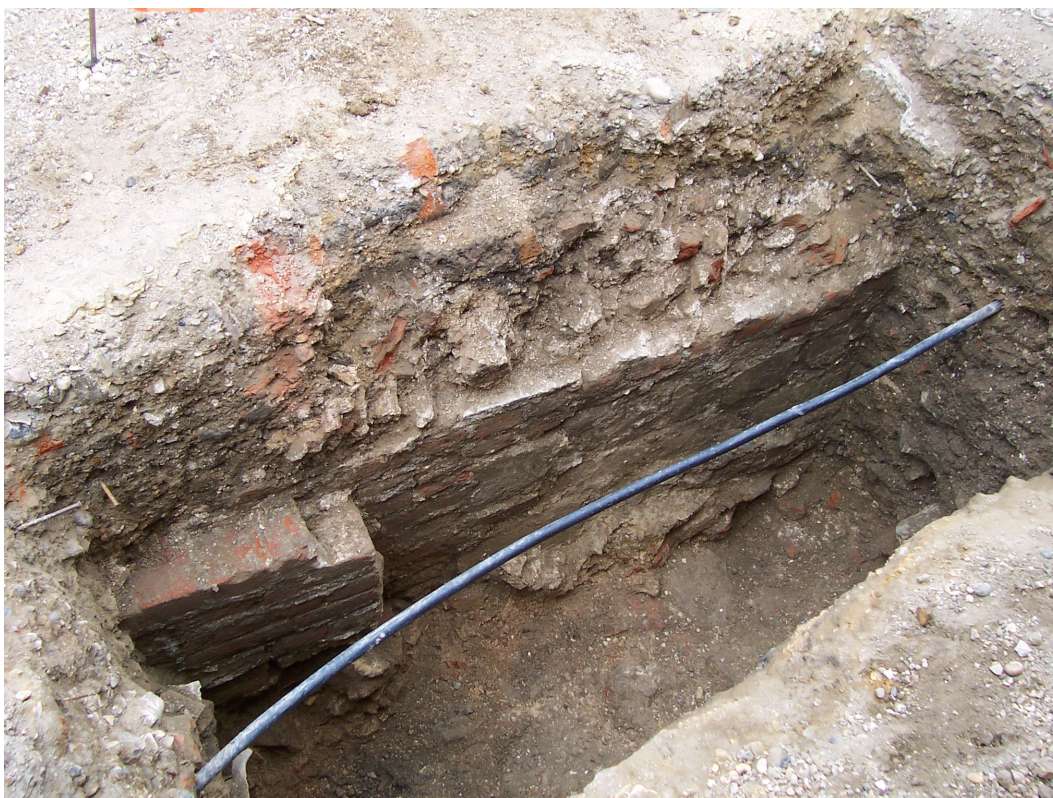
Removal of a service trench (106) that had been cut through the yard surface, the yard surface itself (100) and make up layers (101/102), revealed a wall footing (111) and its foundation trench (117). The wall comprised randomly coursed brick and clunch blocks; the brick measuring approximately 220mm x 100mm x 50mm thick. At its eastern end the wall widened by a single course, possibly representing the position of a pier or buttress. The foundation cut for the wall had been excavated through a stony grey-brown silt sand (103) containing glazed red earthenware and brick, only broadly dateable, but consistent with a late 17th-century/early 18th-century date.

Plate 1: Trench 1: wall 111

| Context: | Type: | Description: | Excavated: | Finds Present: |
|---|---|---|---|---|
| 111 | Wall | Wall visible in southern section of trench, aligned E-W. Constructed with brick and squared clunch blocks with lime mortar bonding. Wall steps out at its eastern end (a possible buttress). Bricks measure 70mm x 220mm x 120mm. Visible dimensions of clunch blocks measure between 20mm and 50mm long and approximately 15mm thick. Wall is sat on mortar and brick foundations (112) and (113) and within foundation trench [117]. Wall is overlain by collapsed/demo material (105). Top of surviving wall is 0.55m below the current ground surface at 46.97m OD. Possibly associated with range of kitchen buildings marked in this location on 17th century maps. | <input type="checkbox"/> | <input type="checkbox"/> |

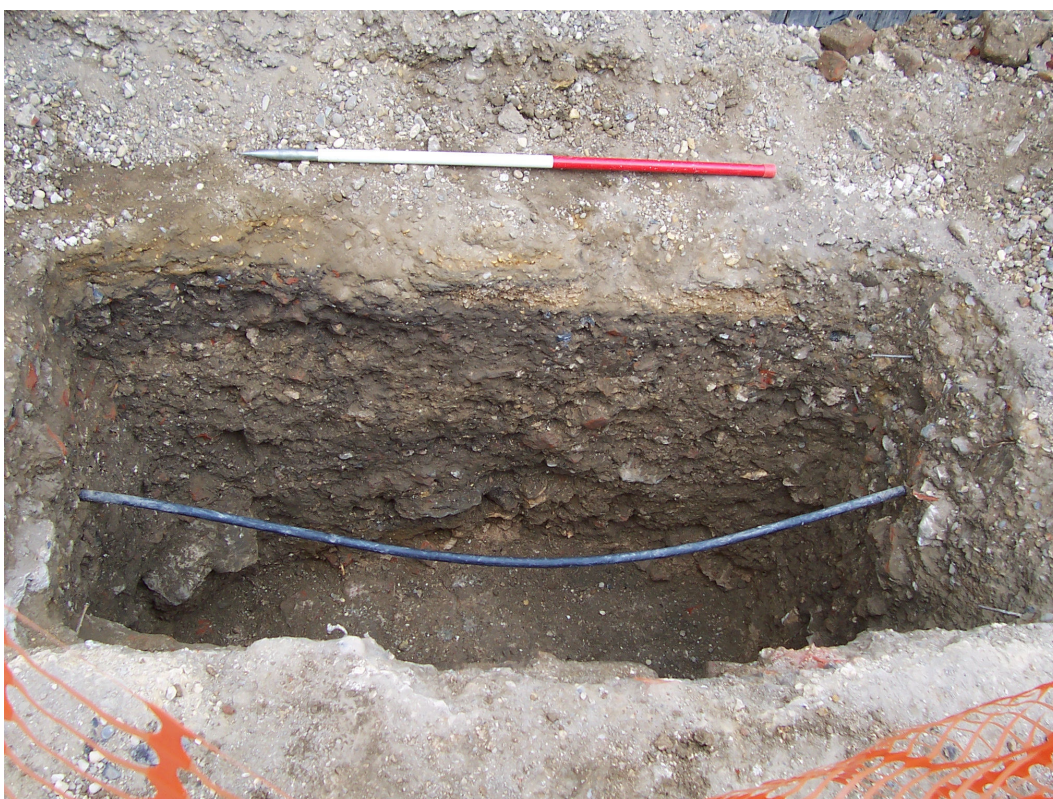
Plate 2: Trench 1: deposit 103. Scale 1m

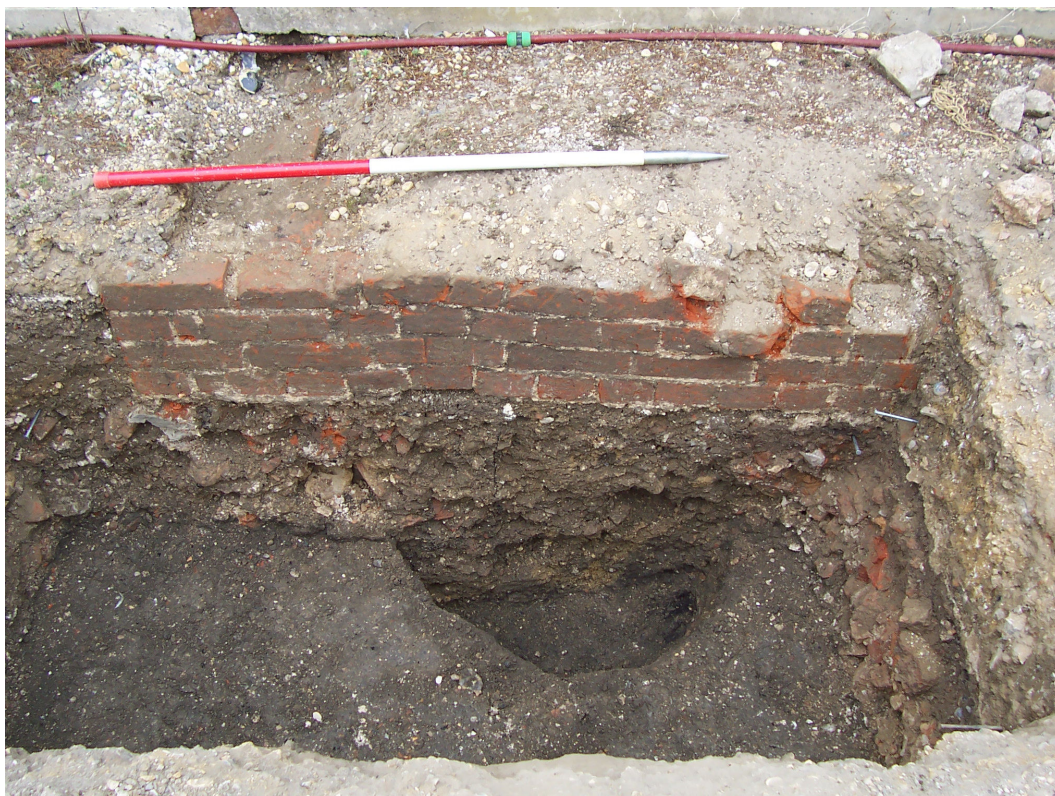
Removal of the yard surface (200) revealed a brick wall along the northern edge of the trench which turned north, towards the existing garages, approximately 400mm from the western end of the trench. The wall was constructed in an irregular English-style bond from bricks measuring approximately 250mm x 100mm x 60mm thick. There was no foundation trench associated with this wall footing, although the bricks had been laid on a thin mortar surface (20mm thick) which extended southwards and continued beyond the southern edge of the trench.

A possible garden soil was identified beneath the demolition layer. This comprised a firm dark grey brown soil (207) 130mm thick and containing occasional brick fragments.

Plate 3: Trench 2: wall 203, pit [213], garden soil 207 (base of trench). Scale 1m

The 19th century layout of buildings within and around the service yard is largely that of today. The brick wall found within Trench 2 represents an earlier alignment of the southern wall of the range of buildings along the northern edge of the service yard. Although the footprint of these buildings is largely consistent with that shown on the 19th century maps, modern blockwork and wooden garage doors are more recent additions.

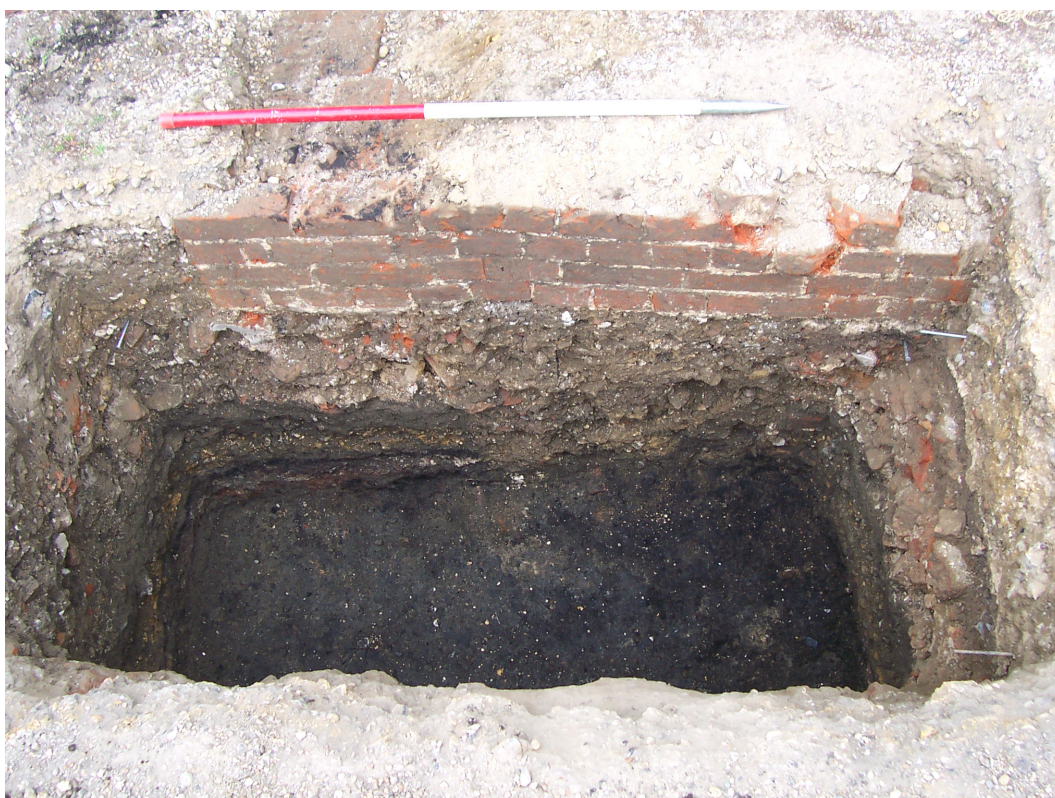
The layer of garden soil was removed to reveal a layer of gravel (208) above a deposit (209) containing charcoal, ash, burnt clay, occasional fragments of tile and brick and a small fragment of coal (7g). These layers possibly represent the backfill of a gravel-capped, rubbish pit, the edges of which were outside the confines of the trench

Plate 4: Trench 2: wall 203, pit [213], charcoal deposits 209 (base of trench).
Scale 1m
