**HALSEY ROAD
AND
ADDISON HOWARD PARK
BEDFORD**

ARCHAEOLOGICAL FIELD EVALUATION

Project: AP3646
Museum accession no. BEDFM 2020.53
OASIS ref.: albionar1-400290

Document: 2020/71
Version 1.0

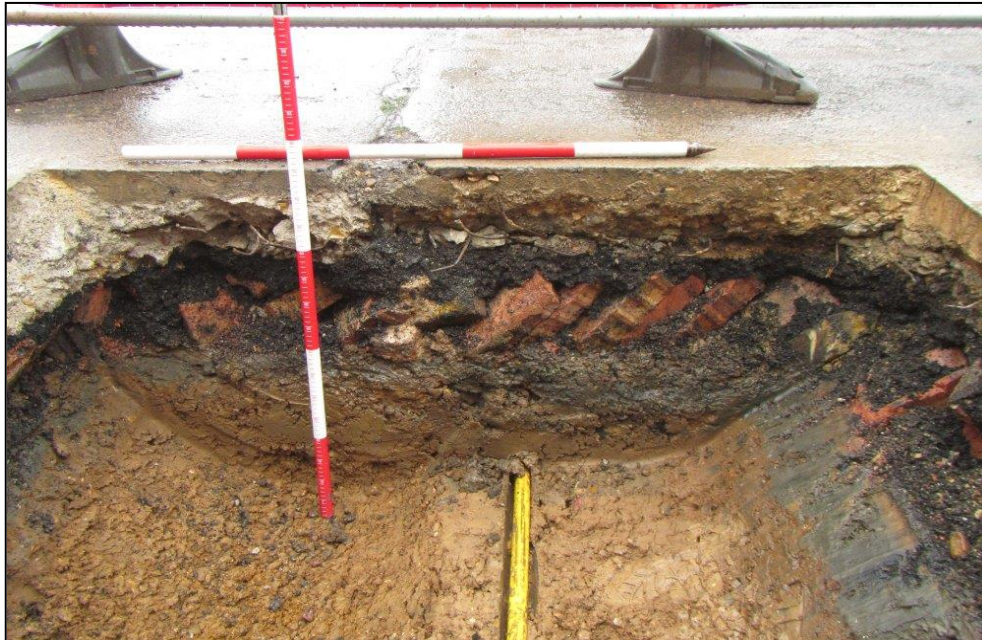
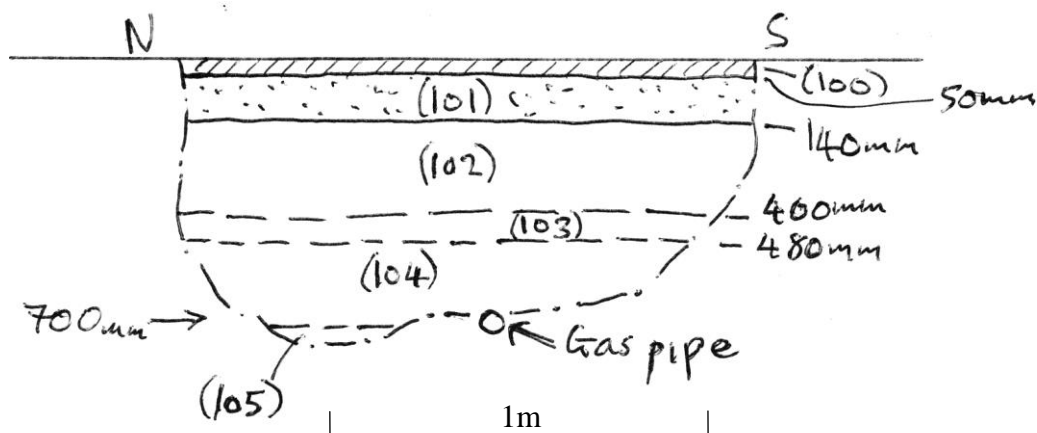
Image 1: Trial Pit 1, west-facing section

The road make-up in the four trial pits in the south-west part of Halsey Road (TP 1, TP 2, TP 3 and TP 4) consisted of a layer of reinforced concrete, 90–200mm thick, above a mixed layer of bricks and cinder.

Context	Description	Interpretation
(100)	Tarmac	Road surface
(101)	Reinforced concrete	Road make-up layer
(102)	Mixed brick and cinder	Road make-up layer
(103)	Dark grey clay silt	Layer
(104)	Mid-brown silty clay gravel	Subsoil
(105)	Mid-orange-brown sandy gravel	Superficial geology

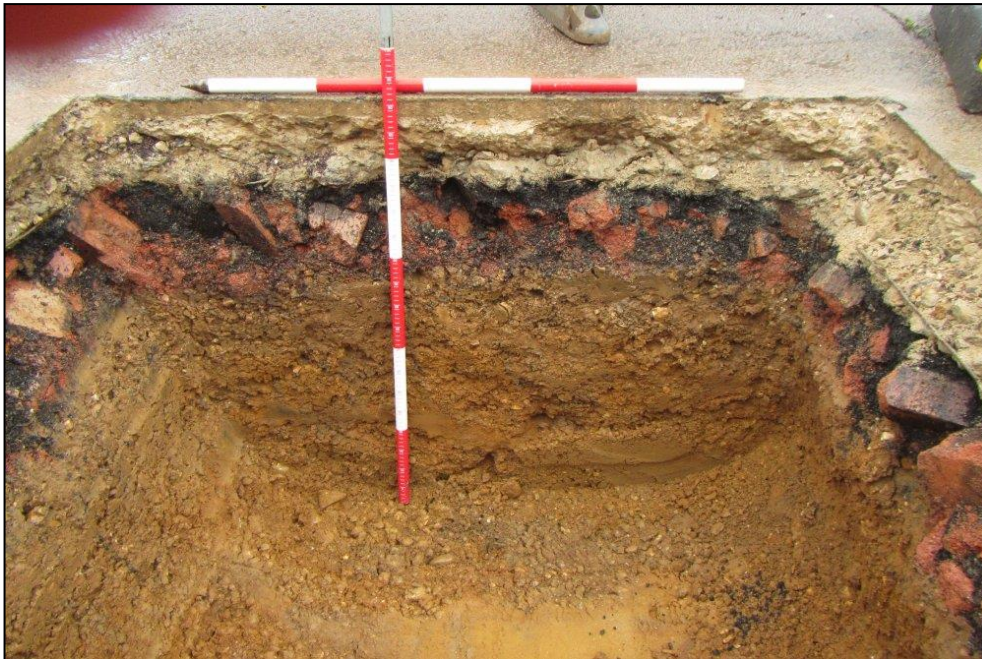
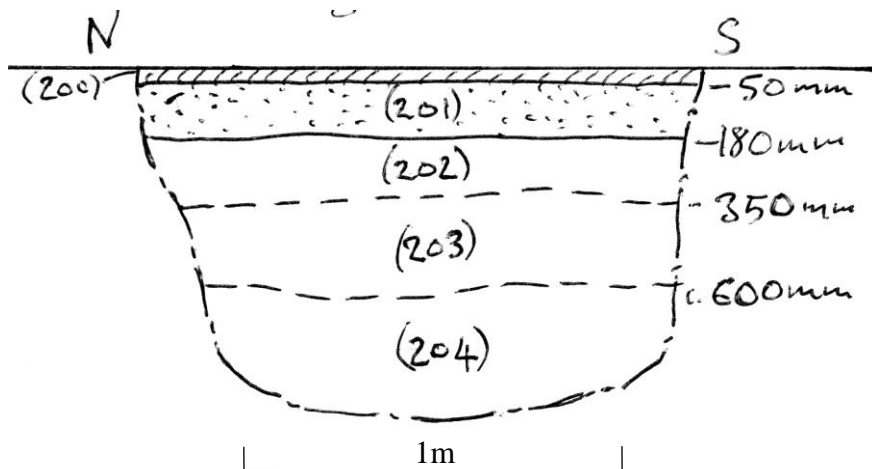
Image 2: Trial Pit 2, west-facing section

The superficial deposits were more variable in TP 2 (204)—a mixed layer of orange-brown sandy gravel and clean yellow sand with irregular patches of mid-grey sandy-silt. This may be indicative of later disturbance in this area.

Context	Description	Interpretation
(200)	Tarmac	Road surface
(201)	Reinforced concrete	Road make-up layer
(202)	Mixed brick and black cinder layer	Road make-up layer
(203)	Mid-brown silty sandy gravel	Subsoil
(204)	Mid-orange-brown sandy gravel with patches of clean yellow sand and irregular pockets of mid-grey sandy silt	Disturbed superficial geology

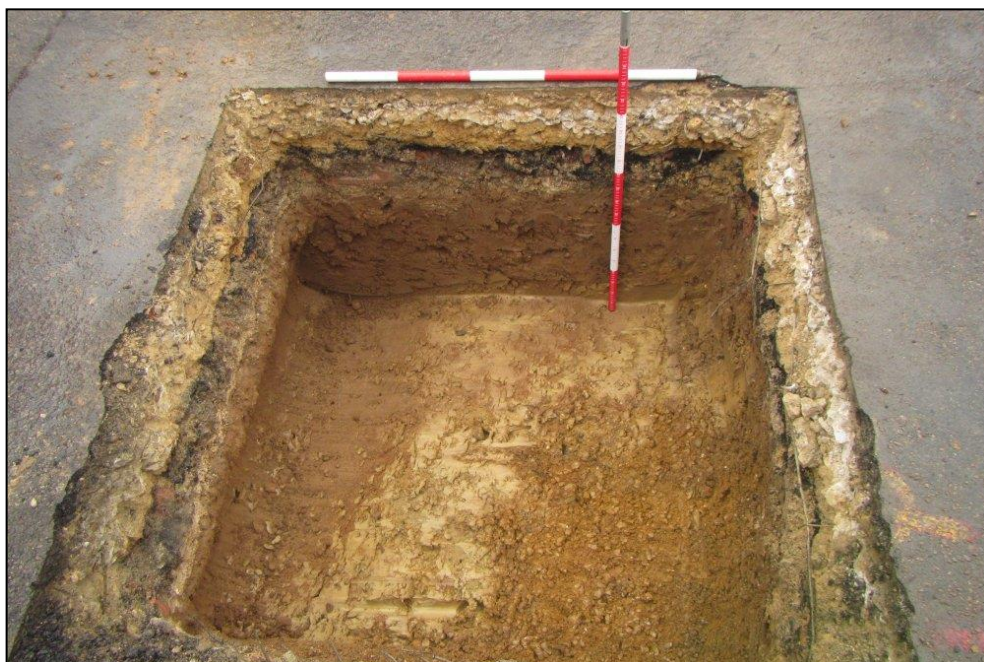
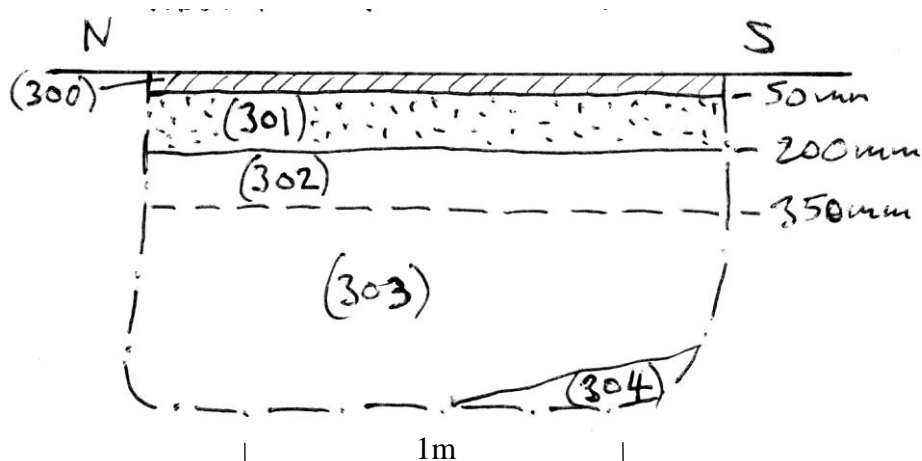
Image 3: Trial Pit 3, west-facing section

TP 3 contained a thicker subsoil-type layer (303). This was a mid-brown sandy clay-silt deposit with occasional small stones. It appeared to be more homogenous and ‘cleaner’ than the other subsoil layers. It was at least 500mm thick and dipped down towards the north side of the trial pit. It is possible that the layer could have been the fill of furrow, although this could not be verified within the limits of the 1.5m square trial pit.

Context	Description	Interpretation
(300)	Tarmac	Road surface
(301)	Reinforced concrete	Road make-up layer
(302)	Mixed brick and black cinder	Road make-up layer
(303)	Mid-brown sandy clay-silt, occasional small stones	Subsoil or possible furrow
(304)	Mid-orange-brown sandy gravel	Superficial geology

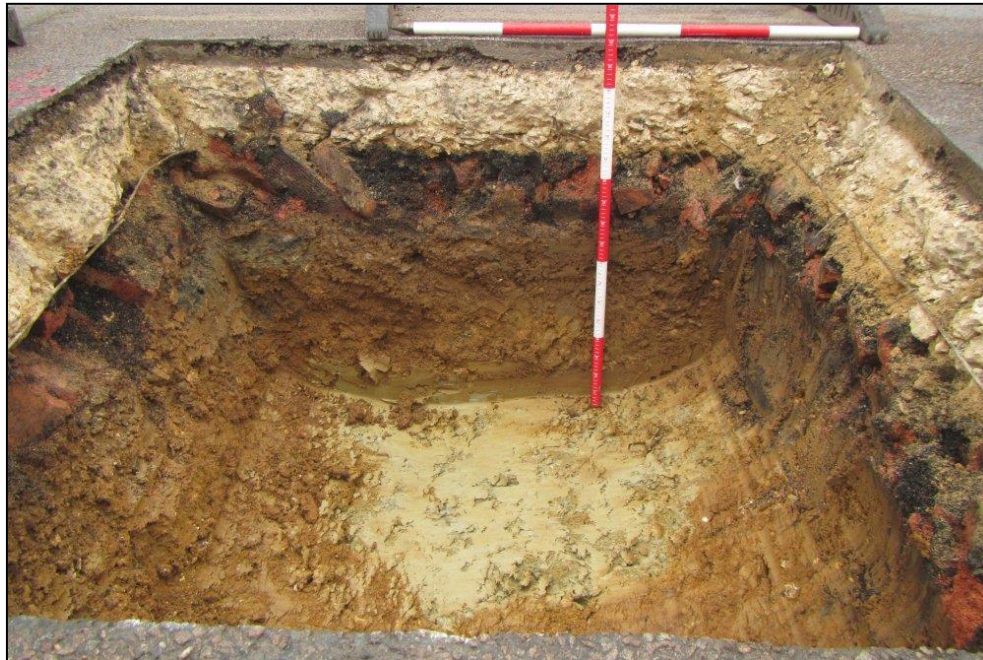
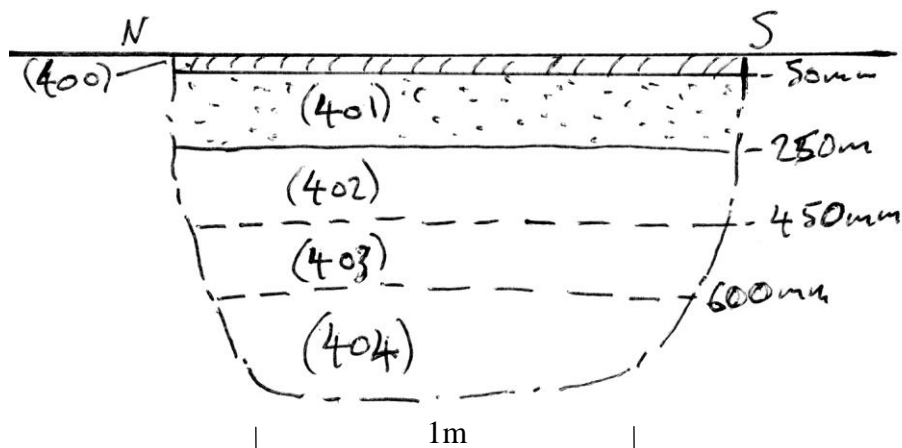
Image 4: Trial Pit 4, west-facing section

Context	Description	Interpretation
(400)	Tarmac	Road surface
(401)	Reinforced concrete	Road make-up layer
(402)	Mixed brick and black cinder	Road make-up layer
(403)	Mid-grey-brown sandy clay	Subsoil
(404)	Mid-orange-brown silty clay gravel	Superficial geology
(405)	Light blue-grey clay (in base of trial pit)	Geological bedrock

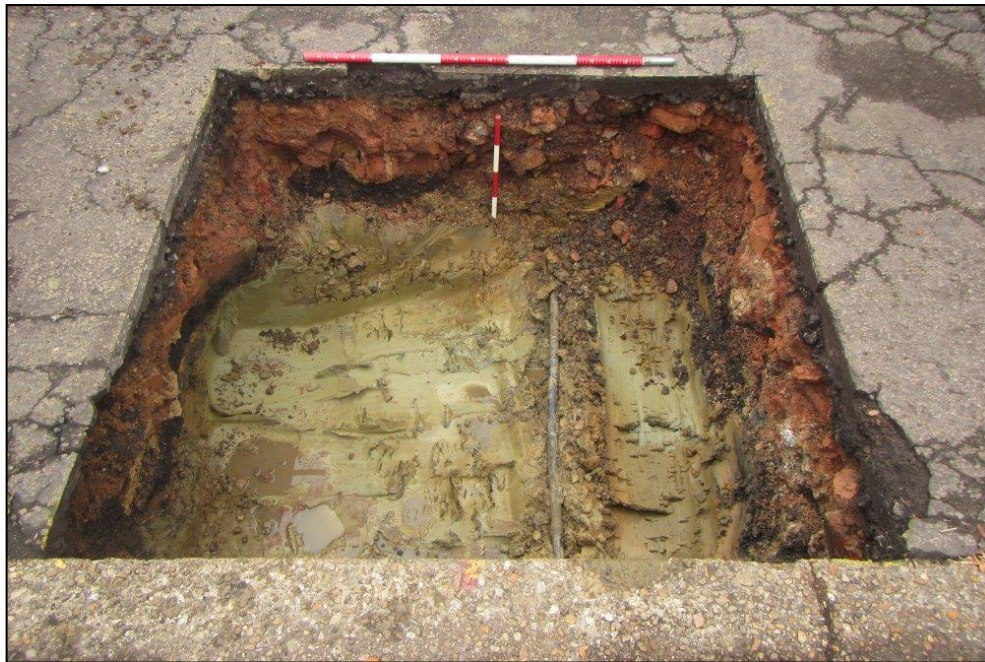
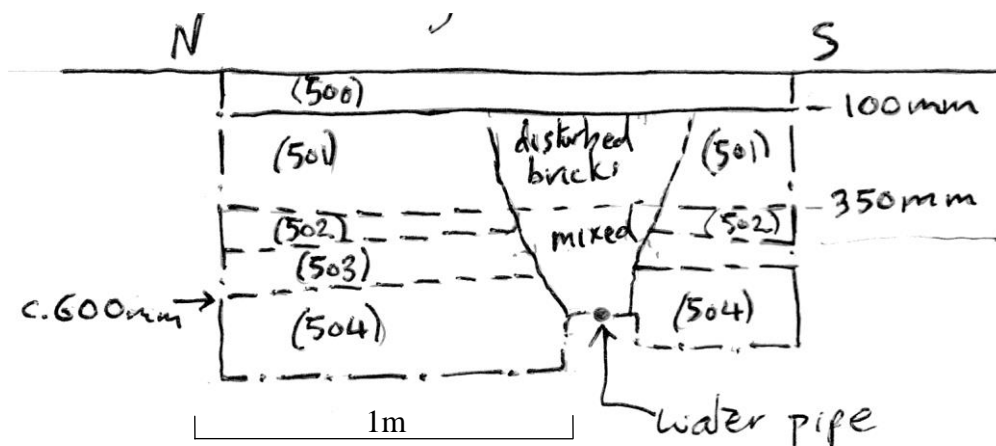
Image 5: Trial Pit 5, west-facing section

The road make-up in a number of the trial pits (TP 5, TP 6, TP 7, TP 8 and TP 10) was very distinctive, consisting of whole bricks arranged in two layers above a thin layer of black cinders. This is best illustrated in the photograph of TP 6 (Image 6). The bricks in TP 6 were carefully arranged with few gaps, with the lower layer flat and with the upper layer set edgewise. The bricks were fletton type bricks and included textured ‘rustics’ and others stamped ‘phorepress’, both typical London Brick Company products.

Context	Description	Interpretation
(500)	Tarmac	Road surface
(501)	Bricks	Road make-up layer
(502)	Black cinder layer	Road make-up layer
(503)	Mixed mid-brown clay	Subsoil
(504)	Light yellow and blue-grey clay	Geological bedrock

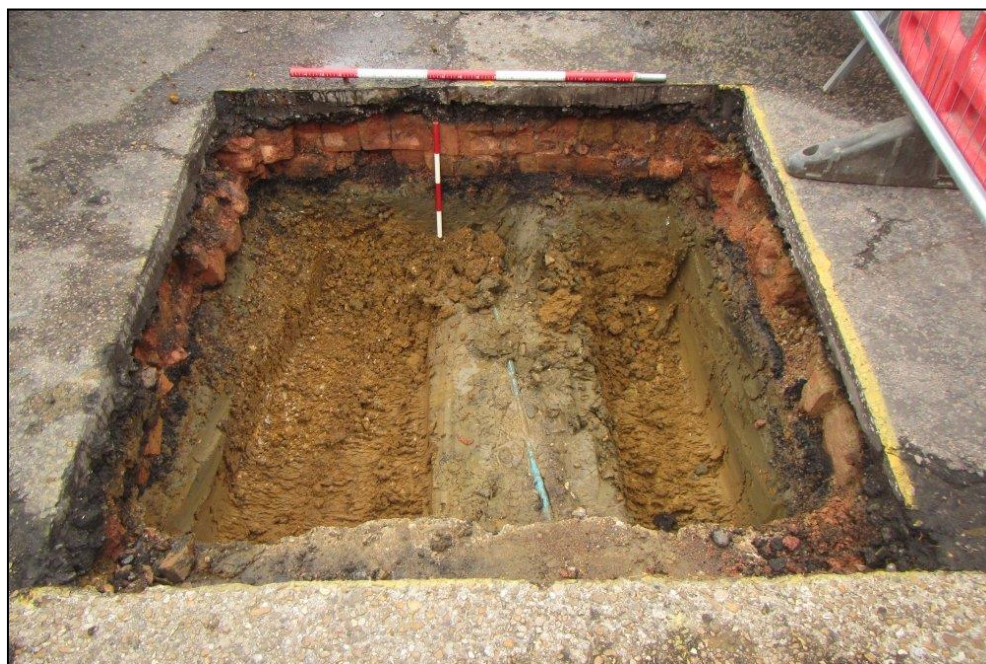
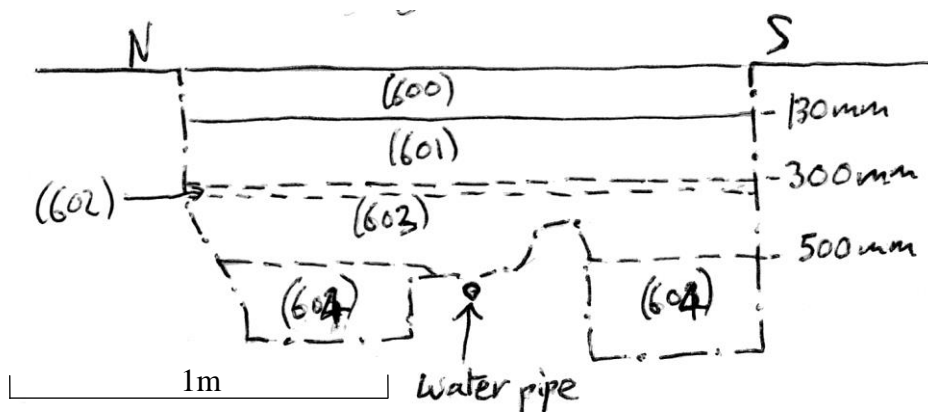
Image 6: Trial Pit 6, west-facing section

Context	Description	Interpretation
(600)	Tarmac	Road surface
(601)	Bricks (whole LBC Phorpress and rustics)	Road make-up layer
(602)	Black cinder layer	Road make-up layer
(603)	Mid-grey-brown silty clay, occasional small stones	Subsoil
(604)	Mid-orange-brown sandy gravel	Superficial geology

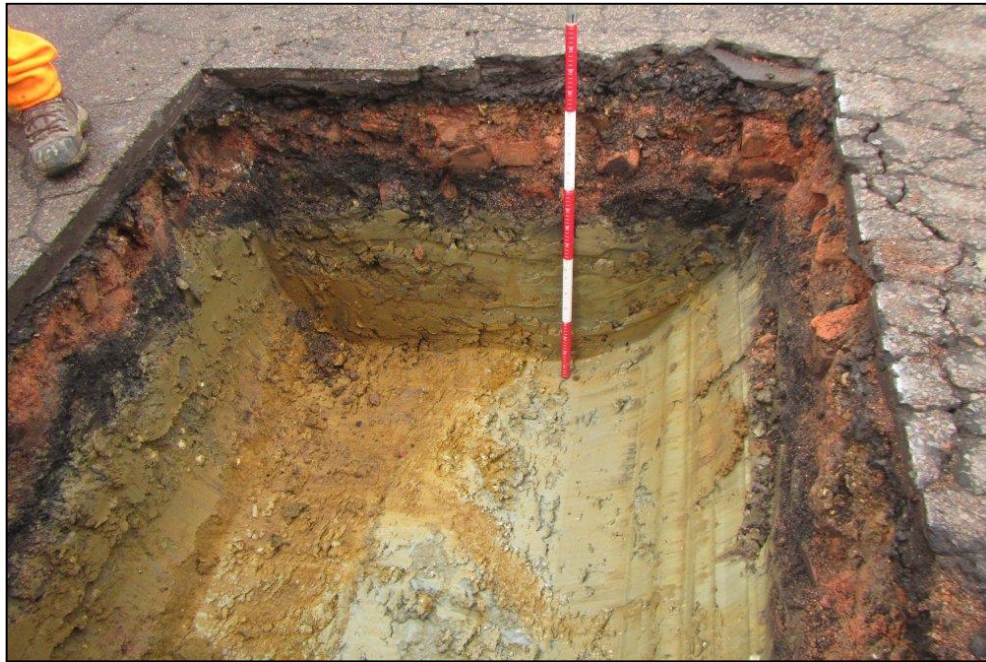
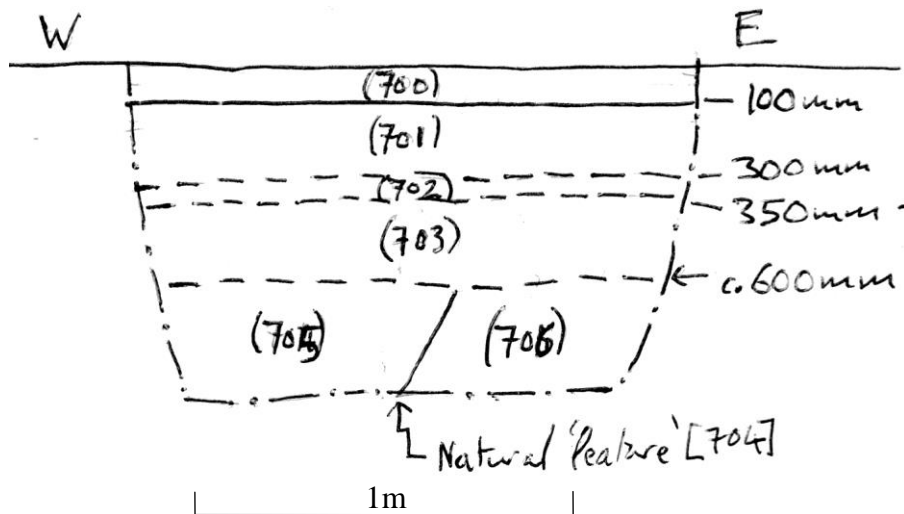
Image 7:

In TP 7 (705) and TP 8 (807) the superficial geological deposits were found within steep-sided intrusions in the top of the underlying clay bedrock, indicating possible periglacial features.

Context	Description	Interpretation
(700)	Tarmac	Road surface
(701)	Bricks	Road make-up layer
(702)	Black cinder layer	Road make-up layer
(703)	Mid-yellow-brown clay	Subsoil
[704]	'Cut' of natural geological feature	Geological feature
(705)	Mid-orange-brown sand	Fill of [704], superficial geology
(706)	Light blue-grey clay	Geological bedrock

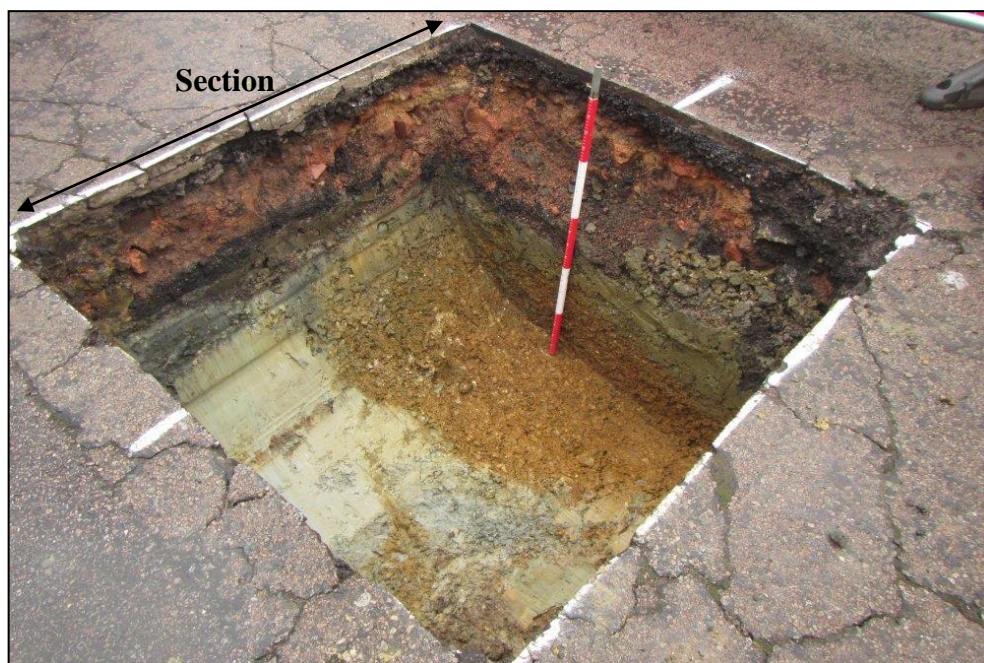
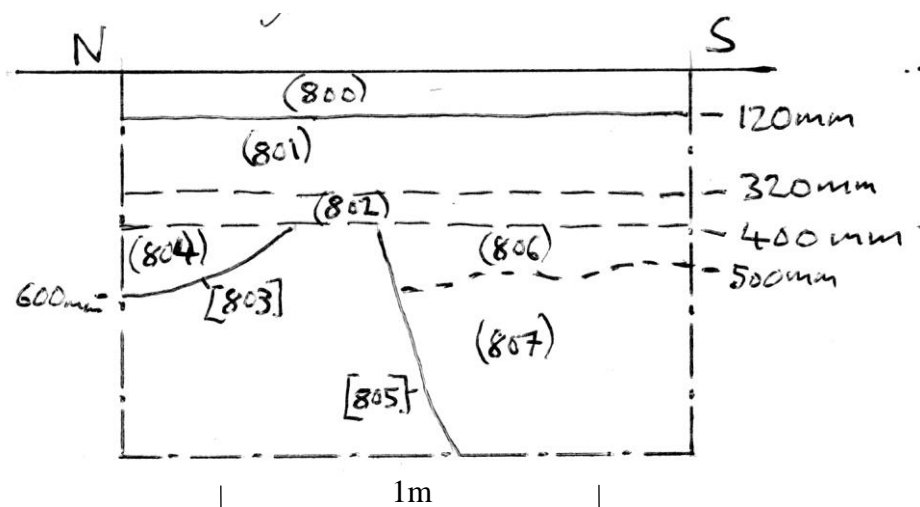
Image 8: Trial Pit 8, west-facing section

In the north-east corner of TP 8, cut [803] was filled with a dark grey clay-silt (804). The cut was irregular in plan with a shallow (180mm), concave profile. No artefacts were noted in the fill. The feature was immediately below the road construction layers and is interpreted as possible construction disturbance. A

large cast-concrete drain aligned approximately north-south was found at a depth of 950mm below the ground surface in the west side of the same trial pit.

No subsoil was noted in TP 8 where the road construction layers were directly above the clay bedrock, suggesting a higher level of truncation in this area.

Context	Description	Interpretation
(800)	Tarmac	Road surface
(801)	Brick	Road make-up layer
(802)	Black cinder layer	Road make-up layer
[803]	Shallow scoop	Layer
(804)	Dark grey clay silt, occasional small stones, no artefacts	Fill of [803]
[805]	Steep-sided natural 'cut'	Natural geological feature
(806)	Mixed mid-brown clay gravel	Upper fill of [805]
(807)	Clean mid-orange-brown sandy gravel	Fill of [805]
(808)	Light yellow and blue-grey clay	Geological bedrock

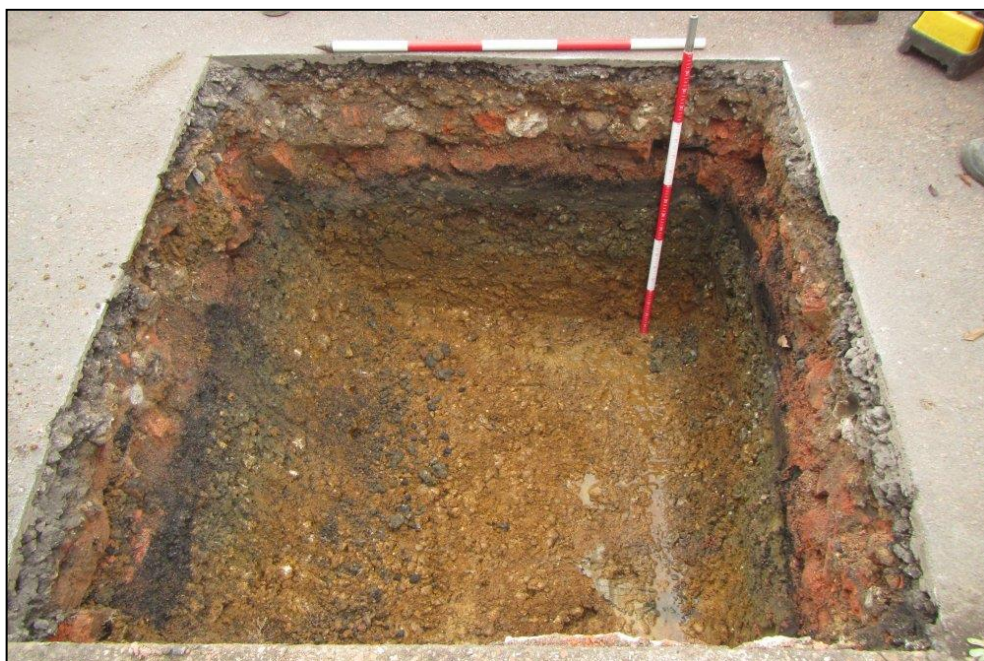
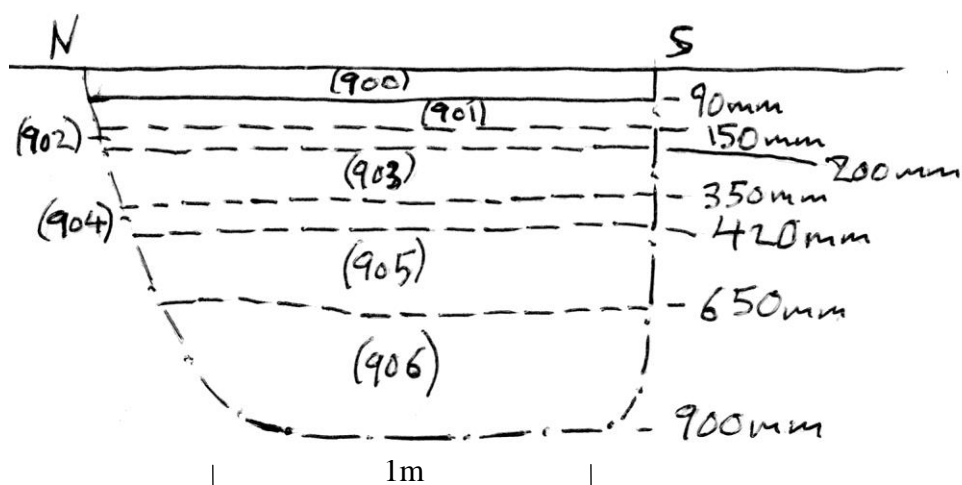
Image 9: Trial Pit 9, west-facing section

The road construction in one trial pit (TP 9) was very different with the tarmac laid above a layer of sand and gravel (901), above mixed concrete rubble and brick (902), above a brick rubble layer (903).

Context	Description	Interpretation
(900)	Tarmac	Road surface
(901)	Mid-yellow-brown sandy gravel	Road make-up layer
(902)	Mixed concrete rubble, brick and yellow-brown sandy gravel	Road make-up layer
(903)	Brick	Road make-up layer
(904)	Black cinder layer	Road make-up layer
(905)	Dark grey-brown clay gravel	Subsoil
(906)	Mid-orange-brown clay-sand-gravel	Superficial geology

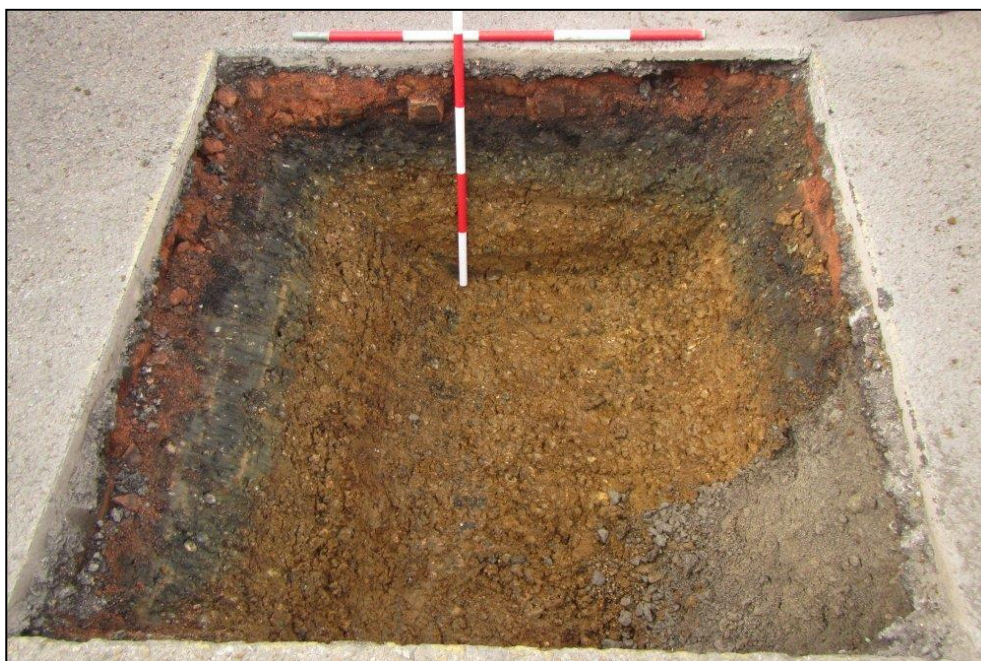
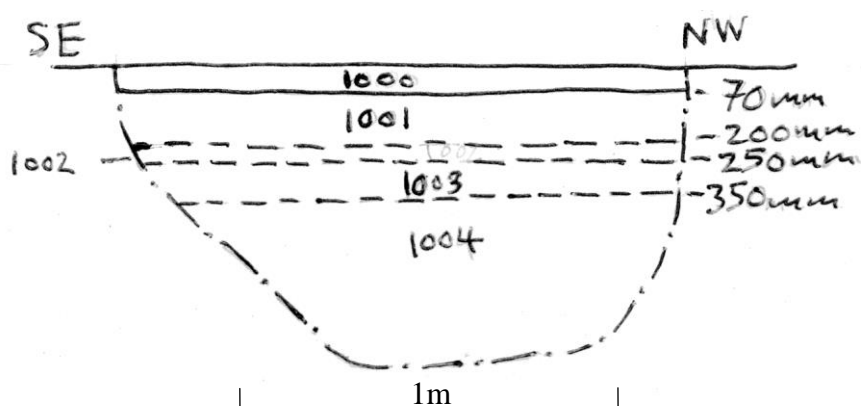
Image 10: Trial Pit 10, NE-facing section

Context	Description	Interpretation
(1000)	Tarmac	Road surface
(1001)	Brick	Road make-up layer
(1002)	Black cinder layer	Road make-up layer
(1003)	Mid-grey-brown gravelly clay	Subsoil
(1004)	Mid-orange-brown clay-sand -gravel	Superficial geology
