**NEW POLICE HEADQUARTERS BUILDING,
WENDOVER ROAD, WALTON, AYLESBURY,
BUCKINGHAMSHIRE**

ARCHAEOLOGICAL WATCHING BRIEF

Project: PHA1293

Document: 2008/04
Version 1.0

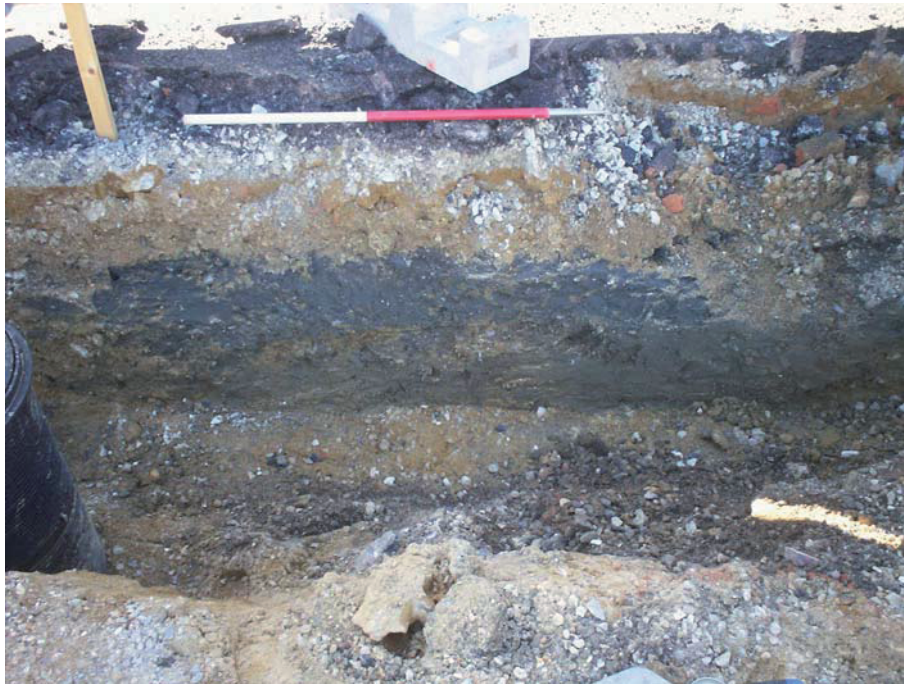
Plate 1: Furrow [122]
Scale 1m

A single probable agricultural furrow [122] was uncovered in the southern end of the site. The alignment was northeast to southwest, identical to the direction of the furrows uncovered in the evaluation.

| Context: | Type: | Description: | Excavated: | Finds Present: |
|---|---|--|---|---|
| 122 | Furrow | Linear NE-SW profile: concave base: flat | <input checked="" type="checkbox"/> | <input type="checkbox"/> |

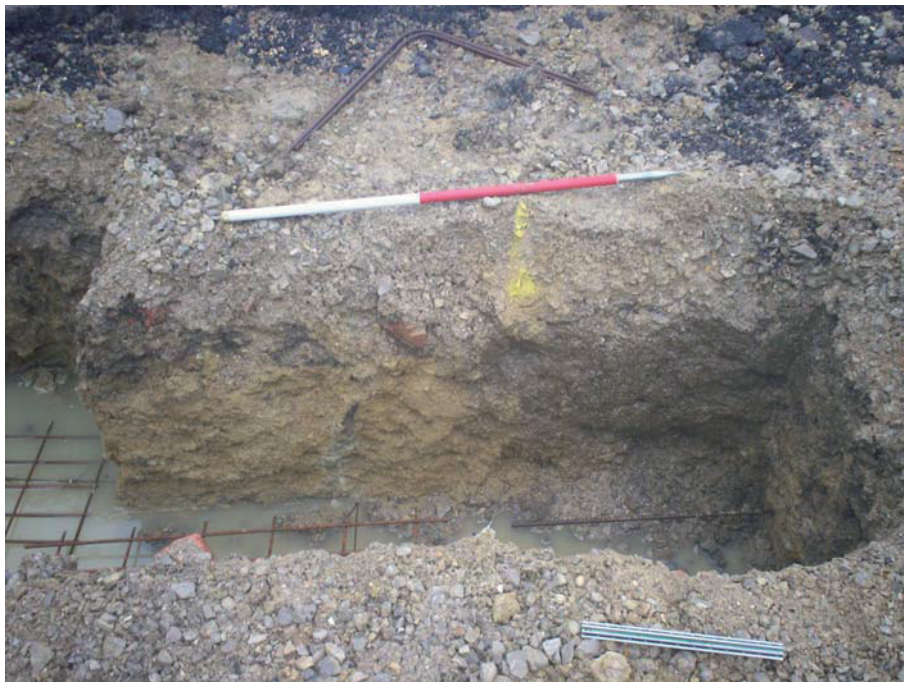
Plate 2: Pit [140]
Scale 1m

| 140 | Pit | Sub-oval profile: concave base: concave dimensions: max breadth 1.65m, max depth 0.55m | <input checked="" type="checkbox"/> | <input type="checkbox"/> |

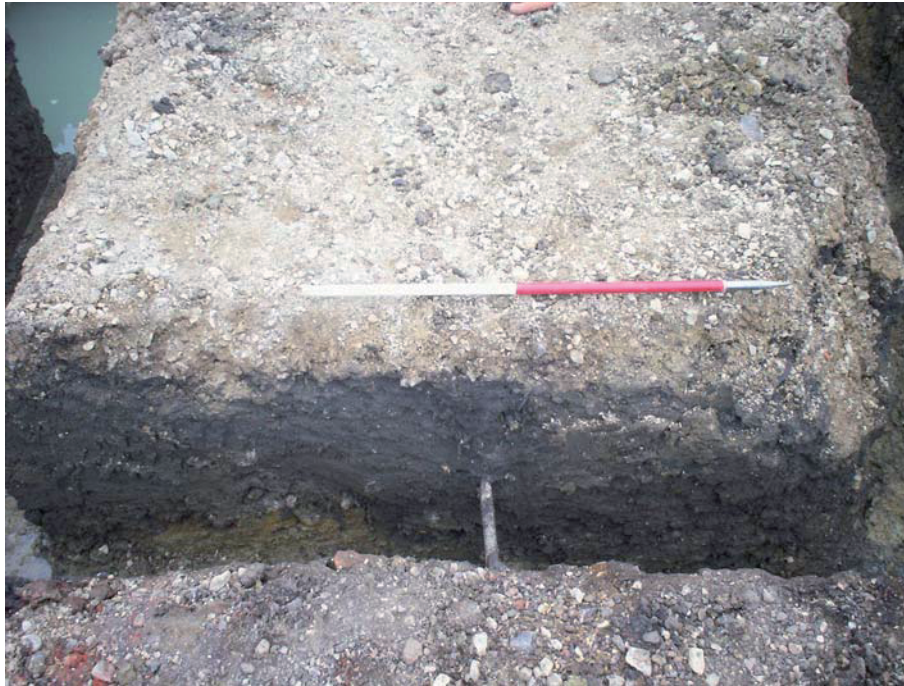
Plate 3: Pits [126] & [128].
Scale 1m

| Context: | Type: | Description: | Excavated: | Finds Present: |
|---|---|--|---|---|
| 126 | Pit | Assymetrical profile: irregular dimensions: max breadth 3.7m, max depth 0.95m | <input checked="" type="checkbox"/> | <input type="checkbox"/> |
| 128 | Pit | Profile: concave dimensions: max breadth 0.5m, max depth 0.5m | <input checked="" type="checkbox"/> | <input type="checkbox"/> |

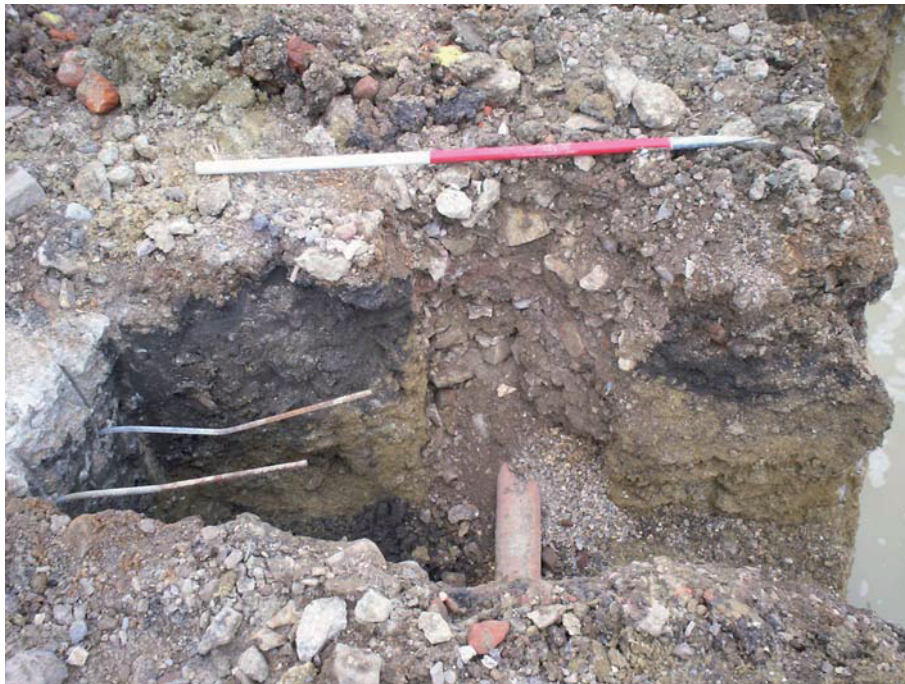
Plate 4: Backfilled trial trench visible either side of drain
Scale 1m

The previous trial trench excavation discovered two undated archaeological features; one pit and one gully. Both of these features extended beyond the trial trench and into the area of the current watching brief, however, they were not detected during the watching brief. This does not mean that the features were not present but instead reflects the difficulty of identifying features due to site conditions and methods of construction, i.e. narrowness of trenches.
