**CHURCH OF ST LAWRENCE  
WILLINGTON  
BEDFORDSHIRE**

**ARCHAEOLOGICAL ATTENDANCE,  
RECORDING AND REPORTING**

Project: SLW1333

Document: 2008/31  
Version 1.0

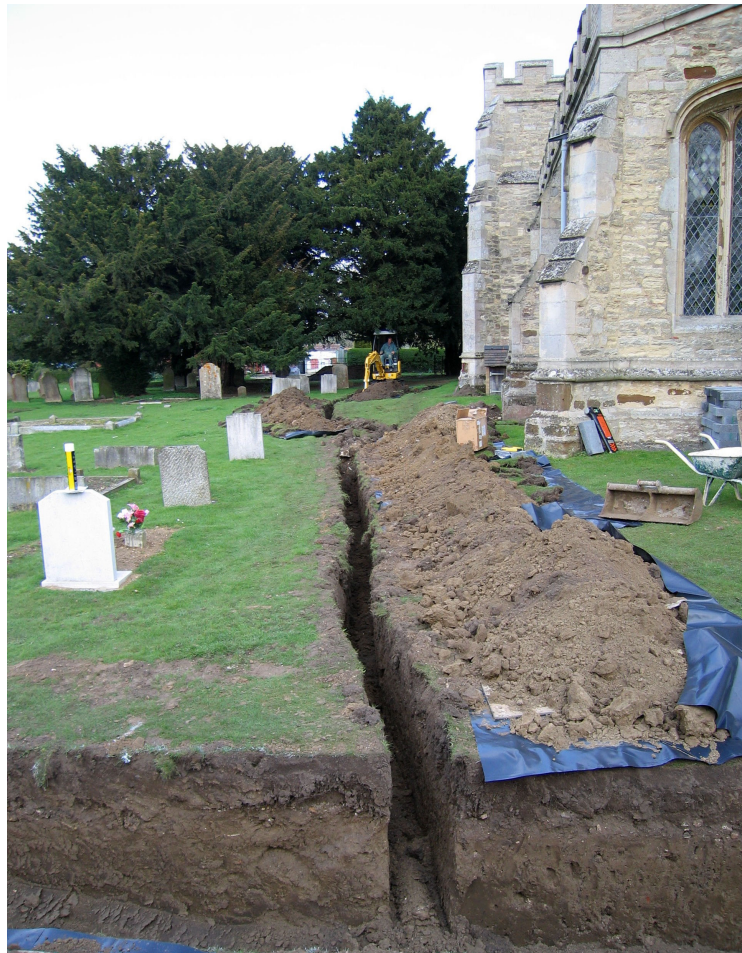
*Excavation in progress north of the church*

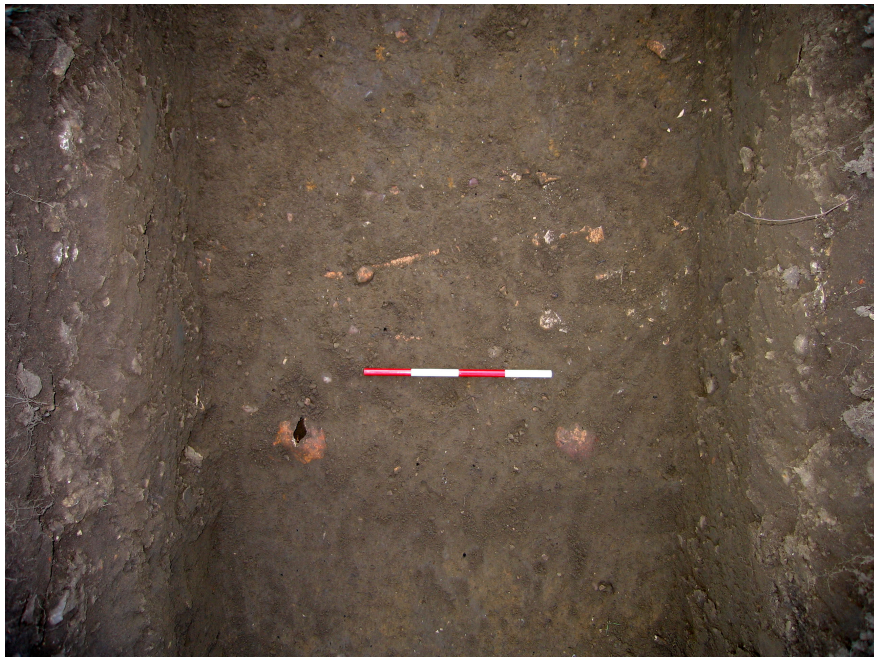
Articulated human remains (6) were revealed at the base of the soak-away trench within grave [5] (Fig. 3), cutting subsoil (4) and sealed by subsoil (2). At least three individuals appeared to be present. Probable articulated remains were also revealed in the service trench to the east, but only as far as deposit (7). Disarticulated human (and occasionally animal) bone was recovered from the subsoil throughout.

*Grave [5]; north is to the bottom of the photograph. Scale 0.4m. Two skulls are visible below the scale; a pelvis and right leg are visible above*
