**OLD GORHAMBURY
BACON'S HOUSE
ST ALBANS
HERTFORDSHIRE**

**ARCHAEOLOGICAL INVESTIGATION,
RECORDING AND ANALYSIS**

Project: OG1392
Document: 2008/82
Version: 1.0

Produced for:
RH Partnership Architects

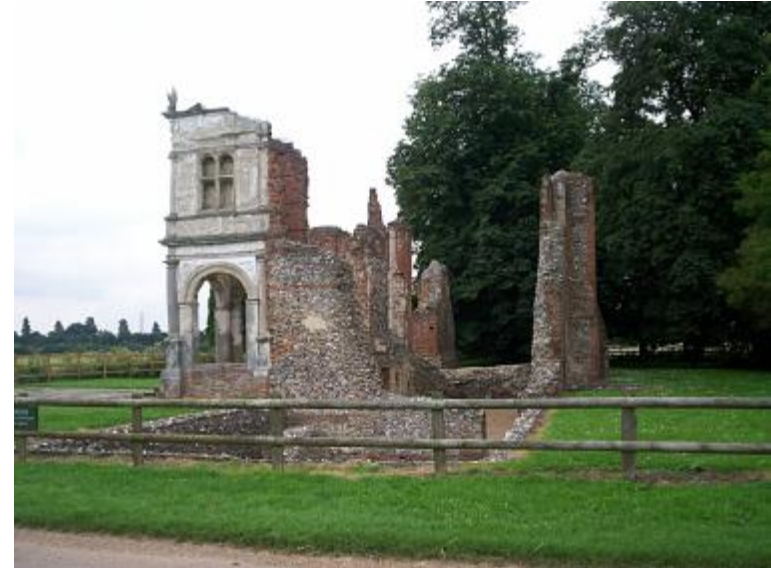
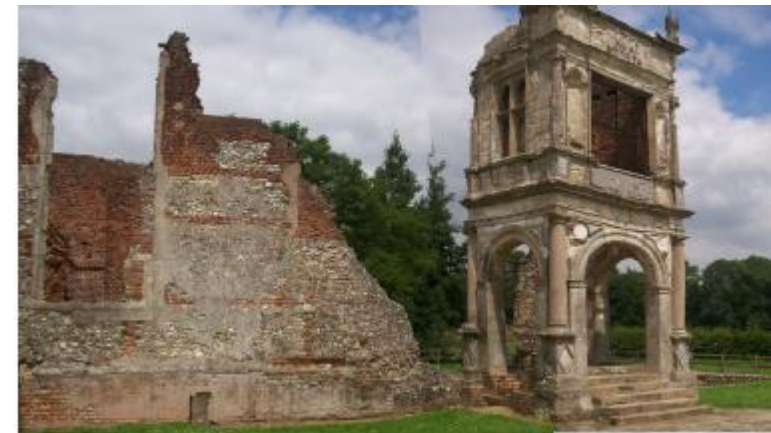
Figure 3: Plan of visible remains

Plan of visible remains, based on survey by RH Partnership Architects

View from the north-east

View of the porch and hall from the south-east

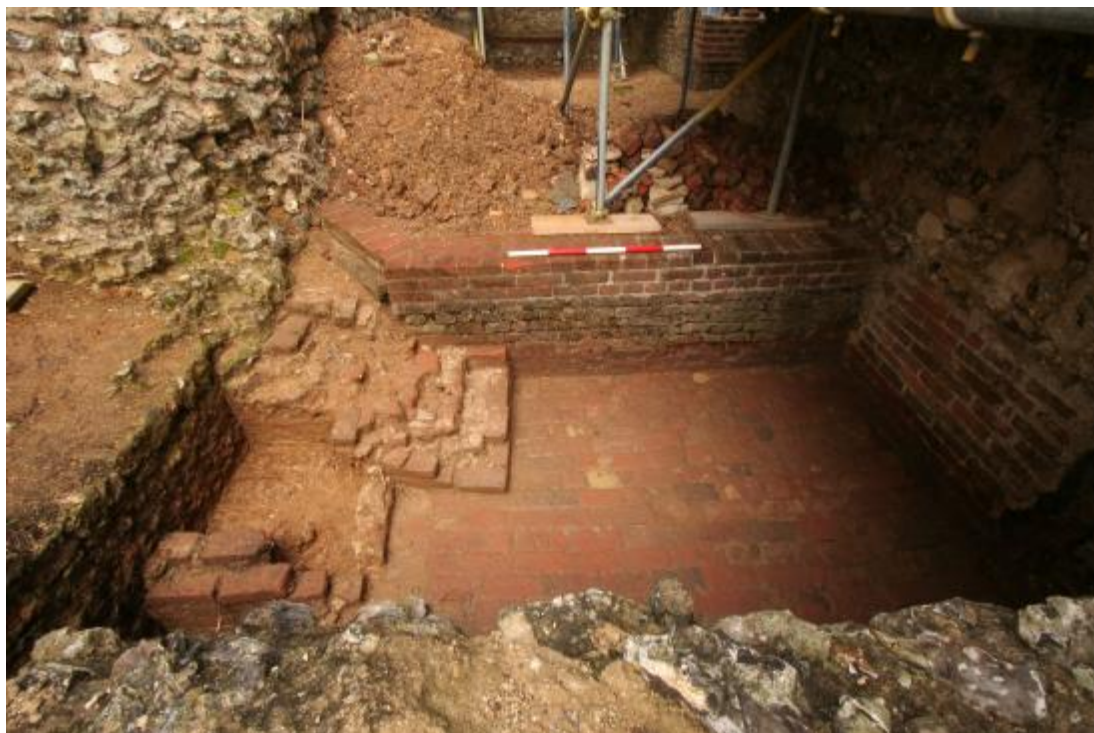
Plate 3: Area 3, looking north

The western wall (311) consisted of flint rubble masonry that survived up to the level of the main basement floor (Plate 6). The northern wall (Plate 3) consisted of a lower section (307) of eight courses of hand-made brick in an irregular bond consisting of a mixture of headers and stretchers. The upper part of the wall (306) consisted of three courses of modern bricks laid in a regular English bond.

At the western end of Area 3 a north-south aligned brick wall (305) separated a rectangular compartment from the rest of the room (Plates 3 and 6). The compartment was subdivided by an E-W aligned wall (304) into two spaces, each *c.*0.6m square internally. The walls had been partially demolished. Only one facing course of (305) remained with a rough deposit of brick rubble and mortar behind in the southern half of the wall. Wall (304) survived to a height

Stairs (301) in the north-west corner of room consisted of a flint and brick rubble in mortar faced with brick (Plate 3 and 6). The lowest two courses of the facing were laid as stretchers with the bottom step formed from bricks laid on edge, one of which survived against the north wall. The top of the stairs appeared to be set back at an angle of 45° with the topmost brickwork surviving beneath the modern brick capping (306) of the north wall.

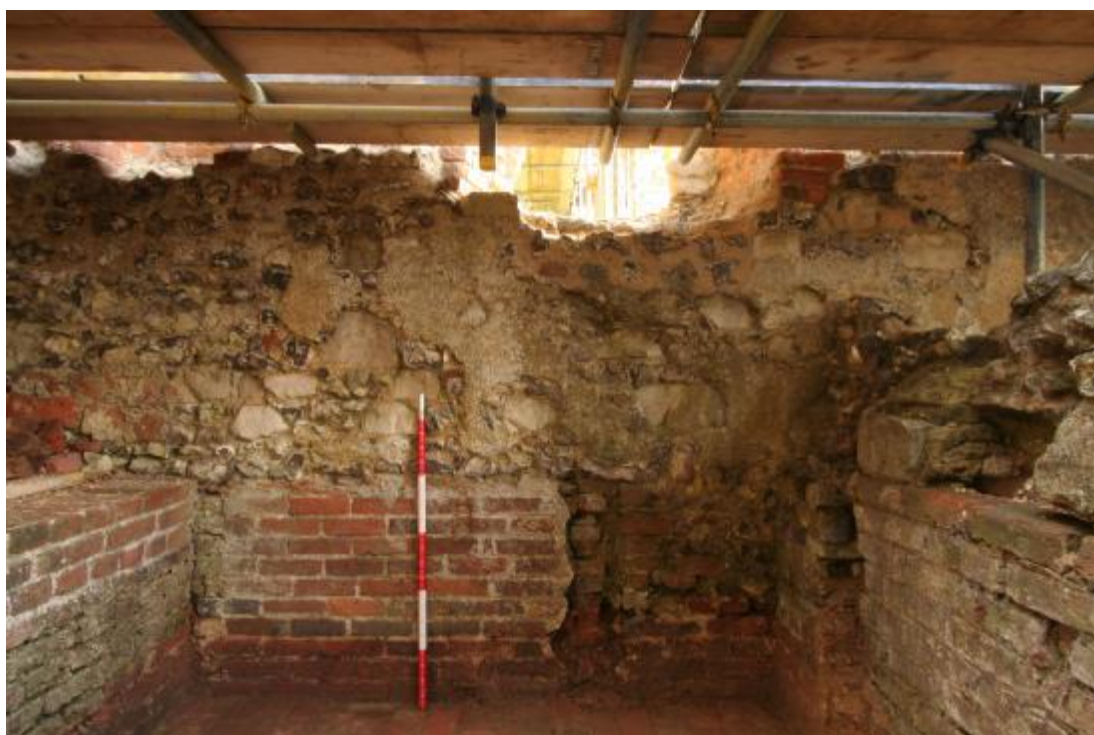
Plate 4: Area 3, looking east

The eastern wall (Plate 4) consisted of a variety of material. The upper part (308) consisted of flint rubble and blocks of clunch roughly coursed. The lower part of the wall (to the south of a ragged vertical slot in the wall)

consisted of a mixture of flint rubble and brick (309). It is possible that the brickwork here may have framed a recess to the north of the slot. The lower part of the wall (310) to the north of the slot consisted of bricks laid in a stretcher bond. These varied in colour from orange to dark blue-grey. Immediately above these bricks, a band of tiles laid diagonally had been used to fill the gap between the bricks and masonry (308).

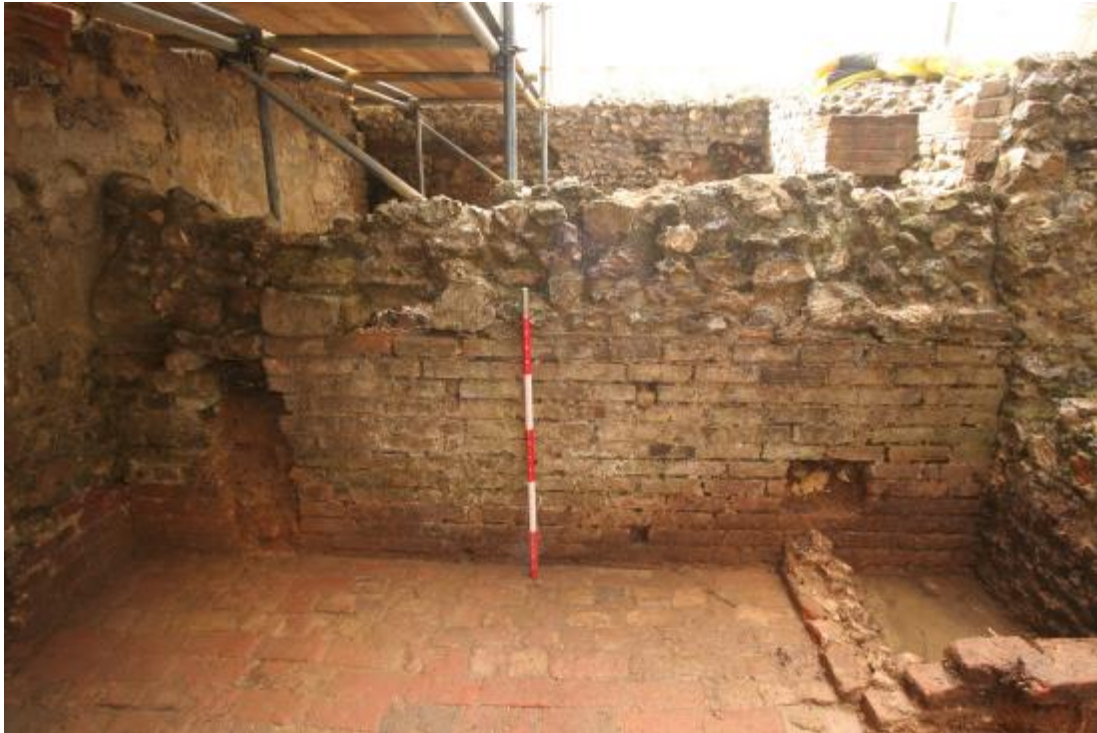
Plate 5: Area 3, looking south

The southern wall (Plate 5) ended in straight join at its eastern and western ends showing that it was built after the side walls. It consisted of a lower section in brick (303) with an upper section of flint and limestone rubble walling (302). The lower part (303) was formed of at least thirteen courses of brick laid in stretcher bond. A single course of tile occurred at the top of the brickwork in the western half of the wall. Towards the eastern end of the wall there was a vertical slot, *c.*0.25m wide, through the brickwork. It is uncertain if this formed a part of the original construction of the wall or was cut through later. The edges of the slot appeared uneven and ragged, as though cut. However, the brickwork to the east of the slot was different in character from the rest of the wall, with the upper seven courses in English bond, in contrast with the stretcher bond used elsewhere in the wall. The central part of the wall contained small holes formed by the use of a three-quarter length brick to leave a gap of *c.*90mm high and 70mm wide. Two of the holes occurred one above the other in the third and eleventh courses from the floor. A third gap occurred in the eleventh course, 0.65m to the east, though this was filled by a piece of brick. Another uncertain hole was identified in line with this at the base of the wall. There was a larger hole towards the western end of the wall in the fifth to seventh course of bricks. It was 310mm wide and 230mm high. The east side of this hole fell directly above the eastern face of an internal wall, (305). The upper part of the wall survived to height of 0.45m above the brickwork. It consisted of a mixture of flint and limestone rubble throughout. Only a small proportion of the face of the wall remained, most having been demolished or eroded.
