**LAND AT NEWBURY MANOR  
AMPTHILL ROAD, SILSOE  
BEDFORDSHIRE**

**ARCHAEOLOGICAL OBSERVATION,  
INVESTIGATION, RECORDING,  
ANALYSIS AND PUBLICATION**

Project: NM1407

Document: 2008/80  
Version 1.0

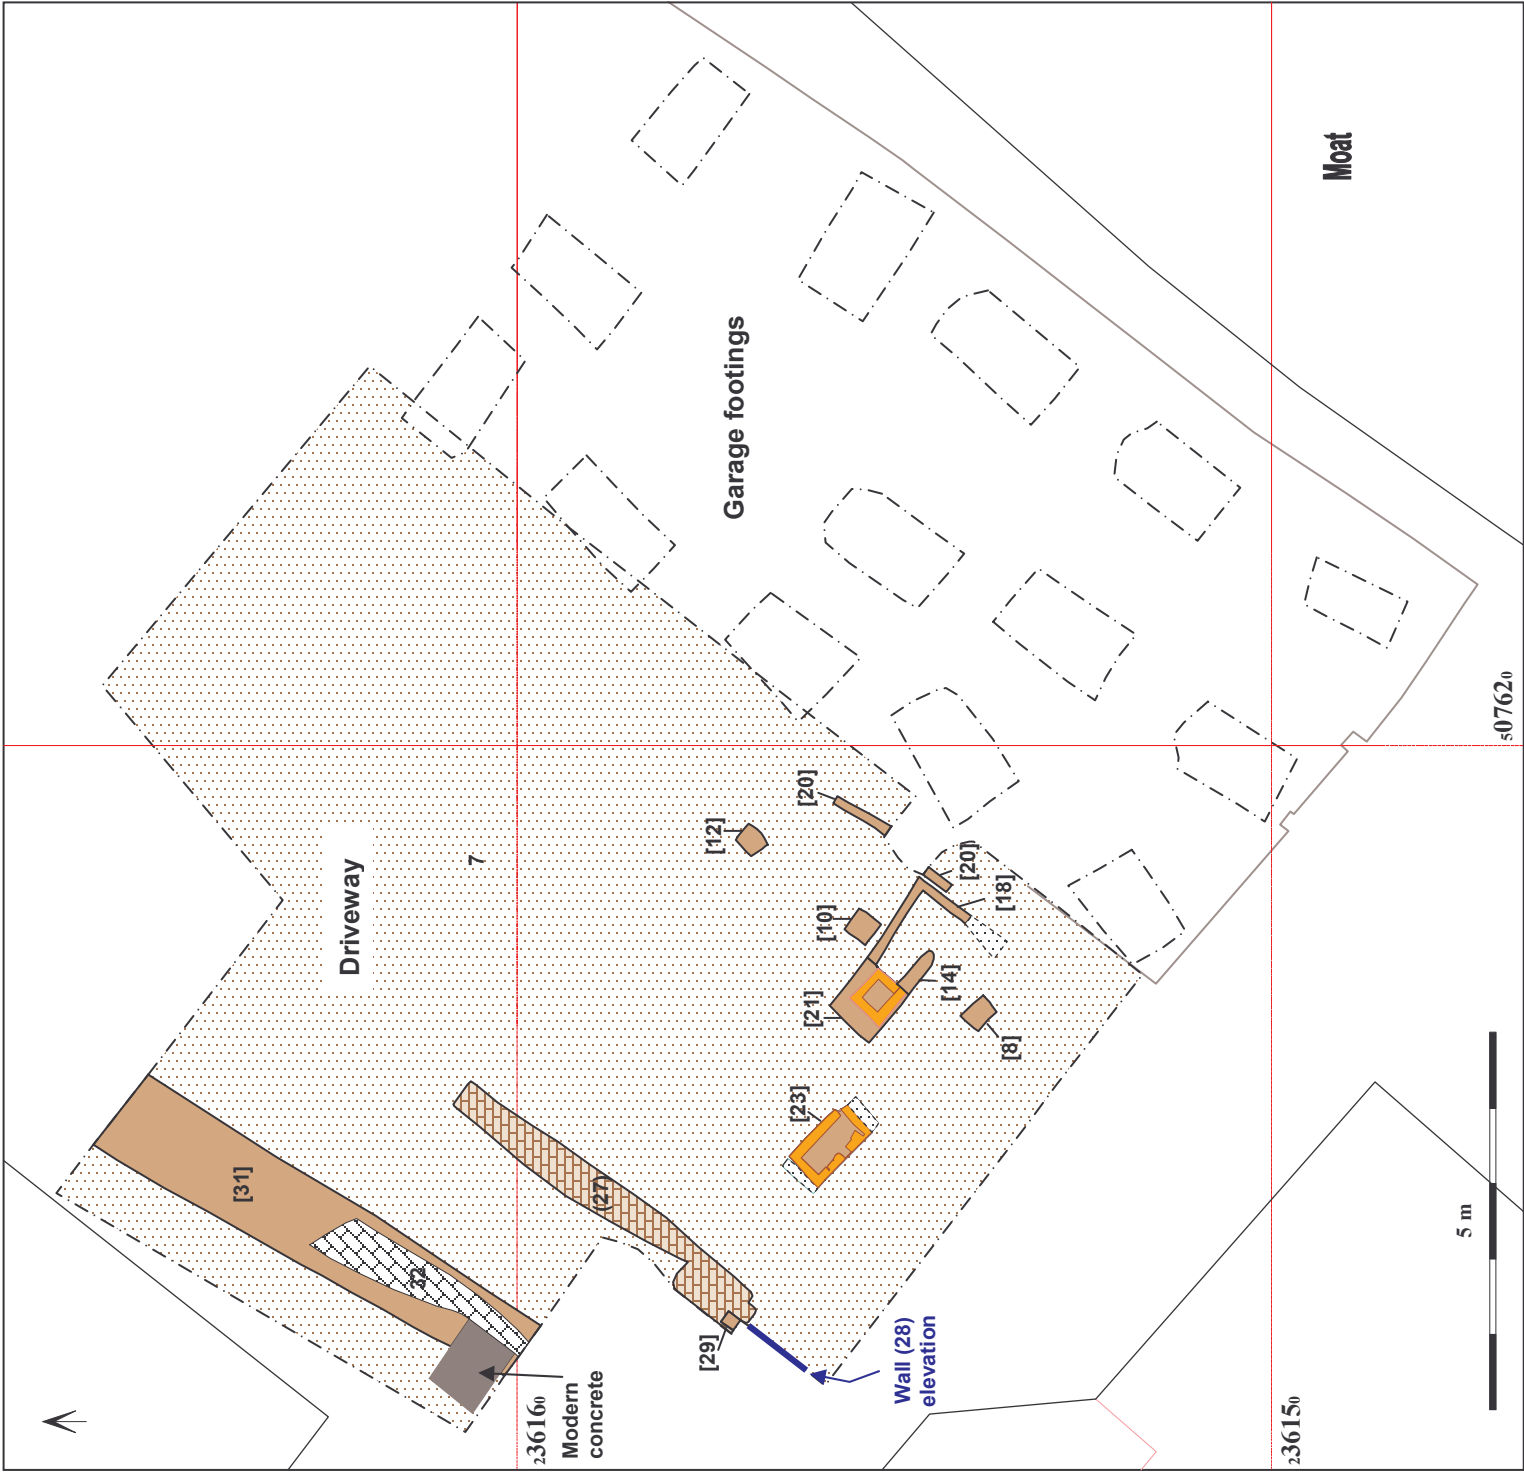
**Figure 2: All features**

Cut into make-up layer (7) were seven features dating to the late medieval / post-medieval and post-medieval periods. They comprised brick walls, brick-lined drains, a sandstone wall and a posthole alignment.

Three separate brick walls were identified. Wall (20) was aligned NE–SW. It was 1.88m long and is likely to date to the post-medieval period. Immediately to the north-west, two walls (18) of stock-moulded, sand-tempered brick (measuring 8¾” x 4” x 2”) were identified.

formed a right angle. They covered an area 1.40m x 1.30m and are likely to be former garden walls, associated with the early post-medieval house.

Two brick-lined drains – one square [21] and one rectangular [23] – were revealed. They are likely to date to the early post-medieval period. Drain [21] cut an earlier gully [14], but whether it was associated with the drain is unclear. Three stock-moulded, sand-tempered brick fragments, each with a width of 4” and depth of 2” were recorded from [21] and [23]. Again, it is likely that these former drains are associated with the house.

Three roughly square postholes [8, 10, 12] were regularly spaced approximately 1.50m apart on a NE–SW alignment. The fill (13) of posthole [12] contained a small sherd (1g) of modern, mass-produced glazed earthenware pottery and a fragment of fired clay (2g). It is likely that these postholes were associated with the garden.

To north-west of the monitored area, a brick-lined culvert [32] continued beyond the site to the north and south. It was intact, presumably associated with the house, and was left unexcavated.

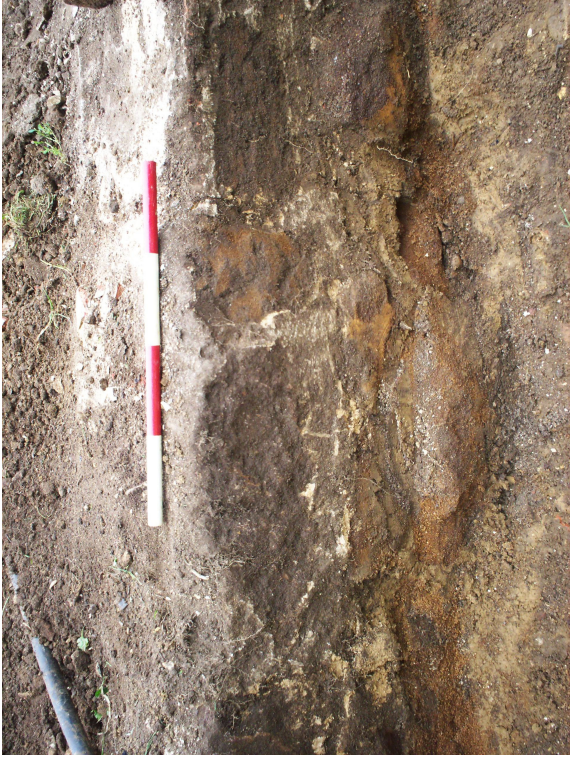
To the north-west of the investigation area was a NE–SW aligned sandstone wall (28), which continued beyond the site to the south-west. The wall comprised coursed, roughly hewn blocks bonded with mortar; it sat on a foundation (27) of irregular sandstone blocks bonded with clay. The wall could be traced for a distance of 5.9m and survived to a maximum height of 0.45m, though for the most part only the foundations still remained.

Wall (28) appears to correlate with a boundary wall marked on the Ordnance Survey map of 1896 that shows it as being connected with the barn that still exists to the north-west.

Photograph showing wall (28) and foundations (27), scale 40cm
