**BROGBOROUGH PIPELINE RELAY
BROGBOROUGH
BEDFORDSHIRE**

**ARCHAEOLOGICAL OBSERVATION
INVESTIGATION AND RECORDING**

Project: BR1409

Document: 2008/133
Version: 1.0

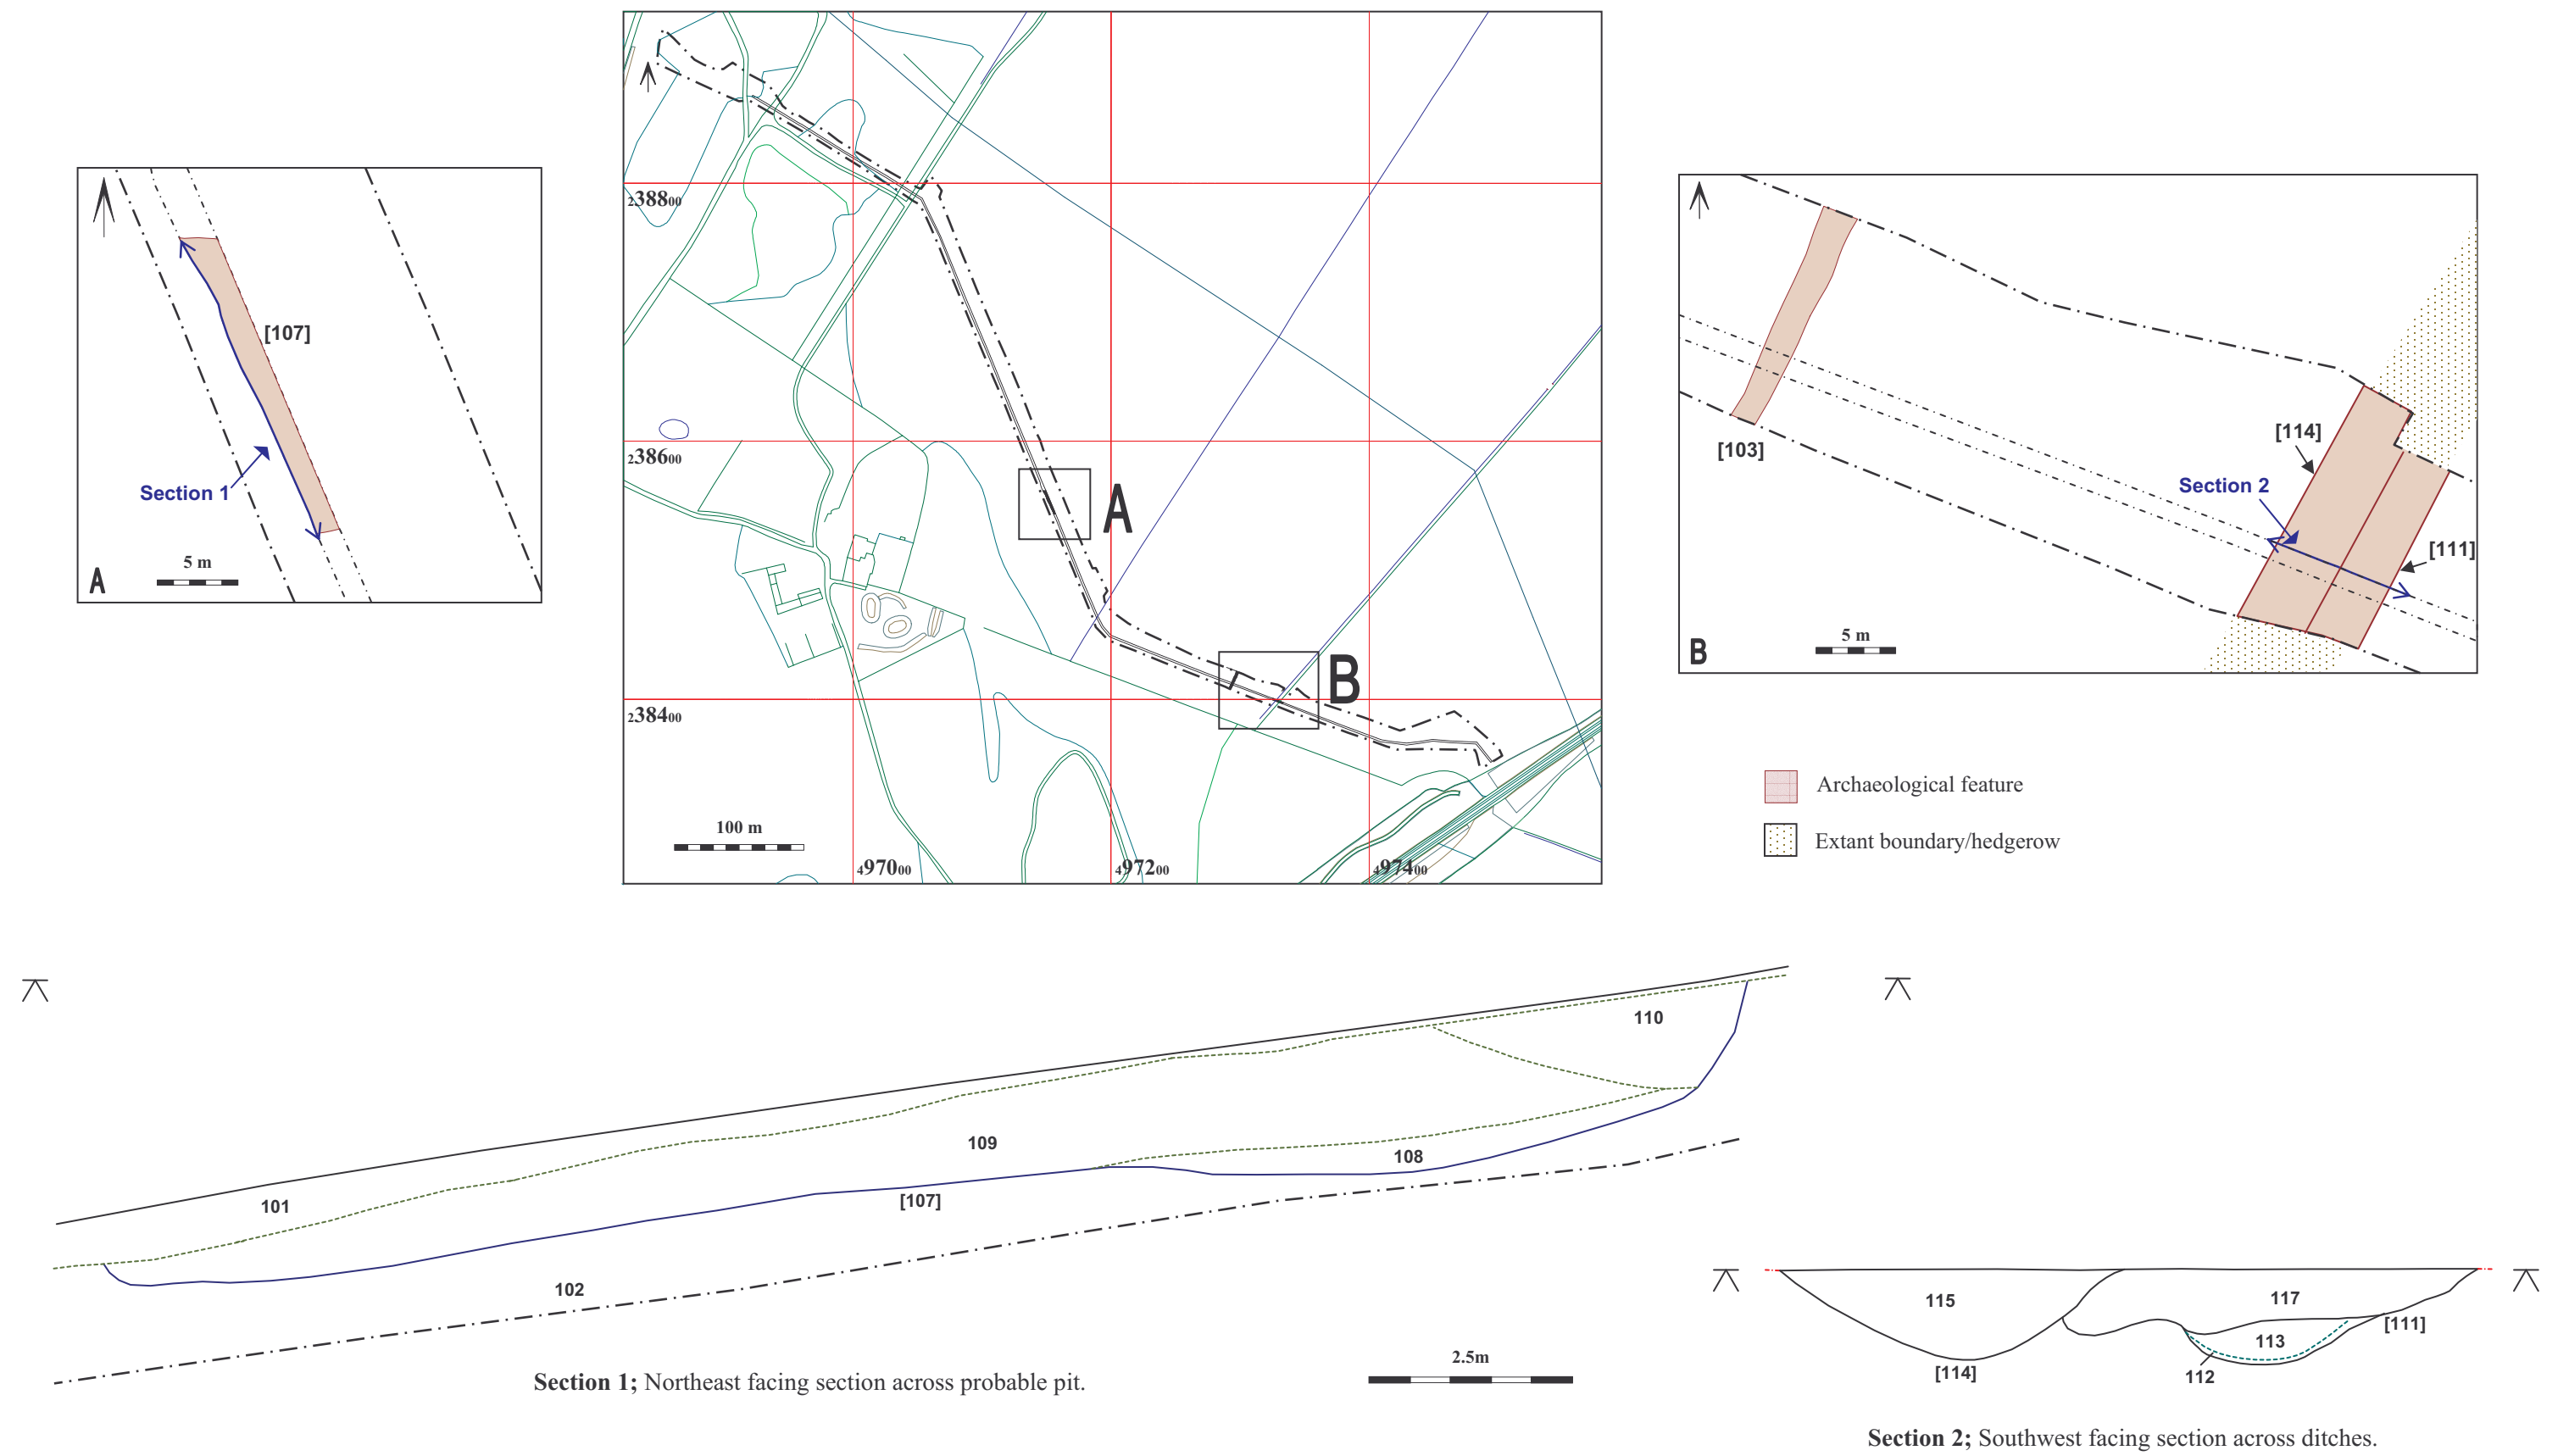
Figure 2: Plan and section drawings

Excavation of the pipe trench across the extant field boundary located towards the south-eastern end of the pipeline (Figure 2) exposed the full profile of the existing boundary ditch [114] (Plate 3). Also exposed in the trench and stripped easement was evidence of an earlier phase of boundary ditch [111]. This feature ran parallel with, and was truncated by, the later ditch and measured around 1.2m in depth. The upper fill of this ditch (117) was significantly disturbed by rooting from the boundary hedgerow.

A further ditch [103] was encountered approximately 35m to the west, on the same alignment as the field boundary. It measured approximately 1.5m wide and 0.27m deep. It contained a single fill (104) of grey brown silty clay.

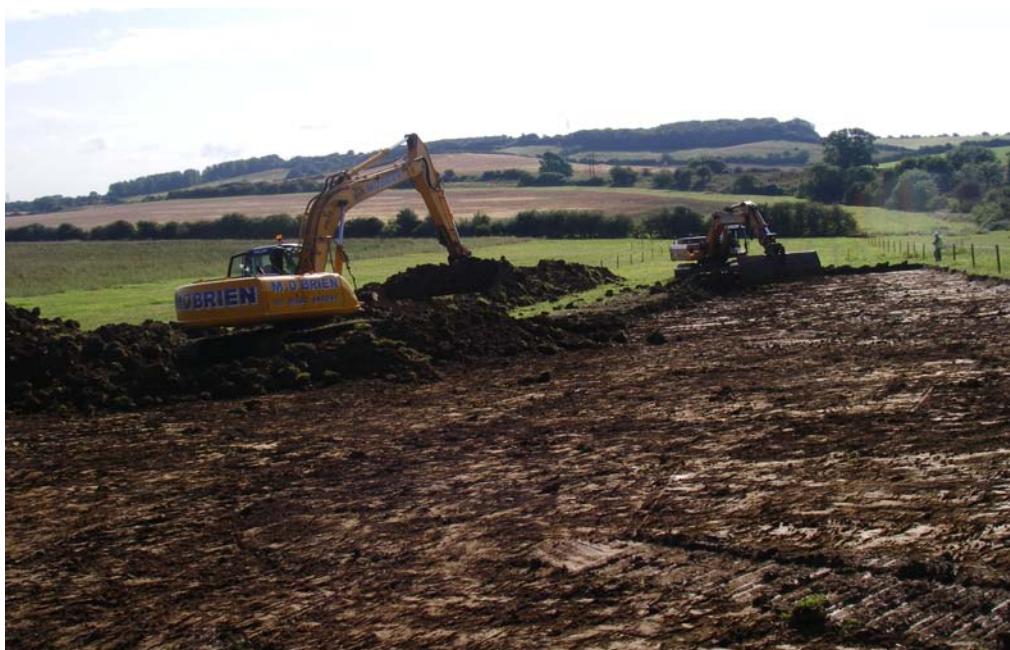
Plate 1: Stripping of topsoil from pipeline easement

These groundworks comprised the stripping of topsoil from an easement (Figure 1, Plate 1) that ran the length of the pipeline route. This easement varied in width but on average measured around 15m wide. This was followed by the excavation of a trench (Plate 2) to accommodate the pipeline itself. Again, the dimensions of this excavation varied depending on ground conditions. However, its minimum width was 1m and average depth between 1.2-1.5m

Between 0.3m and 0.4m of topsoil (100) was removed from the pipeline easement, revealing clayey subsoil (101). Subsoil deposits of around 0.2m in depth were excavated in the pipe trench exposing undisturbed geological deposits of yellow grey clay (102).

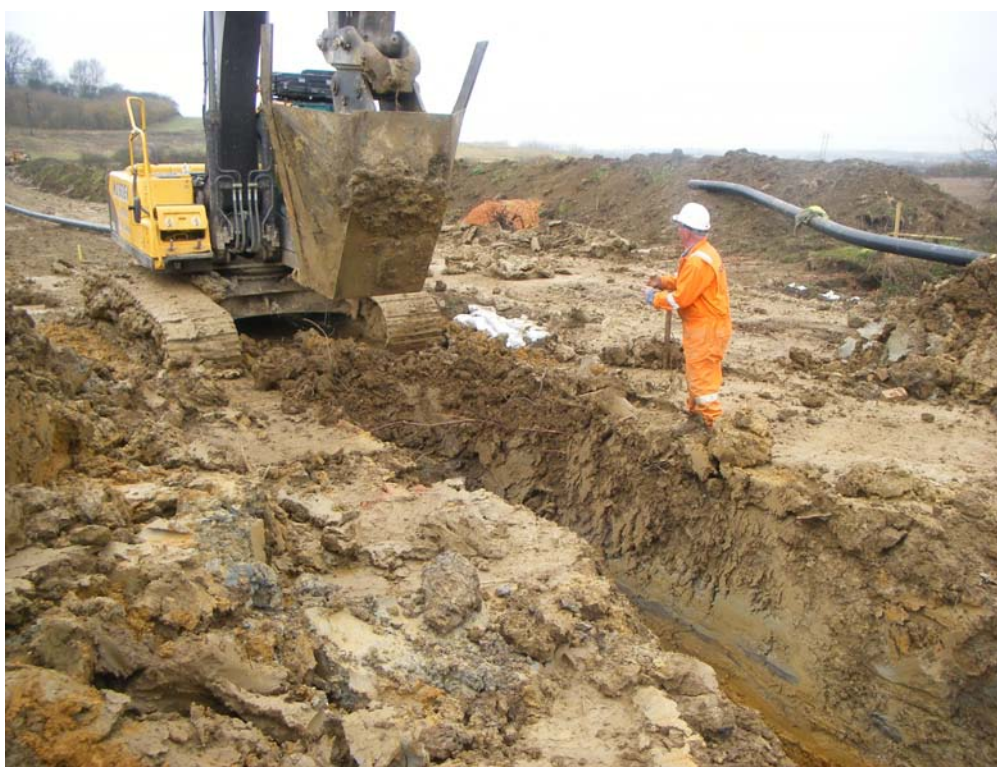
Plate 2: Excavation of pipe trench

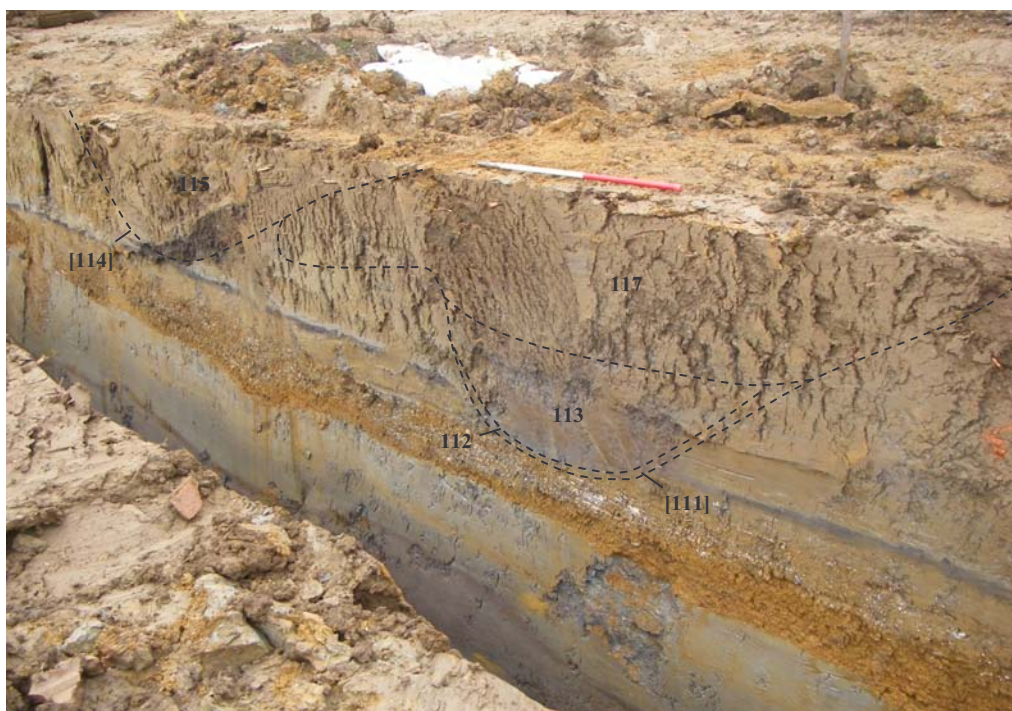
Plate 3: Section showing extant field boundary [114] and earlier ditch [111]. Scale 1m.

One of the ditches was located within an existing land boundary and probably represents an earlier phase of the boundary ditch. The second ditch was located near to this boundary and on the same alignment. Both features most likely functioned as drainage and/or boundary features and, although no dating evidence was recovered from either, their character, location and probable function suggest they are post-medieval or later in origin.

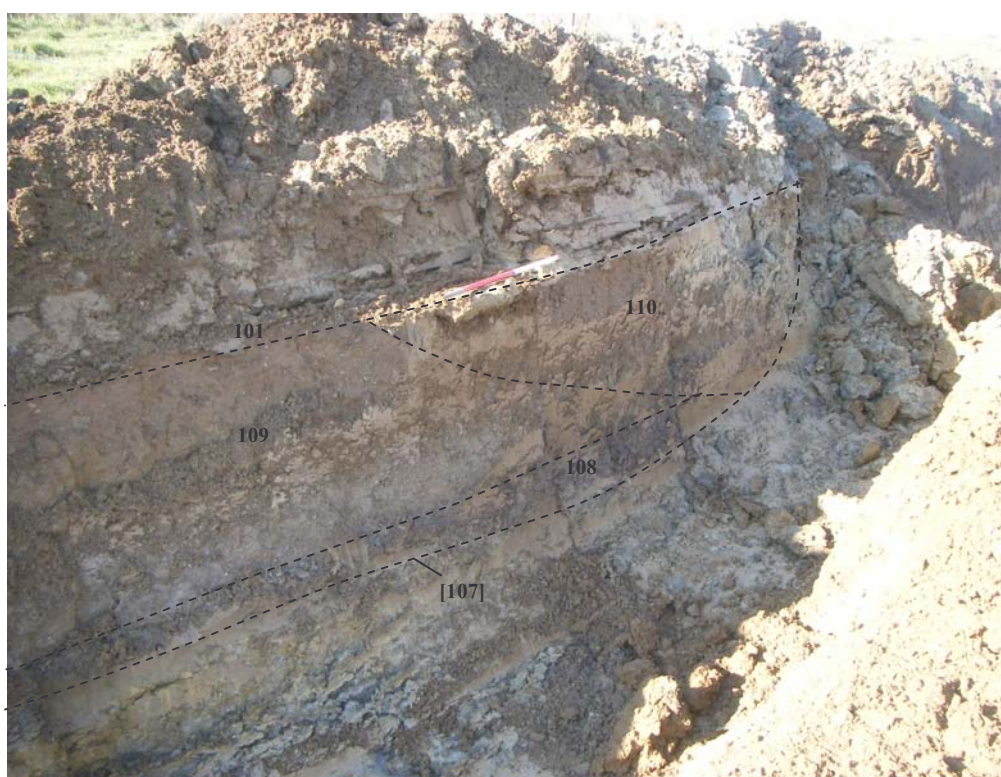
Approximately midway along the pipeline route the pipe trench cut through what appeared to be a large relatively shallow pit [107] (Plate 4). In the trench section, the cut measured approximately 20m wide and 1.75m at its deepest and contained at least three fills. The feature lay beneath the subsoil and therefore its edges within the stripped easement were not visible.

Plate 4: Section showing east end of large pit [107]. Scale 1m.

The function and date of the pit was not apparent from the evidence recovered from the archaeological works. However, post-medieval quarrying is known to have occurred approximately 100m to the south-west, in the vicinity of Park Farm (see 1.3 above). It is likely therefore that such a large pit represents an extension of this activity.
