**CHURCH SQUARE
BEDFORD
BEDFORDSHIRE**

**PROGRAMME OF ARCHAEOLOGICAL
OBSERVATION, INVESTIGATION, RECORDING,
ANALYSIS AND PUBLICATION**

Project: CSB1385

Document: 2008/117

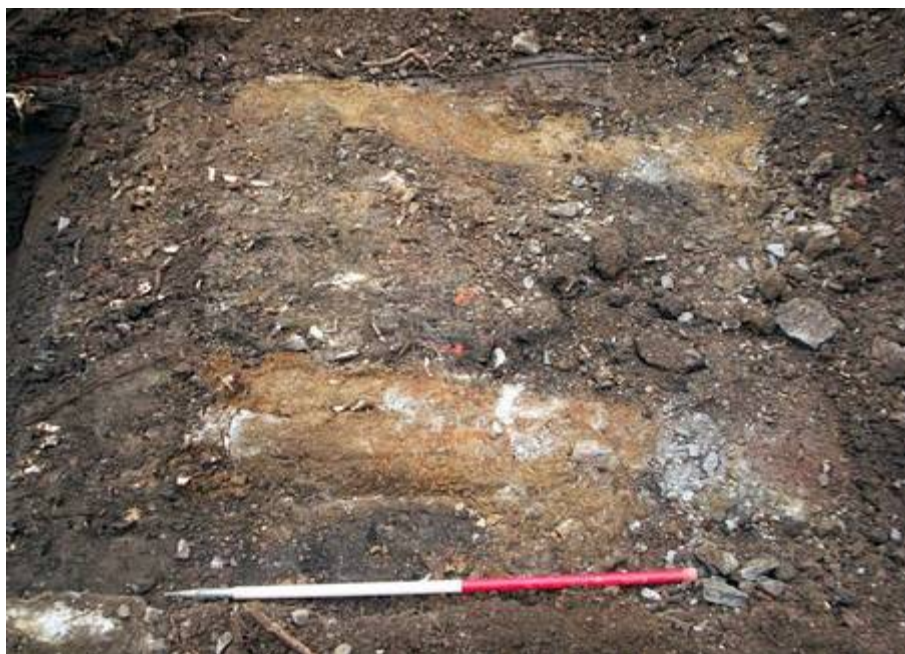
Figure 13: Photographs of Pits 7 and 9 and Trench 2

The foundations of a building were discovered (at *c.* 25.9m OD) in the southern part of the square (Area 7). The foundations consisted of two parallel cuts, [107] and [109], aligned east to west and filled with limestone and clunch blocks. The two foundations had been truncated at each end by existing tree pits (Figure 12 and Figure 13, top).

Pits 7 and 9: 19th-century outbuilding foundations, [107] and [109]. Looking north, scale 1m

The foundations of at least two houses were observed in Pit 6 (Area 1) and adjacent to Pits 7 and 9 (Area 7). These are in all probability the remains of 19th-century houses clearly visible on the Reynolds town map of 1841 (Figure 7).

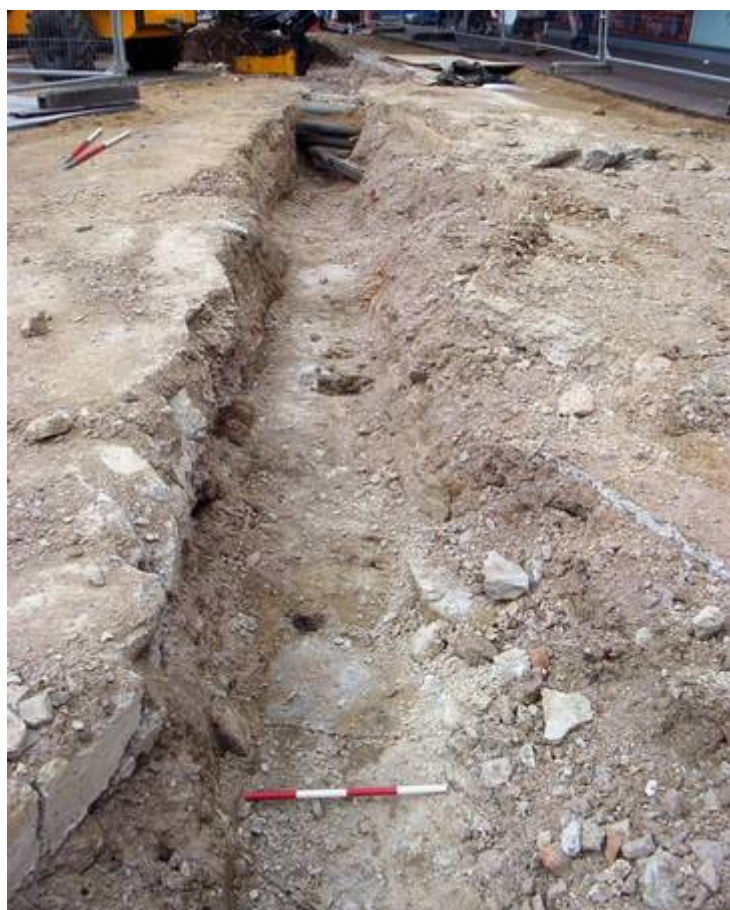
To the north of the square, a suspected surface (Figure 12, Area 2 (111) and (112); Figure 13, bottom) was uncovered in a service trench. This consisted of flat limestone and lay at a height of *c.* 25.7m OD. It was not possible to determine the precise extent of this surface but it might have covered a large proportion of the northern part of Church Square.

Trench 2: limestone surface (111)/(112).
Looking north-west, scale 40cm

A number of make-up layers and the limestone surface (presumably a street or yard surface) testify to the different phases of development and redevelopment of the square from the early 19th century until the present day. However, it was not possible to differentiate more clearly between the phases due to the limited nature of the investigations.

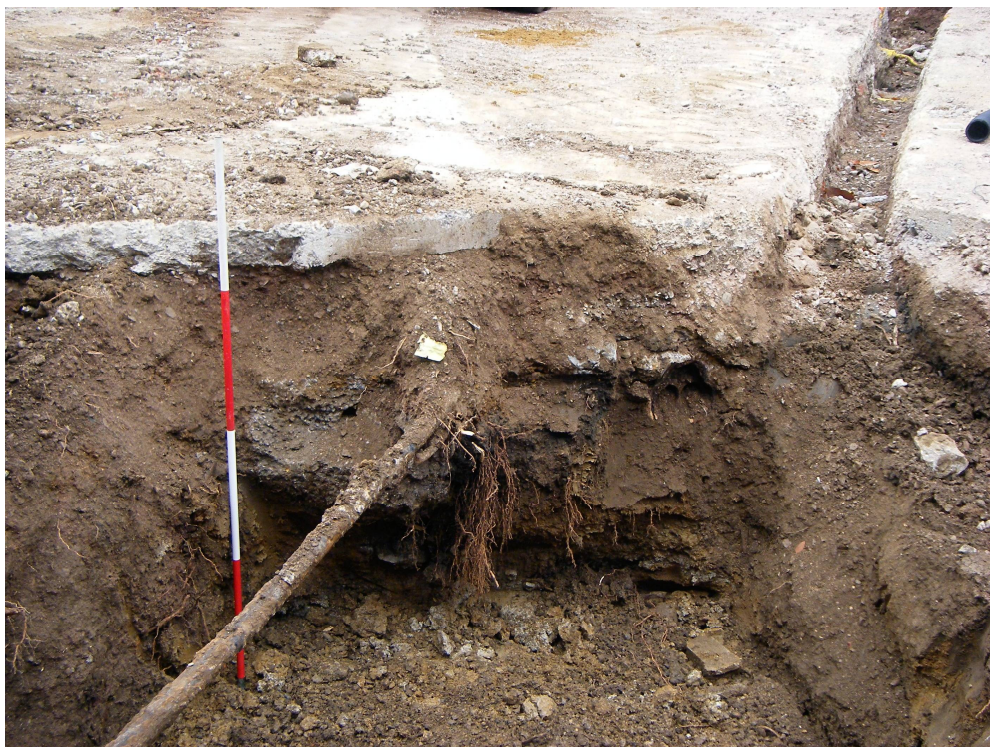
Figure 14: Photographs of Pit 1 and Pit 4

Layers of deeper stratigraphy were observed in the eastern part of Church Square, in Pit 1 (Figure 14, top), Pit 5 and Pit 6 (Figure 15). These layers³ mainly consisted of dark grey or dark brown clay silt and contained Saxo-Norman (850-1150), medieval (1150-1400), post-medieval (1500-1750) and modern (post-1750) pottery. Medieval layers⁴ were only uncovered in Pit 5 and Pit 6.

Pit 1. Looking north, scale 2m

The deeply stratified deposits uncovered in Pits 1, 5 and 6 are not fully explained at present. The earliest of these deposits are likely to date to the early medieval period (c. 1150–1250) whereas the top layers contained modern (post-1750) pottery. In Pit 1, the deposits were dark and silty, perhaps indicating pond- or waterlogged deposits. This could be an indication of a medieval fishpond in the area.

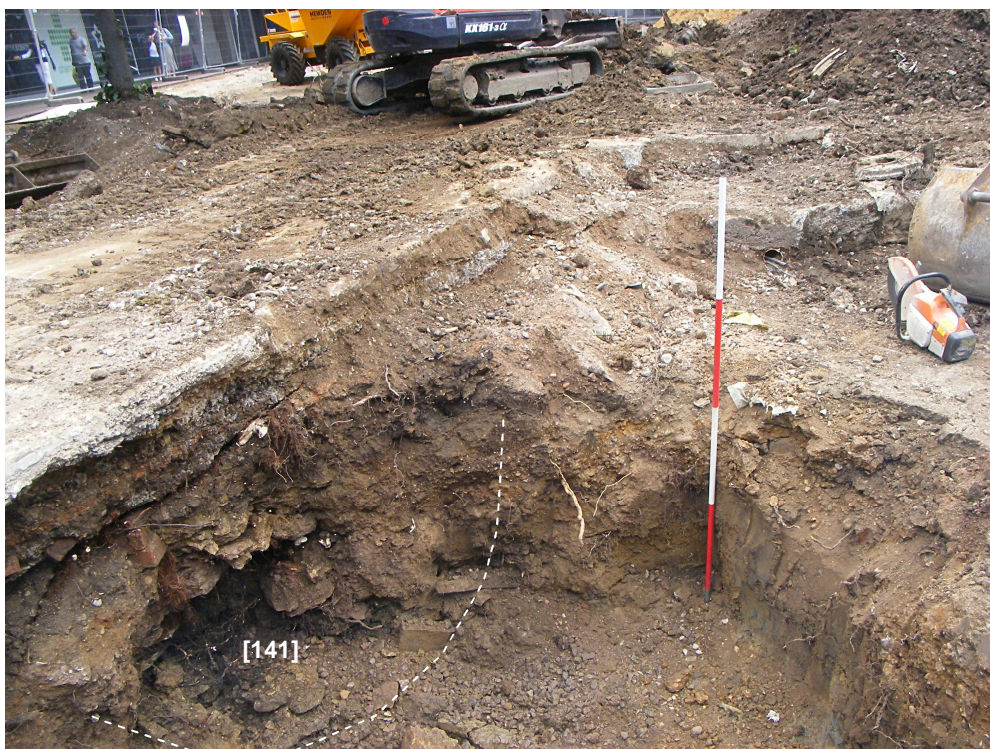
A linear feature was observed in Pits 2, 3 and 4 in the far western part of the Square (Figure 12, Area 3 [141]; Figure 14, bottom). This had been backfilled with modern rubbish (plastic bags and modern bricks) and appeared to have been machine dug. The feature in its present form probably dates from the 1950s / 1960s redevelopment, or later. The current, apparently machine-dug trench could, however, represent a re-excavation and backfilling of an earlier ditch or collapsed culvert.

Pit 4. Looking north east, scale 2m

It is possible that trench [141] found in Pits 2, 3, and 4 represents a continuation of the Empire Cinema ditch to the north (though re-excavated by machine after 1950). The alignment, size and location of the trench are roughly consistent with this interpretation.

Trench [141] is, however, more likely to be a continuation of another ditch uncovered at the Empire Cinema excavation (in trench III, unidentified feature). This was a substantial ditch of 12th- to 14th-century date. It was 1.80m deep, more than 4m wide and north-south aligned. The west edge of the ditch was not discovered. It is possible that this ditch, together with trench

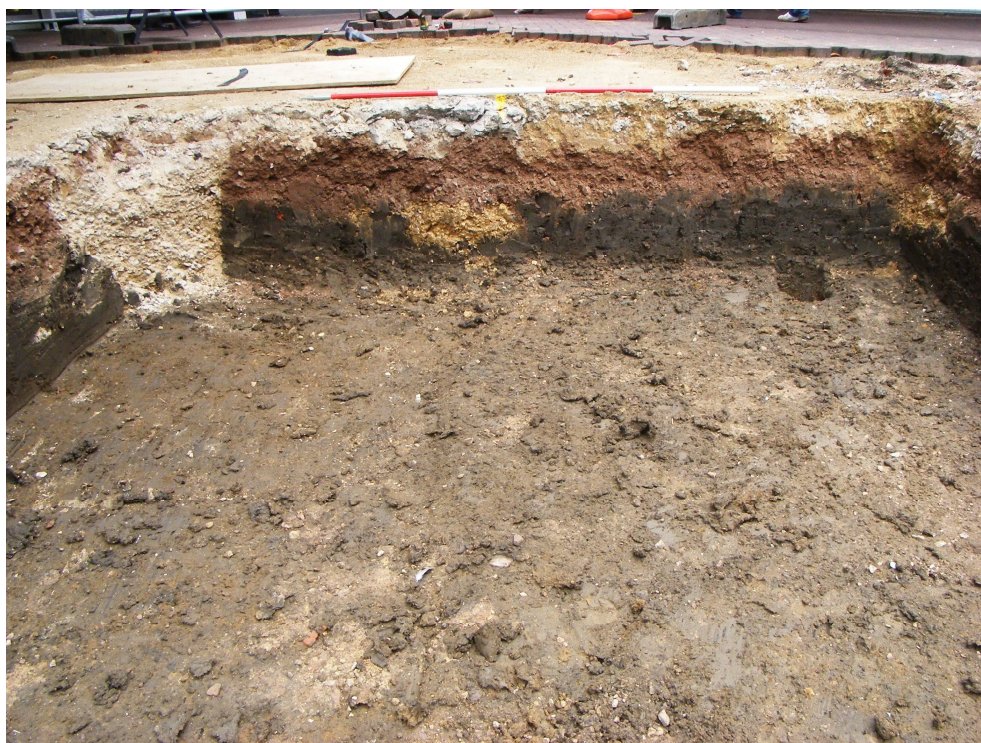
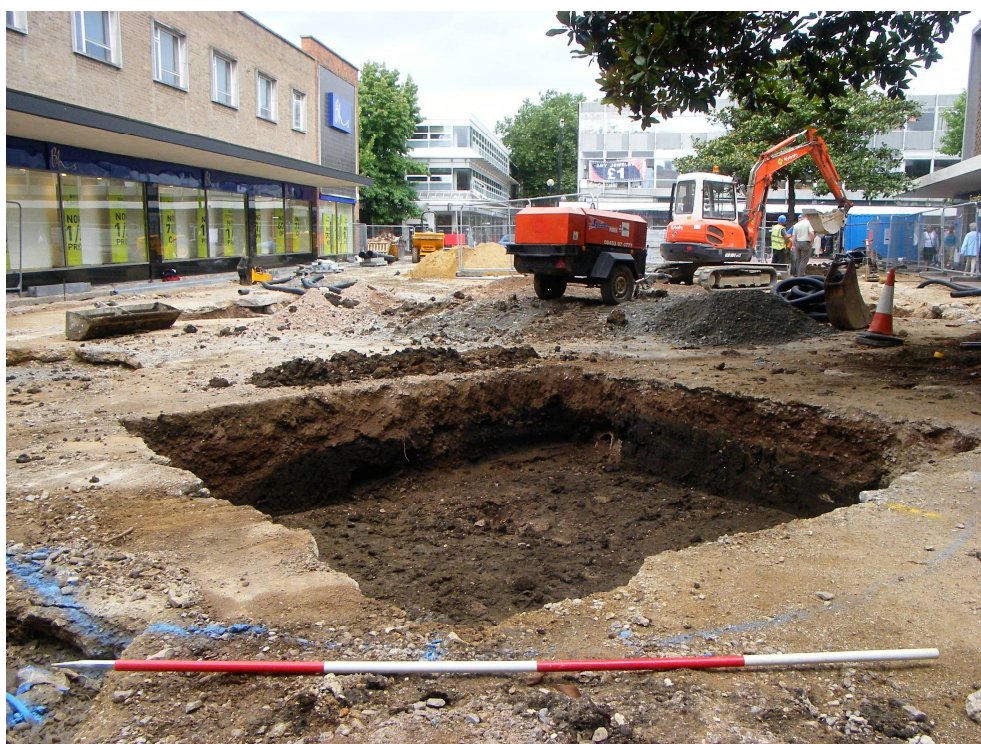
Figure 15: Photographs of Pit 6

A second foundation was discovered in Pit 6 (Figure 12, Area 6 [126] and [128]). This consisted of two construction cuts, filled with gravel and sand, forming the south-western corner of a building. The top of the foundations was at *c.* 25.9m OD and the base of the cut at *c.* 25.6m OD.

Pit 6. Looking north-east,
scale 2m

Site photograph. Looking west, Pit 6 in foreground.
Scale 2m

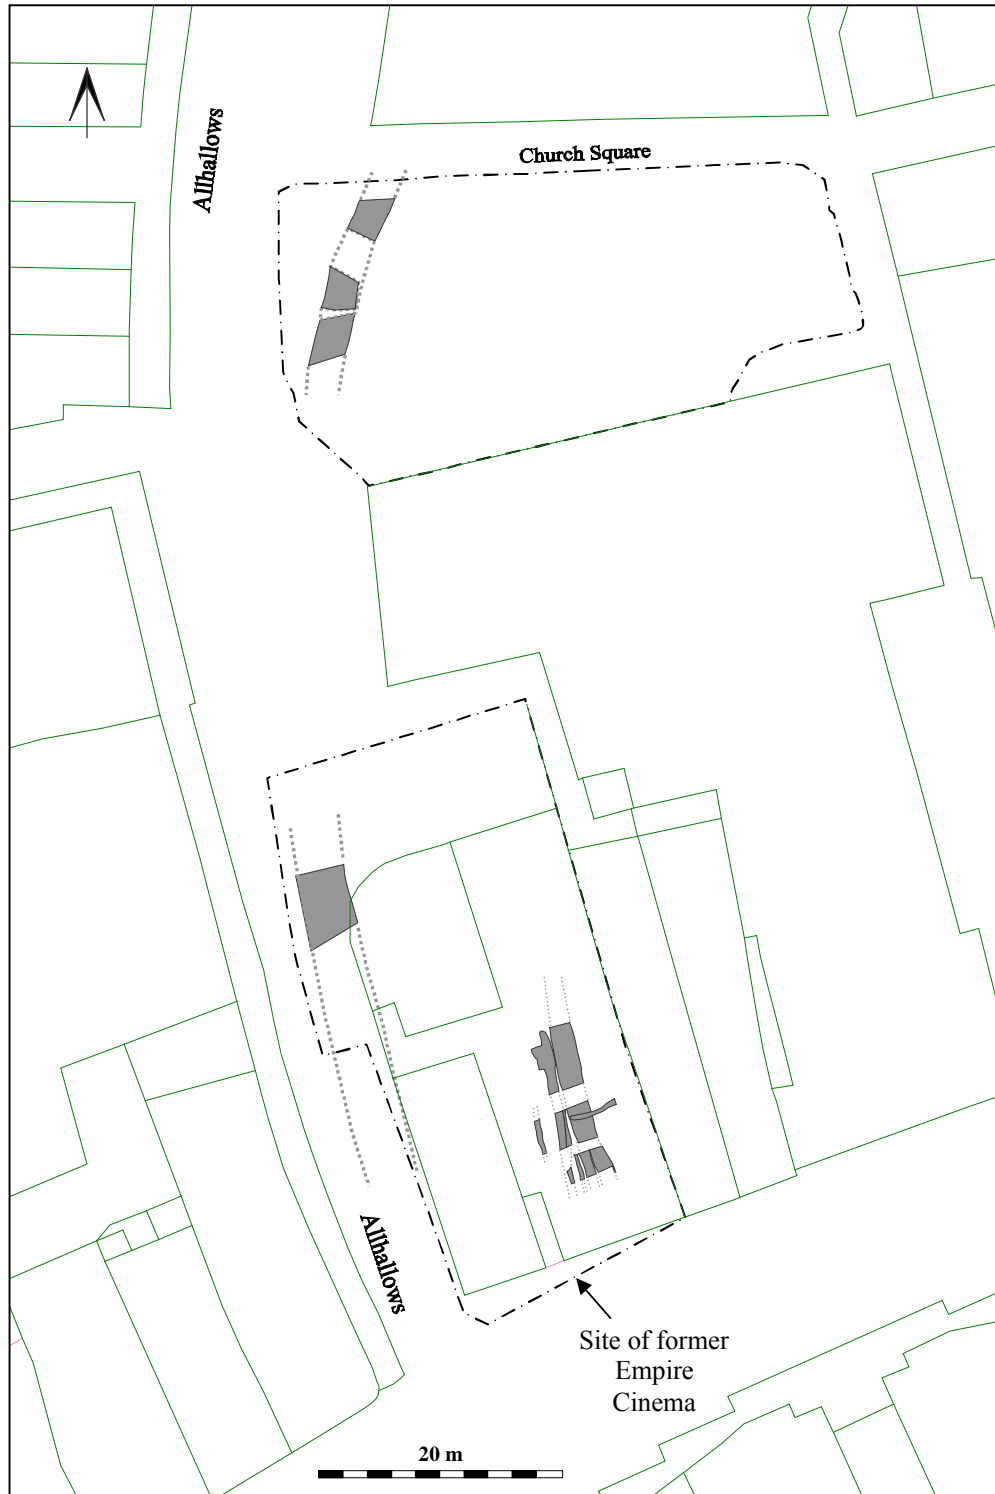
Figure 16: Linear features in Church Square and in The Empire Cinema excavation
(After Hassal 1983)

[141], formed a roadside ditch along the medieval Allhallows Lane (Figures 16-18).

The Empire Cinema excavation further revealed, among other things, a north-south aligned 9th- to 12th-century ditch (ditch 16, in trench I). The ditch was 2m wide and 0.70-0.80m deep and appeared to drain water from the north of the site.
