72–74 HIGH STREET, BEDFORD

**PROGRAMME OF ARCHAEOLOGICAL
OBSERVATION, INVESTIGATION, RECORDING,
ANALYSIS AND PUBLICATION**

Project: WB1202

Document: 2008/16
Version: 1.1

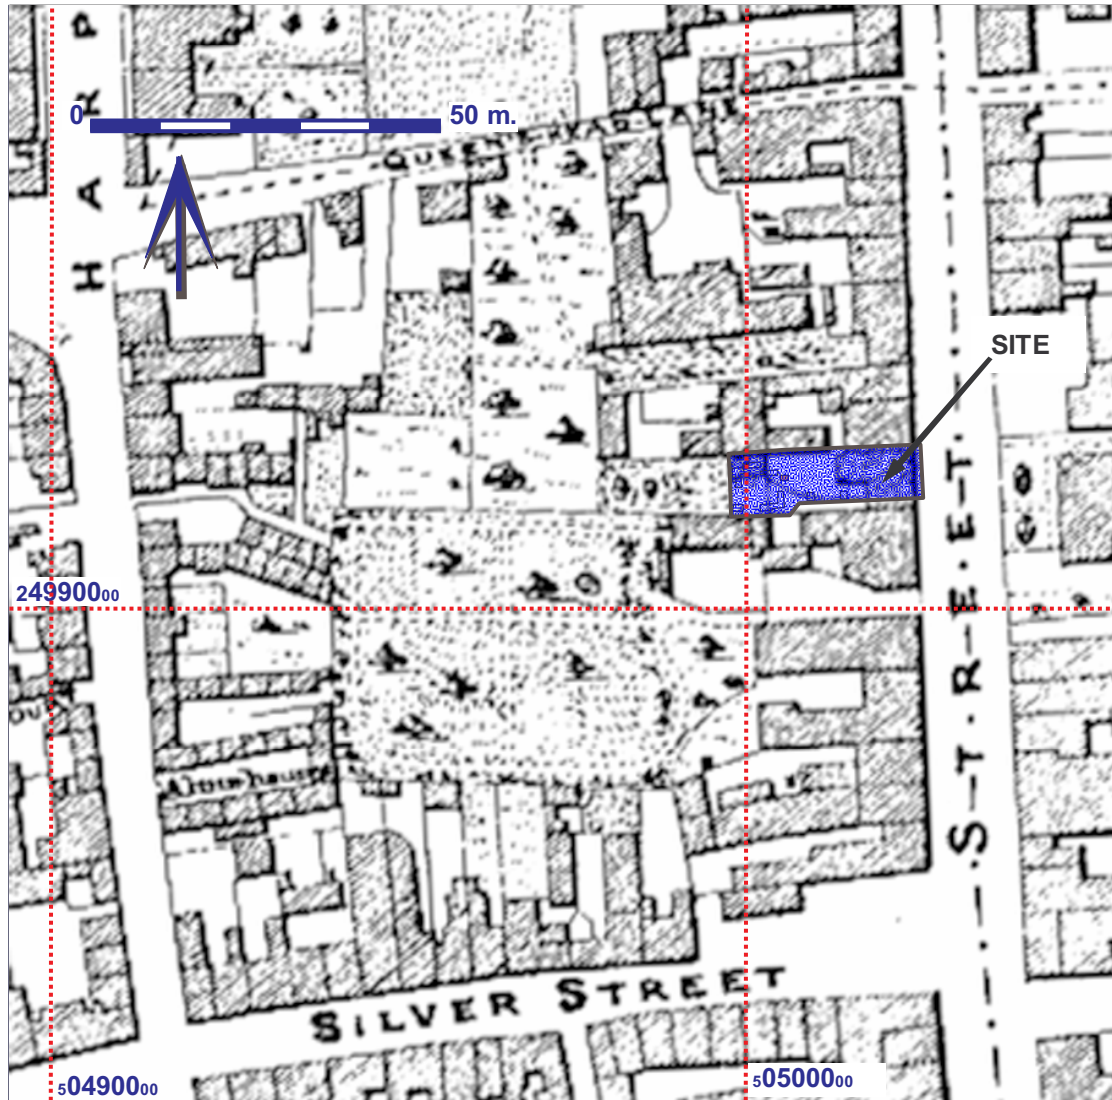
Figure 6: The approximate location of the site in relation to properties depicted on Reynolds's map of Bedford in 1841 (Bedfordshire and Luton Archives and Records Service, ref. X1/88/5)

At 72–74 High Street, the possible subsoil was located *c.* 20m west of the modern street frontage, with the pits between *c.* 22m and *c.* 27m west of the frontage. This area is at the rear of the historic property as indicated by boundaries recorded on 19th-century maps (*e.g.* Reynolds's map of 1841, see Figure 6). The archaeological evidence is admittedly sparse and incomplete, but it is consistent with the sorts of activities that would historically have been undertaken at the rear of tenements, *e.g.* gardening and digging of rubbish pits. The artefacts tentatively suggest that these activities may date back to the early medieval period, but there is insufficient evidence from the present investigation to conclude that present day property boundaries originated in the Middle Ages.
