**LAND TO THE REAR OF HSBC BANK  
53 HIGH STREET  
ALCESTER  
WARWICKSHIRE**

**ARCHAEOLOGICAL BOREHOLE SURVEY**

Project: AL 1419

Document: 2008/110  
Version 1.0

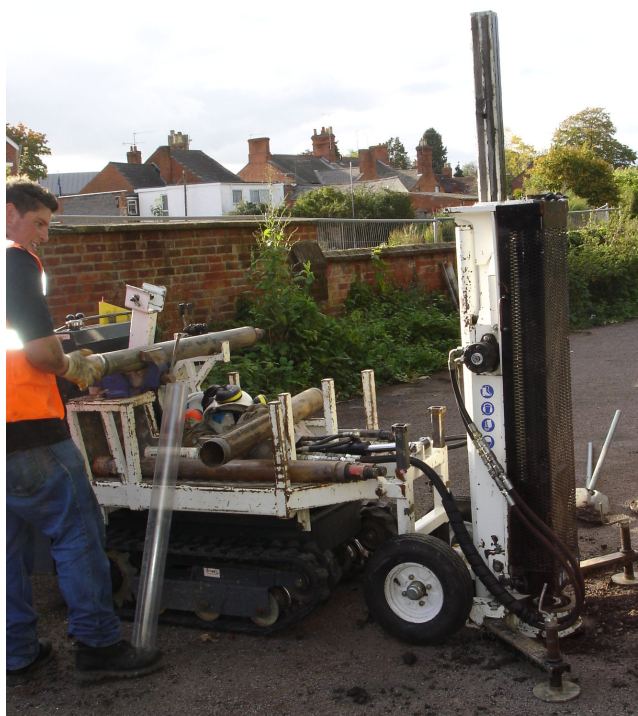
Terrier rig in operation over BH6.

Drilling of the boreholes took place on 8–9 October 2008. A small terrier drilling rig was used for the coring, fitted with a sampler tube containing a plastic sleeve for removing the cores intact (Fig. 3).

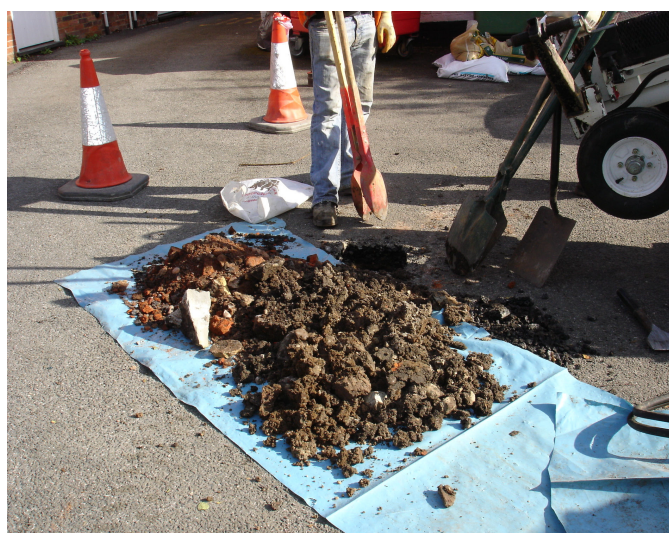
Spoil from the hand-excavated part of BH4 laid out for checking.

Initially, a 0.3 x 0.3m pit was excavated by hand to a depth of 1.1–1.2m in order to avoid any unknown services; the excavated deposits were laid out in sequence on a plastic sheet and checked for archaeological finds (Fig. 3). Excavation of the pit for BH5 revealed a modern layer of gravel at a depth of 0.85m, indicating the presence of a service trench associated with the water culvert that crosses the site (White 1984); the position of the borehole was therefore relocated (BH5a).

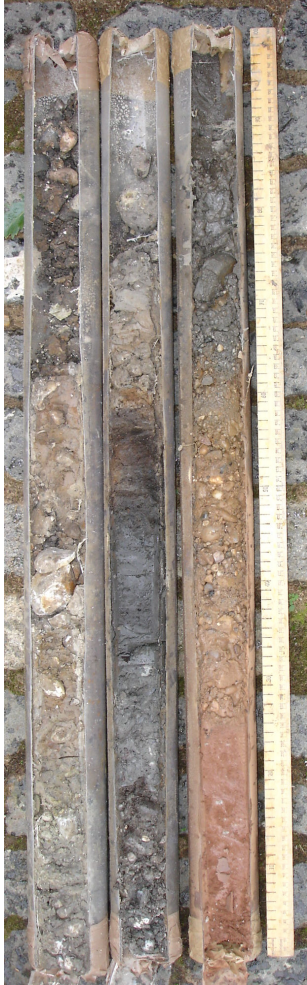
BH1: cores from 1.2–4.0m depth (left to right). Peats are present in the centre of the second core.

BH1 Core 2 (2–3m below ground level)	
Depth (cm)	
0–20	Empty
20–40	Dark grey silty clay loam with freq. quartz pebbles up to c. 5cm in diameter. Browning to base
40–53	Dark brown peat. Silty towards base
53–68	Very dark grey organic silt with visible organics
68–80	Grey, slightly clayey, silty, sandy gravel with quartz pebbles up to c. 3cm in diameter (disturbed terrace gravel)
80–90	Grey, organic, silty, sandy, quartz gravel (disturbed terrace gravel)
90–100	Sandy quartz gravel (top of undisturbed terrace gravel)

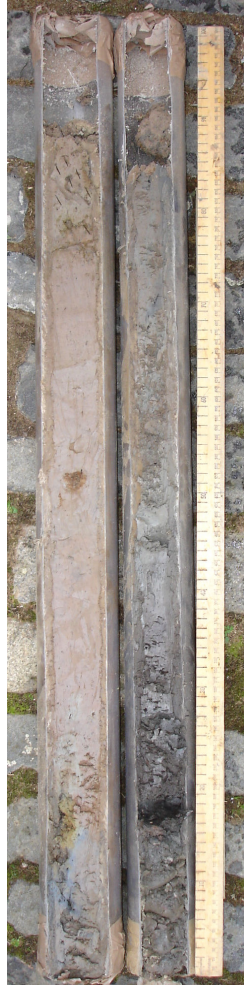
BH4: cores from 1.2–3m (left to right). An organic silt horizon is present towards the base of core 2 (the small hole is where a wood sample was removed).

BH4 Core 2 (2–3m below ground level)	
Depth (cm)	
0–17	Empty
17–32	Grey clay with very dark grey clay patches
32–45	Brownish grey, slightly silty clay
45–62	Grey, silty clay – fine
62–73	Dark grey silty clay with patches of organics
73–84	Dark brownish grey silty clay. Very organic. Wood at base, sample taken at 83cm for potential C14
84–100	Quartz gravel in silty sandy clay. Pebbles up to c. 8cm in diameter (top of terrace gravels)

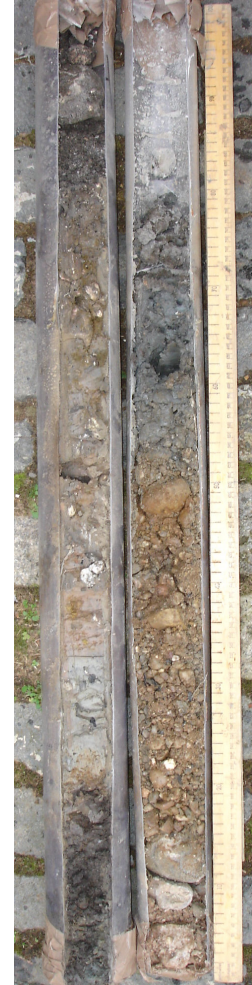
BH7: cores from 1.2–3m (left to right). An organic silt horizon is present at the base of core 1

BH7 Core 1 (1.15–2m below ground level)	
Depth (cm)	
0–15	Dug out
15–19	Building stone
19–47	Grey, slightly silty clay. Freq. pebbles up to <i>c.</i> 7cm in diameter. Patches of brownish yellow sandy clay.
47–58	Grey, slightly silty clay, stiff, with patches of brown clay. Freq. pebbles up to <i>c.</i> 3cm in diameter. Small amount of charcoal
58–66	Brown clay with patches of iron stained roots
66–82	Grey, slightly silty clay with a few pebbles up to <i>c.</i> 3cm. Patches of dark grey clay. Thick patch of iron-stained roots at base
82–93	Very dark grey/brown, organic, slightly clayey silt
93–100	Grey, organic, clayey silt. Patches of brown, organic, clayey silt
