**LAND AT BROMHAM MILL
STAGSDEN ROAD
BROMHAM
BEDFORDSHIRE**

**ARCHAEOLOGICAL
FIELD EVALUATION**

Project: BM1425

Document: 2008/94
Version 1.0

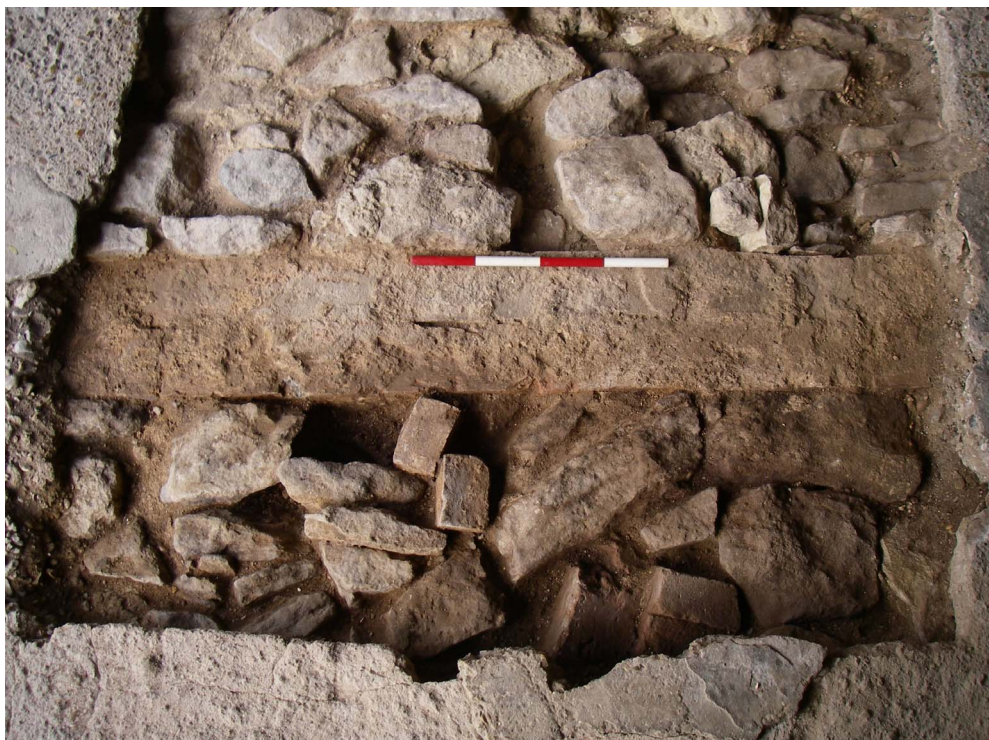
Plate 2: Trench 7 showing detail of wall (704) and post-pipe [706].
40cm scale

In Trench 7, the removal of the modern surfaces revealed a wall (704) and three surfaces (701, 702 and 703) the latter forming part of the packing for a post (707). N-S wall (704) was two courses wide and made of regularly laid post-medieval, un-frogged brick with occasional strengthening courses laid perpendicular to the line of the wall (Plates 1 and 2). The wall was in line with an extant above-ground supporting timber for the hovel roof and may be associated with an internal division related to this support position.

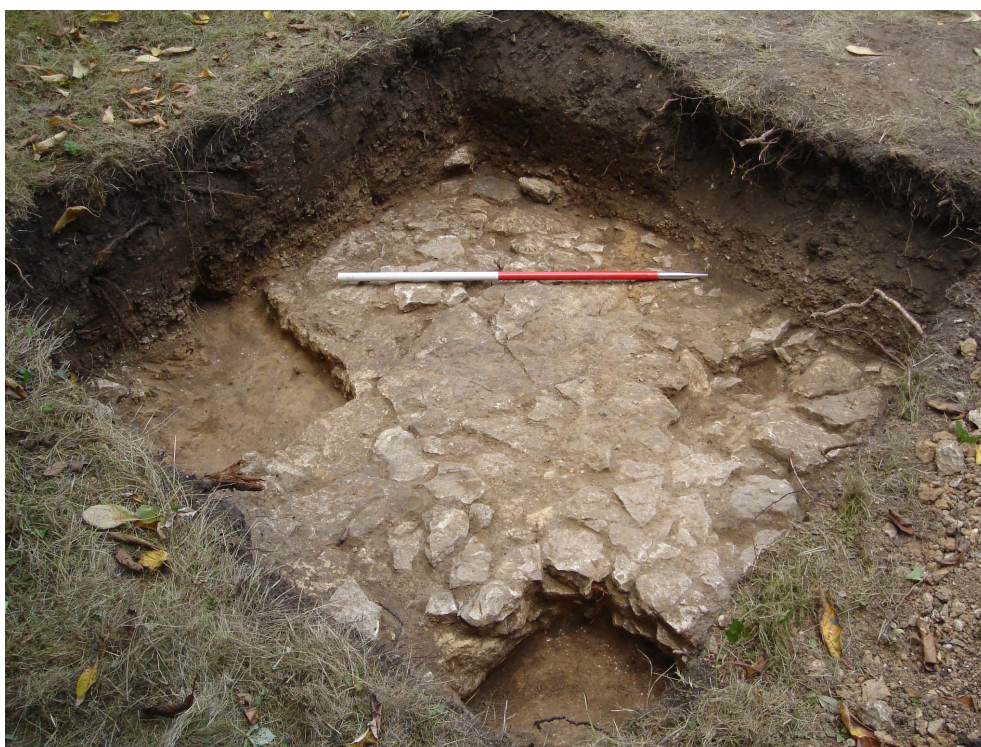
Plate 3: Trench 1 looking NE showing walls (107) and (108/109). 1m scale.

Structural remains comprising two abutting walls and two internal surfaces were revealed in Trench 1 (Fig. 2, Plates 3 and 4). Wall (107) was aligned E-W and formed a 'cross' shape with N-S aligned wall (108/109). Two internal surfaces (112 and 113), divided by the internal continuation of wall (107) were identified to the east of wall (108/109).

The western extent of wall (107) had four courses in total and was between four and five stones wide (maximum 0.84m). It appears to have formed an external wall projecting westwards at right-angles to wall (108/109). Its eastern (internal) extent was thinner (0.3m-0.5m) and almost indistinct against the limestone surfaces abutting it. It appears to form an internal division between surfaces (112) and (113). Wall (108/109) was three courses high and three to four courses wide (0.64m-0.7m). Both walls were constructed using roughly hewn limestone blocks set in uneven courses with a lime mortar bonding.

Both walls had been robbed out or demolished to the same level as the internal surfaces (112 and 113). This was evinced by several thin layers of demolition tumble (110 and 116) directly overlying the walls and internal surfaces. One of these (110) contained fragments of animal bone (Appendix 1). The level to which the walls were reduced may represent the ground level at the time of demolition. Abutting the east side of wall (108/109) was a surface consisting of rough-hewn limestone blocks into which (107) projected. Surface (112) had suffered a small amount of *in situ* burning which may relate to the use of the structure.

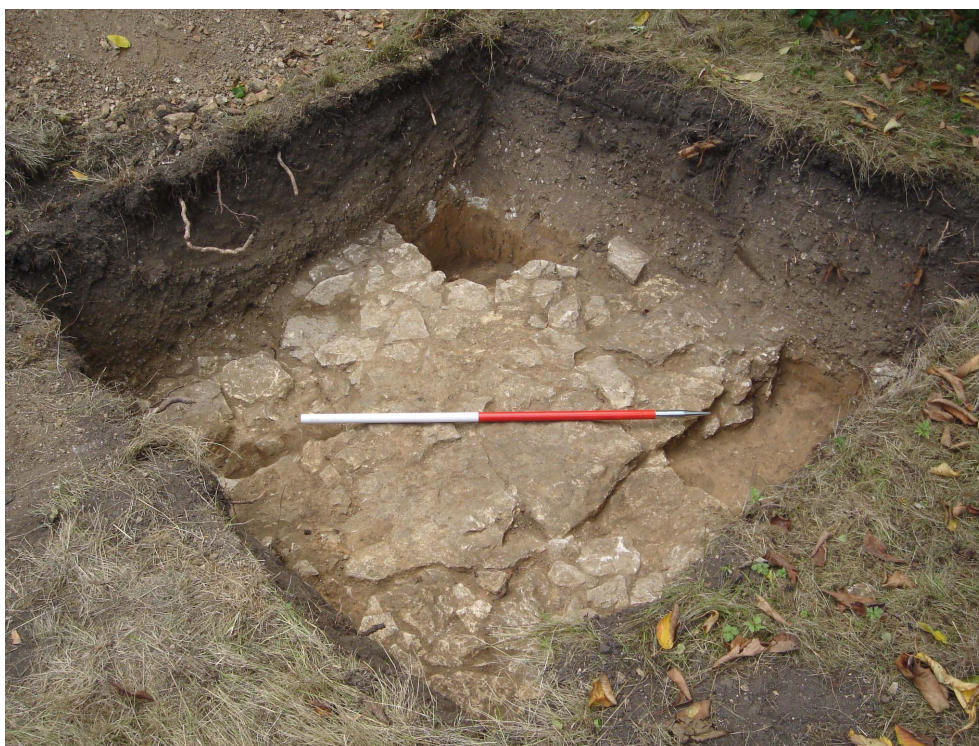
Plate 4: Trench 1 looking SW showing walls (107) and (108/109). 1m scale.

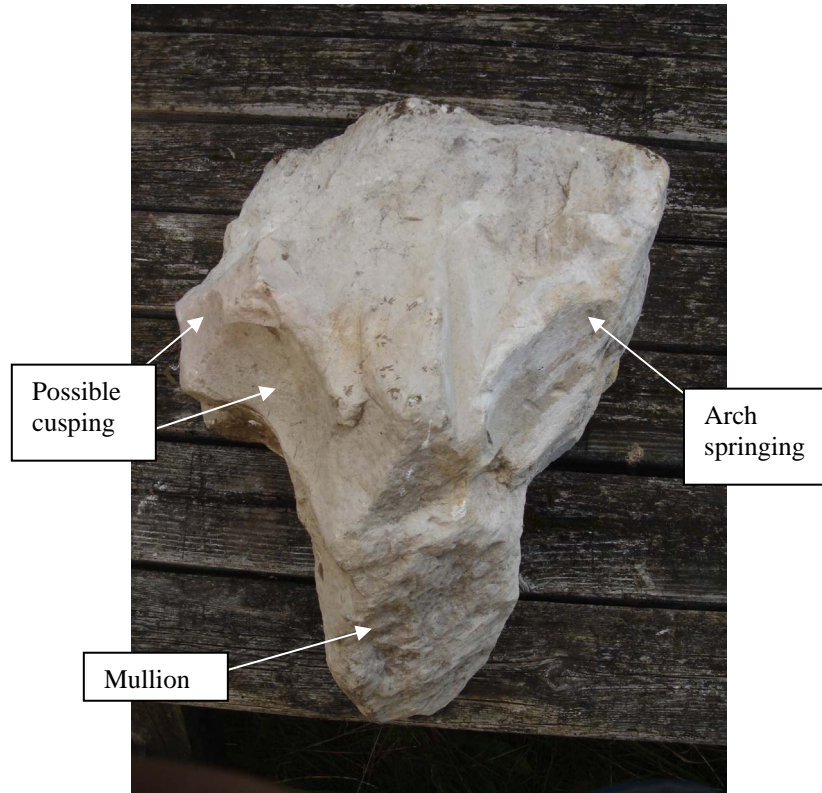
Plate 5: Fragment of window head with mullion to the bottom of the frame.

shown in Plates 5 and 6 is a fragment of a window head in the perpendicular style, comprising part of a mullion and traces of arch springing with glazing grooves on both sides with possible remains of cusping on the left (Phillips 2008 *pers. comm.*). These pieces are not necessarily ecclesiastical in origin, although their presence near the purported site of the chantry chapel adds weight to Harvey's claim that its remains were sealed into the mill house wall.

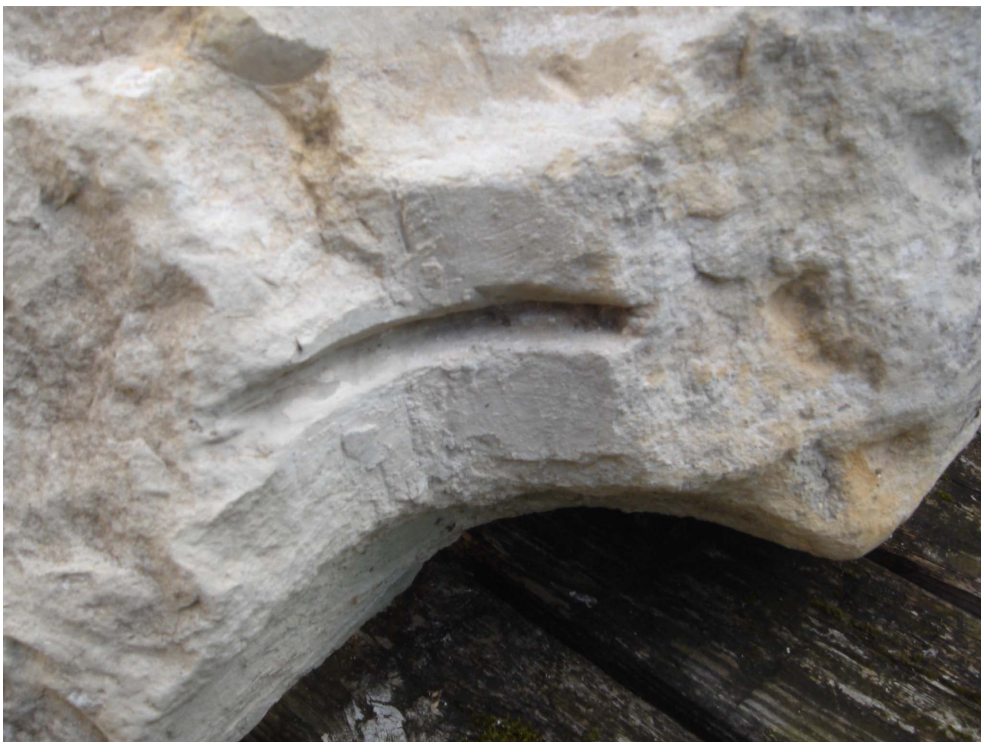
Plate 6: Close-up of window head fragment detailing glazing groove.

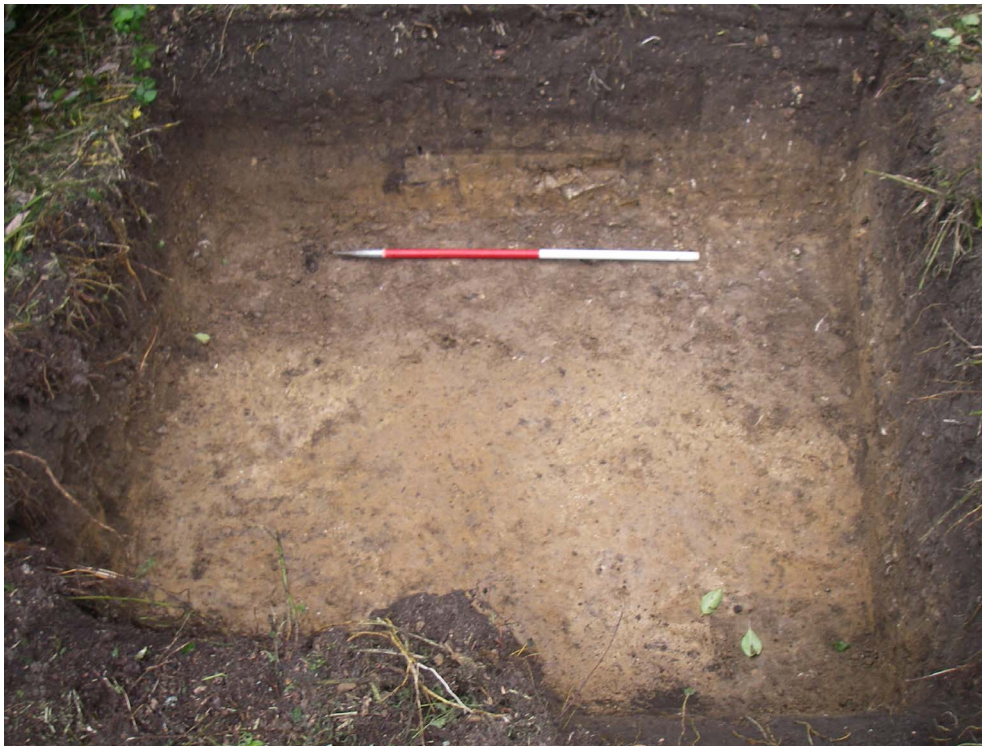
Plate 7: Trench 2 looking WSW showing ditch [203] prior to excavation.
1m scale.

A single ditch [203] aligned broadly N-S was encountered in Trench 2 (Fig. 2, Plate 7). It was filled by deposits partially derived from garden soils. Deposit (205) produced one sherd (weighing 8g) of 17th-18th century pottery and five fragments (weighing 292g) of flat roof tile of a similar or later date (Appendix 1). These artefacts are considered to be residual. Ditch [203] was partially truncated by modern rooting [206] probably associated with the use of the mill house garden. This ditch may represent a plot boundary predating the current walled boundary of the mill house garden, or an internal division associated with the mill house.

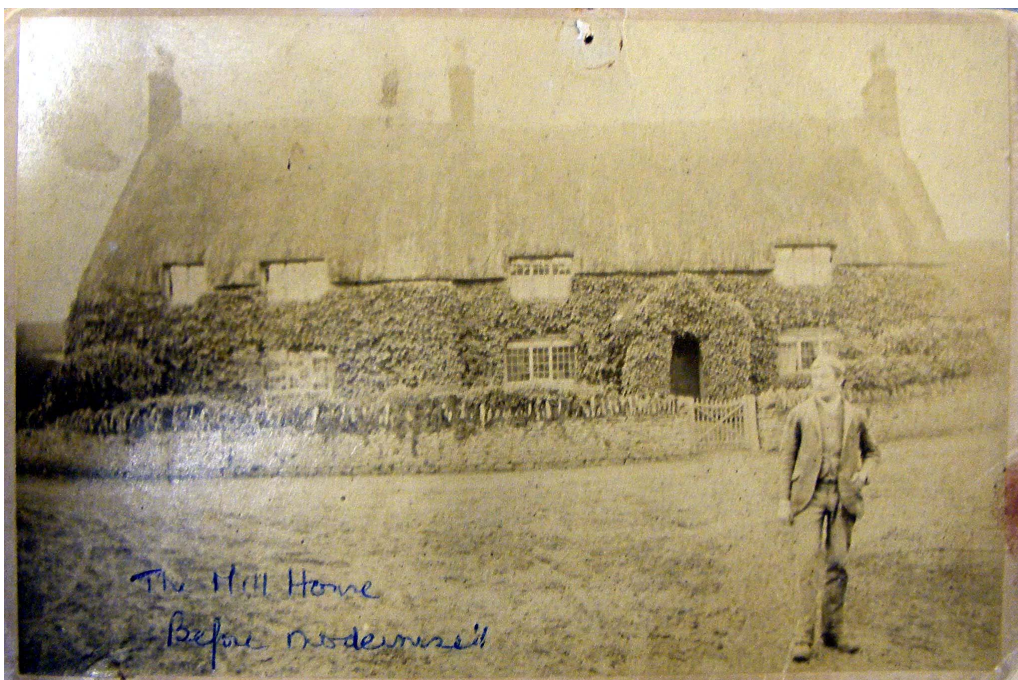
Plate 8: Photograph (Z233/1) c. 1880 of Bromham mill house prior to the 1905 demolition of the south wing (shown to the left of the picture).

Bromham chantry chapel then disappeared from history until 1872 when W. M. Harvey, in his history of the 'Witley Hundred' claimed that the remains of the chapel were at that time visible within the (since demolished) southern wall of the mill house (Plate 8):
