**WREST PARK  
HYDROLOGY RESTORATION PROJECT  
SILSOE  
BEDFORDSHIRE**

**ARCHAEOLOGICAL WATCHING BRIEF**

Project: WP1221  
Document: 2006/117  
Version: 1.1  
12<sup>th</sup> October 2007

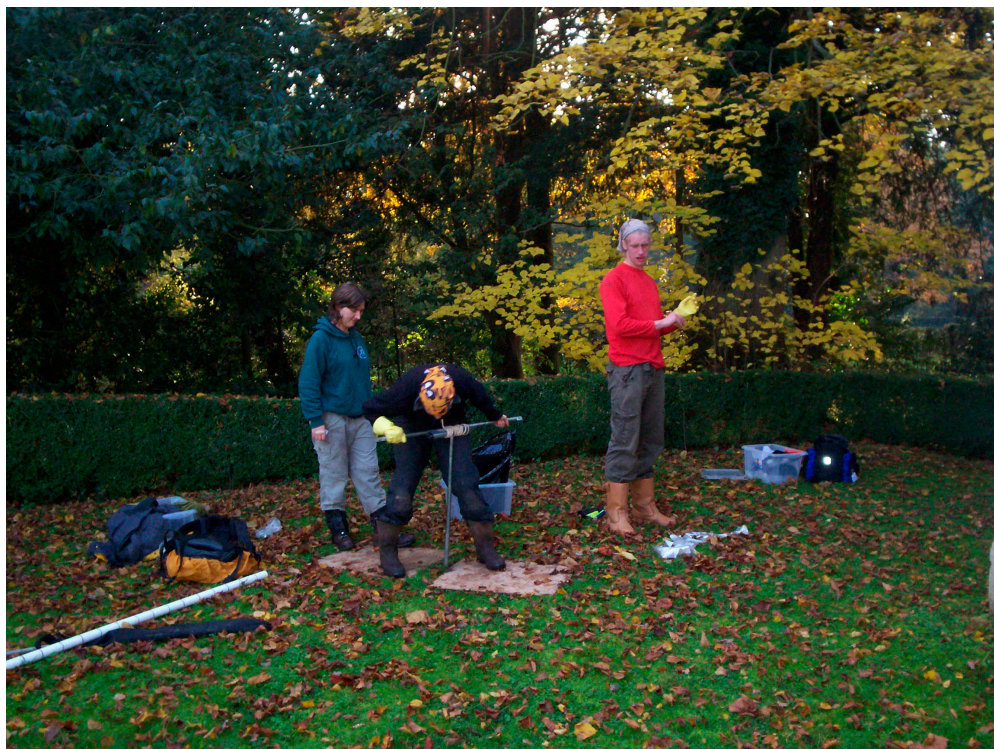
**Figure 3:** Auguring in progress, November 2006

Due to difficult ground conditions, none of the proposed standard wells were undertaken and only the 11 automated groundwater wells were completed (Figure 2). The auguring for the latter was undertaken by Haycock Associates (Figure 3) and recorded by Albion staff between 13<sup>th</sup> and 17<sup>th</sup> November 2006.

- 1 All boreholes were cored by hand using an auger of 20mm diameter.
- 2 Each borehole consisted of 10–15 cores, c. 200mm in length. Each core was individually sealed and logged. The maximum depth of the boreholes was 2.0m.
- 3 A box measuring 0.30 x 0.30 x 0.20m was excavated by hand, close to each borehole for the installation of the digital monitoring equipment. After installation of the equipment it was covered with the excavated turfs.
- 4 The nature of deposits encountered in each borehole and equipment box and their depth below ground level was recorded in accordance with Albion Archaeology's *Procedures Manual*.
- 5 All disturbed soil was scanned for artefacts.
- 6 All archaeological observations were recorded at a scale of 1:10 on base plans that were tied in to the OS national grid using a handheld GPS device.

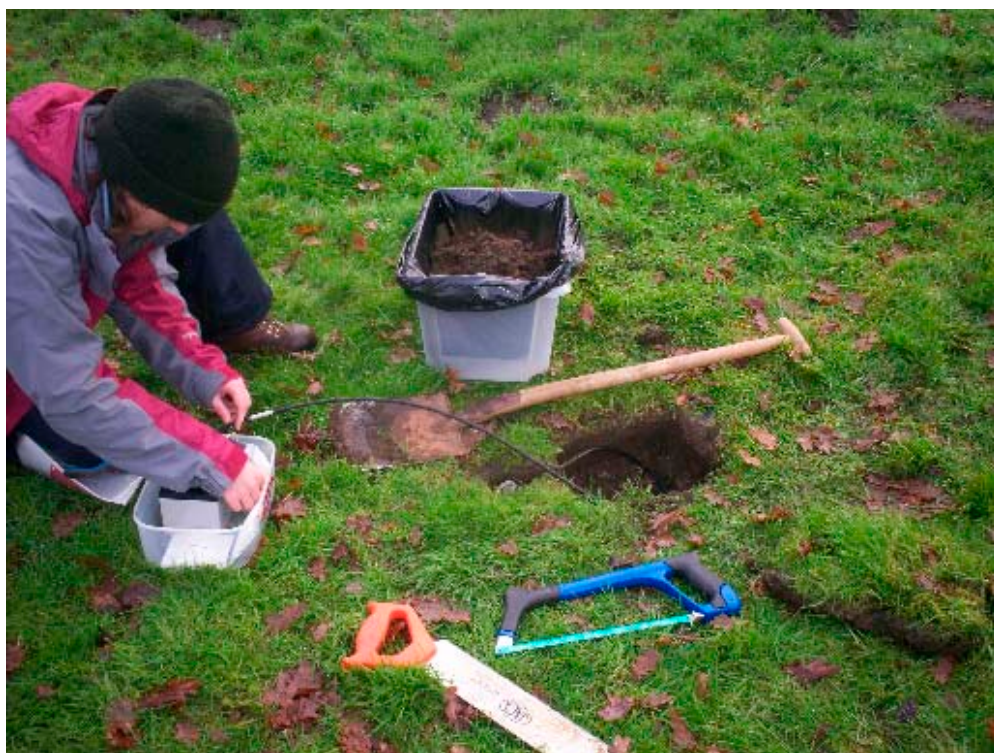
**Figure 4:** Installation of monitoring equipment, January 2007

On 8<sup>th</sup> January 2007, a further watching brief was undertaken for the installation of the boxes for the digital monitoring equipment (Figure 4). The installation of equipment box AG56 was delayed due to the waterlogging of the site.
