**EDF SUNDON TO BEDFORD PYLON  
FOUNDATION REPLACEMENT WORKS**

**ARCHAEOLOGICAL OBSERVATION AND  
INVESTIGATION**

Project: SB1438

Document: 2009/70  
Version 1.0

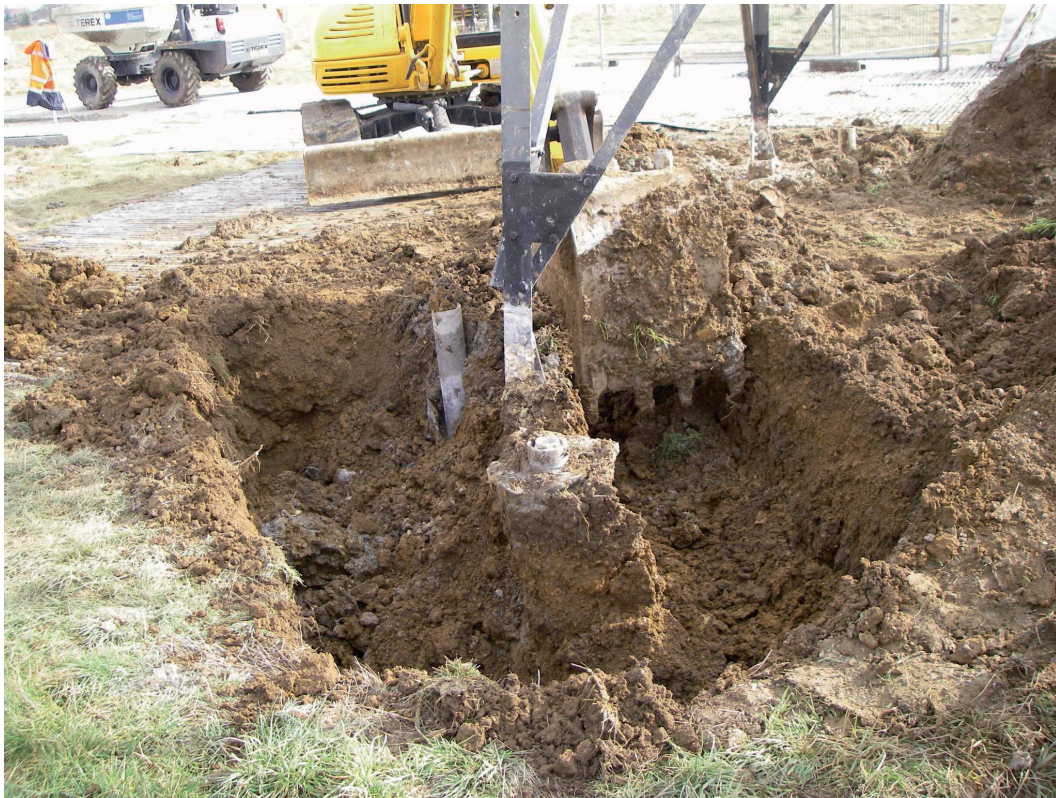
**Figure 2:** Pylon 147. Machine excavation of foundation pit

Each existing pylon comprised a four-legged steel lattice tower. The foundation works comprised the installation of two piles on either side of each of the four existing pylon legs. A rectangular pit was then excavated around each pylon leg and associated piles followed by the installation of a concrete cap (Figures 2 and 3).

The rectangular pits were dug by machine with an archaeologist in attendance to monitor the works. The works were recorded using Albion Archaeology's *pro forma* sheets and planned and photographed as appropriate.

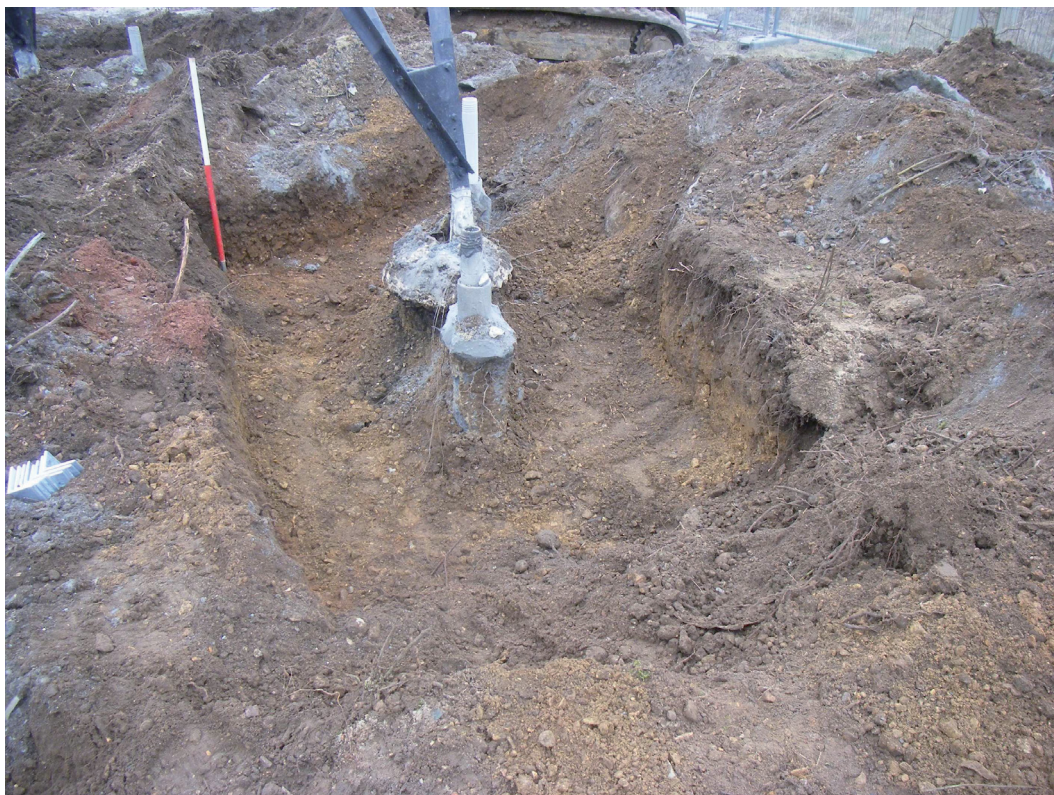
**Figure 3:** Pylon 145. Excavated foundation pit showing piles and existing pylon leg

A total of 16 rectangular pits excavated around the legs of four pylons were monitored during February and March 2009. Each pit measured approximately 3m x 2m x 0.70m deep. Where present, around 0.15m of topsoil overlay 0.20m of subsoil. Beneath this were geological deposits of orange gravel and sand.

The majority of the deposits revealed within each of the pits represented backfill material deposited during the installation of the existing pylon leg foundation. Only at the extremities of the pits were *in situ* soil and geological deposits identified.
