**ST MARY'S CHURCH
FELMERSHAM
BEDFORDSHIRE**

**ARCHAEOLOGICAL OBSERVATION
AND INVESTIGATION**

Project: SMF1311

Document: 2009/62
Version 1.0

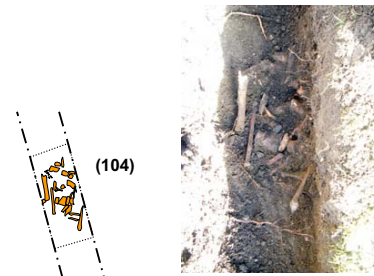
Human remains (104)

To the north of the individual burials a cluster of disarticulated remains representing at least four individuals (104) was uncovered at a depth of 0.20 - 0.60m. The remains included four skulls and numerous long-bones. Again, no grave cut was visible but the remains were most likely contained within a single pit.

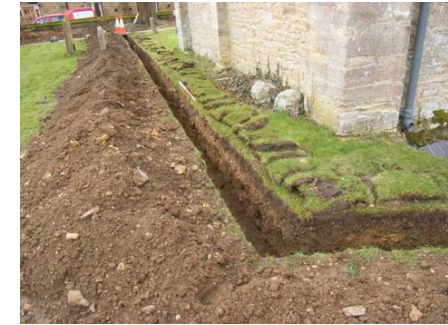
Trench along east wall of Chancel.
Looking south

In the section of trench adjacent to the east wall of the chancel, a mid yellowish grey layer with frequent inclusions of mortar and limestone (101) was visible just below the topsoil.

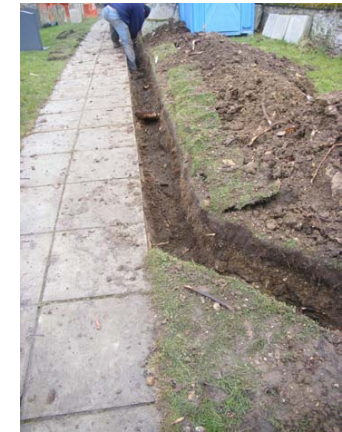
Trench beside path.
Looking south west
