**BATTLEDEN HOUSE
BEDFORDSHIRE**

**ARCHAEOLOGICAL
FIELD EVALUATION**

Project: BH 1506

Document: 2009/41
Version 1.0

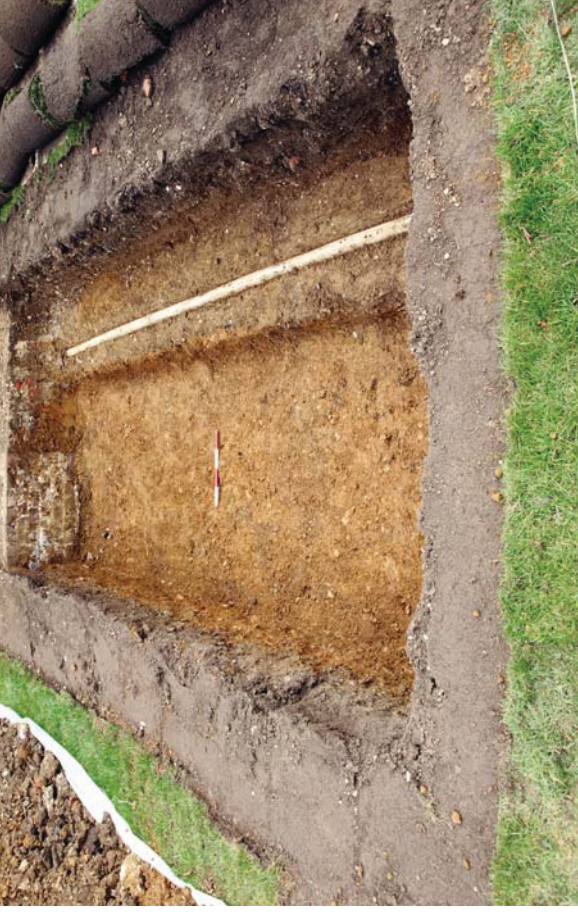
Trench 1 contained a brick-built man-hole shaft with a cast iron cover, probably constructed as part of the conversion of the stable blocks into the extant house. A pipe trench [106] containing a lead water pipe of probable 19th-century origin was also identified heading WNW out of the house (Fig. 2).

Trench 1 looking south-east. Scale 40cm

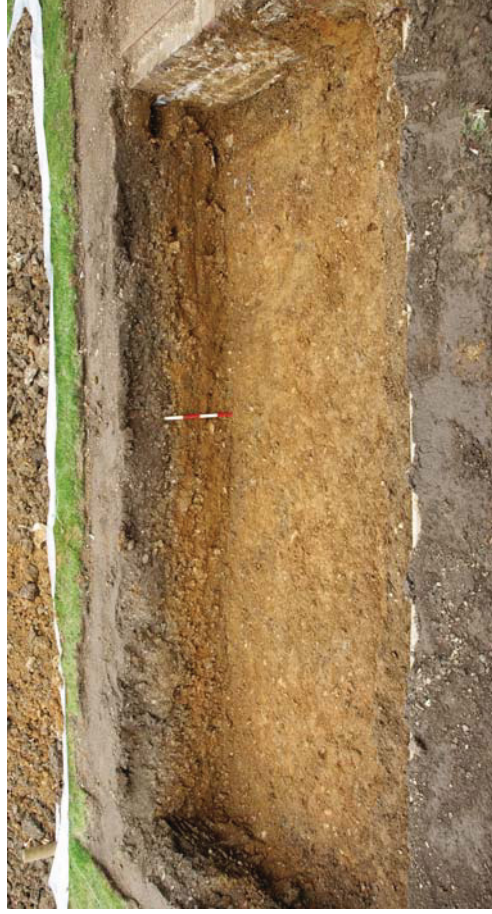
Trench 1 looking north-east. Scale 40cm

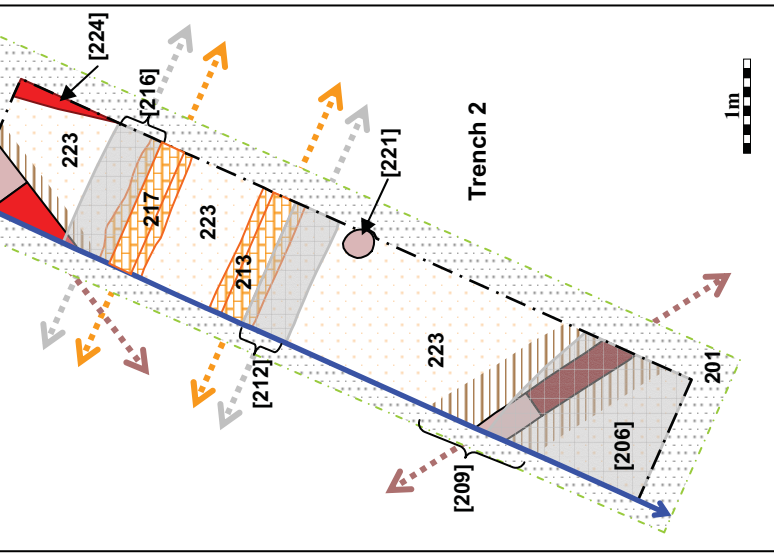
Remains in Trench 2 comprised two modern service trenches [209 and 219], a machine-dug posthole or borehole [221] and a pit [206] containing modern domestic refuse including glass and ceramics (Fig. 3). Trench 3 also contained two modern service trenches [307 and 314] and a small pit [309] which contained modern CBM (Fig. 4). Pits [206 and 309] may be associated with construction and/or demolition works in the 19th and 20th centuries.

Ditch [209] looking

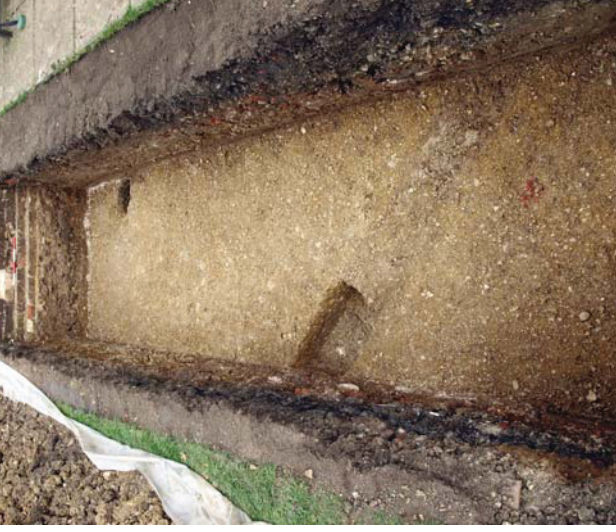
Trench 2 looking north-east.

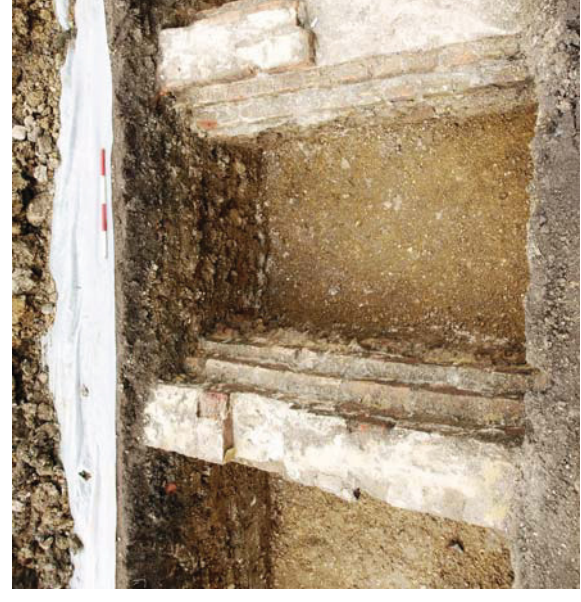
Two parallel foundation walls [213] and [217] were encountered in Trench 2 (Fig. 3). They were aligned broadly E-W and were constructed of evenly coursed, machine-made, frogged bricks. They are likely to represent the walls of a structure shown jutting out from the western side of the stable blocks (the extant Battlesden House) on the 1901 2nd edition Ordnance Survey map (Fig. 6). This structure also appears on the 1926 3rd edition Ordnance Survey map (Fig. 7). It was demolished some time after 1926, possibly during the conversion of the stables.

Walls 213 and 217 looking north-west. See

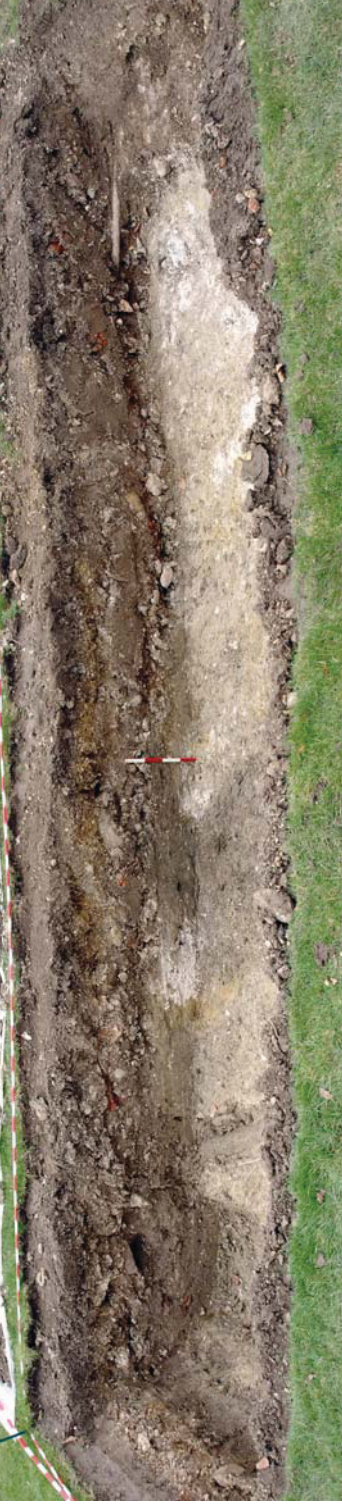
A broadly N-S aligned ditch [304] and a possible pit [309] were encountered in Trench 3 (Fig. 4). The deposits within the ditch contained modern ceramic materials; it is likely to be associated with a trackway or path shown on the 1st edition Ordnance Survey map (Fig. 5). This path lay to the east of the late 19th-century Battlesden House, leading from the then stable block to a larger path that ran towards the front of the main house.

Trench 3 looking north-east. Scale 40cm

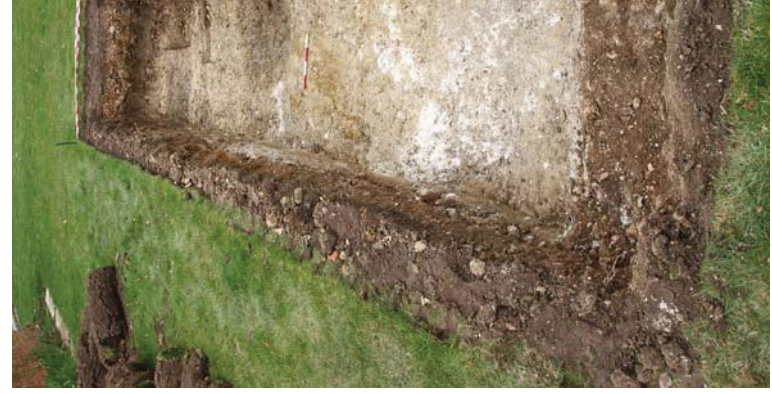
Trench 3 looking south-east
