**LAND AT 13-21 OLNEY ROAD, LAVENDON,  
MILTON KEYNES**

**ARCHAEOLOGICAL  
FIELD EVALUATION**

Document: 2005/3  
Project: LOR 1044

10<sup>th</sup> January 2005

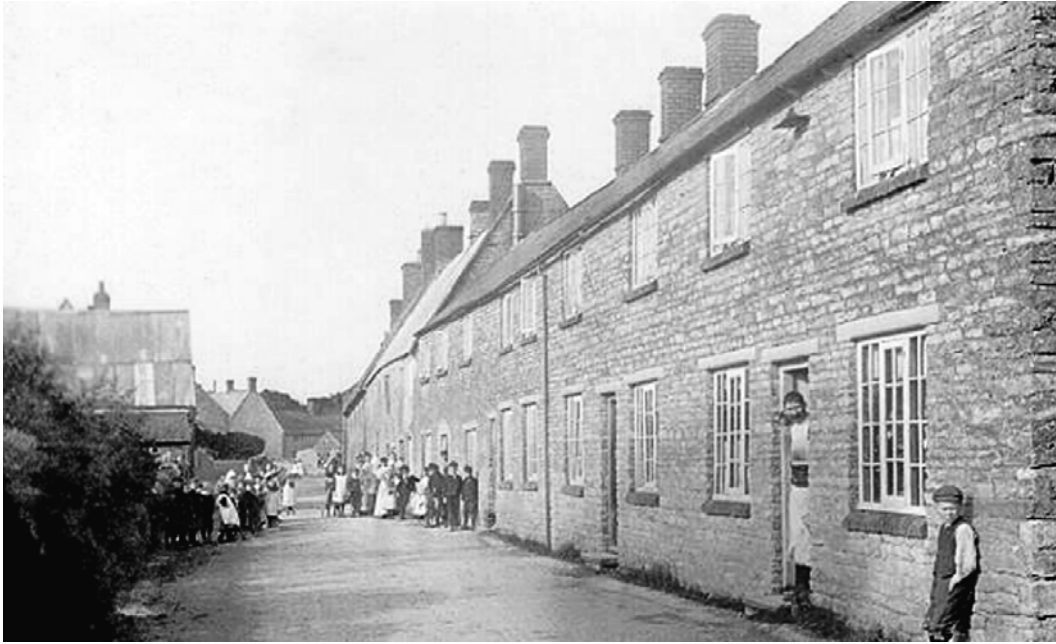
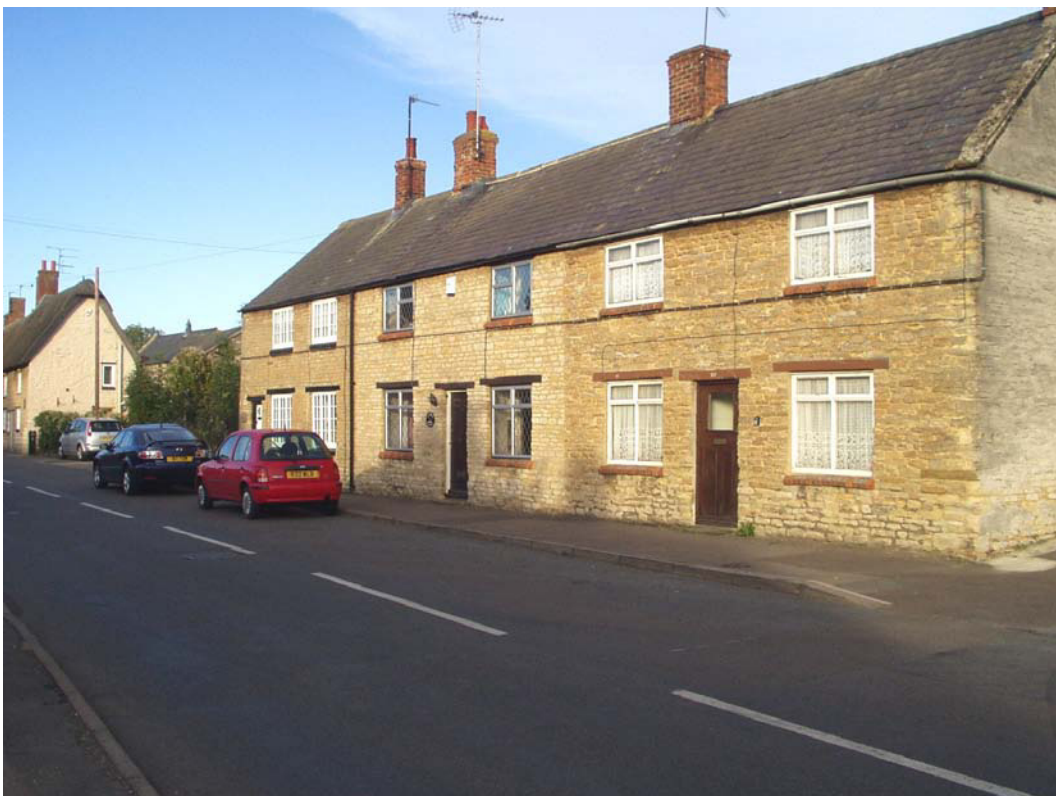
**Figure 3:** Photographic comparison of old and recent views of the street frontage

The complete row of cottages looking towards the center of the village. The taller gable to the center of the image defines the northern limit of current site. Reproduced with kind permission of the Centre for Buckinghamshire Studies (Image Lav 033)

General view of remaining cottages immediately prior to site clearance in 2004. The gable end of the building at the left side of the image corresponds to the taller gable in the upper image.

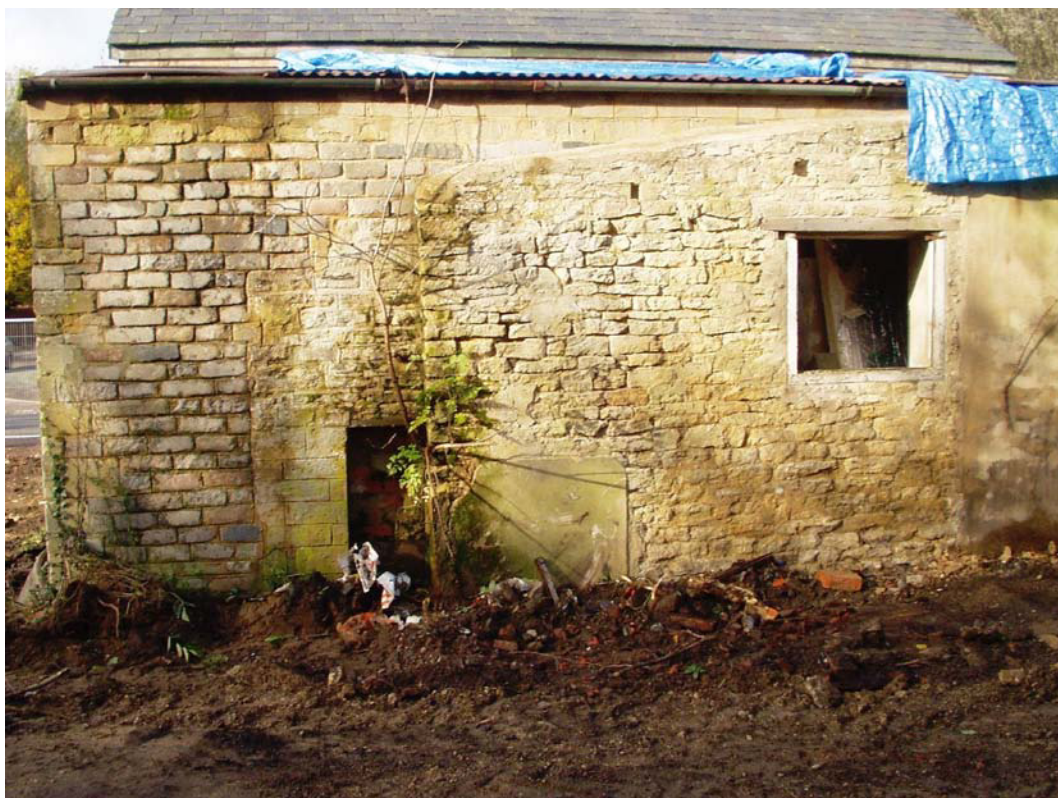
Photograph 1 Eastern elevation of shed, showing incorporation of earlier limestone outbuilding.

The northern margin of the site was occupied by two 'sheds' associated with the Highways depot. However, inspection indicated that the fabric of the sheds incorporated earlier limestone structures which had been enlarged and heightened with modern building materials for their new role in the depot. The original limestone structures were 5.2m wide extending from the northern limit of the site. The elevations indicated sloping roofs 2.5m high in the north dropping to 2.1m in the south (Figure 4: photographs 1 and 2). These structures correspond to outbuildings depicted on the 1882 Ordnance Survey map (Figure 2). The original southern extent would have defined a roughly 6 foot wide passageway, allowing access to the rear to the area. The continuation of this row of outbuildings could be detected in the eastern boundary wall of the site. A contrast in the construction of this wall in the south, possibly suggests a blocked access to the area further east.

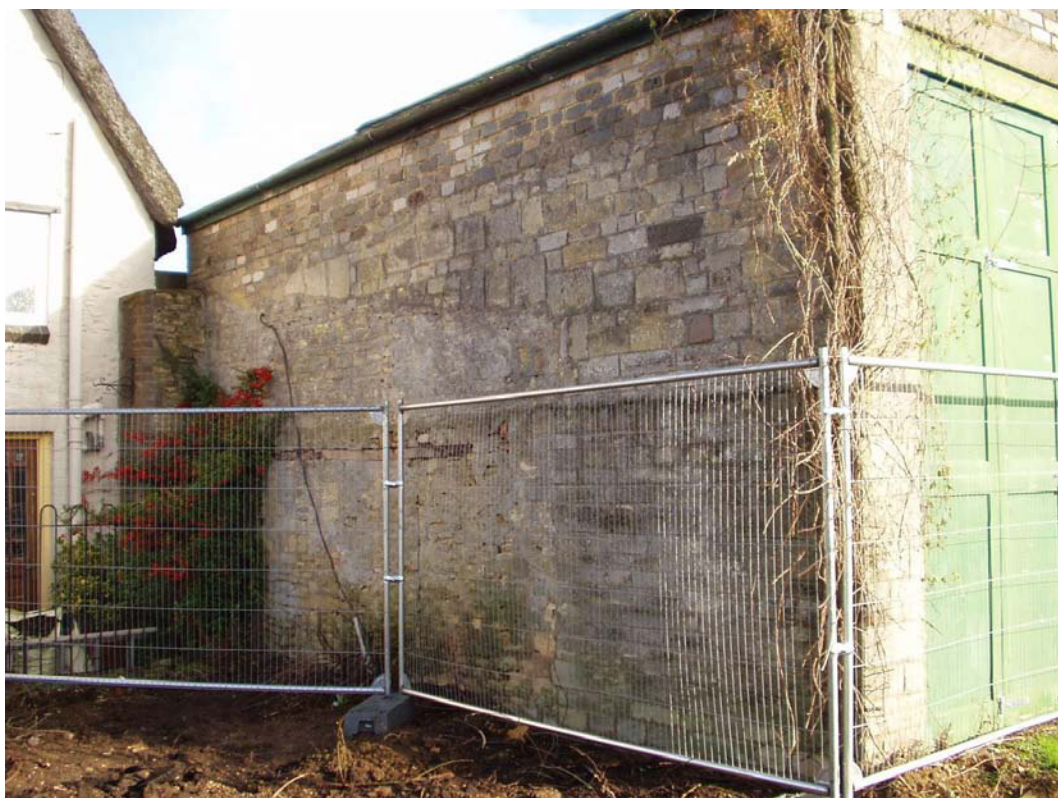
Photograph 2 Western elevation of standing structure showing earlier limestone building incorporated into shed.

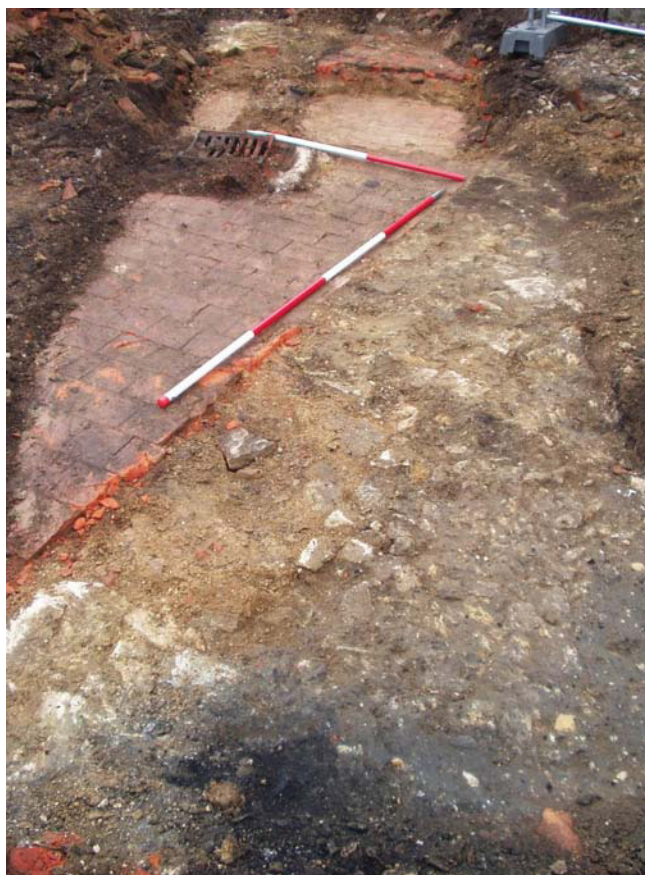
Photograph 3 Structural elements of northern cottage within Trench 1, with lower floor revealed beyond drainage grid. Scales 2m and 1m in 0.5m divisions.

All of the walls had been carefully robbed to the level of the upper tiled surface (101), (103), without significant disturbance to this horizon (Figure 6: photograph 3).

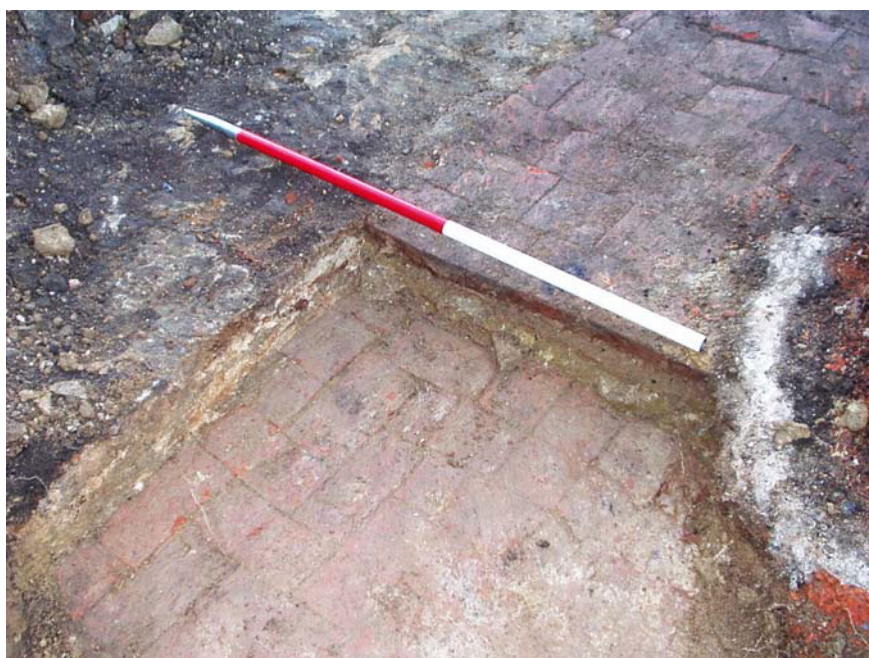
Photograph 4 Detail of sequential floors (103) and (105) in Trench 1, separated by intermediate layer (104), with several courses of limestone of rear wall (108) exposed to left. Scale 1m in 0.5m divisions.

The tiles of (103) were laid on onto a yellowish brown clay 0.07m thick (Figure 6: photograph 4). To the southern margin of the excavated section the clay was approximately 0.05m thick, with a deposit of granular lime mortar directly beneath the upper tiles (103). No artefacts were recovered from this layer, which directly overlay the lower tiled surface (see section 2.3.2.1.4 below).

An area measuring approximately 1.6m by 1m of the lower tiles floor (105) was exposed (Figure 5 and Figure 6: photograph 4). This floor contrasted with the upper tiled surface in that it showed evidence of wear, with traces of lime mortar adhering to the upper surface of the tiles (Figure 6: photograph 4). The surface was undulating with a distinct linear depression parallel to the rear wall (108). The rectangular tiles 0.22m long by 0.10m wide by 0.03m thick (8½ by 4 by 1¼ inches) were laid onto make-up layers (115/116). The tiles were aligned east-west in a staggered bond, across the width of the rear room. A distinct break in this pattern was visible as a band extending up to 0.5m from the inner face of the rear wall (108). In this area the arrangement of the bonding was slightly more irregular, though with a distinct western limit which coincided with an area of settling of the tiles (Figure 6: photograph 4). A section of tiles in this area was removed in order to investigate the cause of this settling.

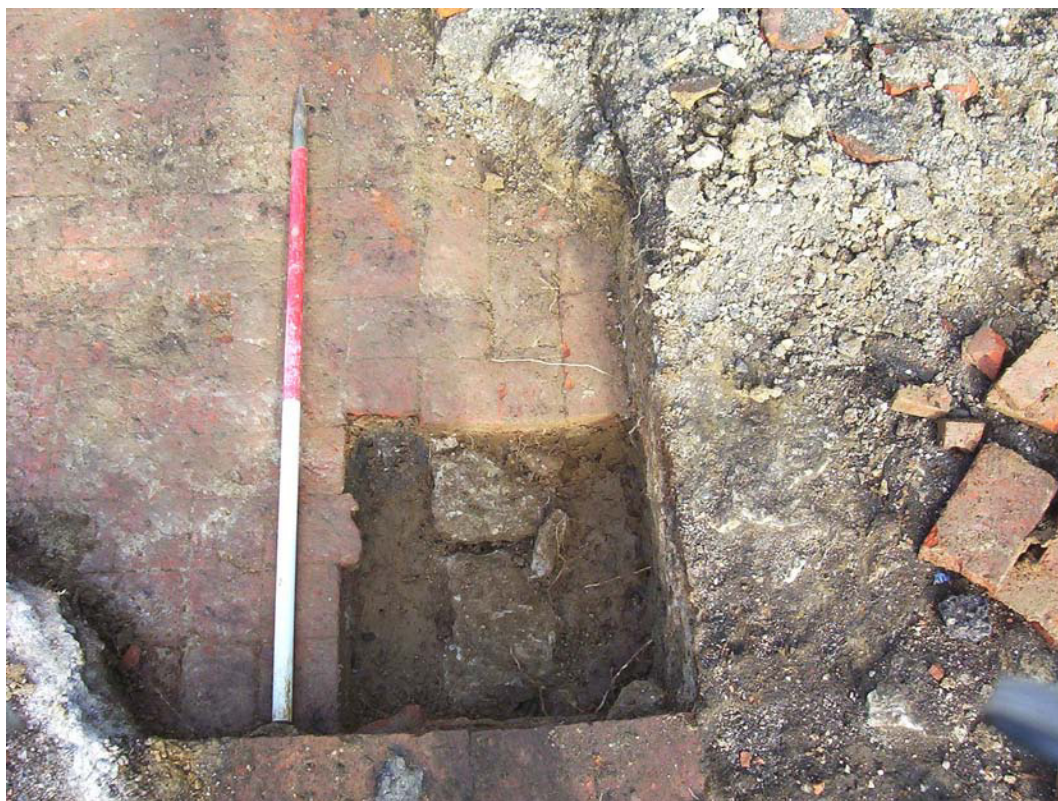
Photograph 5 Limestone capping (113) of drain [112], with distinctive arrangement of tiles of lower floor (105). Scale 1m in 0.5m divisions

Removal of a section of the lower tiled surface (105) revealed a silty clay (115) generally 0.08m thick. This deposit covered the limestone capping (113) of a drain of V-shaped profile, 0.13m wide and 0.08m deep (Figure 7: section 1 and Figure 8: photograph 5). This was aligned parallel to the rear wall (108) of the cottage.

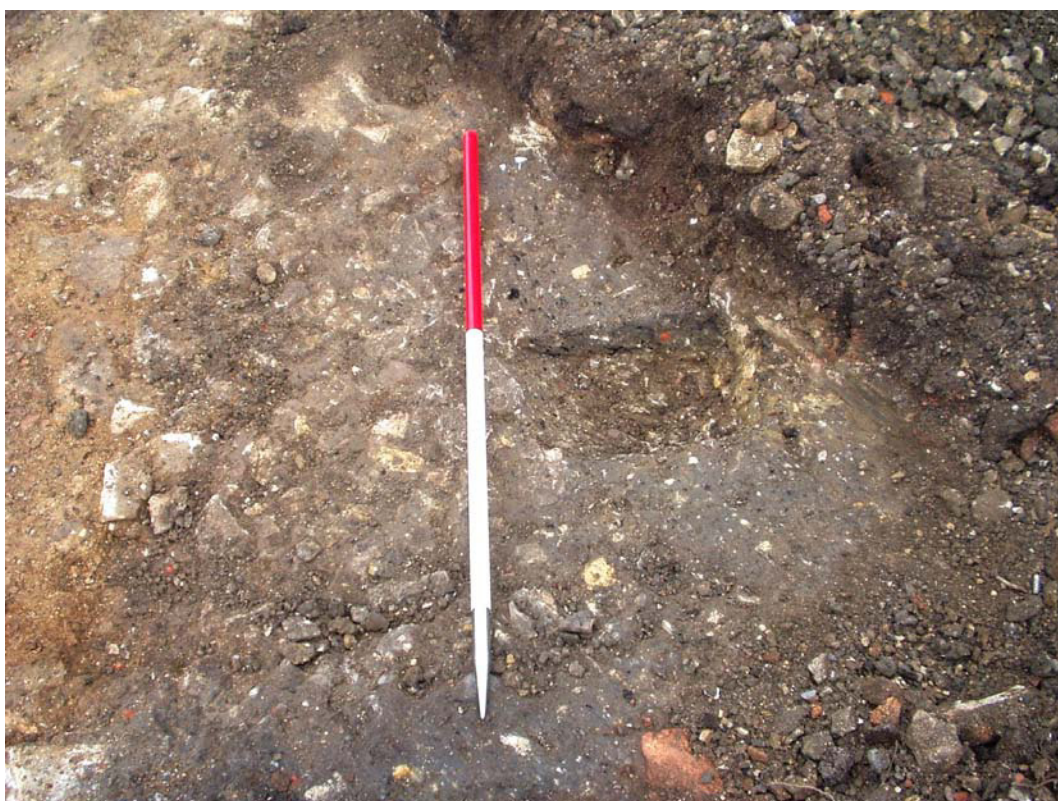
Photograph 6 Shallow ditch [110] truncating external surface (109) with rear wall of northern cottage (108) to left. Scale 1m in 0.5m divisions

To the east of the rear wall of the cottage was an external surface (109), consisting of small to medium sized fragments of slabby limestone in a red

brown silty clay matrix (Figure 8: photograph 6). This had been truncated by a shallow ditch/gully [110] 0.7m (2 foot 4 inches) from and parallel to the rear wall of the cottage (Figure 5). In section the feature had an asymmetrical profile 0.32m across and 0.1m deep, filled with mid greyish brown silty clay. Modern artefacts, including two undiagnostic pottery sherds (10g), roof tile fragments (19g), window glass (1g) and animal bone (3g), were recovered from the feature.

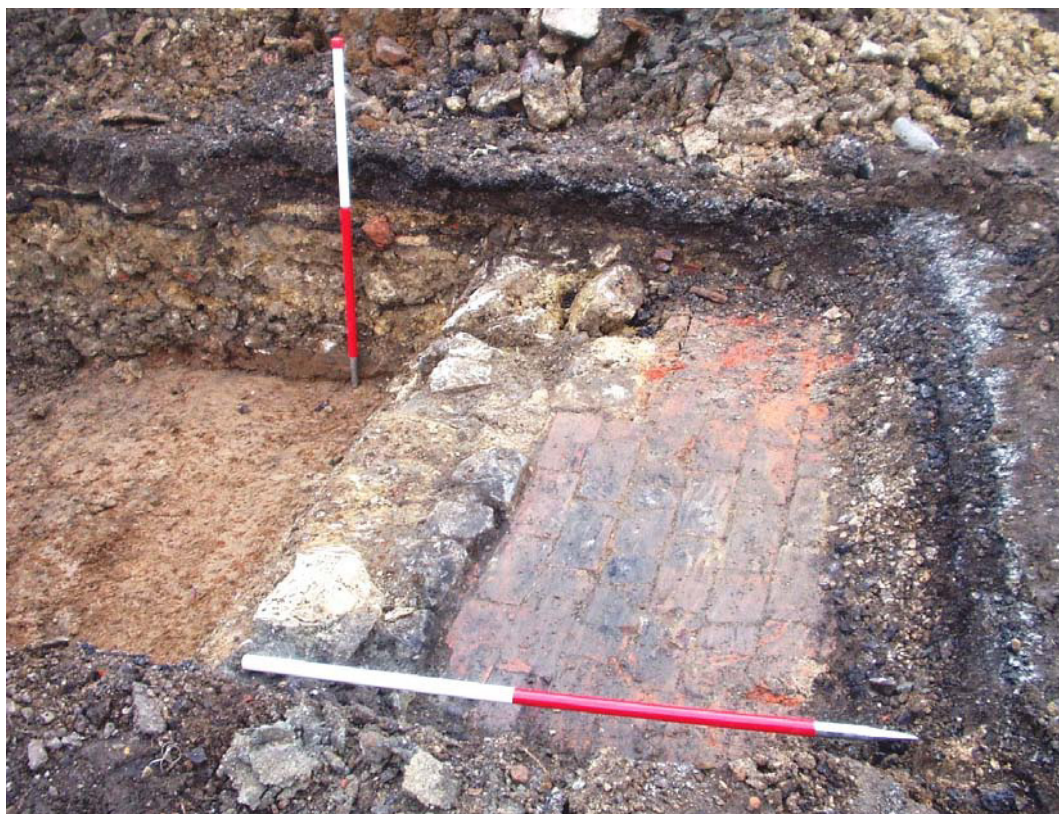
Photograph 7 Western end of Trench 2 showing rear wall of cottage (219) and associated internal tiled surface (220) with construction deposits to left. Discoloration in base of trench is upper surviving fills of the recut substantial ditch. Scales 1m in 0.5m divisions

The wall was similar in construction to (108) to the north, though at approximately 0.3m wide, this was significantly narrower than the northern continuation. The reason for this contrast is uncertain. In the south of the trench the wall thickened to 0.5m, possibly defining the location of a threshold for a doorway (Figure 9: photograph 7). To the west, part of an internal tiled surface (220) approximately 0.8m wide was revealed. This consisted of rectangular red tiles 0.22m long by 0.10m wide (8½ by 4 inches), with the long axis aligned parallel to the rear wall of the cottage. These tiles were arranged in a staggered pattern. This surface showed little evidence of wear or post-demolition disturbance.

Trench 2 revealed a sequence of dumps of material associated with the construction of the cottage, extending approximately 2.7m east of the rear wall, having a combined thickness of approximately 1m (Figure 5, Figure 7: section 2A and Figure 9: photographs 7 and 8).

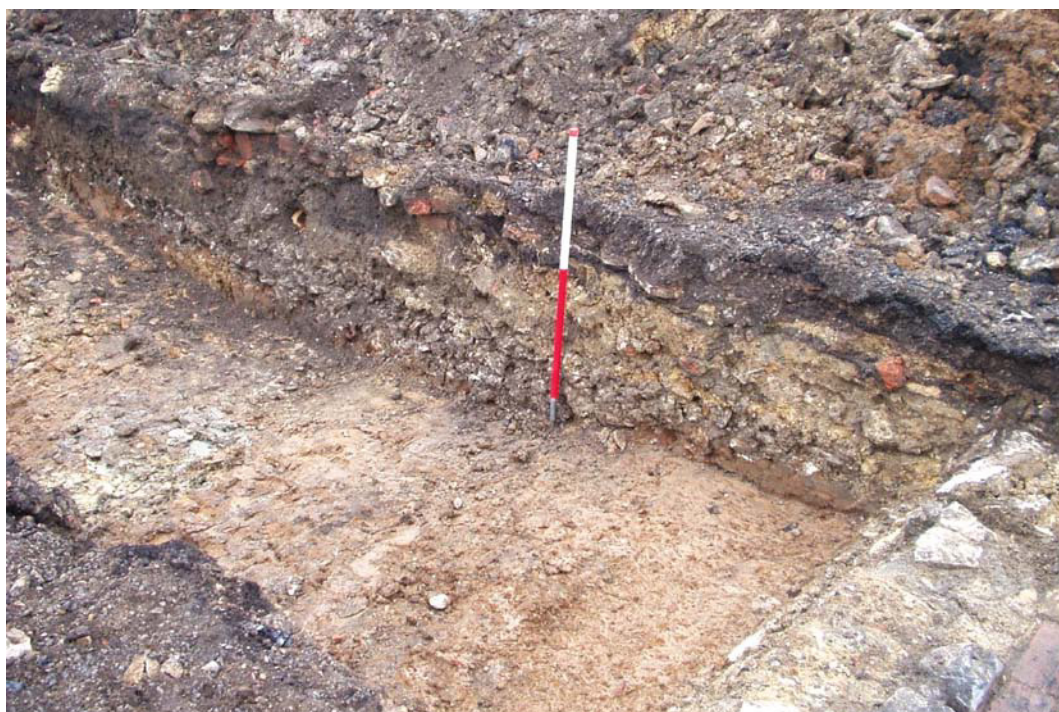
Photograph 8 Southern section of Trench 2 with rear cottage wall (219), yellow brown construction related deposits in center of image and garden deposits beyond. Note sharp boundary between construction and garden deposits

Subsequently a series of generally yellowish brown deposits were dumped in the western part of the trench, associated with the construction of the cottages (Figure 9: photograph 8). The eastern extent of this deposit was characterised by a series of larger stones. This differentiated the limit of the area of consolidation dumps from the 'garden' soil in the area to the east.

Some of the western dumps may be derived from the different phases of construction of the cottage. Based on the pattern of deposits (Figure 7: section 2A and Figure 9: photograph 8) it is possible to interpret the formation in terms of modern construction practice. The earliest deposit in the sequence (218) is a mound of mixed debris in the east, which probably accumulated during the early phase of construction. This would have been located away from the walls so as not to hinder construction, and access to any external scaffolding. After completion of the exterior wall, any scaffold would be removed, leaving a space between the rubble dump (218) and the rear wall. The next phase of dumping could be derived from work within the cottage, being derived from activities such as walling; wall plastering and rendering. This may account for the series of thinner layers (210-217) filling the void between that and the rear wall (Figure 7: section 2A). Layers (210) and (216) respectively contained a late medieval/early post-medieval pottery jar rim (17g), and two fragments of post-medieval vessel glass (24g). These dumps would assist in consolidating the ground for the external surfaces associated with the cottage.

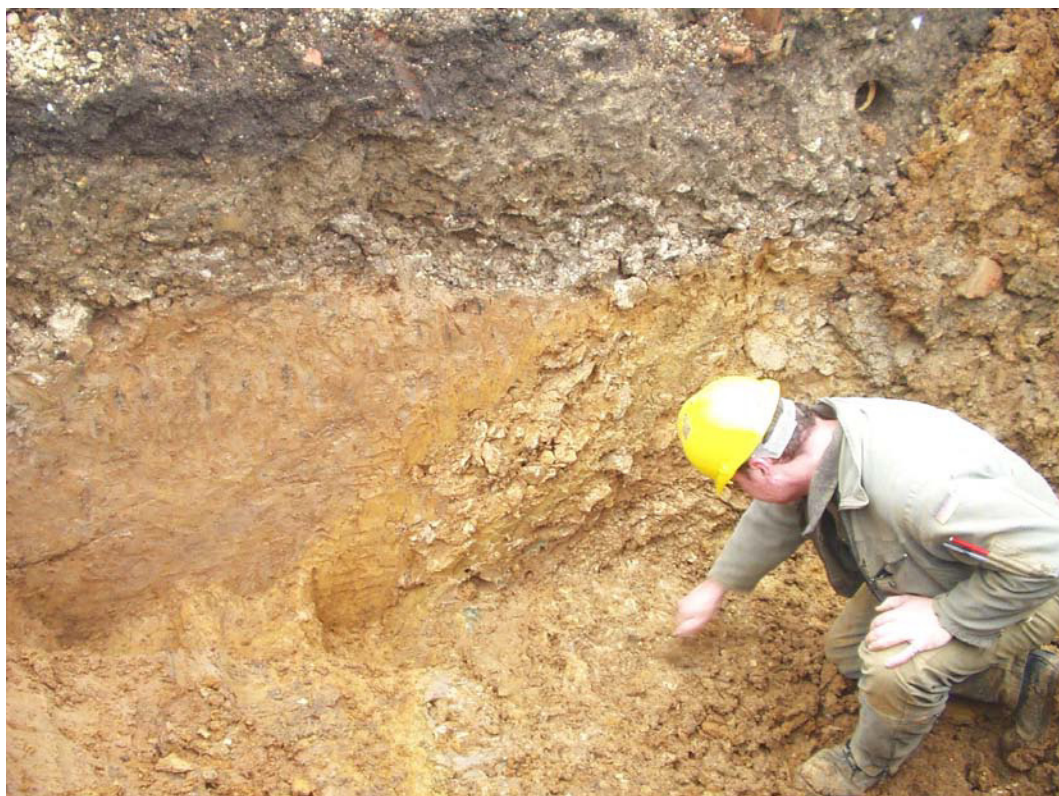
Photograph 9 Investigation of recut ditch in Trench 2 , with yellow clay lined intermediate form [231] clearly defined

Removal of deposit (223) in the central area of Trench 2 revealed a series of bands of material rather than the anticipated cornbrash limestone geological stratum. Investigation was confined to the centre of the trench, revealing a sequence of ditches orientated roughly north-south (Figure 5). Despite careful hand excavation and the sampling of deposits with potential to contain datable artefacts, none were recovered. Although investigation was limited due to the depth, it was possible to identify at least four phases of activity (Figure 7: section 2B and Figure 10: photograph 9) which will be summarised from earliest to latest.

Recut [231] had a steep profile which appears to have truncated the stony fill (230). This recut appears to have significantly altered the form of the ditch, being apparently narrower and shallower. However, the most significant difference was the associated compact yellow clay fill (232), which was up to 0.25m thick. This clay would appear to have been a deliberate dump of material in order to line the ditch, allowing it to hold water.

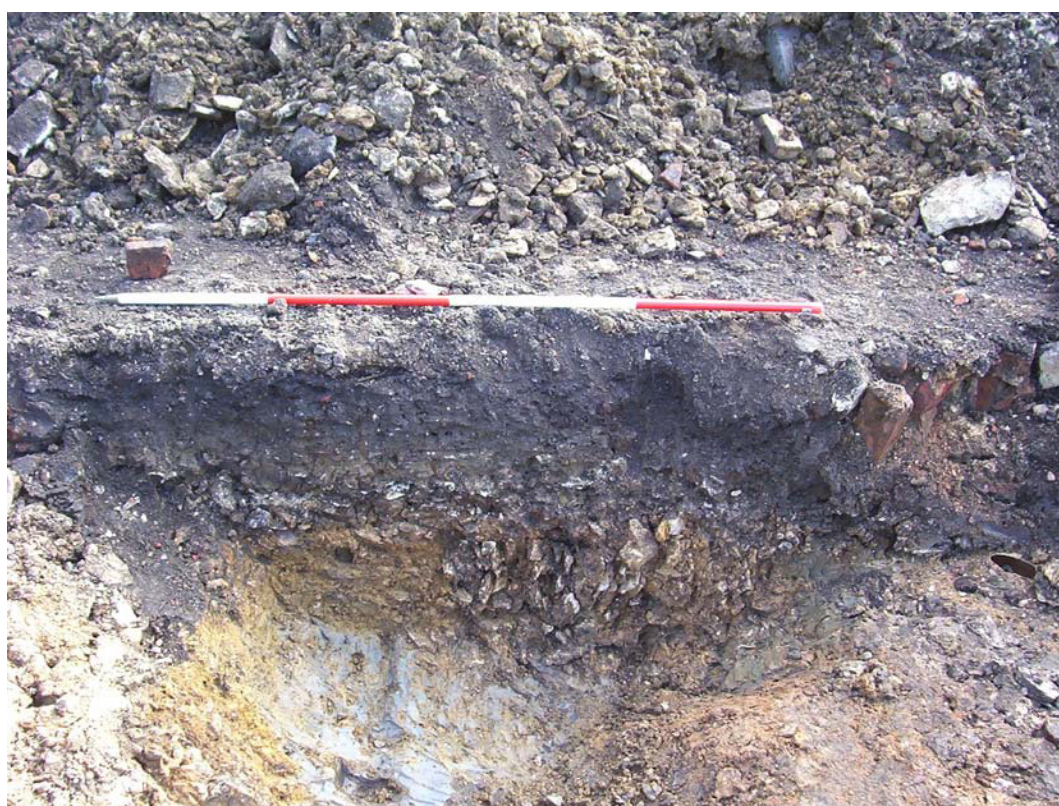
Photograph 10 Pitched limestone footing [312] robbed out wall. Overlying band of material (309) would appear to have been associated with robbing. Scale 2m in 0.5m divisions

312	Foundation trench	<b>Linear NW-SE profile: near vertical base: concave dimensions: max breadth 1.1m, max depth 0.42m, max length 1.4m Foundation trench containing pitched limestone fragments.</b>	<input checked="" type="checkbox"/>	<input type="checkbox"/>
313	Fill	Composed of compacted limestone fragments bonded with a mid red brown sandy clay. Majority of stones confined to northern 0.75m of feature - lesser quantity of stones to south Sealed below (309).	<input checked="" type="checkbox"/>	<input type="checkbox"/>
314	Layer	Friable mid yellow sandy clay The deposit was identified in the area of deeper machining extending at least 1m to the north-east. In section the deposit was up to 0.45m thick, tapering sharply to the north. This may be a variation in the natural stratum rather than associated with [312].	<input checked="" type="checkbox"/>	<input type="checkbox"/>
315	Foundation trench	<b>Linear NE-SW profile: concave base: uneven dimensions: max breadth 1.4m, max depth 0.4m, min length 2.5m Perpendicular to [312] to the south-east.</b>	<input checked="" type="checkbox"/>	<input type="checkbox"/>
