**AYLESBURY CROWN COURT
AYLESBURY
BUCKINGHAMSHIRE**

**ARCHAEOLOGICAL WATCHING BRIEF
PHASE 1**

Project: ACC1520

Document: 2009/120

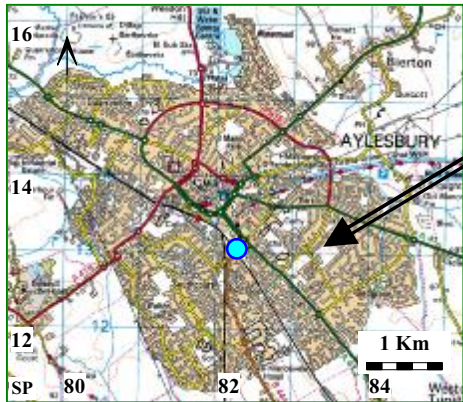
Figure 1: Site location
 Base map reproduced from the Ordnance Survey Map with the permission of the Controller of Her Majesty's Stationery Office, by Albion Archaeology, Central Bedfordshire Council. OS Licence No. 100017358(LA). © Crown Copyright.

Archaeological zones from WSI (Albion 2009b)

The demolition area comprised Zones 2 and 3 and the southern part of Zone 4; no demolition work took place within Zone 1 (Figure 1). A key to the location of photographs taken within the DA is shown in Figure 3.

Parts of the removed foundation slabs extended into the southern part of Zone 4 (Figure 1). The impact of these foundations was shown to have been equally destructive to the archaeological potential in this part of the DA (Plates 1 and 3). As a result of these findings, the Archaeological Zones have been re-assessed so that the heavily impacted areas of Zone 4 are now included in Zones 2 and 3 (Figure 5).

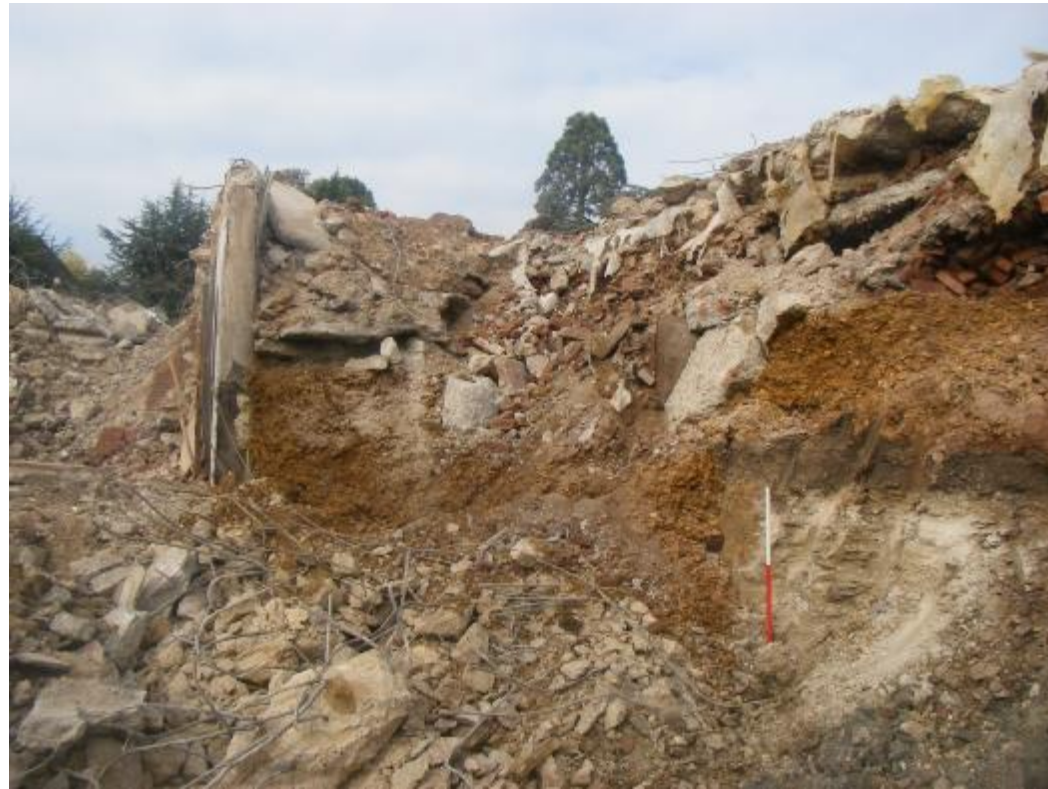
Plate 1: Zones 2-3, partially removed retaining wall facing north showing preserved subsoil and limestone deposits. 1m scale

The removal of the retaining wall for the underground car park and its associated ramp in Zones 3 and 4 (Figure 1) revealed deposits of undisturbed Portland limestone (Plate 3). In some areas (Figures 2-3) the former subsoil and topsoil profiles have also survived (Plates 1-4).

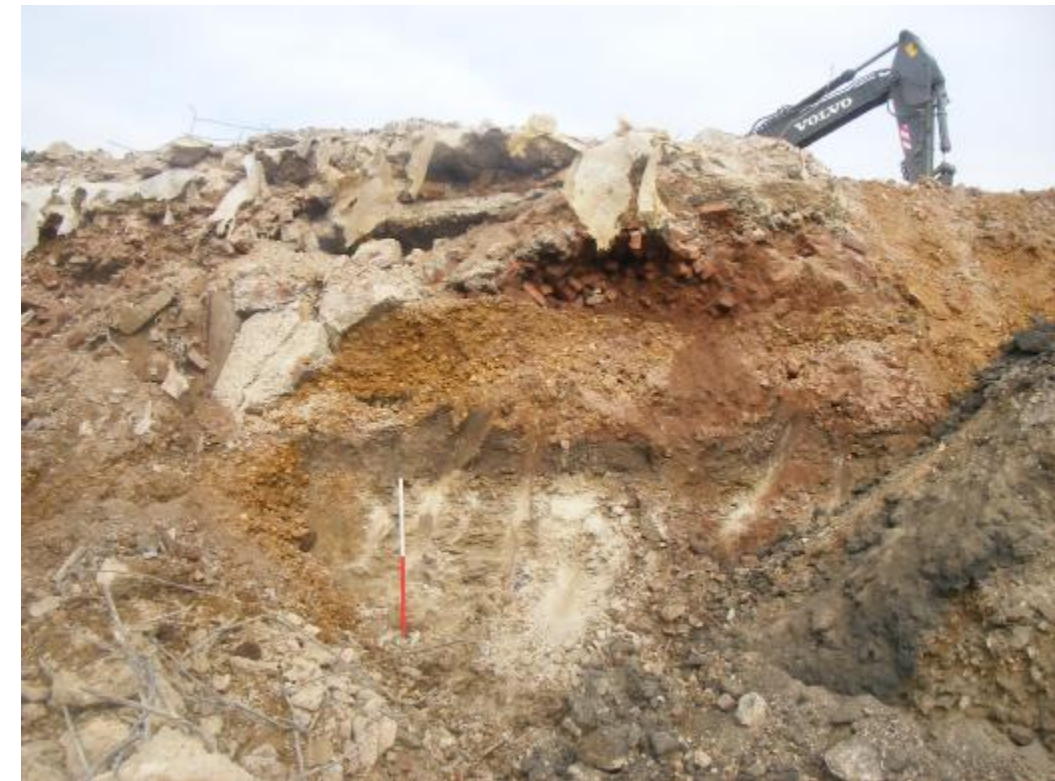
Plate 2: Zone 3, preserved subsoil and limestone deposits after removal of retaining wall facing north-east. 1m scale

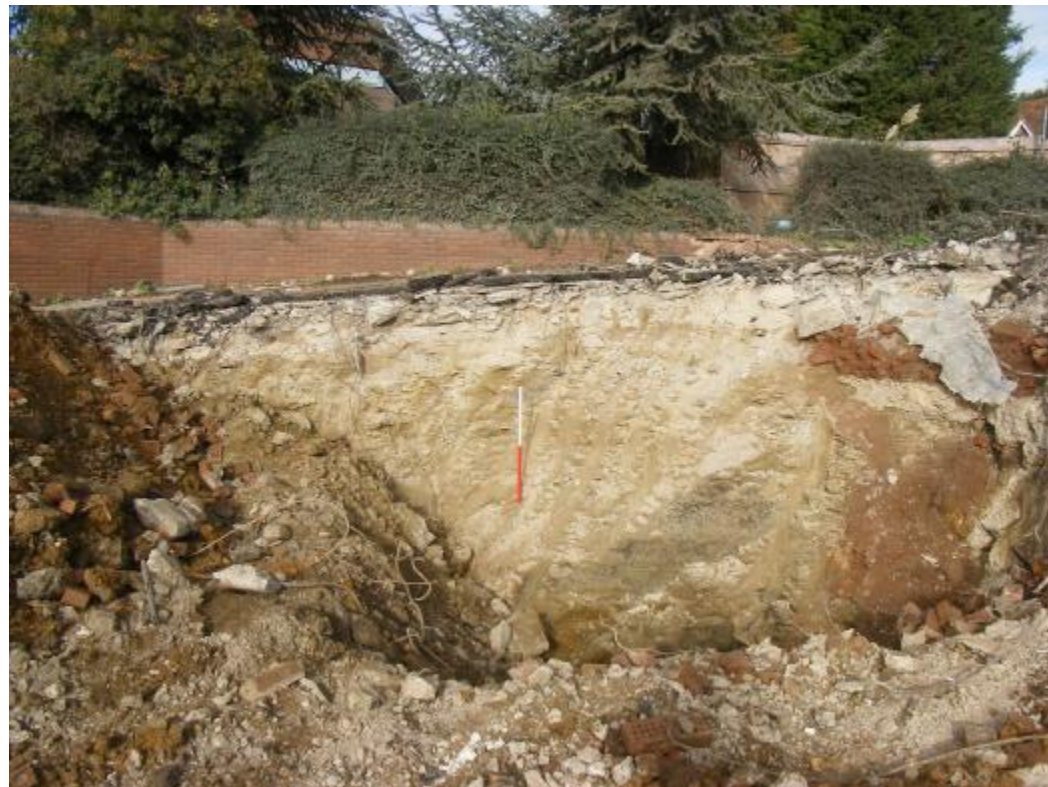
Plate 3: Zone 2/4, preserved limestone deposits after removal of retaining wall adjacent to car park ramp facing north-west. 1m scale

The slabs in Zone 3 had been dug through the Portland limestone (Plate 3) into the underlying dark grey Kimmeridge clays (Plates 5-6).

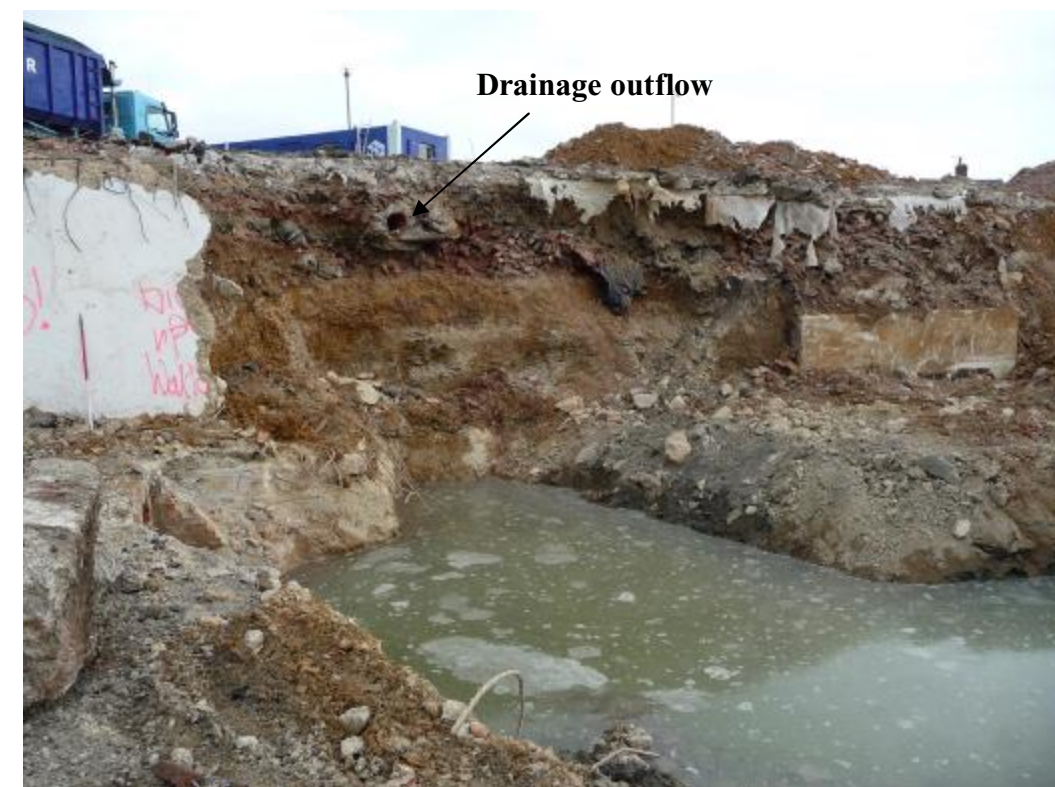
Plate 4: Zones 2-3, partially removed retaining wall facing east showing preserved limestone deposits covered with modern overburden. 1m scale

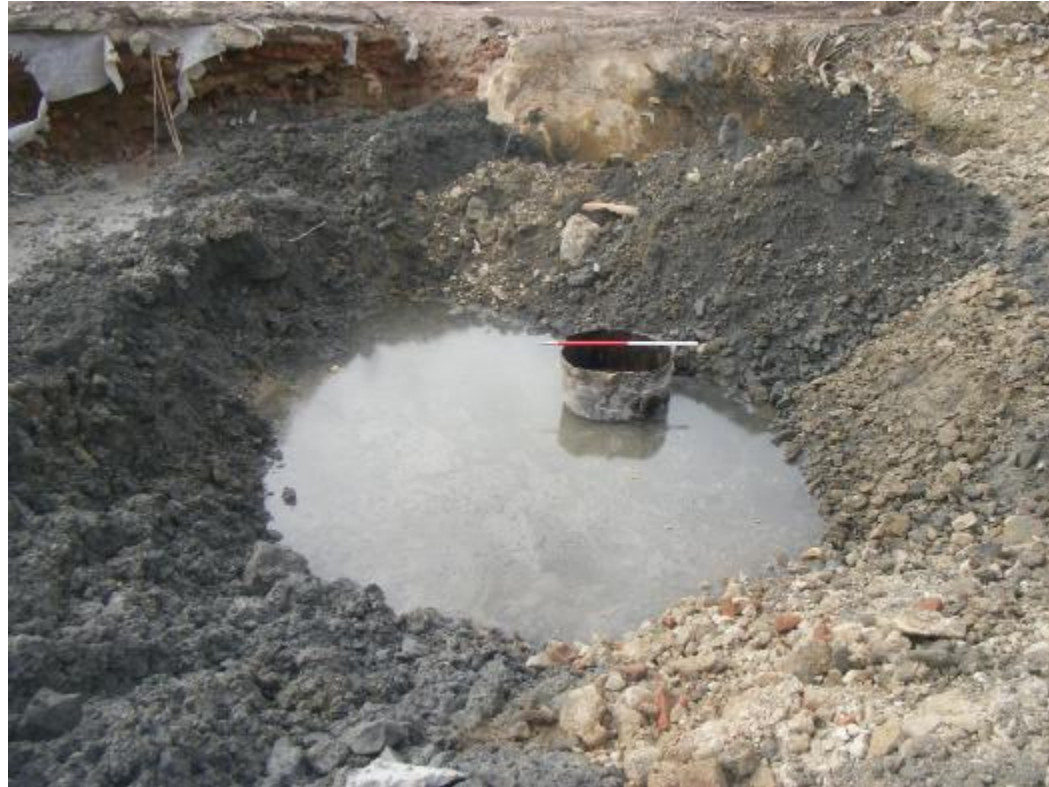
Plate 5: Zone 3 facing north-west showing exposed sump. 1m scale

The removal of the foundation slabs within Zone 3 revealed a concrete capped, water filled sump over 3m deep (Plate 5) and a brick-housed pumping unit (Plate 6). These were constructed at the same time as the 1970s office block in order to collect water to be pumped into the main drainage outflow, visible in Plate 4. Plate 4 also indicates the natural level of ground-water in this area after the removal of the main concrete foundations.

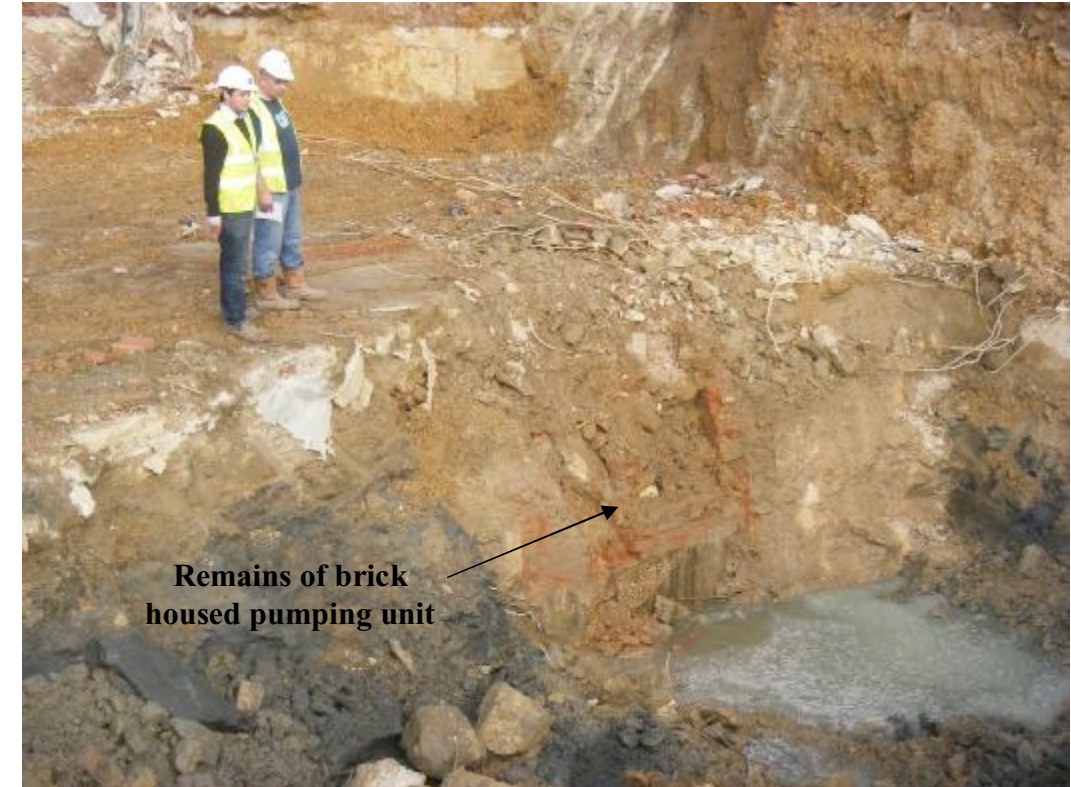
Plate 6: Zones 2-3 facing north-east showing depth of impact of previous building immediately following removal of foundation slabs. 1m scale

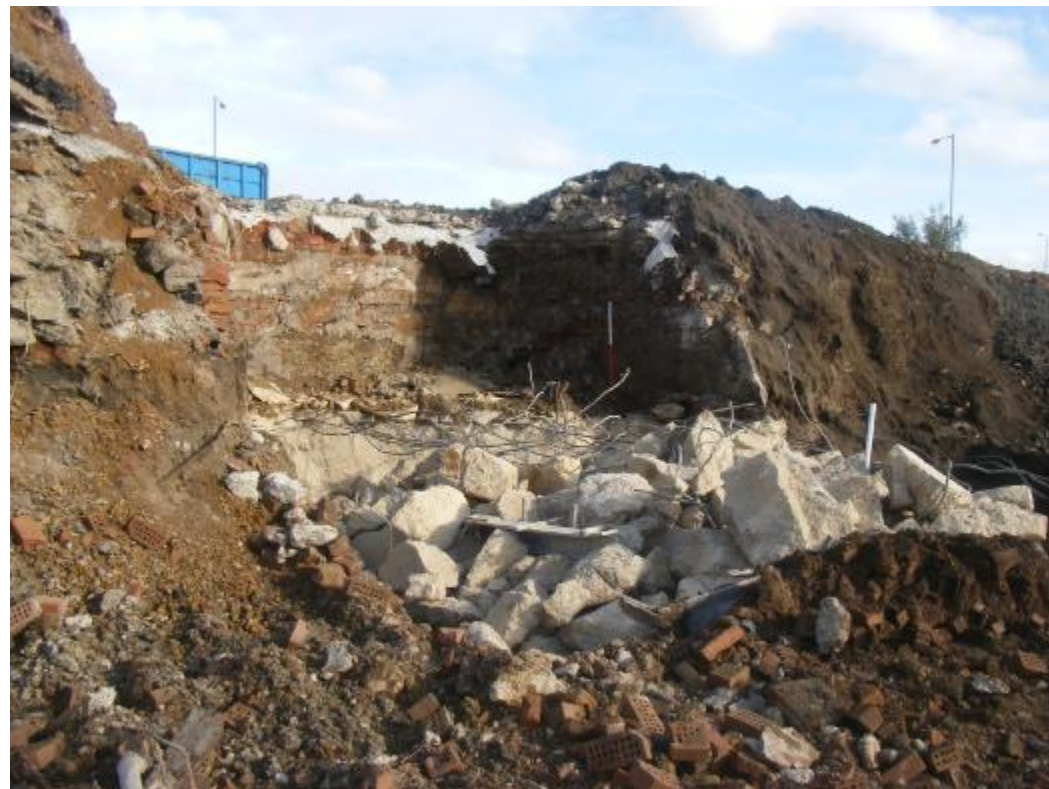
Plate 7: Zone 3 facing east showing scale of foundation slab. 1m scale

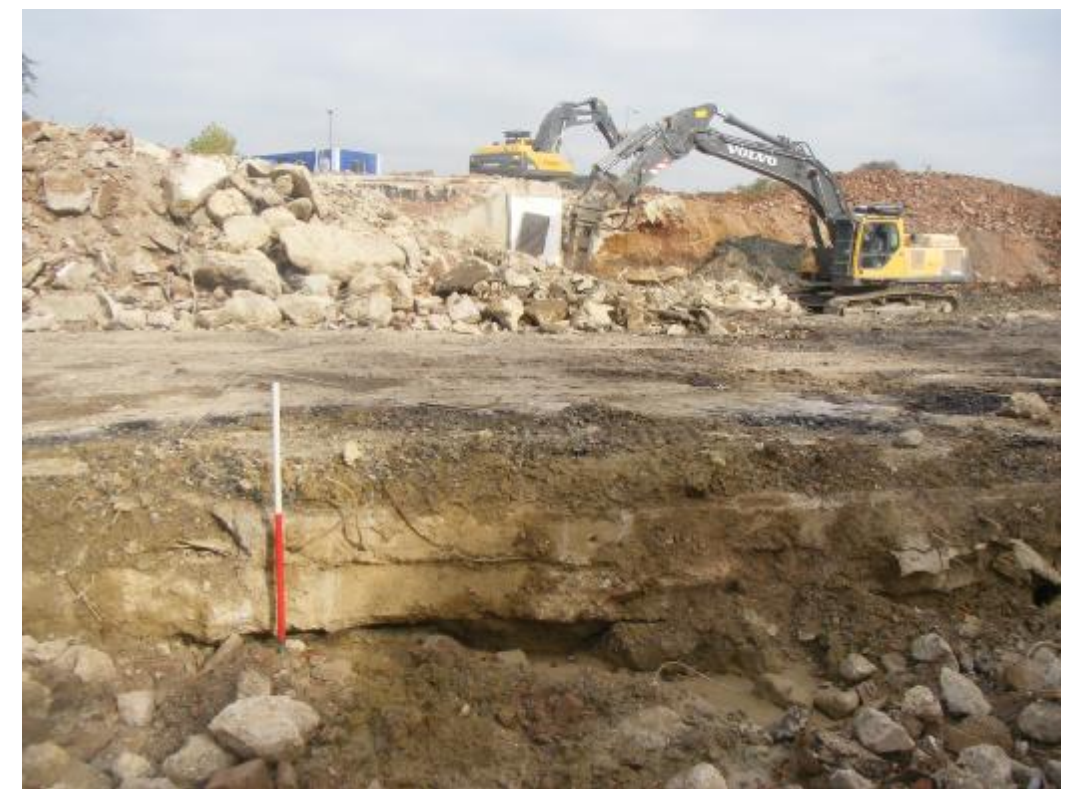
Plate 8: Zone 2 facing north-east showing depth of concrete slabs overlying clay geology. 1m scale
