CHURCH OF ST MARY NORTHCHURCH HERTFORDSHIRE

ARCHAEOLOGICAL INVESTIGATION, RECORDING AND REPORTING

Project: SMN1537

Document: 2009/83 Version 1.0

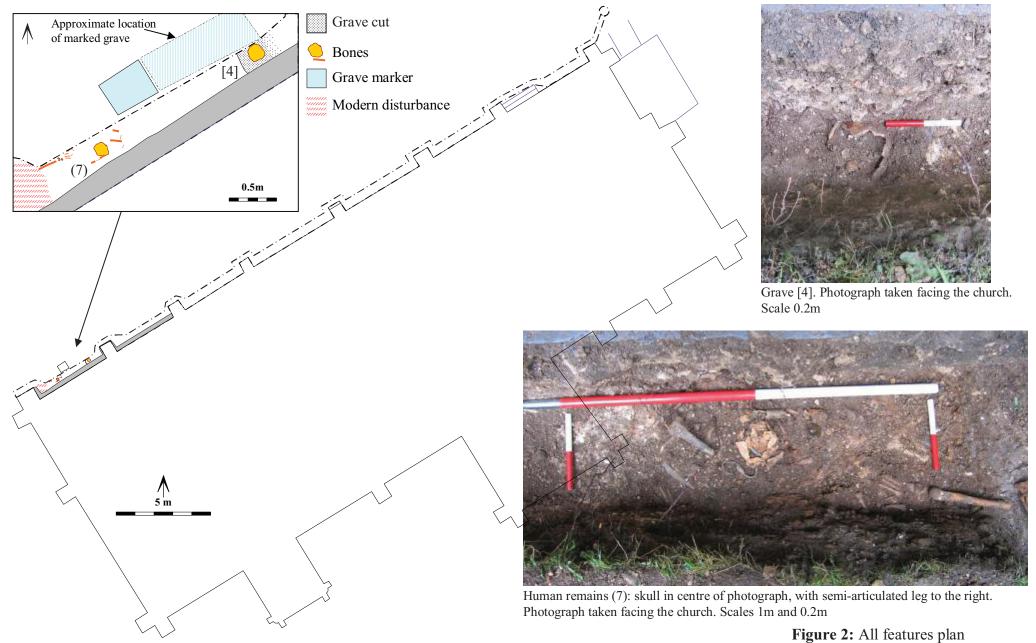
The ground-works comprised the excavation of a French drain trench (0.25–0.5m wide x 0.5m deep) along the north wall of the church, terminating in a circular manhole (0.45m diameter x 0.5m deep) at its eastern end (Fig. 2). The trench was hand-excavated under close archaeological supervision.

Semi-articulated remains of at least two humans (7) were revealed in the base of the western end of the trench (Fig. 2). Ribs, a skull, a foot and the lower part of a leg were exposed, as well as iron coffin handles and lead strips. They probably relate to the two child burials identified in Test Pit 3 during evaluation of the site (HAT 2001). These remains were left *in situ* and the depth of the trench was reduced to 0.4m in this area.

Articulated human remains (5) were also revealed c. 1m further east within grave [4], cutting subsoil (2) and sealed by made ground (3). Only the skull was exposed and lifted, as the rest of the skeleton lay at a greater depth than the base of the trench. The east end of the grave cut for a child burial that lay outside the trench, located by a stone marker, was observed in the side of the trench. No bones were exposed. Disarticulated human bone was recovered throughout the trench, in slightly greater quantities towards the west end.

The ground-works revealed unmarked inhumations by the north-west corner of the church (Fig. 2). Their east—west alignment is indicative of Christian burial. The articulated and semi-articulated remains were buried at a sufficient depth to be preserved *in situ* beneath the drain, except for the skull in grave [4], which was lifted and left securely on site for reburial.
