2a CASTLE LANE, BEDFORD

**ARCHAEOLOGICAL DESK-BASED ASSESSMENT
AND
FIELD EVALUATION**

Project: CL1439

Document: 2009/117

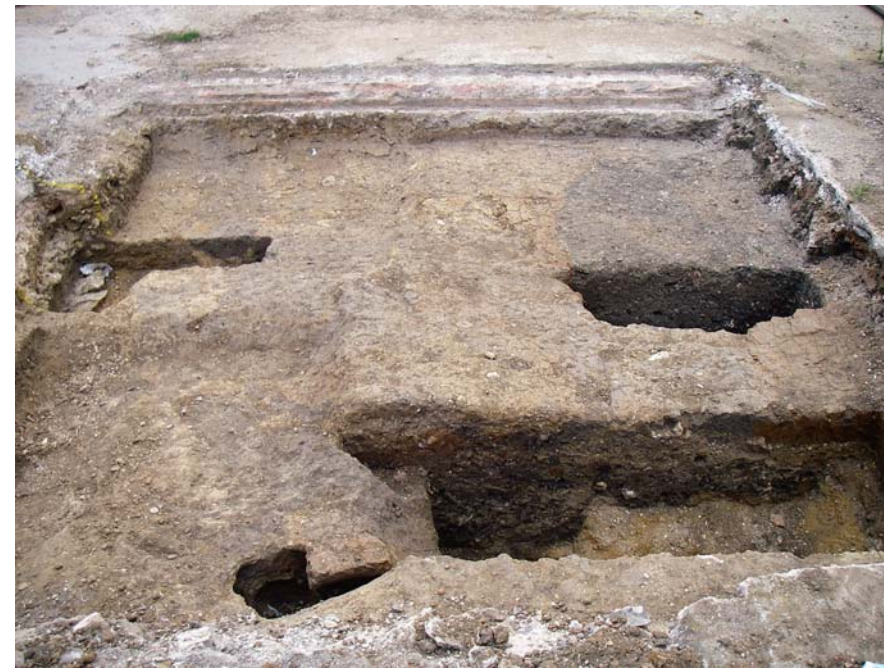
Figure 22: Trench 1

Trench 1, looking east

A sequence of cut features and layers dateable to the post-medieval period was found in the south-western part of the trench, immediately below the modern surfacing. The latest feature in this sequence was a large sub-rectangular pit [104]. Artefacts recovered from the upper fill of this feature included bottle glass, post medieval pottery, clay pipe. The features included cut features [120] and [123] filled with hard red-brown clay. These may have been constructed as structural features with deliberate fills of compacted clay. These features were cut through two layers, (124) and (125), which formed horizontal bands of deliberately dumped material in the south-west part of the trench.

The underlying geological deposits (163) consisted of layers of sand and gravel deposits interleaved with occasional layers of finer grained material. These deposits were observed in the sides of some of the excavated features. Over the majority of the trench the gravels were capped by a layer of mid orange red clay (162).

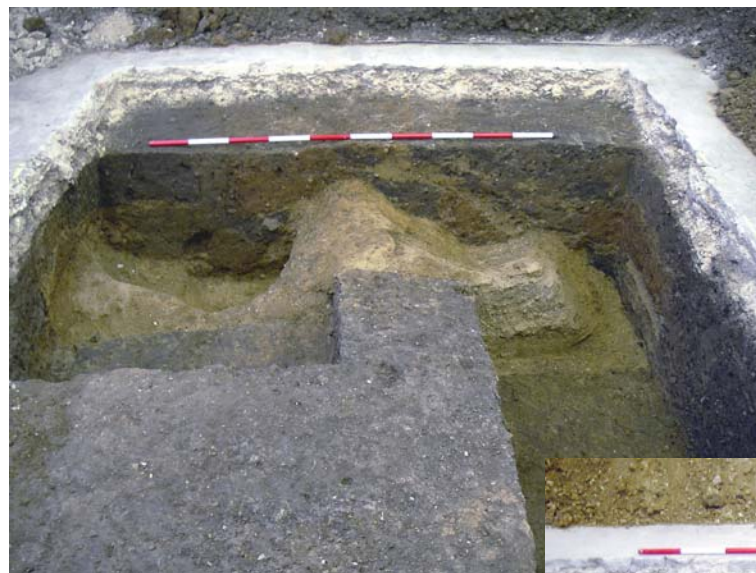
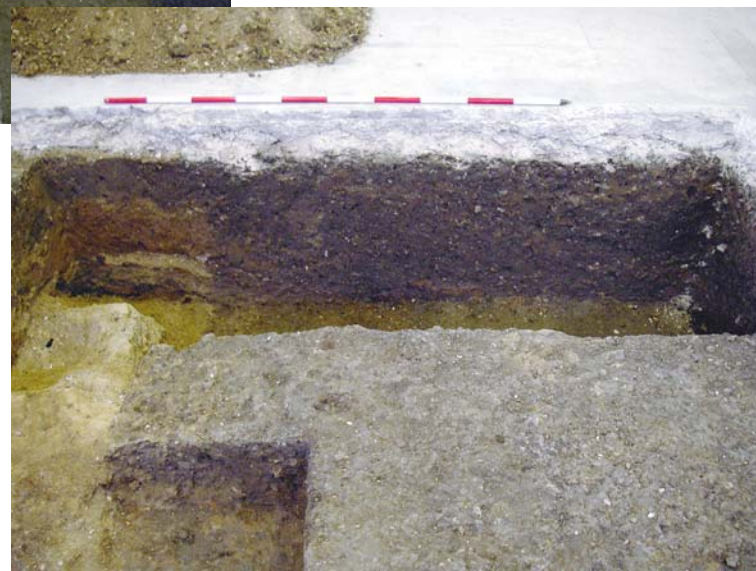
Figure 23: Trench 2

Trench 2, looking east. Scale 2m

Trench 2, looking south. Scale 2m

The eastern extension to the trench contained five inter-cutting pits [214, 219, 223, 225 and 231]. The pits all extended beyond the limit of excavation to the east. Four of the pits [214, 219, 225 and 231] were broadly similar, with rounded outlines, irregular sloping sides and concave bases. The latest of these four pits had been truncated on its western end by feature [203, 208]. The other pit found in the eastern side of the trench [223] was different in character, having vertical sides and a flat base. Fills in four pits contained small amounts of Saxo-Norman pottery. A single sherd of early medieval pottery was recovered from the lower fill of [231], but this was arguably the latest pit in the sequence. In addition, some fills contained small amounts of animal bone, ferrous slag and in the fill of [223] oyster shell.

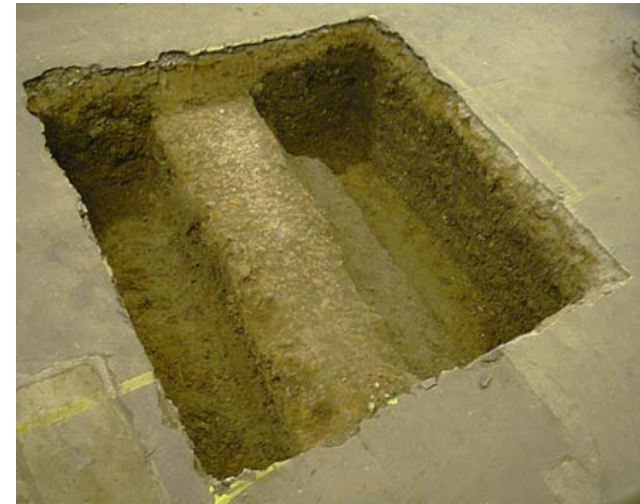
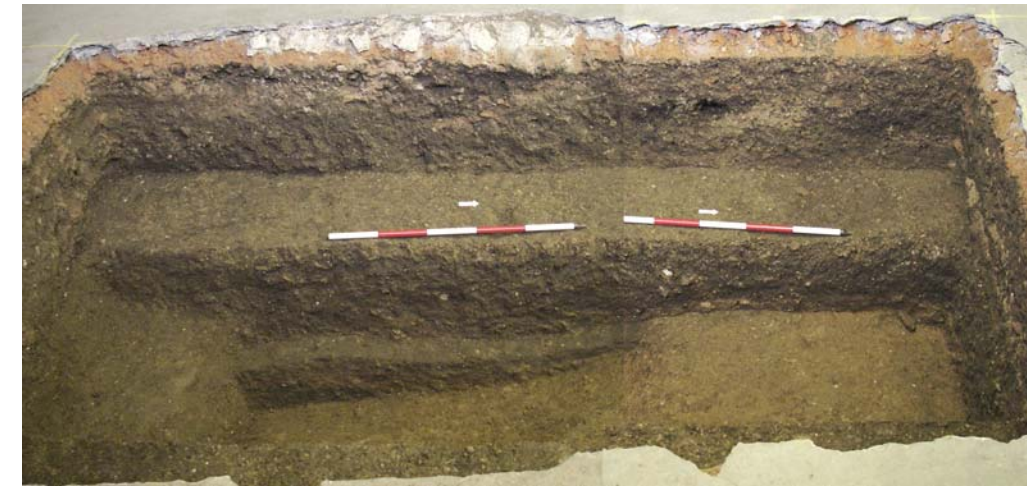
Figure 24: Trenches 3 and 7

Trench 7: Photograph, looking north-west.

Trench 3: Composite photograph, looking west.
Scales 1m

The internal floor of the existing building comprised a thin layer of bituminised floor surface (714) or concrete (713) above a rubble layer (712) consisting of broken brick, limestone fragments and mortar.

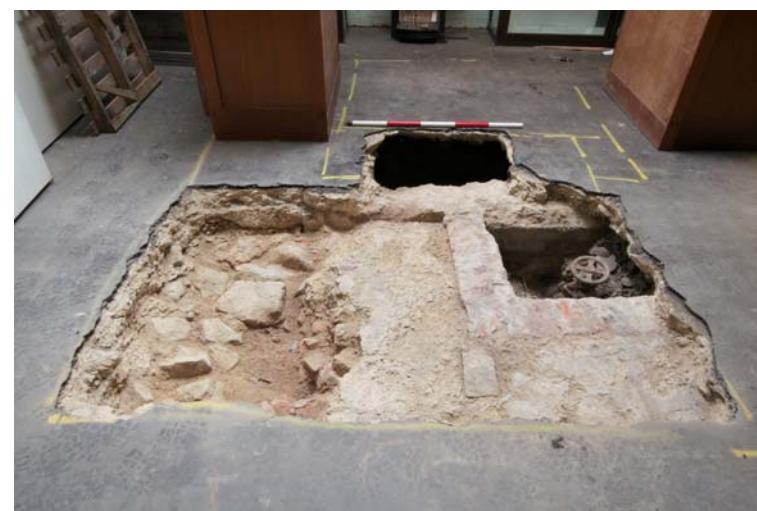
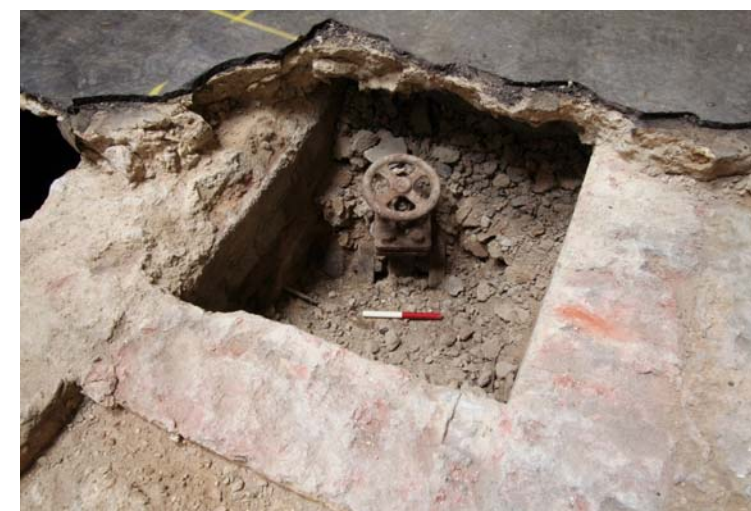
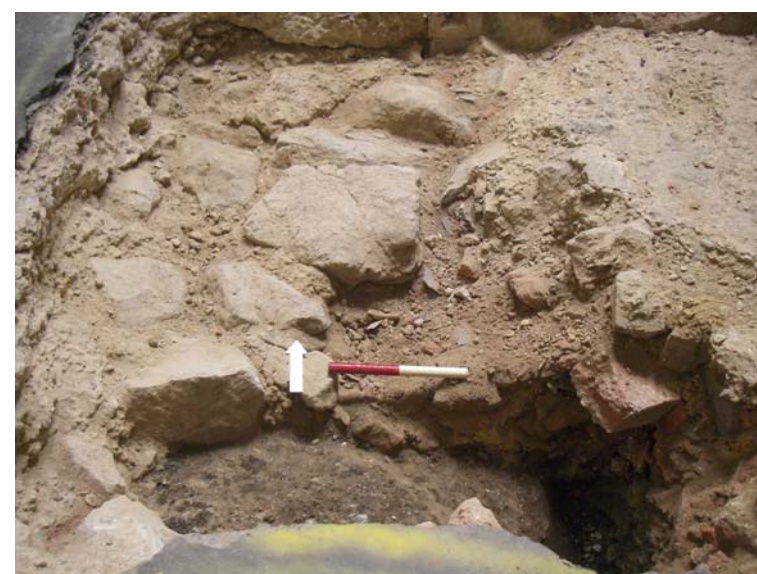
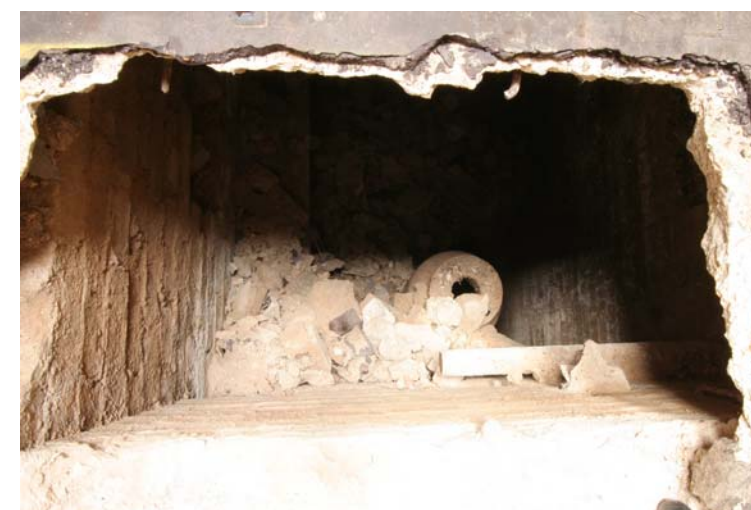
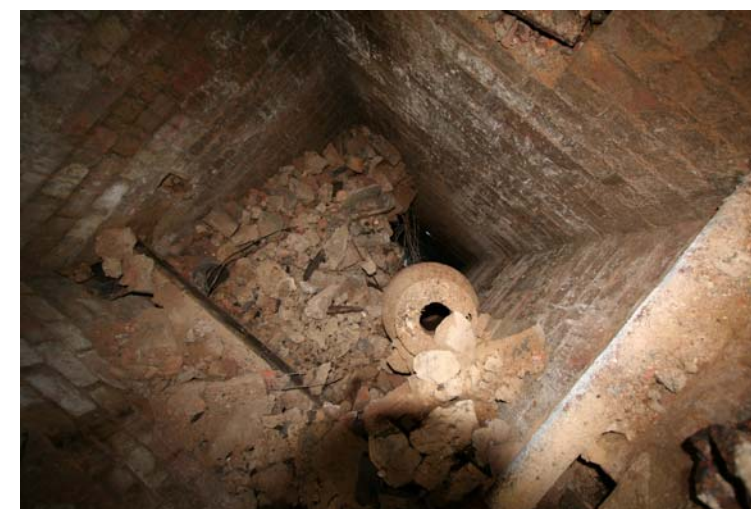
Figure 26: Trench 5

Trench 5, looking north by north west

Valve

[510] and layer 509

Well shaft

Unexpectedly, the modern floor was found to span a disused well and associated access pit containing valve gear. The well (503) consisted of a brick-lined shaft, 1.24m square. The shaft was only partially filled with rubble and by feeding a tape measure down it was possible to determine that it was at least 12m deep. The shaft contained a large cylindrical iron tube which may have been a pump barrel. The access pit (505) was a brick-lined, rectangular pit containing a cast iron wheel operating a stop valve in a cast iron pipe which fed into the well shaft. Excavation in the south-west corner of the trench uncovered the western side of a feature [510] that was aligned with the western wall of the well, suggesting that it was the construction cut for the well shaft or its associated pipework. This cut was filled by a soil deposit (511) under a layer of brick rubble (508). The well is not shown on any of the documents examined for the desk-based assessment, so must have gone out of use before these plans were drawn up. From its construction, it appears to date from the 19th century and is most likely to have functioned when the building to the south (now housing Bedford Museum) was in use as a brewery.

Some deposits that predated the construction of the well were observed in the section excavated in the south-west corner of the trench. Here, the construction cut of the well [510] was cut through a layer of dark grey clay loam (512) that lay above a layer of compacted mid red brown gravel with a clayey sand matrix (513), which formed a hard surface. Although very similar to the layers or surfaces found in Trench 3 and Trench 7, this layer was higher, at 28.93m OD.

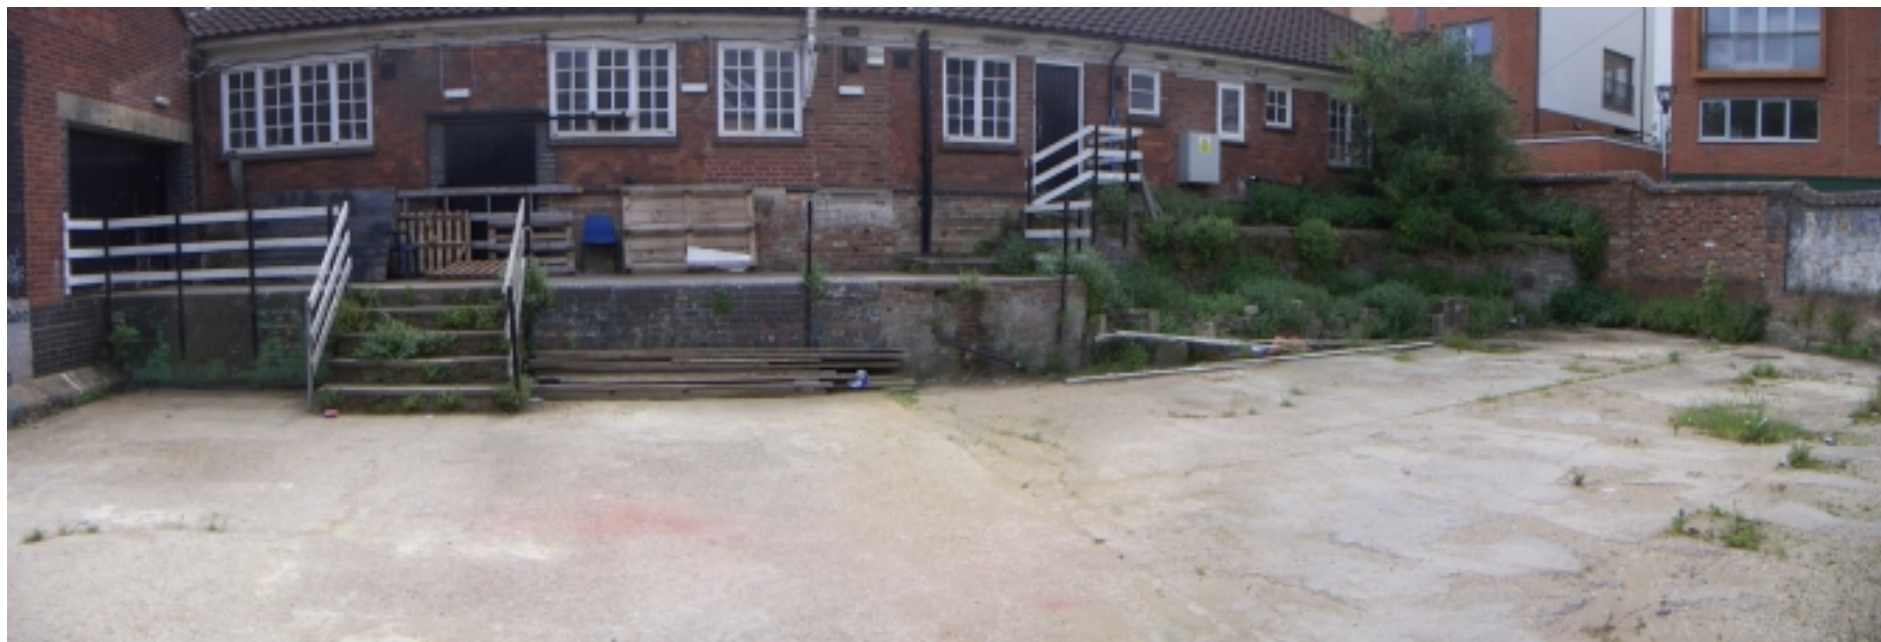
Figure 33: Composite photograph of the yard (Area A), loading platform and north elevation of the existing building at 2a Castle Lane
