2a CASTLE LANE, BEDFORD

**PRELIMINARY ARCHAEOLOGICAL DESK-BASED
ASSESSMENT**

Project: CL 1439

Document: 2009/65
Version: 1

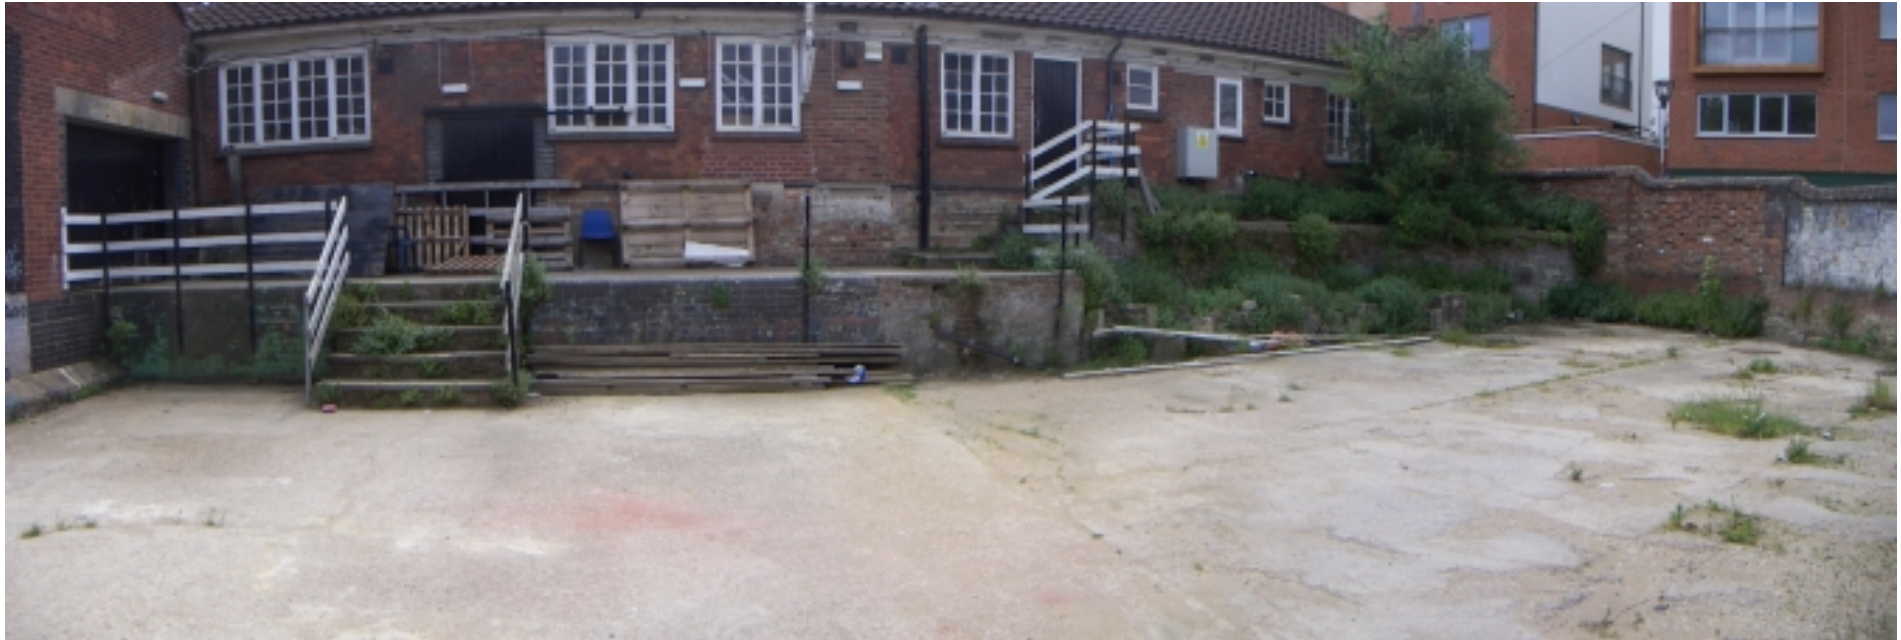
Figure 21: Composite photograph of the yard and north elevation of the existing building at 2a Castle Lane
