**ROMP HALL
THURLEIGH
BEDFORDSHIRE**

**ARCHAEOLOGICAL OBSERVATION,
RECORDING, ANALYSIS AND PUBLICATION**

Project: RH1509

Document: 2009/81
Version: 1.0

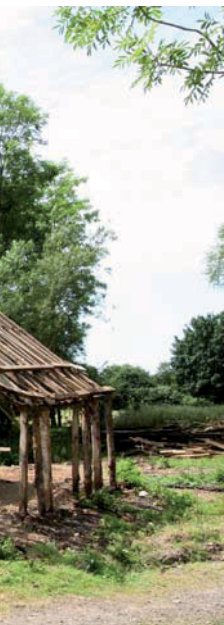
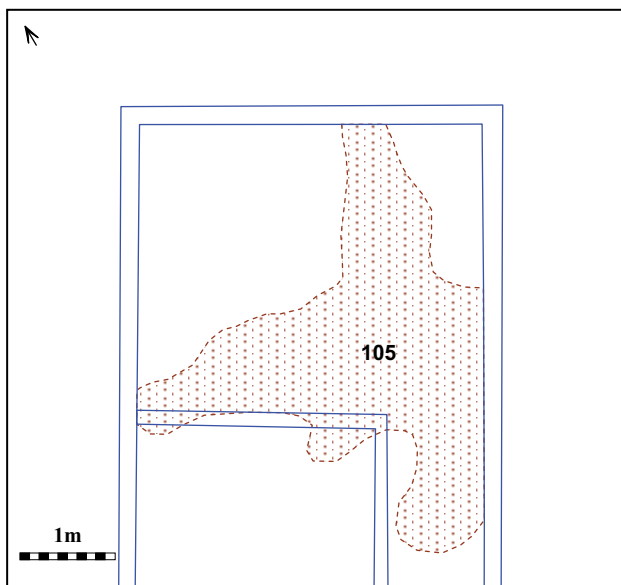
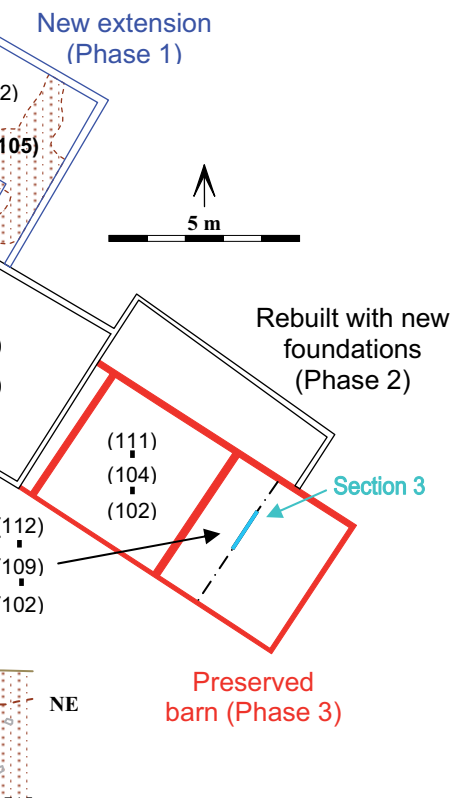
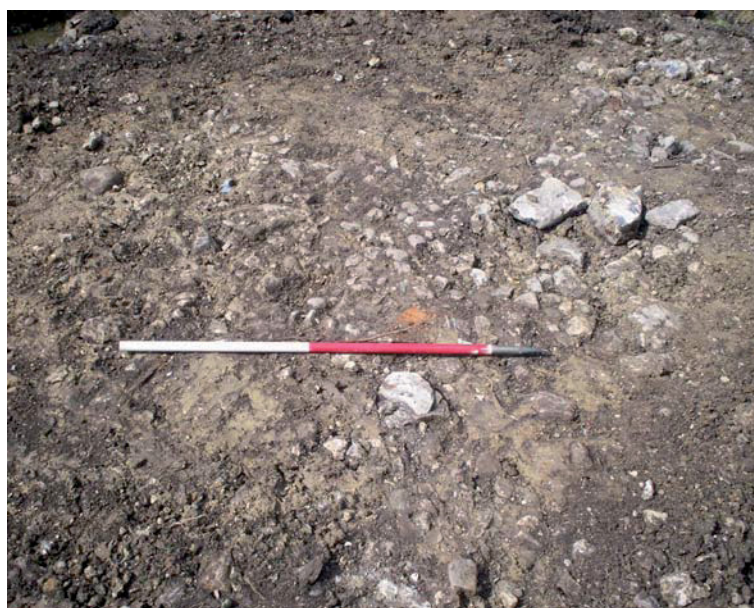
Figure 2: All features

Observation of ground reduction within the interior of the Phase 1 extension revealed the partial remains of a metalled stone surface (105). The surviving surface covered an area of *c.* 3.5m by 4.5m and consisted of pebbles and flint nodules between 50mm and 300mm in size. A single sherd of 16th-17th century roof tile was also recovered from within this surface (Appendix 2). The stones had been pressed into the underlying undisturbed geology, suggesting that ground reduction had taken place in preparation for the surface (Figure 2).

105 looking northeast Scale 40cm

Ground reduction within the interior of the north-eastern part of the barn (Phase 2) revealed the truncated remains of a narrow trench [106] (Figure 2), *c.* 3.6m in length and aligned parallel with the north-eastern gable end of the barn. This trench was sealed beneath the surface of the (now removed) 19th century structure and is, therefore, un-associated with its construction. Excavation demonstrated it had a flat base and steep sides and that its fill

(107) contained numerous stones and a single sherd of 12th-13th century pottery (Appendix 2).

The morphology, alignment and positioning of [106] suggest it was designed to support the beam and/or posts for an earlier phase of the barn. Indeed, the stones contained within deposit (107) were of a sufficient quantity and size to represent packing material for such timbers. However, the deposits did not appear to be *in situ* and, despite the relatively unabraded state of the pottery, it may be residual.

century barn. Beneath surfaces (104) and (109) were disturbed deposits consisting of re-deposited clay (108/110) up to 0.35m thick (Figure 2). These contained over 1.3kg of Saxo-Norman, medieval and post-medieval pottery as well as a fragment of post-medieval clay pipe and a medieval whetstone (Appendix 2). The Saxo-Norman to post-medieval artefactual assemblage recovered from these deposits, provides indirect evidence for activity at Romp Hall dating from the Saxo-Norman to the post-medieval periods.

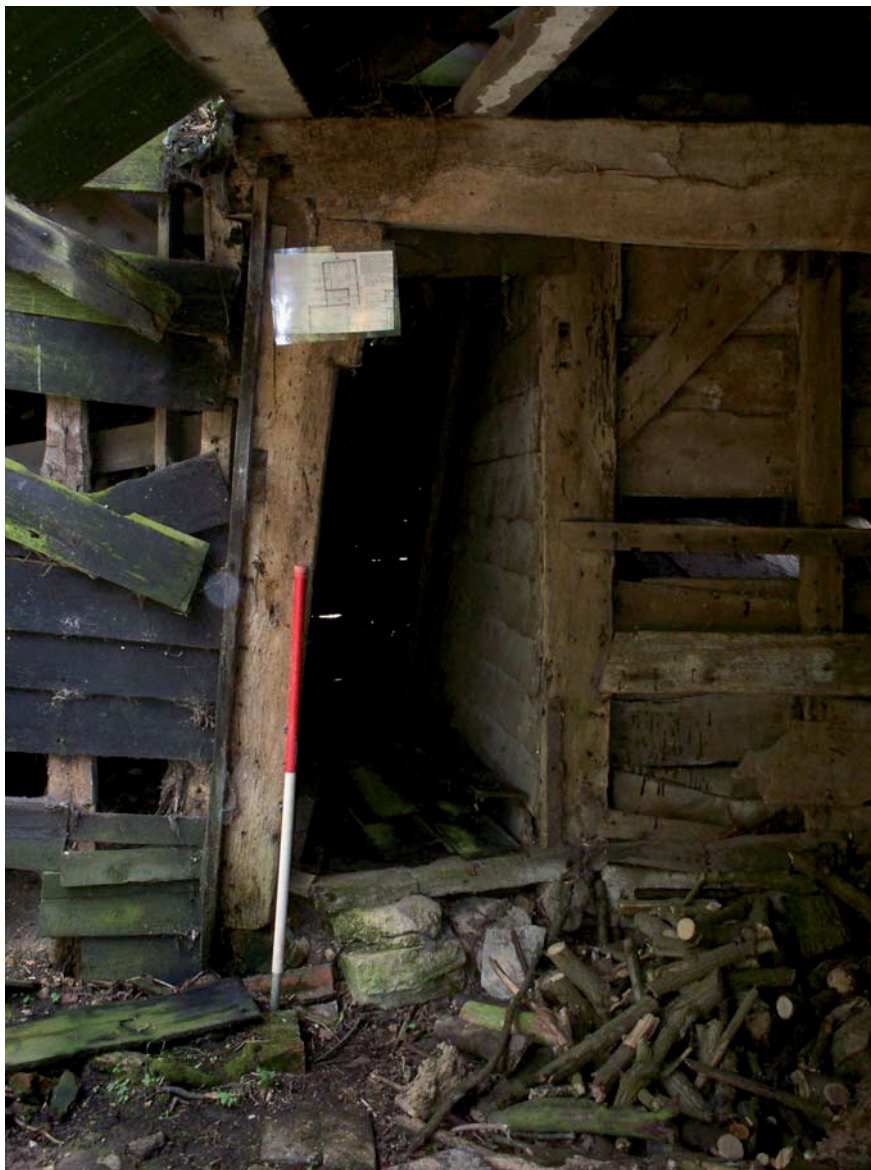
The replacement of the 19th century barn (Phase 2) necessitated the removal of its internal surface (113). This surface was informal, consisting of wood chips and fragments, built up during its former and recent use as a wood store (Plate 1).

Plate 1: Interior of 19th century extension, facing SE towards 17th-18th century barn. 1m scale.

The composition of the internal surface of the larger 19th-century extension (113), north-east of the older barn, suggests it was used as a wood store for some time. It is possible that the south-eastern half of the older barn ceased to be used as a wood store after the construction of the newer extension. By implication, it is likely that cobbled surfaces (111) and (112), which overlie (109) were installed after this change had occurred, probably sometime in the 19th century.

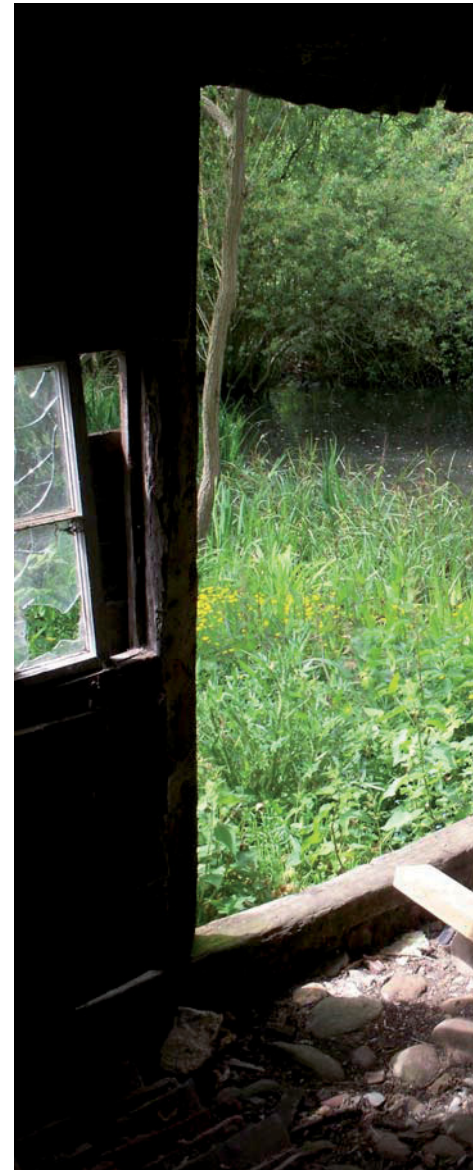
Beneath the cobbled interior surfaces (111) and (112) of the 17th-18th century barn (Plates 2-3), were two distinct former internal surfaces (104) and (109) which lay to the north-west and south-east (respectively) of the barn's internal dividing wall (Figure 2). Both surfaces represented a build up of material associated with a former use of the barn.

Plate 2: Interior of south-eastern showing cobbled surface (1)

Surface (104) contained post-medieval ceramic building materials and a single sherd of residual 12th-13th century pottery. Surface (109) principally consisted of wood chippings and fragments, suggesting this half of the structure had also been used as a wood store prior to the laying of cobbles.

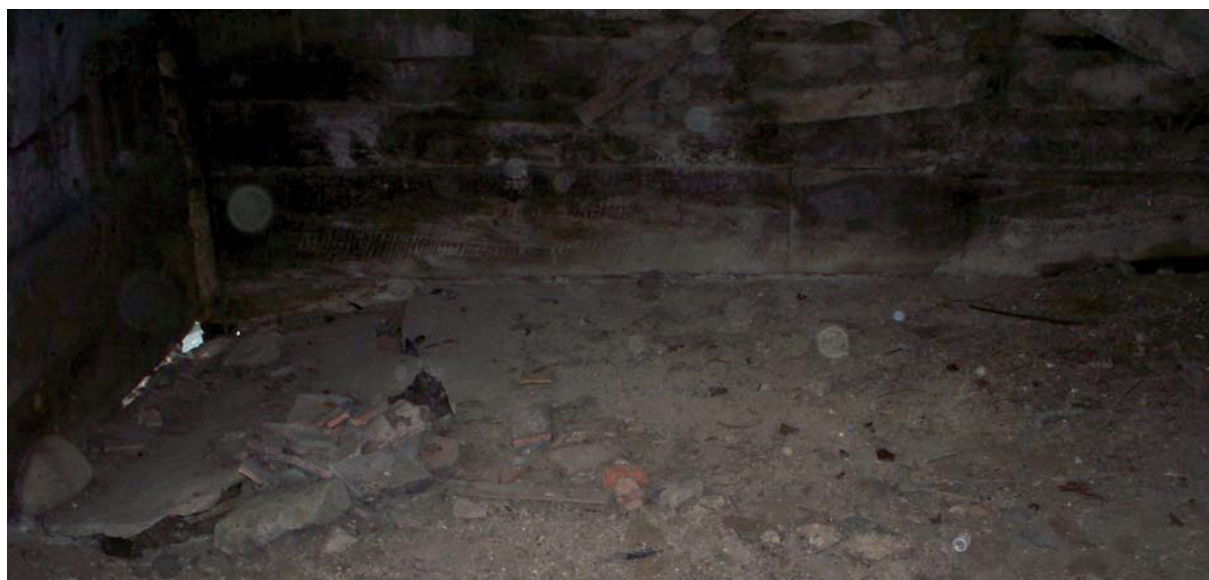
Plate 3: Interior of north-western half of 17th-18th century barn showing damaged cobble surface (111) facing NW
