**OLD PARK WEIR
WREST PARK
BEDFORDSHIRE**

ARCHAEOLOGICAL EVALUATION

Document: 2007/109
Project: WP1221

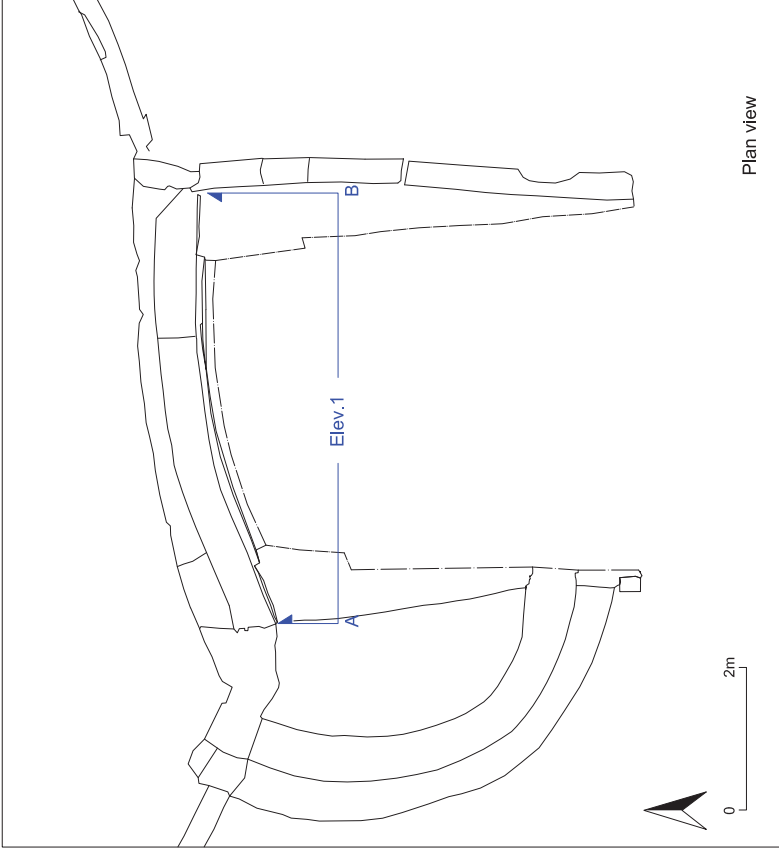
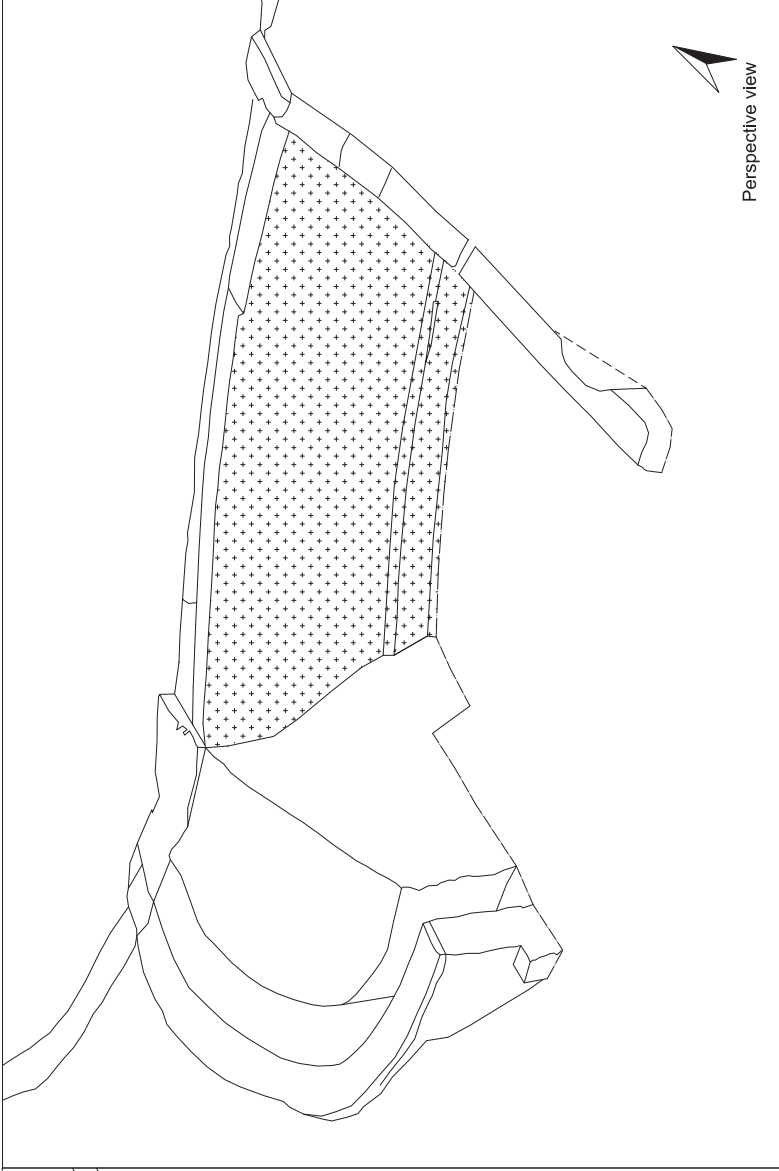
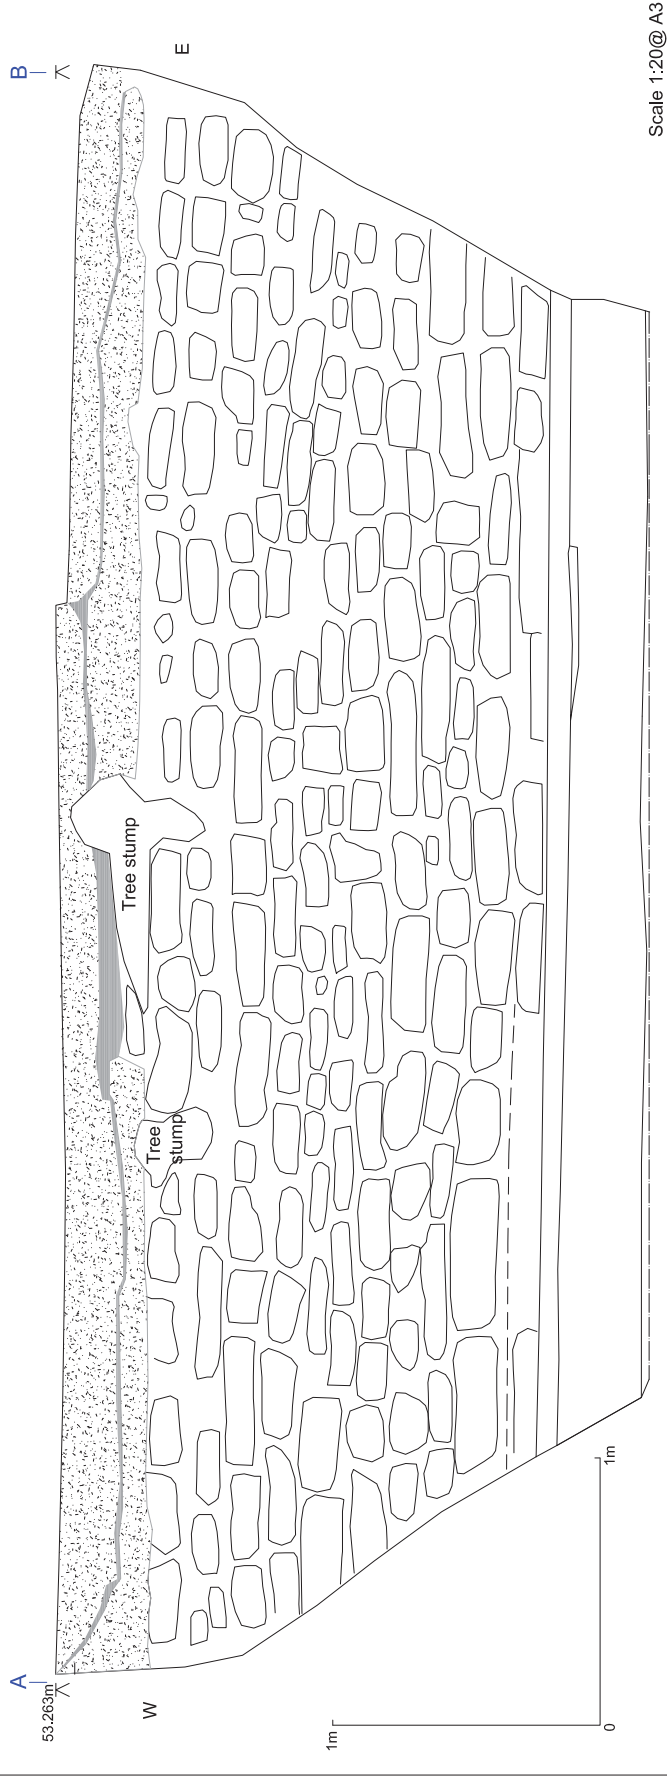
Elevation 1:
South-facing
wall of weir

Crack in wall
-

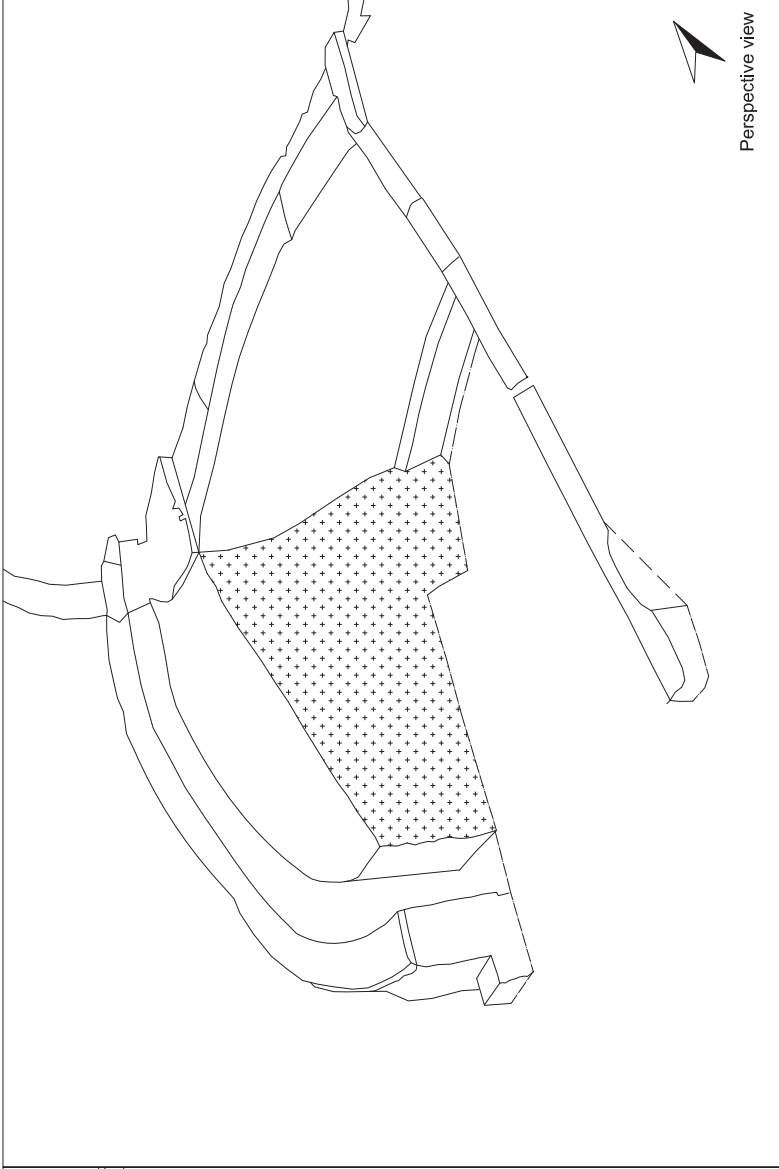
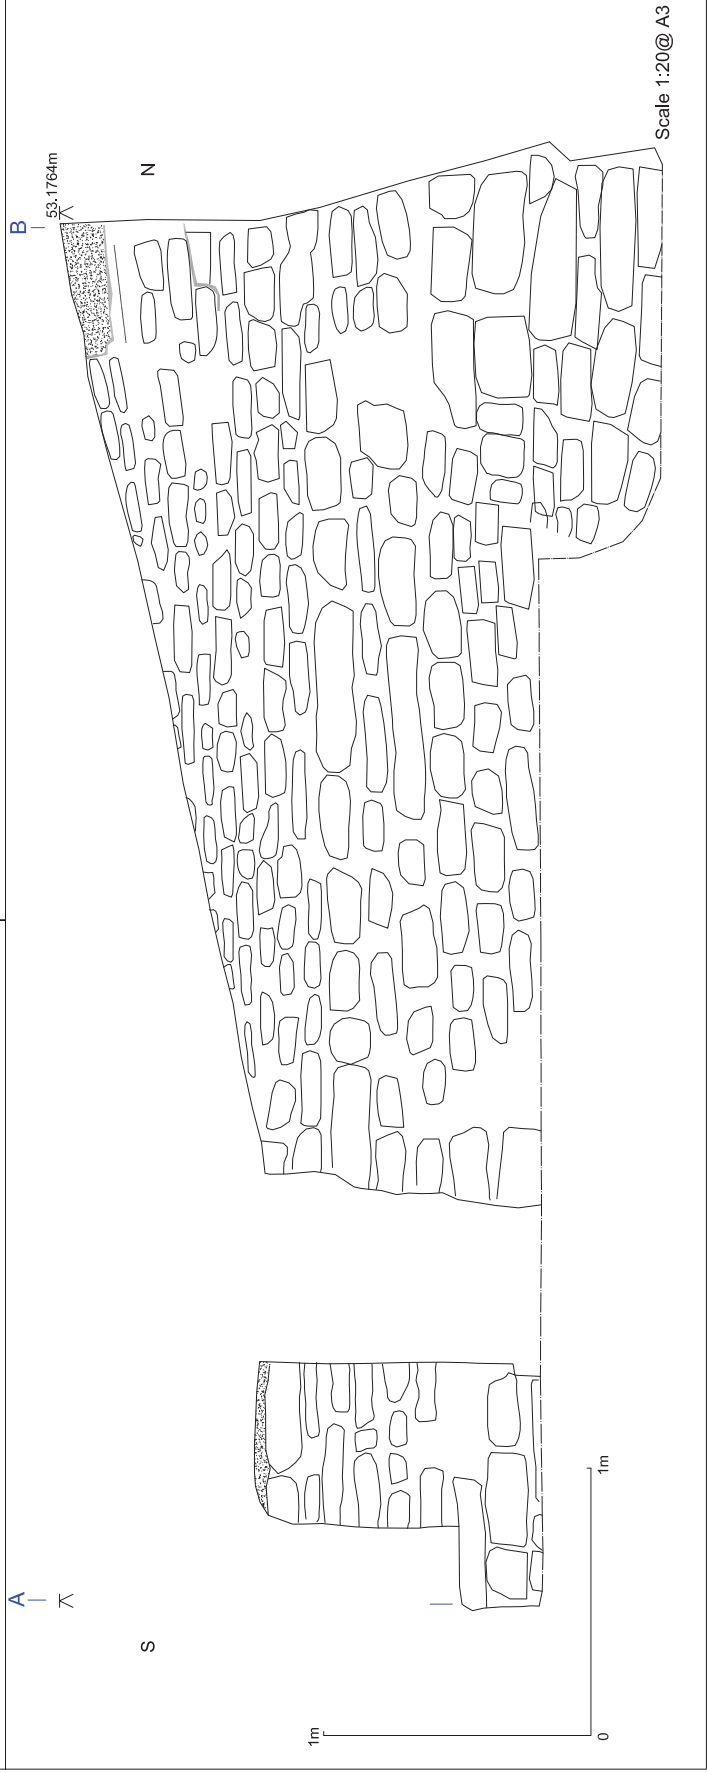
**Elevation 2:
East-facing
wall of weir**

Crack in wall
-

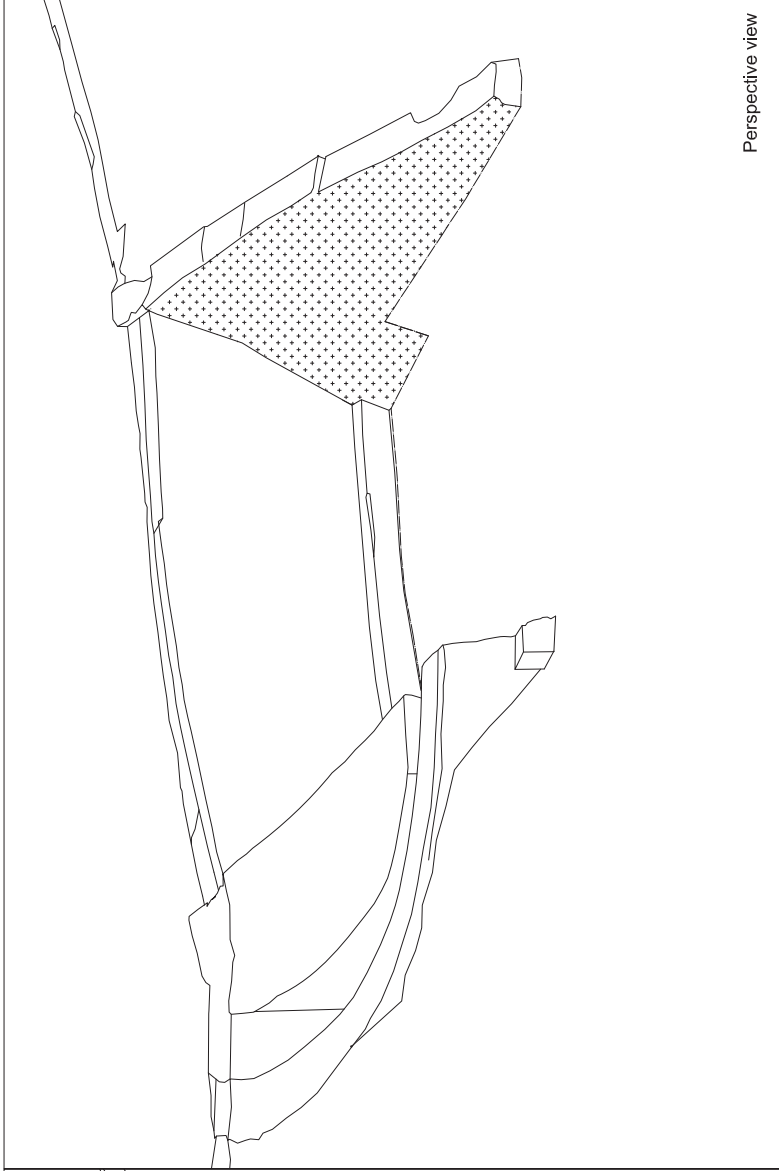
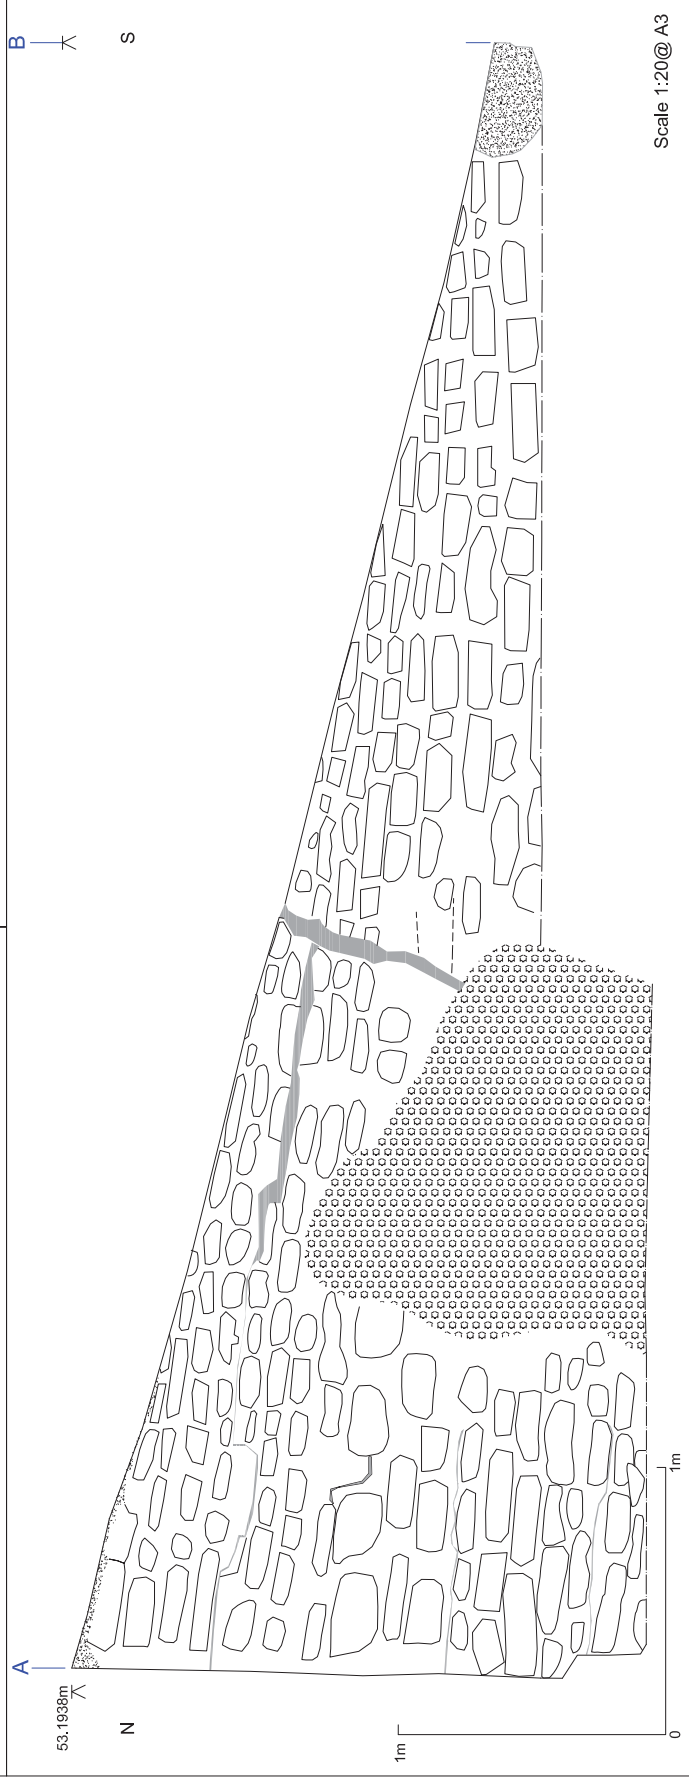
**Elevation 3:
West-facing
wall of weir**

Crack in wall
-

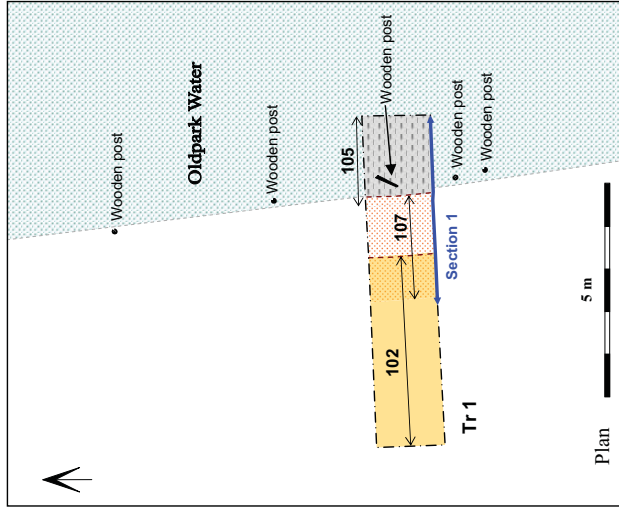
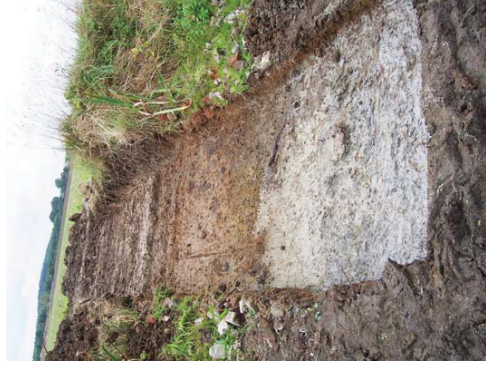
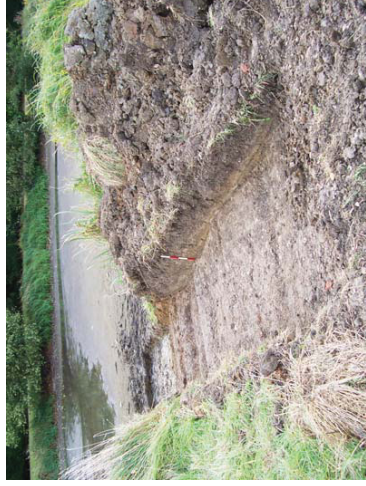
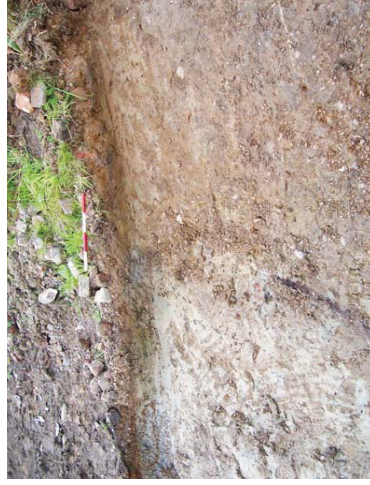
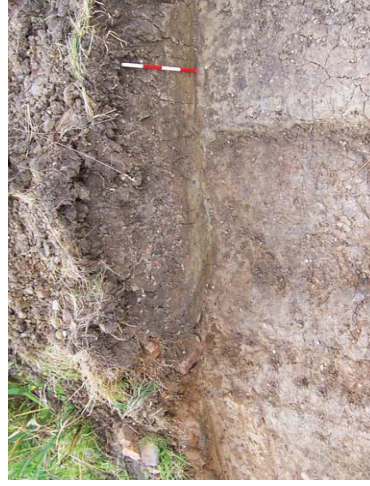
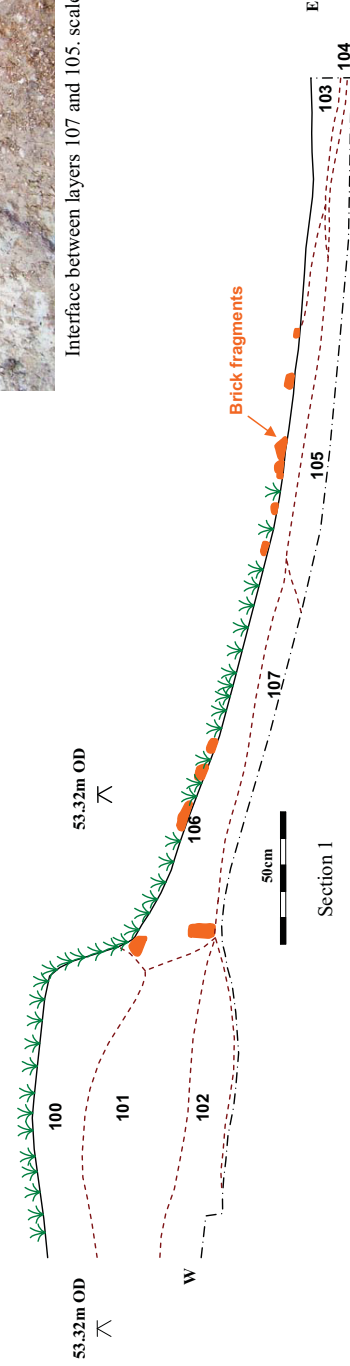
Figure 2: Trench 1

Following removal of topsoil and subsoil deposits of up to 0.6m thick, a mid-brown clay layer (107) was revealed at a depth of 52.87m OD (Fig. 1). It was overlain by alluvial clay (102), probably derived from repeated flooding to the area adjacent to Old Park Water, and partially overlay clay (105) deposited for the lake bed. The location and nature of layer (107) indicates it is a remnant of a deliberately created bank and likely to date back to when Old Park Water achieved its present form in the 18th century.

A later sandy layer with frequent modern brick (106) (Fig. 1), and probably associated with 20th century containment of Old Park Water, also overlay layer (107). The remains of a line of wooden posts, likely to once have formed a fence designed to retain this layer, are still visible.

Trench 1, looking west

Trench 1, looking east. scale 40cm

Interface between layers 107 and 105. scale 40cm

Interface between layers 102 and 107. scale 40cm

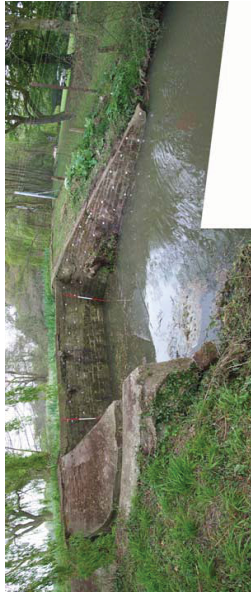
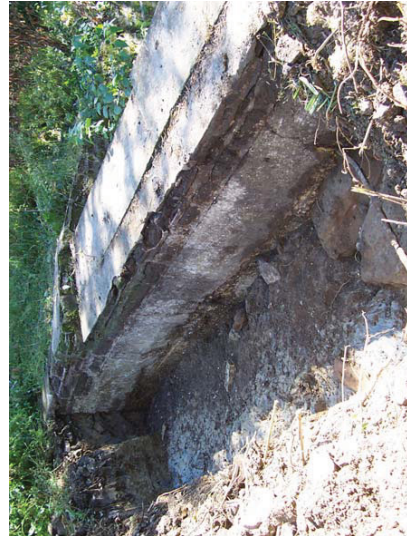
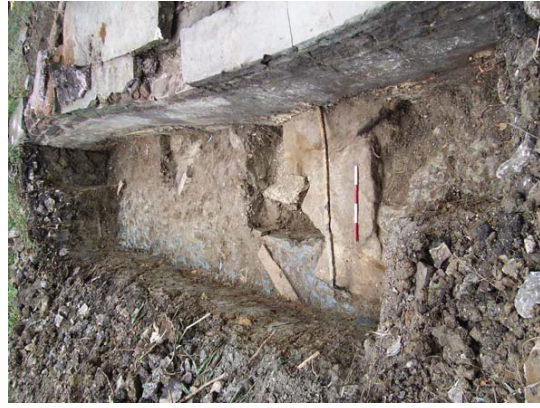
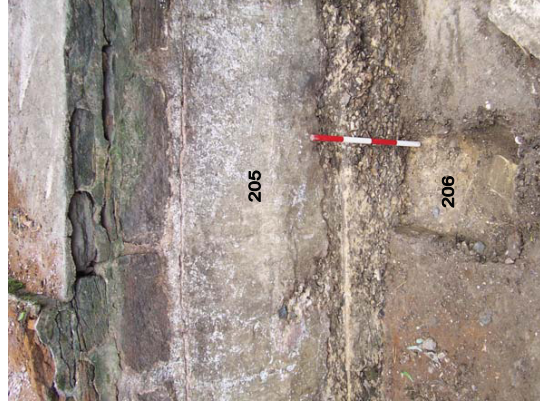
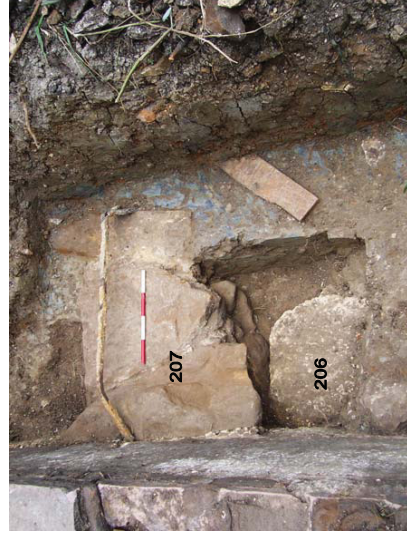
Figure 3: Trench 2

Wall (205) was built against the upstream side of weir wall (208) and over the top of the possible buttress (207). It continues around the eastern side of Old Park Water and appears to be a 20th century rebuild of part of the retaining wall, presumably built to reinforce the weir and help prevent leakage onto the adjacent gardens.

Old Park Weir, looking north-east.
Scales 2m in 50cm increments

Trench 2 and weir retaining wall (205), looking south-east.

Trench 2, looking east.
Scale 40cm

Trench 2, retaining wall (205), looking south.
Scale 40cm

Trench 2, possible buttress (207), looking west.
Scale 40cm

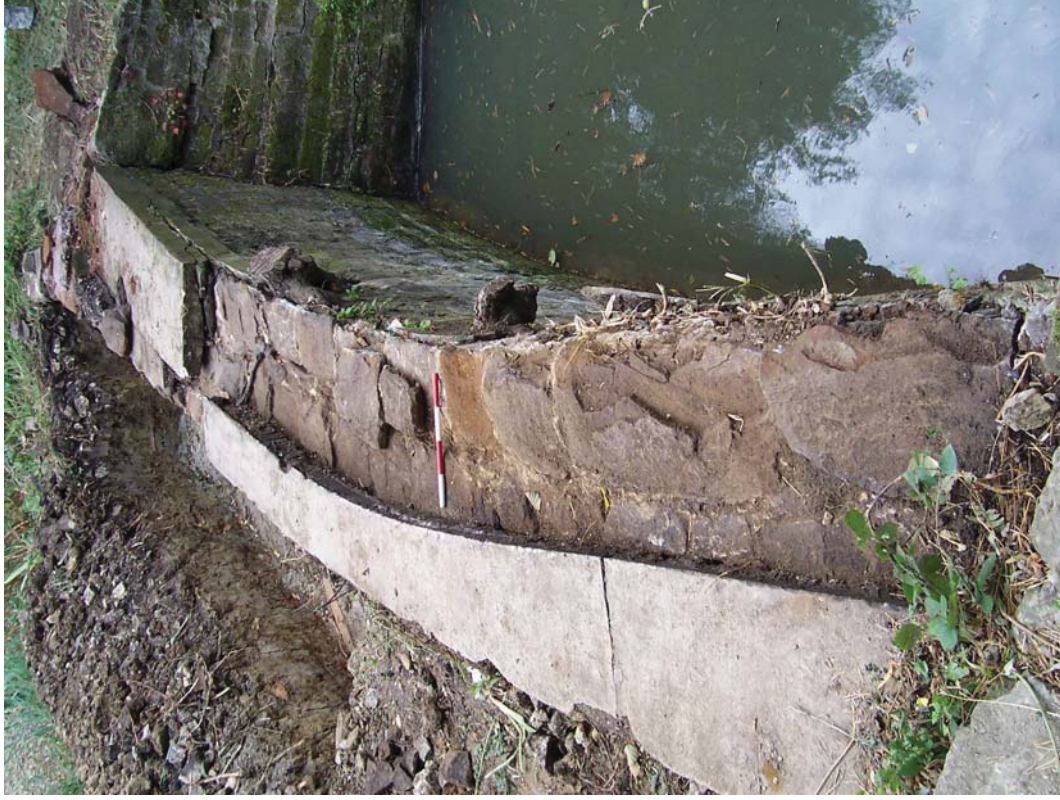
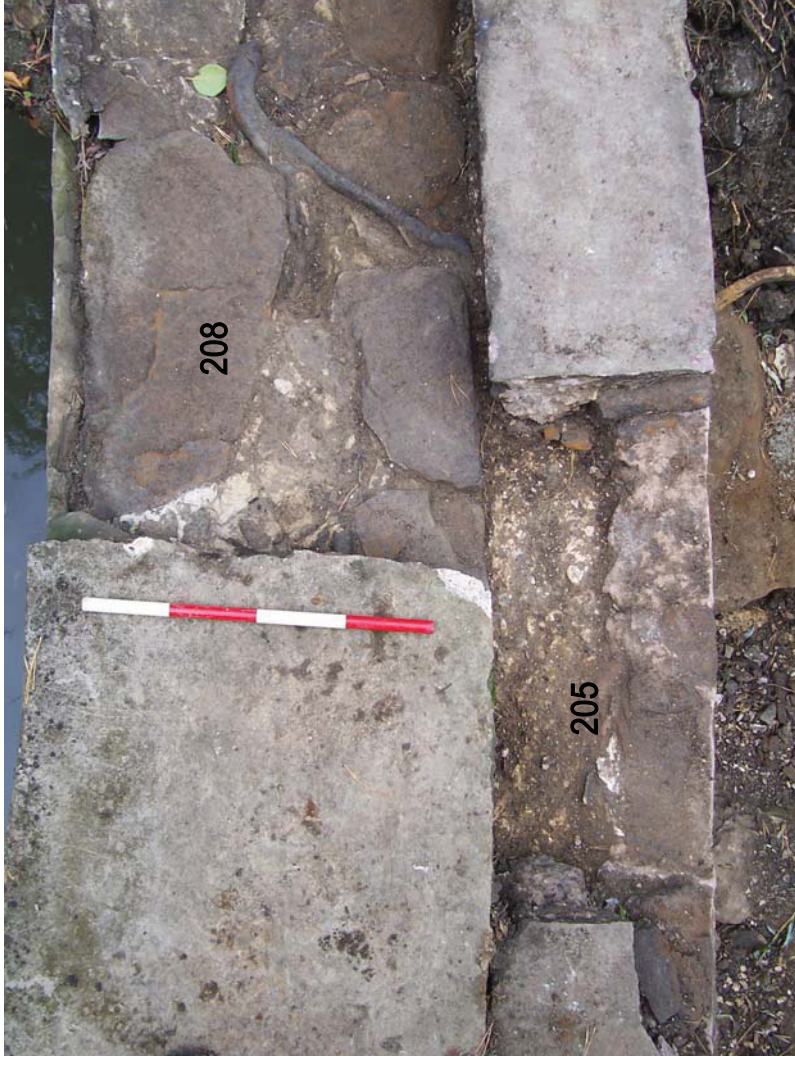
Figure 4: Top of weir after removal of sections of the concrete capping

As reported in Albion Archaeology (2007a), weir wall (208) is constructed of random blocks of iron-rich greensand, and capped with a concrete sill (Figs. 3 and 4). Its southern face has been entirely re-pointed using cement. However, removal of the concrete capping revealed randomly sized rough hewn greensand blocks (53.07m OD) that have been bonded together with a yellow lime and sand mortar (Fig. 4). Although substantially repaired, this indicates the weir wall has not been completely rebuilt. The visible width of the wall at this point measured 0.55m wide.

Following removal of the concrete capping on the top of the weir, its northern face was clearly revealed to be part of a separate wall to that visible from the southern side (Figs. 3 and 4). This wall (205) was largely constructed using a concrete mix of sand and small stones and rendered with cement. In addition, courses of greensand blocks, bonded together with sand and cement, have been added to the top and capped with the concrete sill.

Top of weir wall (208) after removal of concrete capping. Looking east. Scale 40cm

Top of weir wall (208) (top of picture) and 20th century retaining wall (205) (bottom of picture), after removal of sections of the concrete capping. Scale 40cm

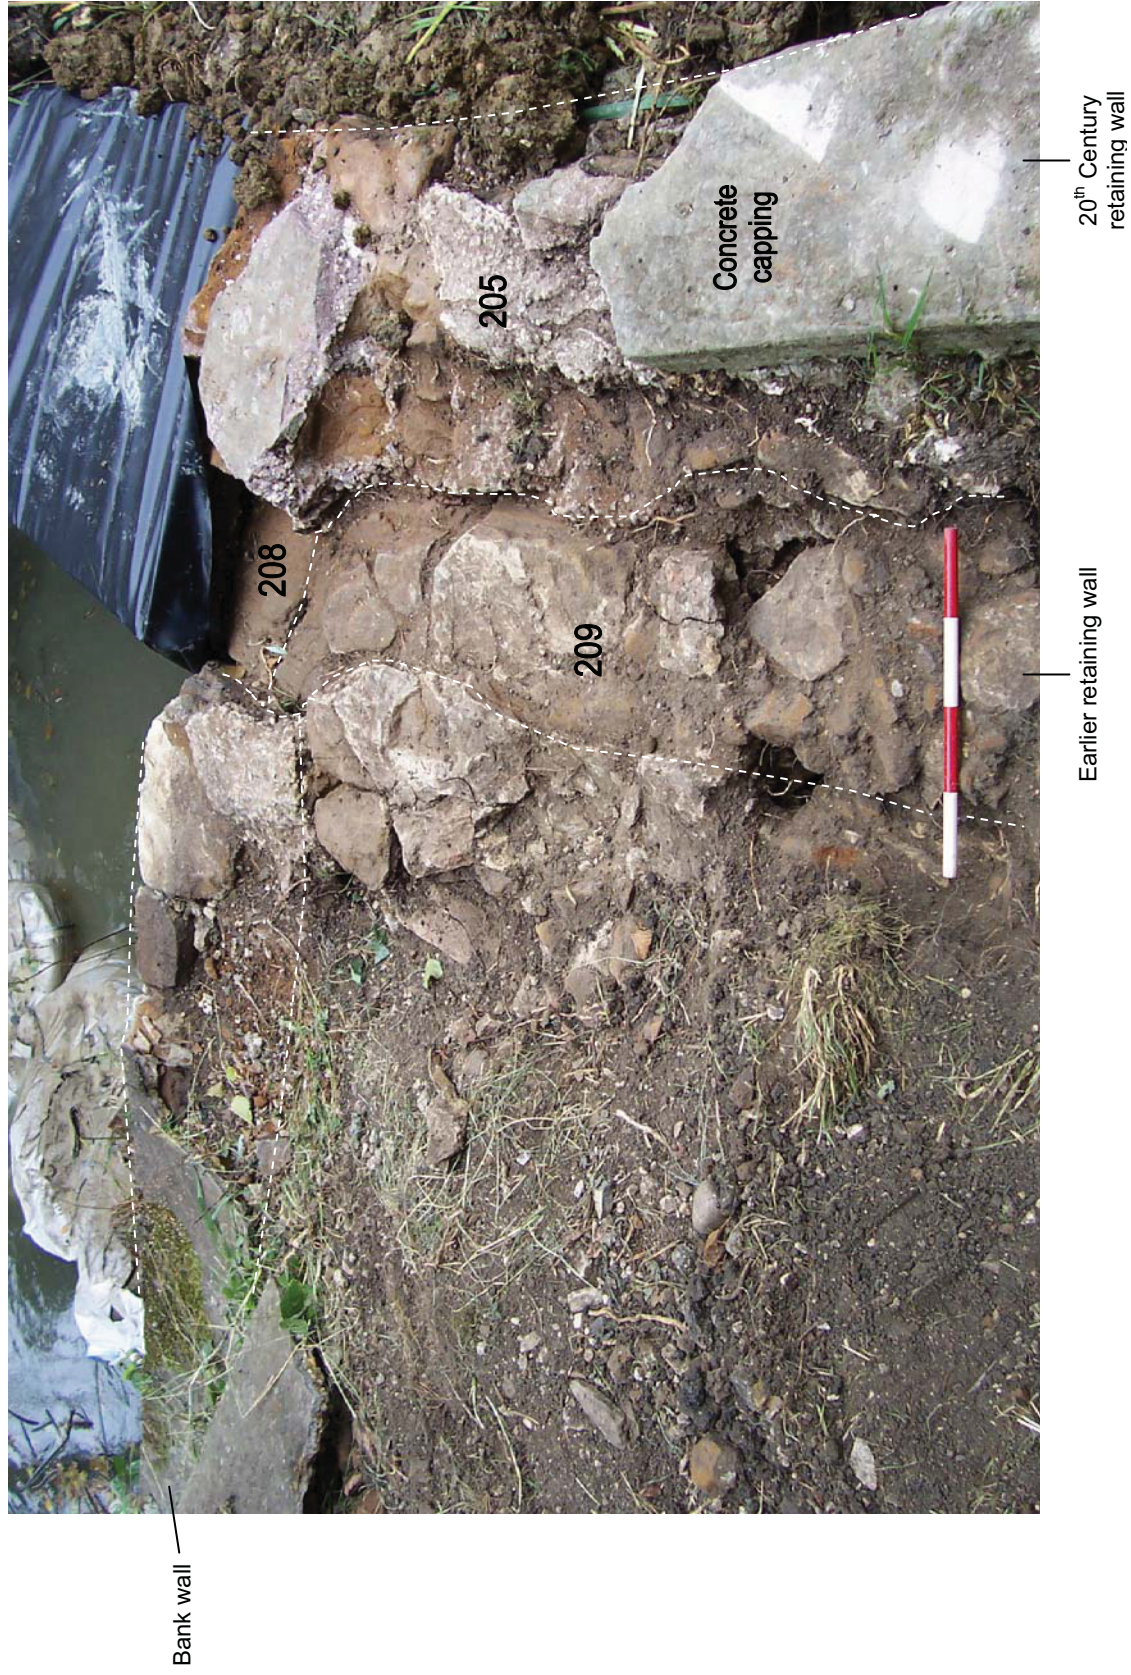
A small area was examined on the east side of the weir adjacent to the eastern portion of the retaining wall (Fig. 5). Here a greensand block wall (209) was observed in plan at 52.9m OD, just beneath the current ground surface adjacent to the south side of retaining wall (205). It measured approximately 0.5m wide and is likely to be the remains of the earlier eastern portion of the retaining wall, contemporary with and possibly joined to weir wall (208).

Figure 5: Junction of eastern bank wall, weir wall (208), 20th century retaining wall (205) and earlier retaining wall (209). Scale 40cm

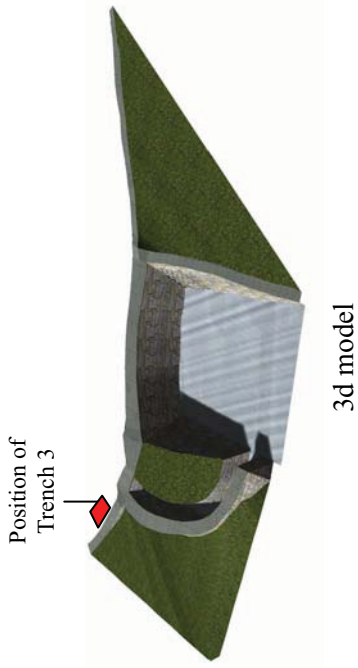
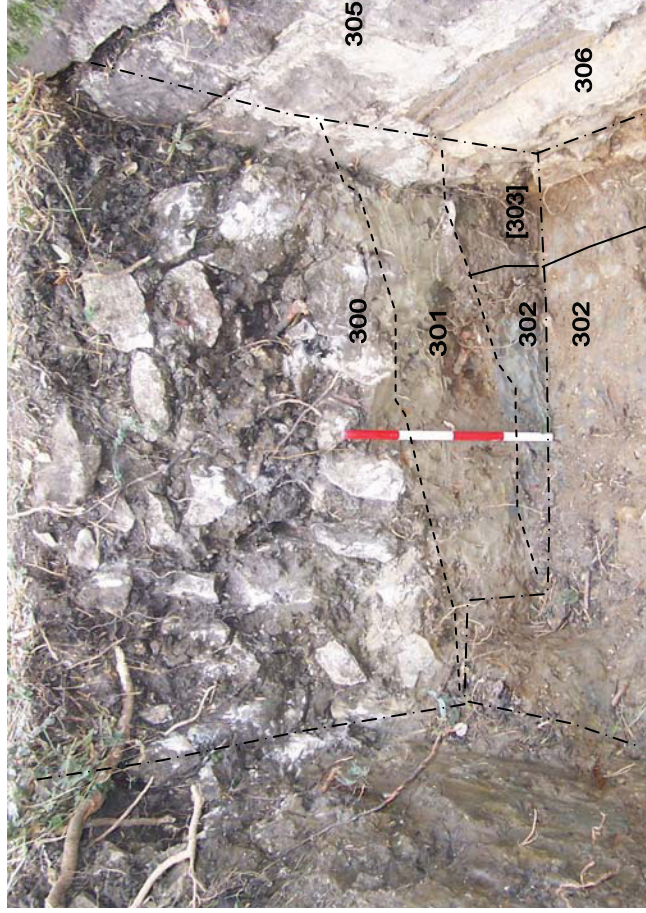
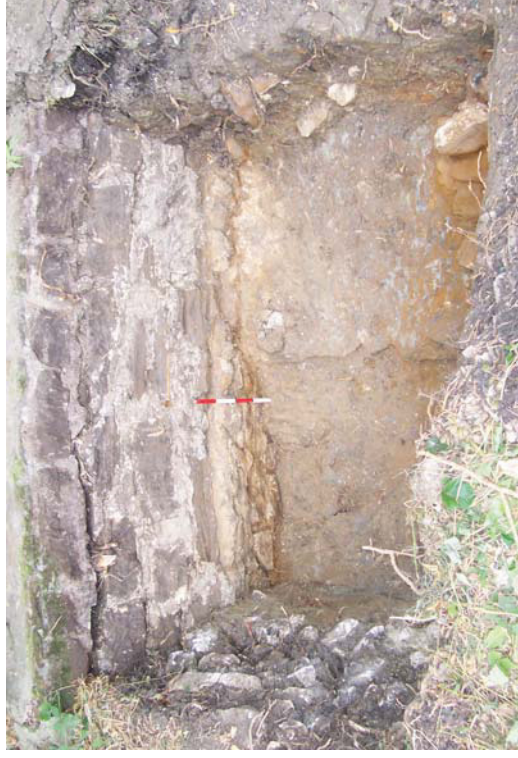
Figure 6: Trench 3

The upstream side of the western portion of the retaining wall (305) was examined in Trench 3 (Fig. 6). It was similarly constructed to that of weir wall (208), using rough hewn random coursed sandstone blocks and re-pointed using cement. A concrete cap has also been added. The wall was sat on foundations (306) of coursed rough hewn sandstone blocks, though smaller than that used in the wall, bonded together with a yellow sand and lime mortar. It was contained within a foundation trench [303] that was cut into the clay (302) of the lake bed.

South-east side of Trench 3. Scale 40cm

Trench 3; retaining wall (305), looking south-west. Scale 40cm
