**GREEN FARM HOUSE
TILSWORTH ROAD
STANBRIDGE
BEDFORDSHIRE**

**ARCHAEOLOGICAL OBSERVATION,
INVESTIGATION, RECORDING,
ANALYSIS AND PUBLICATION**

Project: GF1569

Document: 2009/113
Version 1.0

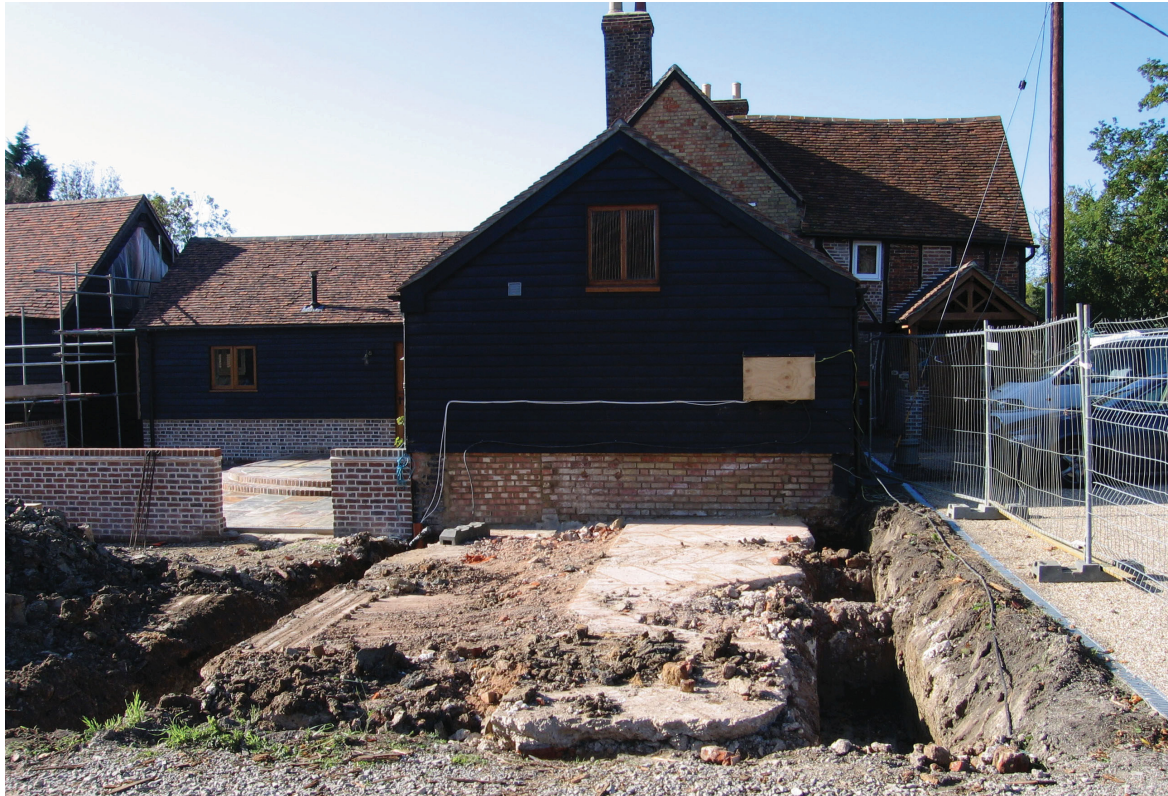
Photograph 1: Extent of the garage footings

The groundworks comprised the mechanical excavation of footing trenches for the new garage, which has external dimensions of 8.8m by 5.7m (Fig. 1 and Fig. 2, Photograph 1). The trenches — 0.6m wide and *c.* 1m deep — followed the footprint of the previous building, the concrete floor of which lay on a thin bed of rubble set directly into the undisturbed geological stratum (Fig. 2, Photograph 2). The outer faces of the trenches revealed 0.5m of mixed overburden; the presence of brick and concrete fragments throughout suggests that this material constitutes infill of the construction trench for the former barn.
