**4-6 LONDON ROAD
SANDY
BEDFORDSHIRE**

ARCHAEOLOGICAL FIELD EVALUATION

Project: LRS1577

Document: 2009/125
Version 1.0

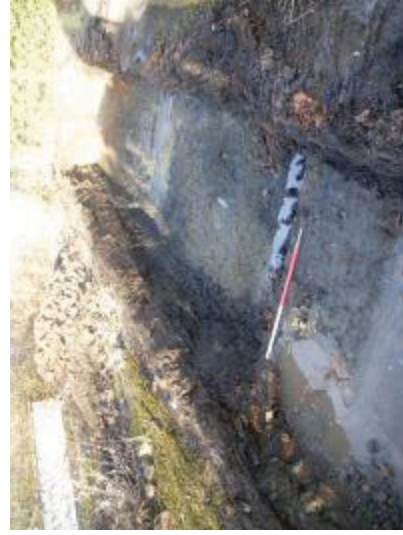
A brick surface (501) was revealed directly beneath the existing tarmac in Trench 5 which, together with two circular drains (507/510), is likely to be associated with the back yards of the properties that fronted onto London Road.

Trench 5. Buried drains [507] and [509] (foreground) Looking WNW. Scale 1m

507	Drain	Circular brick drain 1.2m diameter.	<input checked="" type="checkbox"/>	<input type="checkbox"/>
506	Fill	Dark grey silty clay	<input checked="" type="checkbox"/>	<input type="checkbox"/>
509	Drain	Circular brick drain 1.2m diameter.	<input checked="" type="checkbox"/>	<input type="checkbox"/>
508	Fill	Dark grey silty clay	<input checked="" type="checkbox"/>	<input type="checkbox"/>

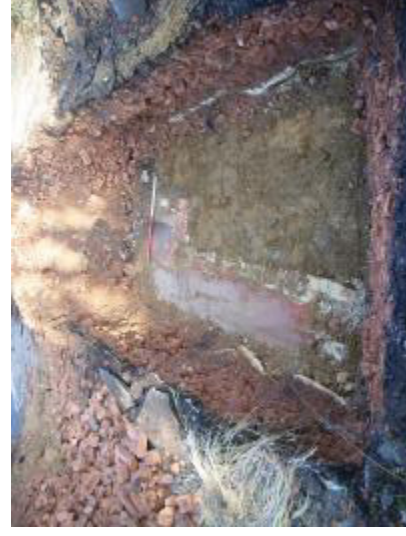
A thick layer of brick rubble (401) sandwiched between the existing tarmac surface and floor surface (402) in Trench 4 is the result of 20th-century landscaping to raise the ground level in this location. An insubstantial brick wall (103) revealed within the topsoil in Trench 1 is associated with a now demolished 20th-century garden nursery.

Trench 4. Concrete and tile floor (402)

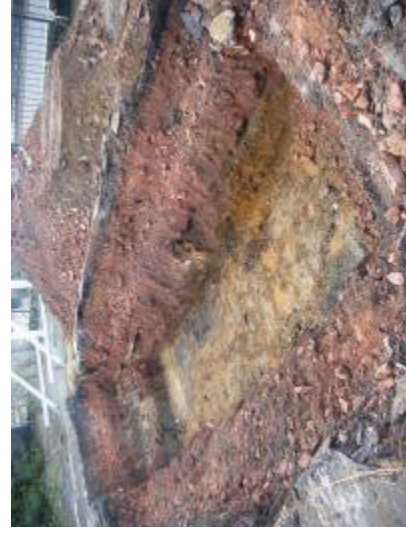
Trench 4. Looking SW.

The undisturbed geological deposits and subsoil within Trenches 4 and 5, located in the area of hardstanding in the southern half of the site, were overlain by up to 0.5m of demolition and make-up layers. These were overlain by a yard surface (Trench 5, 501) and floor surface (Trench 4, 402) associated with 19th- and 20th-century development of the site, revealed at *c.* 22m OD. Yard surface (501) was revealed directly beneath the existing tarmac surface, whilst floor surface (402) was overlain by a 0.85m thick deposit of brick rubble (401), creating a raised area of hardstanding in this part of the DA.
