**CHICKSANDS PRIORY DII(F) WORKS
BEDFORDSHIRE**

**ARCHAEOLOGICAL OBSERVATION
AND INVESTIGATION**

Project: CP1344

Document: 08/118

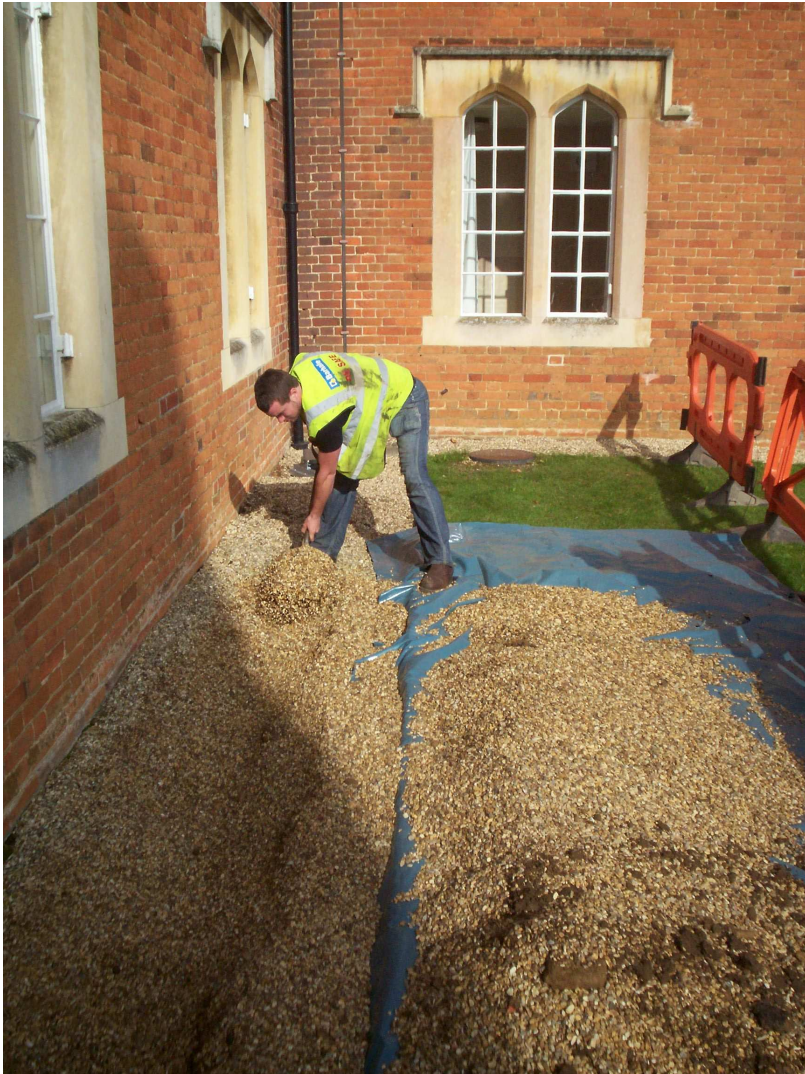
The French drain within which the new cabling and turning chambers were installed measured 1.0m wide and approximately 0.10m deep and was filled with gravel (Figure 2). The cable was laid within the 0.10m depth of the gravel; only the excavations for the turning chambers (Figure 3) extended c.0.15m below this level.

Figure 2: Removal of French drain gravel fill prior to installation of cable

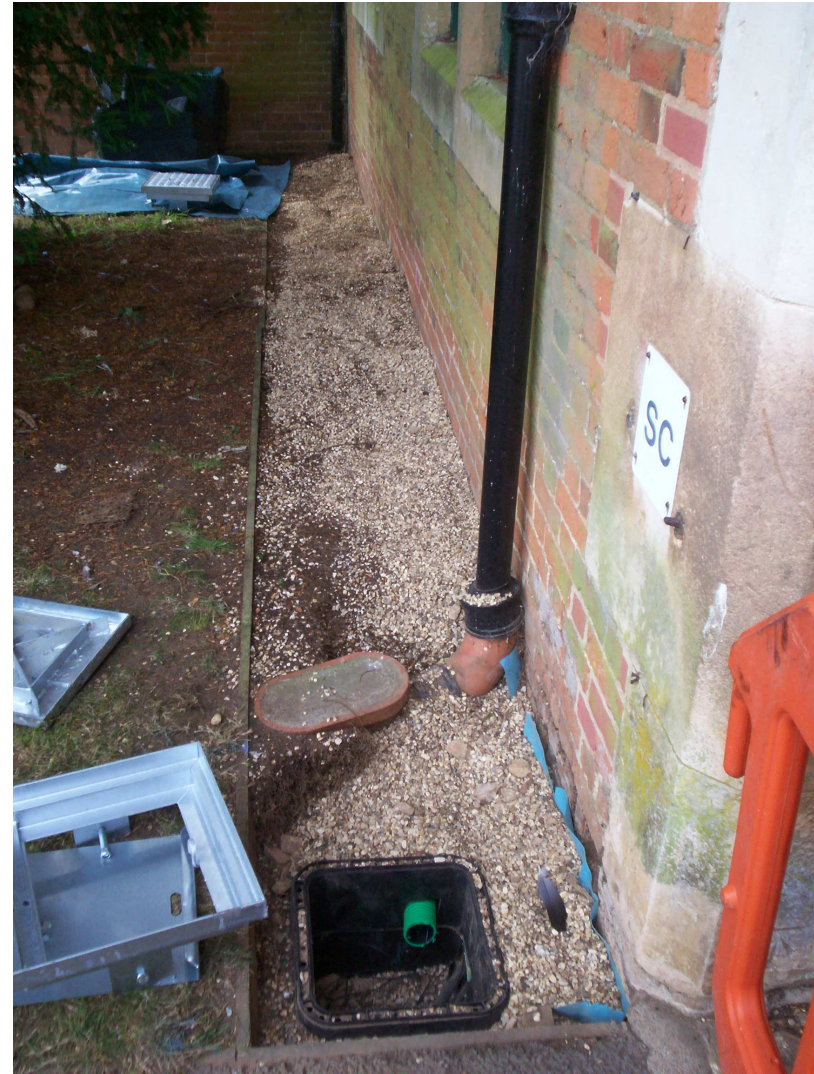
Figure 3: Installation of turning chamber

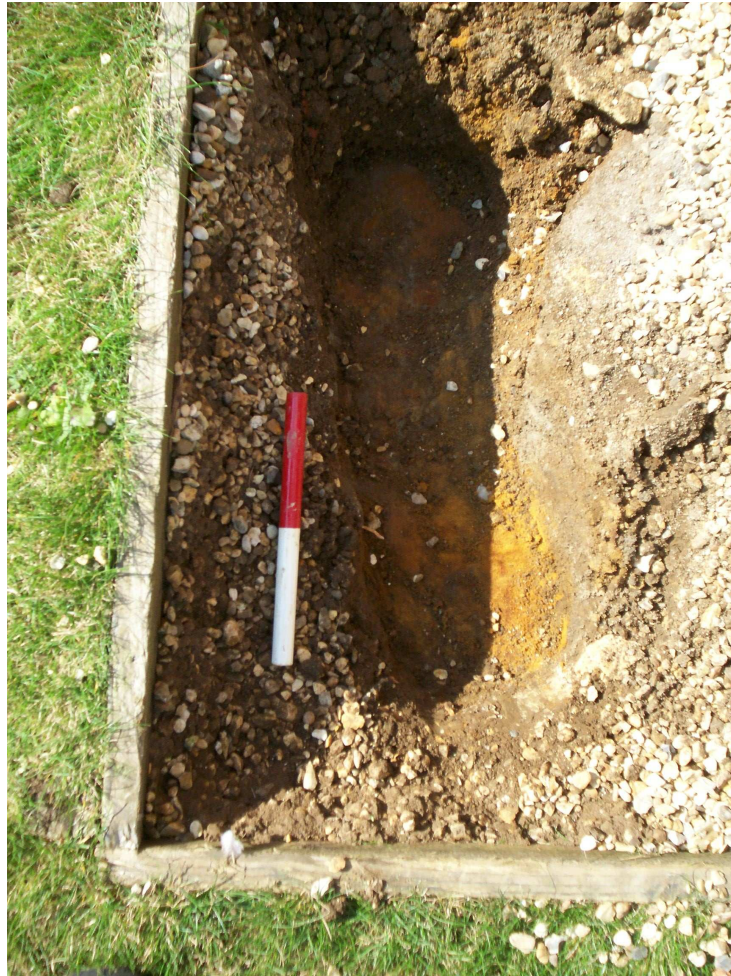
In one turning chamber excavation potential archaeological remains were revealed (Figure 4). They comprised fragments of orange sandstone which were uncovered at a depth of c. 0.20m below surface level.

Figure 4: Exposure of sandstone within turning chamber excavation

The limited nature of the building works associated with the installation of the communications cable at Chicksands Priory meant that they had very little impact on deposits that had the potential to contain archaeological remains. Although some sandstone was encountered at a relatively shallow depth, because only a small surface area of this material was exposed it is not possible to say whether it formed part of the remains of larger structure or was just a rubble deposit.
