**THE CHURCH OF ST MARY THE VIRGIN
WOOTTON
BEDFORDSHIRE**

**ARCHAEOLOGICAL OBSERVATION
AND INVESTIGATION**

Project: SMW1518

Document: 2010/31
Version 1.0

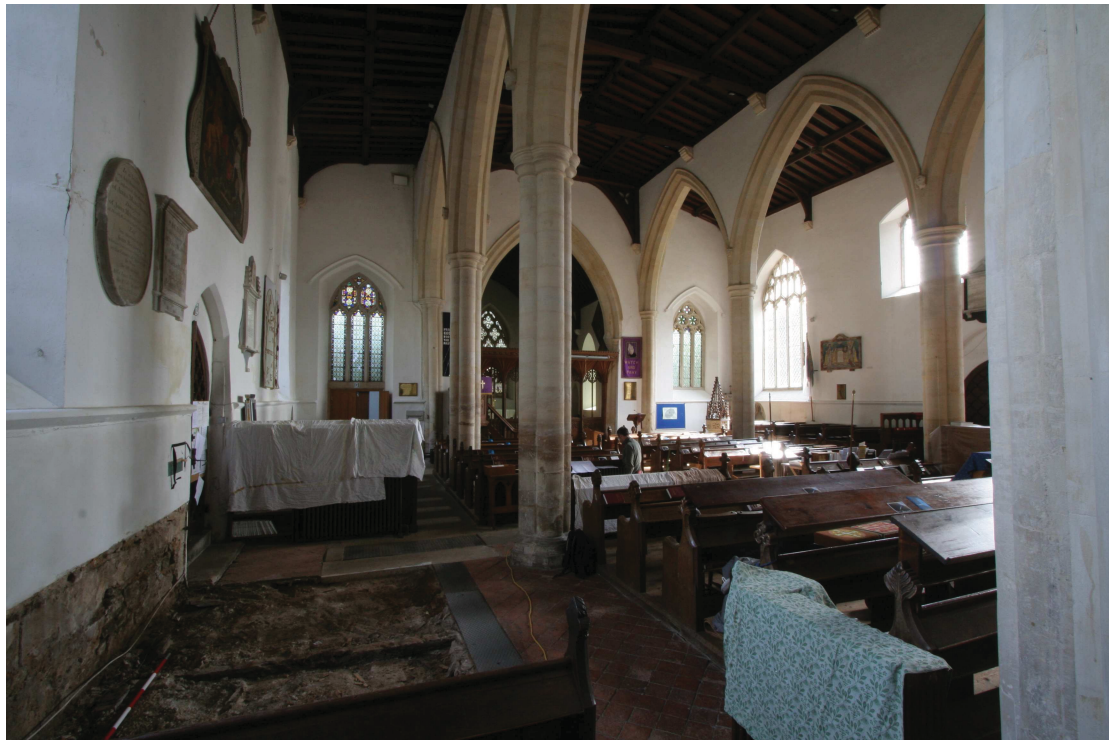
Figure 3: Location of works in north aisle

The creation of the mingling area involved the removal of four rows of pews in the north aisle, along with their wooden plinth. The area exposed by the removal of the plinth (3.55m by 2.25m) was then excavated by the contractor to a depth of 150mm below the surrounding floor level to form a base for a stone flagged floor (Figure 3).

The surface exposed beneath the plinth in the north aisle was 120mm below floor level. The surface consisted of uncompacted soil and accumulated dust with building debris which included fragments of limestone and roofing slates. Masonry forming the inner face of the north aisle wall was exposed by the removal of the pews. This was coursed

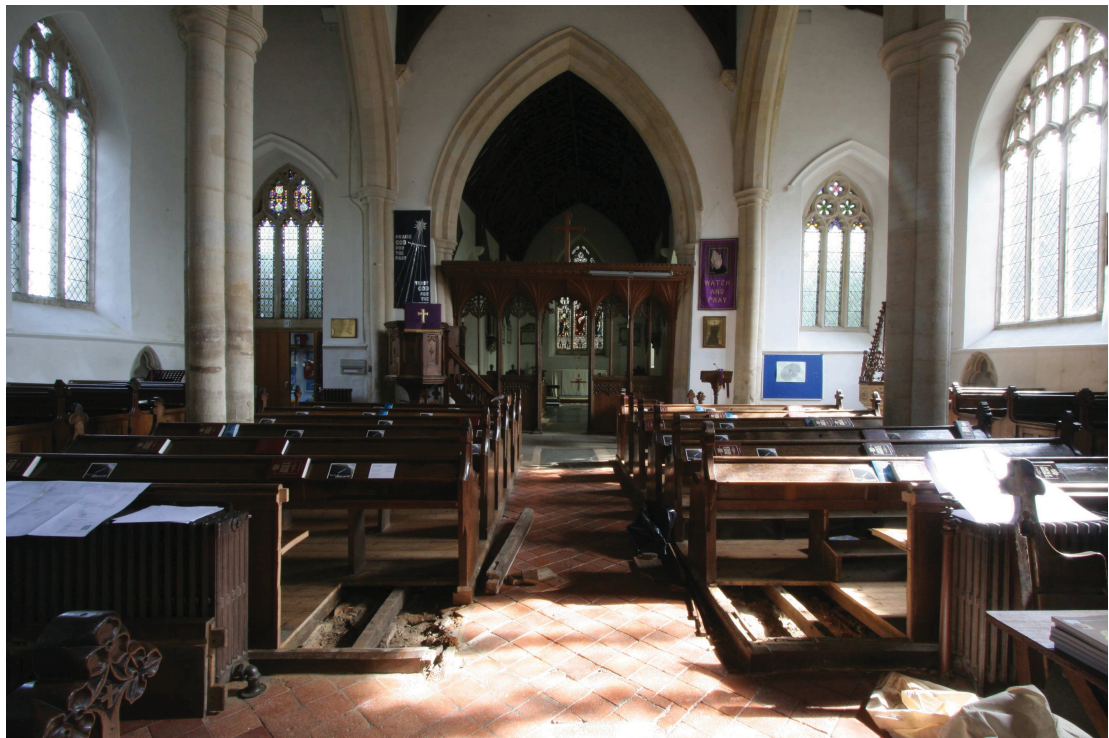
Figure 4: Location of works in nave

Wheelchair spaces were formed in the nave by shortening two rows of pews. A square section of the planking in the underlying wooden plinth was removed and reframed. The ground beneath was excavated by the contractor to a depth of 150mm below the surrounding floor level (Figure 4).

The surface beneath the sections of plinth removed in the nave lay 60mm below the adjacent tiled floor surface. It consisted of uncompacted soil and accumulated dust.

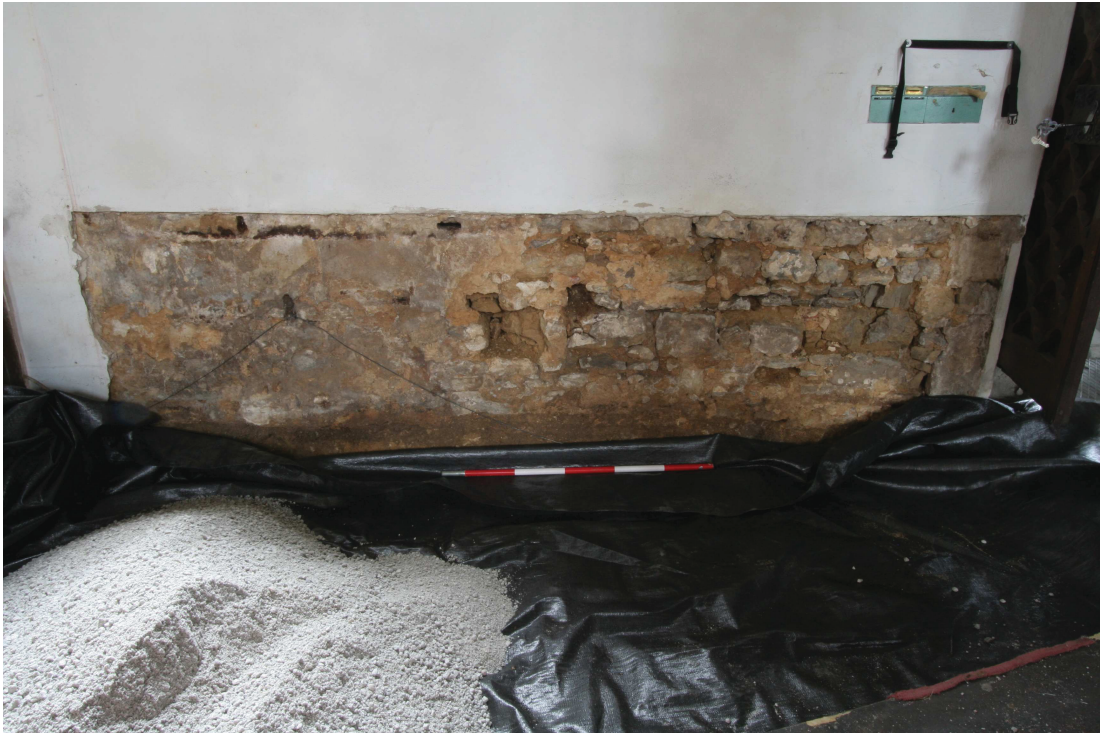
Figure 5: Exposed masonry in north aisle

limestone rubble with small slabs and larger, roughly squared blocks measuring approximately 200mm. It was bonded with soft, light yellowish brown mortar which was missing in places leaving voids between the stones. Larger roughly shaped blocks at the east end of the walling formed the west side of the north door. The masonry was of the same character throughout with similar materials and finish (Figure 5).

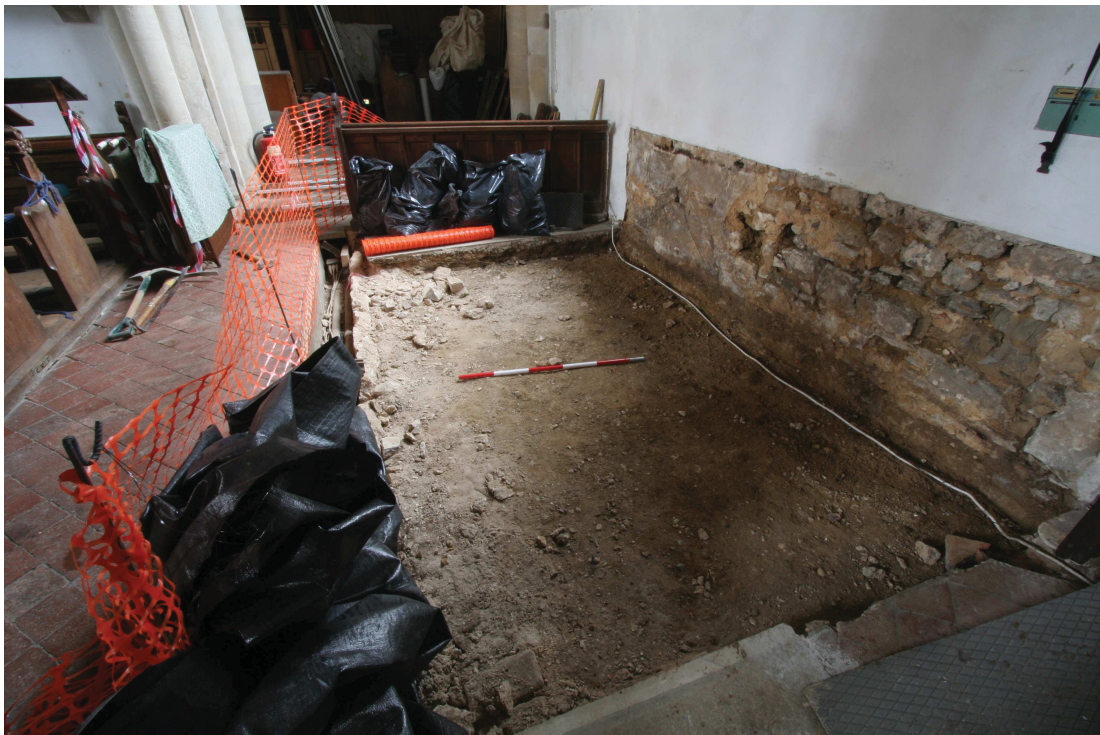
Figure 6: Trench in north aisle

The works were inspected following ground reduction to formation level which was 150mm below floor level. The area in the north aisle contained a firm mid yellow brown silty clay soil with fragments of limestone debris and mortar (Figure 6). The two small areas in the nave contained loose grey soil with fragments of mortar.

The excavations beneath the pews in the nave and the north aisle produced no significant observations. Due to the voids beneath the pews only a limited depth of soil had to be excavated to reach formation level, limiting the potential for archaeological observations.
