**LUTON DUNSTABLE BUSWAY
BEDFORDSHIRE**

**ARCHAEOLOGICAL OBSERVATION,
INVESTIGATION, RECORDING, ANALYSIS
AND PUBLICATION**

Project: LDB1654

Document: 2012/7

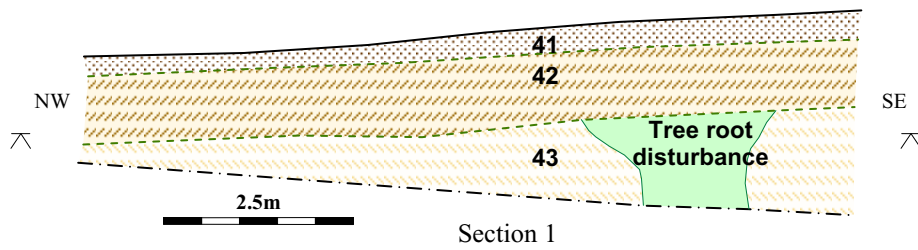
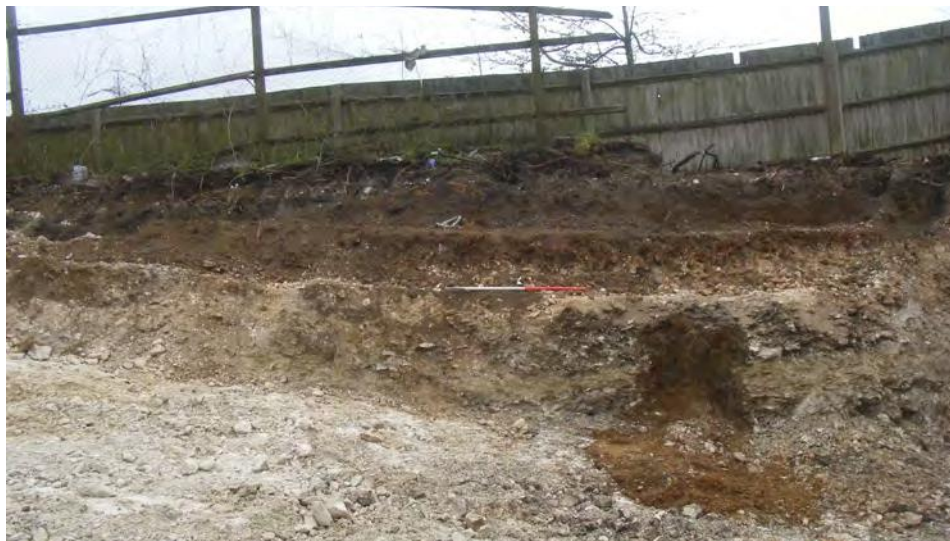
Figure 2: Area 1A

Ground reduction in this area revealed overburden consisting of up to 0.3m of topsoil (41) and a dump of material associated with the former railway embankment (42) which was at least 1.0m thick (Figure 2: Section 1). An area of root disturbance was also observed consisting of a roughly circular and steep sided feature measuring up to 2.5m across and filled with a mottled dark brown silty sand.

Photograph of tree root disturbance in Area 1A

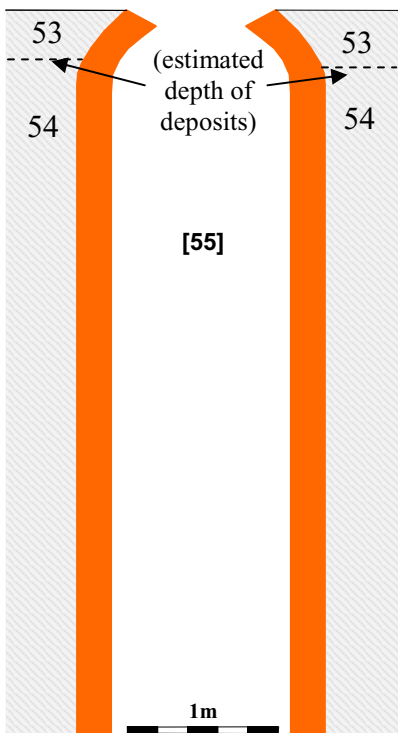
Section 2: Presumed cross-section of well [55]

A circular well [55] was uncovered approximately 50m to the south of the A505 road (Figure 3). It was constructed with un-frogged red bricks and measured *c.* 1.0m across and at least 20m deep. The top seven courses of the well lining were bonded with mortar and laid head-wise (regular courses), with each layer protruding a little further towards the centre of the well, which may suggest the well was originally topped with a lid (Figure 3: Section 2). The lower courses appeared to have been constructed with a single skin of un-mortared bricks laid in string (head-stretcher) courses.

The feature appeared to have been cut into the deposits associated with the railway embankment (53), which may indicate an association with the nearby former Dunstable Town railway station (HER15558).

56	Well lining	Brick lining of well [55]. Top 7 courses bonded with light grey sandy lime mortar in regular (head) courses. These courses get narrow up- and inwards. Below that unmortared numerous string brick courses (head-stretcher). At least one top course missing (mortar seen on top). Brick dimensions: 228x108x69mm.	<input type="checkbox"/>	<input type="checkbox"/>

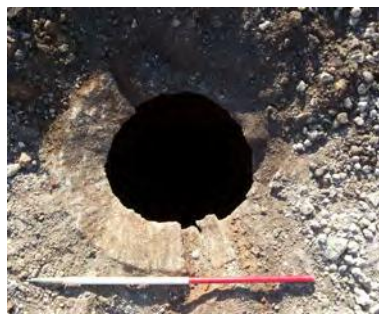
Photograph of top of well [55]. Scale 1m

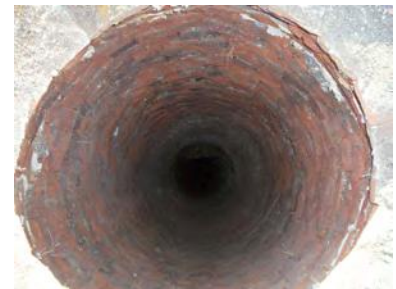
Photograph of inside of well [55].

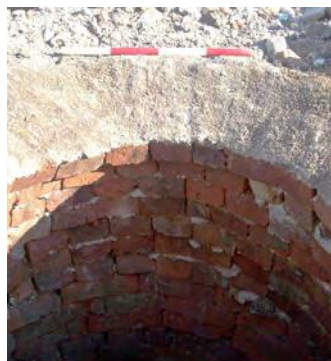
Photograph of wall of well [55]. Scale 40cm

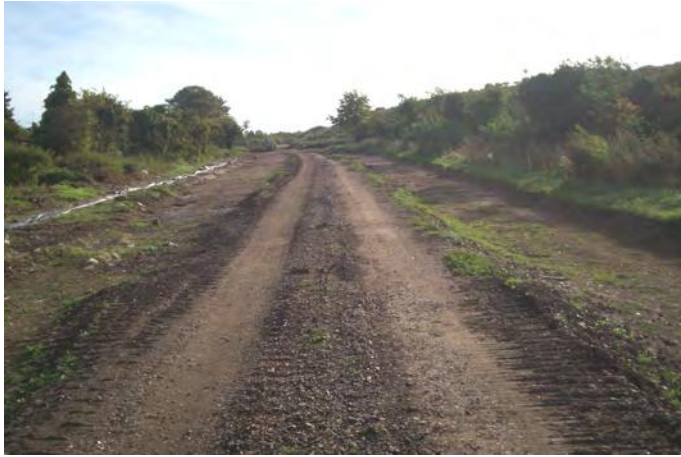
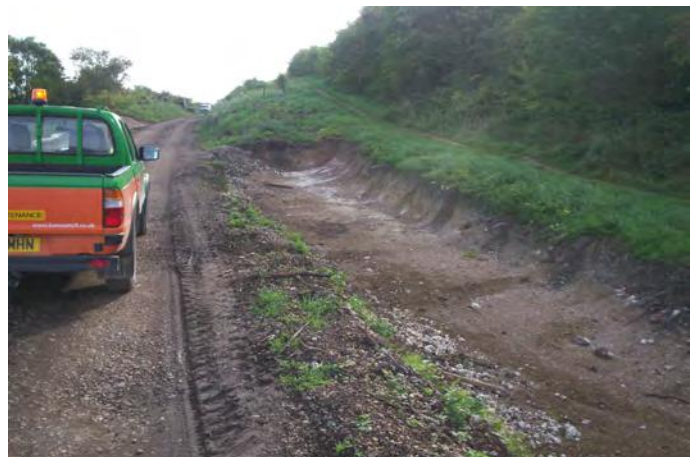
Figure 4: Area 2

Deposits revealed along Blow's Downs comprised up to 0.3m thick topsoil (61) overlying subsoil (62) that was generally 0.15–0.2m thick. The latter, in turn, sealed at least 0.3m of railway bank material (63) (Figure 4) that overlay the natural chalk (64).

West end of Area 2, looking east

East end of Area 2, looking east

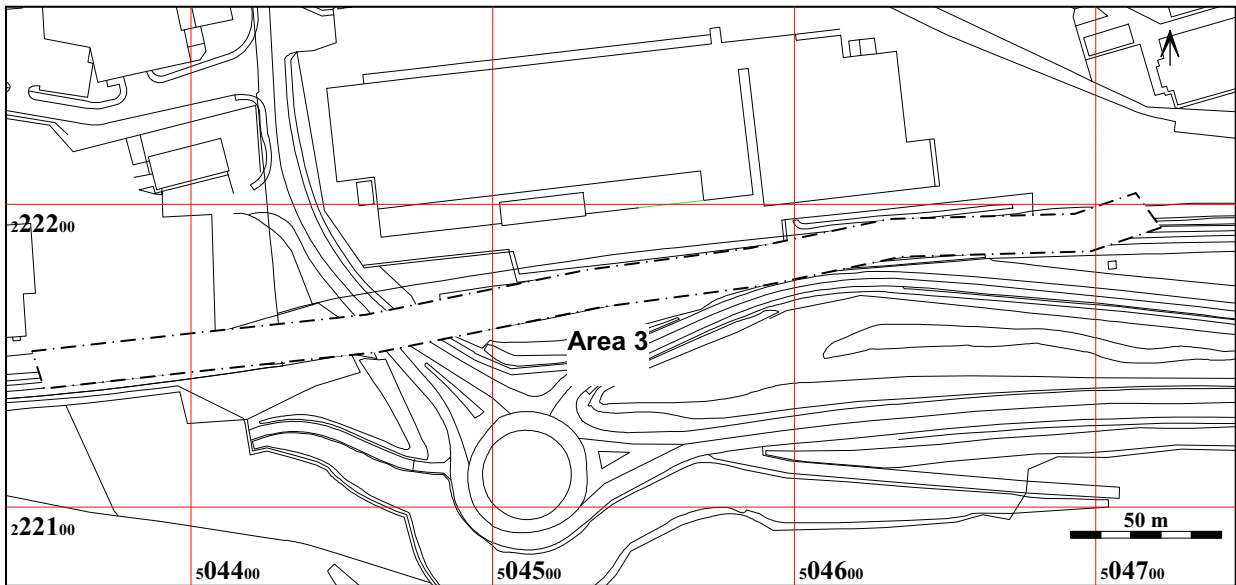
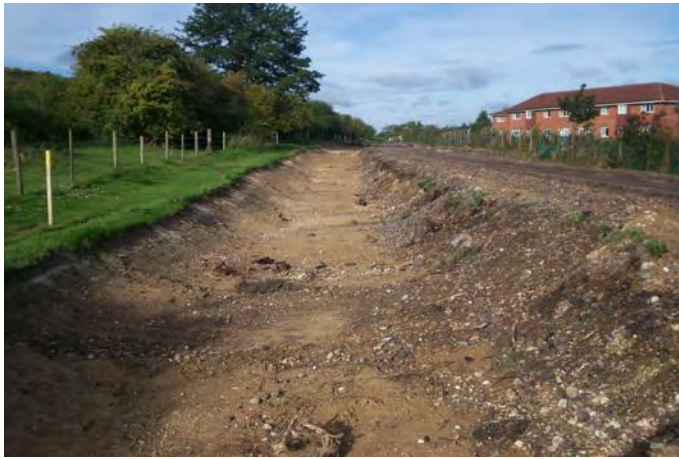
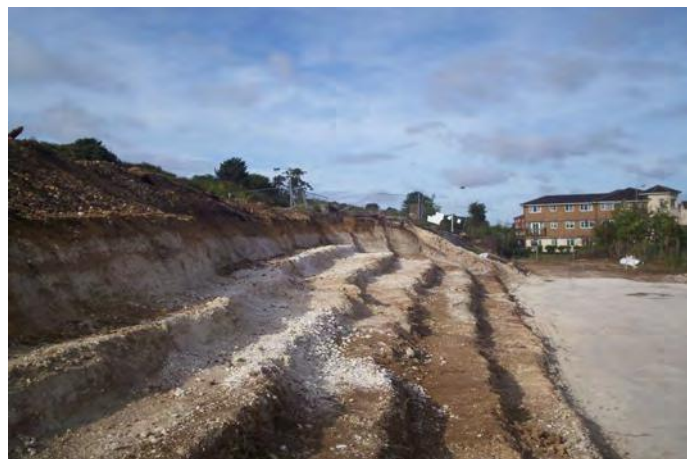
Figure 5: Area 3

The groundworks revealed similar deposits to that of Area 2 — a 0.2m thick topsoil (71) and up to 0.25m of subsoil (72) which overlay material forming the railway embankment (73). The latter was at least 0.3m thick (Figure 5) and overlay the natural chalk (74).

West end of Area 3, looking west

East end of Area 3, looking west

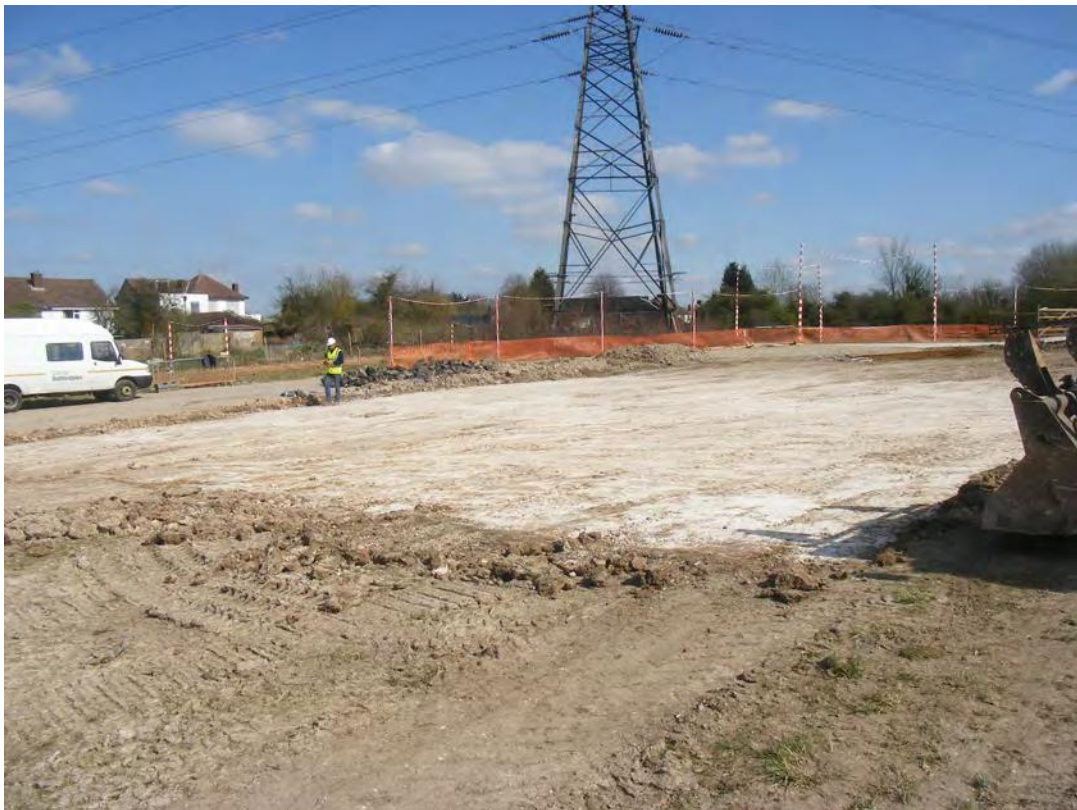
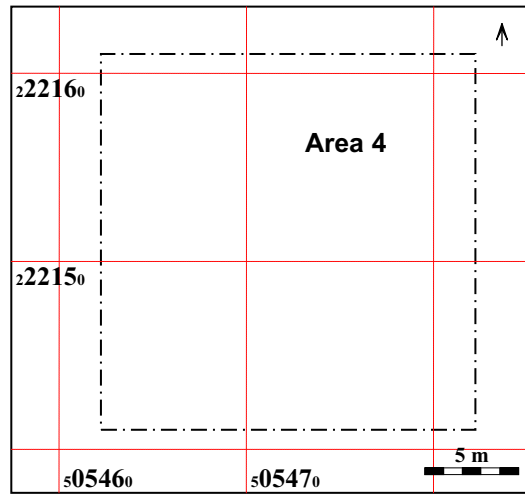
Figure 6: Area 4

The groundworks associated with the construction of a site compound revealed only 0.1–0.25m thick topsoil/vegetation (81) (Figure 6).

Photograph of Area 4, looking north-east

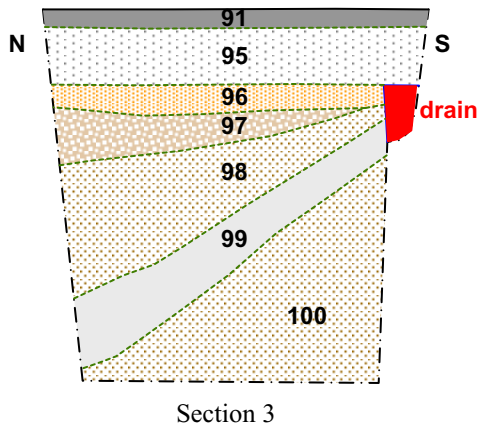
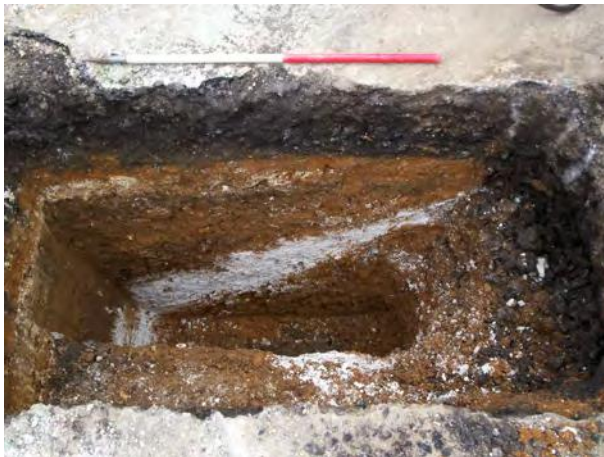
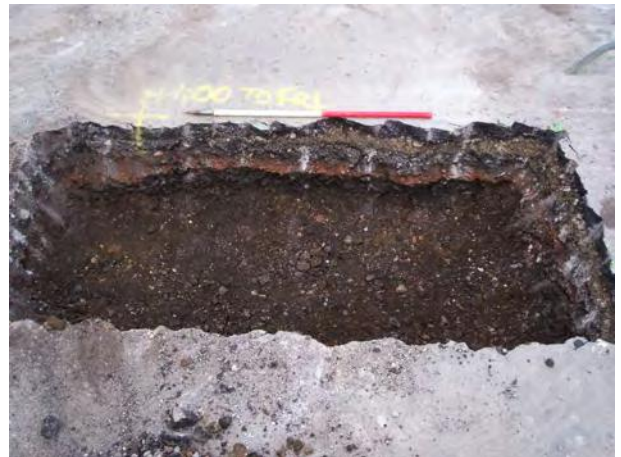
Figure 7: Area 5

Groundworks monitored included the machine-excavation of four test pits (nos 17-20) that were excavated to a depth below ground level of between *c.* 0.4m (Test Pit 20 – at the eastern end of the development area) and *c.* 1.95m (Test Pit 17 – at the western end of the site) (Figure 7). A series of make-up layers (91-96) associated with the former station car park were revealed. These overlay deposits probably associated with the railway embankment (99-100) and subsequent levelling layers (97-98) for the car park (Figure 7: Section 3 and 4).

Photograph of TP 17.
Scale 1m

Photograph of TP 18.
Scale 1m
