**THE CHURCH OF ST MARGARET OF ANTIOCH
KNOTTING
BEDFORDSHIRE**

**ARCHAEOLOGICAL OBSERVATION
AND INVESTIGATION**

Project: SMK1581

Document: 2010/56
Version 1.1

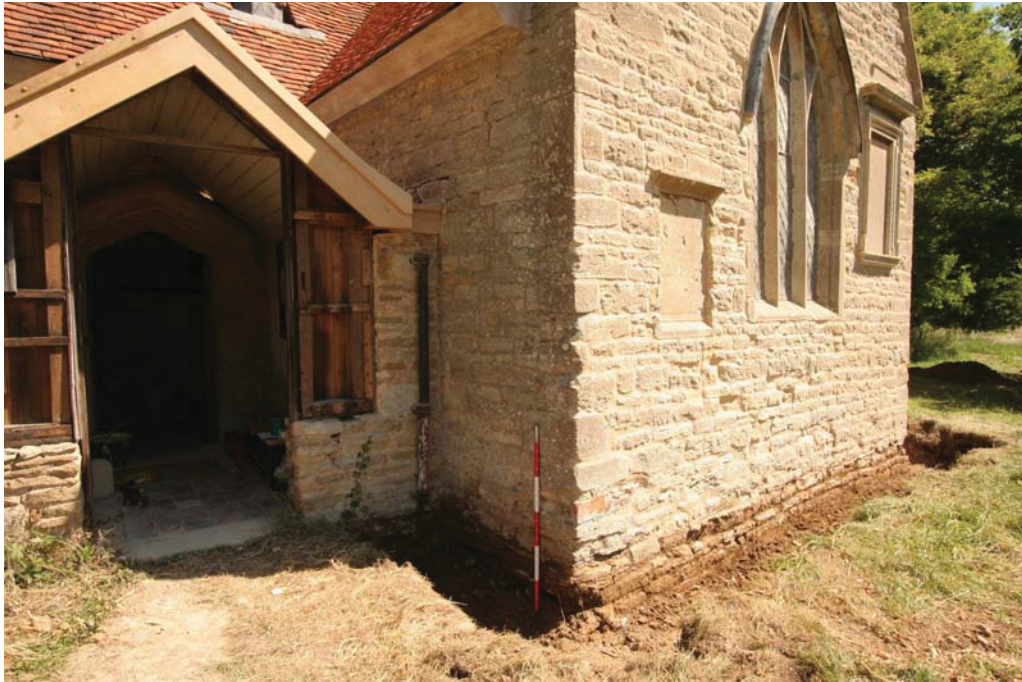
Excavations for the French drain began at the transept (Figures 3-5) and progressed anti-clockwise around the church. The trench measured approximately 0.6m wide and 0.4m deep. It exposed two courses of masonry and the top of a third. The masonry comprised roughly dressed rectangular limestone blocks with the dimensions of the exposed face being a maximum of 0.40m x 0.14m. The lowest courses of the west and south walls of the transept stepped out 0.1–0.15m from the wall above; the visible foundations of the east wall were flush with the overlying stonework.

Figure 3: Porch and transept. 1m scale

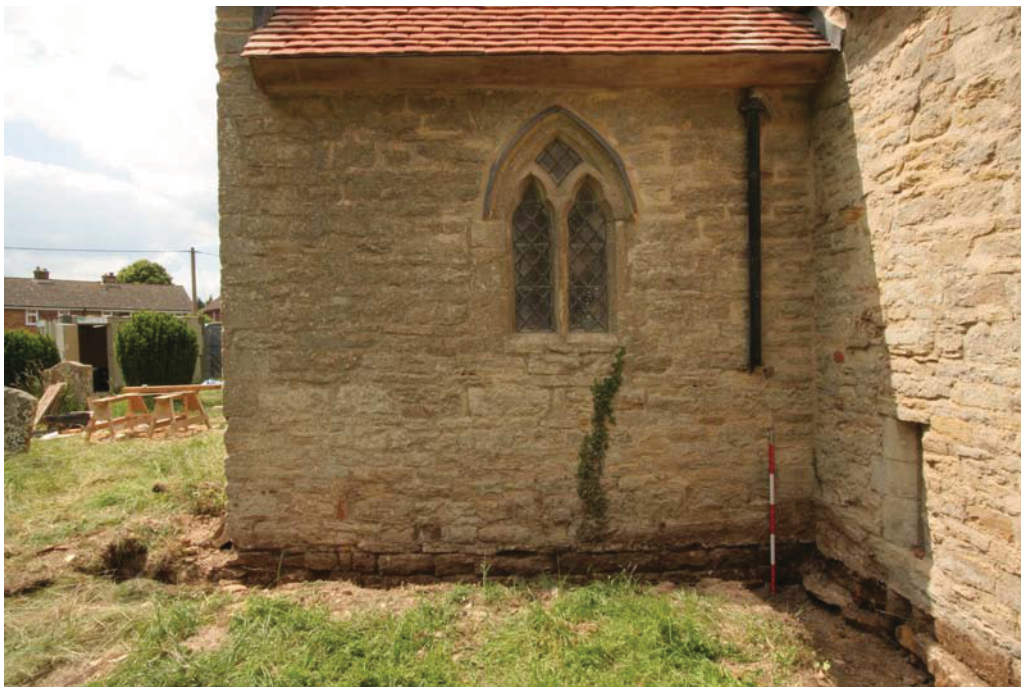
Figure 4: Transept east wall. 1m scale

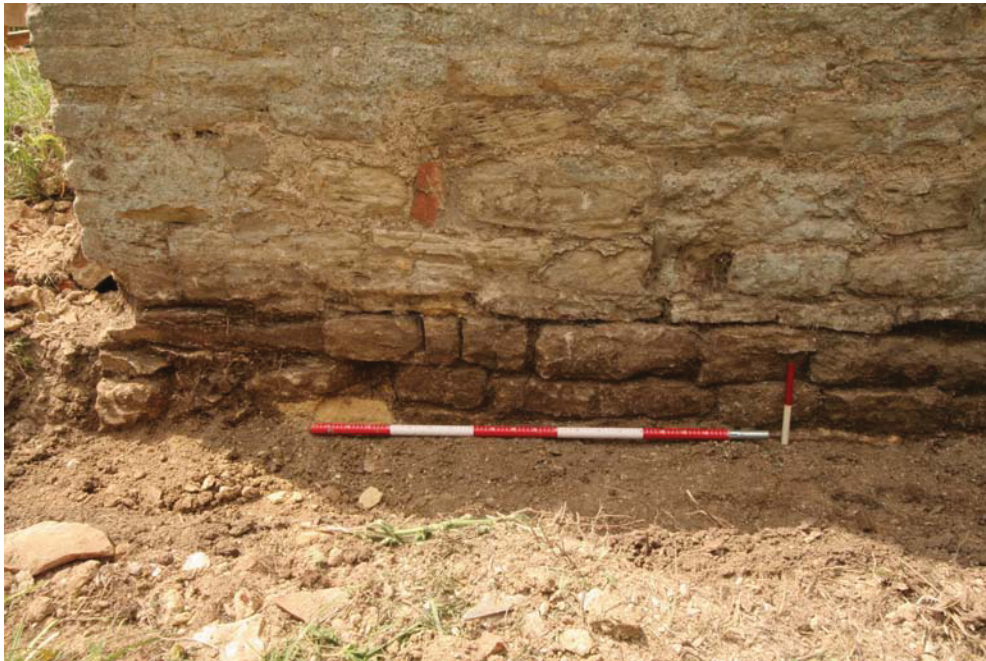
Figure 5: Transept south-east corner. 1m and 0.20m scales

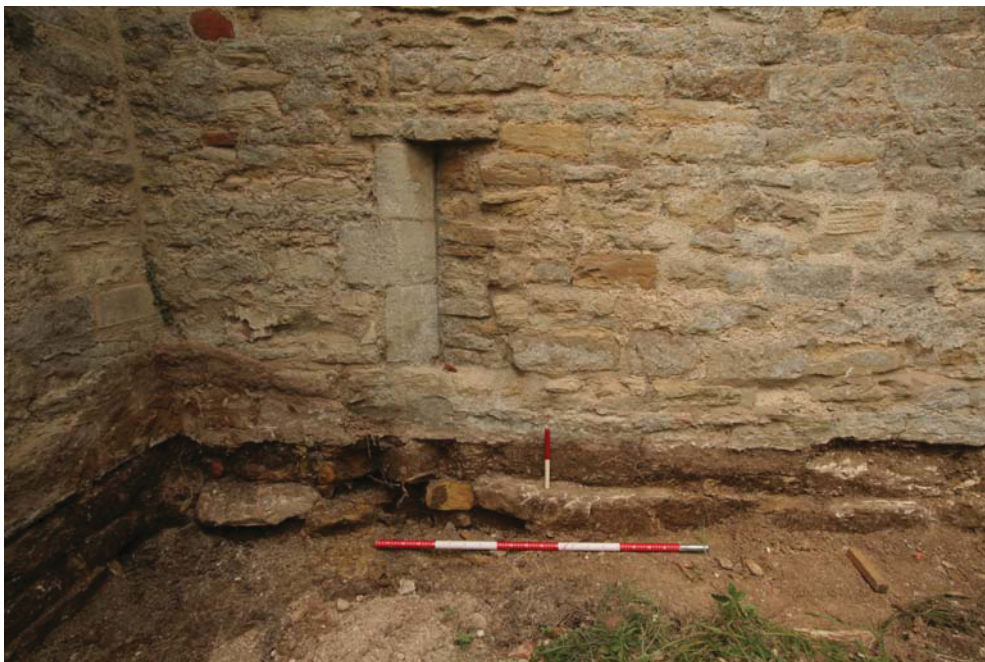
The lower of the two exposed courses of stonework beneath the south wall of the chancel projected *c.*70mm from the wall above (Figures 6 and 7). This off-set stonework was

Figure 6: Transept and chancel south corner. 1m and 0.20m scales

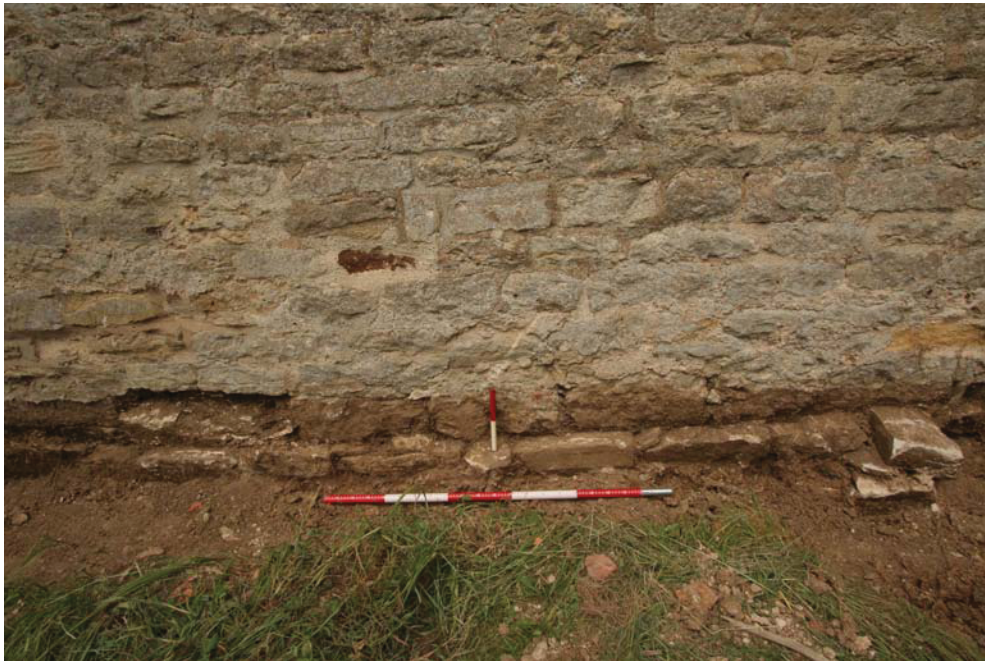
Figure 7: chancel south wall central area. 1m and 0.20m scales

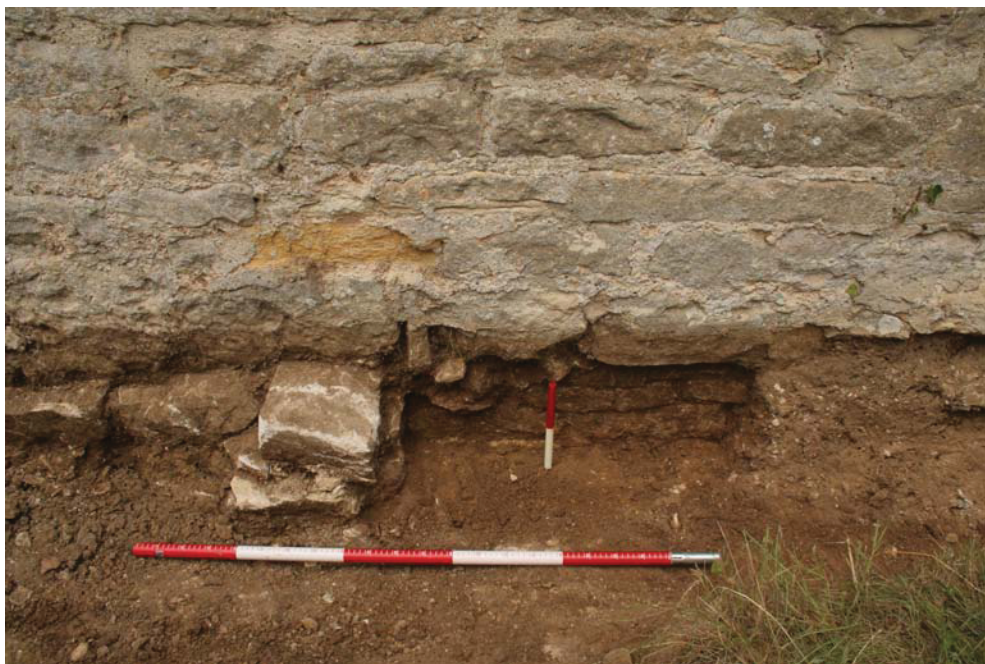
present for *c.*4.85m from the junction with the transept and comprised irregular, mostly roughly dressed, limestone blocks with the largest measuring 0.37m long and 0.1m high. At the end of the plinth were two square blocks that projected 0.16m from the face of the wall (Figure 8). The upper of the two blocks was squared and measured 0.20m long and 0.09m high. It had two finely finished faces with fine diagonal tool marks. The exposed foundation masonry beyond these blocks was stepped in *c.*60mm from the wall above. A small section was investigated in detail and found to comprise three courses of roughly dressed limestone measuring *c.*50–80mm high and 0.15m long.

Figure 8: Transept south wall central area detail. 1m and 0.20m scales

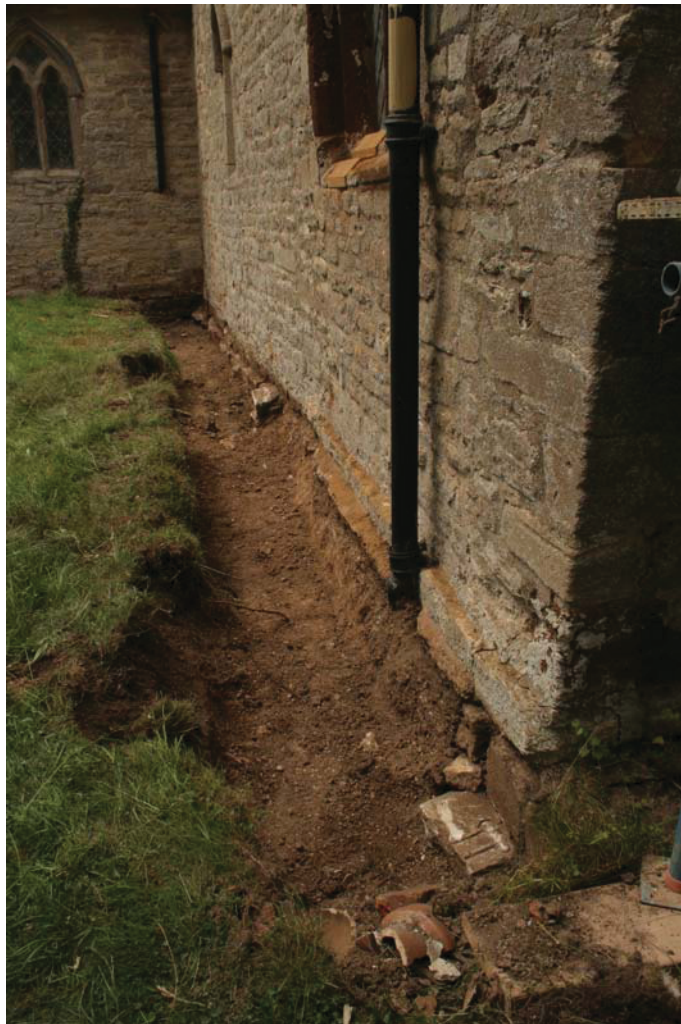
The south-east corner of the chancel was supported by two large pieces of reused stonework (Figure 9). The upper piece comprised a large squared block; its exposed face was 0.22m wide and 0.18m high and was finished with broad diagonal tool marks. Below this was a piece of medieval limestone coffin lid with part of an incised cross in its upper surface (Figure 10). The stone was 0.10m thick and chamfered at the edge.

Figure 9: Chancel south-east corner

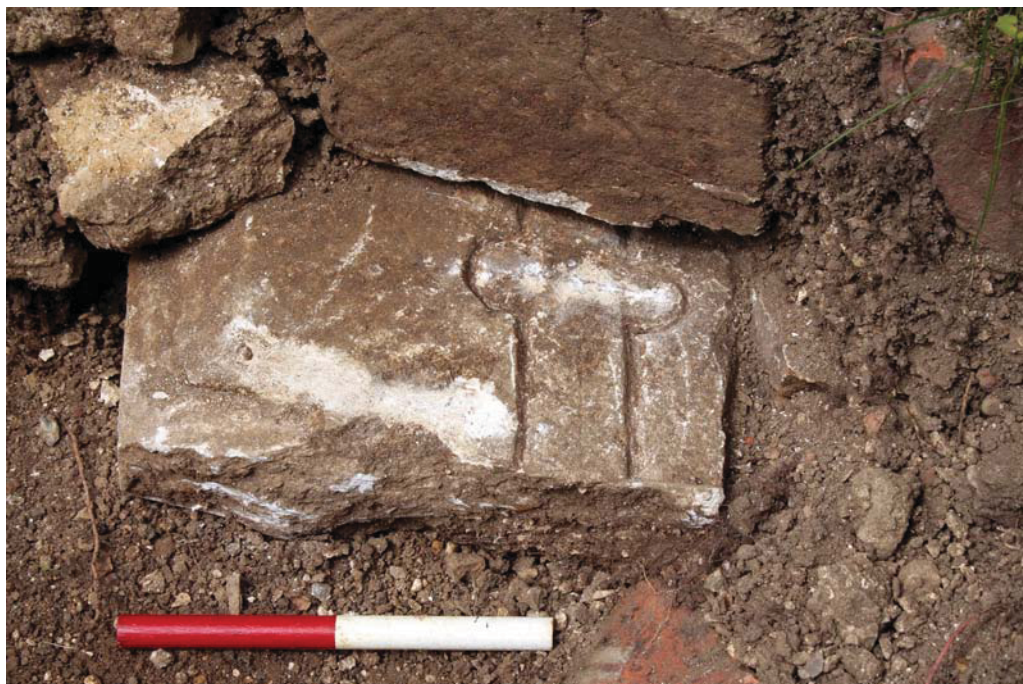
Figure 10: Stone coffin lid beneath south-east corner of chancel. 0.20m scale

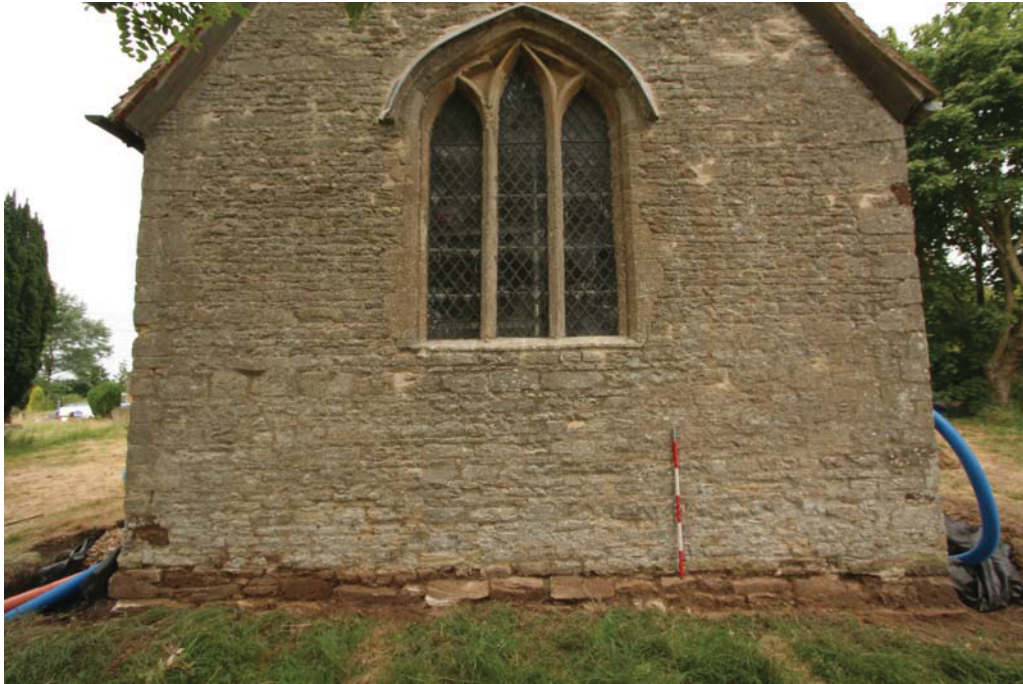
The off-set masonry plinth of irregular stone blocks was again present in the trench along the east wall of the chancel (Figure 11). Some of the stones were finely dressed with one having a chamfered edge.

Figure 11: Chancel east wall. 1m scale

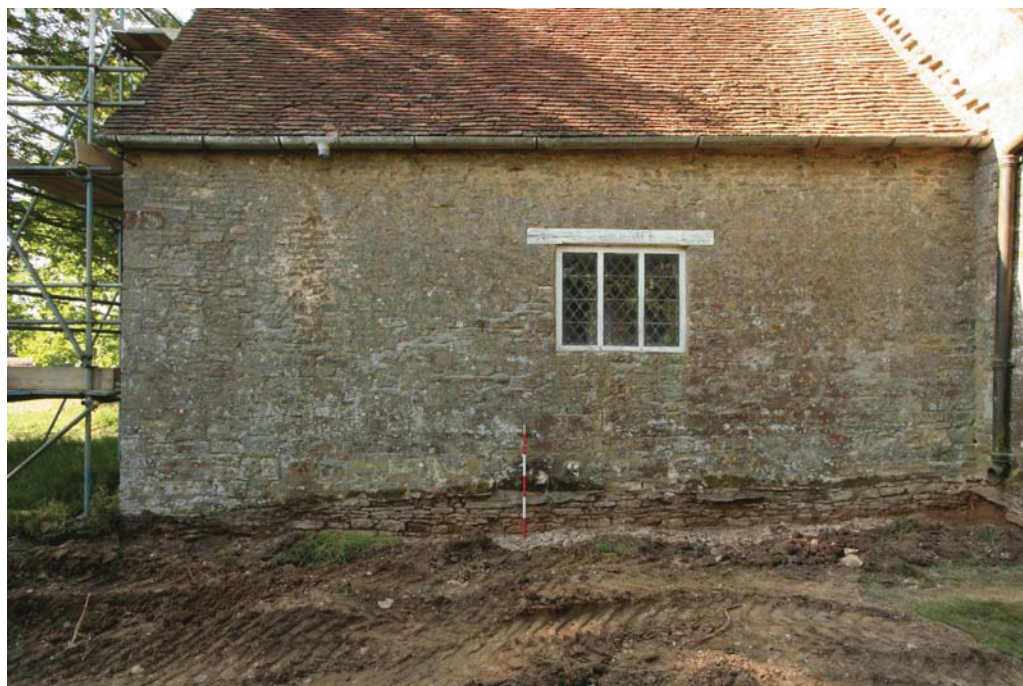
Figure 12: Chancel north wall. 1m scale

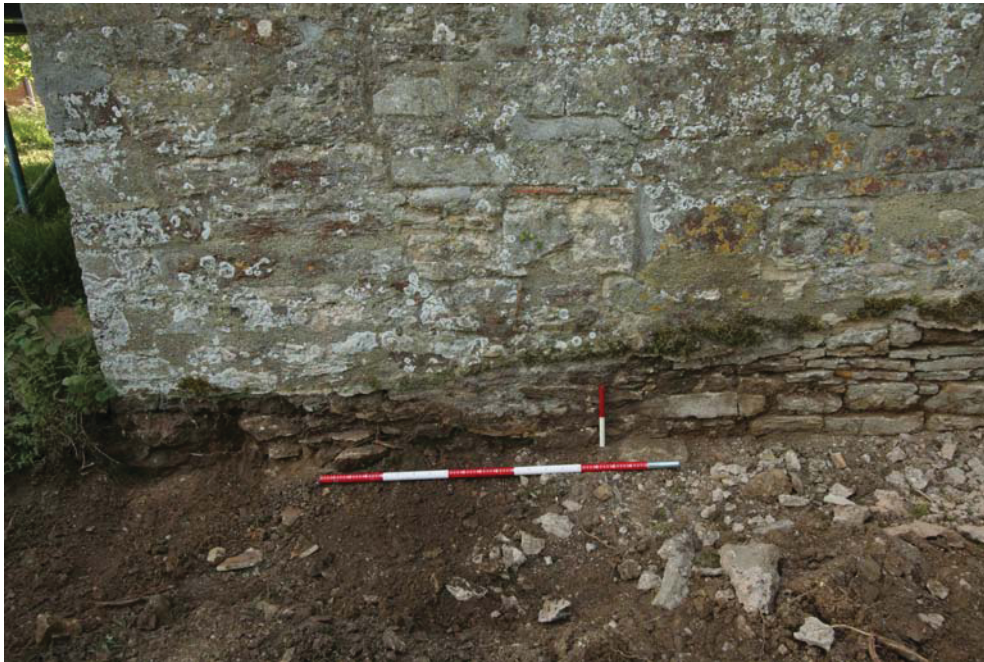
Figure 13: Chancel north-east corner. 1m and 0.20m scales

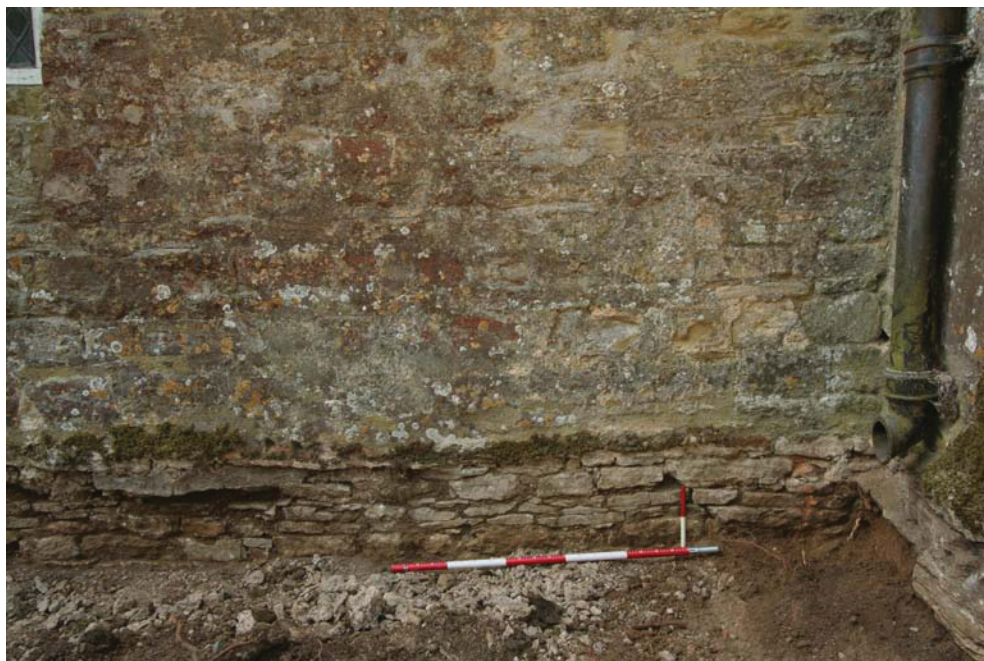
Figure 14: Chancel north-west corner. 1m and 0.20m scales

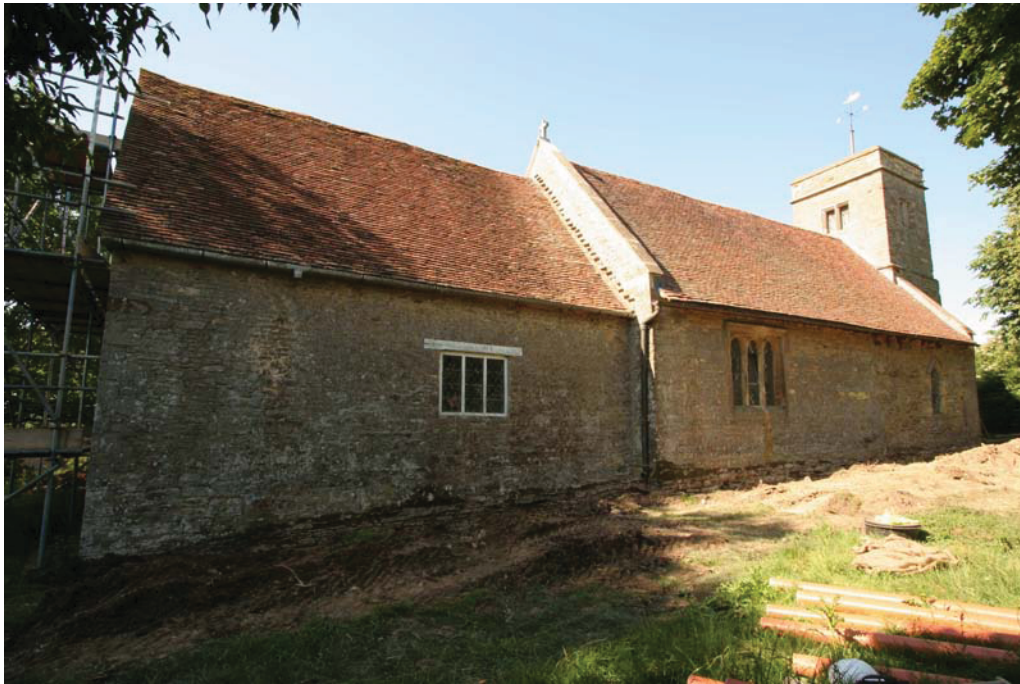
Figure 15: North side of church

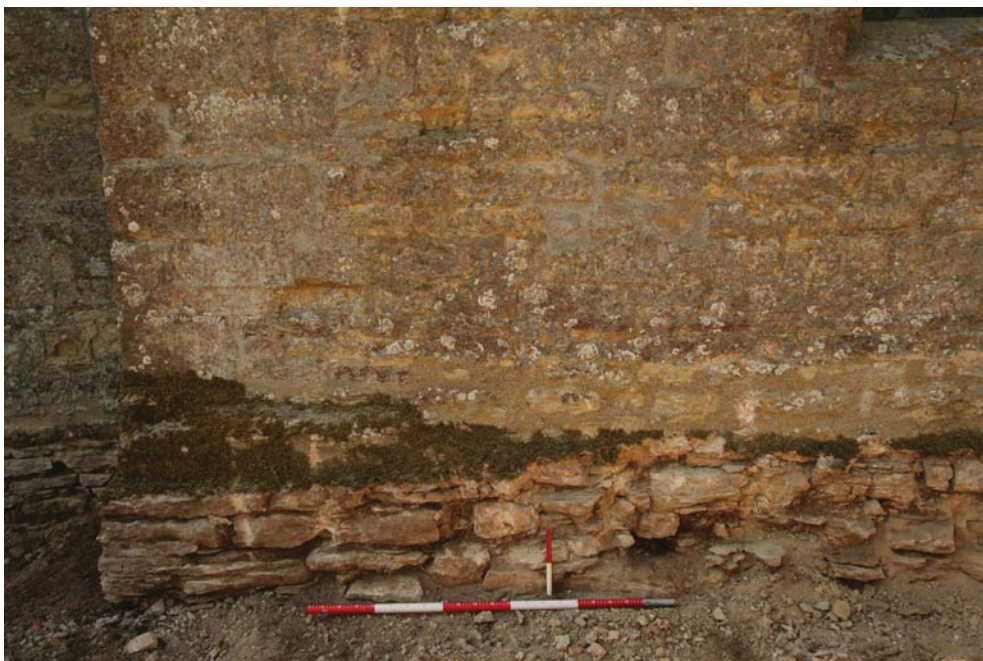
The offset foundation plinth was again present beneath the north wall of the nave, from its north-east corner to a point where there was a clear change in the fabric of the wall above (Figures 16 and 18). The masonry comprised thin slabs above two courses of larger limestone blocks, roughly squared with occasional smooth, dressed faces. Beyond this, the exposed foundation was again flush with the wall above and comprised irregular courses of limestone slabs. The foundation of the north-west corner of the nave was more substantial and corresponded with the buttress above (Figure 19). It comprised three stepped courses of large, roughly tooled and squared, limestone blocks, with the lower course projecting 0.2m from the wall above. The largest of the blocks measured 0.45m long and 0.18m high.

Figure 16: Nave north-east corner. 1m and 0.20m scales

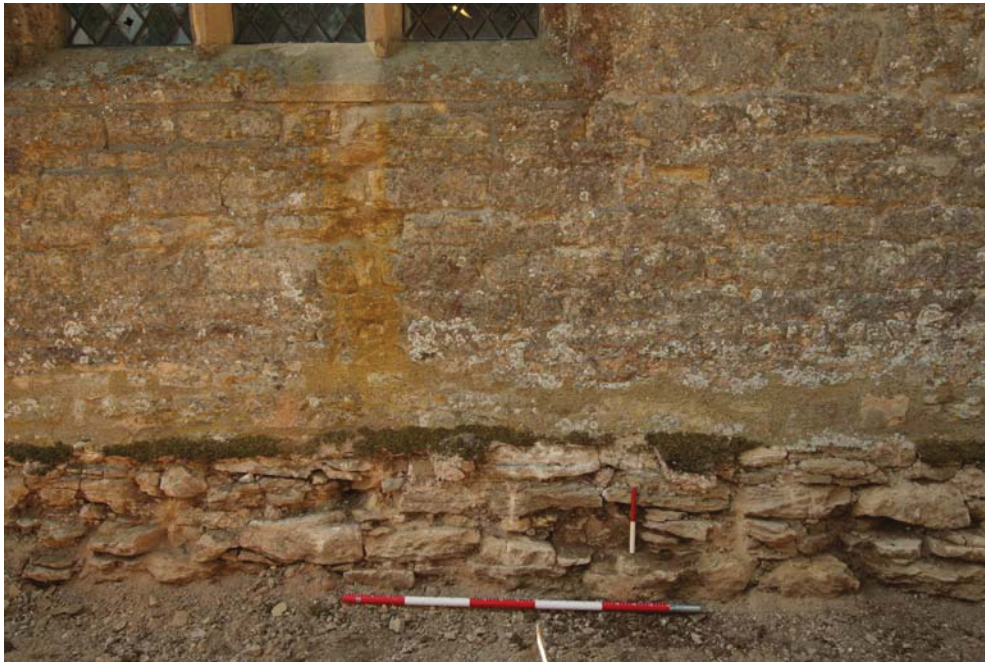
Figure 17: Nave north wall central east area. 1m and 0.20m scales

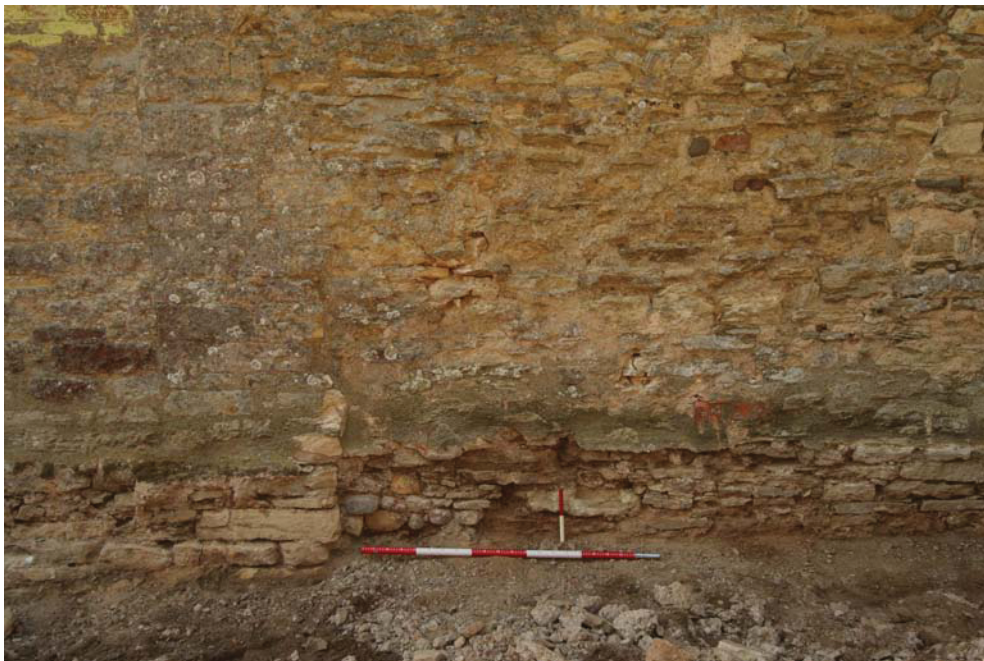
Figure 18: Nave north wall central west area. 1m and 0.20m scales

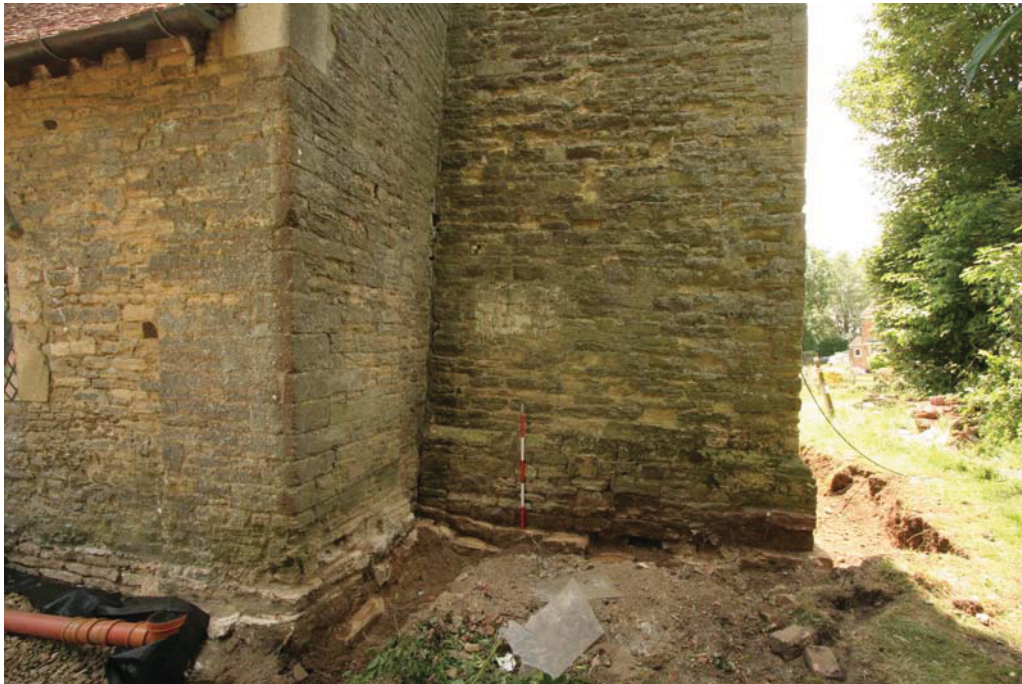
The exposed stonework of the tower comprised two courses of large, roughly squared limestone blocks, flush with the wall above, sitting on a course of larger blocks projecting up to 0.25m from the wall (Figures 19 and 20). These foundations were not keyed into the stonework of the nave. Single, very large stones measuring *c.*0.65m x 0.38m x 0.12m high were located at both the outer corners of the tower.

Figure 19: Nave and tower north-west corner. 1m scale

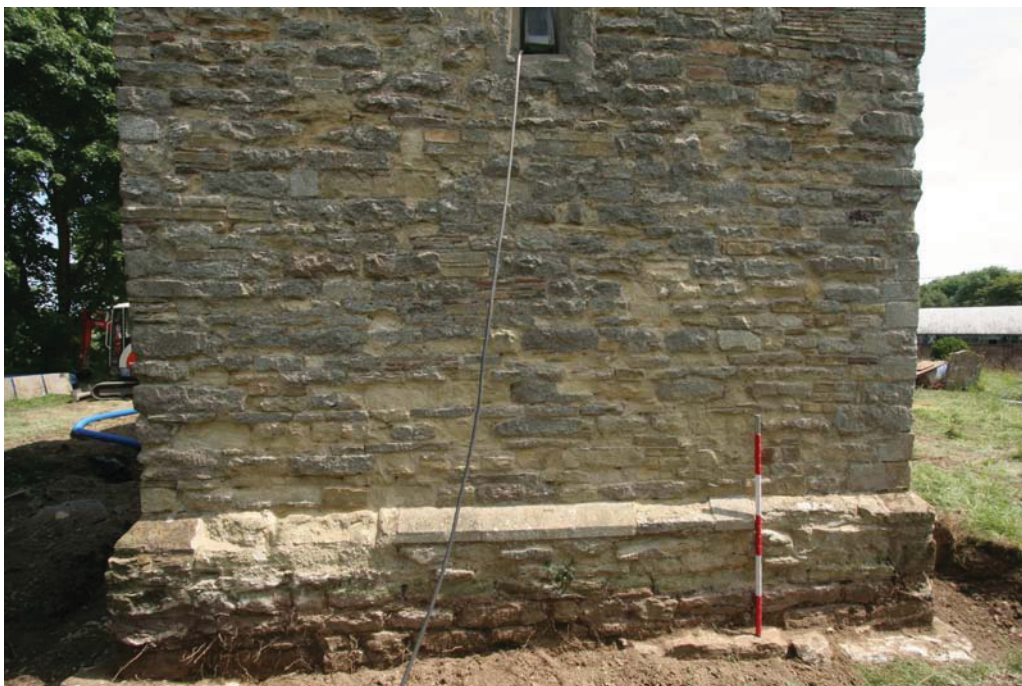
Figure 20: Tower west wall. 1m scale

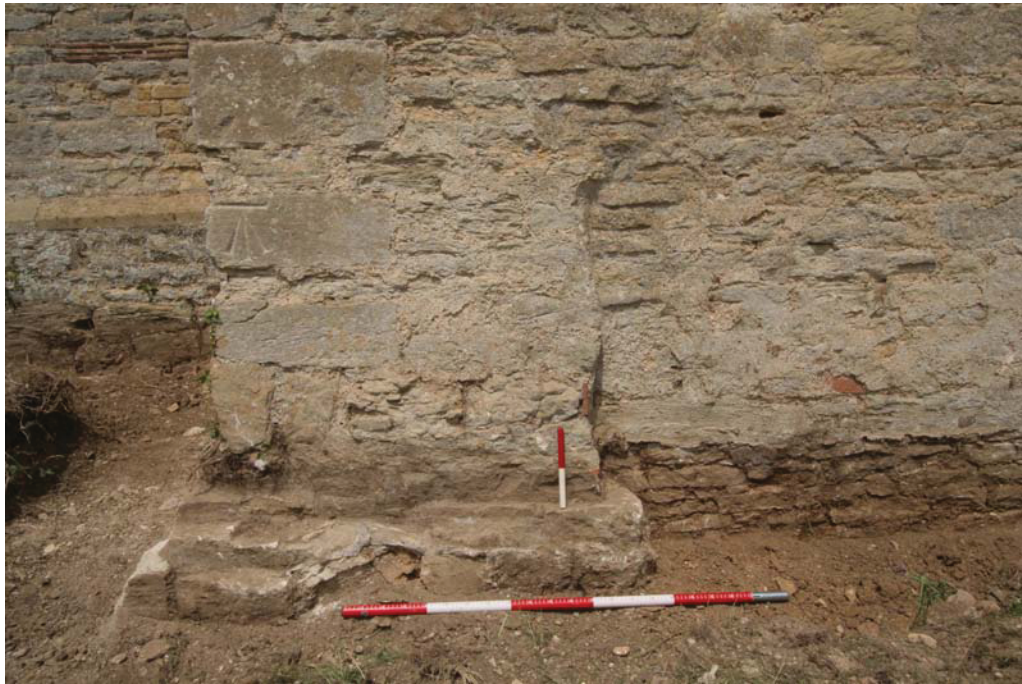
The south-west buttressed corner of the nave was supported in a similar fashion to the opposite corner, with the exposed foundations comprising three stepped courses of roughly squared limestone blocks, with the lower course projecting up to 0.20m from the wall above (Figure 21).

Figure 21: Nave south-west corner buttress. 1m and 0.20m scales

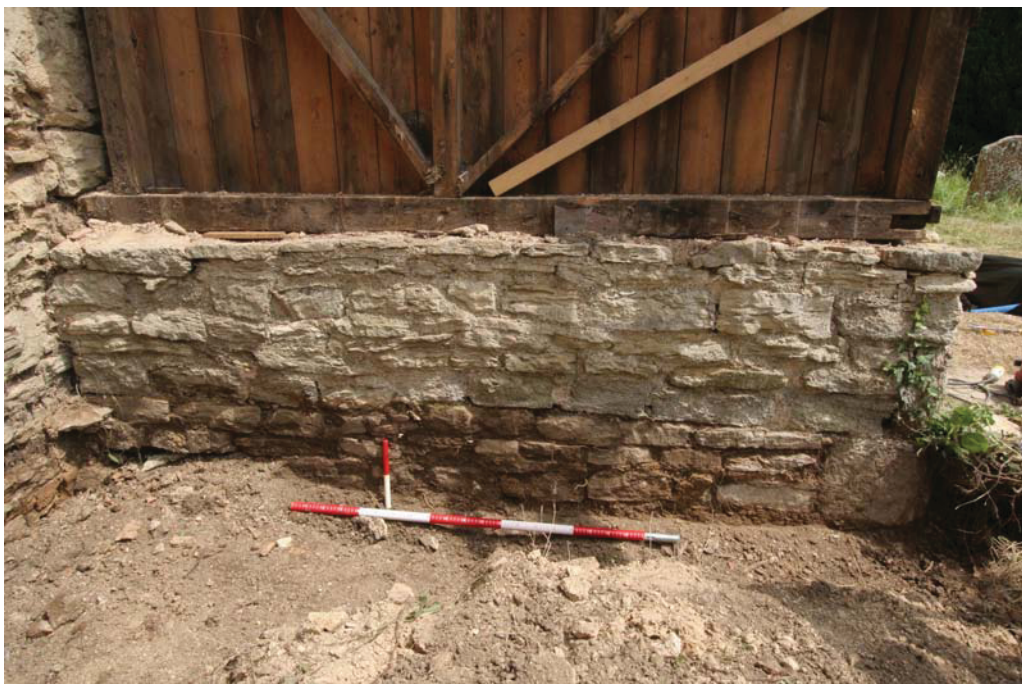
The exposed foundation of the south wall of the nave and the west wall of the porch were flush with the wall above and comprise three or four courses of roughly dressed masonry blocks similar in character and construction to the wall above (Figure 22).

Figure 22: Porch west wall. 1m and 0.20m scales

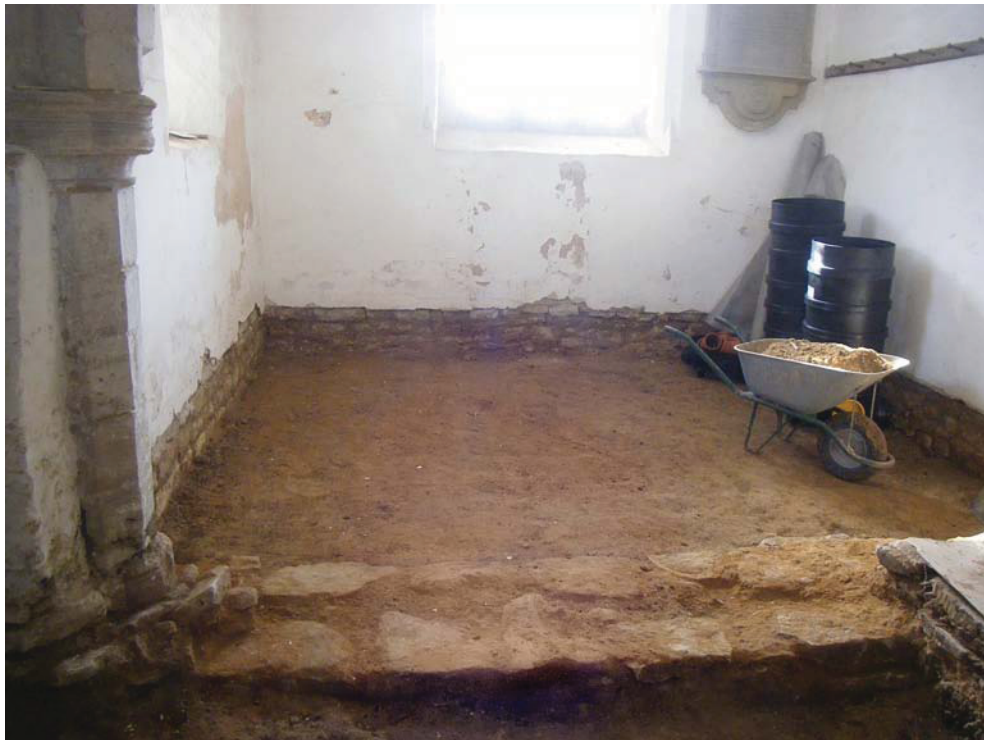
Approximately 0.3m of sandy soil containing frequent fragments of stone rubble was excavated from within the transept (Figure 23). Excavations stopped at the level of a compacted dark grey soil surface. Finds from within the excavated deposit comprised two pottery sherds, a peg tile fragment and an incomplete ceramic floor tile. The pottery comprised a 12th–13th-century jug handle in a shell-tempered fabric (type B07), and a Potterspury ware body sherd (fabric C10) of mid-13th to later 14th-century date. The roof tile is likely to date from the late medieval period onwards; the floor tile is of uncertain date. The exposed transept wall base comprised four courses of roughly dressed limestone masonry.

Also exposed within the ground reduction excavations were the remains of the footings of the nave south wall, which would have been removed when the transept was constructed (Figures 23 - 27). A single course of masonry, comprising large limestone slabs, was uncovered along most of its length. At the western end, this course was set upon a short

Figure 23: Transept excavations viewed from nave

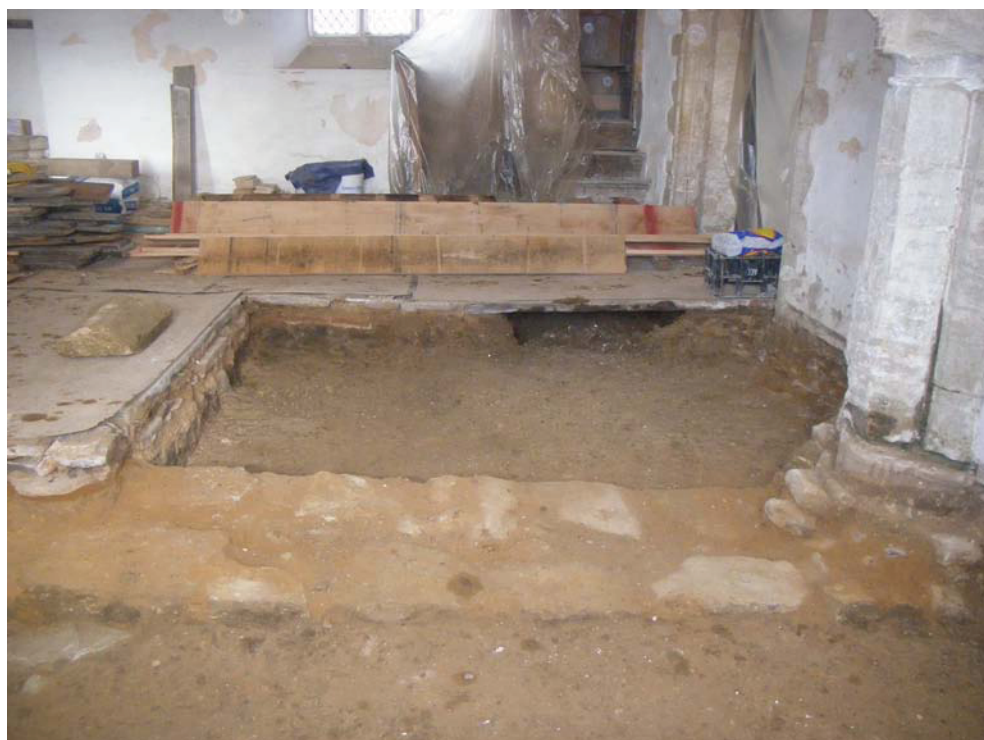
The ground level of a 3m x 2.3m area in the nave between the transept and the central aisle was reduced by 0.5m in total (Figure 24). Material removed included the remains of a previous ceramic tiled floor which lay 0.1m beneath the existing paved floor and its mortar bedding layer. The tiles were made of gault clay and were set on a thin layer of white mortar, which overlay a levelling layer of loose pink mortar/rubble, which in turn overlay the footings of the demolished nave wall (see below). The tiles are of uncertain date and no complete examples were present. The available dimensions were c.0.2m x 40mm thick. Beneath the mortar/rubble was the same compact soil deposit seen in the transept. The excavations continued into this soil layer by a further 0.14m and from this deposit a large piece of medieval limestone coffin lid was recovered (Figure 28). The fragment represented the bottom third of the lid and measured 0.31m wide at its narrowest point to 0.37m wide at its broken edge. The stone was chamfered along the edges and was 0.1m thick.

A large void appeared along the aisle side of the excavation, exposing a partially collapsed, probable burial vault located beneath the nave floor (Figure 24). The vault was examined by torch through the opening. It was brick-built and capped at both ends by limestone slabs. Above this was a soil infill which lay beneath further stone slabs that formed the nave floor. The middle capping stone for the vault appeared to have collapsed at some time in the past taking with it a large amount of the soil infill. This led to the creation of the void beneath the slabs of the nave floor, and the exposure of the vault in the northern edge of the excavations. No human remains were visible in the vault, although the base of the chamber could not be seen.

Figure 24: Nave excavations viewed from transept

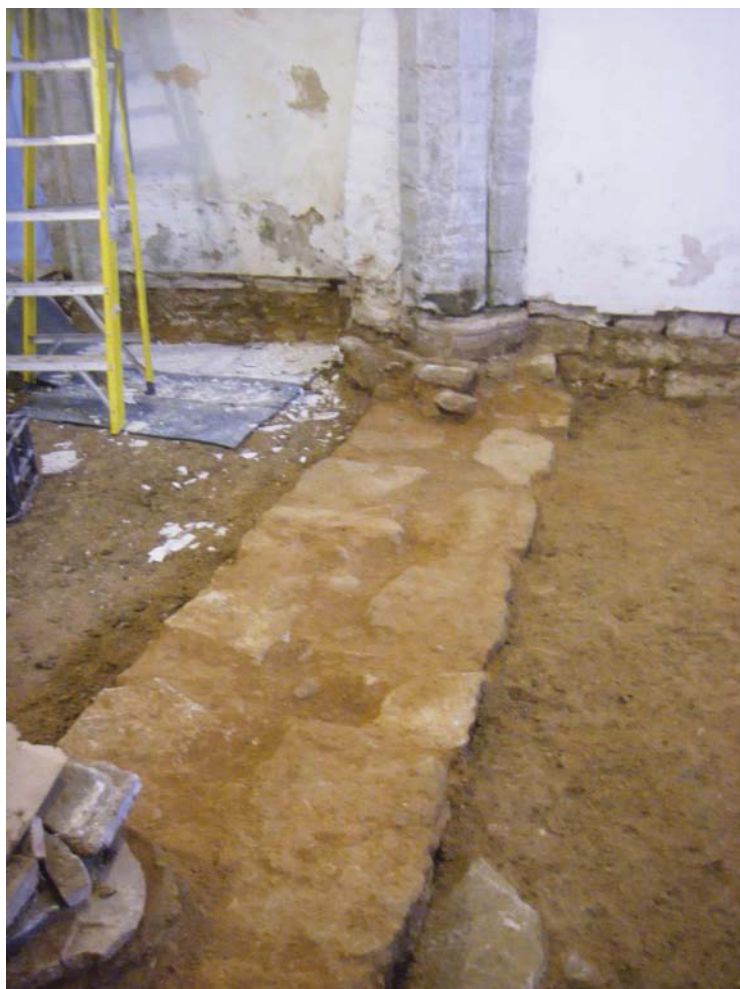
length of offset stones projecting 0.2m from the face of the stones above. Set upon each end of the demolished wall foundation were the footings for the transept arch responds. The eastern footing (Figure 25) comprised what appeared to be a partially exposed moulded quatrefoil column base set upon rubble masonry. This was slightly offset from the polygonal respond above. The western footing (Figure 26) appeared to comprise moderately large pieces of stone rubble. Both footings were offset from the demolished wall foundation by c.0.2–0.3m in the direction of the nave.

Figure 25: Exposed wall foundation looking east

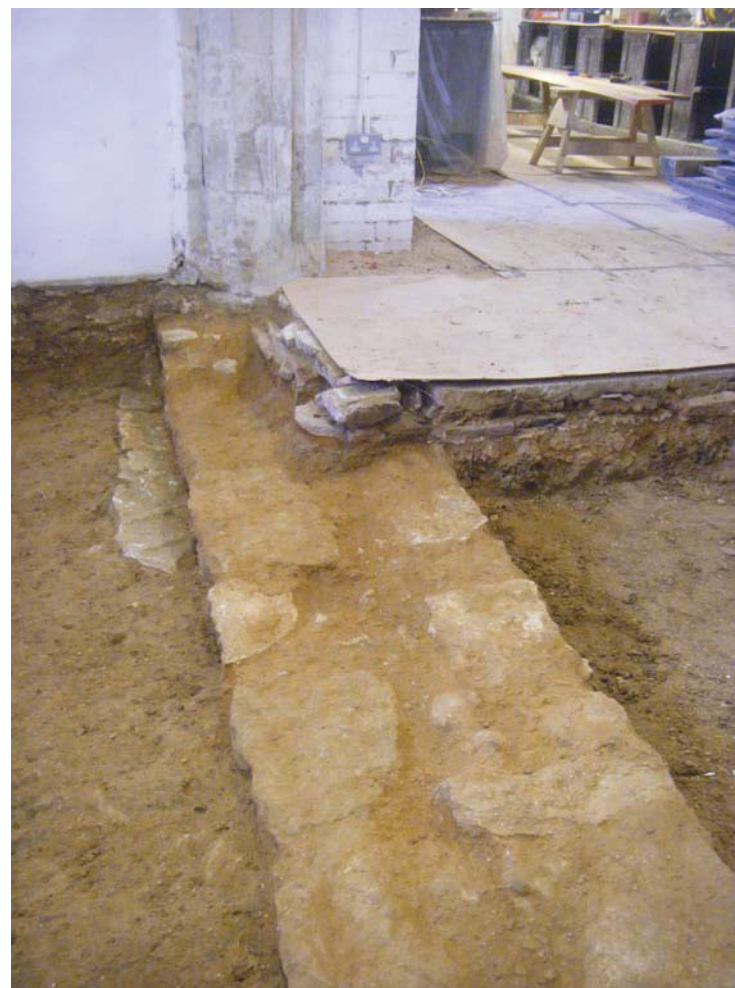
Figure 26: Exposed wall foundation looking west

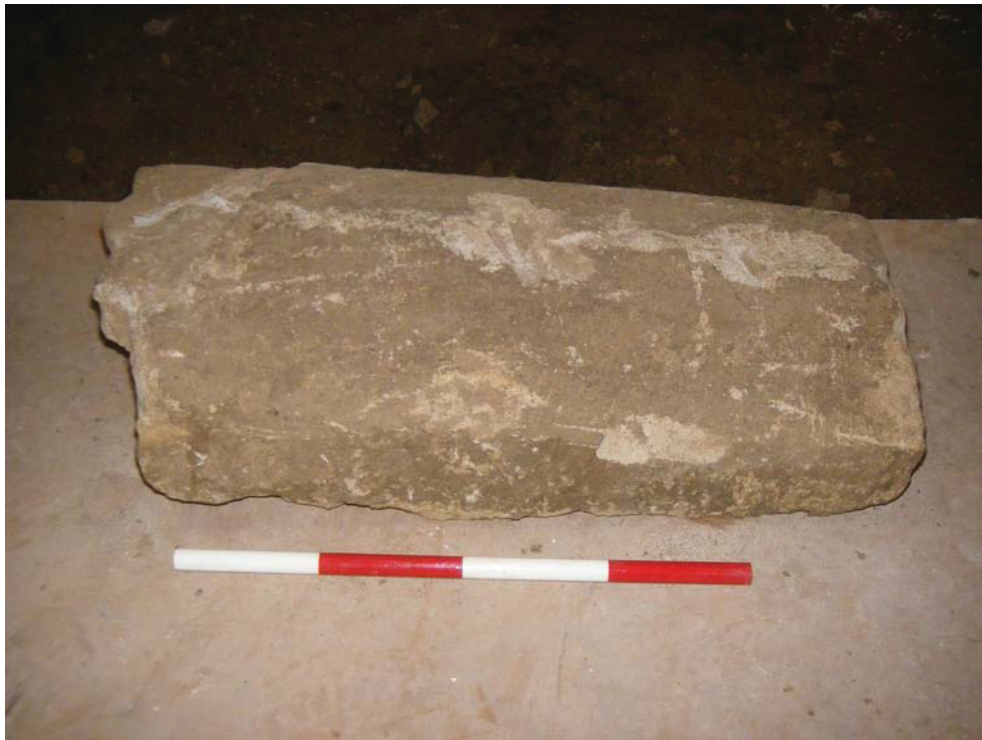
Figure 28: Stone coffin lid recovered from nave excavations. 0.40m scale

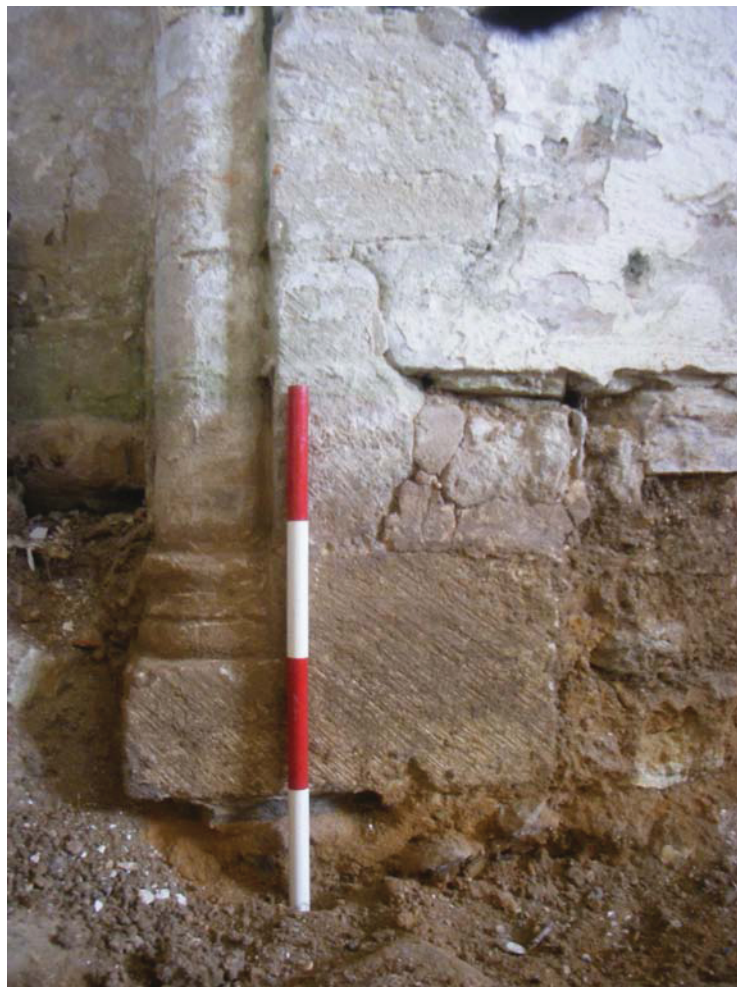
The eastern side of the excavations exposed the base of the nave wall and southern chancel arch respond. The exposed stonework for the respond comprised a moulded and finely dressed plinth stone supported by rubble masonry (Figure 29). The exposed nave wall foundation comprised 3-4 courses of roughly dressed masonry rubble.

Figure 29: Exposed chancel arch respond footing. 0.40m scale
