**LAND OFF CHURCH STREET
LANGFORD
BEDFORDSHIRE**

BUILDING RECORDING

Project: CSL1597

Document: 2010/5
Version: 1.0

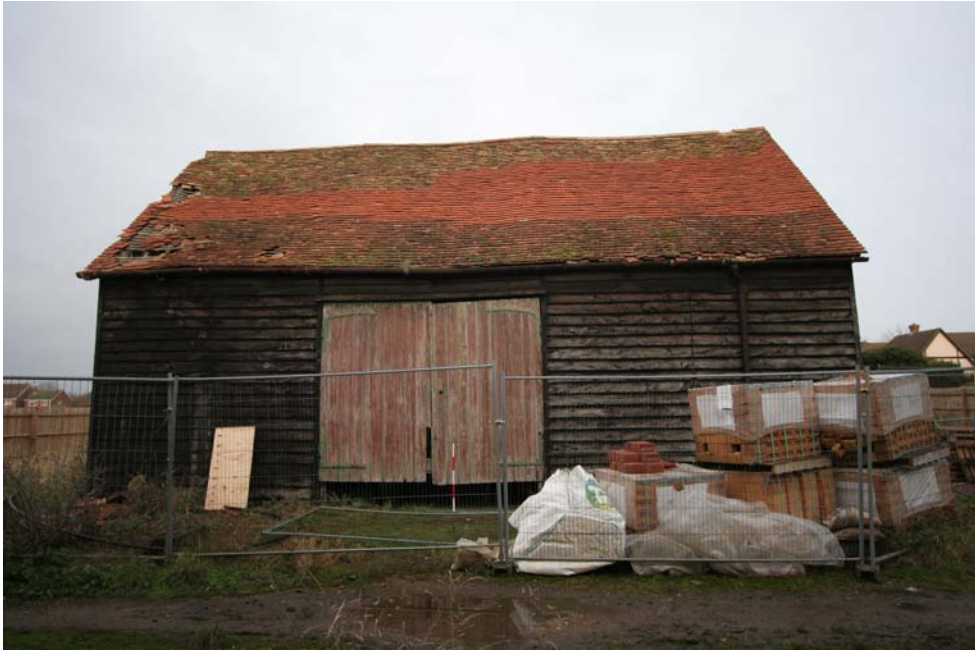
Plate 1: South elevation

The building was rectangular in plan, aligned east–west. The walls were covered in weatherboard cladding and the gable roof with plain red tiles. Openings consisted of a full height, double door in the southern wall, a single door in the north end of the east wall, a high level taking-in door in the east wall and a window in the gable of the west wall.

The ground floor was accessed via a large pair of double doors in the south

wall and via a small door located towards the northern end of the west wall. The double doors extended almost up to the level of the wall plate and the opening was strengthened by curved braces. The base of the double doors stopped approximately 0.4m above ground level. Rebated blocks were fitted to the door posts for leap boards, horizontal planks used to fill the gap below the door. The low fence formed by leap boards could help to retain grain on threshing floors and restrict access to animals; also the shortened doors would remain clear of uneven ground. The central part of the building, corresponding to the position of the double doors was open to the roof.

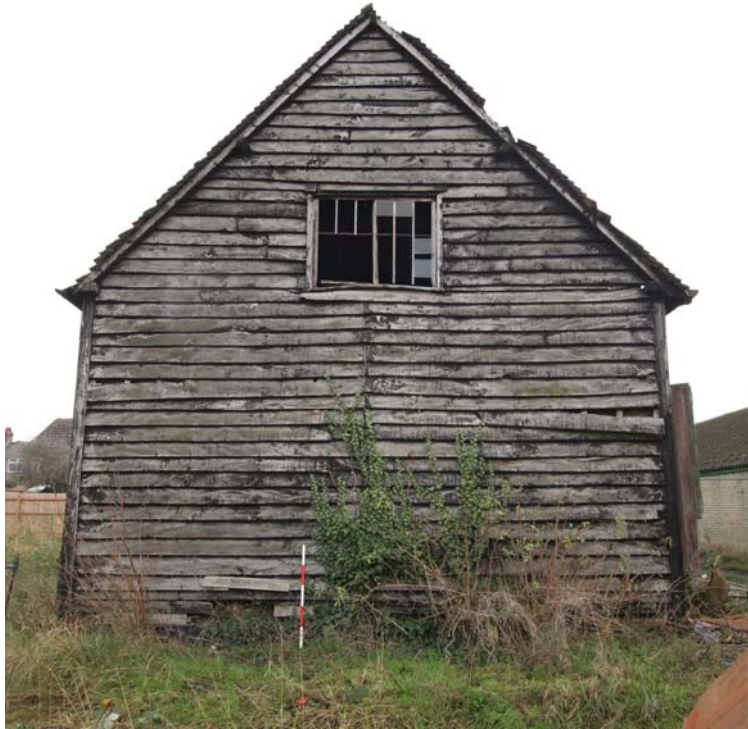
Plate 3: West elevation

The loft in the western end was divided from the central bay by an internal, weatherboard partition which extended up to tie beam level. Its planked floor was supported by narrow joists which were in turn supported by two east-west aligned beams. The eastern end of these beams were supported by two vertical posts made from reused railway sleepers whilst the western end was supported by rectangular section posts of c. 0.15m x 0.05m section. The beams themselves and a beam that supported the partition were constructed from relatively thin sections of timber, paired up to form more substantial beams. The western loft was accessible either via a door in the partition wall or via a trapdoor situated in its south-eastern corner. A ladder of horizontal timbers was fixed to the south wall above and below the trapdoor. Internally the loft was lined with weatherboarding up to eaves level with area above on the gable wall left unlined. The loft was lit by a single window in the gable wall. The window was divided into six by vertical glazing bars.

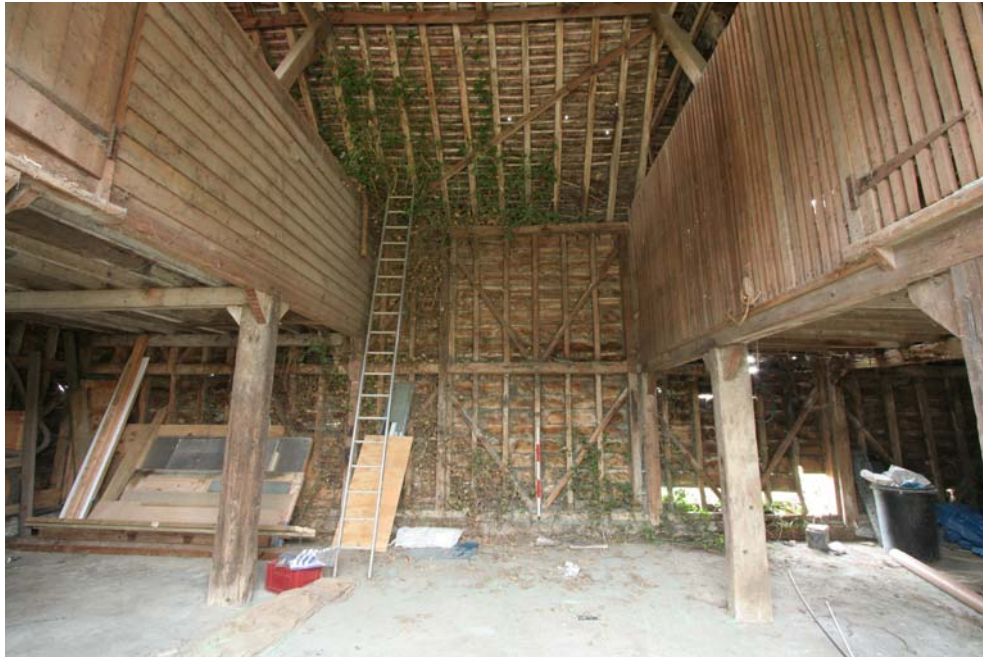
Plate 5: Interior view of central bay looking north

The ground floor of the barn was continuous with no permanent divisions, though the headroom was limited by the presence of mid-height floors at either end and partly obstructed by vertical posts used to support the floors above.

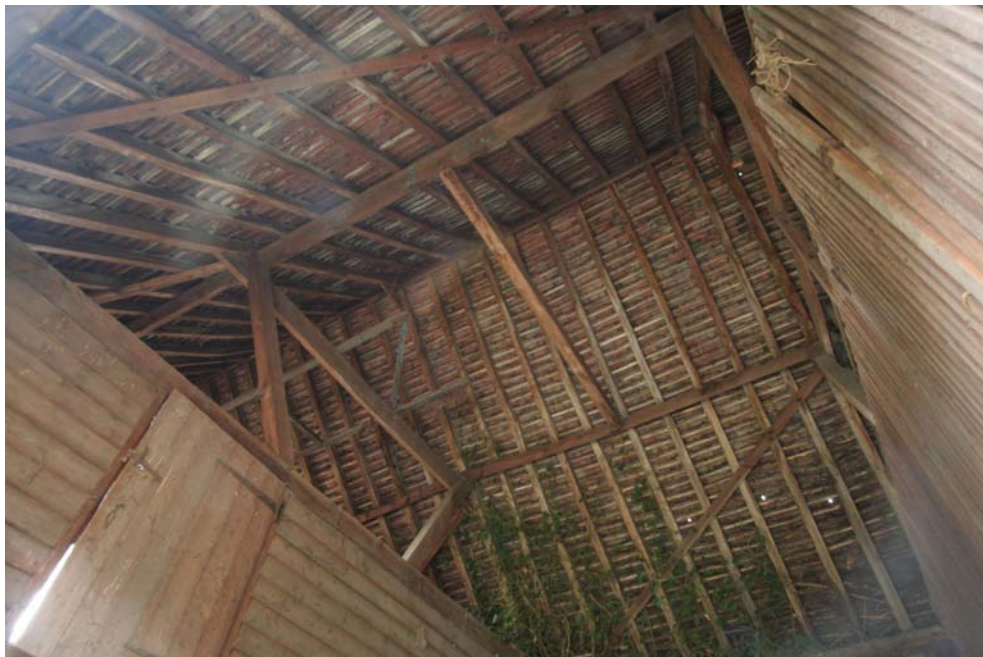
Plate 6: Interior view of roof structure

Roof trusses consisted of a collar and tie beam with raking struts. The purlins were clasped between the principle rafters, tie beams and the notched ends of the raking struts. The roof structure is braced by diagonal beams running from the wall plate level on one truss up to the collar beam level on the adjacent truss.

All of the timber used in the frame was machine-sawn softwood of square or rectangular cross section. A possible Baltic timber mark was seen on one of the frames. This was lightly scored and not replicated elsewhere in the building. The joints in the main parts of the wall frames such as the junctions between mid rail and wall posts were joined with pegs. All of the other fixings appear to have been made with nails.

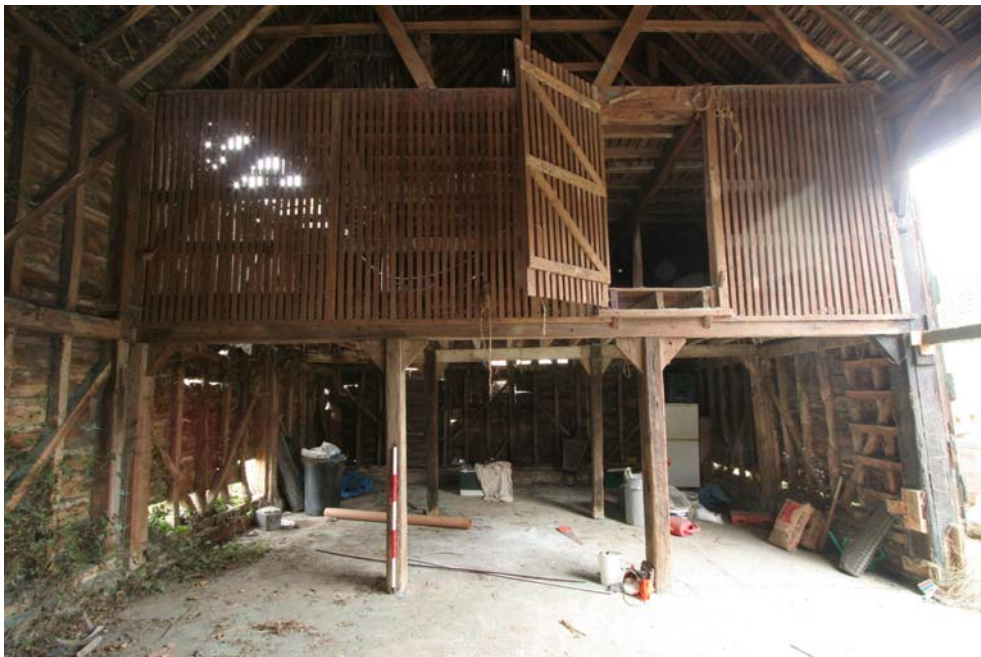
Plate 7: Interior view looking east

The loft in the eastern end of the building had two floors. These floors and a partition wall up to tie beam level were lightly constructed using narrow wooden battens with gaps between. The first floor was supported by four vertical posts which in turn supported north-south aligned beams. As in the western loft the beams were made up from thin sections used in pairs and the two westernmost posts consisted of reused railway sleepers. The second floor was supported by three posts arranged above the central beam that supported the joists of the first floor. Access to the eastern loft was provided by a door in the partition, a trapdoor in the south-west corner of the loft or a high level door in the eastern wall. The partition door was constructed in the same method as the partition itself, using narrow vertical battens with gaps between. Details of the trapdoor were similar to that seen in the western loft, with a ladder built into the southern wall. Additional ventilation for the upper floor was provided in the form of horizontal vent in the upper part of the eastern gable of the building. It was not possible to access this feature for detailed examination. An external horizontal projection above the vent may have been to prevent the entry of water. It is unclear whether this was hinged to allow the vent to be closed. A vertical post above the vent held by iron staples may have been part of a mechanism for operating the vent.

The construction of the two floors in the eastern bay is consistent with use for the storage of onions. Examples of a particular type of purpose built onion sheds with slatted walls occur in this part of Bedfordshire around Biggleswade. This barn though of standard construction was modified internally for this specialised use, leaving little external evidence.
