**PARSONAGE HOUSE, CHURCH LANE
FARN DISH
BEDFORDSHIRE**

**ARCHAEOLOGICAL OBSERVATION
INVESTIGATION, RECORDING
ANALYSIS AND PUBLICATION**

Project: PH 1676
Document: 2011/45
Version 1.1

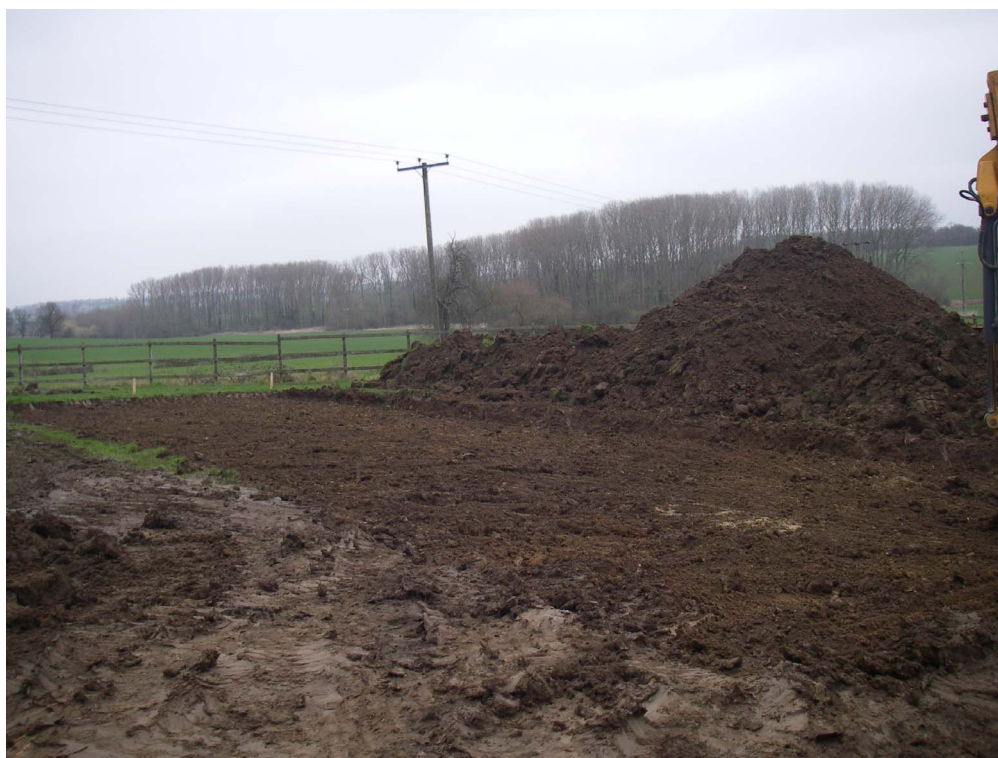
Figure 4: Area of soakaway trench, stripped of topsoil

The area of ground reduction for the soakaway was 25m by 6m wide and 0.30m deep (Figures 2 and 4). Only the overburden was removed. This consisted of friable mid to dark brown loamy clay topsoil, above a subsoil of mid yellowish brown loamy clay with occasional small to medium limestone fragments.

No archaeological features were revealed and a scan of the soil bunds recovered no artefacts. The soils were more or less completely sterile.

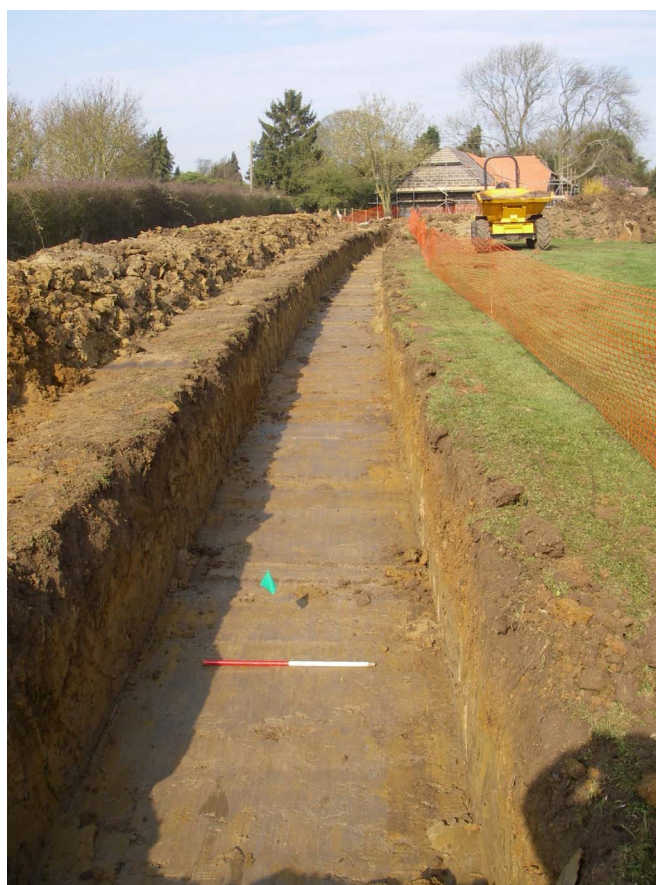
The trench was located to the south-east of the new games room and extended to the southern boundary of the paddock (Figure 2). It was 2m wide and 1.2m deep. Throughout most of the trench a layer of topsoil, 0.2m thick, lay directly above orange clay (Figure 5). In the northern part of the trench was a thicker, more disturbed layer of mixed topsoil and garden soil with occasional brick fragments. It was up to 0.8m thick and extended for c.10m southwards. It was above a layer of ironstone, which was 0.2m thick and extended a further 5m into the trench.

No archaeological features or artefacts were revealed.

Figure 5: Ground source heating coil trench, looking north towards new games room. Scale 1m
