**William Cowley Parchment Works
Caldecote St
Newport Pagnell
Milton Keynes**

**A PROGRAMME OF HISTORIC
BUILDING RECORDING**

Document: 2010/04
Version: 2.0

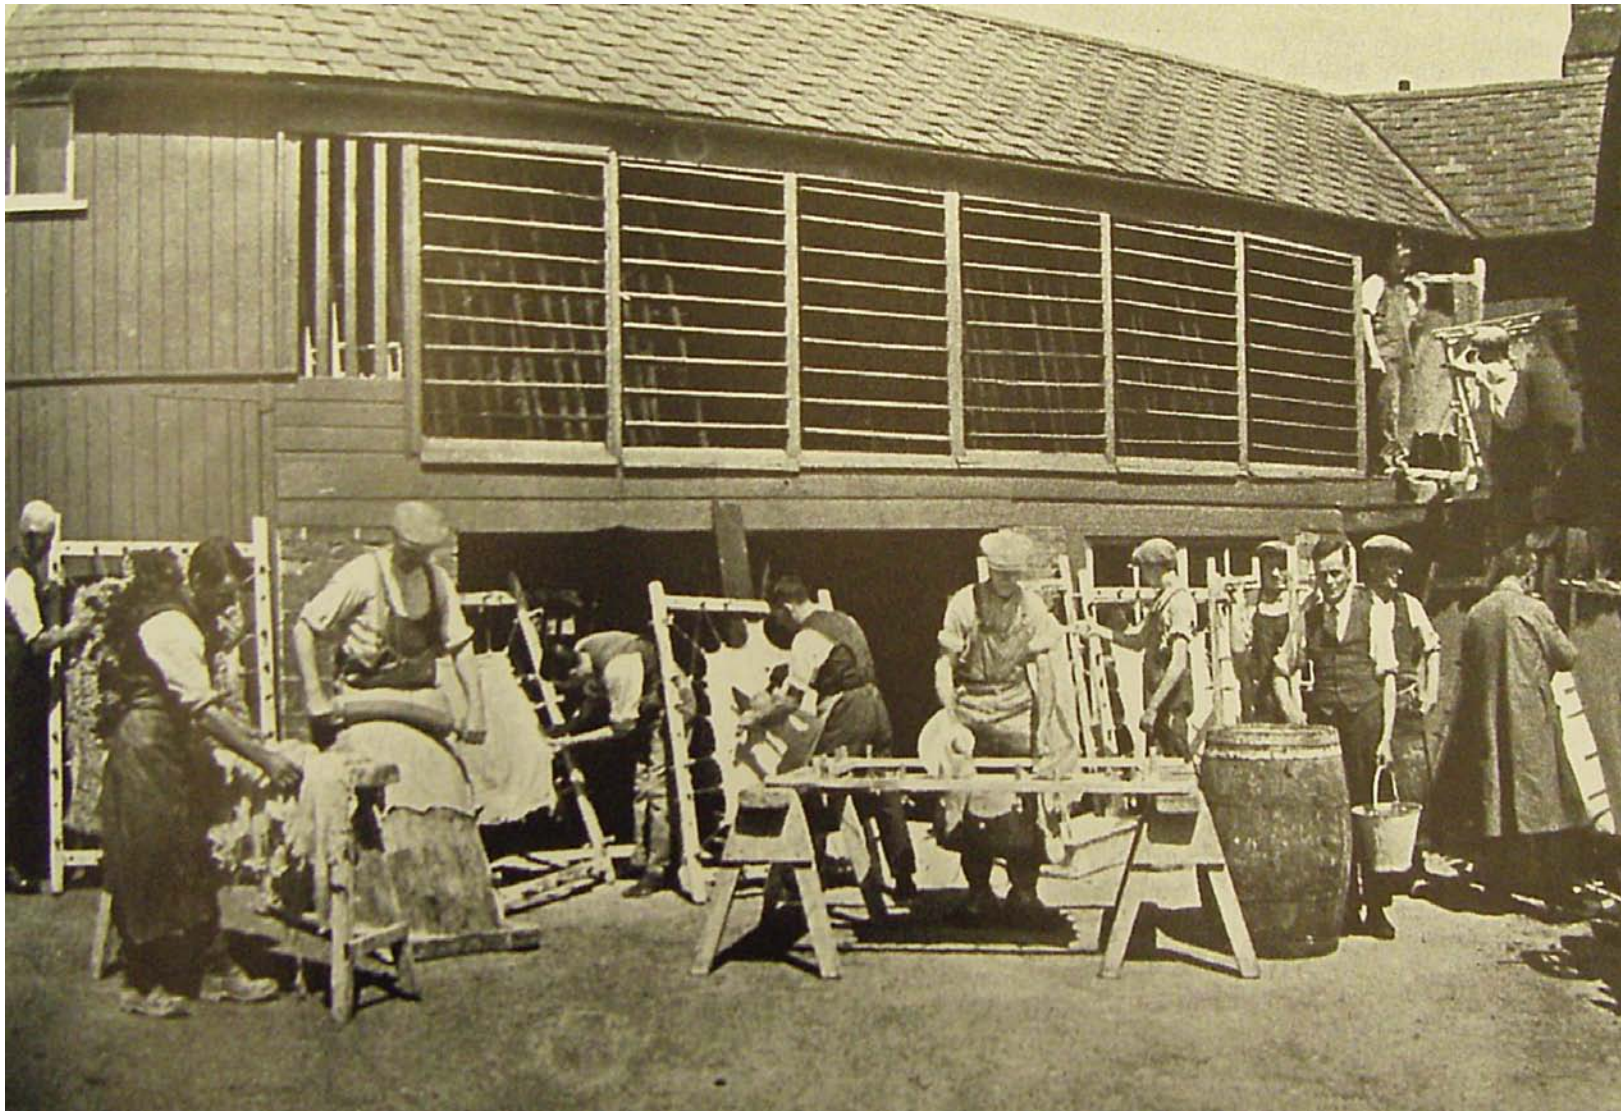
Plate 1: Historic photograph of parchment works (date unknown, courtesy Wim Visscher)

Another historic photograph (Plate 1) shows the wet processing area A and although a brick wall and long strip of glazing has replaced the open fronted lower portion and louvered upper portion of the façade, the function and overall impression of this part of the building is recognisable today. The upper storey of this part of the building, now open to the roof, was clearly being used for the drying of skins on their stretching frames.

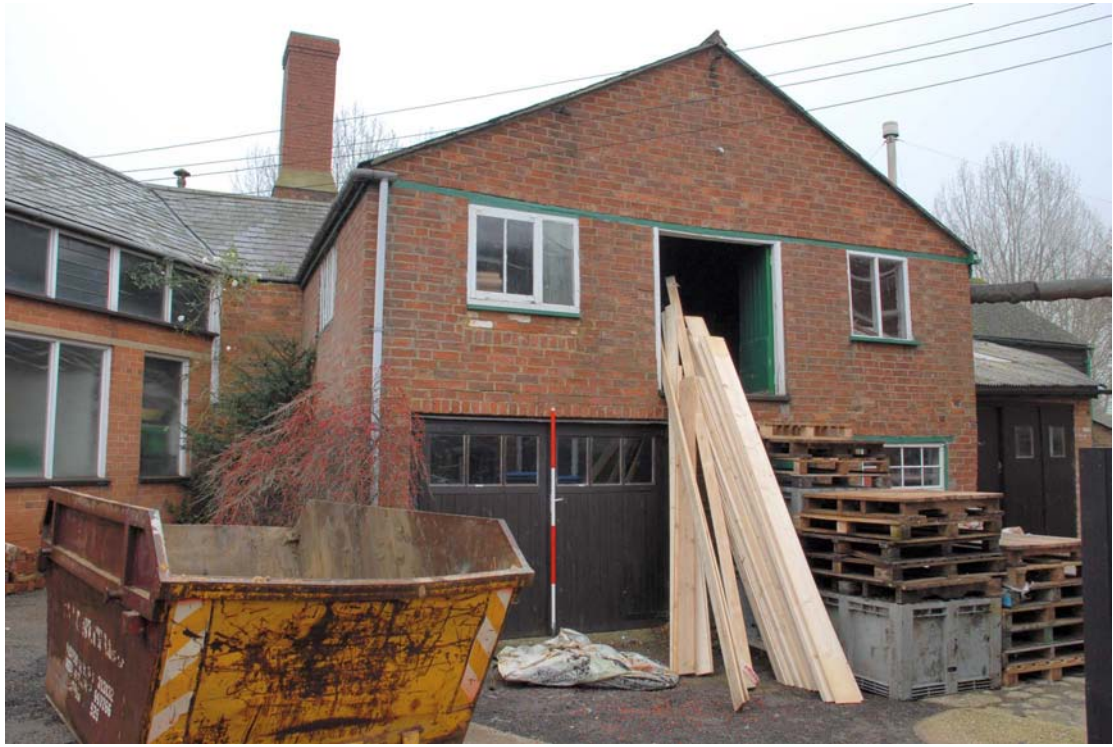
Plate 5: Workshop (area H)

The western projection (H) seems to be largely unaltered since it was built sometime before 1882 even though repairs to the brickwork in its western façade suggest that the dimensions of some windows and doors have changed (Plate 5). The yard-facing façade of this part of the building contains two principle door openings: a double door, made of wood with an upper horizontal band of square glass lights, set in the northern part of the ground floor, and within the centre of the elevation to the south of the double door, a single door opening. There is also a centrally-placed, taking-in door in the upper storey. At the time of recording there was no evidence for the hoist or pulley that would have been used to take material into the upper storage space. (Plate 5)

There is a single, ground-floor window opening in the northern elevation of the western projection containing a rectangular frame divided into a series of small rectangular panes. Two windows are set to the left and right of the taking-in door. The northern window replaces a previous larger opening, as indicated by a horizontal row of brick headers that mark the location of the earlier sill. The present window opening is rectangular with a fixed, frosted pane in the southern part, set adjacent to a casement opening with clear window glass. A simple near-square window is set to the south of the central door, divided into two fixed, vertical panes. The unaltered brickwork surrounding it suggests that it has remained close to its original size. The north-facing façade has a central window opening on the ground floor with a window comprising three adjacent frames, each subdivided into four rectangular panes. The central frame contains a horizontally sliding window. A smaller rectangular window is set centrally, directly below the eaves within the upper storey of the north-facing façade. It consists of three frames, each divided by a mullion into two long vertical panes. The central frame is set within a thicker wooden casement and can be opened. All the window openings in the western projection have wooden sills and lintels. (Plate 5)

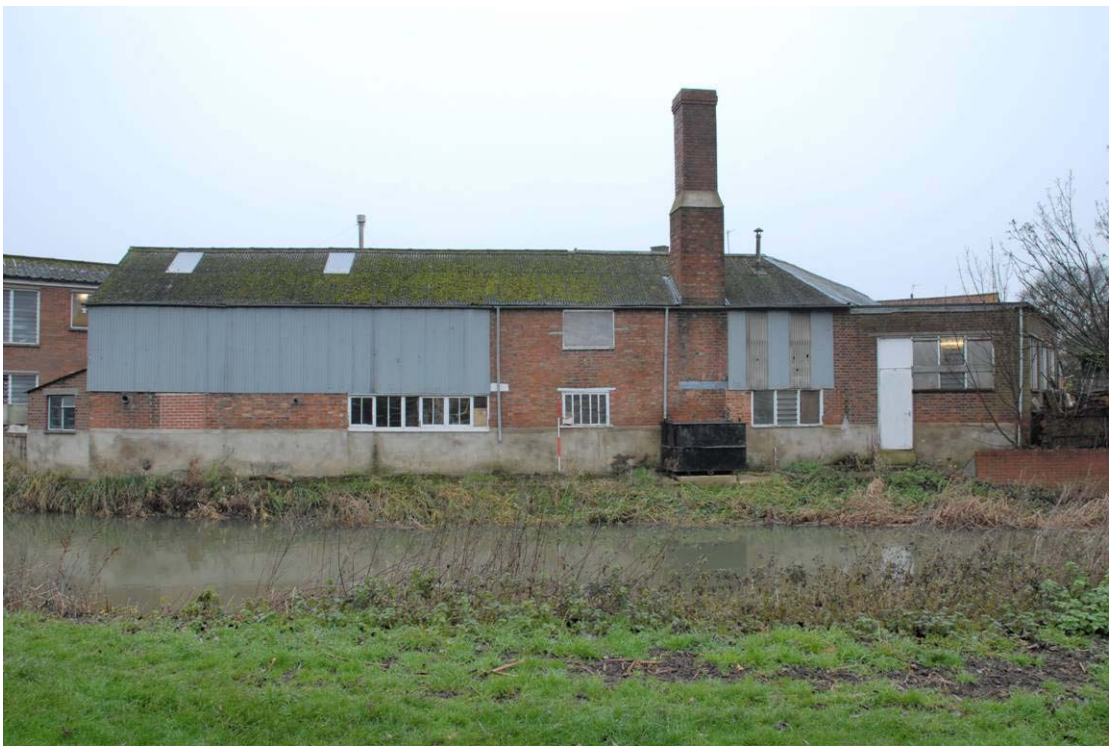
Plate 8: Eastern elevation

The eastern part of the northern wing consists of a largely rectangular block with a flat roof (B) (Plates 8-9). The flat roof replaced an earlier single pitched roof (Visscher pers. comm.). Three large rectangular window openings dominate its north-eastern elevation. The frames are divided into three vertical panes with mesh-enforced, frosted, industrial glass. The central pane of each frame contains glass louvers. The same type window overlooks the river in the eastern elevation but the outer panes are boarded up externally with plaster board (Plate 9). A single door adjacent to this window leads onto the narrow bank between the river and the building.

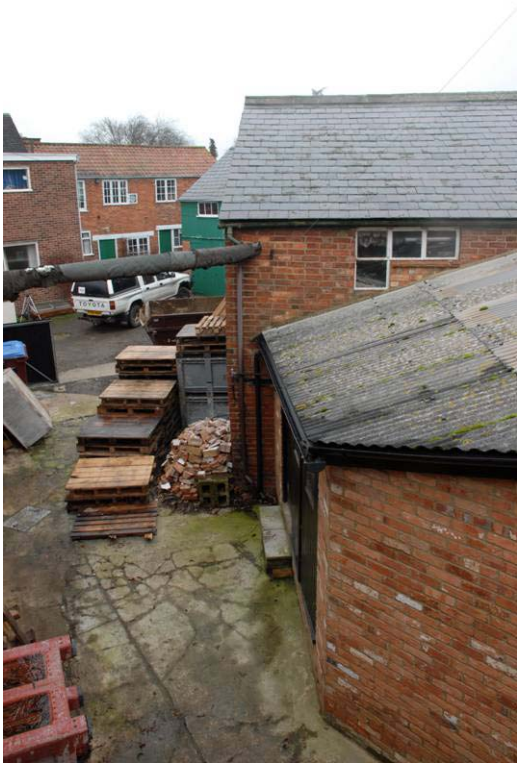
Plate 9: General view of yard (boiler house G, western projection H)

A vertical seam within the brickwork of the elevation near the southern end of the building also suggests that the building was extensively repaired at this end. Although the single-storey lean-to shed (J) at the far southern end of the building appears to be of more modern build, a similar structure, is depicted on the OS map of 1882. The lean-to extension has large wooden double doors set in its western, yard-facing elevation and two window openings with concrete lintels and sill; one set in the western elevation, south of the door and the other in the eastern, river-facing elevation. (Plate 9)

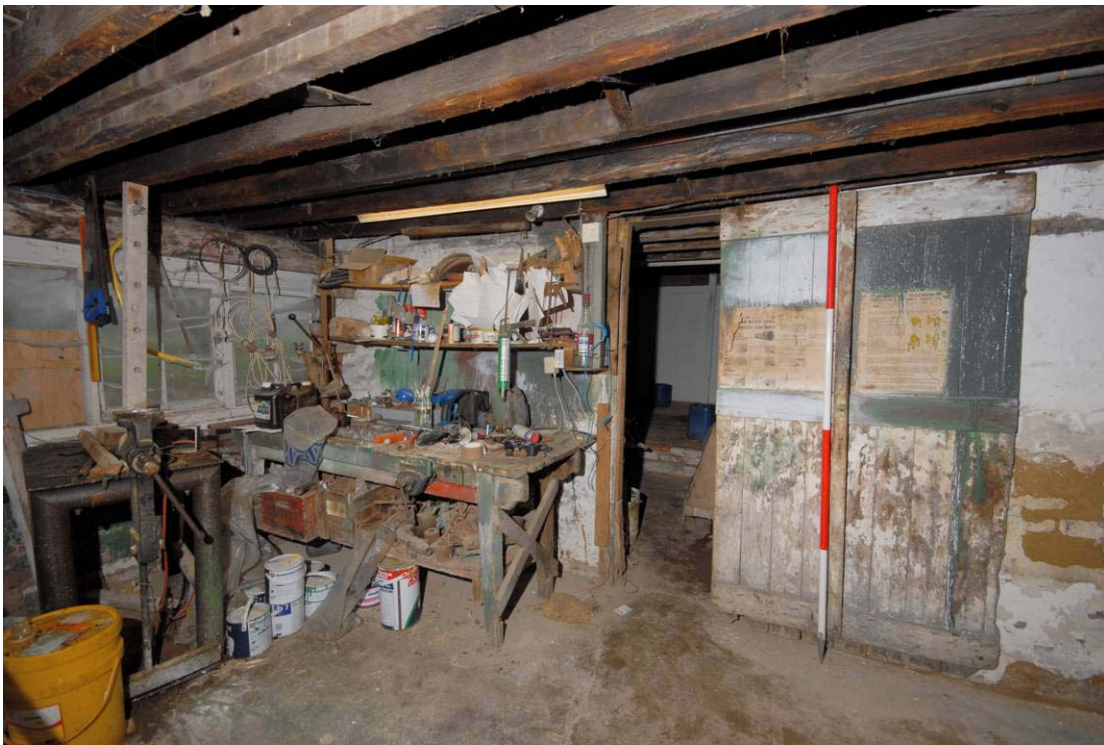
Plate 16: Workshop area D, view towards drying area F

Room D is used as a workshop and storage area (Plates 16-18). Bags of lime and ammonium chlorate powder are stored along the western wall of the room, workbenches are placed against the southern and eastern wall and parchment frames and other tools and utensils in various stages of repair are stacked in the centre and around the available edges of the room. The north-eastern corner of the room is taken up by the chimney with its separate flue and firing area built of a mixture of squared new bricks and white-glazed bull-nosed bricks (Plate 17). Metal shutters on pulleys and chains attached to the ceiling allow the flue to be open and closed in order to control both draught and heat to the upper drying floor (Plate 26). Test Pit 2 of the subsequent archaeological evaluation revealed fragmentary remains of a north-south aligned wall to the west of the chimney (Albion Archaeology 2010). It is thought that this represents a former partition wall within this area of the building.

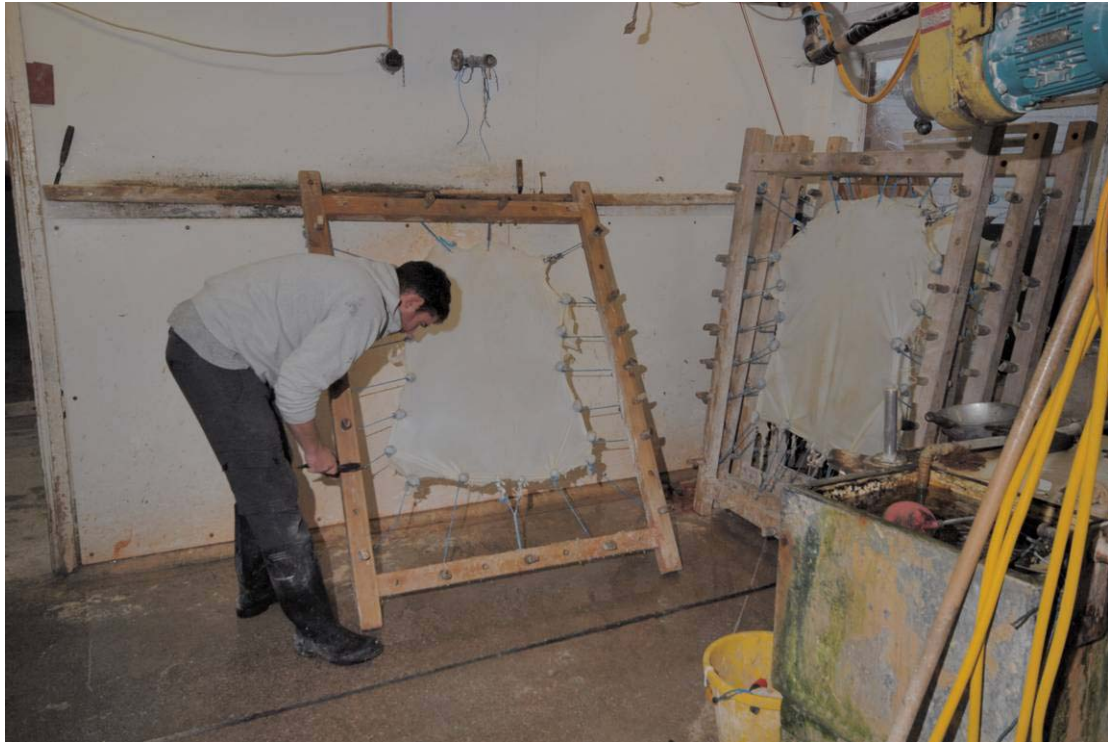
Plate 30: The process: stretching frames

parchment-making is the treatment and drying of the skins under continuous tension, which transforms them into a smooth and near transparent material and makes them suitable for writing (Plate 30).
