**LABURNUM COTTAGE
CHAWSTON LANE, CHAWSTON
BEDFORDSHIRE**

**ARCHAEOLOGICAL OBSERVATION
INVESTIGATION, RECORDING
ANALYSIS AND PUBLICATION**

Project: LC1718
Document: 2012/54

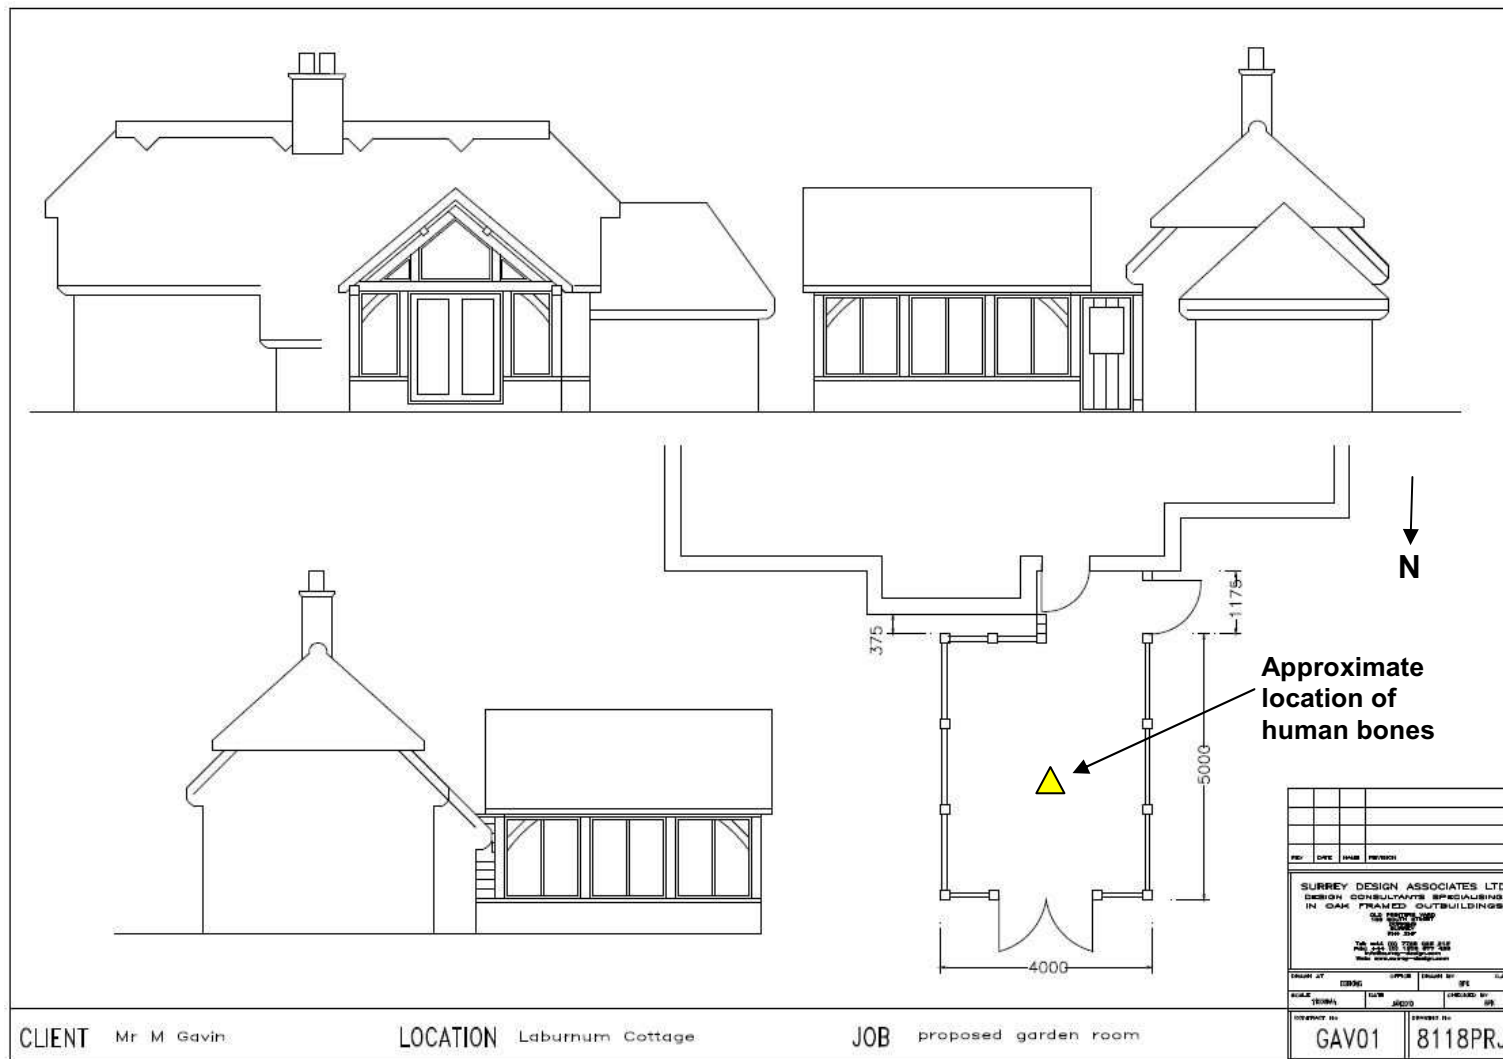
Figure 2: New extension — architect’s plan, showing approximate position of human bones.
 (drawing 8118PRJ contract GAV01 by Surrey Design Associates Ltd.)

The nature of the works changed during the course of the development. The old garage remained standing and in place of the new garage a gravel driveway was constructed. The works for the proposed extension remained the same (Figure 2).

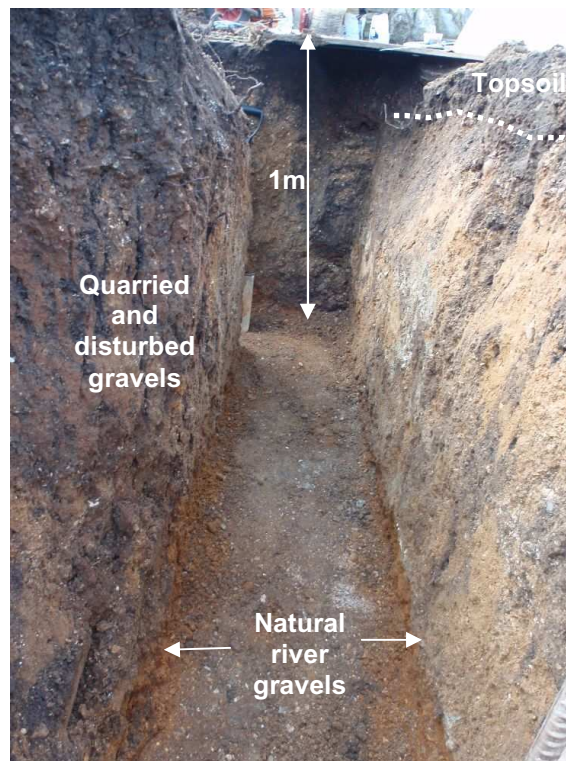
Figure 3: New extension — foundation trench looking north.

The soil profile throughout the site consisted of *c.* 0.20–0.35m of garden turf and topsoil above 0.6–0.8m of made-up ground. Undisturbed geological strata, comprising clean orange gravels were observed at a depth of 0.8–0.9m below modern ground level (Figure 3).

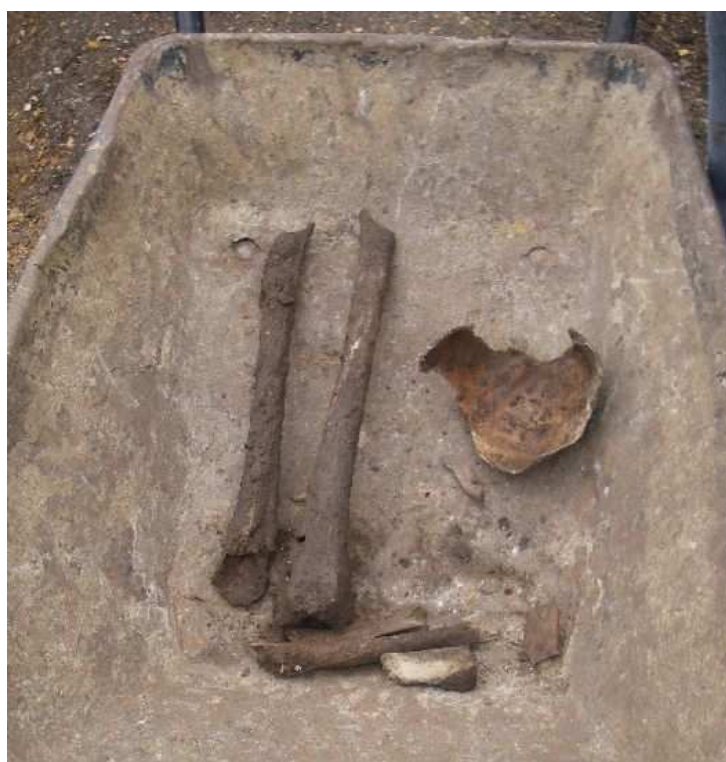
Figure 6: Human bones (2 femurs and one skull fragment; other bones are animal)

Within the dark gravelly garden soil in the footprint of the new extension two human femurs and part of a skull (Figure 6) were discovered at a depth of *c.* 0.5m below modern ground level, which in this area was equal to 0.5m below the formation level of the removed former paved area.

The origin of the bones is unclear. Their fragmentary nature and deposition in the mixed gravel deposits which form potential made-up ground or quarry pit backfill indicate that they do not represent part of a burial *in situ* but were brought to the site as part of previous earthmoving operations, possibly prior to the construction of the cottage. Mr Gavin indicated that disarticulated bone, probably human, had previously been recovered from the rear garden of an adjacent property, suggesting extensive remodelling of the area, probably in the post-medieval period. The source of these deposits and associated human bone is uncertain, though probably fairly local.
