HS2 Phase 2a: Cadent Gas Pipeline Diversion HP32 Trial Trenching, Including Unstratified Survey Final Report

Document no: UC47-CDG-UT-REP-A000-000041

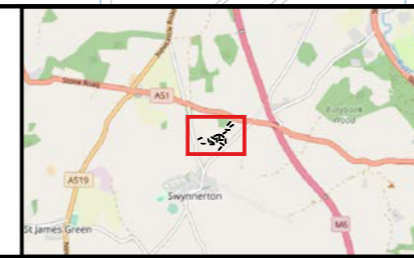
Map Number: **Figure 2**

- trench location
- archaeological feature
- sondage

Map Name: **HP32 Trial Trench: Trench Plan**

- 1.1.26 The programme of archaeological works was carried out by Headland Archaeology (UK) Ltd between the 7th and 17th March 2022 and consisted of 18 trial trenches and 54 test pits (Figure 2).
- 1.1.27 All works were undertaken in accordance with the detailed methods set out in the LS-WSI (Harris 2021; UC47-CDG-EV-ESH-A000-000001), and in accordance with current industry best practice and guidance (CifA 2020a & b and 2021) and in line with the standards set out by HS2 in the HS2 Technical Standard - Specifications for Historic Environment Investigations (HS2-HS2-EV-STD-000-000035).

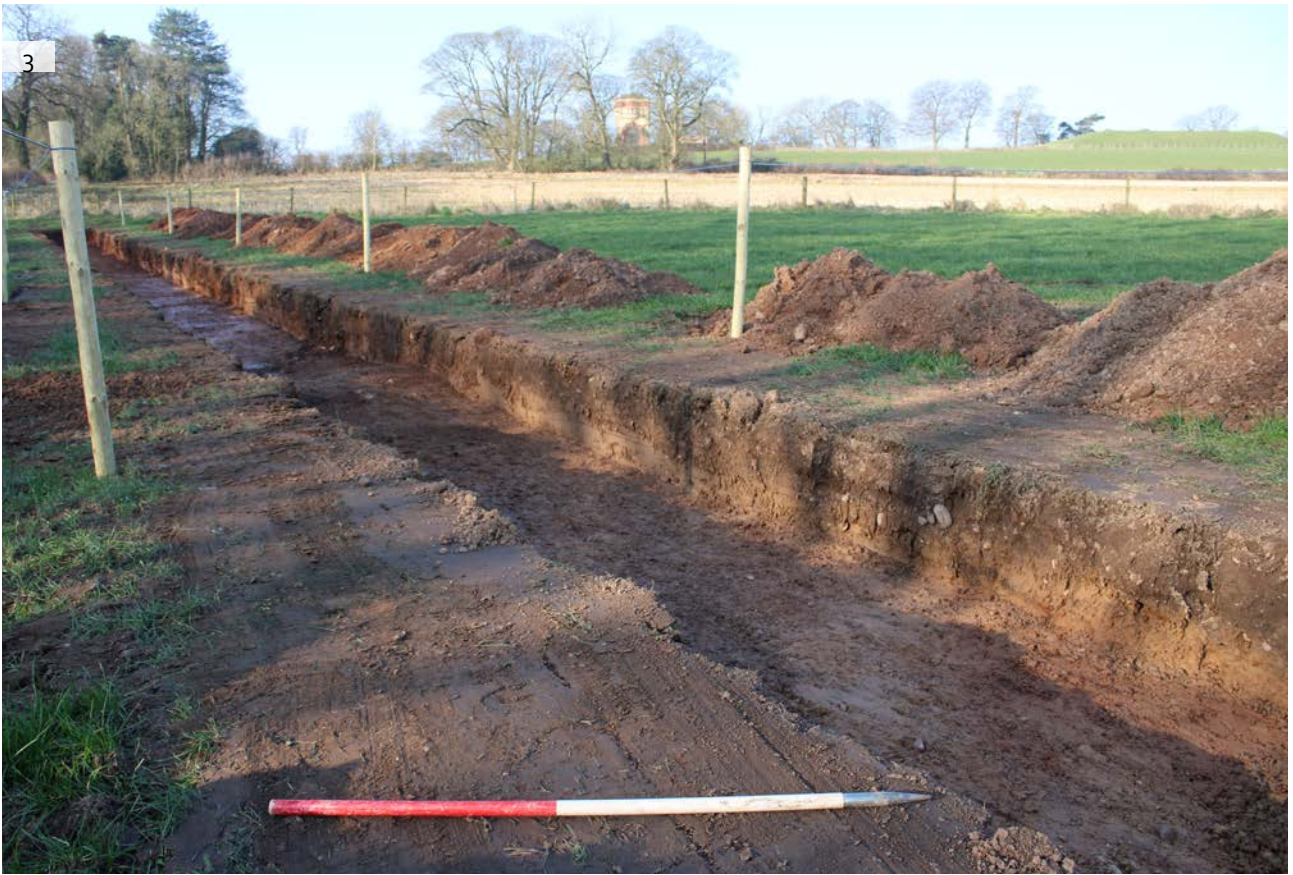
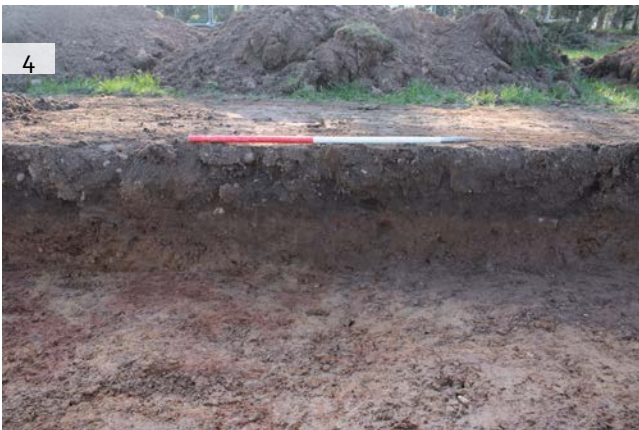
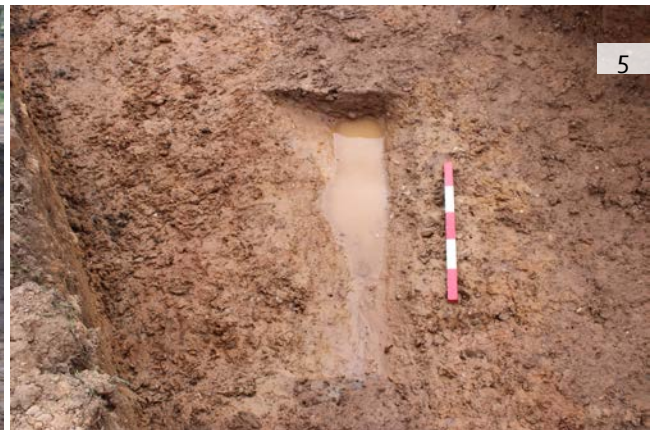
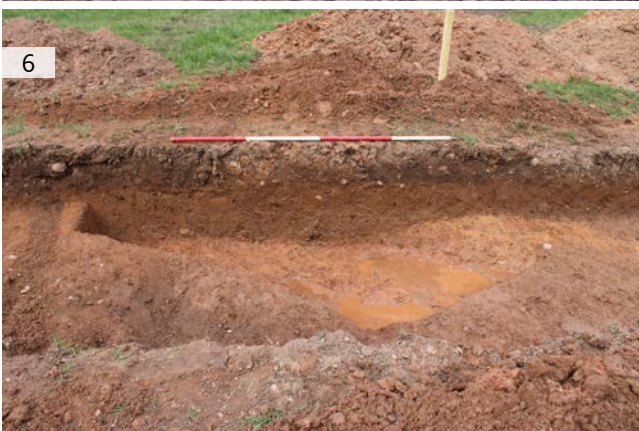
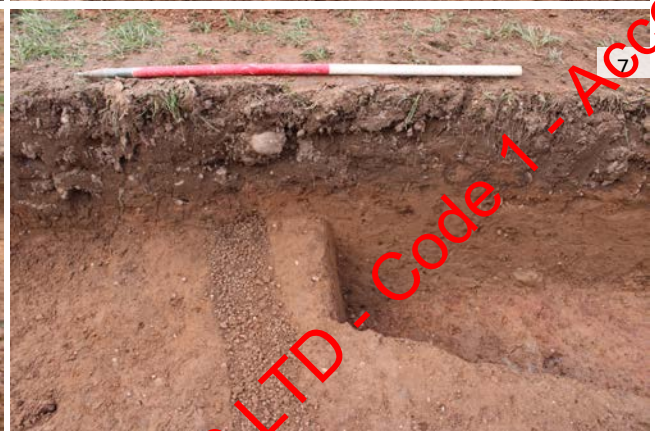
FIG 3 Trench 1 showing ditch alignment with water tower to the west cut [001007] through subsoil FIG 4 Trench 1 north west facing trench section showing ditch cut [001007] through subsoil FIG 5 Plan shot of gully [001007] FIG 6 South-east facing section of ditch [001004] FIG 7 South-east facing section of ditch [001004] cut by modern drain

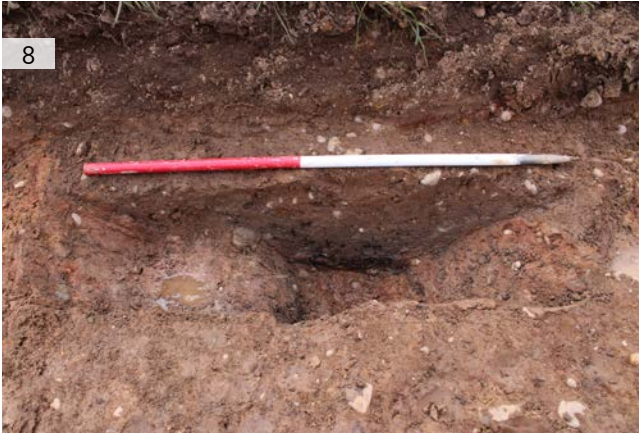
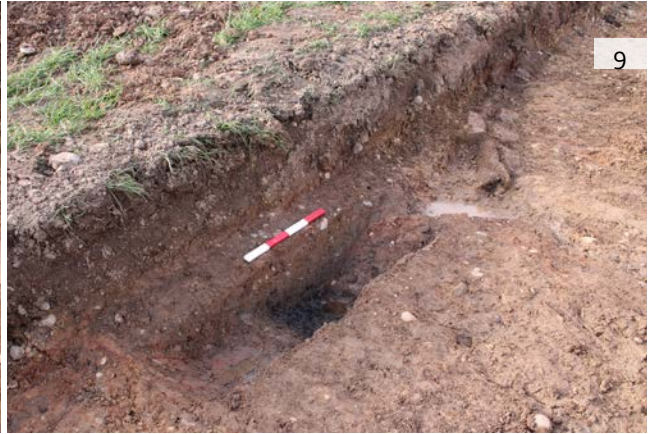
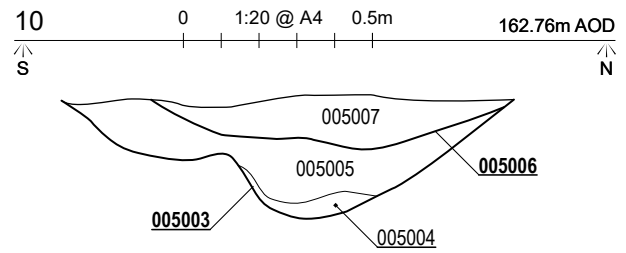
FIG 8 East facing section of ditches [005003] and [005006] FIG 9 Oblique shot of ditches [005003] and [005006] FIG 10 East facing section of ditch [005003] and [005006]

- 1.1.66 The second ditch cut the upper fill (005005) of ditch [005003] and measured 0.95m in width. There was one fill present (005007) measuring 0.11m in thickness, which was likely a natural infilling based on the homogenous character of the reddish-brown silty sand fill. Small sub-rounded stones were occasionally found throughout, but otherwise no artefactual material.

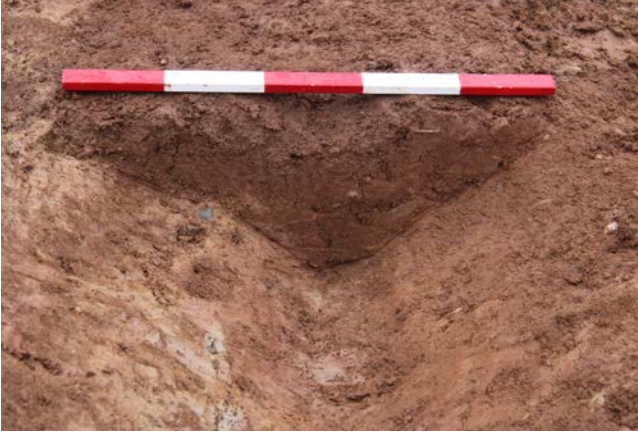
FIG 11 South facing section of gully [010003]

- 1.1.67 Oriented north-east to south-west, Trench 10 contained one gully which ran north to south (Figure 11).
- 1.1.68 Gully [010003] measured 0.64m wide and contained one fill (010004). It had a V-shaped cut and an uneven base deepening towards the north-west end of the trench. Within the sterile, grey clay-silt fill (010004) a concentration of rounded stones were noted at the base, indicating a waterborne natural infilling. There were no finds within this feature.

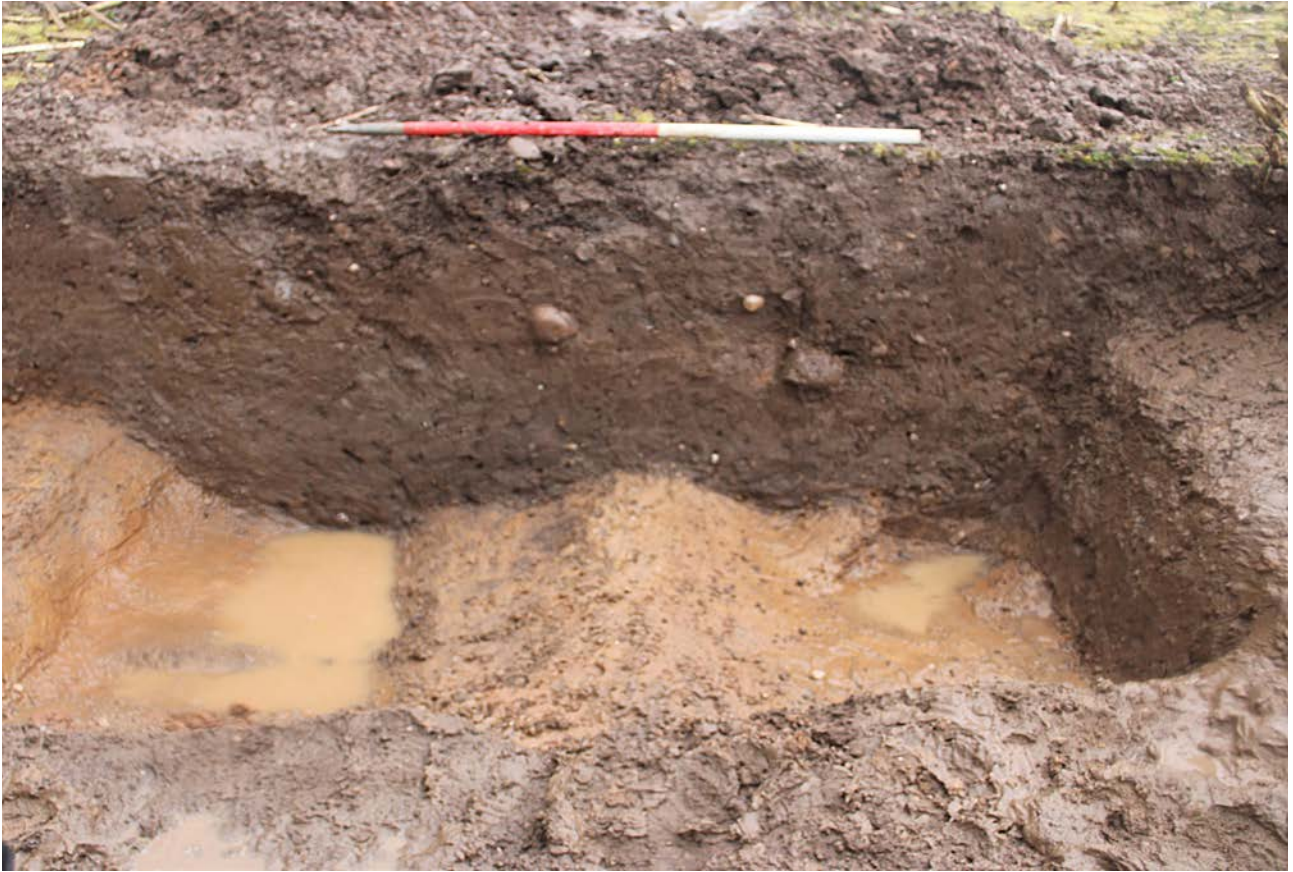
FIG 12 South-east facing section of ditch [011004] and hedgerow [011006]

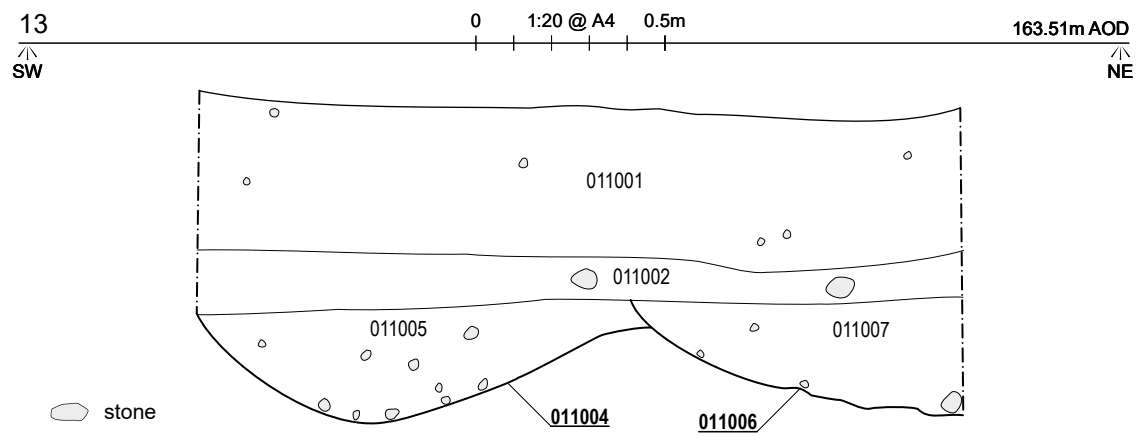
FIG 13 South-east facing section of ditch [011004] and hedgerow [011006]

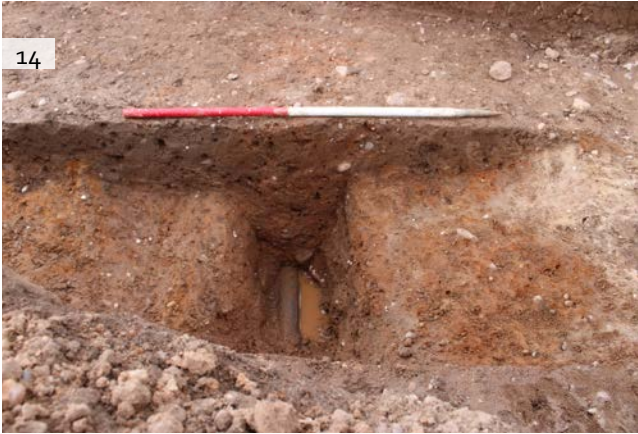
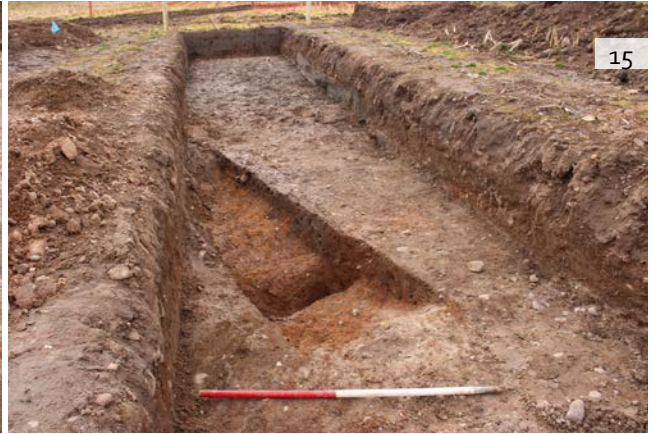
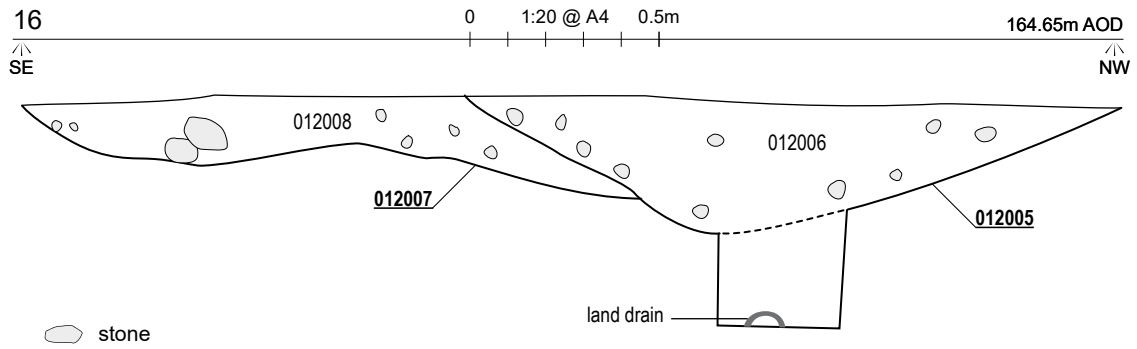
FIG 14 North east facing section of ditch [012005] and hedgerow [012007] FIG 15 Location shot of ditch [012005] and hedgerow [012007] looking south FIG 16 North-east facing section of ditch [012005] and hedgerow [012007]

1.1.71 Trench 12 was oriented north to south and was heavily disturbed from modern activity. A dark organic deposit was found at the south end of the trench, along with a ditch and a hedgerow of similar nature to those found in Trench 11 (Figure 14-16).

1.1.72 Deposit (012004) was 4.40m in width and 0.09m in depth, present only in the south end of the trench. Displaying a dark blackish-grey colour, the deposit comprised of a clayey silt and was of irregular shape, with occasional small, rounded stone inclusions. It is possible that this was a result of modern disturbance; no dating evidence or artefactual material was found.

1.1.73 Similar to the features found in Trench 11 ([011004] and [011006]), a ditch and a hedgerow were present at the south end of Trench 12, both of north-east to south-west alignment. Ditch [012005] measured 1.73m in width, with an average depth of 0.36m. With a 'U' shaped cut and shallow sloped edges, the ditch contained one fill (012006) which consisted of a firm greyish-brown silty fine sand, with moderate small to medium sub-rounded stone inclusions. The ditch was truncated by a steep cut for a field drain towards the centre, suggesting that its original purpose may have been water management, though it may have served as a field boundary.

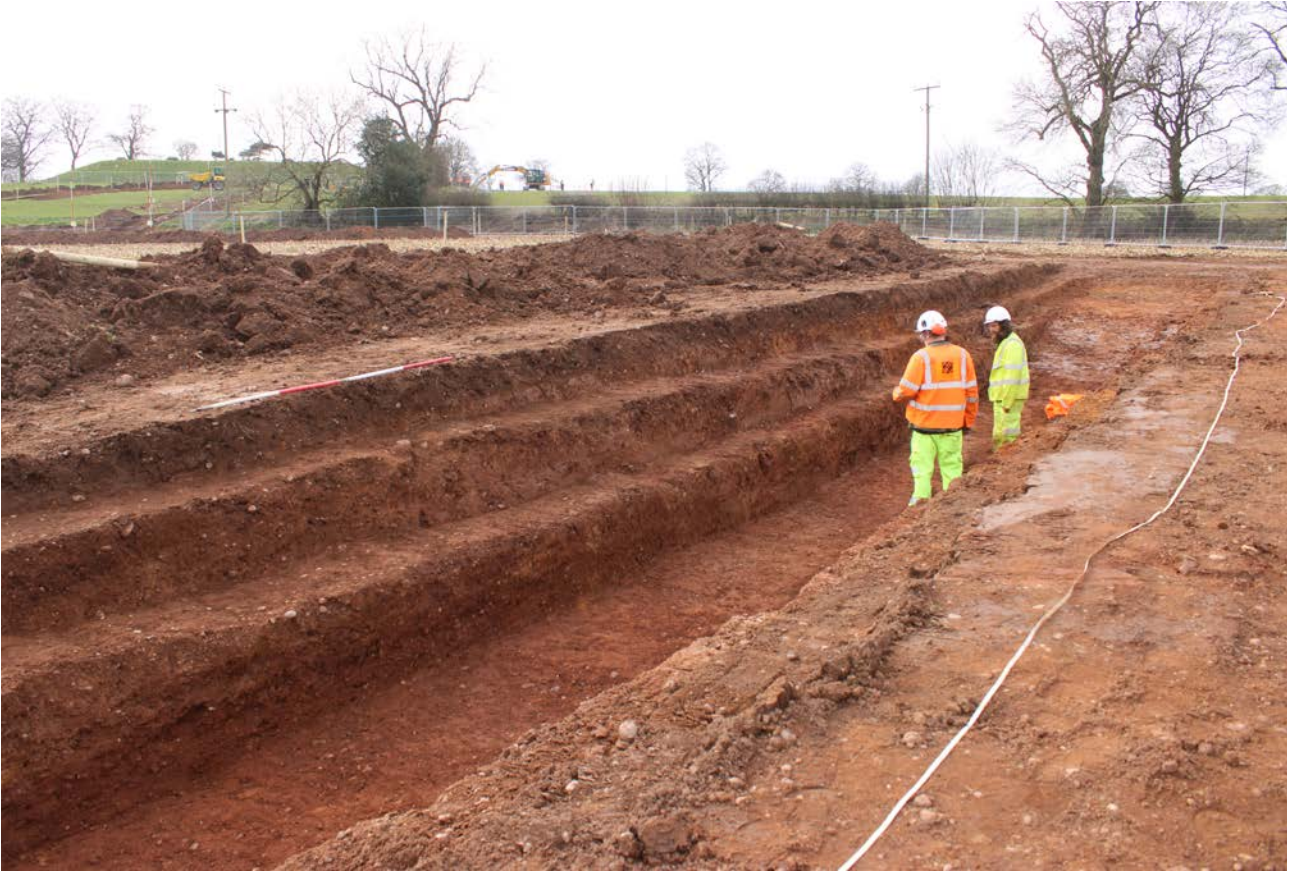
FIG 17 Working shot of Trench 13 after stepping

1.1.22 The programme of archaeological works comprised 18 trenches, all initially measuring 50m x 1.8m. Trench 13 was stepped after machine excavation to a depth >1m to allow the geoarchaeologist to assess the geological deposits in that area. Sondages were also machine excavated in trenches 14, 15, 16 and 18 for further geological analysis. Where trench depths exceeded 1m, these were recorded and backfilled immediately to mitigate the risk of harm to personnel on site and the public.

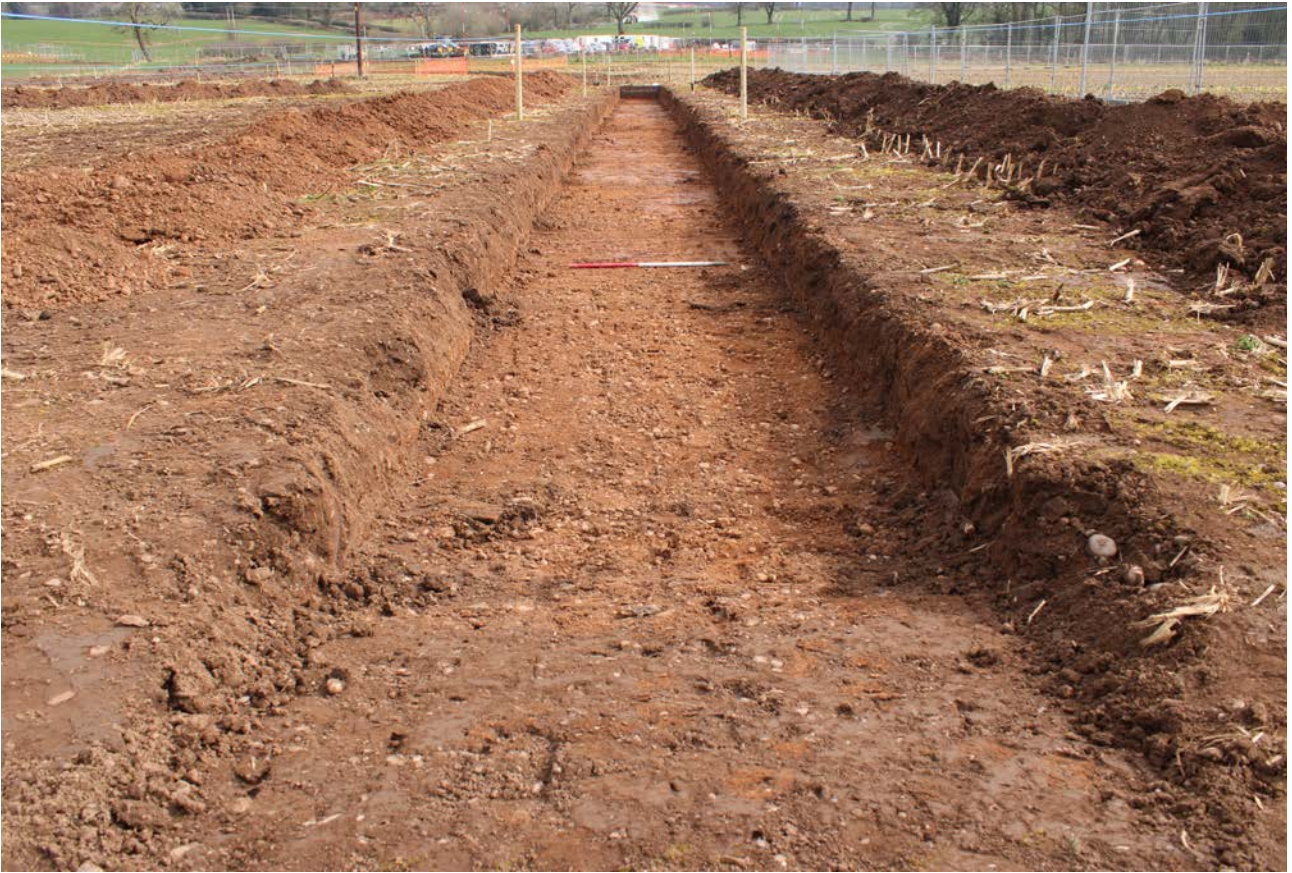
FIG 18 Trench 15 facing east

FIG 18 TRENCH 15 FACING EAST

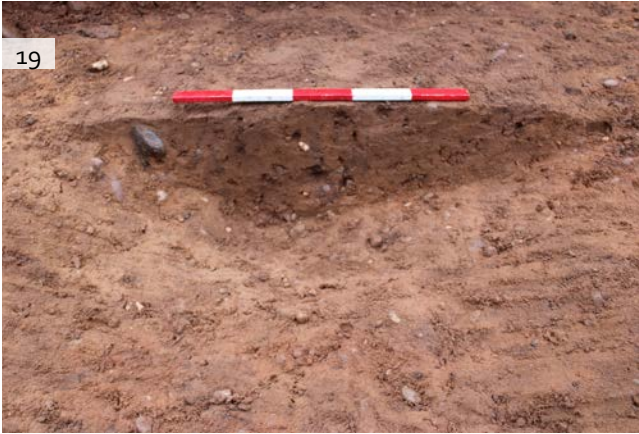
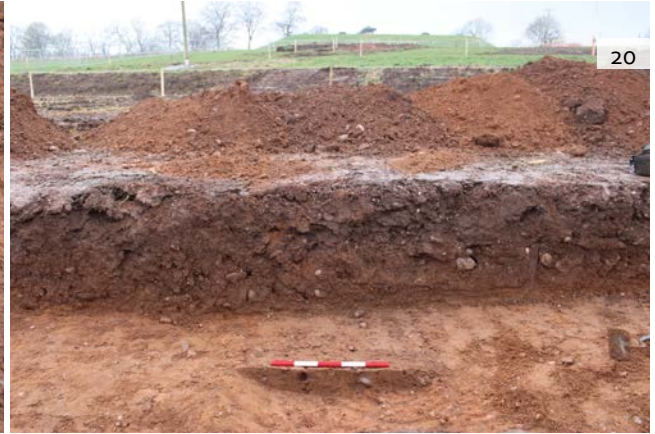
FIG 19 West facing section of ditch [016004] FIG 20 Location shot of ditch [016004] facing west

- 1.1.76 Trench 16 was excavated on a north to south alignment and was found to contain one gully (Figure 19 and 20).
- 1.1.77 Gully [016004] was aligned east to west, measuring 0.95m wide and 0.22m deep. The irregular, 'U' shaped profile was filled by light grey-brown, coarse sand infilling with occasional rooting throughout (016005). This was likely a natural geological feature.
