## 1MC12 – Stage 2 – Main Works Civils for C2 and C3 Sectors

# Fieldwork Report for Construction Integrated Recording at C25148 Chetwode Mill Buckinghamshire

Document no: 1MC12-EKF-EV-REP-CS09-000343

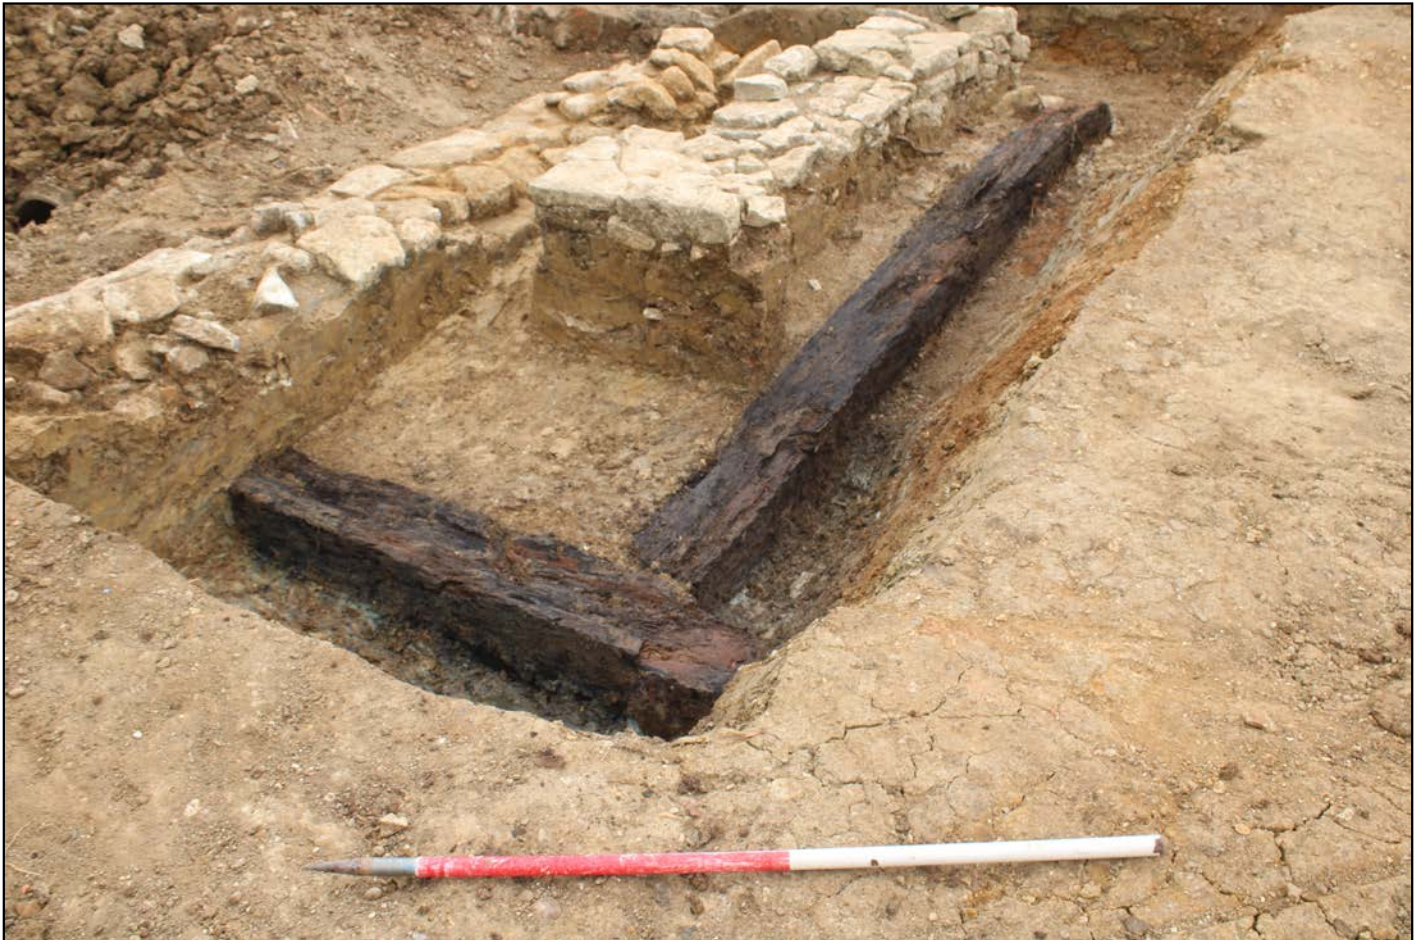
- 4.1.3 A series of timber beams and stakes, potentially related to the early phase of the mill house construction identified in C25147 (1EW03-FUS\_COP-EV-REP-CS06\_CL10-000005), were uncovered. These included four well-preserved worked timber beams; (10012), (10015), (10027), and (10028). Adjacent to the timber remains, were two wall foundations (10007) and (10017) (Figure 4).

| | Map Name | Area shot of timber beams and stone walls | |

- 4.1.7 Adjacent to the timber remains were the remains of two east to west orientated wall foundations: (10007) and (10017). Wall (10007) was the more northerly of the two walls and was located directly south of timber beam (10012). Wall (10007) formed a corner and likely represents the surviving southern wall of the mill building. Wall (10007) measured 0.6m wide, and had a length of 2.9m, with a height of 0.6m. The construction cut for wall (10007) [10008] measured 2.9m in length, with a width of 1.8m, and a depth of 0.6m, and had a flat base and sloped sides. Sherds of 16<sup>th</sup> century pottery were recovered from the packing fill of the cut.

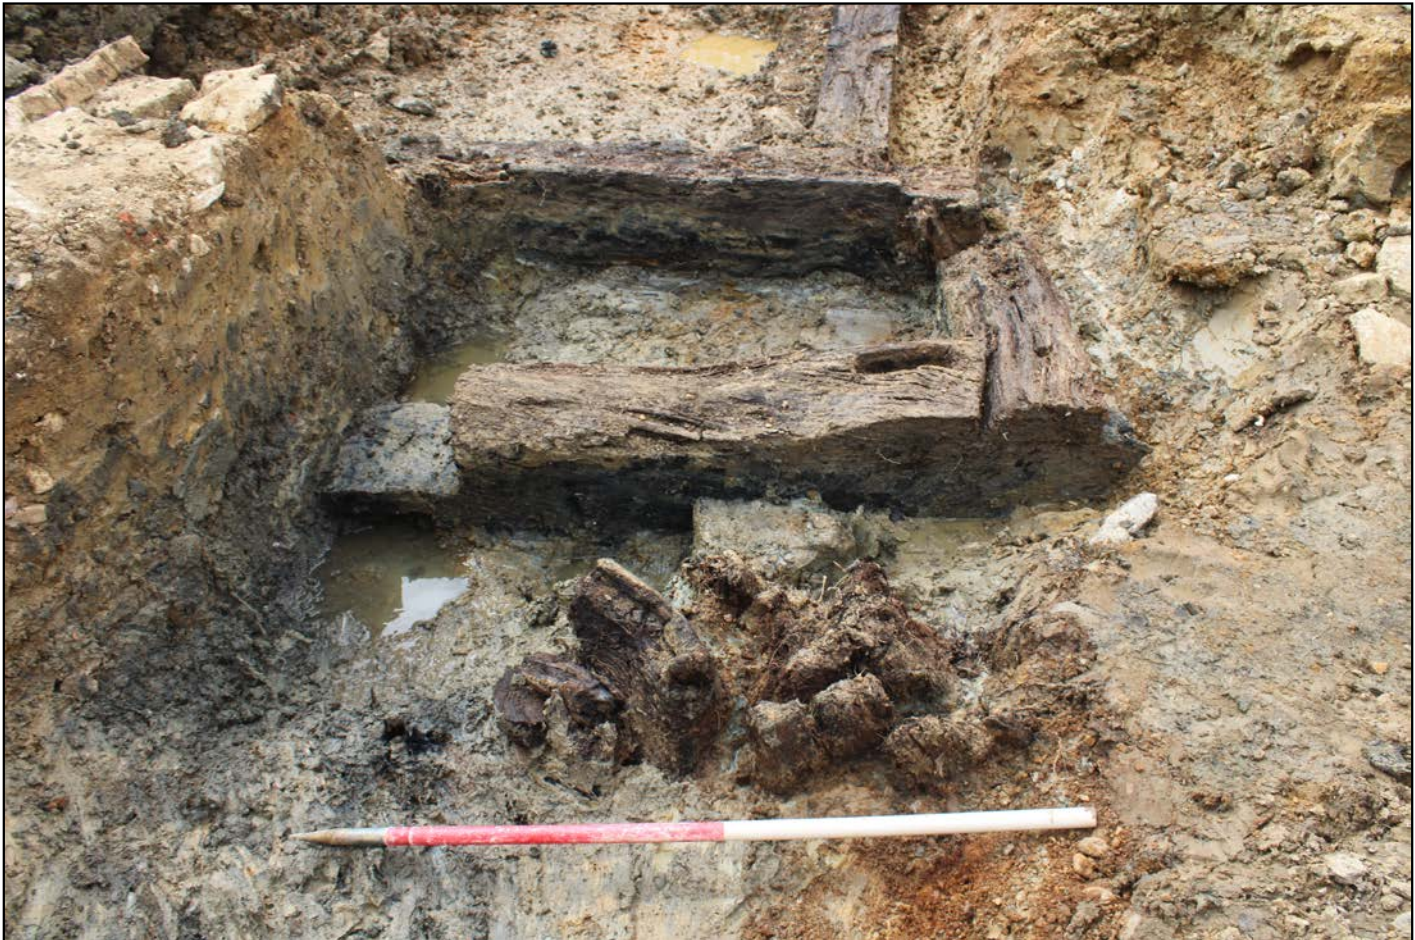
| | Map Name | West facing shot of stake cluster | |

- 6.2.16 A group of seven uprights were encountered, aligned roughly north/south, to the east of the horizontal timbers. The tops of all are degraded. The uprights were not extracted, but probably represent driven piles. Conversions range from boxed halves (10032, 10033 and 10034), though boxed quarters (10037 and 10038) to tangentially boxed items (10035 and 10036). The method of conversion is unclear. Cross sections range from 120 x 120mm to 280 x 180mm.

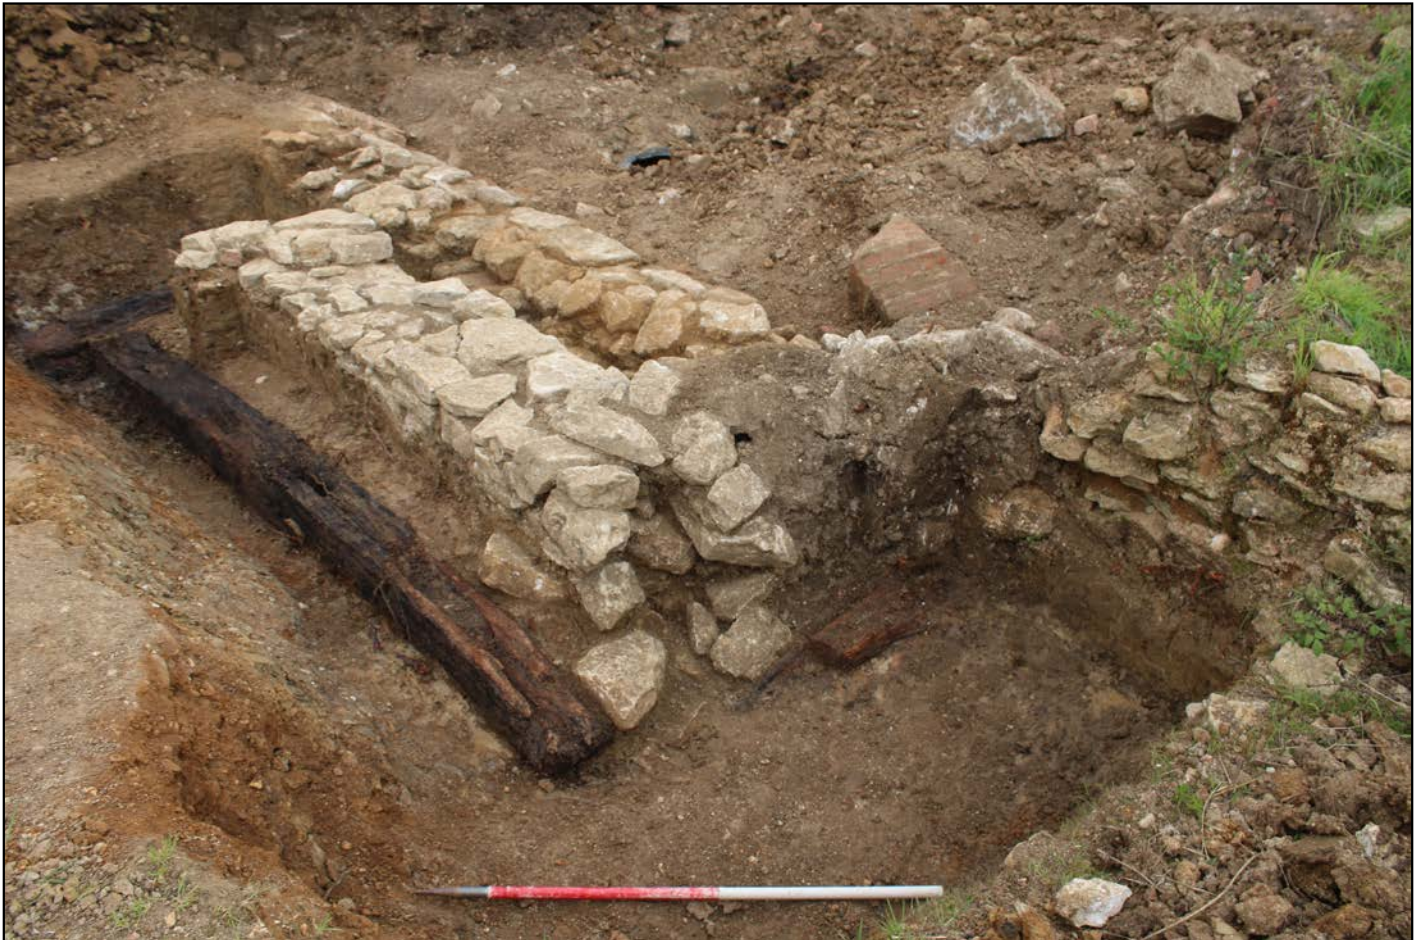
| | Map Name | Area shot of timber beams and stone walls | |

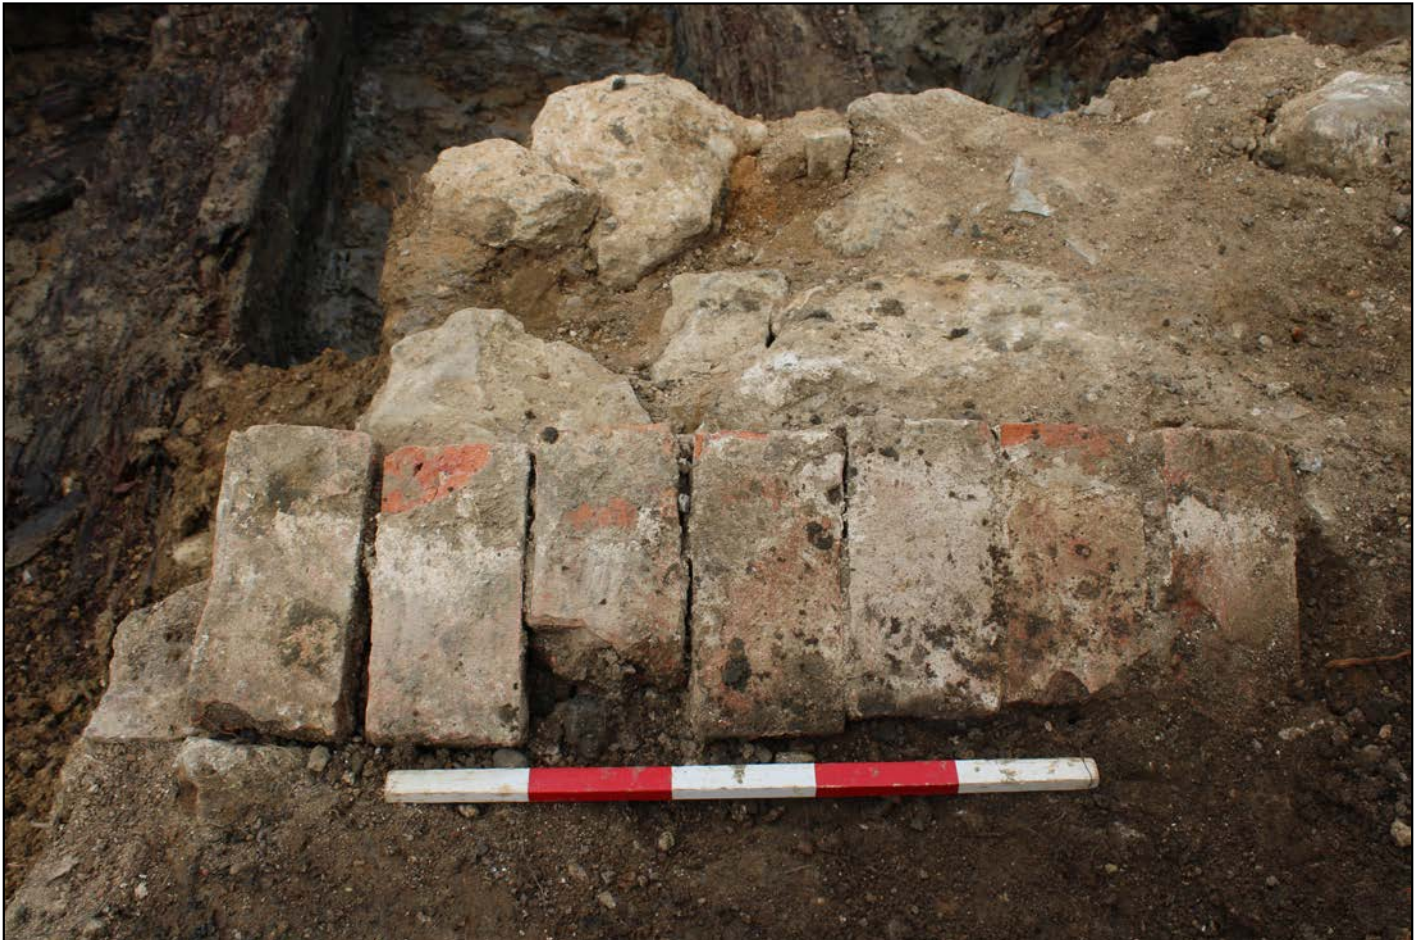
| | Map Name | Plan shot of bricks | |

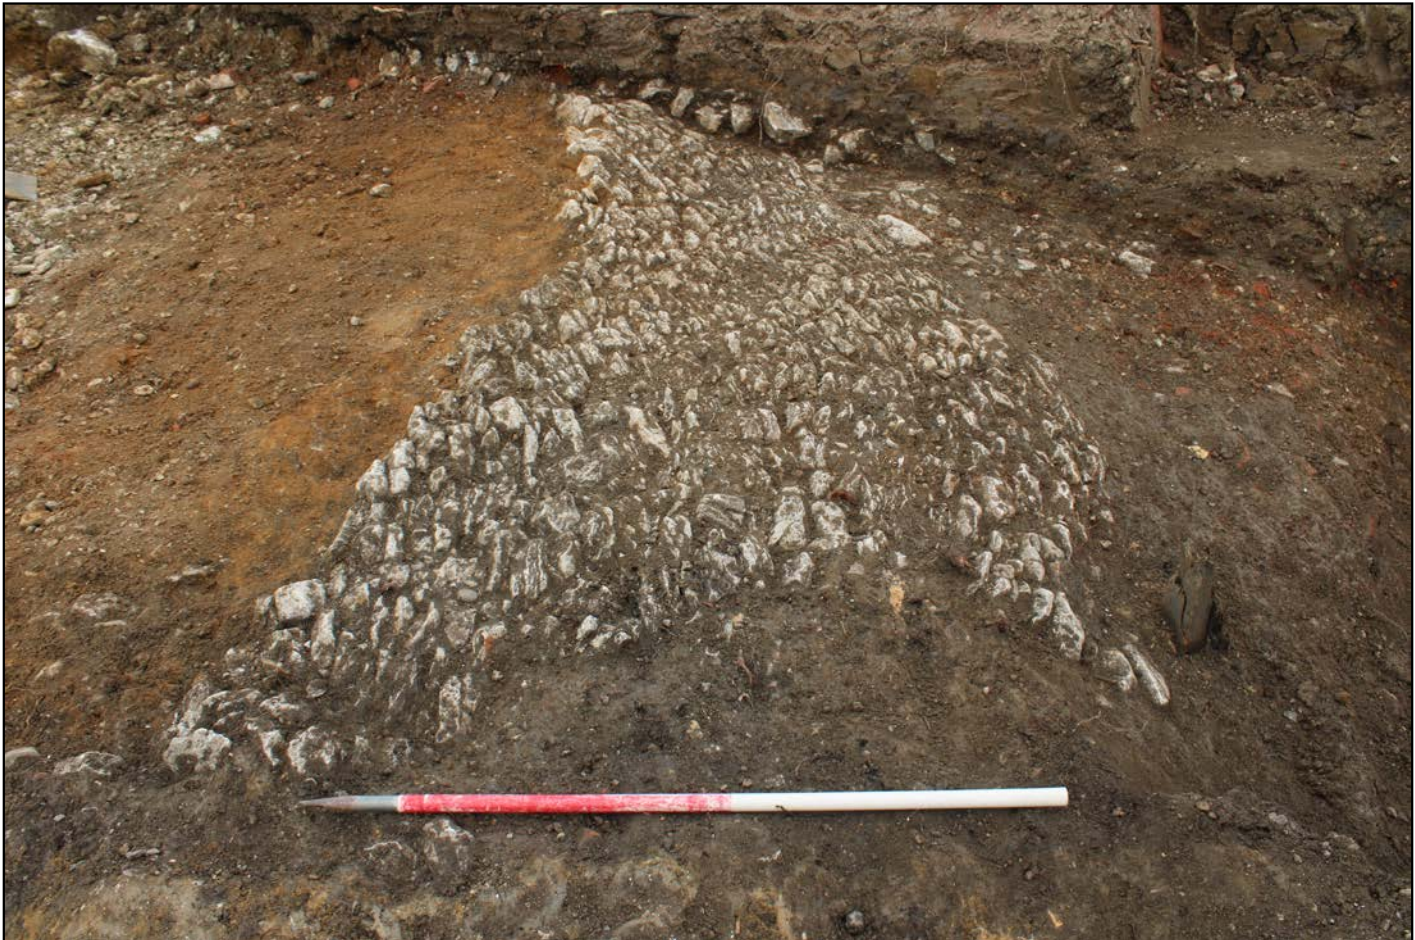
| | Map Name | North-west shot of cobbled surface | |
