# BARNS AT CAUTLEY FARM, WHASSETT, MILNTHORPE, CUMBRIA

Archaeological Building Recording

Planning ref: SL/2015/0989

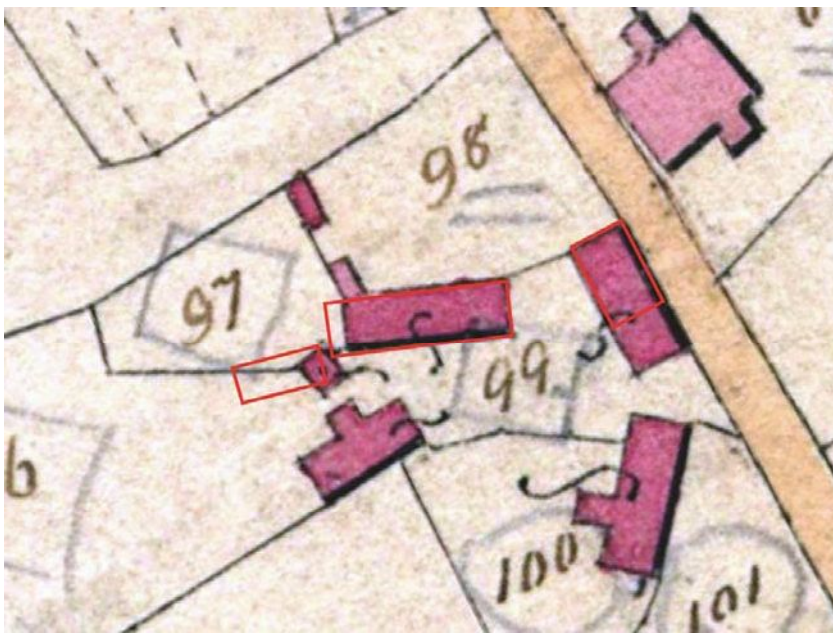
3.1.2 **Tithe Map, 1839:** this shows the site comprises three buildings, with Building A and Building C easily distinguishable, although the latter is somewhat longer than it is now. Building C only comprises a small square block and it is not clear how much this relates to the current building or represents something that was there before it. More significant is the building immediately to the south of Building C, which no longer exists, and the building to the south-east of that, which has either been subsequently rebuilt or substantially modified. The accompanying schedule lists Plot 99 as owned and occupied by Richard Dennison and describes it as 'house, outbuildings & yard'.

Plate 1: Extract from the tithe map of 1839 (NA IR 30/37/10 1839) showing the site

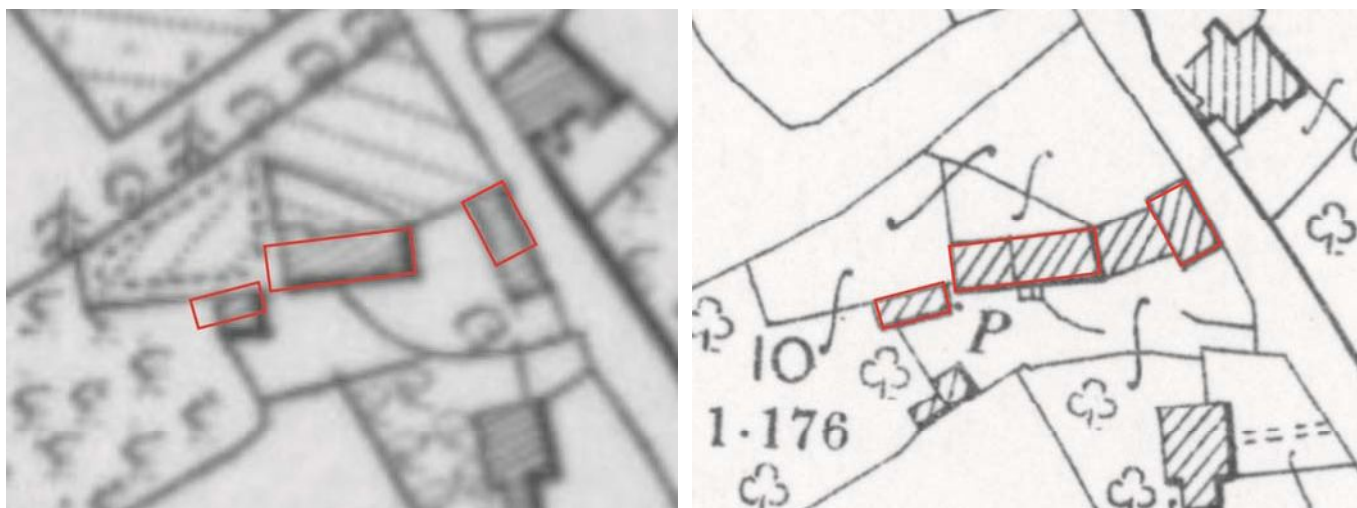
3.1.3 **Ordnance Survey c1857:** this 1:10,560 scale edition of the Ordnance Survey map was surveyed in 1857 and presumably published shortly thereafter (Plate 2). It shows a similar arrangement to the earlier tithe map, with a small square building to the west on the site of Building C, a long east-west building in the centre (Building A), and a long north-west/south-east aligned building along the side of the road to the east (Building C). These broadly correspond to the three buildings as they are now although Building B is slightly shorter than it now is and Building C is slightly longer.

Plate 2 (left): Extract from Ordnance Survey map c1857

Plate 3 (right): Extract from Ordnance Survey map 1898

3.1.4 **Ordnance Survey 1898:** the first available 1:2,500 scale Ordnance Survey map, revised in 1897, shows that Building B has become more rectangular in plan by this date but Buildings A and C are closer to their current form although they have also been joined by the construction of another building in between (Plate 3). An internal division is shown west of centre of Building A and what appear to be east/west steps are shown attached to its south side.

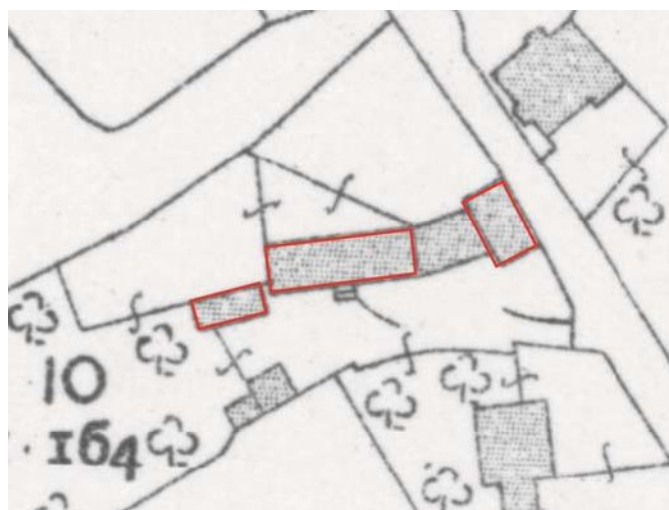
3.1.5 **Ordnance Survey 1934:** the 1934 edition of the Ordnance Survey map was revised in 1911, but shows the same layout as the previous edition (Plate 4). No internal divisions are shown within Building A and the 'steps' to the south side of it are marked north/south as opposed to east/west (as they were on the previous edition).

Plate 4: Extract from the Ordnance Survey map of 1934

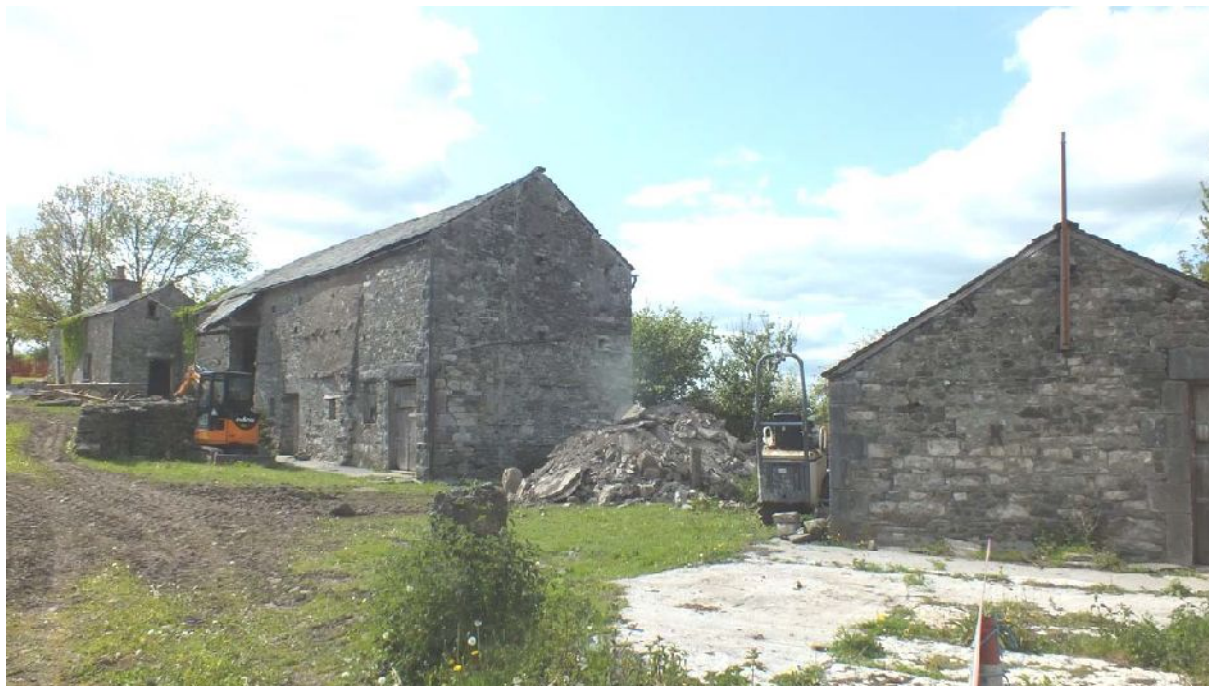
4.1.1 The site comprises three separate buildings: a large bank barn in the centre (Building A), a smaller building to the west of this of essentially domestic origin (Building B), and a small building set against the eastern boundary along the road, which was clearly used for additional animal housing (Building C) (Plate 5). Buildings A and B are orientated essentially east/west, while Building C is orientated north-west/south-east. All three are constructed from locally derived limestone and volcanics, with slate roofing finished with ceramic bonnet ridge tiles. The timber is typically of sawn types, although within Building A there is lots that is hand finished and also reused. In addition the remains of a fourth building were observed incorporated into the west end of the southern boundary wall (Plate 6).

**Plate 5: General view of the site from the south-east showing the relationship of the three buildings**

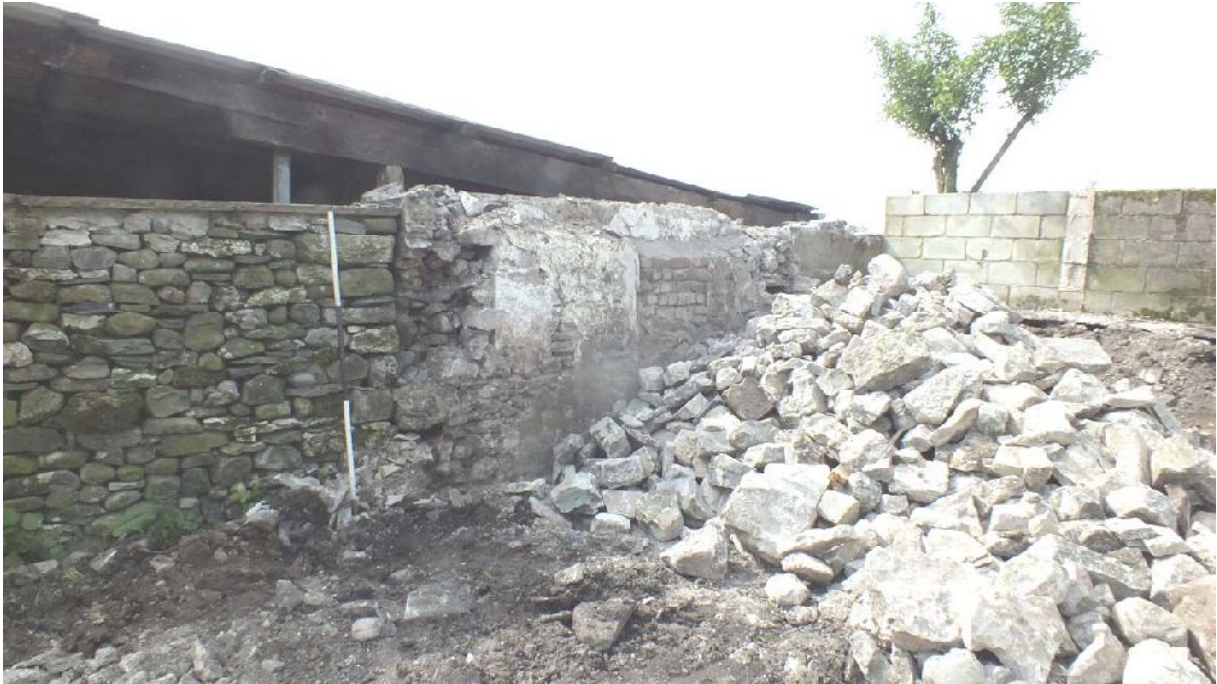
**Plate 6: Remains of a building incorporated into the west end of the southern boundary wall, viewed from the north-east**

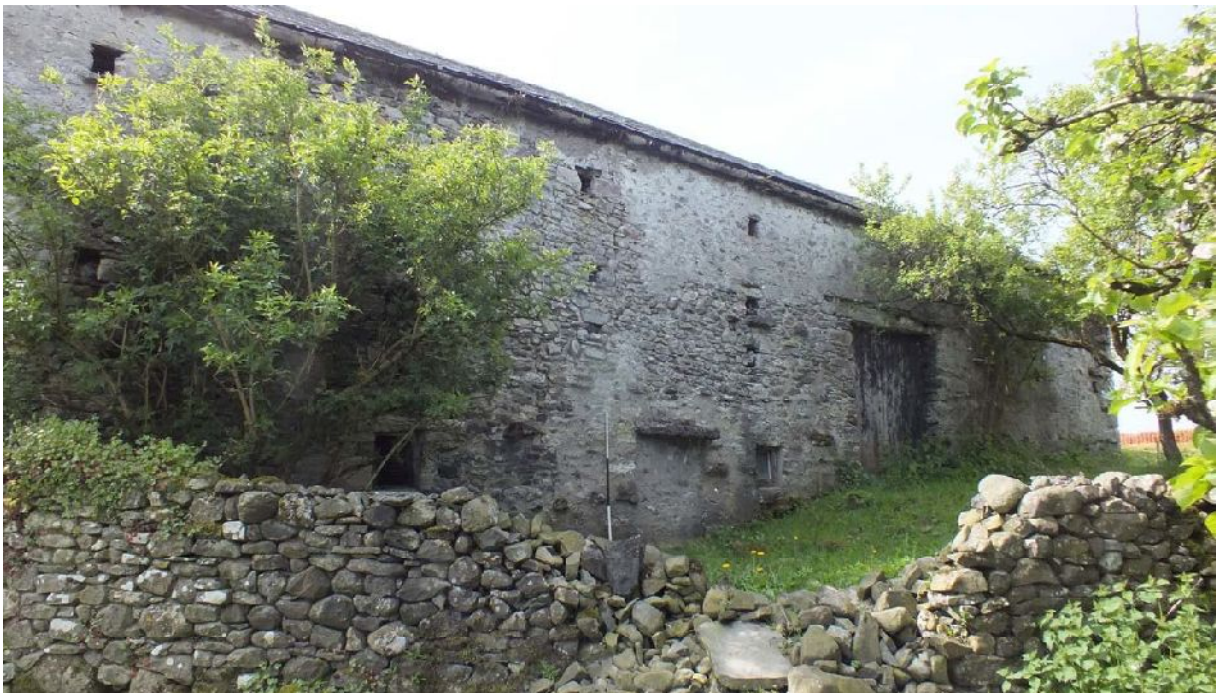
4.2.1 **Building A, north elevation:** there are two storeys at the east end with rough quoins at either end. There are two small windows in the lower section at the east end, one with a grill, and the other with a single light casement. Both windows have timber surrounds and projecting stone lintels (Plate 7). There is a blocked doorway between, with a projecting lintel, numerous through stones and three rows of square vents two per row in the centre upper level. There is a window or pitching door at the east end, with a stone lintel and sill. The west end has a wagon door with a rough timber lintel, no rough quoins, and a plank and batten double door. The west end beyond has two more rows of two vents.

**Plate 7: North elevation of Building A, from the north-west**

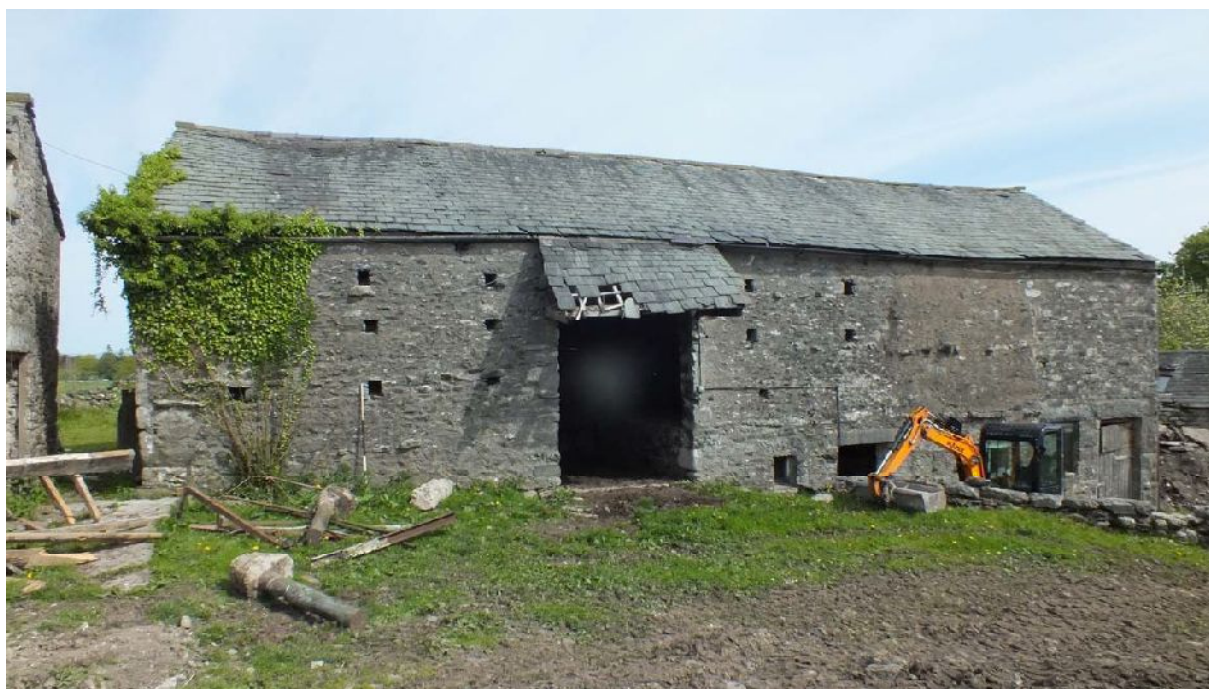
4.2.3 **Building A, south elevation:** at the west end there were three rows of three square vents to the west of the wagon doorway, which had a canopy over, made of slate on hand-finished timber (Plate 8). The doorway has a rough curved timber lintel – possibly a reused cruck blade. There were no real quoins. The east side of the elevation is two storeys, and the lower level has two small windows either side of the doorway with a dressed jamb with rounded quoins on the east side and a dressed lintel with drill holes from where it has been quarried (Plate 9). There are three rows of two square vents above, the lowest row only having one, and throughstones below the west window and above. The east window has a timber lintel. Both windows are gridded. The east end has clearly been rebuilt at least once, possibly from the doorway but certainly beyond a deep and jagged step in the wall line (Plate 10). Beyond this the wall is flat with no throughstones. There is a window and door on the lower floor, with dressed lintels and quoins, with a plank and batten door.

Plate 8: South elevation of Building A, from the south

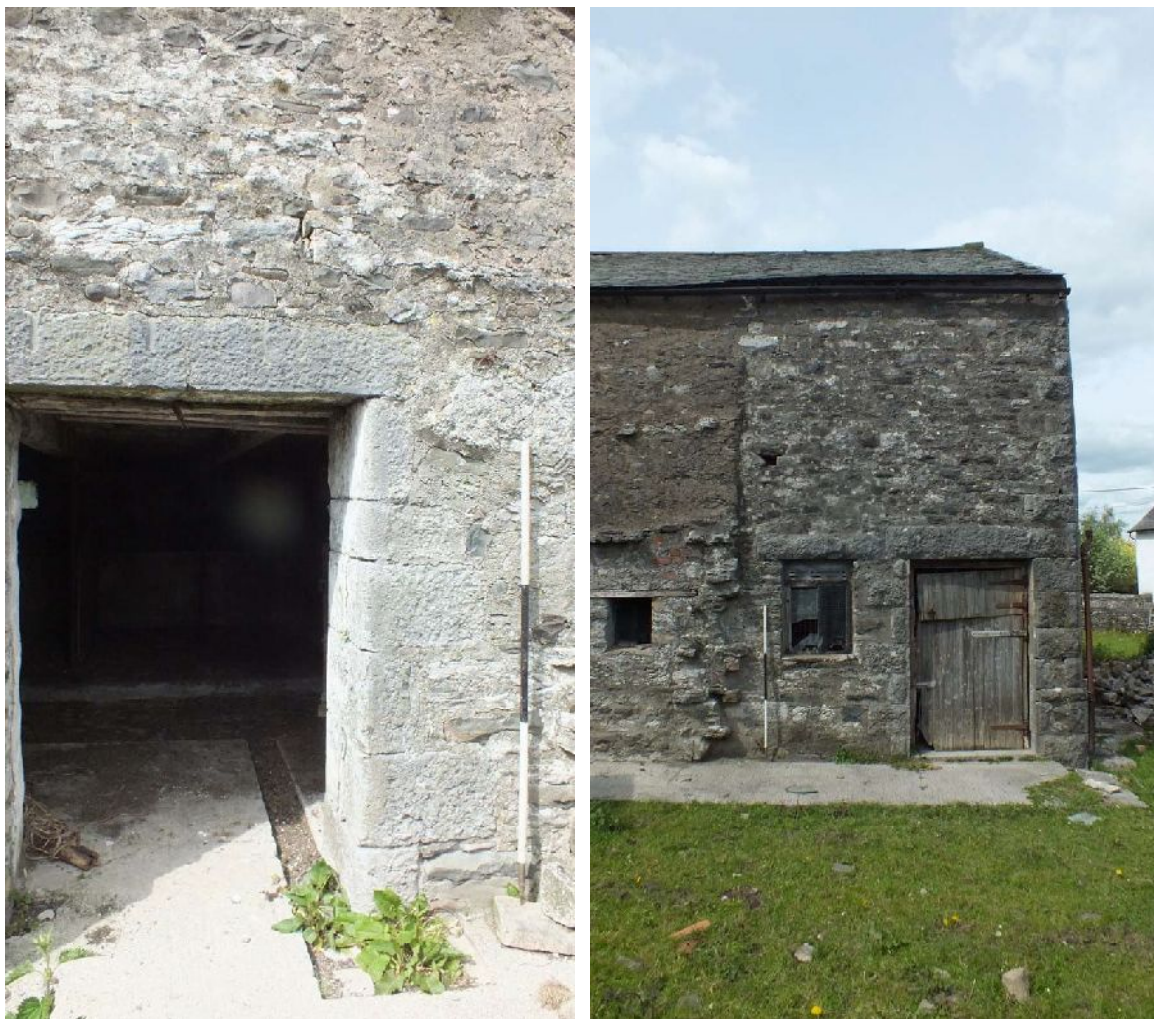
**Plate 9 (left): Detail of door in south elevation of Building A, from the south**

**Plate 10 (right): East end of south elevation of Building A, from the south**

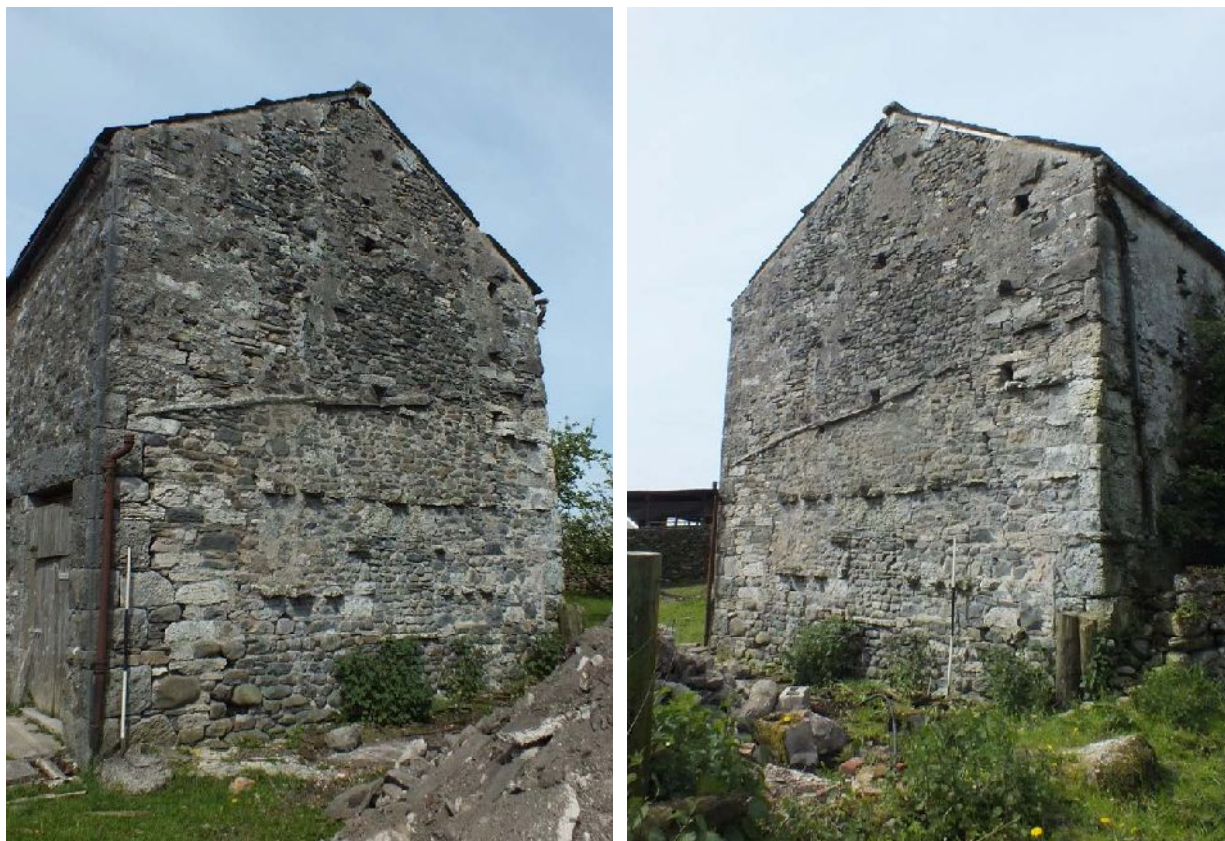
4.2.4 **Building A, east elevation:** this is a gable end. The south end of it has been rebuilt, with dressed quoins with detailed edges, and a tall plinth (Plate 11 and Plate 12). There are two to three rows of throughs and two rows of square vents. There is a blocked opening in the centre, with a limestone lintel. The quoins at the north side are much rougher, and there is the concrete scar of a former lean to.

Plate 11 (left): East elevation of Building A, from the south-east

Plate 12 (right): East elevation of Building A, from the north-west

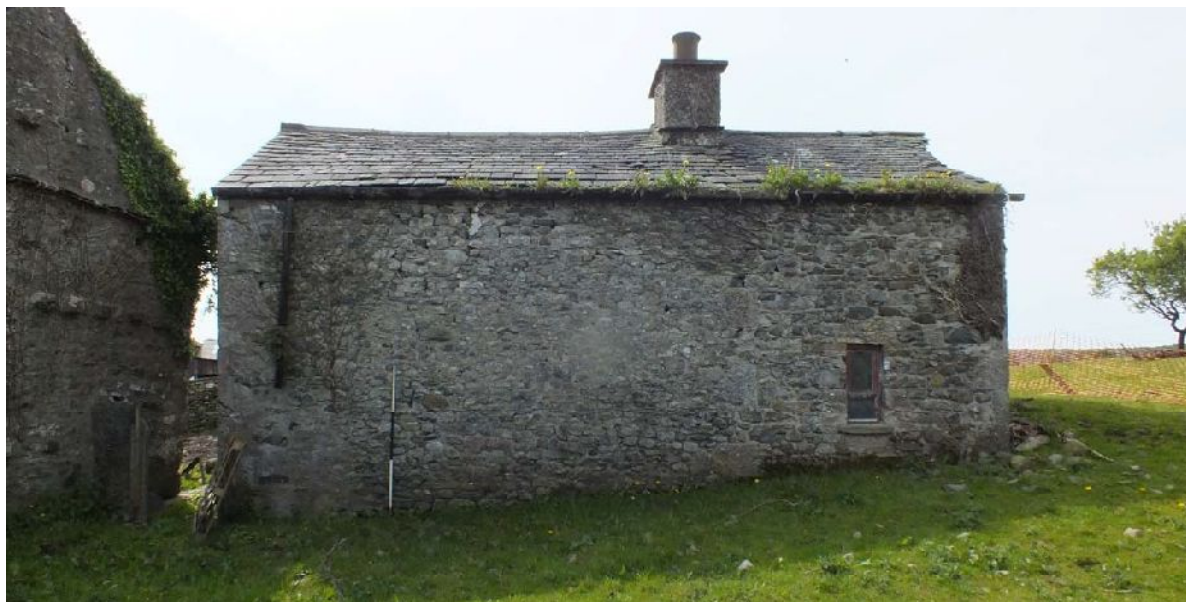
4.2.5 **Building B, north elevation:** this is a largely plain side wall. There are quoins at either end and there are also some quoins west of the centre showing that the west end is an extension (Plate 13). This contains a single small window, with a two-light casement, a rough stone sill and lintel.

Plate 13: North elevation of Building B, from the north

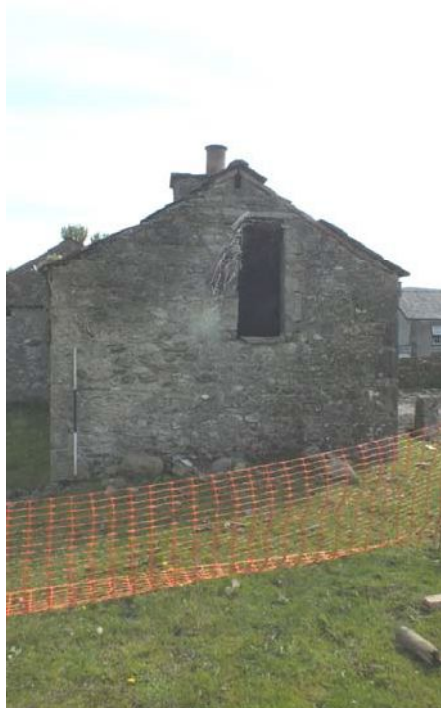
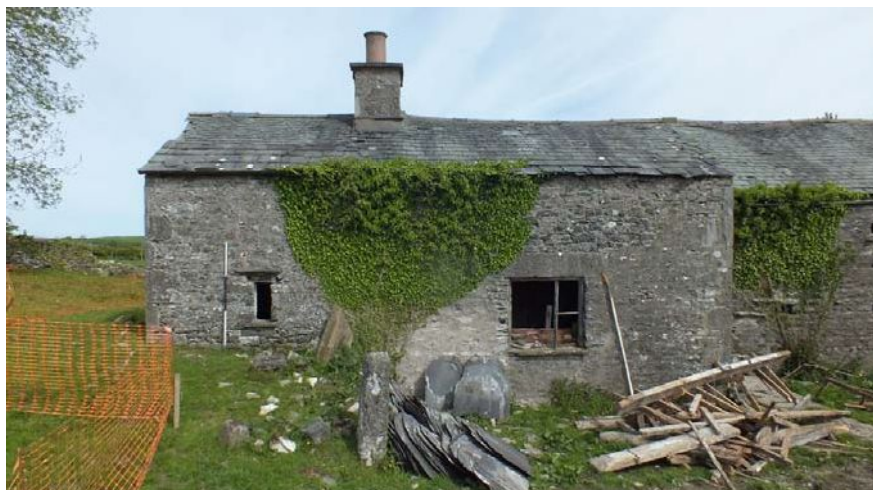
4.2.6 **Building B, west elevation:** this is a gable end. South of the centre on the upper floor is a narrow doorway or window, with small quoins and a thin stone sill and lintel (Plate 14). There are quoins to either end.

Plate 14 (left): West elevation of Building B, from the west

Plate 15 (right): South elevation of Building B, from the south

4.2.6 **Building B, south elevation:** this drops down to the east. There is a narrow window on the west side, with a thin stone sill and a slate drip course over the lintel (Plate 15). There is a larger window to the east with a heavy dressed limestone lintel and a projecting thin stone sill with the remains of a timber casement, possibly six-light. There are dressed quoins at either end.

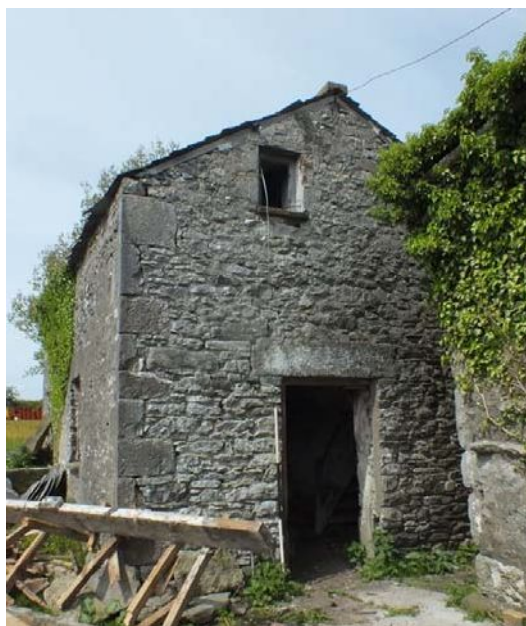
4.2.6 **Building B, east elevation:** this is a gable end, with a doorway on the ground floor, with a heavy dressed limestone lintel, and dressed quoins at either end (Plate 16). There is a small window on the upper level, with dressed (reused?) blocks in the south jamb and brick in the north jamb. The window has a projecting sill and a thin lintel.

Plate 16 (left): East elevation of Building B, from the east

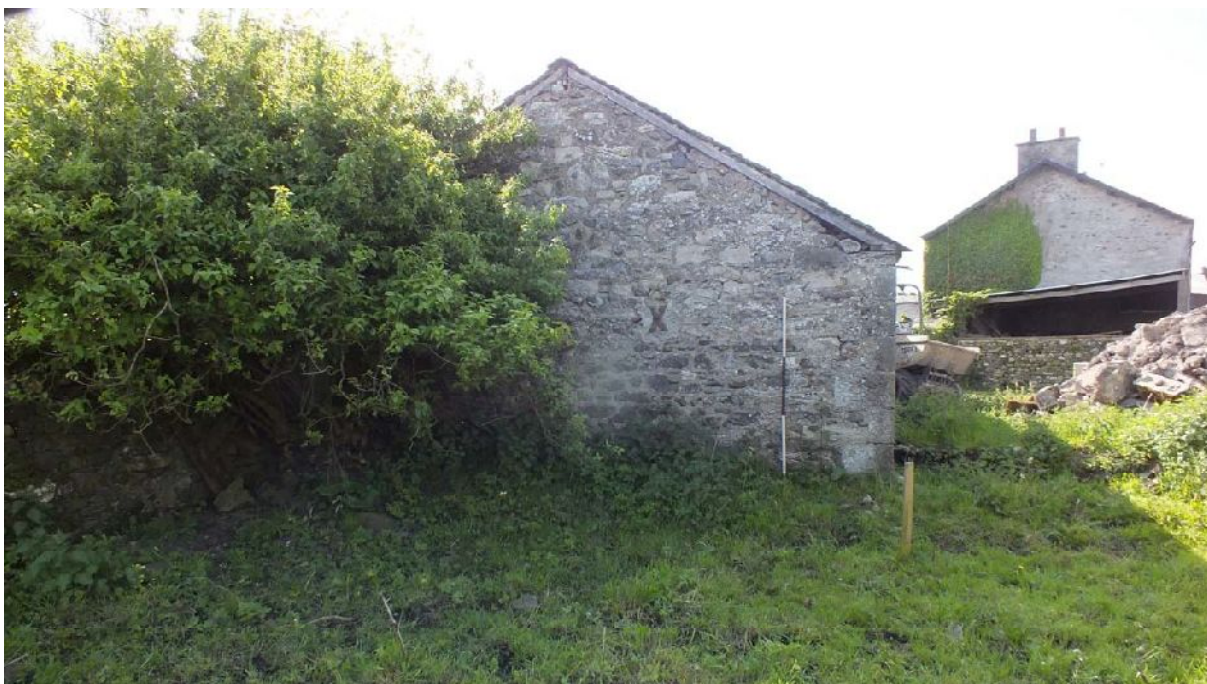
4.2.7 **Building C, north-west elevation:** this is a plain gable, with quoined ends, which are sat on a larger boulder on the south-west side, and there is an X-shaped tie rod off centre (Plate 17).

Plate 17: North-west external elevation of Building C, from the north-west

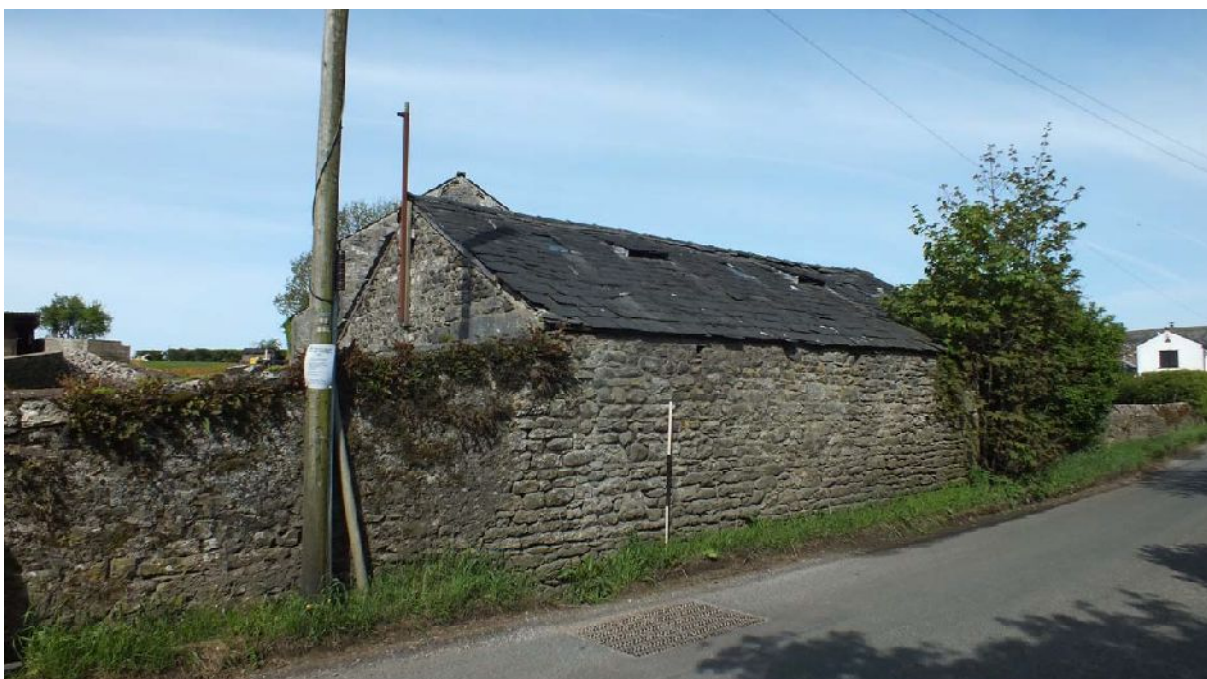
4.2.8 **Building C, north-east elevation:** this elevation faces onto the road, and is plain, and incorporated into the boundary wall at the south-east end at least; the north-west end is largely obscured by vegetation. There is a doorway at the north-west end with quoined jambs running into the corner, with a machine-cut timber lintel and a plank and batten door. There is a row of three small square vents below the eaves, the north-west one is blocked with stone (Plate 18).

Plate 18: North-east external elevation of Building C, taken from the east

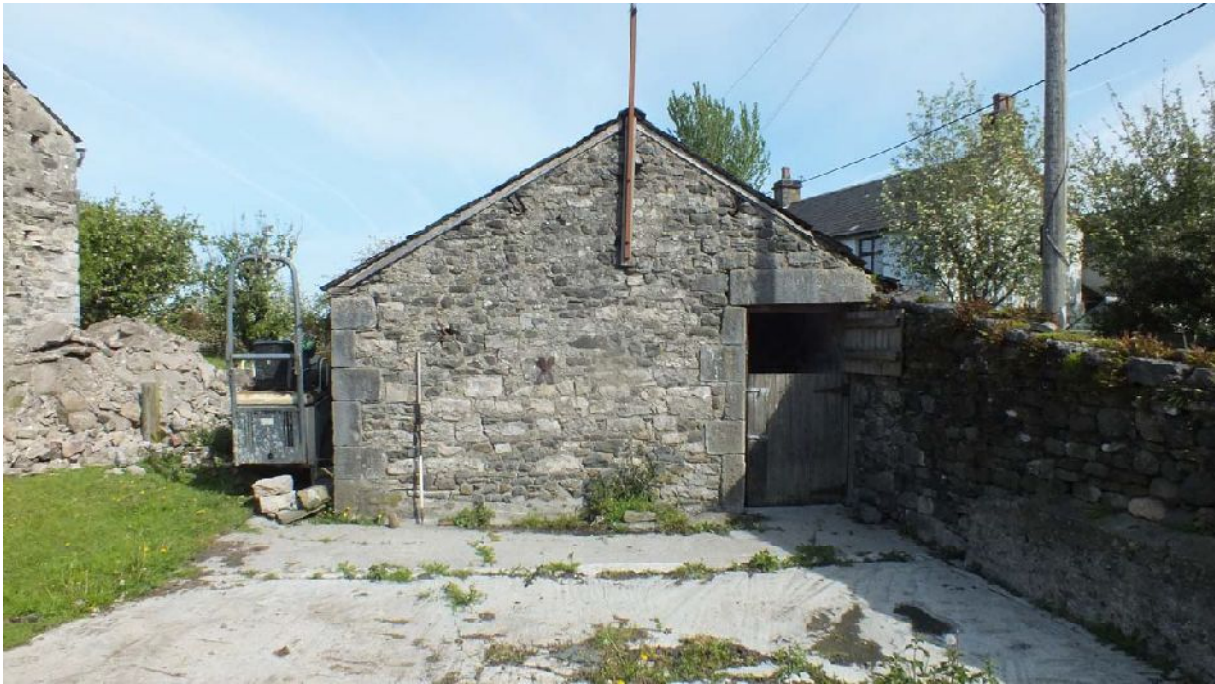
4.2.9 **Building C, south-east elevation:** this is a gable end. There is a doorway on the south-west side, with quoined jambs running into a quoined corner and quoins at the opposing end (Plate 19). The

doorway has a split plank and batten door, with the battens fixed to the centre with an iron pole attached and an X-shaped tie rod end off centre.

**Plate 19: South-east external elevation of Building C, from the south**

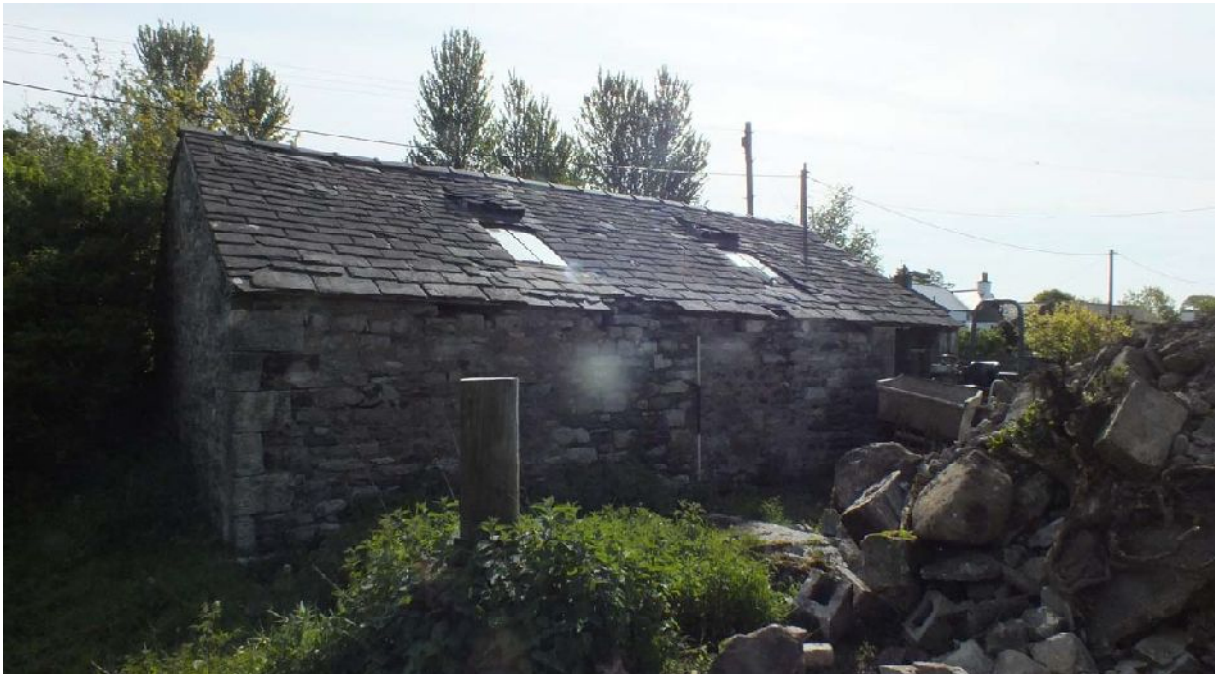
4.2.10 **Building C, south-west elevation:** this is a side elevation, and is fairly plain. There is a row of small square vents along the top, perhaps three of them, but there are various points of collapse hiding them. The elevation is quoined at the north-west end and there is a doorway at the south-east end with quoined jambs, a machine-cut timber lintel, and quoins running into the corner (Plate 20).

**Plate 20: South-west external elevation of Building C, from the west**

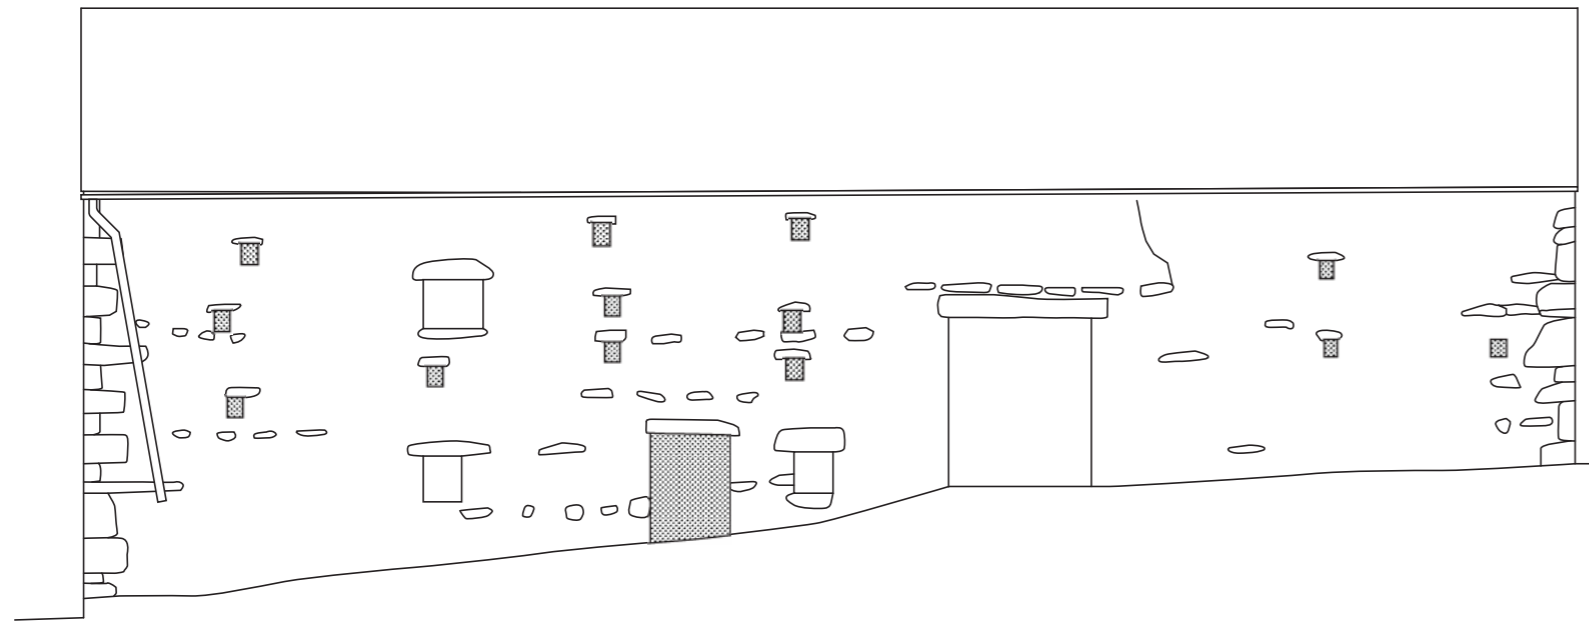
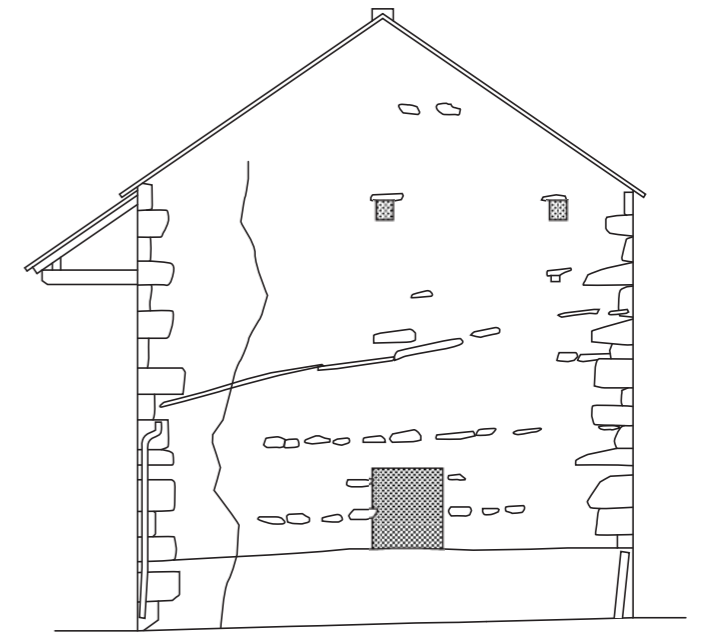
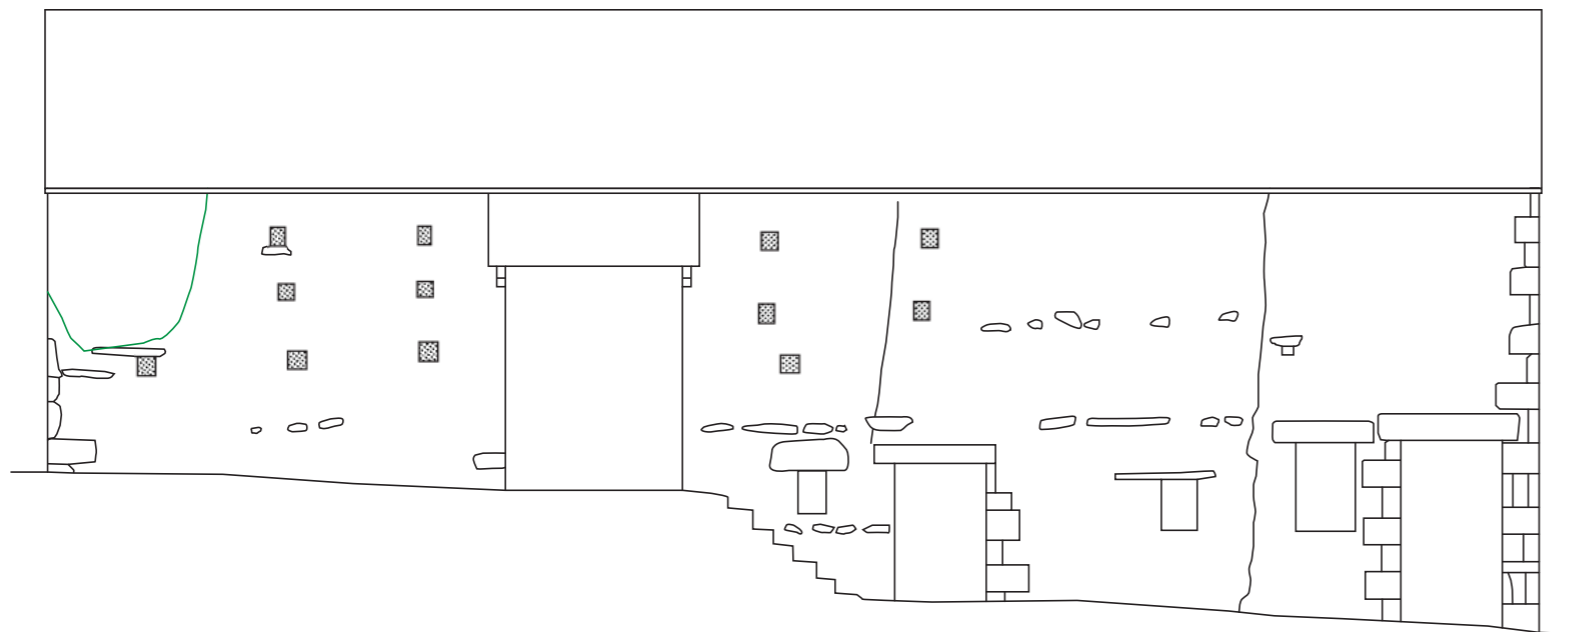
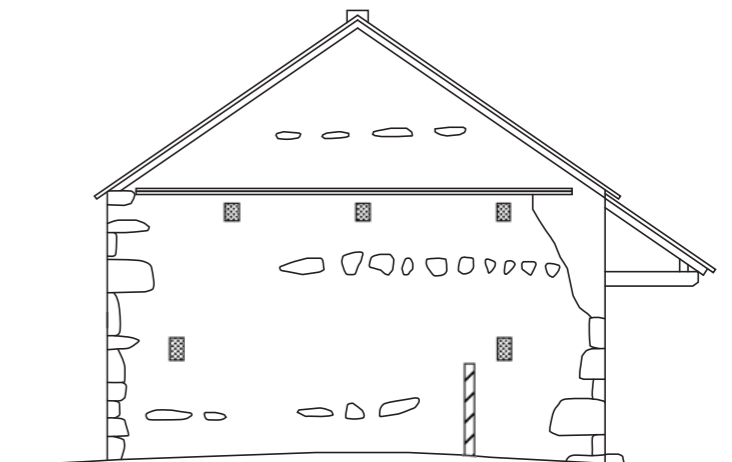
NORTH EXTERNAL ELEVATION (BUILDING A)

EAST EXTERNAL ELEVATION (BUILDING A)

SOUTH EXTERNAL ELEVATION (BUILDING A)

WEST EXTERNAL ELEVATION (BUILDING A)

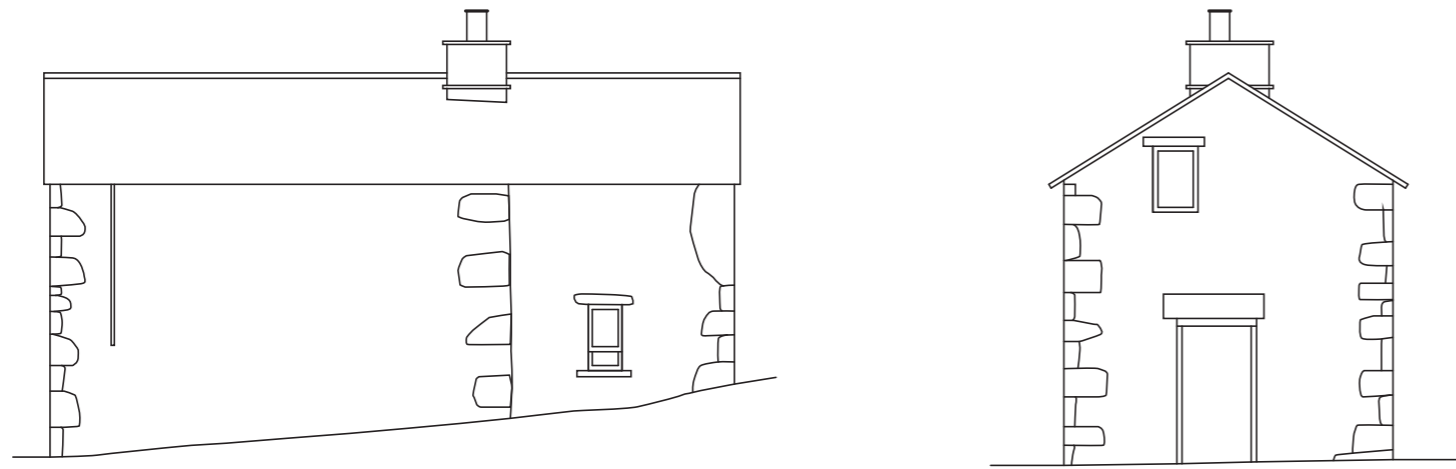
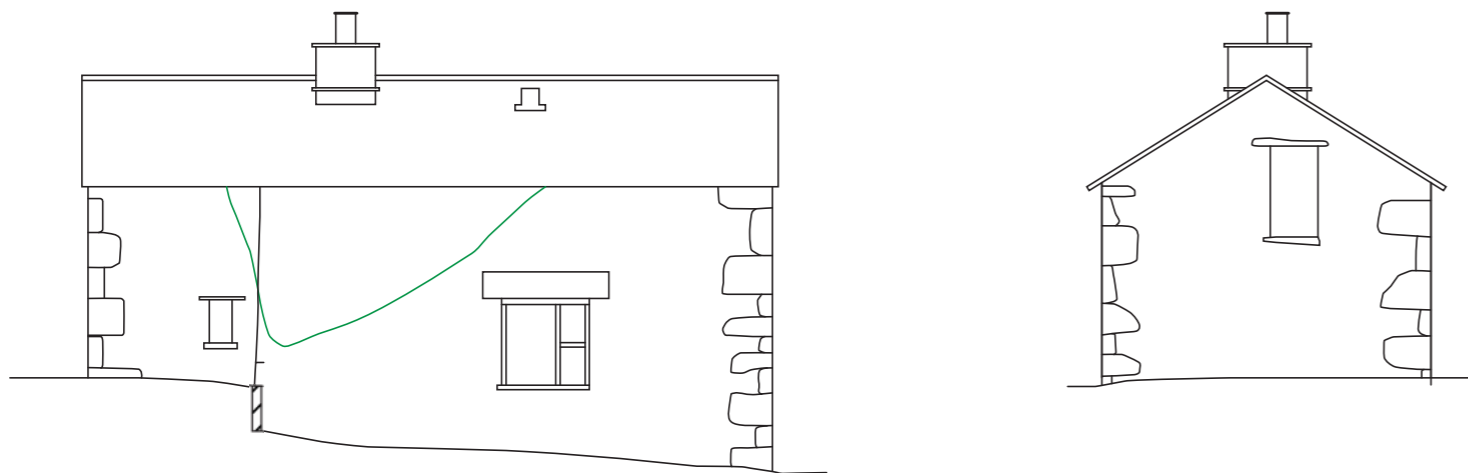
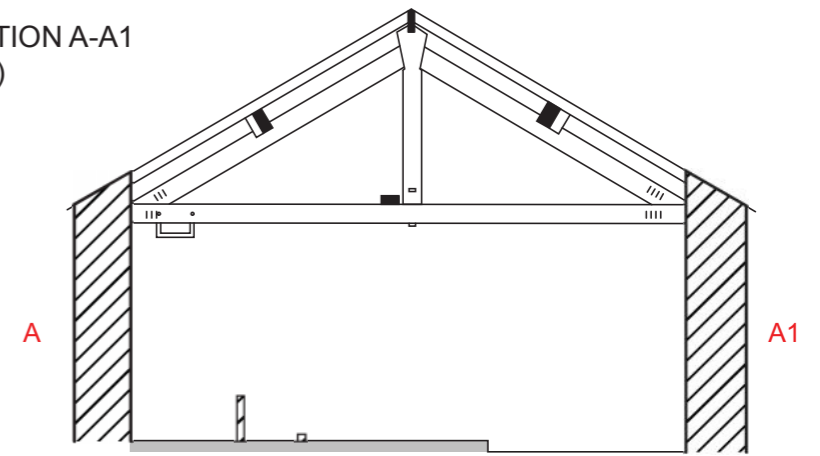
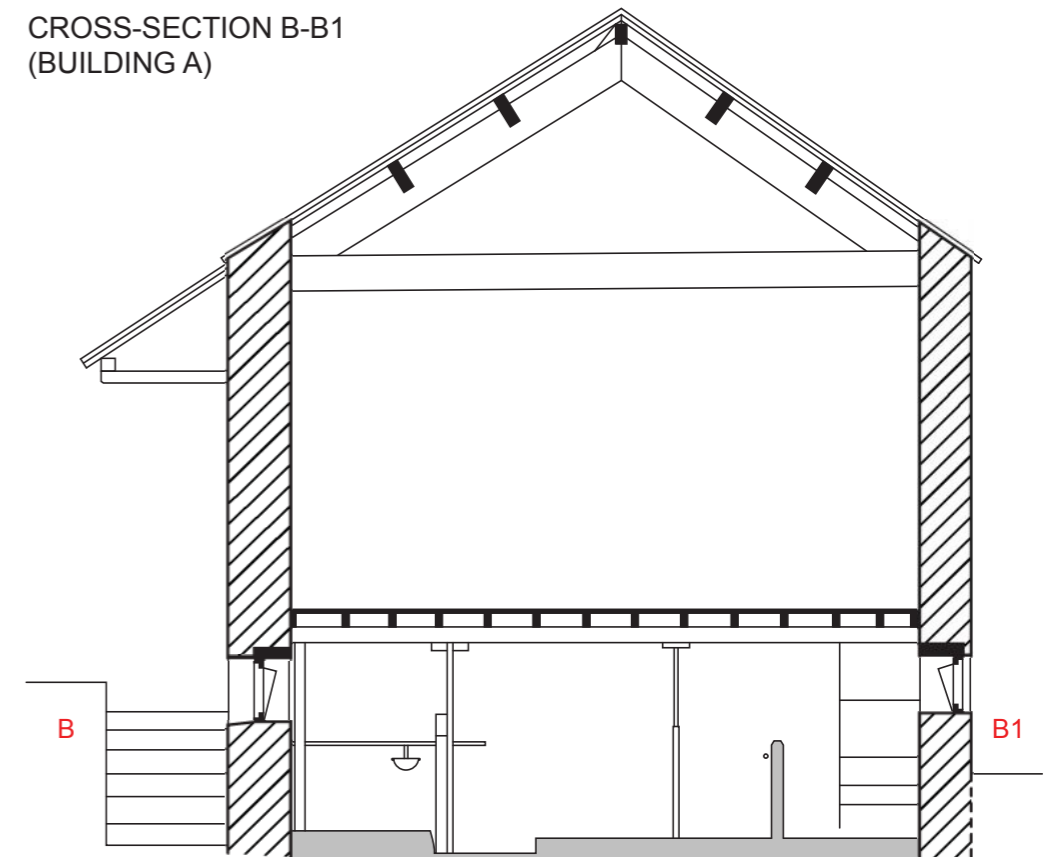
Figure 3: External elevations of Building B and cross-sections A-A1 and B-B1

NORTH EXTERNAL ELEVATION (BUILDING B) EAST EXTERNAL ELEVATION (BUILDING B)

SOUTH EXTERNAL ELEVATION (BUILDING B) WEST EXTERNAL ELEVATION (BUILDING B)

CROSS-SECTION A-A1 (BUILDING C)

CROSS-SECTION B-B1 (BUILDING A)

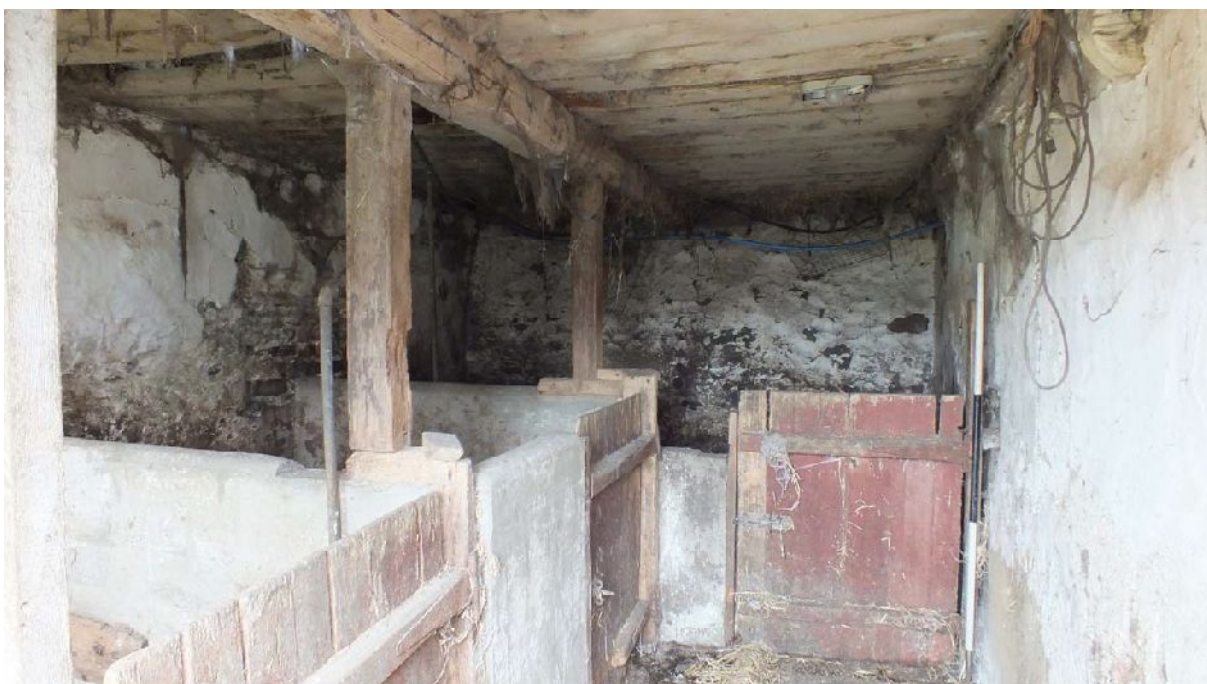
4.3.1 **Building A, lower floor, Room 1:** this has a concrete floor, divided along the west side by concrete stalls with timber plank and batten doors, with posts from the stalls supporting the ceiling which comprises a chamfered beam running north/south supporting the floor boards directly (Plate 21). There is a further beam against the east wall on timber corbels with small wedges between. The walls are finished with lime wash over stone, with some patching in concrete. The north and east elevations are plain. The south elevation has a doorway on the east side with a sawn timber lintel and a plank and batten door. There is a window to the west with a timber lintel and a stone sill, with a two-light timber casement with a slatted timber vent above (Plate 22). The west elevation has stalls set against it.

Plate 21: Stalls and ceiling in lower floor Room 1 of Building A, from the south

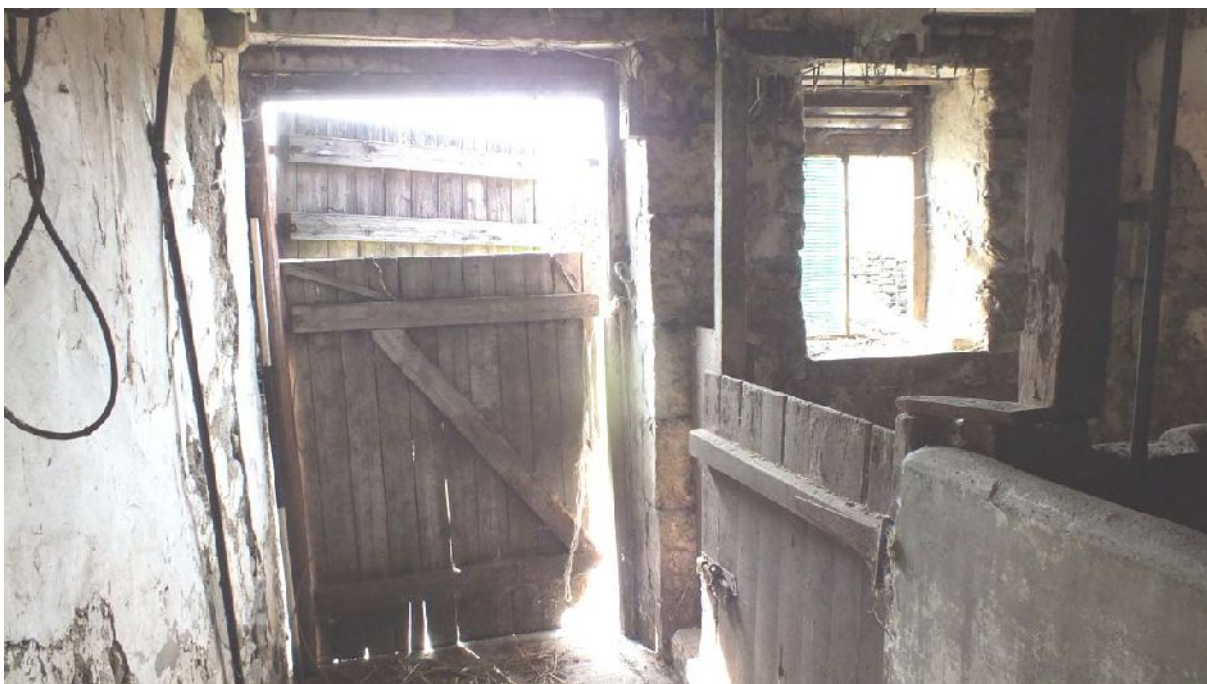
Plate 22: Door and window in lower floor Room 1 of Building A, from the north
