# BARNS AT CAUTLEY FARM, WHASSETT, MILNTHORPE, CUMBRIA

Archaeological Building Recording

Planning ref: SL/2015/0989

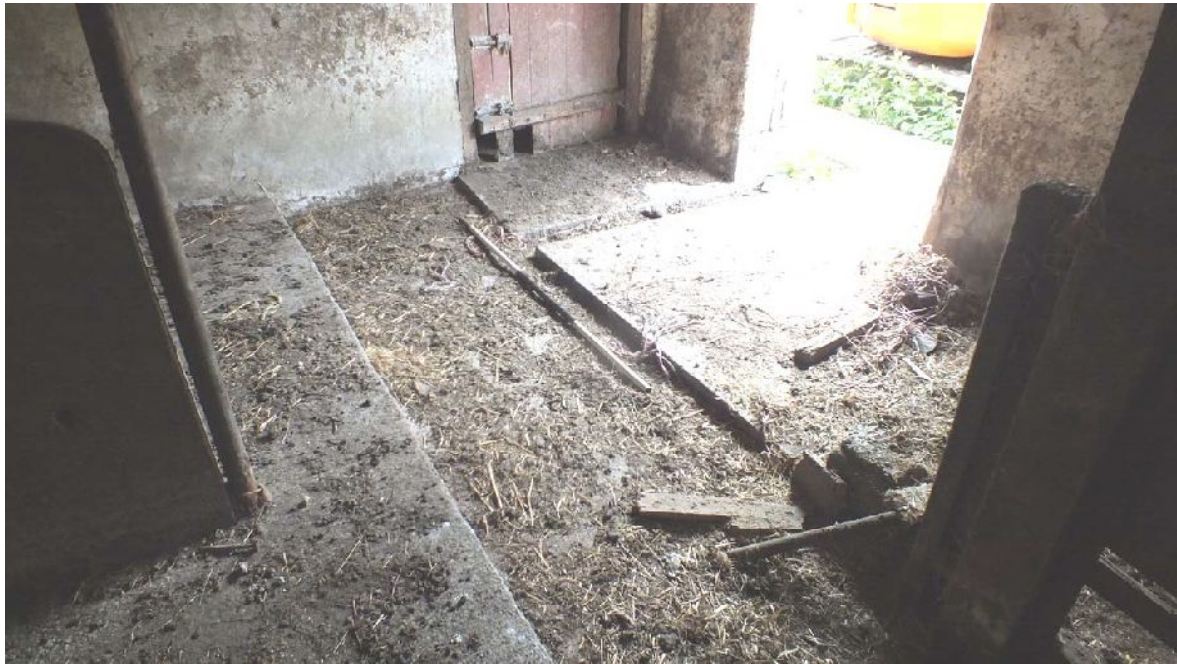
4.3.2 **Building A, lower floor, Room 2:** this room has a concrete floor with a dung channel running east/west connecting to a narrower drain to the door to the south (Plate 23). There are concrete stalls to the north, east, and west with a large bay to the east (Plate 24 to Plate 26), and a feed channel along the north side (Plate 29). The ceiling is supported by two main chamfered beams running north/south to which two extra beams have been added, all supported by timber, concrete, and iron elements of stalls. The walls are limewashed stone, some with a concrete skim. The north elevation has two small windows, with rough timber lintels (Plate 27). There is a grill over the east windows, and a single light to the west, with a fitting for a tilting timber casement. The east elevation is plain. The south elevation has two windows, one either side of a plain doorway (Plate 28), with rough timber lintels and grills and with the west window with a tilting opening. The west elevation is plain except for a doorway high on the north side, which is narrow, with a stone sill. It has no lintel, and extends into the room above (Plate 29). There are two or three stone steps down to the feed channel.

Plate 23: Dung channel in floor in lower floor Building A, lower floor Room 2, from the north-west

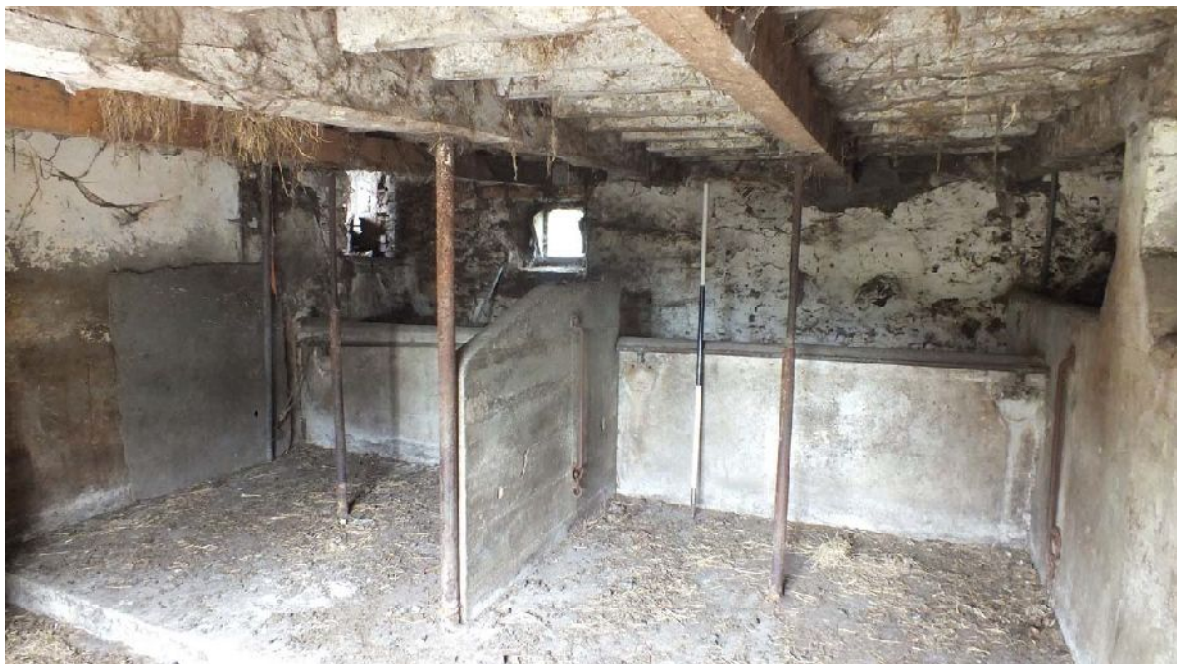
Plate 24: Stalls on the north side of Building A, lower floor Room 2, from the south-east

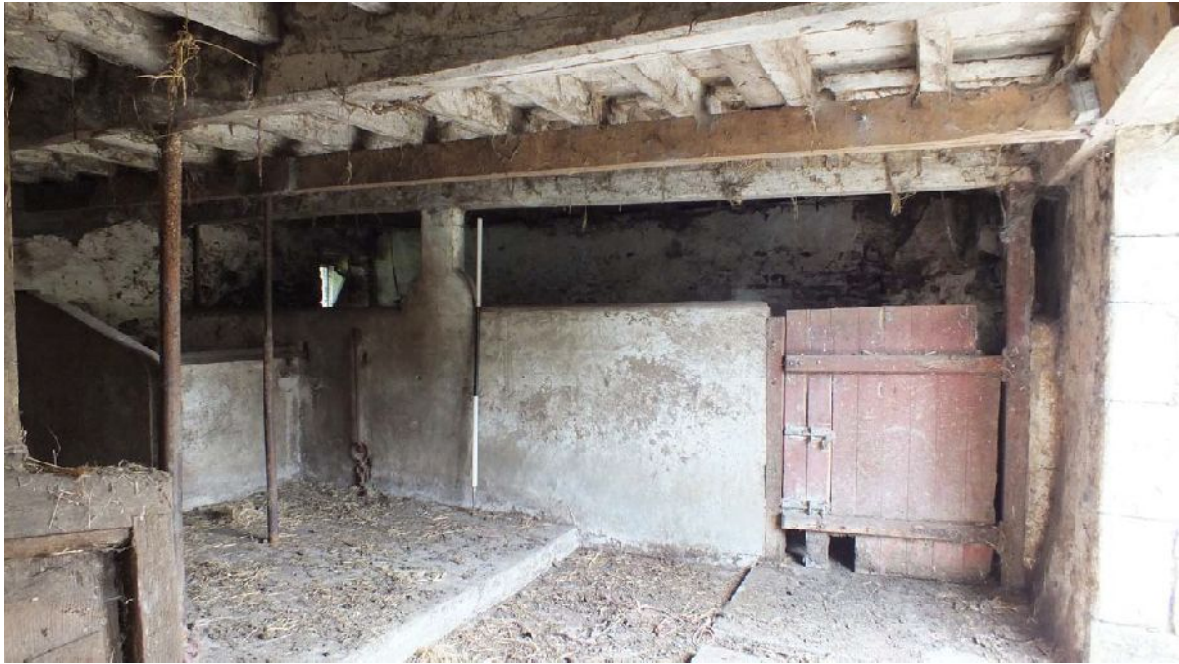
**Plate 25: Stall partition on the east side of Building A, lower floor Room 2, from the west**

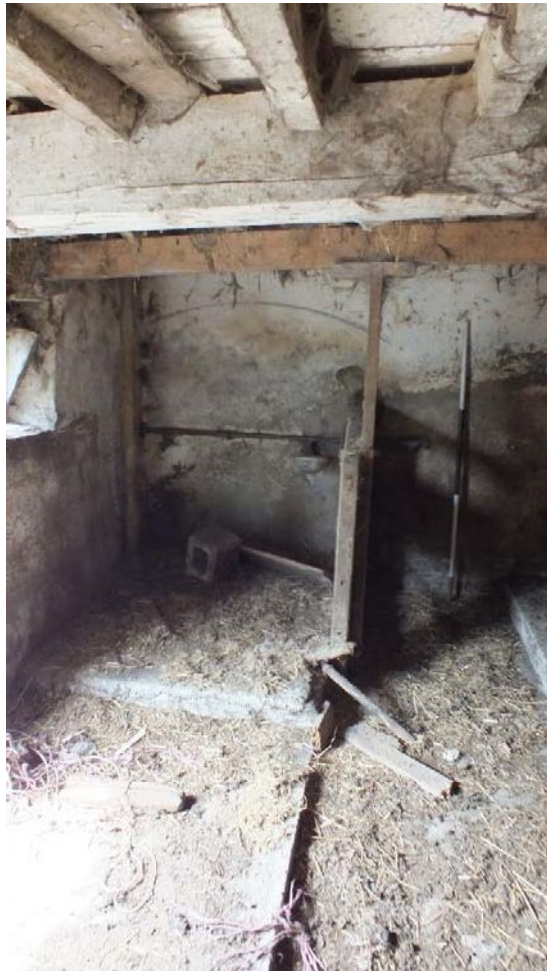
**Plate 26: Stall on west side of Building A, lower floor Room 2, from the east**

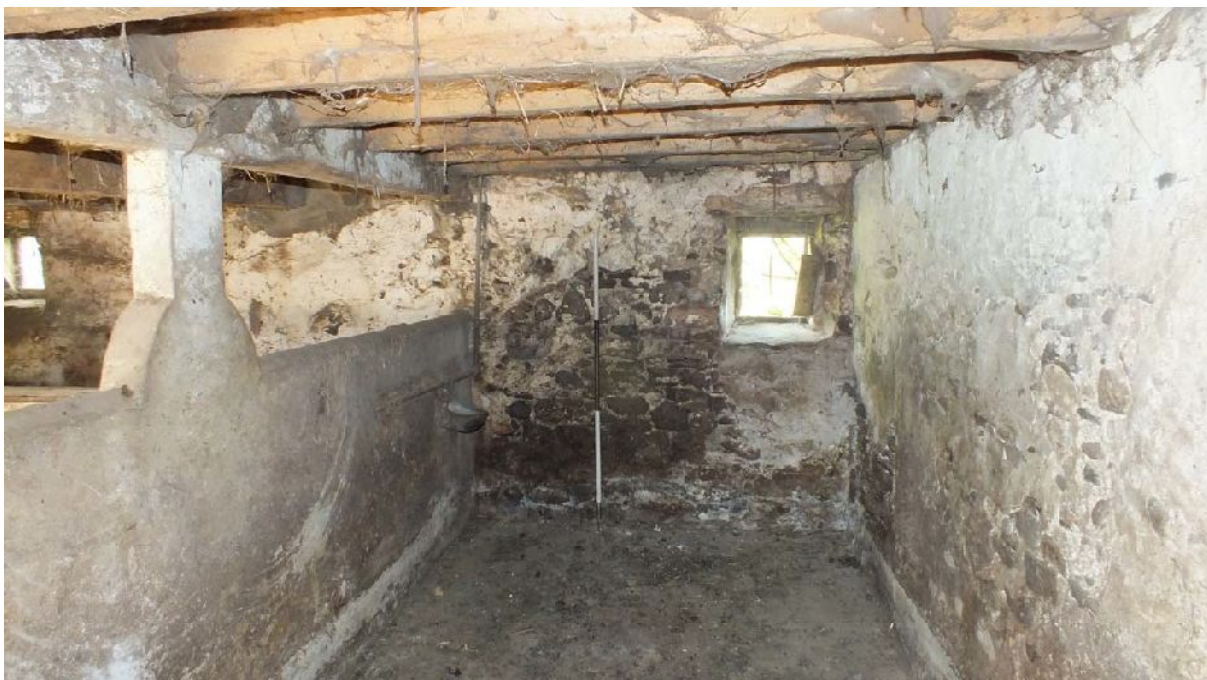
**Plate 27: Window on the east side of the north elevation in lower floor of Room 2 of Building A, from the south**

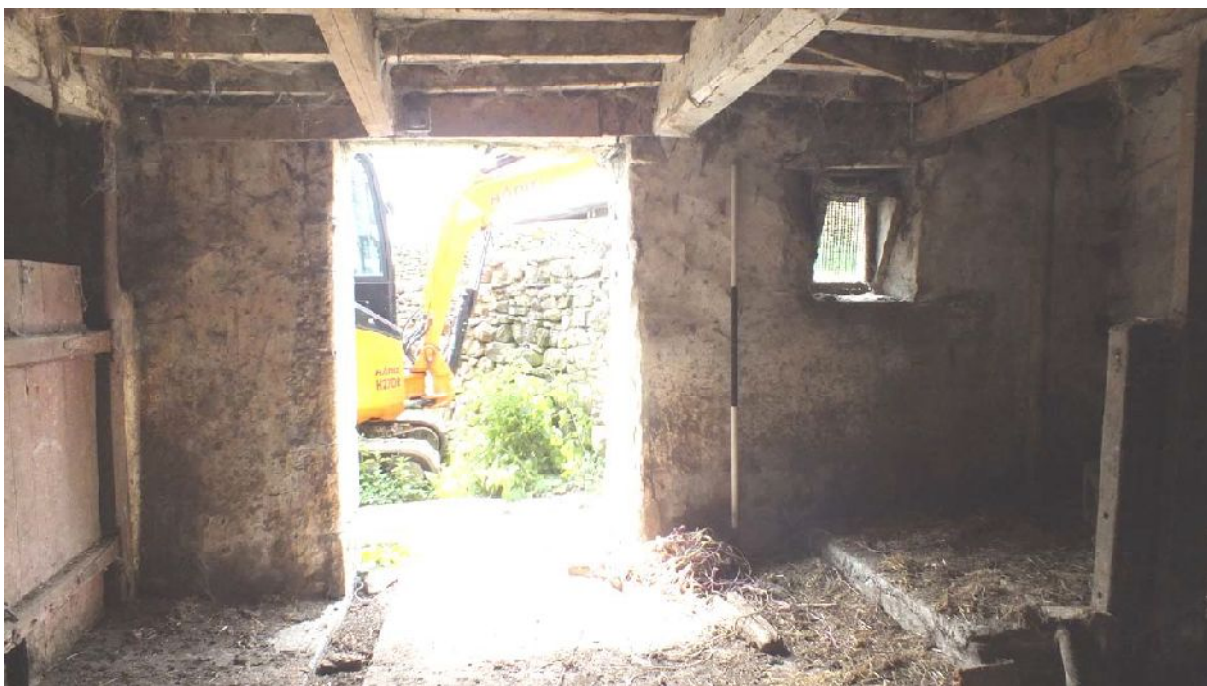
**Plate 28: South elevation doorway and window in lower floor Room 2 of Building A, from the north**

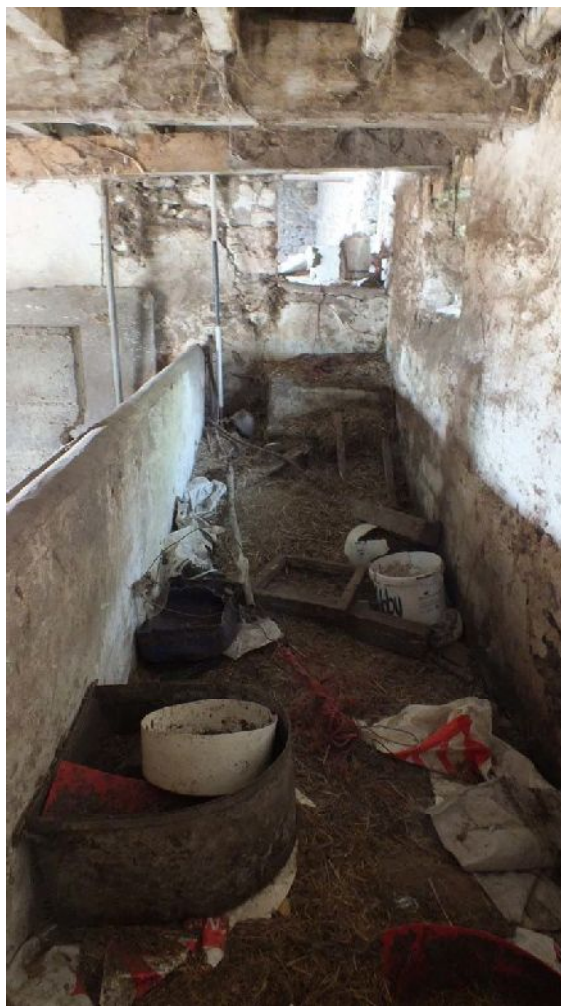
**Plate 29: West elevation door in lower floor Room 2 of Building A, from the east**

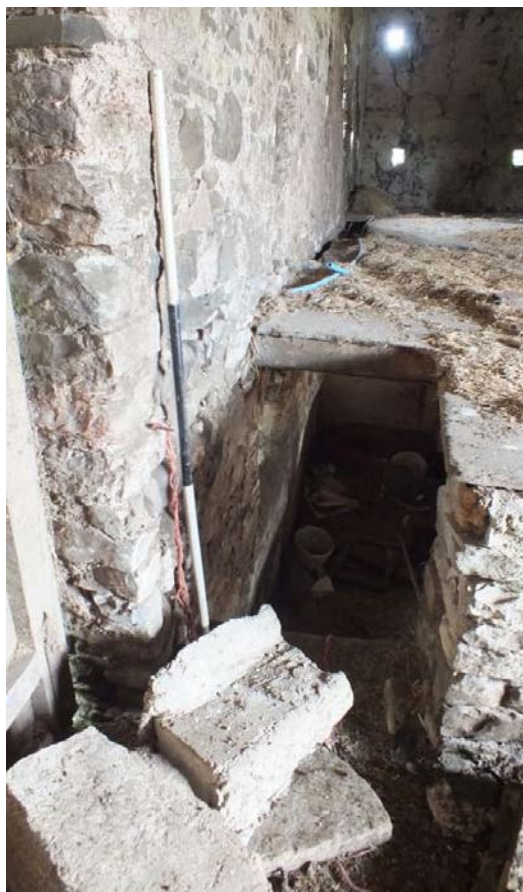
4.3.3 **Building A, upper floor, Room 1:** this room has an earth and manure floor on the west side, stepped up to the east over the lower floor. The floor on the east side is boards, with a section cut out in the north-west corner accessing steps to the feed channel below (Plate 30). The roof is supported by four tie beam trusses, all sawn and bolted between the tie beam and the principal. The principals meet at a simple flat joint (Plate 31). The walls are exposed stone with lime mortar. The north elevation has three rows of square vents with a wagon door west of the centre with a rough timber lintel, and a plank and batten door (Plate 32). In front of the wagon doorway there are the remains of a concrete block wall incorporating an iron post, which turns and is set into concrete within a former alcove, which has a timber lintel. To the east is a single pitching door or window, with a timber lintel, the still collapsed (Plate 33). The east elevation is a gable end, with two rows of two square vents, probably originally three but some lost to later rebuilding (Plate 34). The south elevation is mostly plain but is stepped at the east end then stepped back again, although not as far, and coming to a jagged end where it has been rebuilt (Plate 35). Beyond this, to the west, there are two further rows of two vents, then a wagon door with a curved timber lintel. There is a small alcove in the wall to the west of this, with a stone lintel and a thin timber sill. The west elevation is a gable, with a row of through stones but otherwise fairly plain (Plate 36).

**Plate 30: Access to steps in upper floor of Building A, from the west**

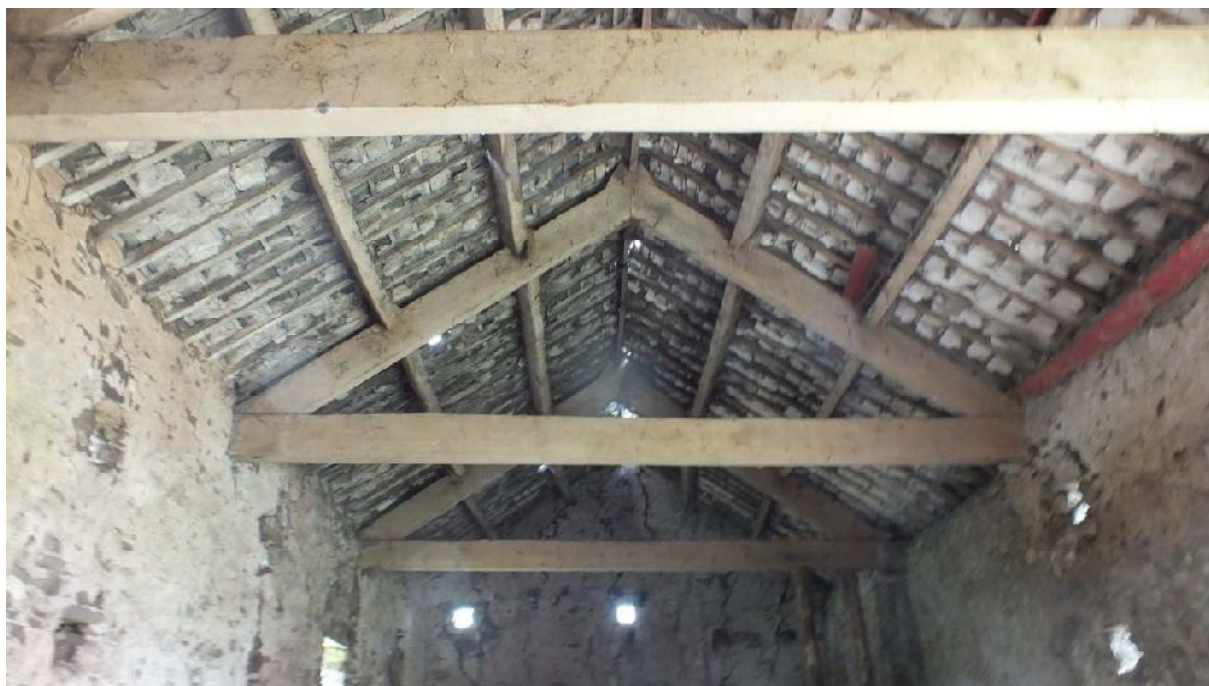
**Plate 31: Trusses in upper floor of Building A, from the west**

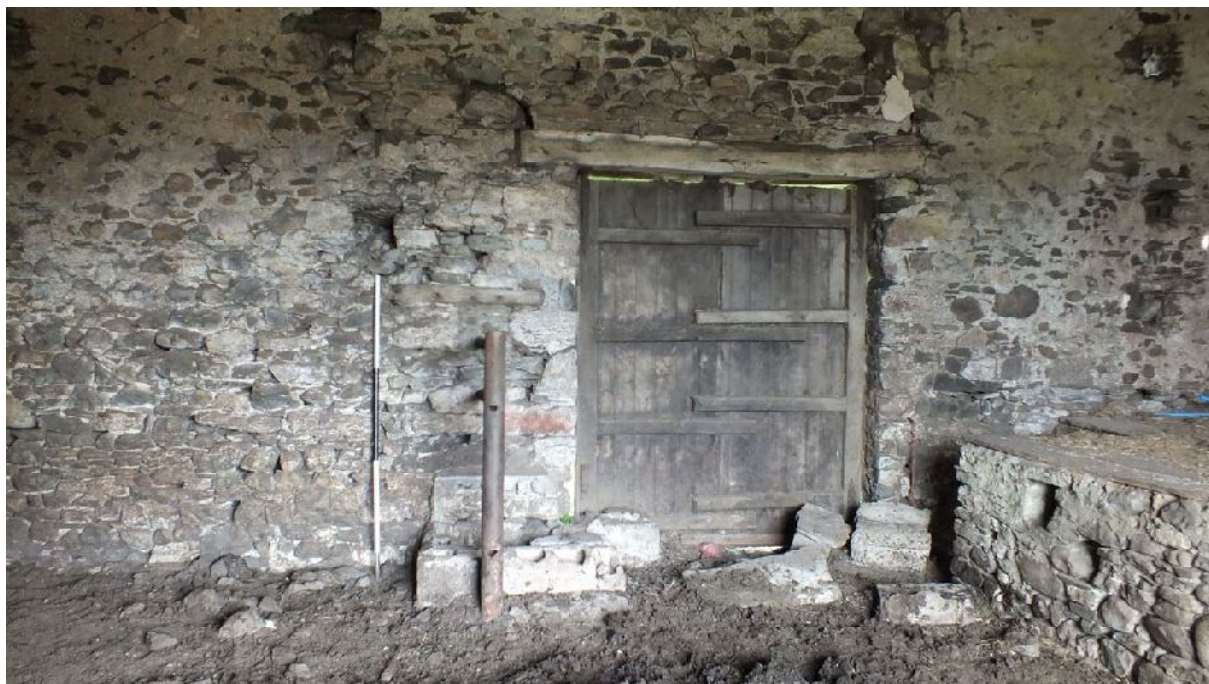
**Plate 32: North elevation door in upper floor of Building A, from the south**

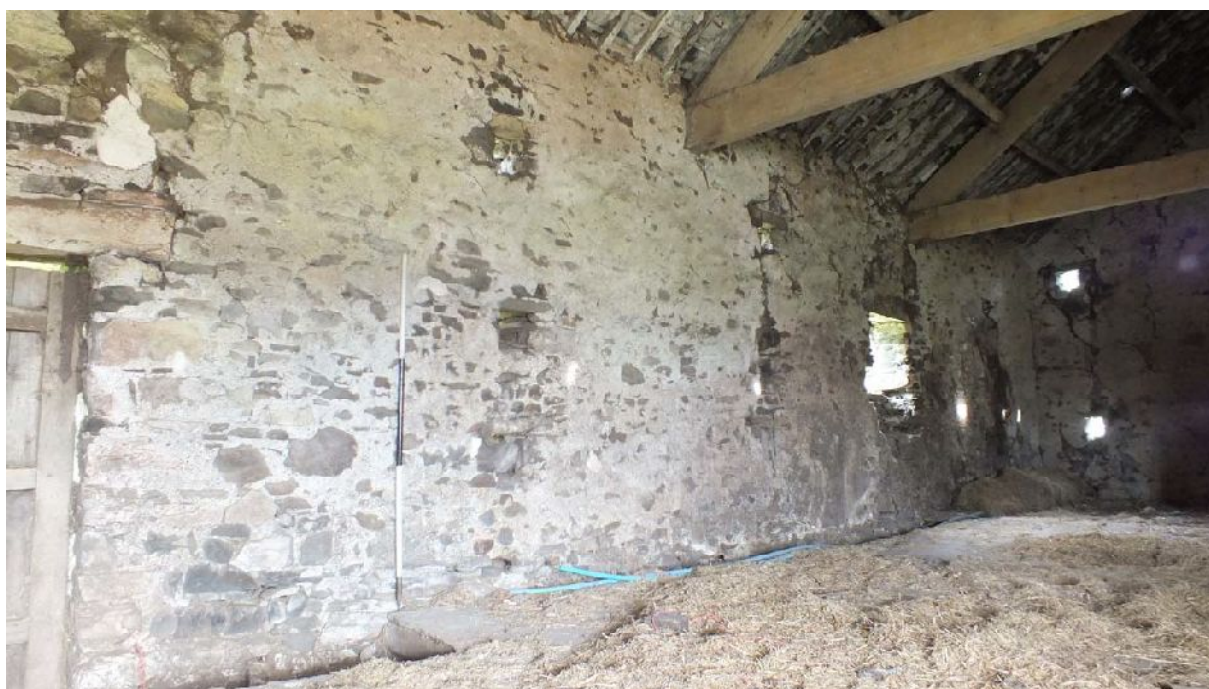
**Plate 33: East side of the north elevation of upper floor of Building A, from the south-west**

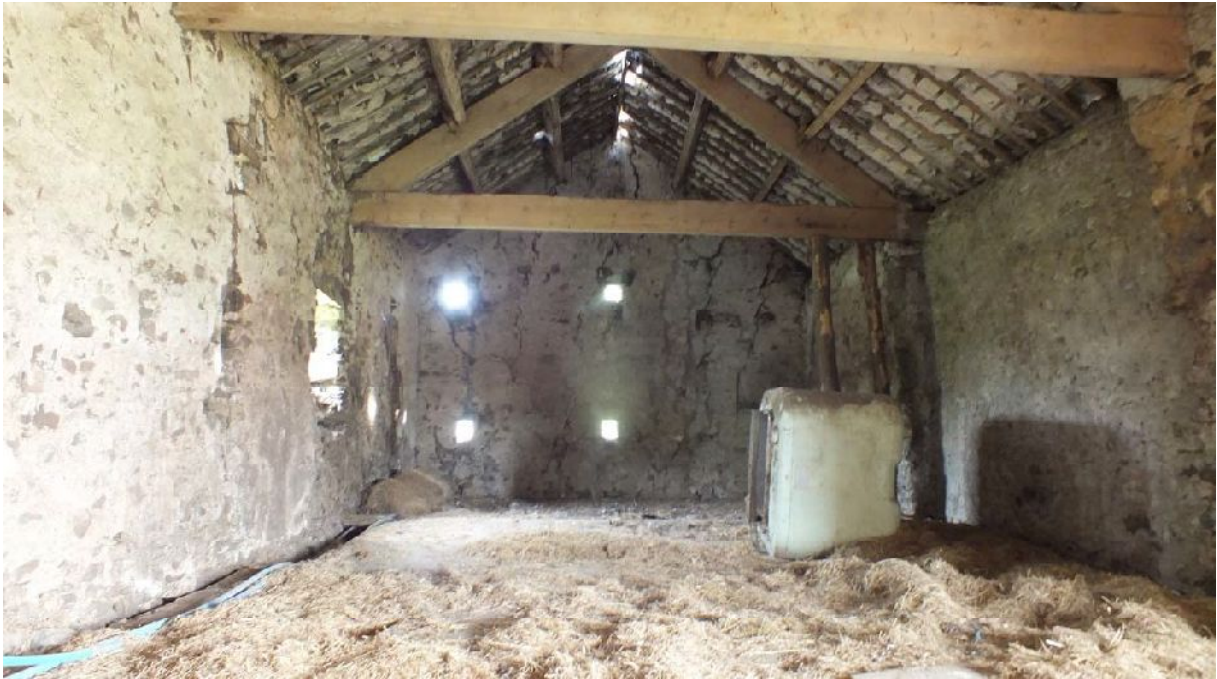
**Plate 34: East elevation of upper floor of Building A, from the west**

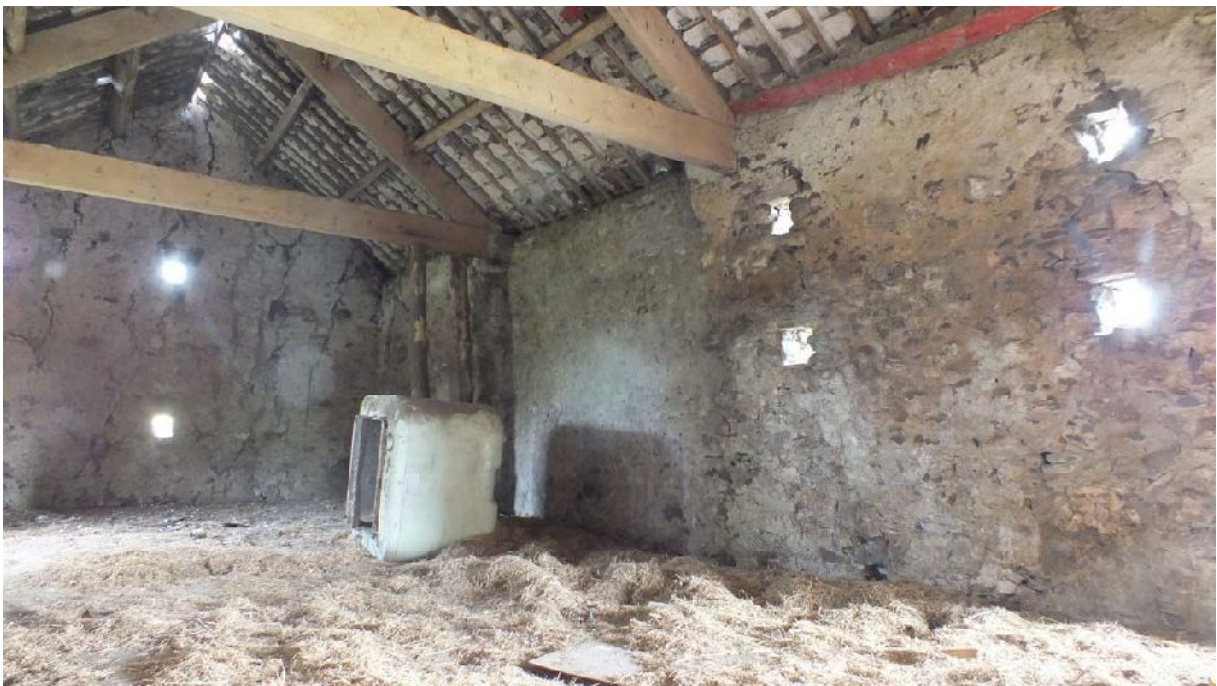
**Plate 35: South elevation of upper floor of Building A, from the north-west**

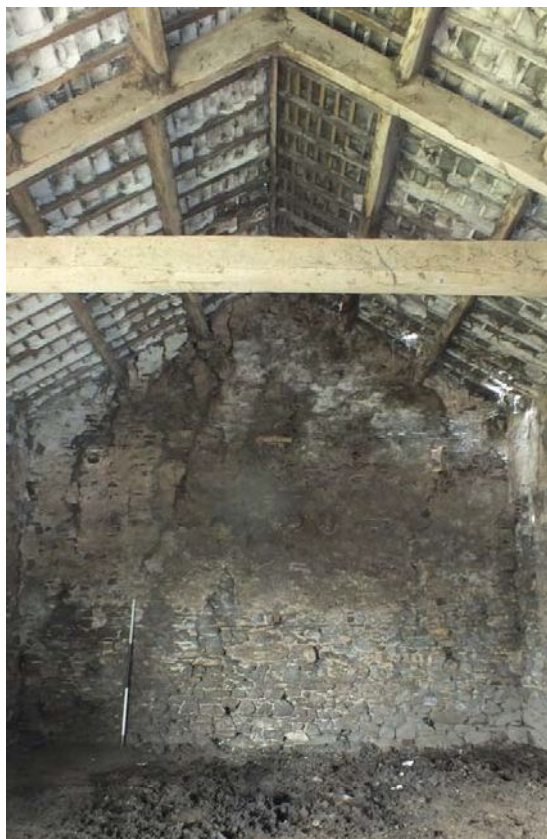
**Plate 36: West elevation of upper floor of Building A, from the east**

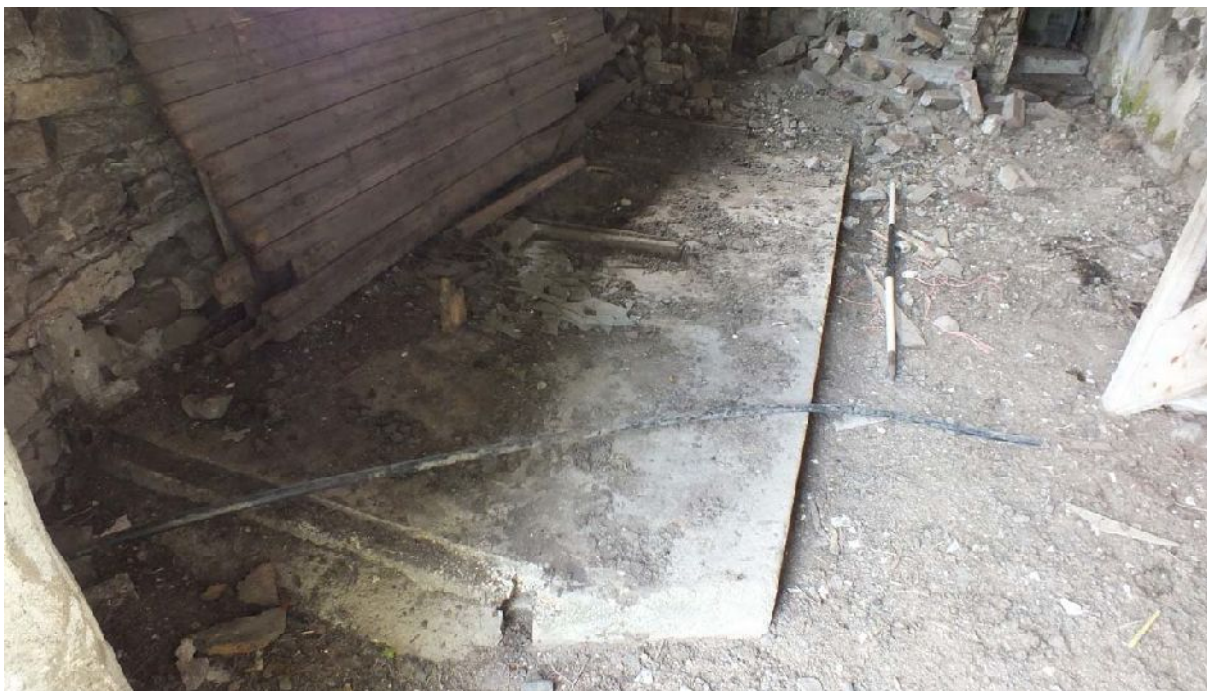
4.3.4 **Building B, ground floor, Room 1:** this has a concrete floor stepped up on the south side with bases for a post and stalls (Plate 37) and an iron tether in the west elevation. The ceiling has sawn timber joists running north/south, supporting wide floor boards (Plate 38). There is a stair case in the north-east corner, with a machine cut, very plain thin hand rail, a beaded edge board, and a chamfered newel and skirting (Plate 39). There are thin square cross-sectioned spindles on the upper part and spray painted graffiti “K ♡ R 2K13” is present underneath the south side (Plate 40). The walls are finished with plaster and limewash and distemper, which has come away in various places. The north elevation is plain, with a scooped section on the west side and stairs attached on the east. The east elevation has stairs attached running over the doorway (Plate 41), which has a plain timber surround, with graffiti “KT” spray painted and scratched and in pencil “K. He B[??]ness”. The south elevation has a large central window with the remains of a timber casement, with splayed jambs, partially bricked up internally with red machine-made brick laid on the sill (Plate 42). The plaster the west has the imprint of an attached bracket or shelf. The west elevation has a central projecting chimney breast, with the fireplace largely collapsed but some evident brick infill (Plate 43). The bricks are marked ‘CLAUGHTON’ and one ‘GINDRILS’(?) and ‘ACCRINGTON NORI’ and ‘CLAUGHTON MANOR BRICK CO’. There is a doorway to the north, with a beaded timber surround, but no door. To the south of the chimneybreast is a projecting section of brickwork and concrete blocks to which has an iron tether post is attached (Plate 44).

**Plate 37: Floor of lower floor Room 1 of Building B, from the east**

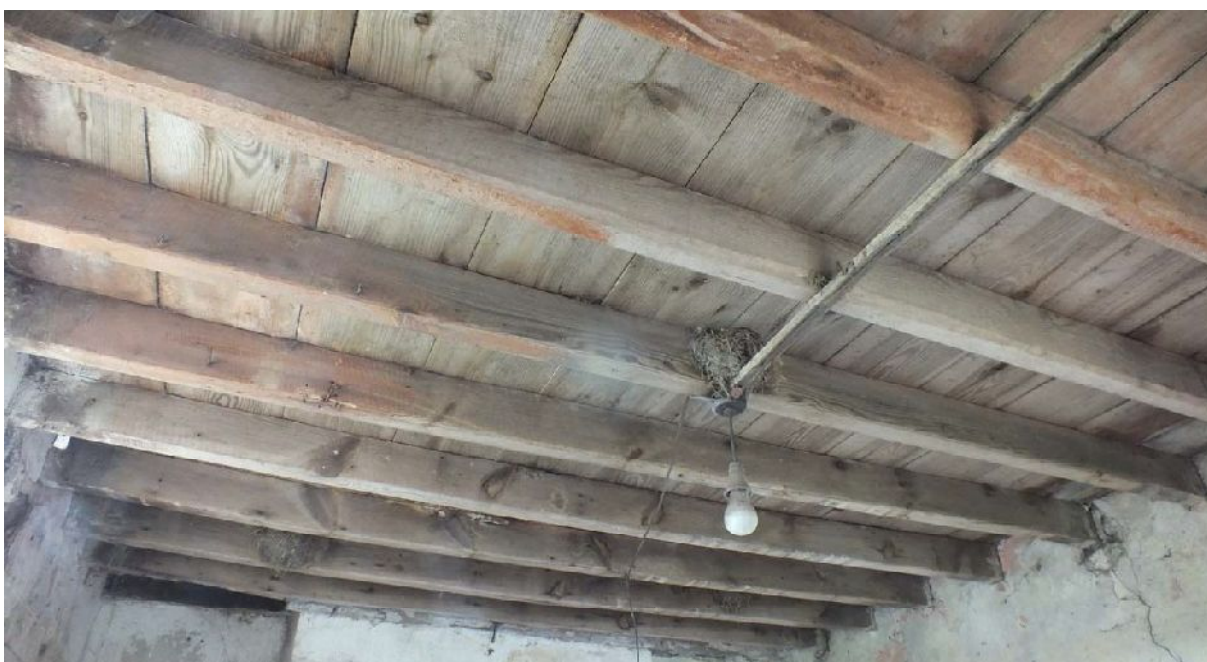
**Plate 38: Ceiling in lower floor Room 1 of Building B, from the east**

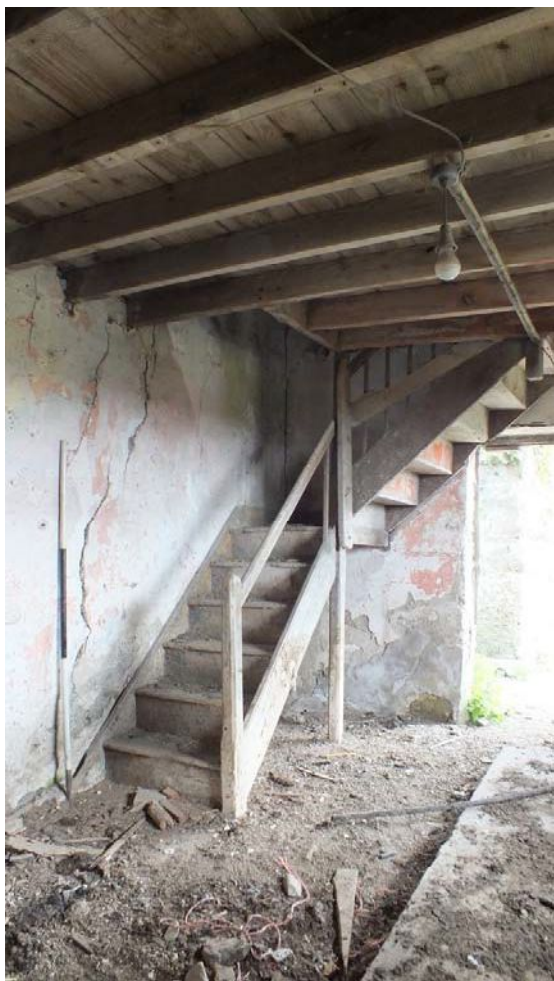
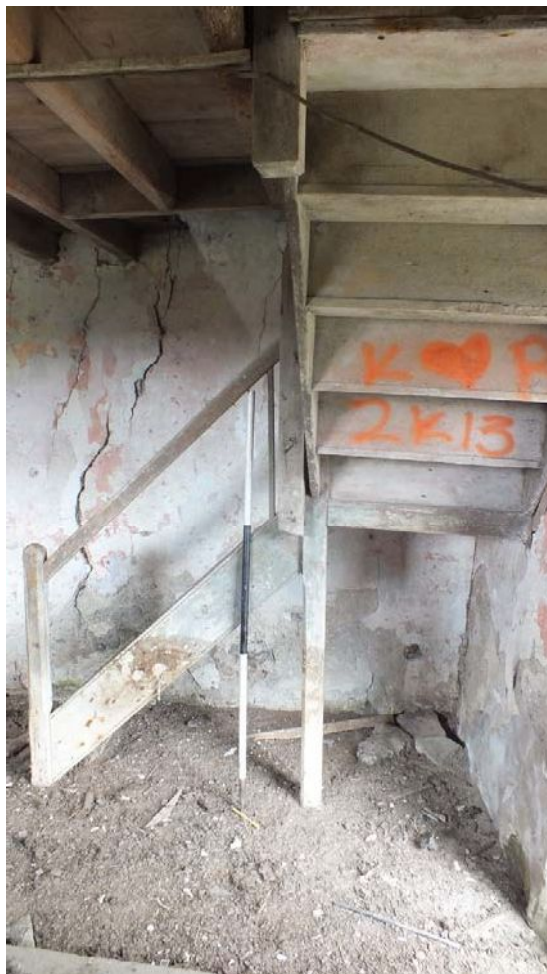
**Plate 39 (left): Stairs in lower floor Room 1 of Building B, from the south-west**

**Plate 40 (right): Stairs in lower floor Room 1 of Building B, from the south**

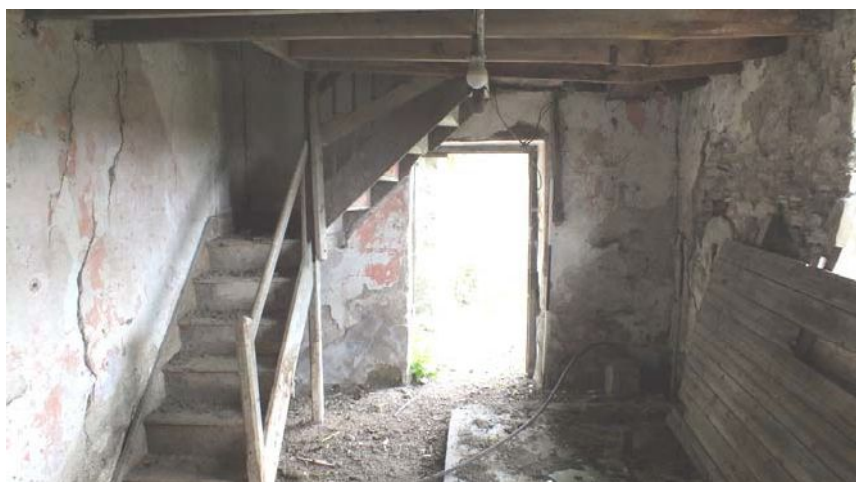
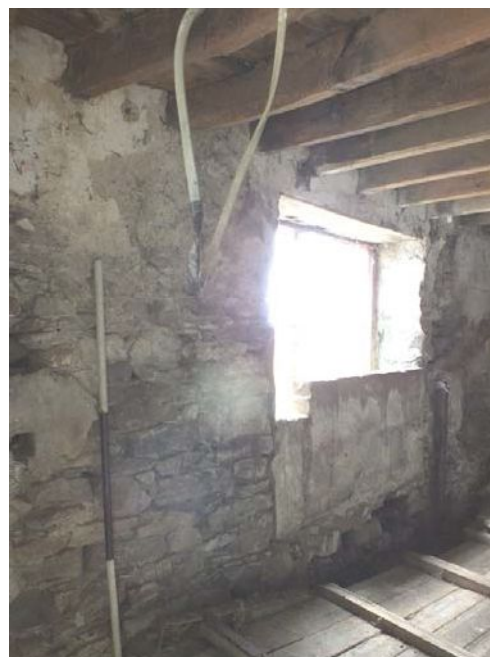
**Plate 41 (left): East end of lower floor Room 1 of Building B, from the west**

**Plate 42 (right): Window in the south elevation of lower floor Room 1 of Building B, from the north-east**

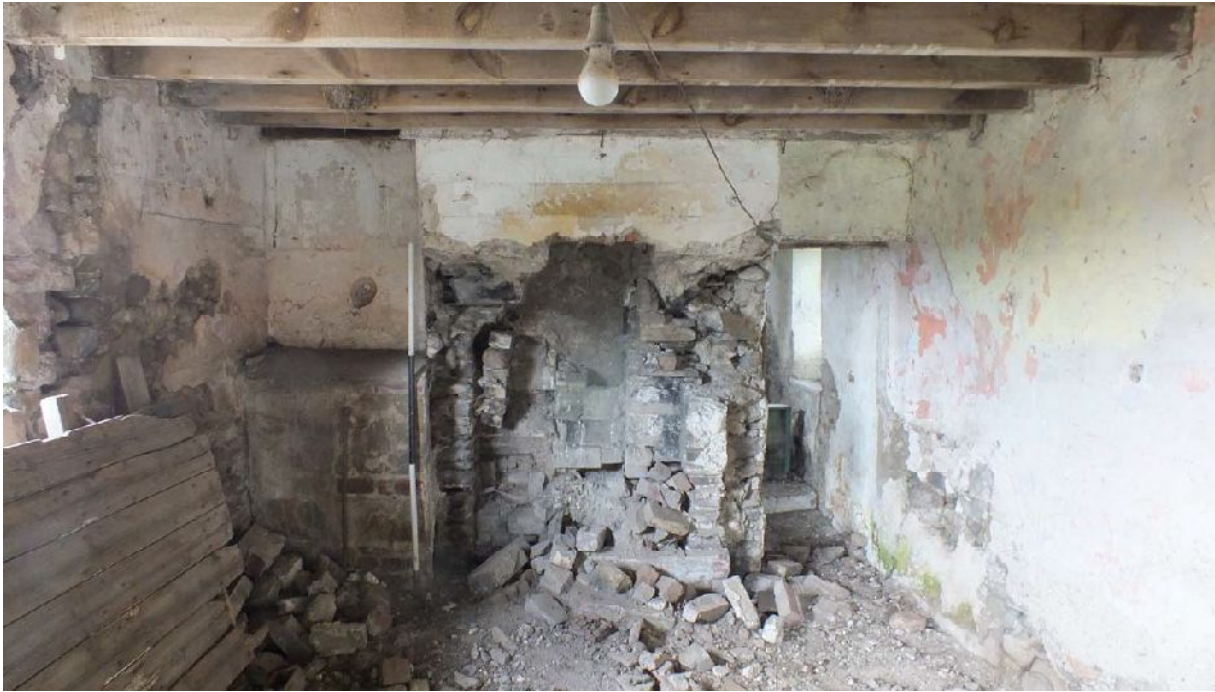
**Plate 43: West elevation of lower floor Room 1 of Building B, from the east**

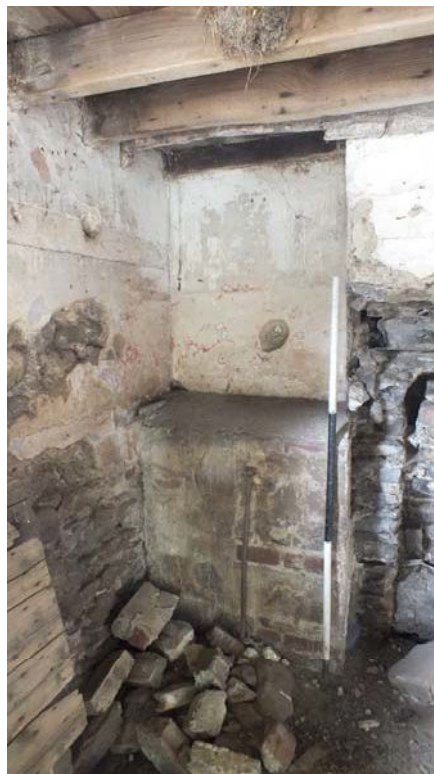
**Plate 44: Added bricks on south side of west elevation of lower floor Room 1 of Building B, from the north-east**

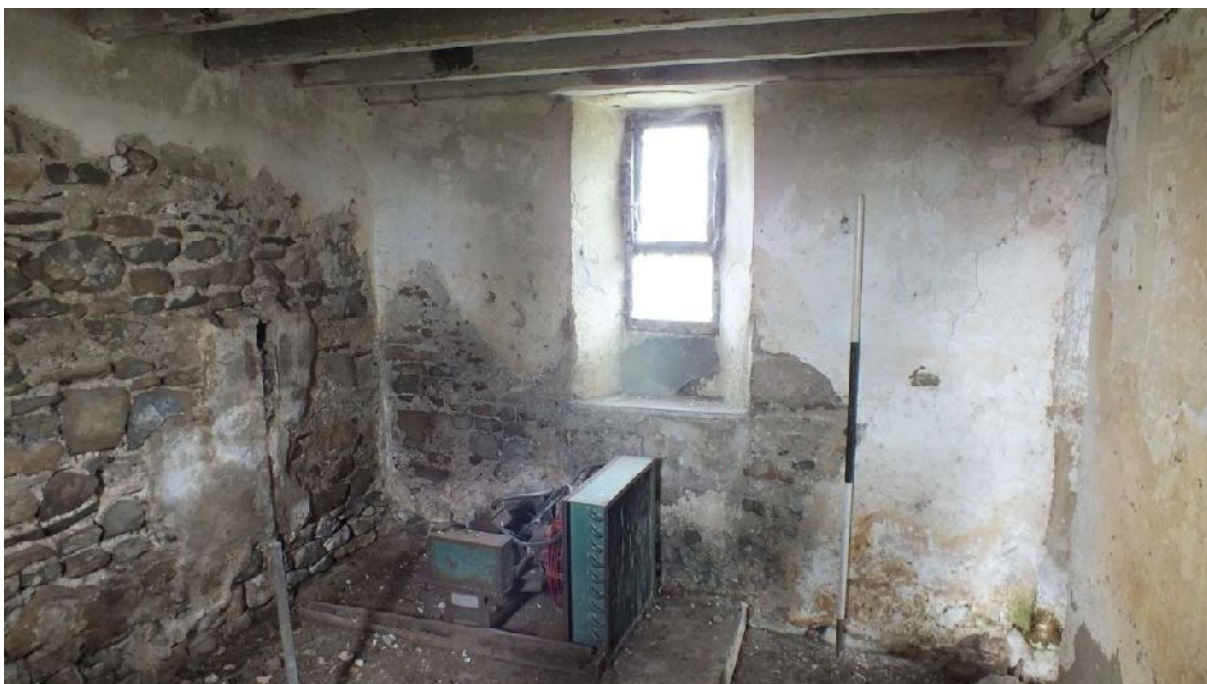
4.3.5 **Building B, ground floor, Room 2:** this has a concrete floor, stepped up on the west side, with timber bases for stalls, and upright posts, and an engine with a fan sat on the north end (Plate 45). The ceiling is sawn timber finished with limewashed comprising mainly joists running east/west, with a beam along the east wall with iron meat hooks (Plate 46). The walls are finished with plaster and limewash or distemper, except this was mostly gone from the west. The north elevation has a window on the west side, with splayed jambs, a lower stone sill, and a plain two-light hinged casement (Plate 45). The east elevation has a doorway on the north side, and a plain surround and sawn timber lintel (Plate 46). The

**Plate 45: North elevation of lower floor Room 2 of Building B, from the south**

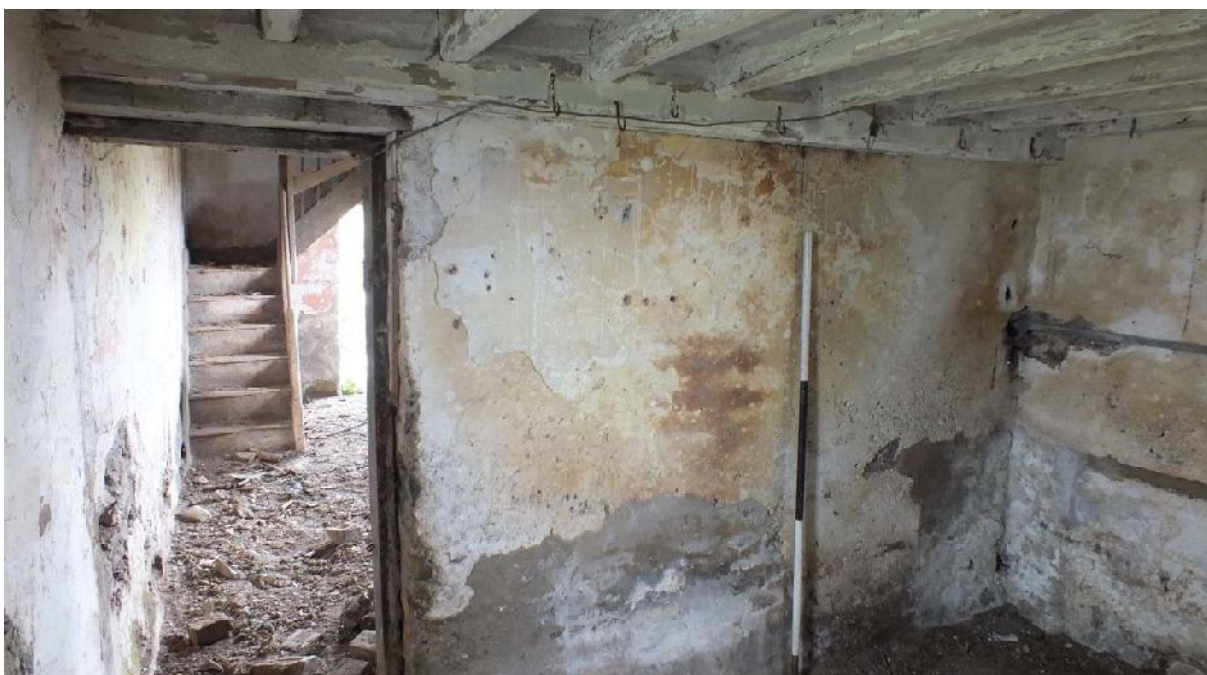
**Plate 46: East elevation of lower floor Room 2 of Building B, from the west**

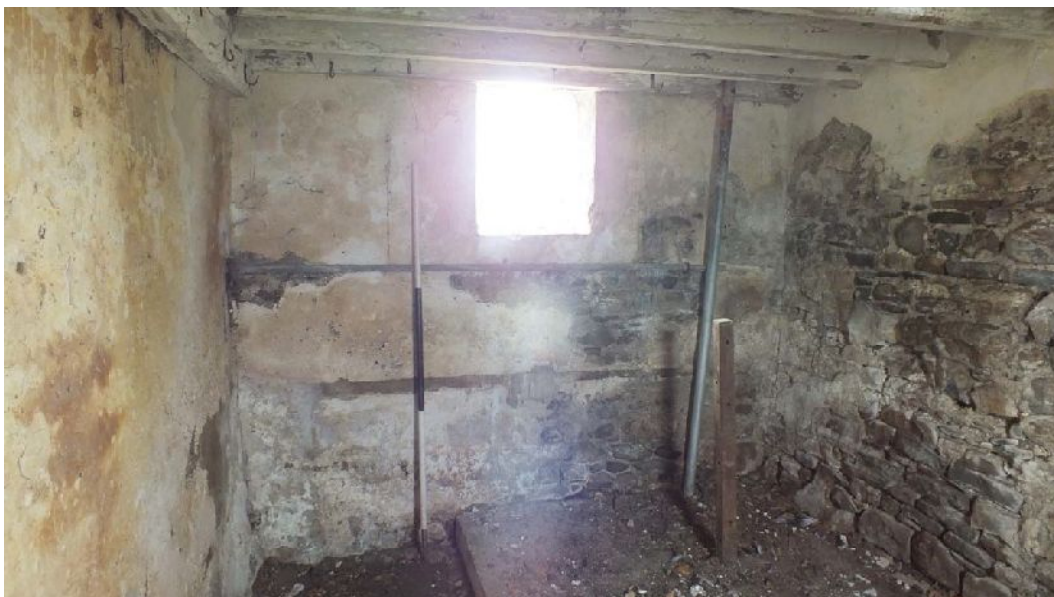
south elevation has a metal pipe attached, a small window with splayed jambs and sill, and a timber lintel with battens over (Plate 47). The west elevation is plain apart from scars for two stalls.

**Plate 47: South elevation of lower floor Room 2 of Building B, from the north**

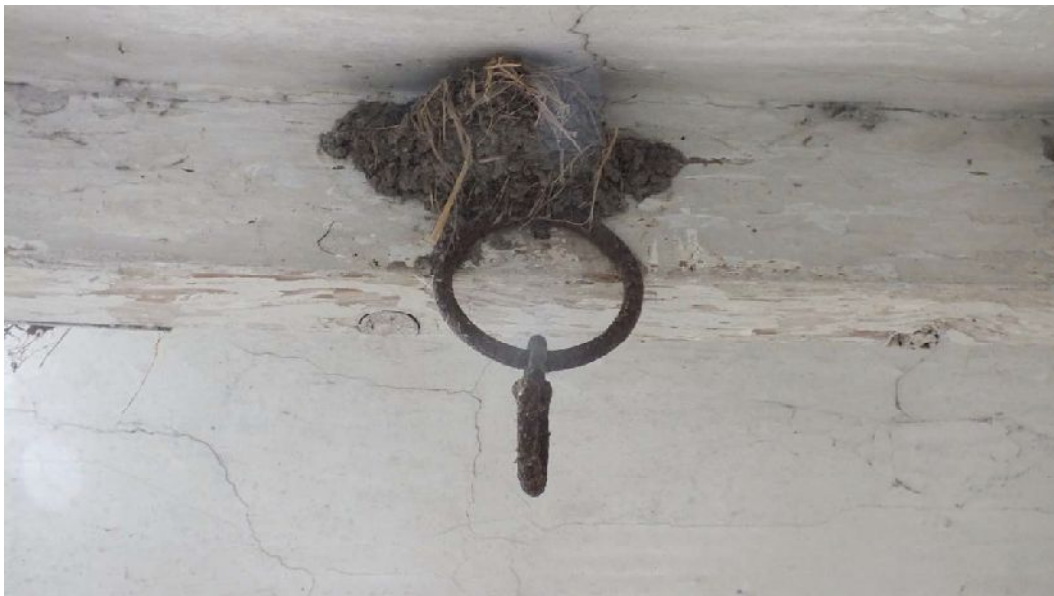
4.3.6 **Building B, first floor, Room 1:** this has a wide board floor with the boards running east/west, and it is open to the roof, finished with plaster and limewash with a ridge purlin exposed and a single small skylight to the south. There is an iron loop fixed to the north face of the west end of the west purlin (Plate 48). The walls are all finished with plaster and limewash. The staircase comes up in the north-east corner and has added timberwork to support wire mess has been added (Plate 49). The north and south elevations are plain, with graffiti to the north “HS GD HS TA CD GA”. The east elevation has a small window on the south side, with a timber lintel and sill, and a chamfered single light casement with the remains of an iron frame (Plate 49). The west elevation has a central chimney breast, with a step on the south side, and no evident fireplace (Plate 50). There is a door to the south in a sloping topped gap in the wall, with a plain surround and a step down to the west.

**Plate 48: Loop in first floor Room 1 of Building B, from the north**

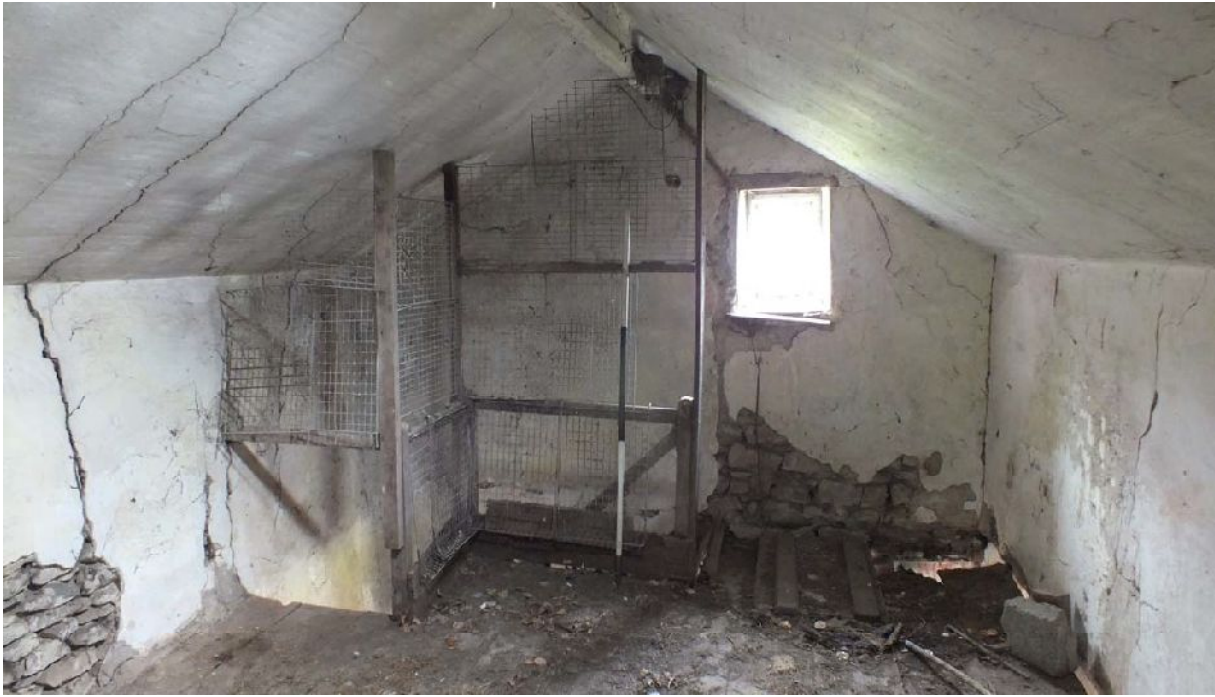
**Plate 49: East end of first floor Room 1 of Building B, from the west**

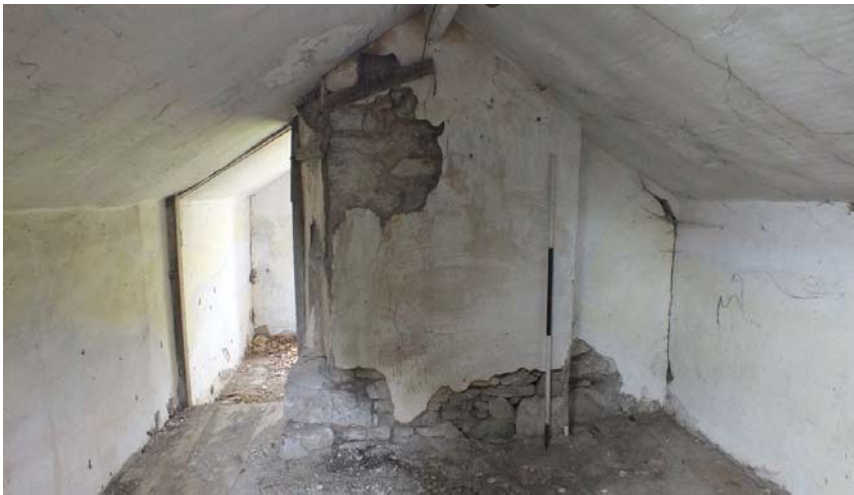
**Plate 50: West end of first floor Room 1 of Building B, from the east**

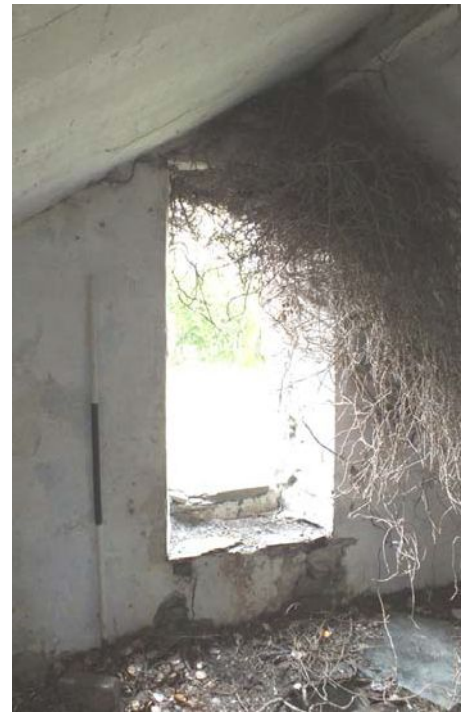
**Plate 51: West elevation of first floor Room 2 of Building B, from the east**

4.3.7 **Building B, first floor, Room 2:** this has a narrower board floor, with the boards running north/south. It is open to the roof, which is finished with plaster, and has a ridge purlin. The walls are finished with plaster and limewash. The north and south elevations are plain. The east elevation has a doorway up a step to Room 1, with a plain surround. The west elevation has a tall narrow opening, possibly a window, with a sill lower than that outside and forming a seat, although the lintel is obscured by ivy (Plate 51).
