# BARNS AT CAUTLEY FARM, WHASSETT, MILNTHORPE, CUMBRIA

Archaeological Building Recording

Planning ref: SL/2015/0989

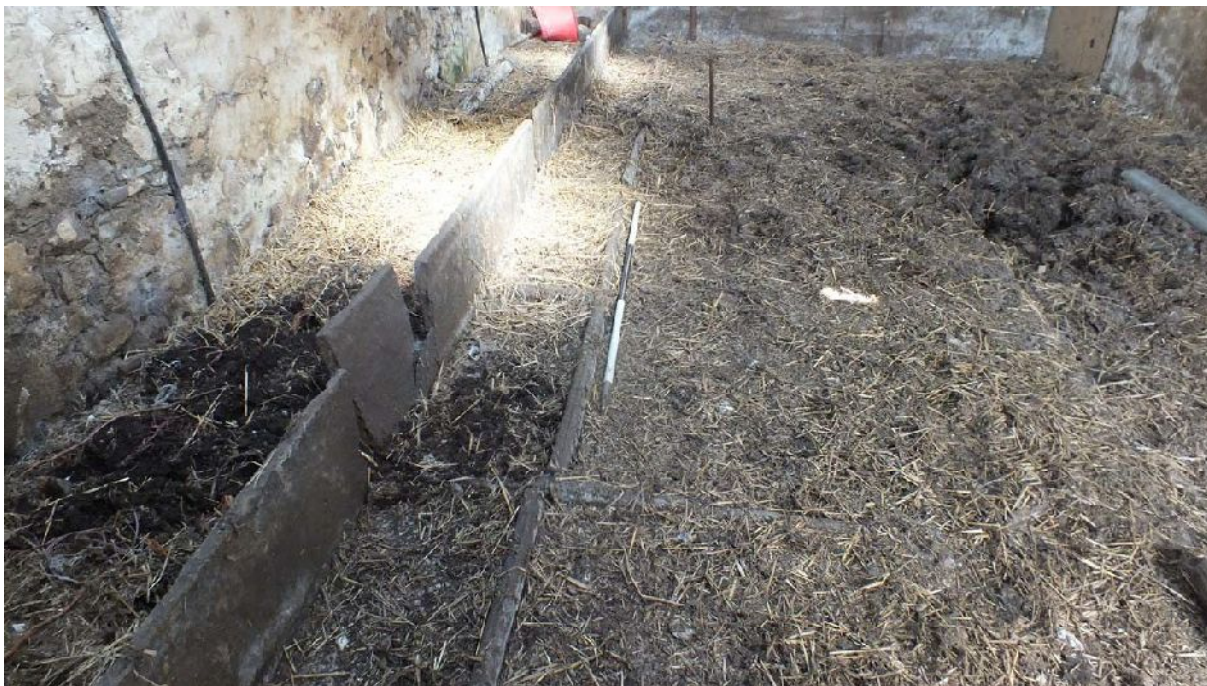
4.3.8 **Building C, Room 1**: this has a concrete floor with a dung channel on the south-east side, stepping up on the north-west side. It has a row of stone troughs and upright divisions (Plate 52). The roof is supported by two trusses of simple king post type, with a joggled top where it is met by the principal rafters (Plate 53). A set of carpenter's marks running from I to IIII from the west corner to the east is cut into the each junction of the tie beam and principal rafters (Plate 54). There is a single purlin per pitch and a ridge plank. The king post is bolted to the tie beam and there are the remains of a thick plank or thin beam sat on the top of the tie beam running the full length of the building. A single large square iron bracket hangs from the south-west end of each truss. The walls and trusses are finished with limewash over stone. There is a concrete skim over the lower part of all except the south-west. The north-west elevation has a post on the south-west side forming part of the stall and one row of posts to the north-east, and projecting end of timber lining up with the piece extending over the top of the tie beams. The north-east elevation has a doorway on the north-west side, with a machine-cut timber lintel and a plank and batten door partly covered by modern timber sheet along the south-east with machine-cut timber lintel and thin timber sill. There is a row of three vents along the top and a small alcove near the centre with a timber lintel and thin timber sill (Plate 55). The south-east elevation (Plate 56) has a doorway on the north-east side, with a machine-cut timber lintel and a split plank and batten door (Plate 57). There is projecting timber near the centre, which has been sawn off, and there are bolts above that evidently support the post evident on the outside. The south-west elevation has a doorway on the south-east side, with a machine-cut lintel and a plank and batten door. There is a row of three square vents along the top and a horizontal timber bracket extending to north-west elevation (Plate 58).

**Plate 52: Stone divisions for troughs in Building C, from the south-east**

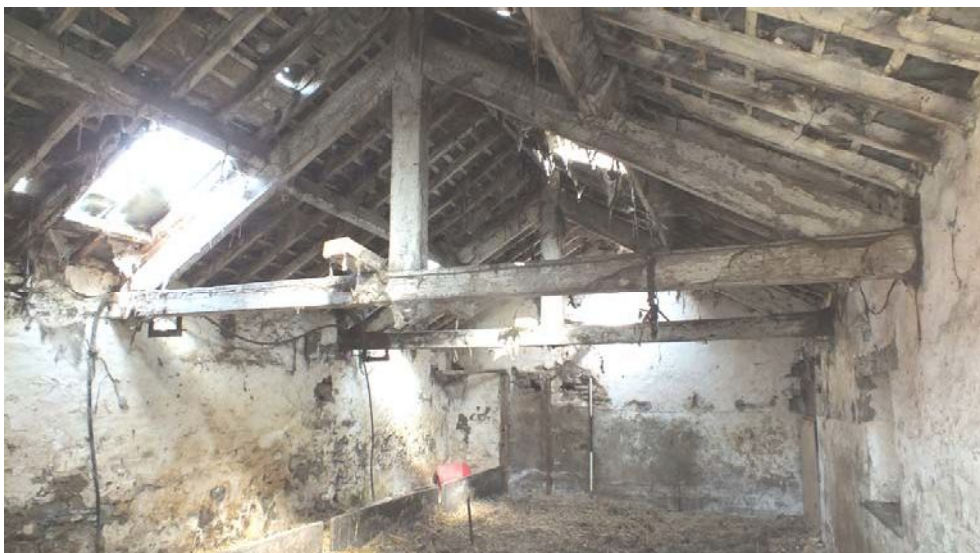
**Plate 53: Trusses in Building C, from the south-east**

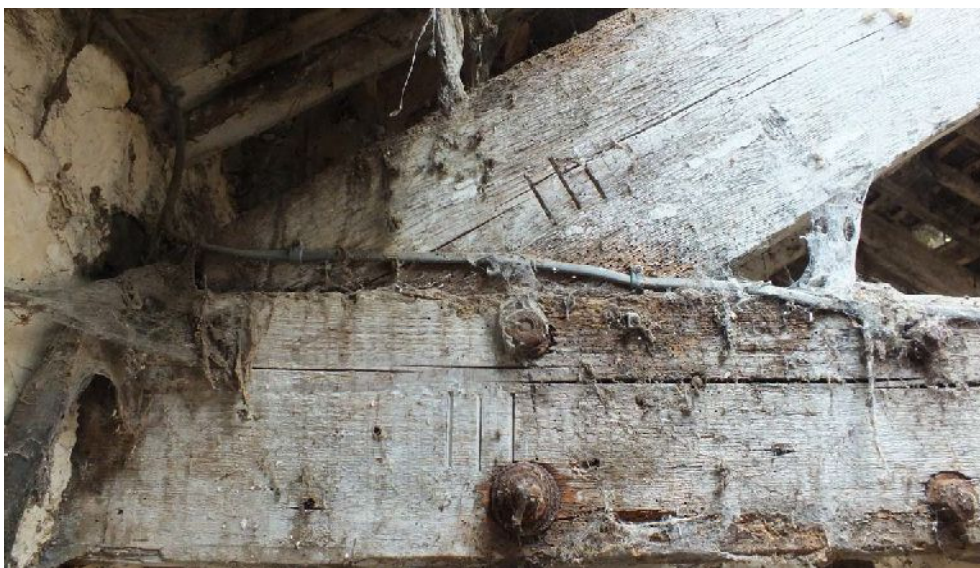
**Plate 54: Carpenter's mark III in Building C, from the south-east**

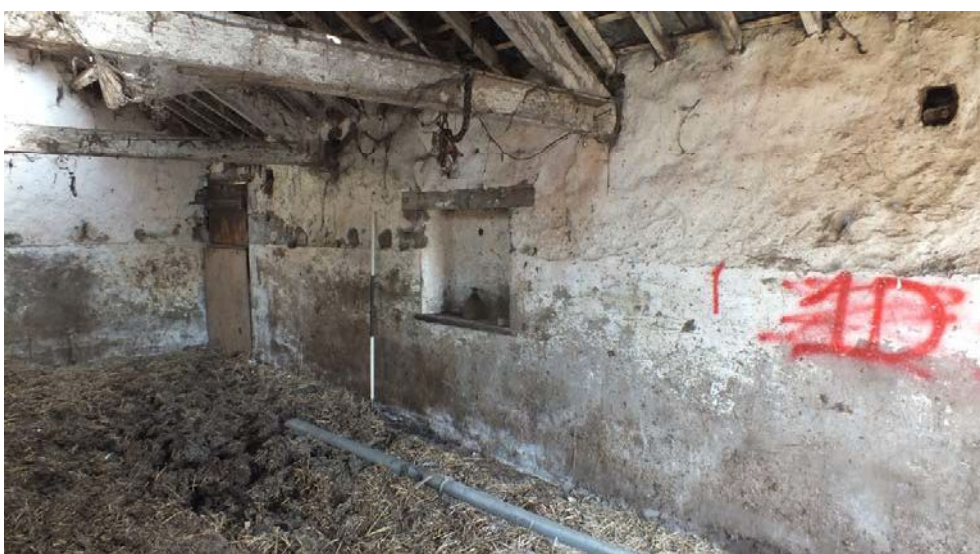
**Plate 55: North-east elevation of Building C, from the south**

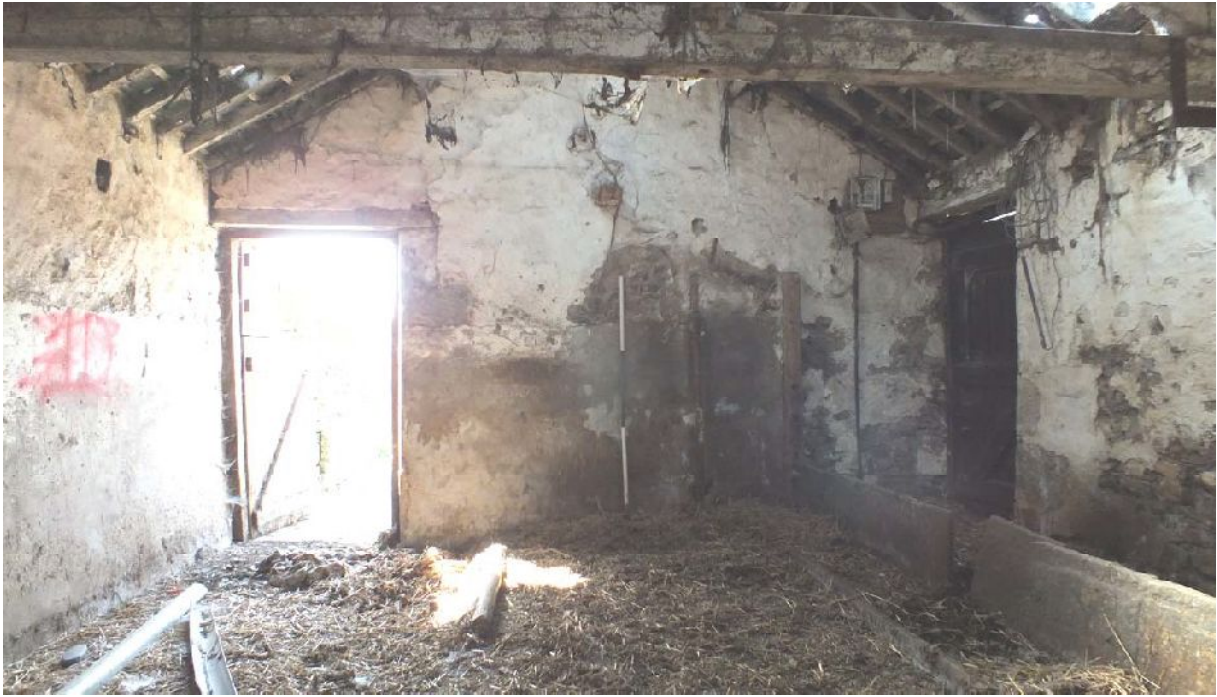
**Plate 56: South-east elevation of Building C, from the north-west**

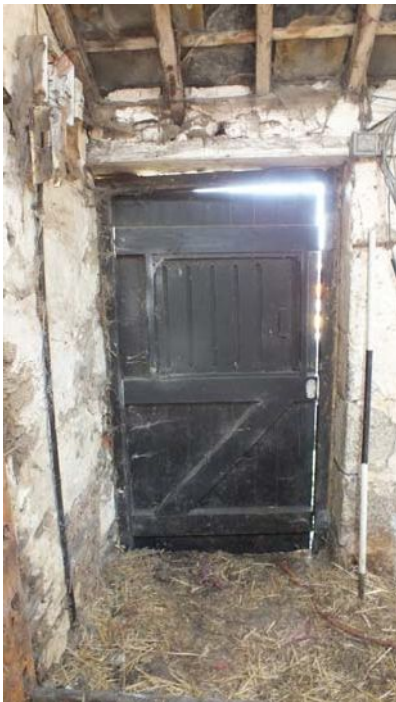
**Plate 57 (left): Door in south-west elevation of Building C, from the north-east**

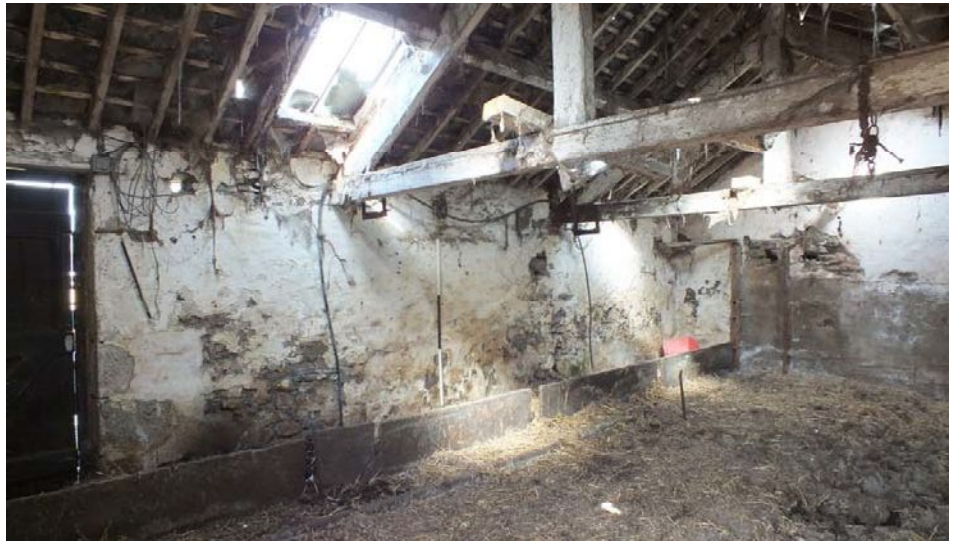
**Plate 58 (right): North-west end of the south-west elevation of Building C, from the east**
