COACH HOUSE, STOCKBRIDGE HOUSE, STOCKBRIDGE LANE, ULVERSTON, CUMBRIA

Archaeological Building Recording

Client: Steve Meyer

July 2018

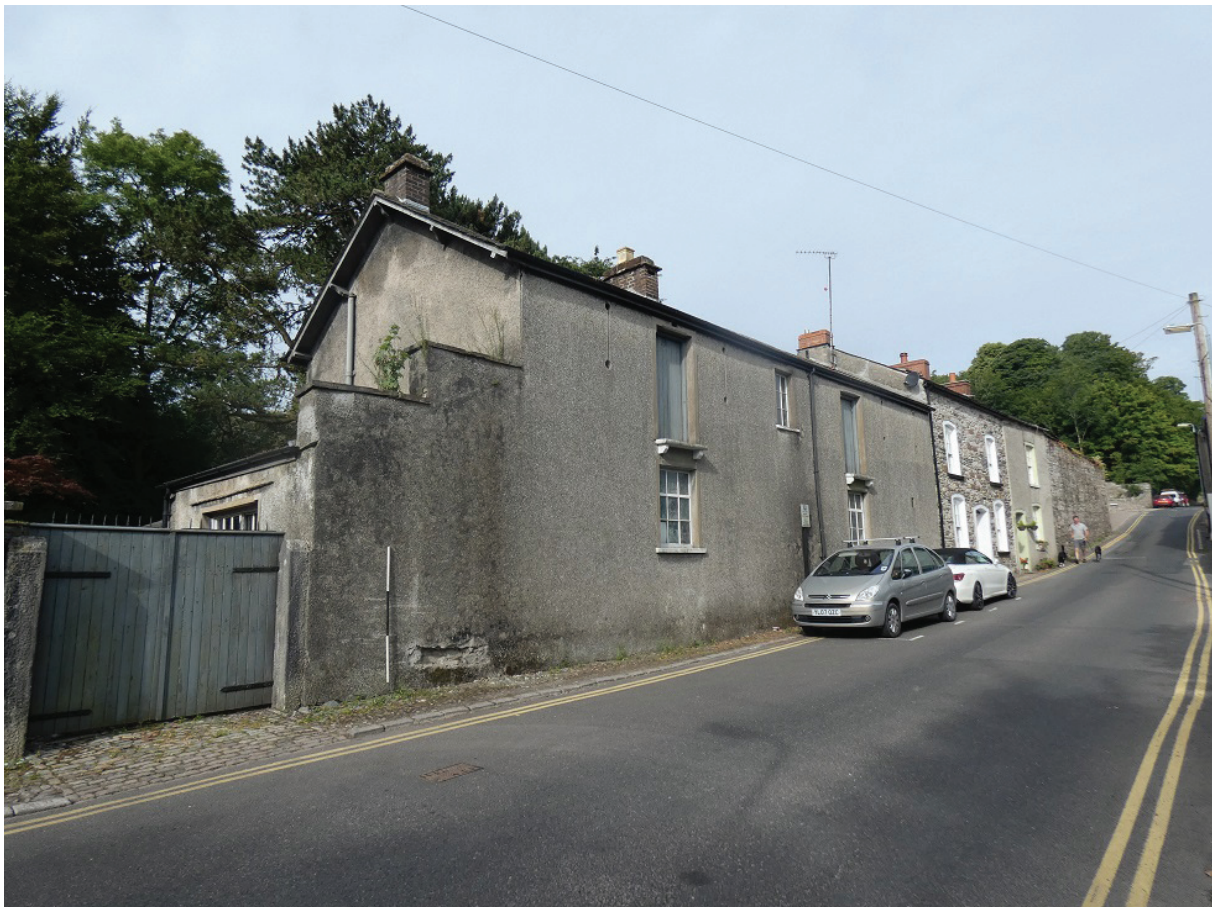
4.2.1 **North external elevation:** this has concrete render over stone. There are two windows on the ground floor, and they are nine-light, with the top three possibly hinged, and they have square render bands and a thin sill, with the stone neatly dressed. The first floor has a row of four vents – circles at either end of a slot, with a loading doorway at either end with a timber plank and batten door with concrete stop chamfer band round and a projecting stone sill, thin and nearly dressed, on angled corbels. Over the east there is a small rectangular hole cutting through the surround. There is a central window between, small, with nine lights, fixed, and with a concrete band around and a thin dressed stone sill. This elevation is continued by a tall boundary wall to the east and butts a row of two cottages to the west, at first floor level at least.

Plate 11: General view of the north external elevation, from the north-east

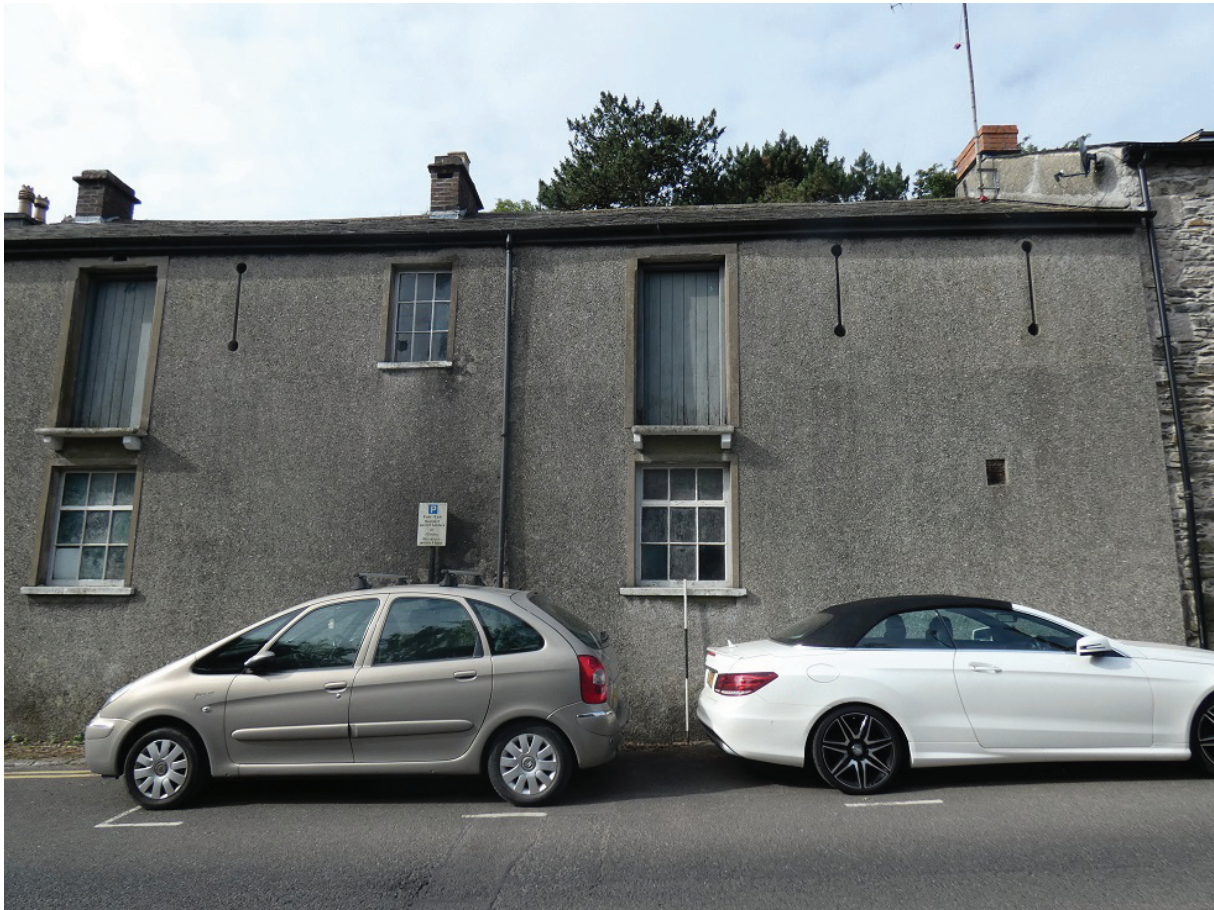
Plate 12: Detailed view of the north external elevation, from the north

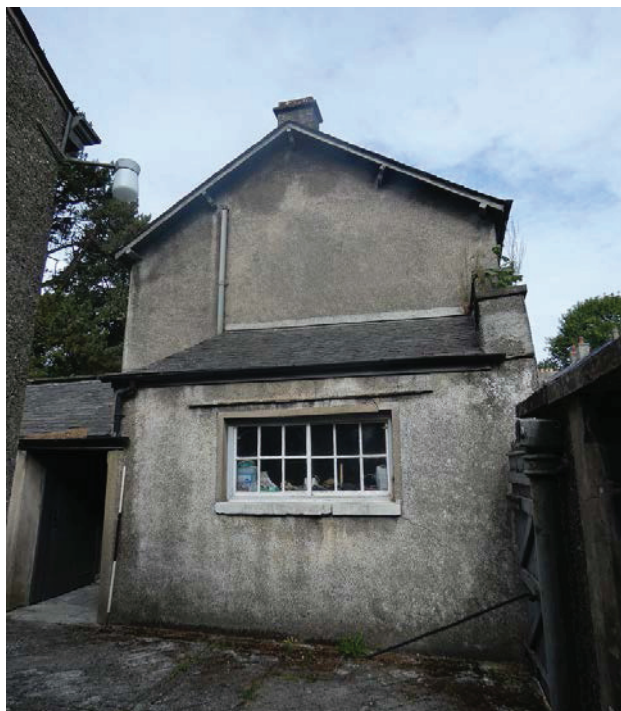
4.2.2 **East external elevation:** this is the gable end of the building, extended slightly to the south and partly covered by monopitch extensions. It has a roughcast concrete render finish. There is some more recent render evident where the lead flashing has been redone. The main gable is fairly plain, with projecting scrolled purlin ends supporting eaves and topped by a brick chimney. There is an iron vent pipe on the south side. The lower part of the elevation is covered by two monopitch outshuts, the north one slightly taller, with a long low 12-light window, the top six pivoting, with a slate drip course over it and a heavy stone sill. The south outshut is plain with just a doorway at the junction with stop chamfered concrete bands over the jambs, a timber lintel hidden behind a barge board to which the gutter is fixed. There is a single skylight in the roof of the south outshut and there are stone flags on top extending to the east beyond the main line of the building.

Plate 13 (left): The upper part of the east external elevation and the northern side of the monopitch outshut, viewed from the east

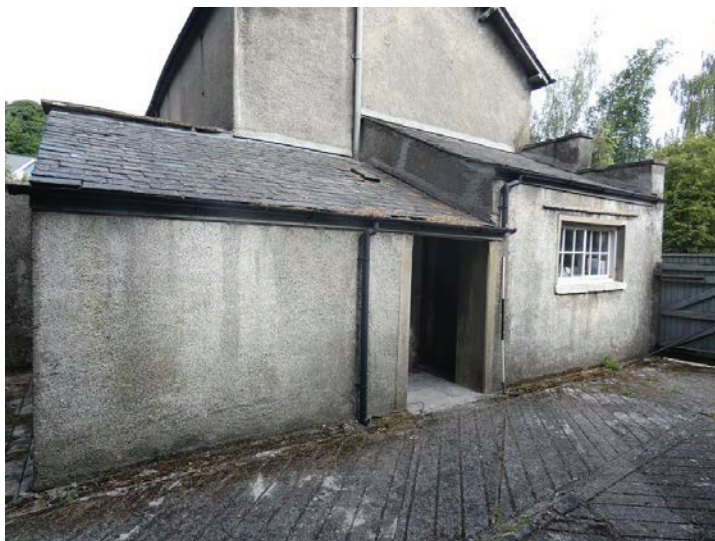
Plate 14 (right): The monopitch outshuts forming the lower part of the east external elevation, viewed from the south-east

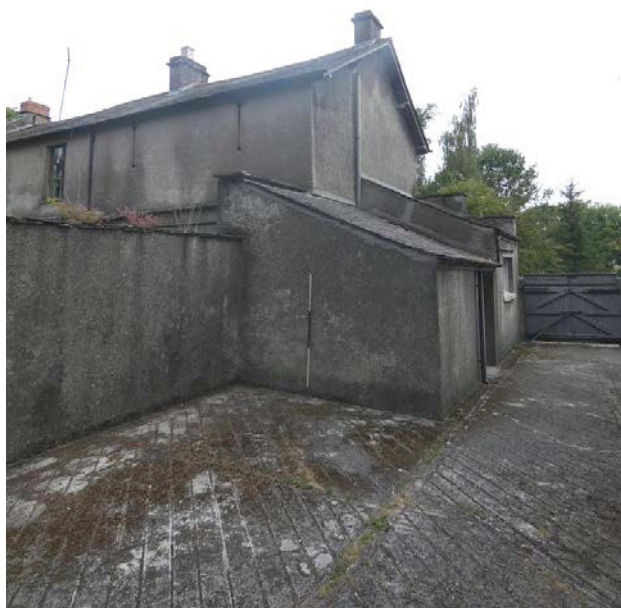
4.2.3 **South external elevation:** the east side is extended by the two monopitch outshuts, with the lowest obscuring the tallest. Both have a plain render finish. The tall boundary wall extends from the west side to the south and is topped by flags, which also top the smaller outshut. The main elevation has a large double sliding door on the east side with beaded plank and batten construction, sliding in an iron rail below the timber lintel with a slate drip course. The beaded rail attached over the lintel is fire damaged on the east side as is the east end of the sliding doors. There are two vents at first floor level on the east side, as per those in the north elevation. To the west is a covered walkway comprising a pent roof supported on iron columns with a small half truss at the east end. There is a stop chamfered tie beam and two upright posts. The roof has two three-light skylights, and the roof extends around to the south (see below). There are two iron posts to the south elevation, one at each corner, which are probably original, and a third thinner one that is likely to be a later addition.

Plate 15 (left): The outshuts on the east side of the south external elevation, viewed from the south-east

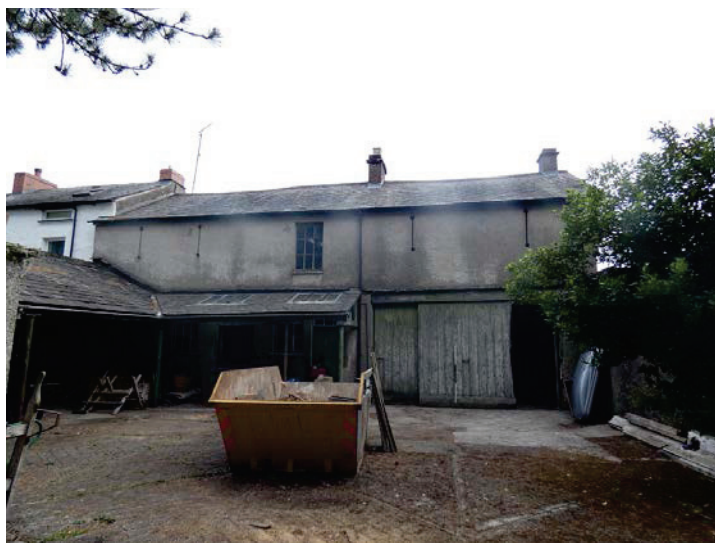
Plate 16 (right): The south external elevation, viewed from the south

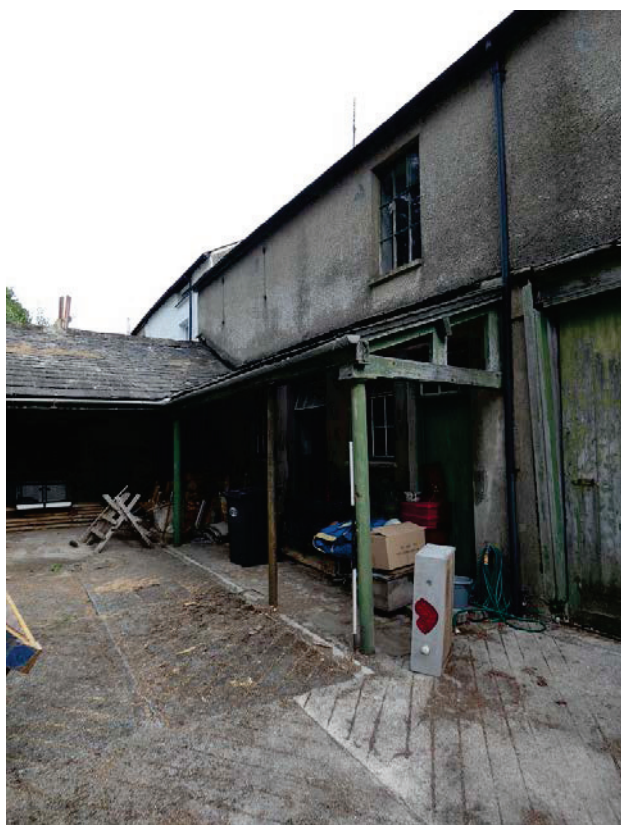
Plate 17 (left): Detail of the pent roof on the south external elevation, viewed from the south-east

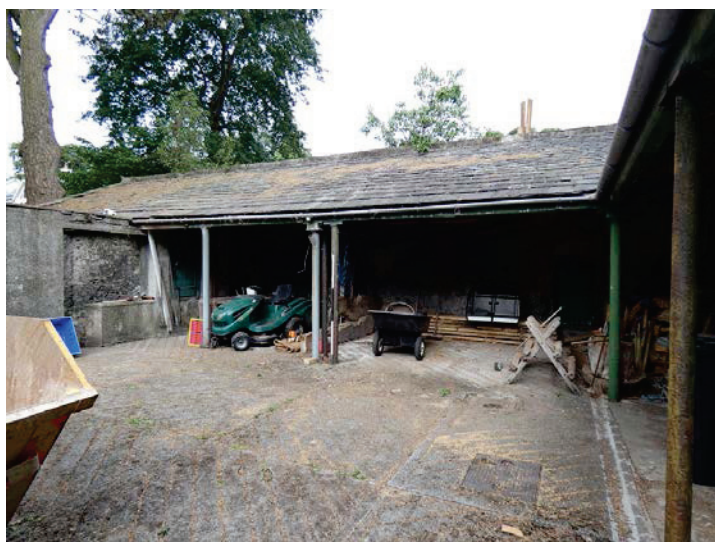
Plate 18 (right): The pent roof against the east external elevation inside the courtyard, viewed from the north-east

4.2.4 **East external elevation inside courtyard:** this is covered by a walkway formed by a pent roof supported on four iron columns, three presumably original, one of which has an end for a down pipe from the gutter, and one later. The tall wall to the west is finished with smooth concrete. There is a small doorway on the north side with plain surrounds, a beaded plank and batten door and fairly long strap hinges. There is a further plank and batten door to the south, with long strap hinges, hung on pintels, with a square concrete stop chamfered surround. The pent roof is supported by a single half truss, with a king post against the wall, supported by an iron post at the east end and an extra one to the west.

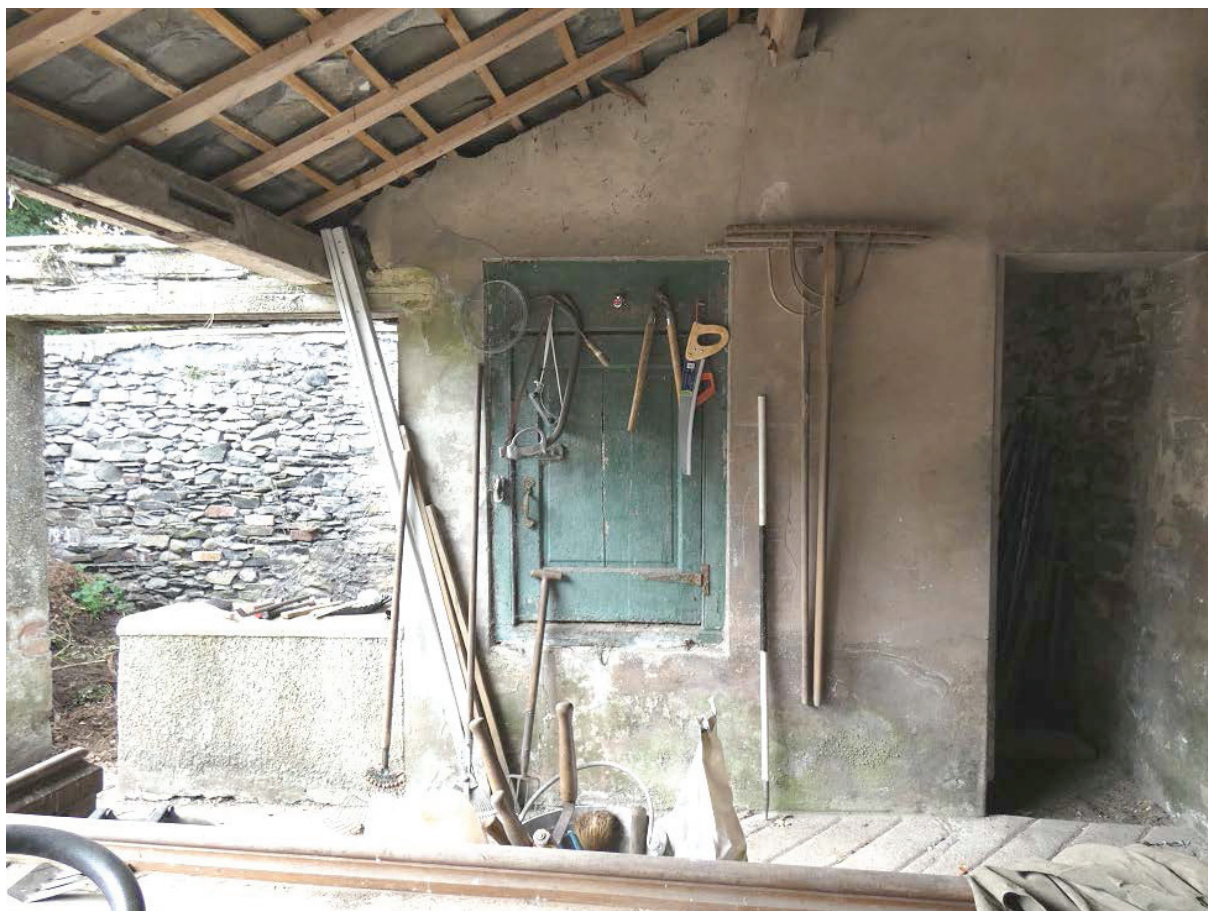
4.2.5 The elevation is continued at the south end by a return for the outbuilding. Underneath the pent roof to the west this has two further doorways, the western one just a simple opening with a plain surround set against the wall, the eastern raised off the ground by 0.6m and with a single panel door and early hinges and beaded surround. The east return has a further doorway with a square concrete band surround, stop chamfered with a wide doorway with two iron L-shaped beams for a lintel with concrete between and a partial sill. There are flags on top of the concrete rough cast wall and no roof.

Plate 21: Doorways underneath the pent roof on the east return of the external wall of the courtyard, viewed from the north

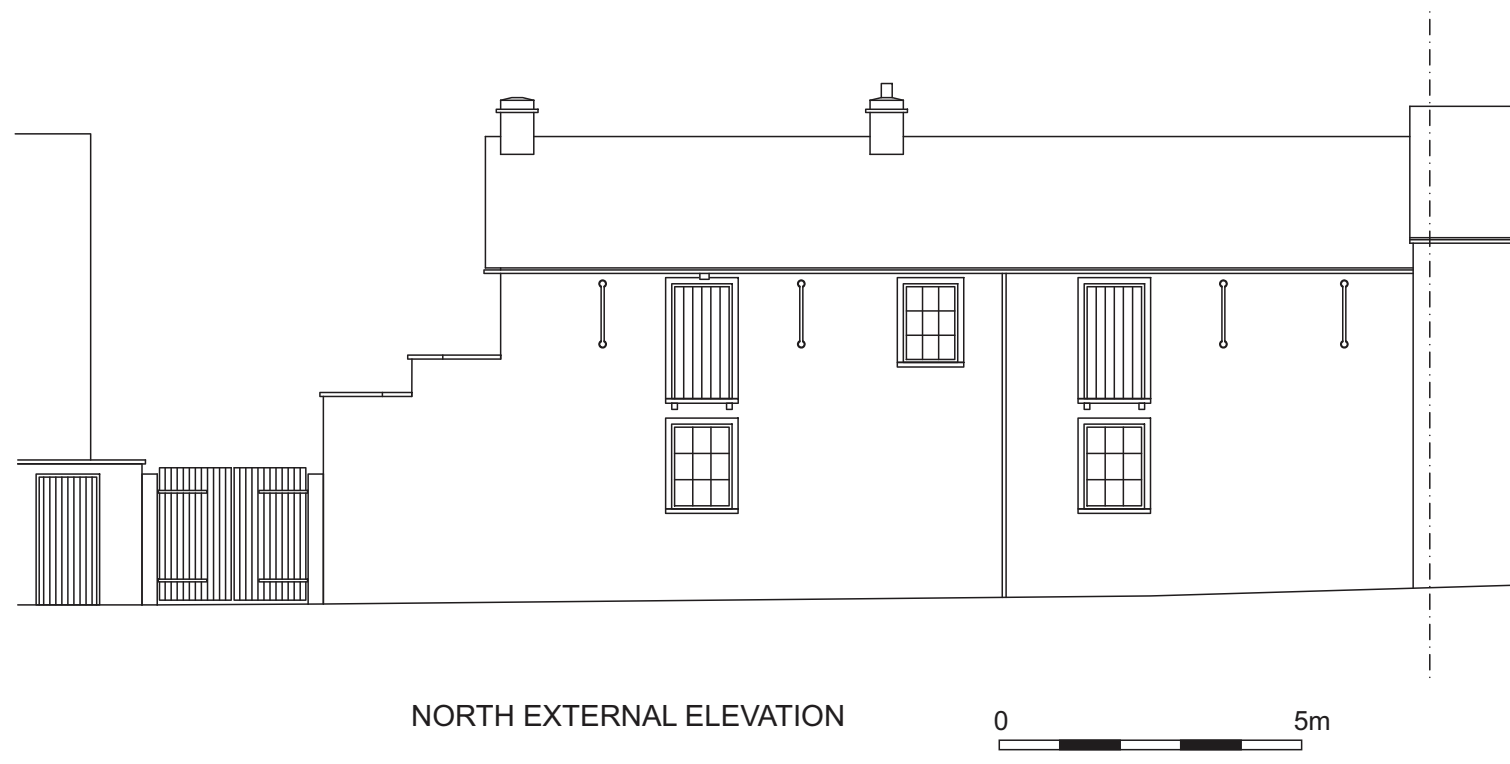
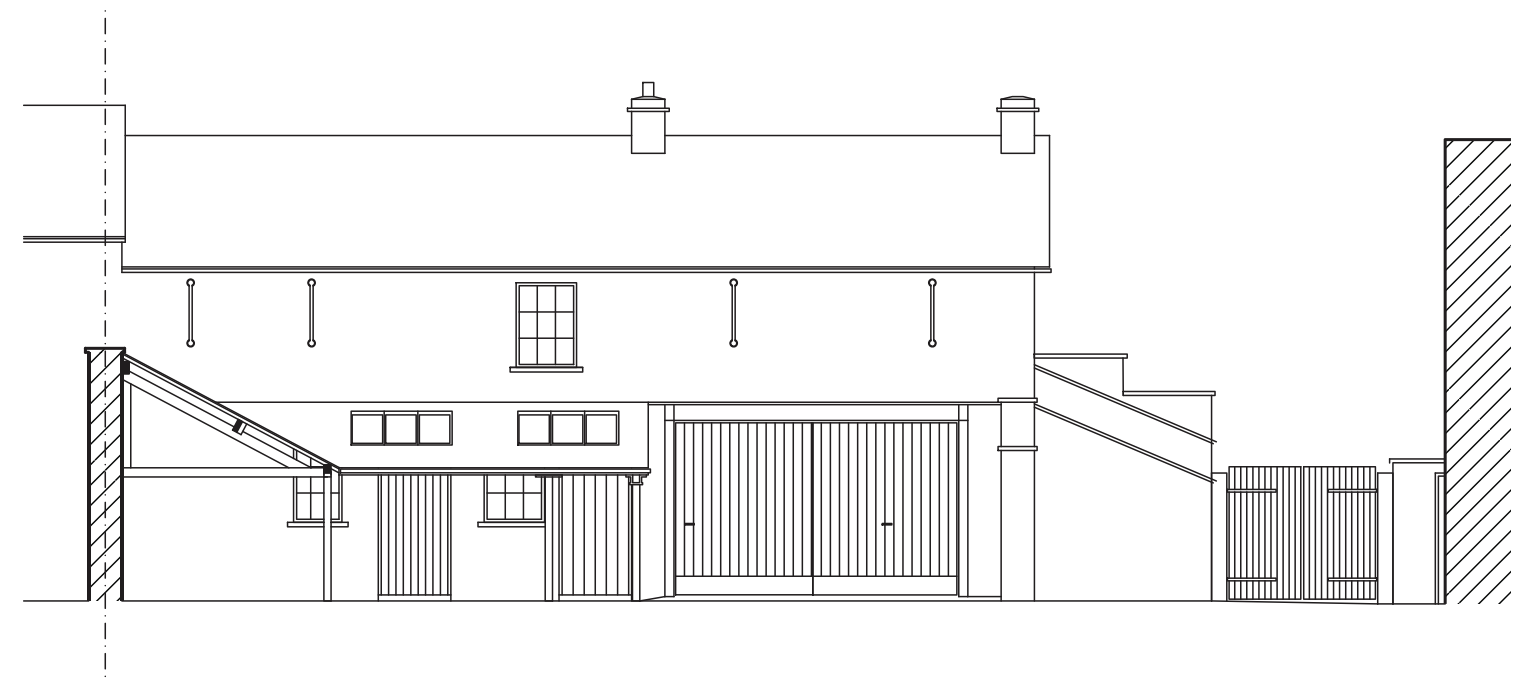
Figure 2: External elevations

NORTH EXTERNAL ELEVATION

EAST EXTERNAL ELEVATION

SOUTH EXTERNAL ELEVATION

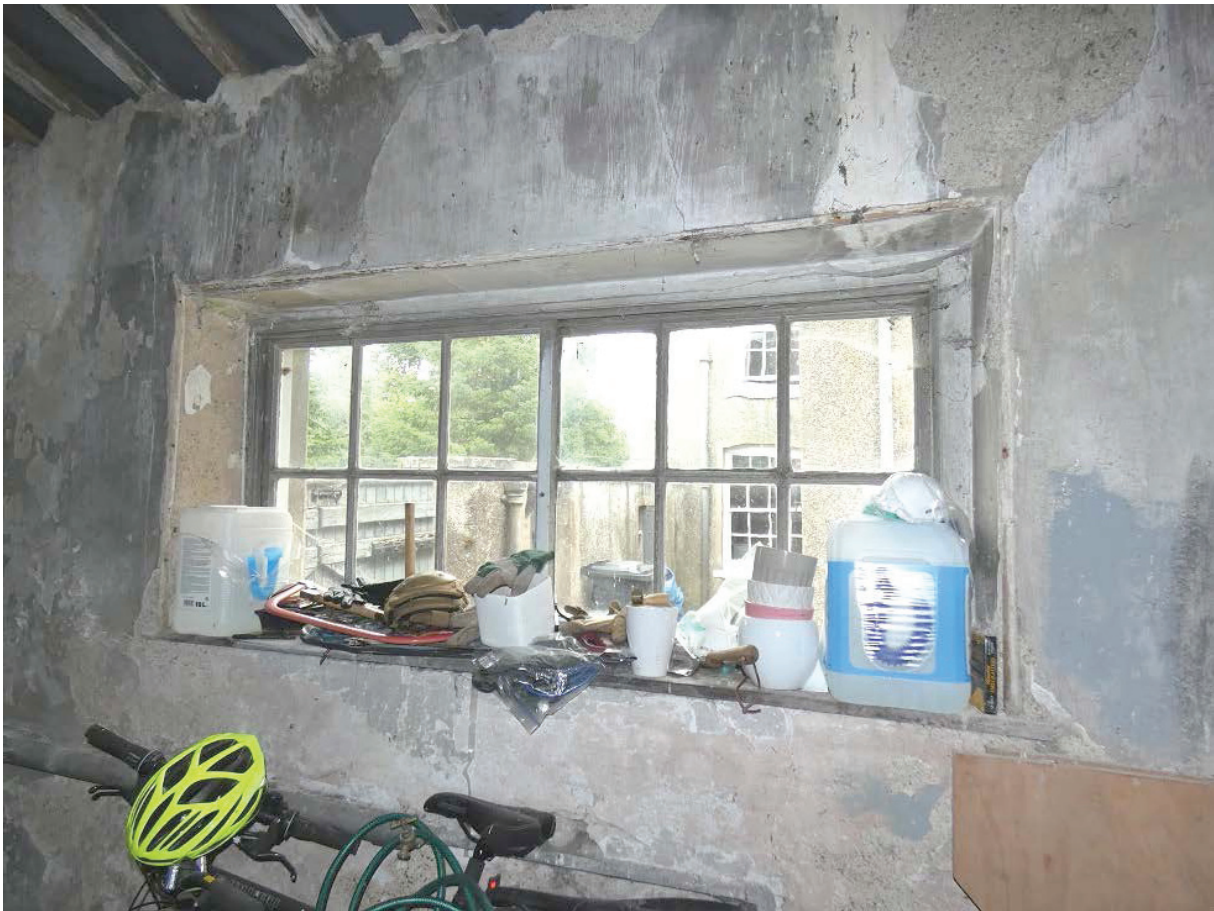
4.3.1 **Ground floor Room 1:** this has a slate flag floor, and is open to the monopitch roof, with a single purlin running north/south and another against the west wall, all stop chamfered and limewashed. The rafters are original with space for a skylight on the north-west side but the roof laid on modern plastic backing. The walls are finished with plaster and limewash or distemper. The **north elevation** is plain apart from a projecting wash boiler in the north-west corner, semi-circular in plan with a slate top and a round timber lid and an opening in the south-east side for the hearth. There is also a small alcove in the wall behind the copper. The **east elevation** is plain apart from a long low horizontal sliding sash window of 12 lights. It has a thin timber sill and a beaded surround. The **south elevation** has a doorway on the east side with a plank and batten door on strap hinges with an early lock and latch. The **west elevation** has a central fireplace, with a wide hob grate with side panels decorated with floral mouldings. There is a flat round arch over and plain surrounds.

Plate 23: Horizontal sliding sash window in the east elevation of Room G1, viewed from the south-west

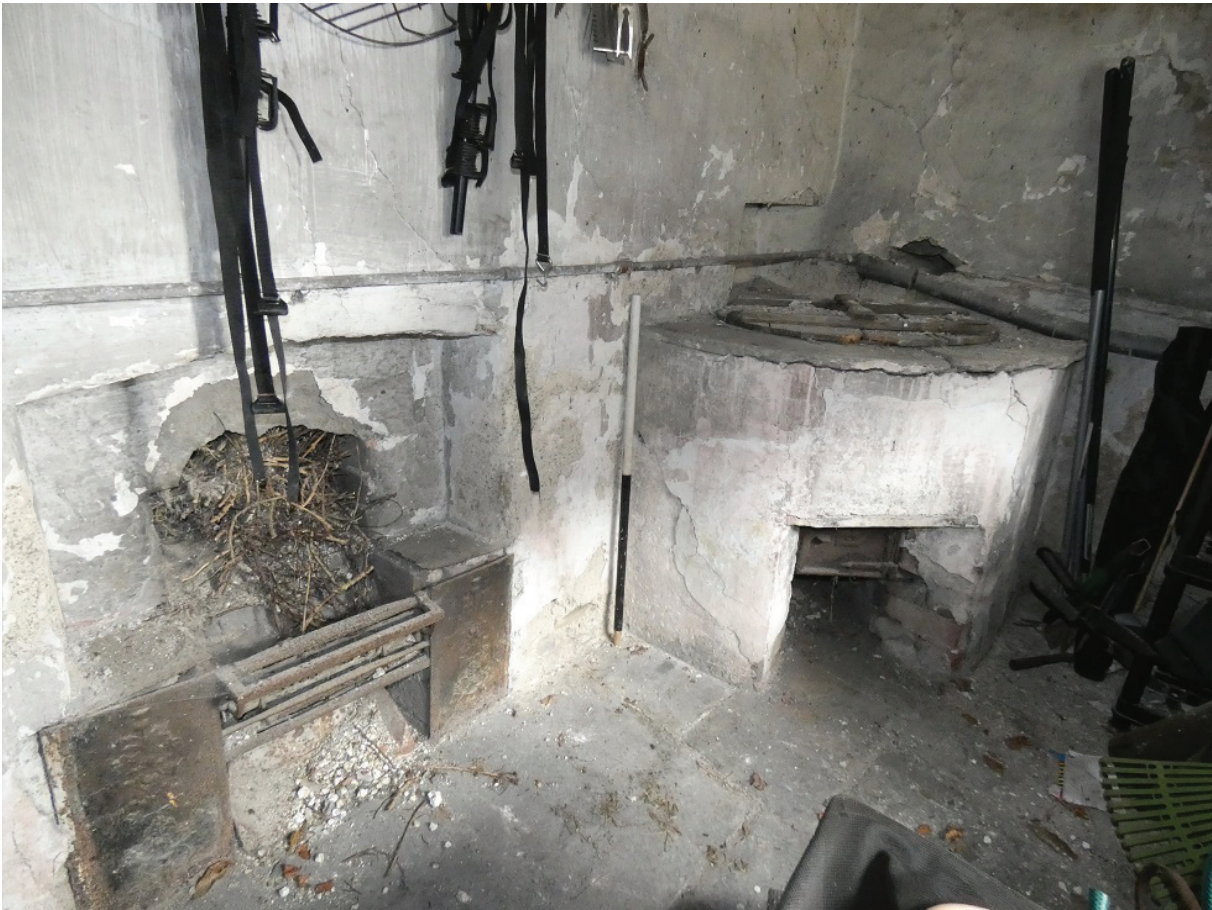
Plate 24: Hearth and copper on the west side of Room G1, viewed from the south-east

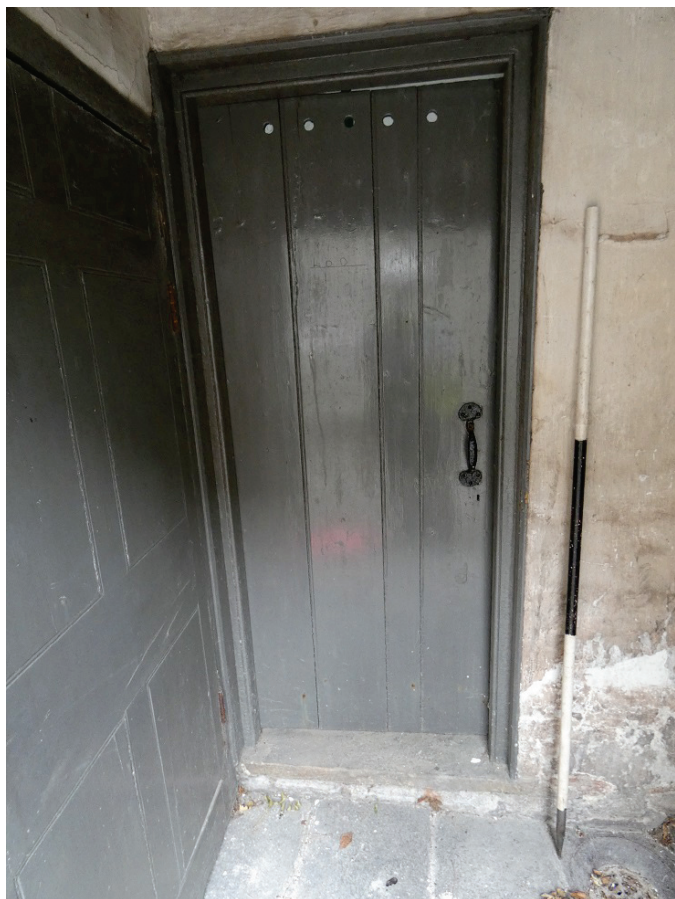
Plate 25 (left): Doorway to the west in the lobby of Room G2, viewed from the east

4.3.2 **Ground floor Room 2:** there is a small lobby to the east leading to the toilet to the west. There is a flag floor in the lobby, which is open to the roof. It has purlins only, all new with modern plastic behind. The walls are plaster with limewash/distemper. There are doors to the north, south, and west, and it is open to the east below a timber lintel. The door to the north has wide beaded planks and the remains of an early latch. The door to the west is the same. The door to the south is a cut down six beaded panel door with an early latch. The surrounds are plain, except the west which is beaded. The toilet to the west is up a single step, and there is a flag floor but it is not slate – possibly sandstone. It is open to the roof, plastered, and with a single light skylight. The walls are plaster and paint, and mostly plain. The toilet is attached to the west, and is early with a timber seat, with a transfer-printed mark ‘Superex British Made’, and there is a vent pipe to the north, and a timber cistern. There is a plank and batten door to the east.

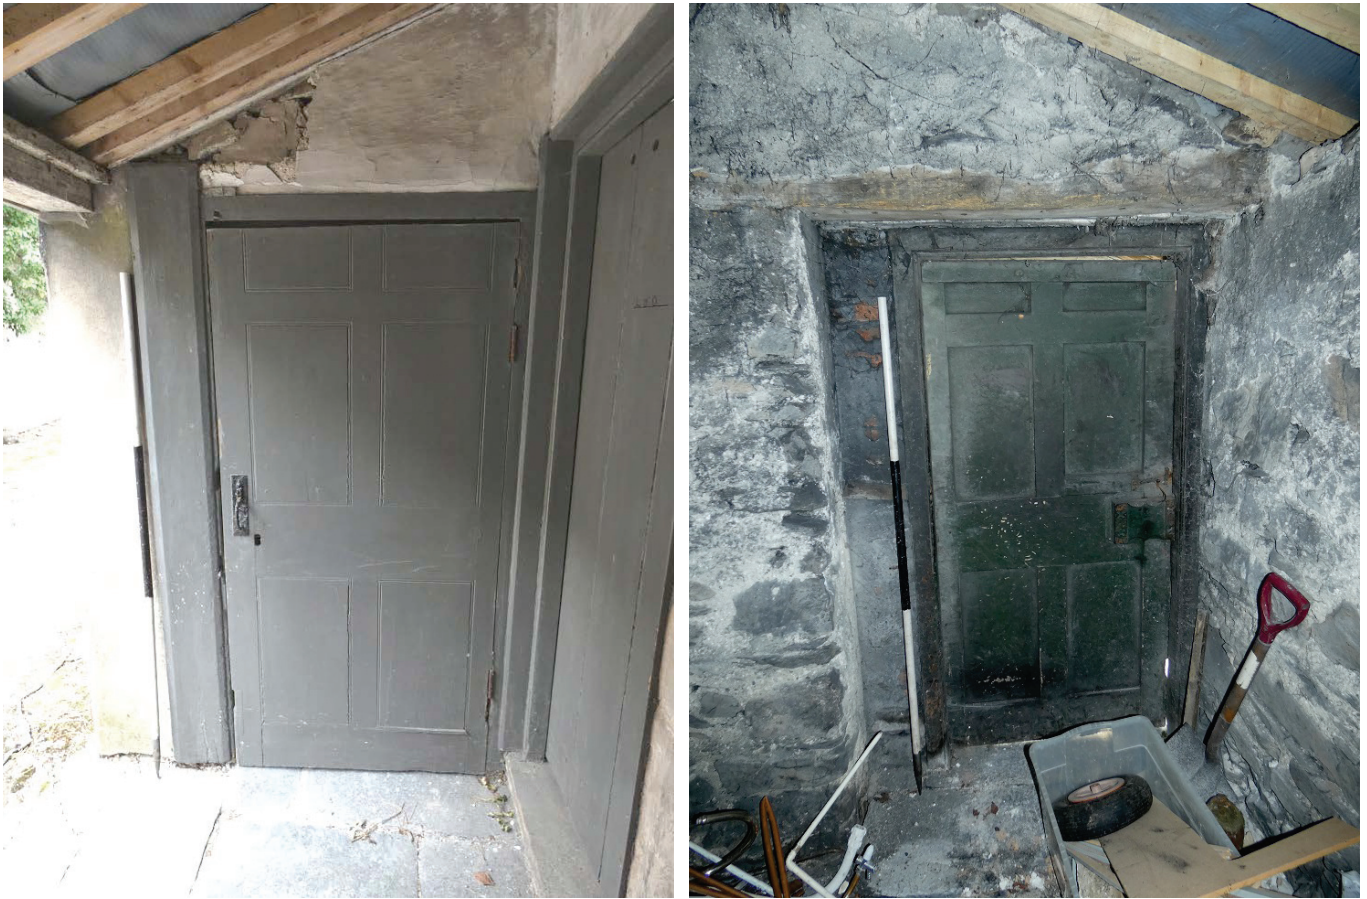
Plate 27 (left): Doorway to the south, Room G2, viewed from the north

Plate 28 (right): Reverse of the same door, viewed from within Room G3

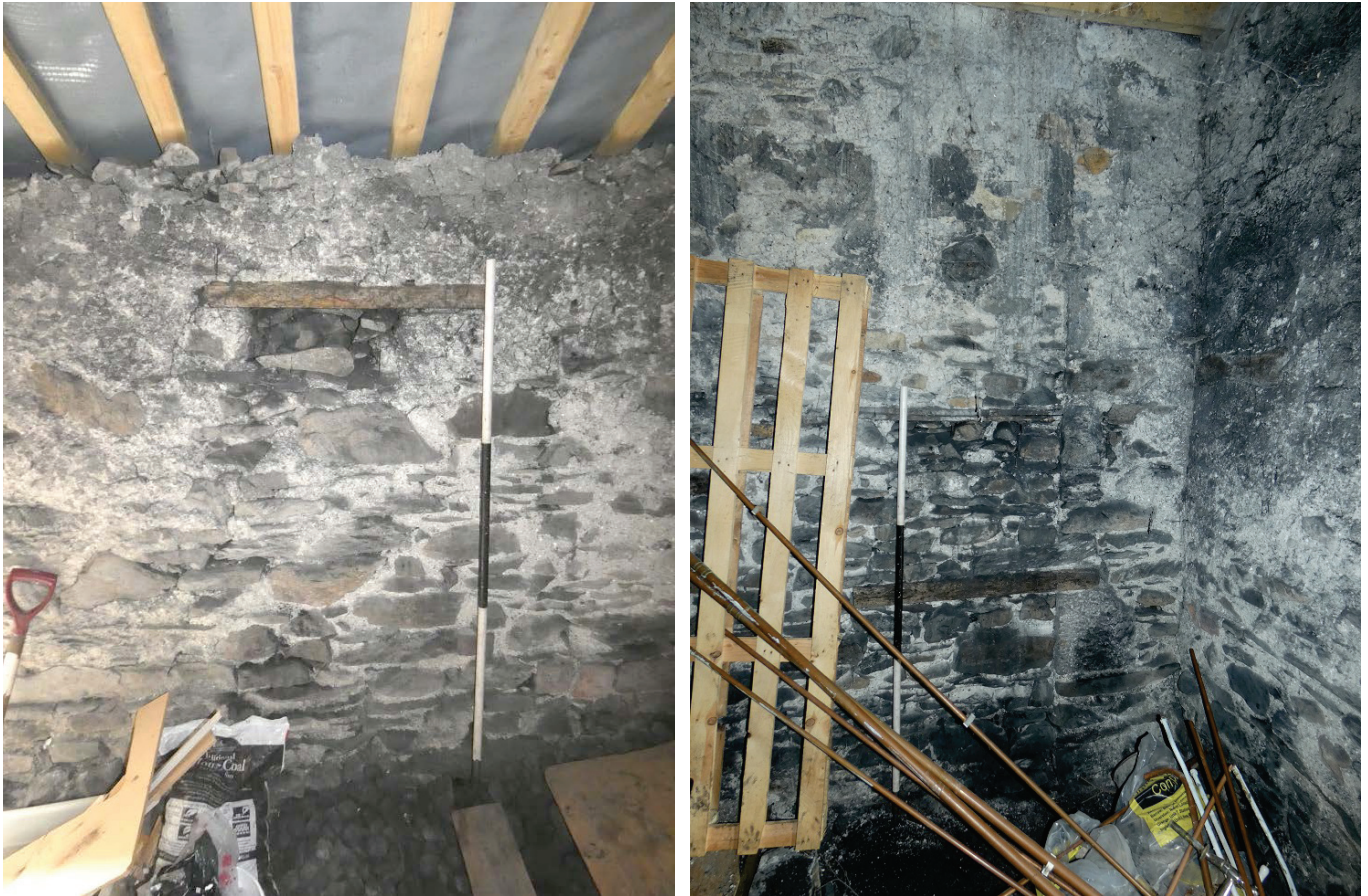
4.3.3 **Ground floor Room 3:** this has a cobble floor with a stone threshold to the north. The walls are rough stone and lime mortar. It is open to the roof, which is monopitch, with one original purlin, modern rafters and backing and a modern purlin to the west. The **north elevation** has a doorway on the east side, with the opening bigger than the door, leaving an alcove on the west side. It has a reused timber lintel and a cut down four-panel door with an early lock, and a beaded surround. The **east elevation** is plain, except for a small alcove near the centre, with a rough timber lintel. The **south elevation** is plain, with a possible small alcove with a stone lintel. The **west elevation** is evidently butting the north elevation, with quoins evident and supporting timbers.

Plate 29 (left): Small alcove in the east elevation of Room G3, viewed from the west

Plate 30 (right): Junction of the walls in the north-west corner of Room G3, viewed from the east

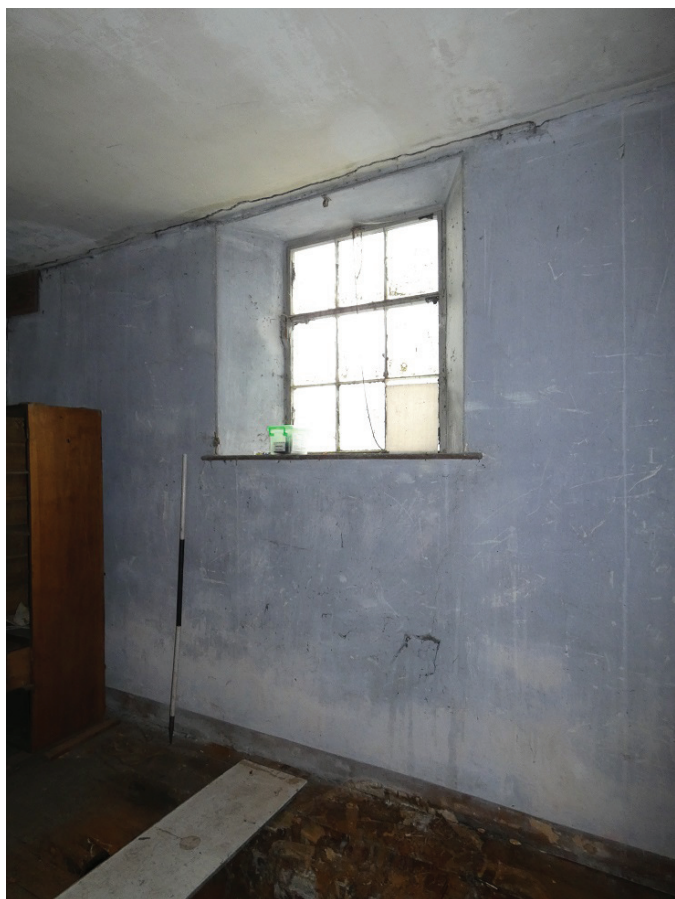
Plate 31 (left): Window in the north elevation of Room G4, viewed from the south-east

4.3.4 **Ground floor Room 4:** this has a tongue and groove board floor running east/west, with space below, with joists on bricks. It has a flat lath and plaster ceiling. The walls are finished with plaster and distemper/paint. The **north elevation** is plain except for a high central window, which has a nine-light casement with the top three pivoting (?). The **east elevation** is plain, with a beaded batten with an iron hook and timber pegs on the south side and a curved timber bracket, possibly a saddle or tack stand. The **south elevation** has a double sliding door, beaded plank and batten, with a timber lintel supported by an iron column with a flanged bracket at the top and a flat plate at the bottom. There is a plain square truss to the east with pencil graffiti with calculations and diagrams of the truss. The **west elevation** has a doorway on the south side with a beaded plank and batten door on early pointed strap hinges. It has a plain surround and jambs. To the north is an alcove with splayed jambs, blocked with iron sheets and with a brick structure on the south side, possibly a fireplace. There is a bracket for a gas lamp over it.

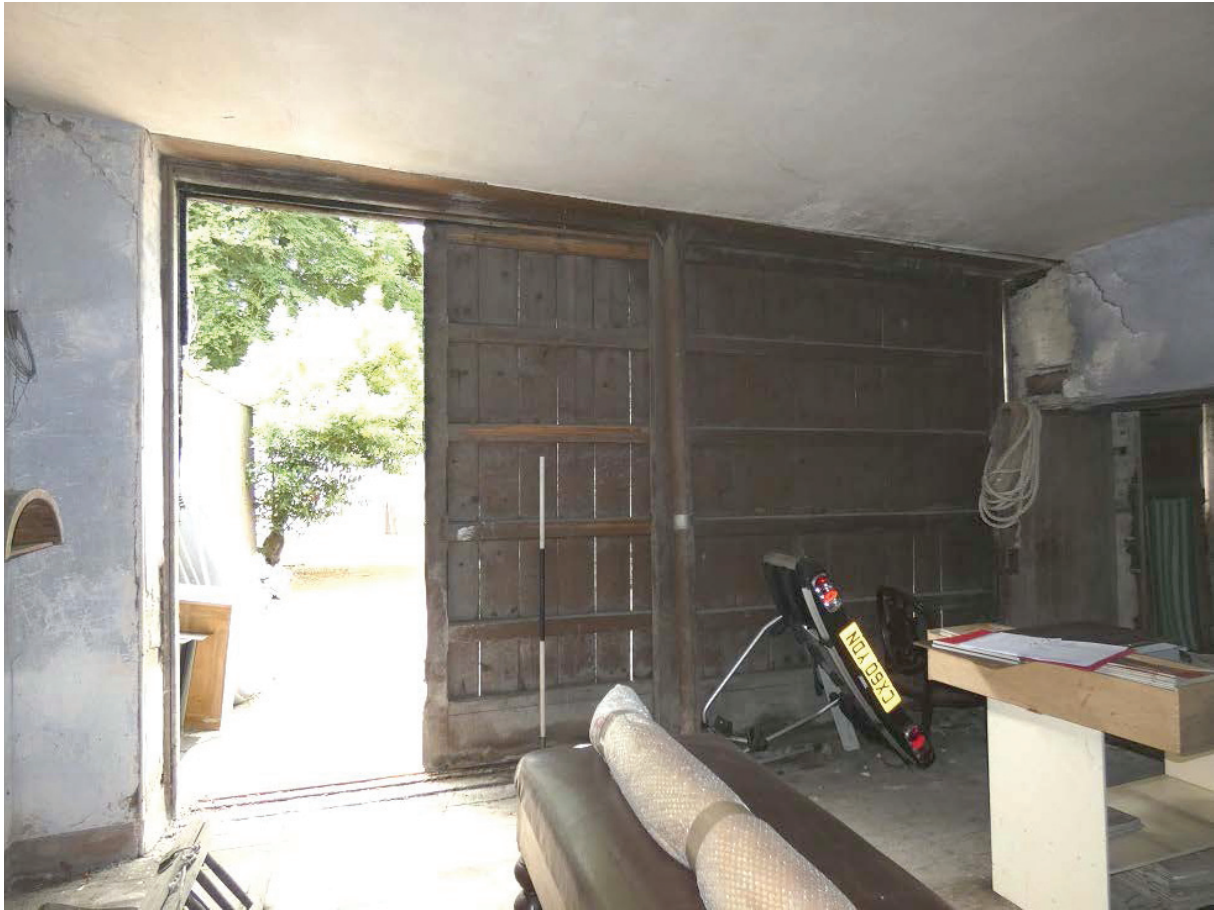
Plate 33: Sliding wagon doorway in the south elevation of Room G4, viewed from the north

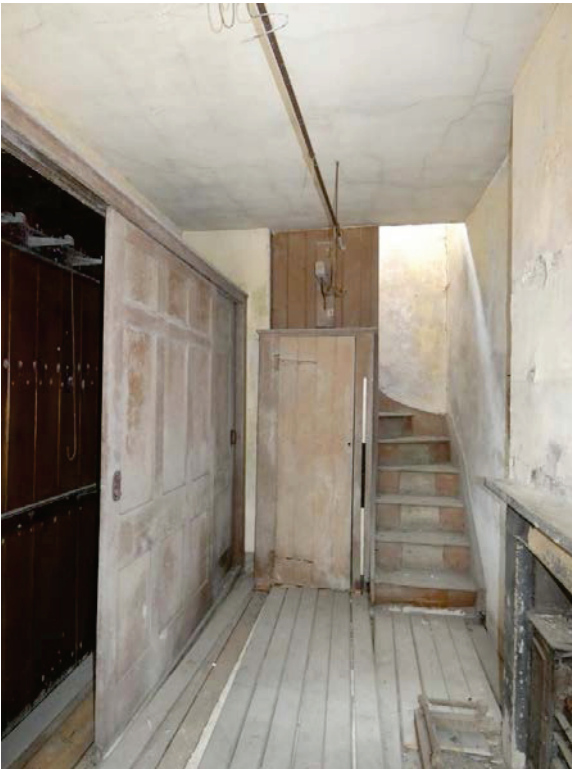
Plate 36 (left): Stairs and cupboard on the north and west side of Room G5, viewed from the south

4.3.5 **Ground floor Room 5:** this has a tongue and groove floor running north/south, with a flat plaster ceiling with an iron bar hung from iron rods (a drying rack) running north/south down the centre. The walls are finished with plaster and distemper. The **north elevation** has an attached cupboard on the west side (see below) and stairs on the east side, timber with low beaded skirting. Between is a fixed cupboard with a plank and batten door on strap hinges with moulded entablature. Behind this, forming the side of the staircase, is a beaded plank and batten section with a large bracket attached with a curved top and a curved iron support below. The **east elevation** has a projecting chimney breast with a fireplace with a square stone surround with a beaded edge, square stone mantle and hob grate with moulded panels and water tank with tap on south side, iron fender still in place and stone hearth. There is a doorway to the south with a chamfered surround and a plank and batten door. There is a bracket to the north. The **south elevation** has a doorway on the east side, a plank and batten door with long strap hinges and three-light overlight. There is a window to the west with nine lights, with the top three hinged and a thin timber sill. The **west elevation** has a doorway on the south side, a beaded plank and batten door with long strap hinges and an early lock, with the surrounds otherwise plain. There is a fixed cupboard to the north with a double sliding door, each nine panels on timber runners, beaded plank interior, and batten with timber pegs fixed to the back, and a beaded outer surround. There is a bracket with iron hooks to the south.

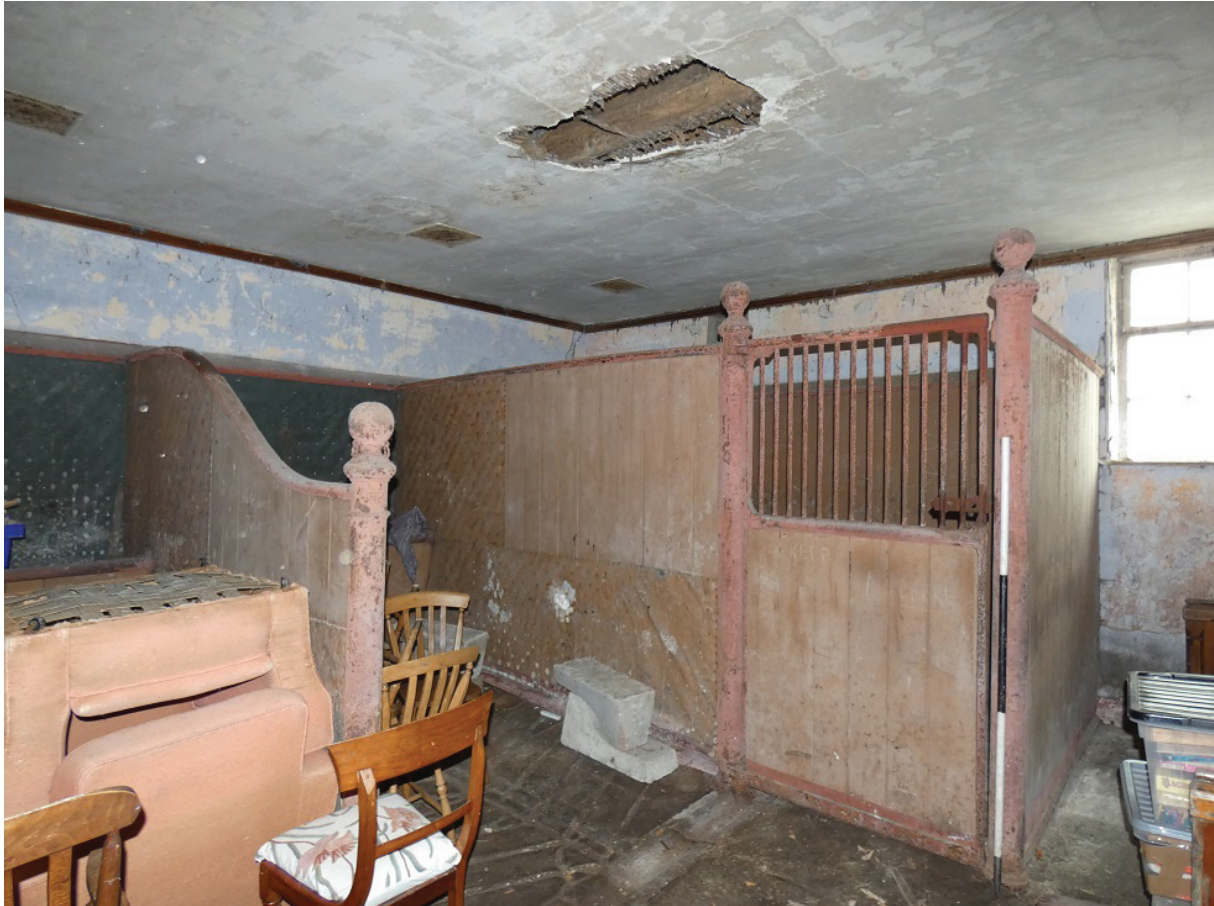
4.3.6 **Ground floor Room 6:** this has a flag floor on the east side, and scored concrete to the west. It is divided by a U-shaped drain of stone blocks, turning at the south end to drain to the east. It is divided on the west and north side by timber and iron partitions into three stalls. The stalls have tongue and groove plank walls finished with metal sheeting attached over the lower part, topped with iron rails coming to posts at the end with ball finials and marked 'Musgraves Patent Belfast'. There is also a door to the north with an iron grill on top between two timber posts. There is a corresponding feed trough along the west side and a manger in the north-west corner. There is a lath and plaster ceiling with two decorative metal vents on the west side. There is a narrow cornice throughout the north, south, and west elevations. Most of the lower part of the **north elevation** is covered by beaded tongue and groove boards with plain skirting and a moulded cornice. There is a further decorative metal vent on the west side, partially below the cornice. The east end has a window with a nine light casement and a thin timber

Plate 38: Stalls in Room G6, viewed from the south-east

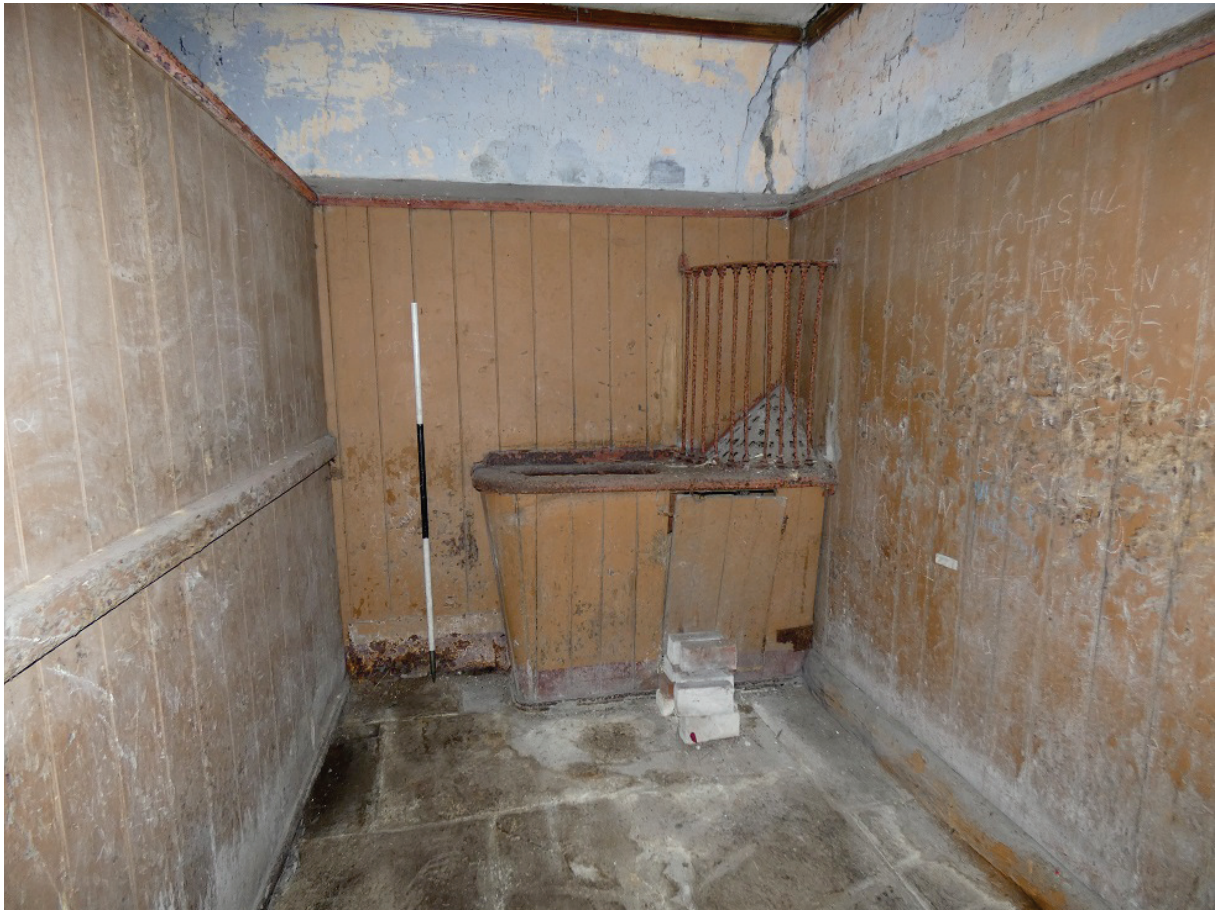
Plate 39: Detail of manager and feed trough in the northern stall in Room G6, viewed from the east

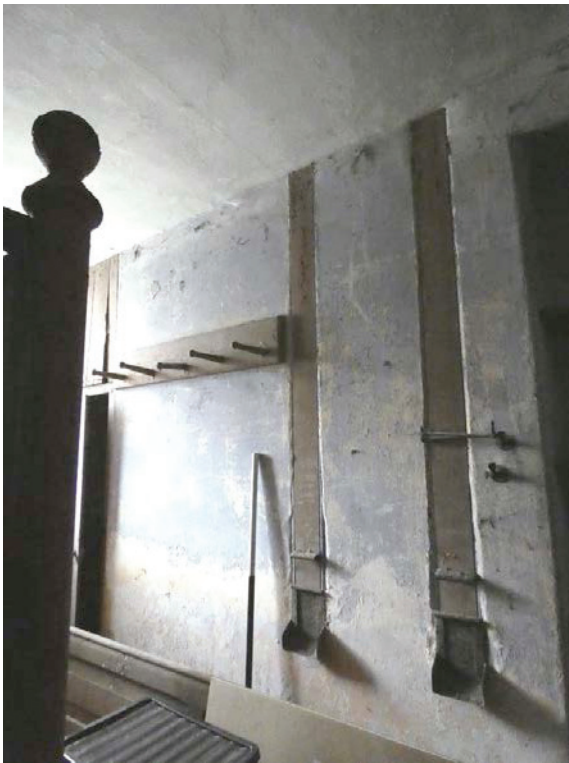
Plate 40 (left): Grain chutes built into the east wall of Room G6, viewed from the south-west
