COACH HOUSE, STOCKBRIDGE HOUSE, STOCKBRIDGE LANE, ULVERSTON, CUMBRIA

Archaeological Building Recording

Client: Steve Meyer

July 2018

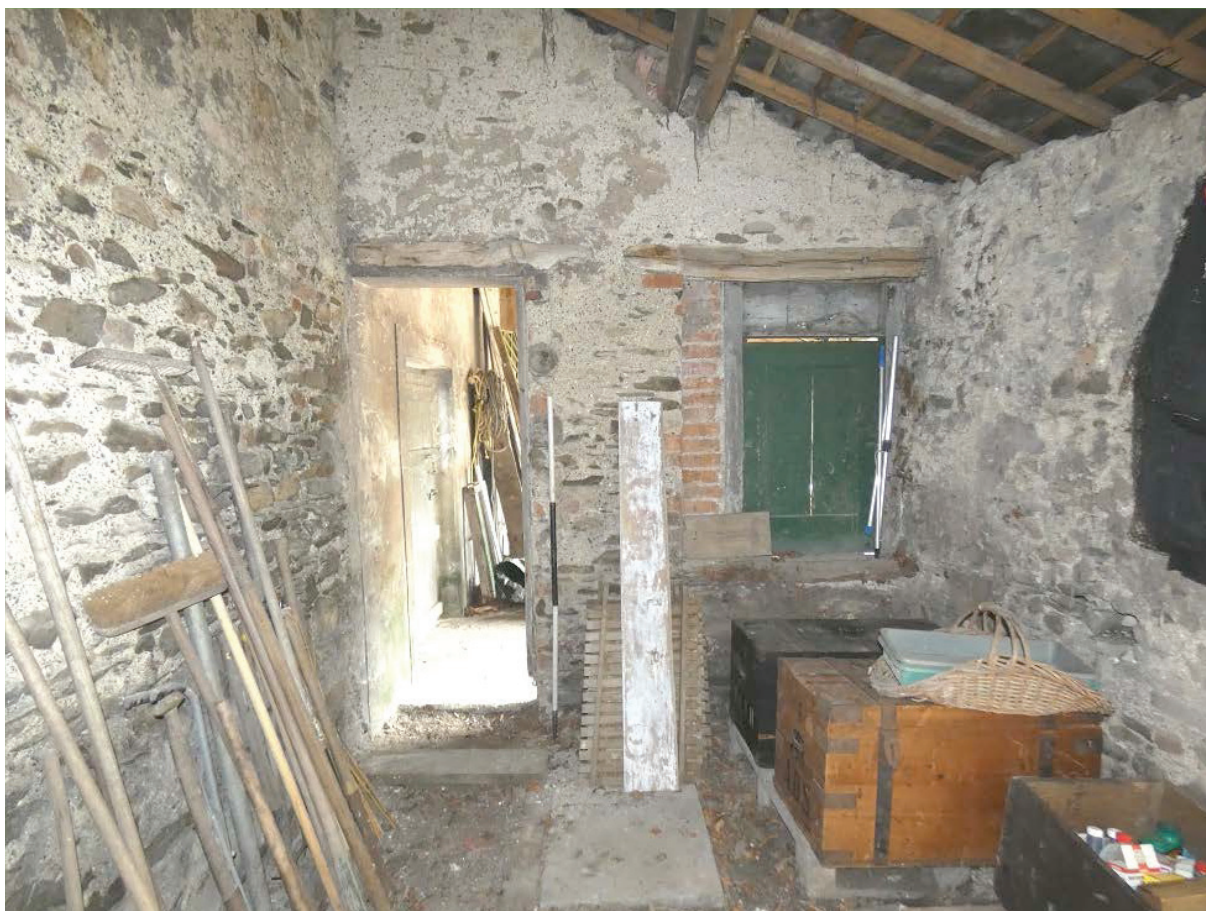
Plate 42: North side of Room G7, viewed from the south

4.3.7 **Ground floor Room 7:** this is an L-shaped room, the west side with a monopitch roof and the east side unroofed. The floor is rough flags, and earth. It is slightly raised in the south-west corner (originally a small room with a toilet – Andrew Smith pers comm). The roof is mostly modern rafters and slates, with a single pair of purlins next to each other and a beam over the opening to the east. The walls are rough stone and rough cast render. The **north elevation** has a doorway on the west side, with concrete over the jambs, and a step up to the concrete floor beyond. It has a rough timber lintel. There is a further doorway to the east, raised off the floor in an originally wider opening, partially blocked on the west side with bricks. The door is planks set in a wide surround which is roughcast, and it has a timber sill. The return to the south is plain. The return to the east is roughcast. The **east elevation** has a doorway to the courtyard with the remains of a plain surround, sandstone lintel, and a stone step up. The **south elevation** is mostly plain and rough cast. There is a scar of a partition wall at the west end corresponding to the floor. There is a small window above, which has a four light fixed casement, and a rough timber lintel. The **west elevation** has a corresponding scar in the render but is otherwise plain.

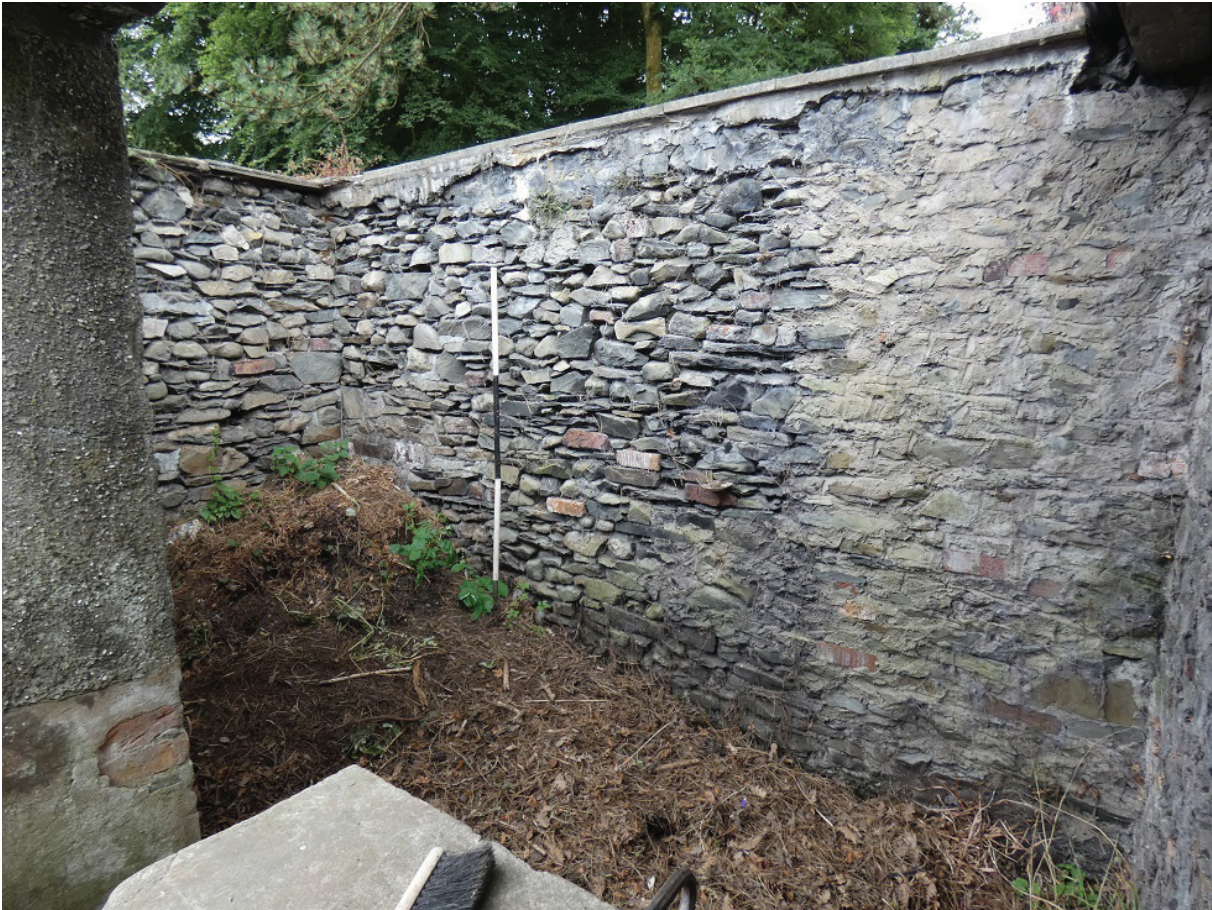
Plate 45: General view of Room G8, from the north-west

4.3.8 **Ground floor Room 8:** this has an earth floor covered in compost. The walls are exposed stone some brick and sandstone and modern concrete pointing in places. There is no roof. The walls are topped with stone and concrete flags. There is a doorway on the north side with two iron L-shaped lintels. The beam from the pent roof continues along the west side.

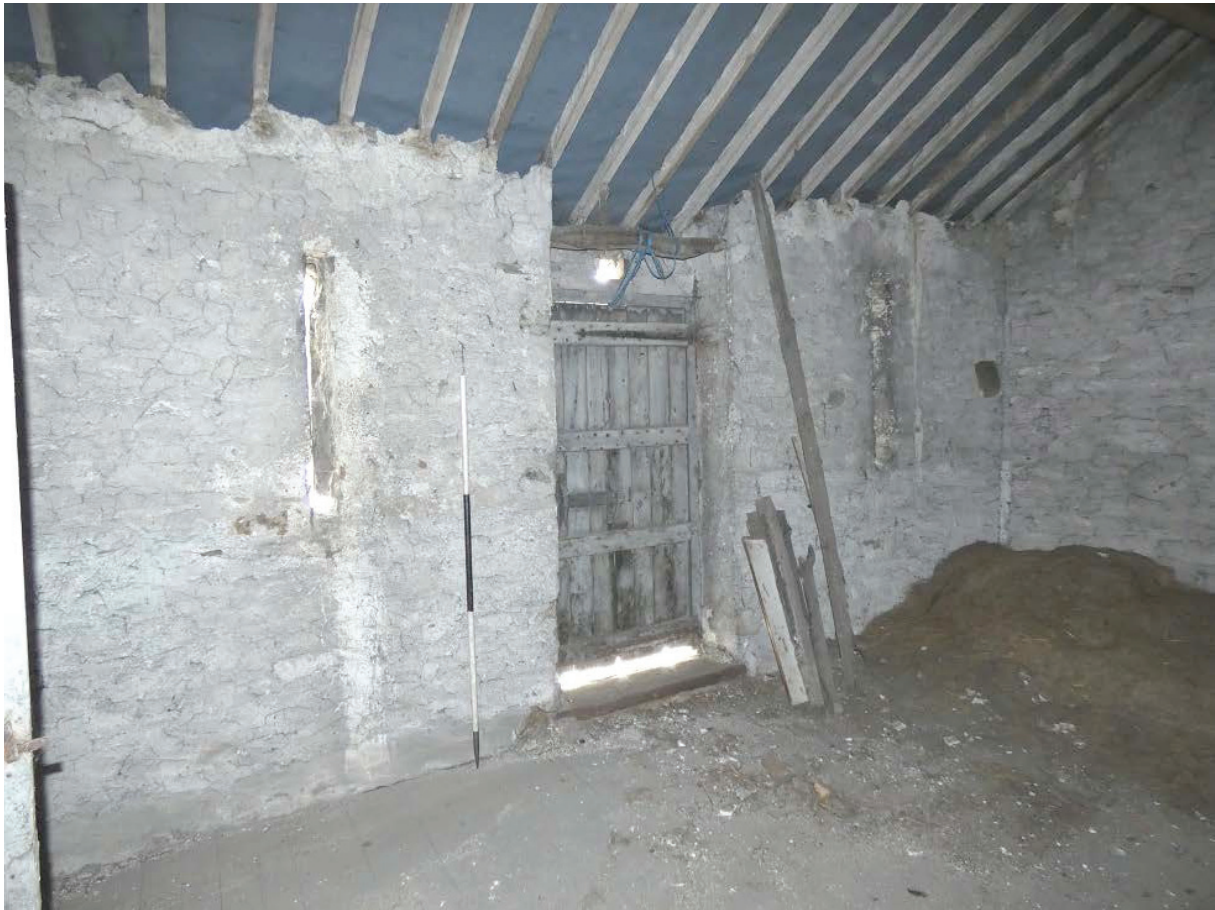
4.3.9 **First floor Room 1:** this has a board floor running north/south, with the boards relatively wide. It is open to the roof, which has new slates and plastic backing, a single purlin per pitch and a ridge plank, neatly finished, sawn with runout stop chamfer. The walls are rough plaster. The **north elevation** has two vent slots either side of a central doorway, with a plank and batten door with long strap hinges set into a wider opening with a rough beam across and a hole in the wall. The **east** and **west elevations** are plain gables. The **south elevation** has two vent slots. The west side has brick at the top for the chimney, and a two-panel door on the north side with L-shaped hinges.

Plate 46: North elevation of Room F1, viewed from the south-west

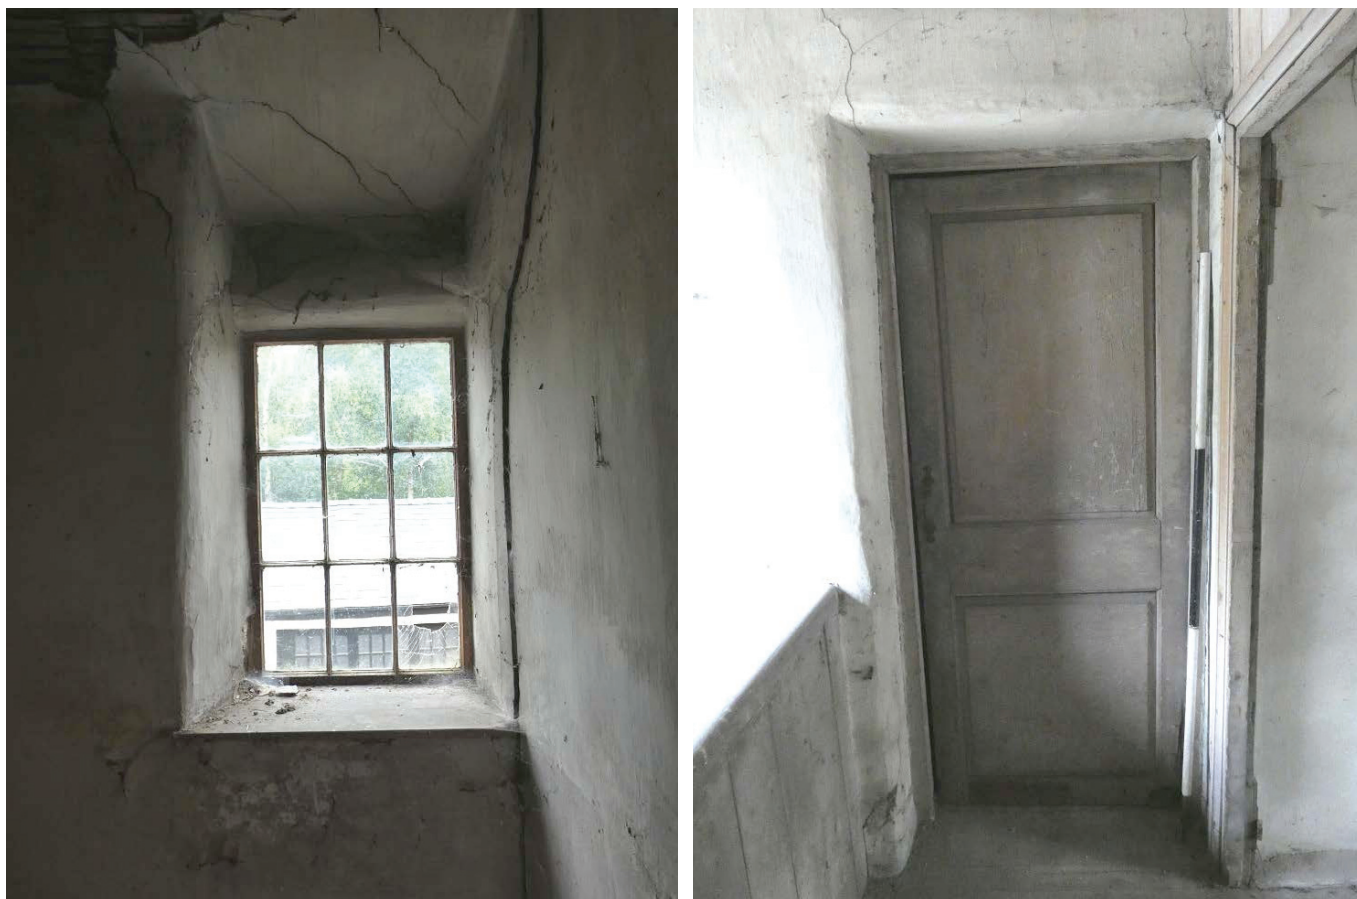
Plate 49 (left): Window in the north elevation of Room F2, viewed from the north
Plate 50 (right): Doorway in the east elevation of Room F2, viewed from the west

4.3.10 **First floor Room 2:** there is a landing at the top of the stairs, and a board floor running north/south with relatively wide boards. It has a flat lath and plaster ceiling, sloping down on the north side. The walls are finished with plaster and distemper, except for the south wall which is beaded tongue and groove planks. The west is mostly brick. There are stairs on the north side. The **north elevation** has a window on the east side, with a 9-light fixed casement, thin timber sill and recessed up to the roof. The **east elevation** has a single door with two raised and fielded panels. The **south elevation** has a doorway on the east side, the door now detached but the same as that to the east but with strap hinges. The **west elevation** has a single door, also two panels. There is a shelf to the north at the top of the stairs, which butts the north elevation.

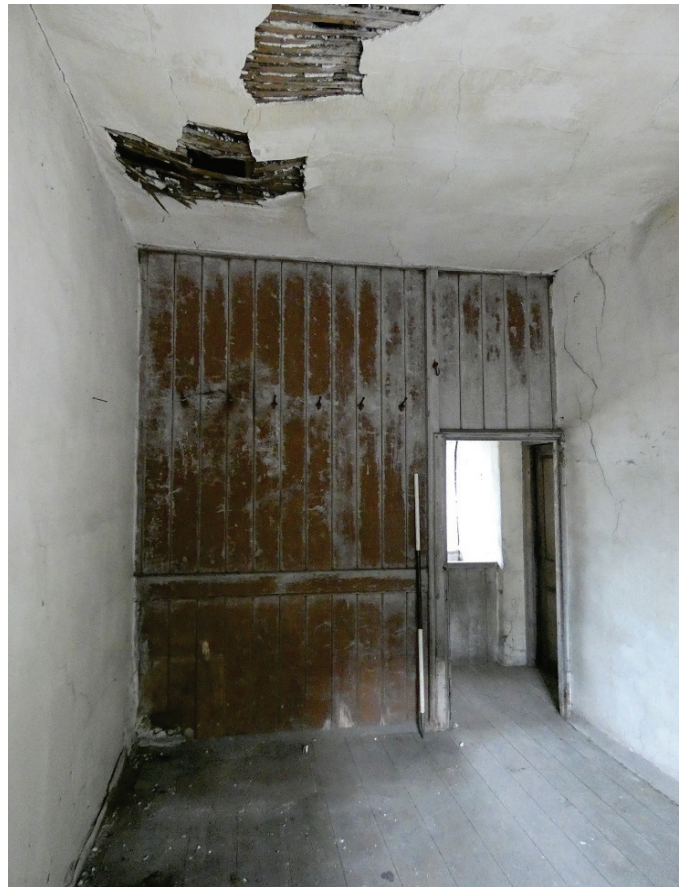
Plate 52 (right): Timber wall forming the north elevation of Room F3, viewed from the south

4.3.11 **First floor Room 3:** this has a timber board floor running north/south, running into room **F2**, with fairly wide boards. There are various areas that have been patched with thin metal sheets and pieces of slate. There is a lath and plaster ceiling, sloping down to the south with a small attic above (inaccessible). The east and west walls are plain, with plaster and paint. The north wall has timber boards, beaded, with a beaded batten and a row of iron pegs. There is a doorway on the east side, and the door is missing but there is a beaded surround. The door is loose in the room, with two raised and fielded panels and strap hinges and an early lock and latch. The **south elevation** has a central window, nine light casement, one hinged, with a timber sill and splayed jambs.

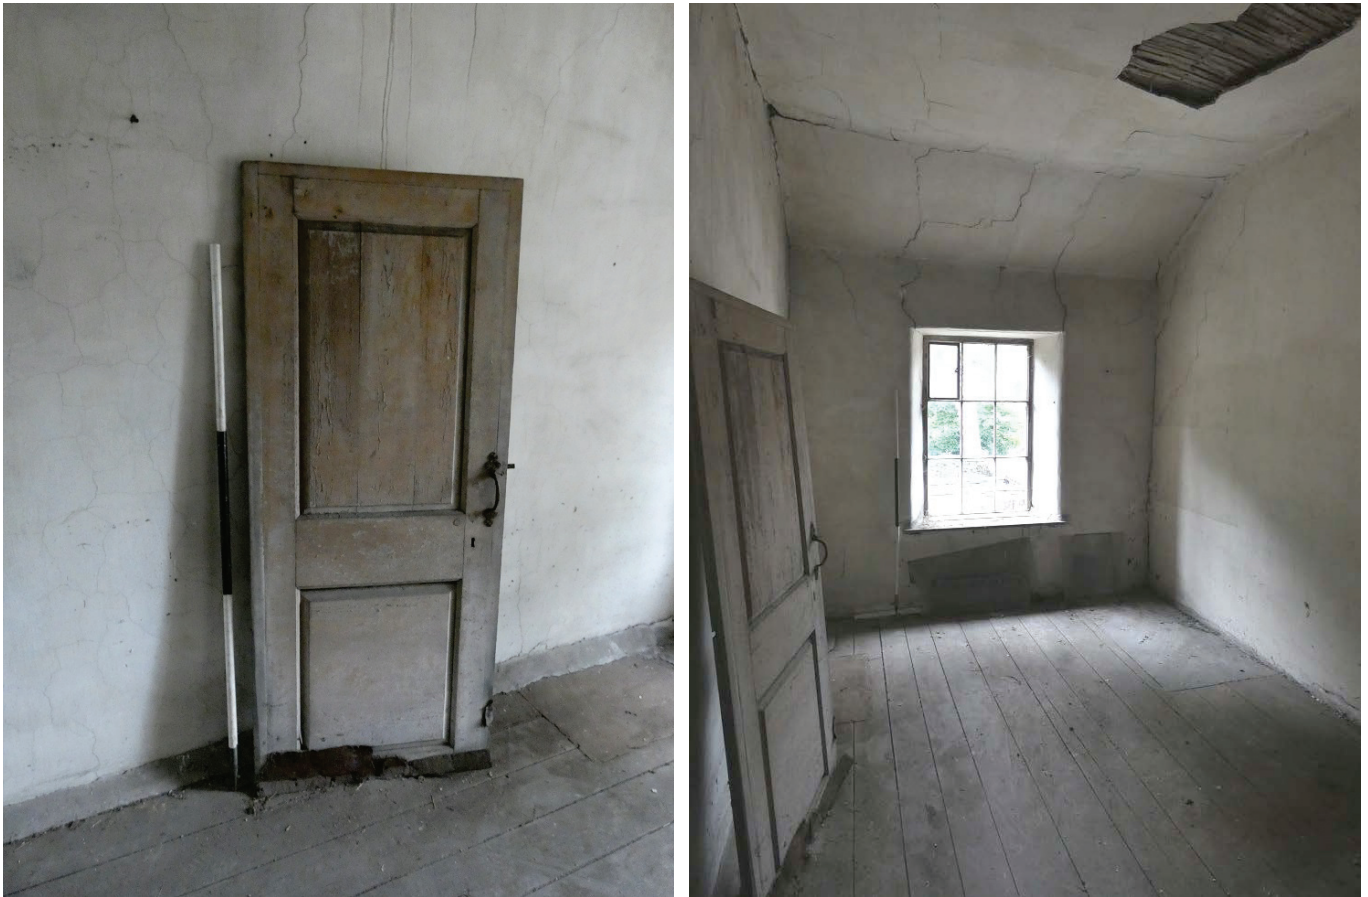
Plate 53 (left): Loose door in Room F3, viewed from the north-west

Plate 54 (right): South elevation of Room F3, viewed from the north

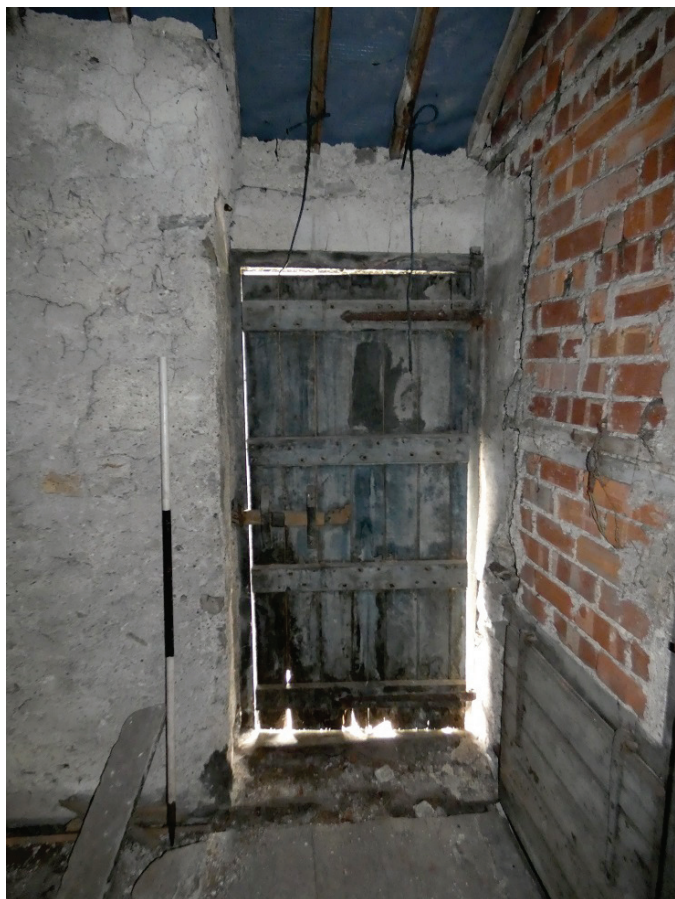
Plate 55 (left): Doorway in the north elevation of Room F4, viewed from the south

4.3.12 **First floor Room 4:** this has a board floor running north/south, with fairly wide boards in poor condition so there was limited access to this room. It is open to the roof, with a single purlin per pitch and a ridge plank, neatly sawn with run out stop chamfer, overlapping with rougher earlier/reused purlins above **F3**. The roof has modern slate and backing. The walls are mostly stone with mortar, the east is constructed from brick. The bricks are very neatly machine-made, typically 23cm by 13cm by 8cm, and with timber battens every 10-12 courses. The **north elevation** has a doorway on the east side, extending to the roof, with plank and batten door with long strap hinges and wooden latch. There are two vents to the west. The **east elevation** is brick butting a short stone section on the north side 0.3m long. There is a hatch low on the north side on long strap hinges, leading into a cupboard below the stairs below, and with a chamfered stop, with tongue and groove planks below a machine cut lintel. The door to the south has a plain surround, reused (?) below a machine cut or sawn lintel. The two is two panel on long strap hinges, with slight moulding, and concrete filling round the sides. The brick is laid in stretcher bond. The **south elevation** is plain with two vents. The **west elevation** is plain, with patches of external early roughcast and some through stones and a large piece of timber low on the north side and a corbelled stack below an arch supported by two iron brackets. The relationship with the north elevation is not clear.

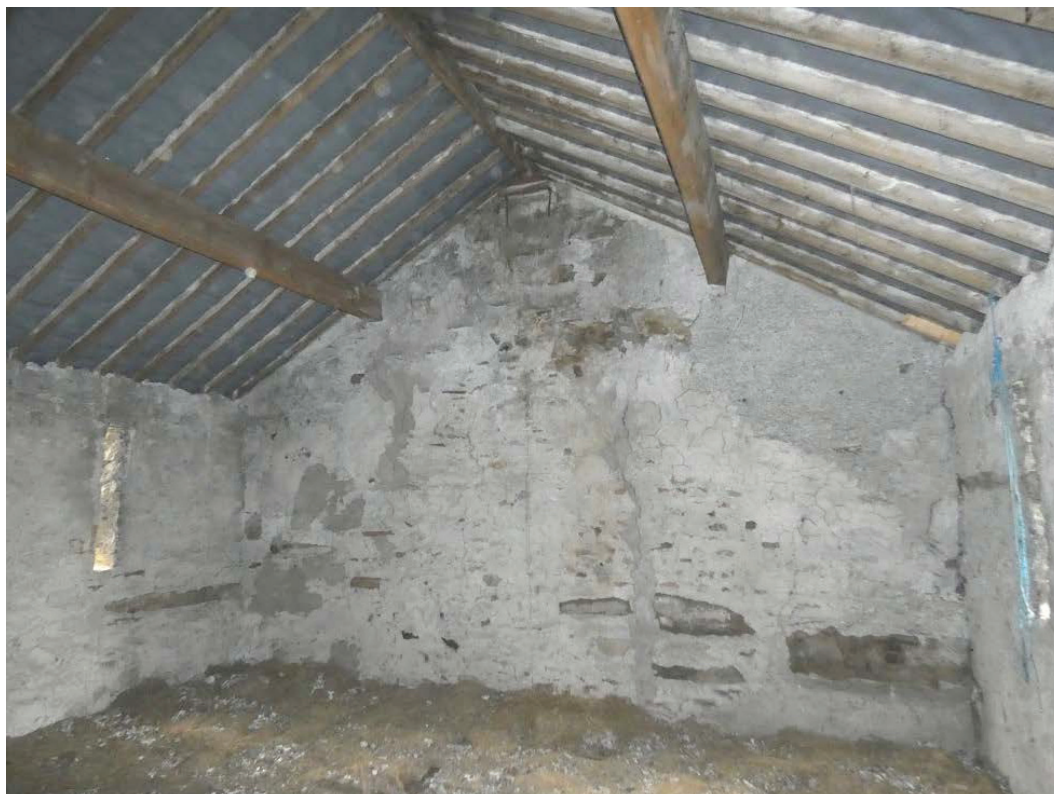
Plate 57: West elevation, Room F4, viewed from the east
