PETTY HALL BARN, ORTON, CUMBRIA

Heritage Statement

April 2019

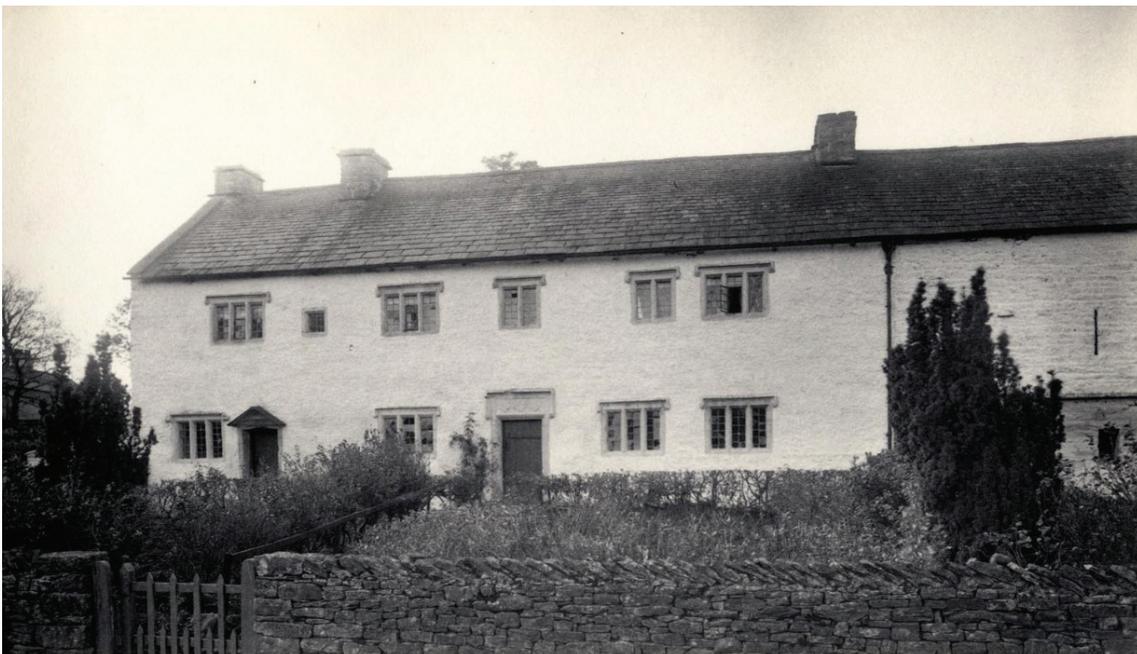
Plate 4: Photograph of Petty Hall and south end of adjoining barn, 1894

3.1.5 **Photograph, 1894:** Petty Hall and the south end of the adjoining barn were photographed by Herbert Bell in 1894, and the photo is number 53 in Vol.1 of an album, *Examples of Early Domestic and Military Architecture in Westmorland*, assembled in 1910 (Norgate and Norgate 2013a). Only part of the barn is shown but it is clearly finished with limewash by this time. A later photograph taken in the mid-20th century shows that this limewash remained well into the 20th century (reproduced in Palmer and McIntire 1983, 99).

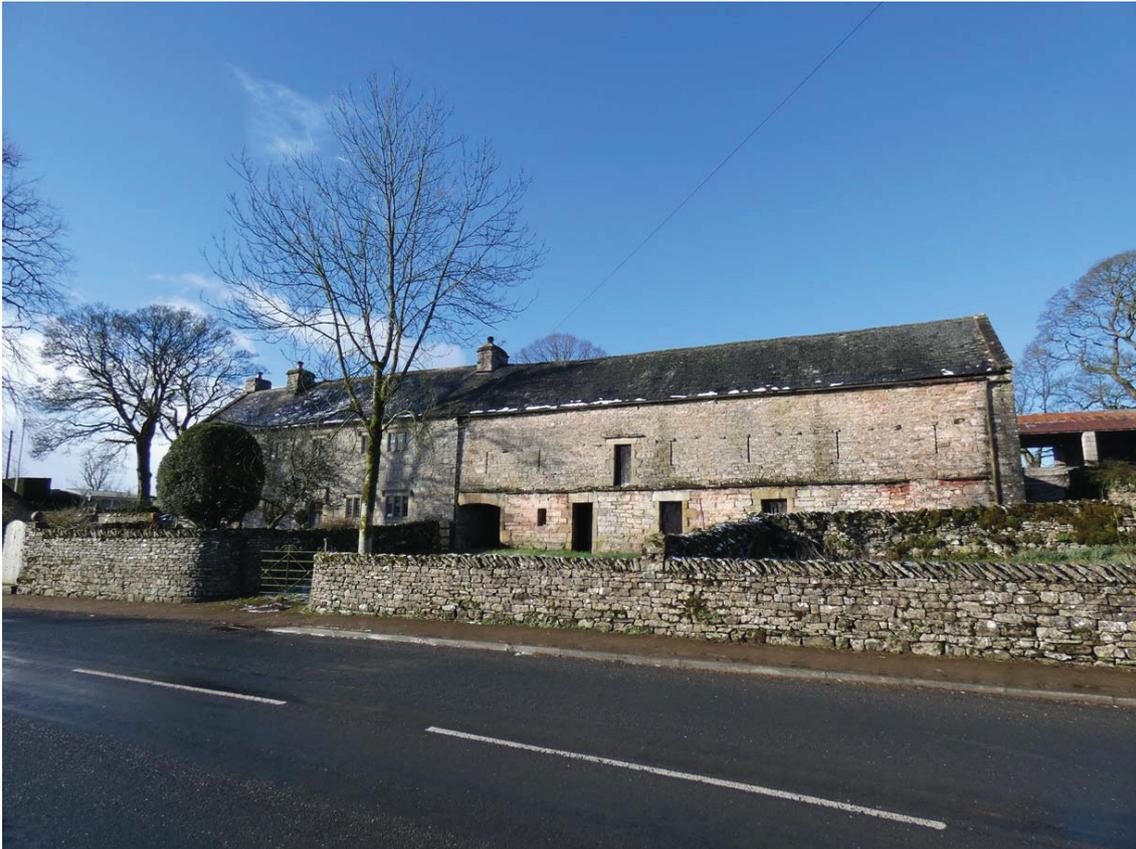
4.1.1 **Arrangement:** the building primarily comprises part of a long linear range orientated north/south and is attached to Petty Hall at the south end (Plate 7), although there is a small outshut at the centre of the western elevation of the barn. It has been further extended at the north end of the west elevation with a concrete block addition and a timber shed finished with corrugated metal sheeting also extends from the west elevation but this is not actually attached to the barn. The front elevation of the barn faces east towards the road; the building is a bank barn built into the slope along the long west side, which allows for the lower floor level.

Plate 7: General view of the barn, with Petty Hall to the south, viewed from the north-east

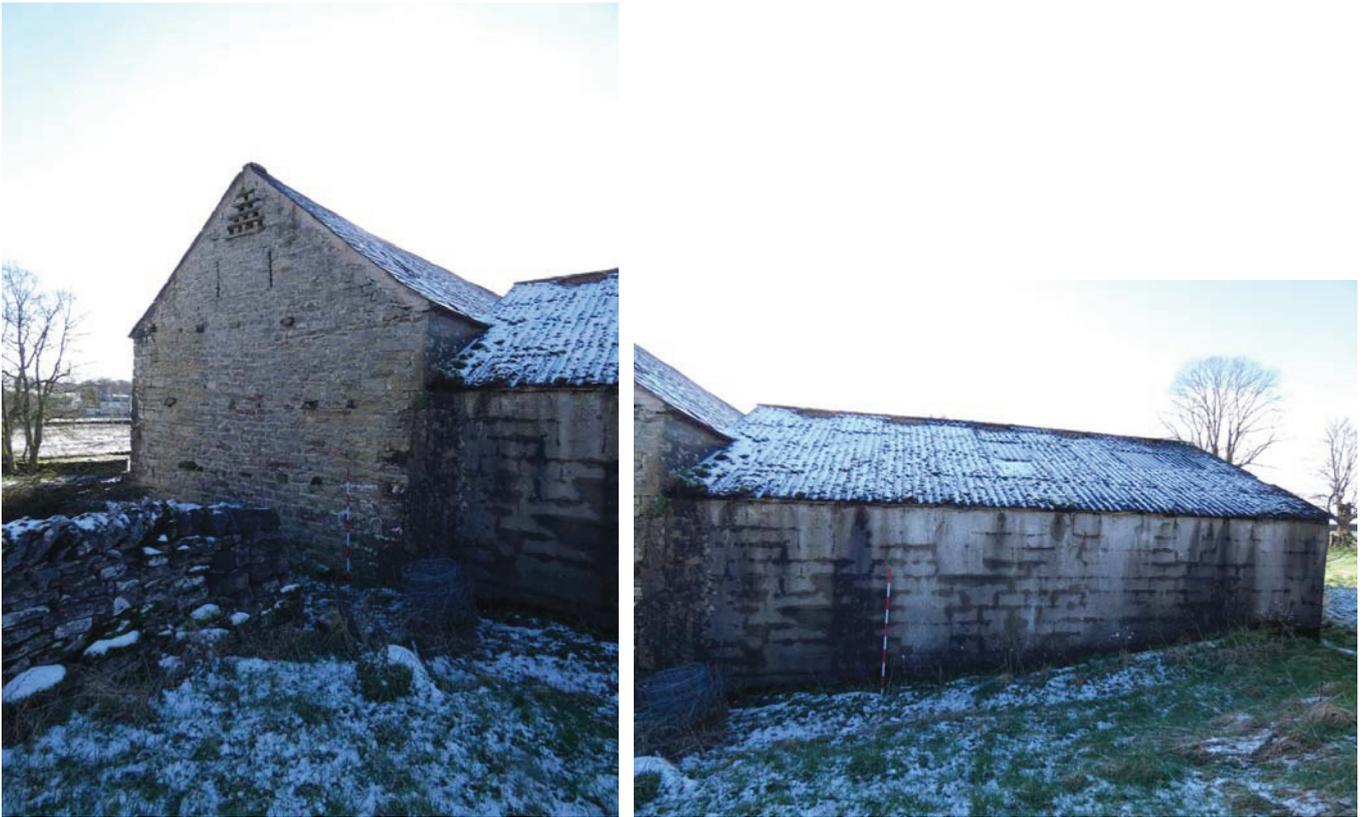
4.2.1 **North external elevation:** this is the gable end. It is repointed in concrete along the eaves, and has defined quoins at both end and three rows of through stones. There are two slot vents at the top and a row of five projecting slabs housing dovescotes at the eaves (Plate 8). It is extended to the west by the side of the concrete block extension, which is plain (Plate 9). There is a further extension after a return, with the back of a monopitch section to the concrete extension, with a single doorway in a plain surround, and a plank and batten door.

Plate 8 (left): The gable end of the barn forming the main part of the north external elevation, viewed from the north-west

Plate 9 (right): The extension to the west of the north external elevation, viewed from the north

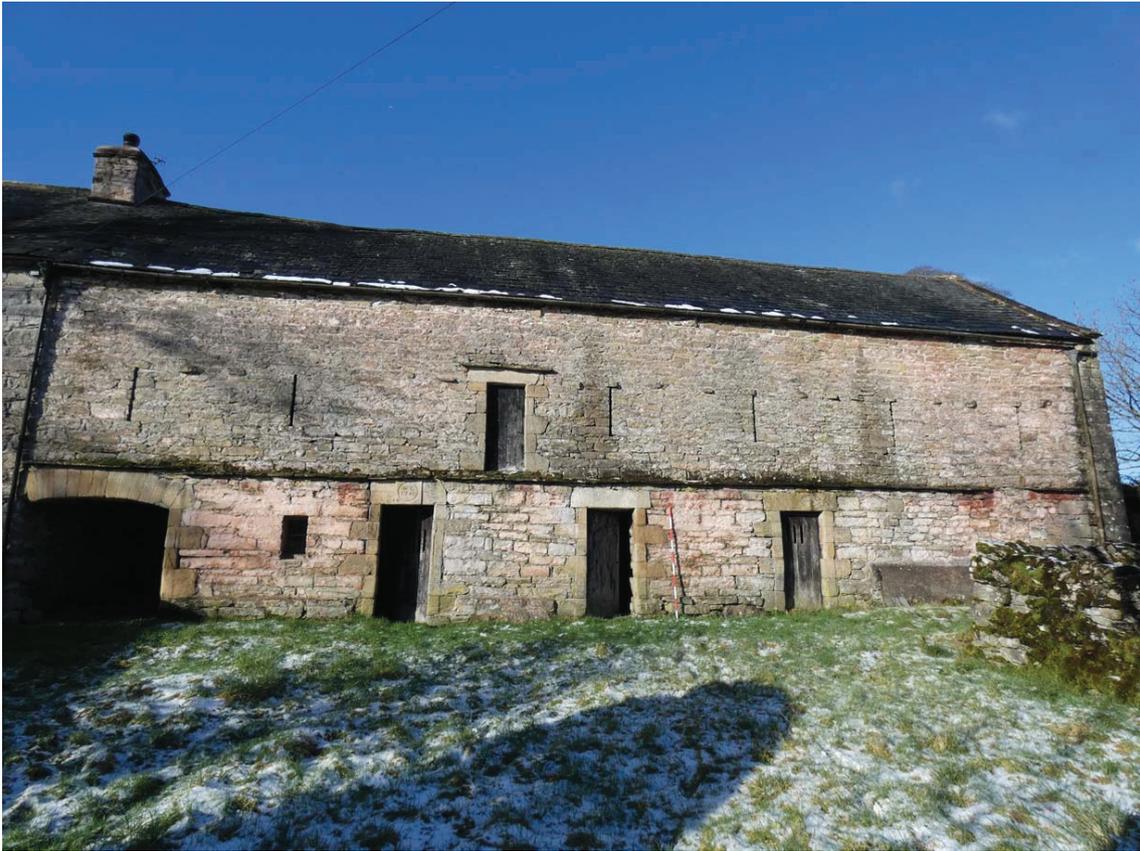
4.2.2 East external elevation: this is the front elevation, it is two storeys high, and it is facing onto the road (Plate 10). There are quoins at the north end and iron rain water goods and stone coping over the slates at the north end. There is a concrete skim over the lower part at the north end with part of the projecting concrete block wall to the south, presumably denoting the position of a former outshut (Plate 11). There is a small blocked window at the north end. There is a row of three doorways on the lower floor, each with neatly dressed quoins, the long ones rebated and scored for render, neatly chamfered. The southern door has a datestone in a moulded circular medallion above the lintel: 'W : G 1740' (Plate 12), and there is also graffiti initials 'JH' scored into its south jamb (Plate 13). All of the doorways have timber plank and batten doors, the north and south with three vent slots. There is a small window to the south, with a two light fixed casement. There is a narrow wagon doorway to the south into the passage below the building with a dressed voussoir arch and quoins (Plate 14). The barn clearly butts the house to the south – the house has a datestone 'GB 1604 MB'. There is a projecting plinth along the base of the elevation and a drip course of thick slabs above the lintels of the doorways. The upper floor has five vent slots and a row of through stones. There is a central winnowing/pitching door with dressed quoins, and a slight chamfer and drip mould over.

Plate 10: General view of the east external elevation, viewed from the east

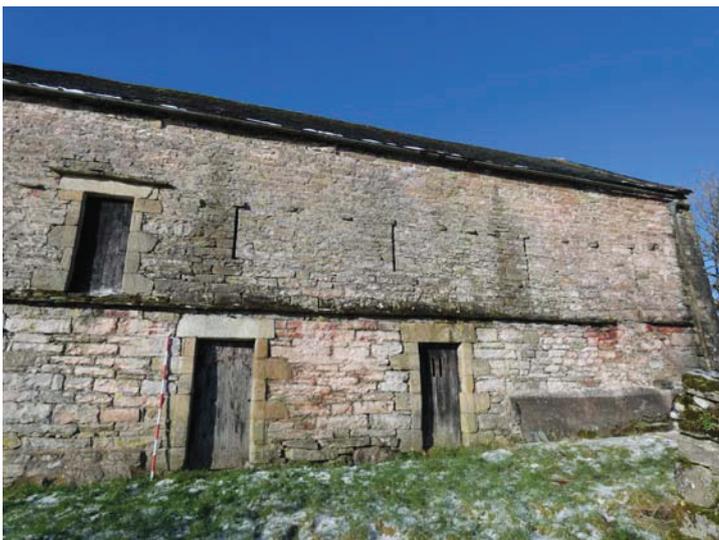
Plate 11 (left): The north end of the east external elevation, viewed from the south-east

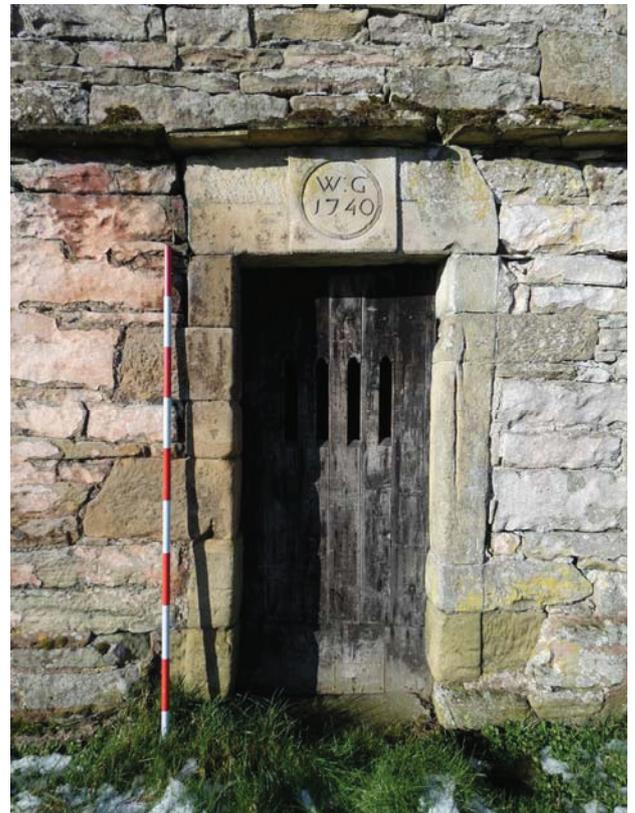
Plate 12 (right): The southernmost lower level doorway in the east external elevation, viewed from the east

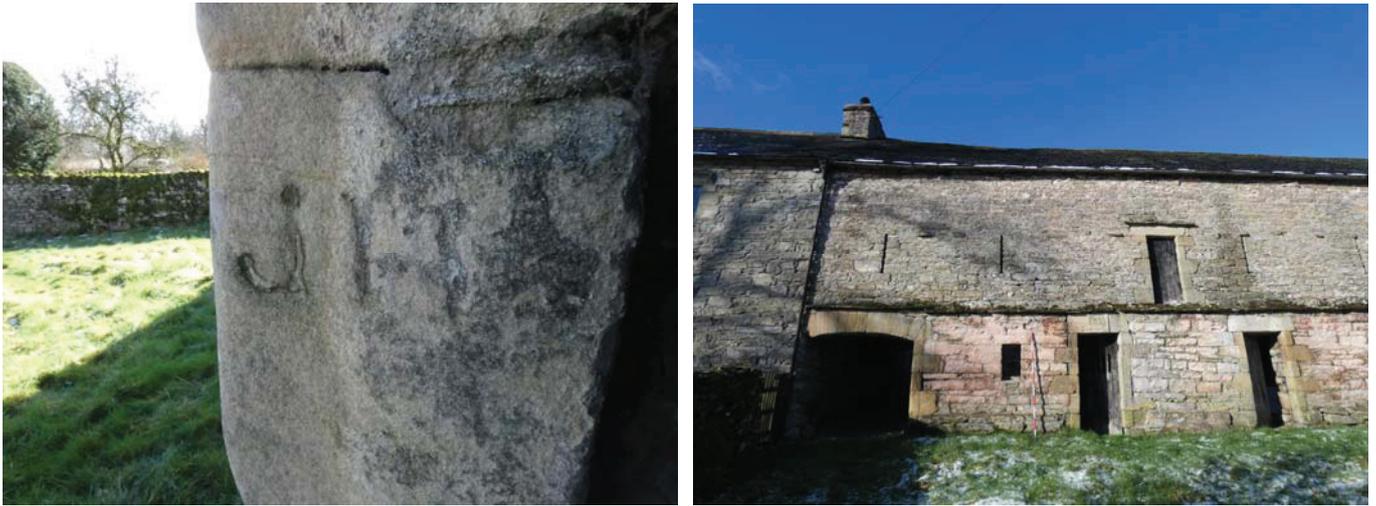
Plate 13 (left): Graffiti on the southern jamb of the southernmost doorway in the east external elevation, viewed from the north

Plate 14 (right): The south end of the east external elevation, viewed from the east

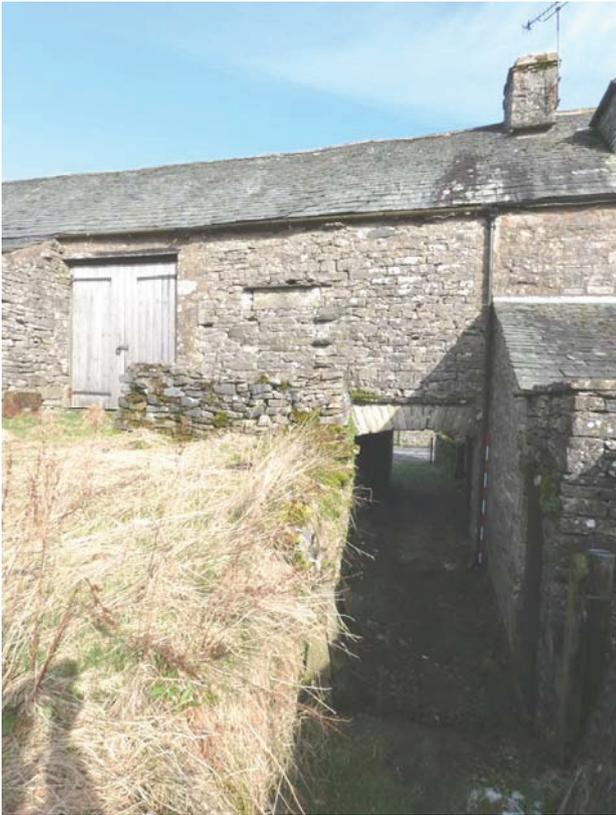
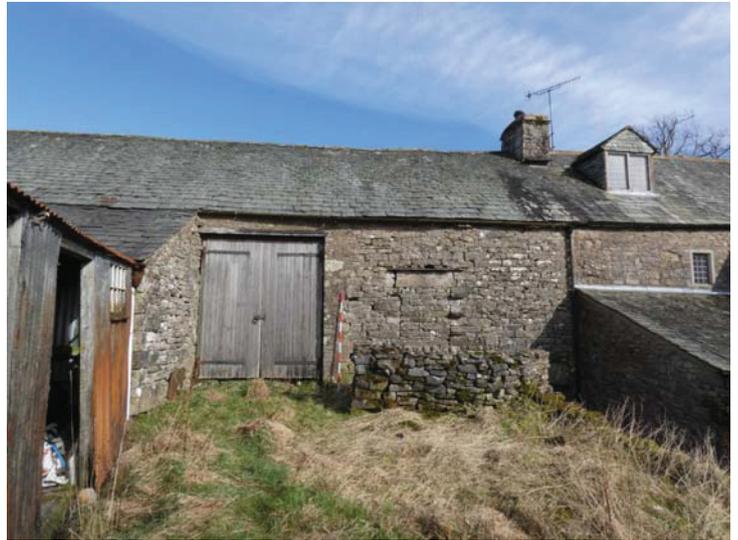
4.2.3 West external elevation: the south end of this elevation butts the house. There is a lower level opening to the passage below the building against this, with a voussoir arch in yellow stone (Plate 15). The rest of the elevation is in a much more obviously limestone at the upper level. There is a blocked doorway on the south side with a stone lintel with a drip course over, blocked with stone, and no quoins as such (Plate 16). There is a wagon door to the north of this in the centre, and it has been inserted or widened as there is concrete rebuild in the jamb to the south and a projecting line of concrete, presumably for an attached outshut that is now missing. The wagon door has a reused sleeper for a lintel and is rebuilt above and in the south jamb. To the north of the wagon doorway the wall returns at the small extension to the west, which is built in a much rougher limestone with large quoins and has a rough hole apparently purposefully broken through it at the base. The side of the monopitch is repointed along the top in concrete. There is a return to the north which is plain and is butted by an extension to the north (this is all largely obscured by a timber shed). The return of the extension is plain concrete blocks, and continues as the side of the monopitch section, with a single window with an eight-light casement, with secondary glazing over it (Plate 17). The north end is the gable of the extension, and has a wide doorway with a detached sliding door and an eight-light window above, with secondary glazing over (Plate 18).

Plate 15 (left): The south end of the west external elevation, viewed from the west
Plate 16 (right): The central part of the west external elevation, viewed from the west

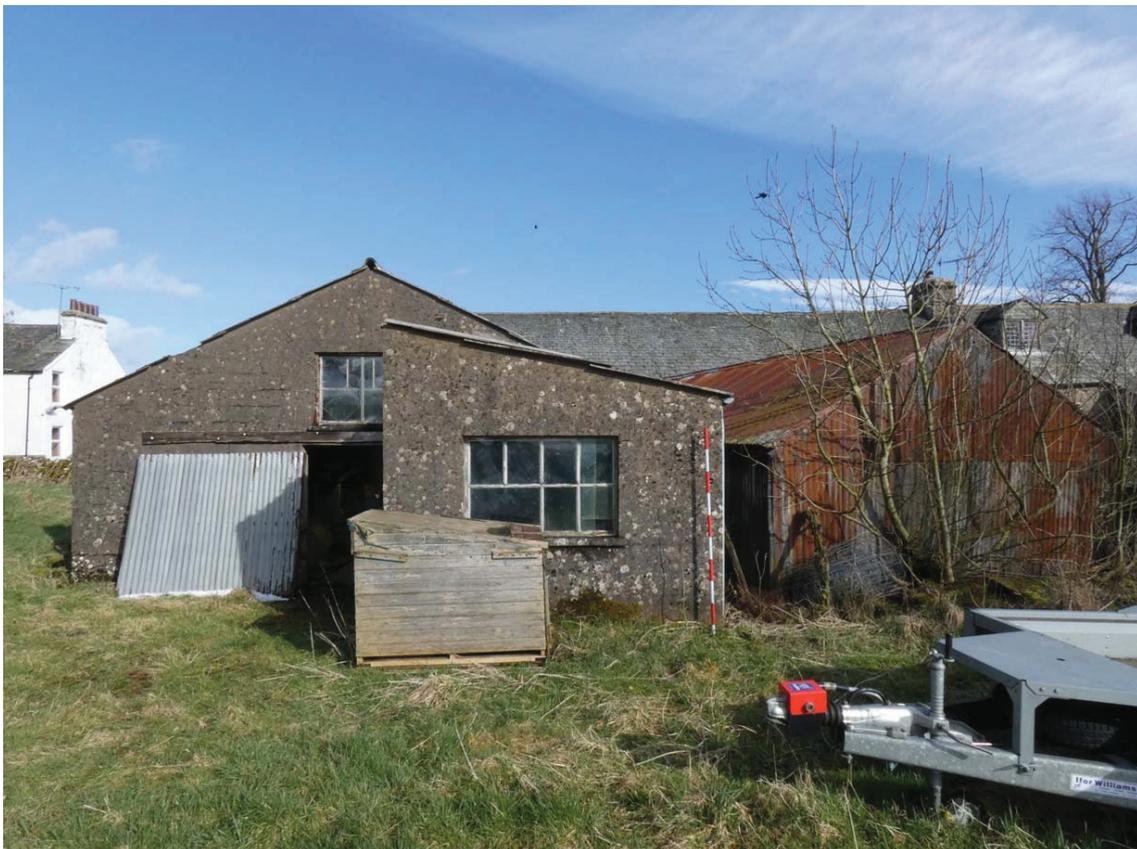
Plate 17 (left): The north end of the west external elevation showing the later extension, viewed from the west

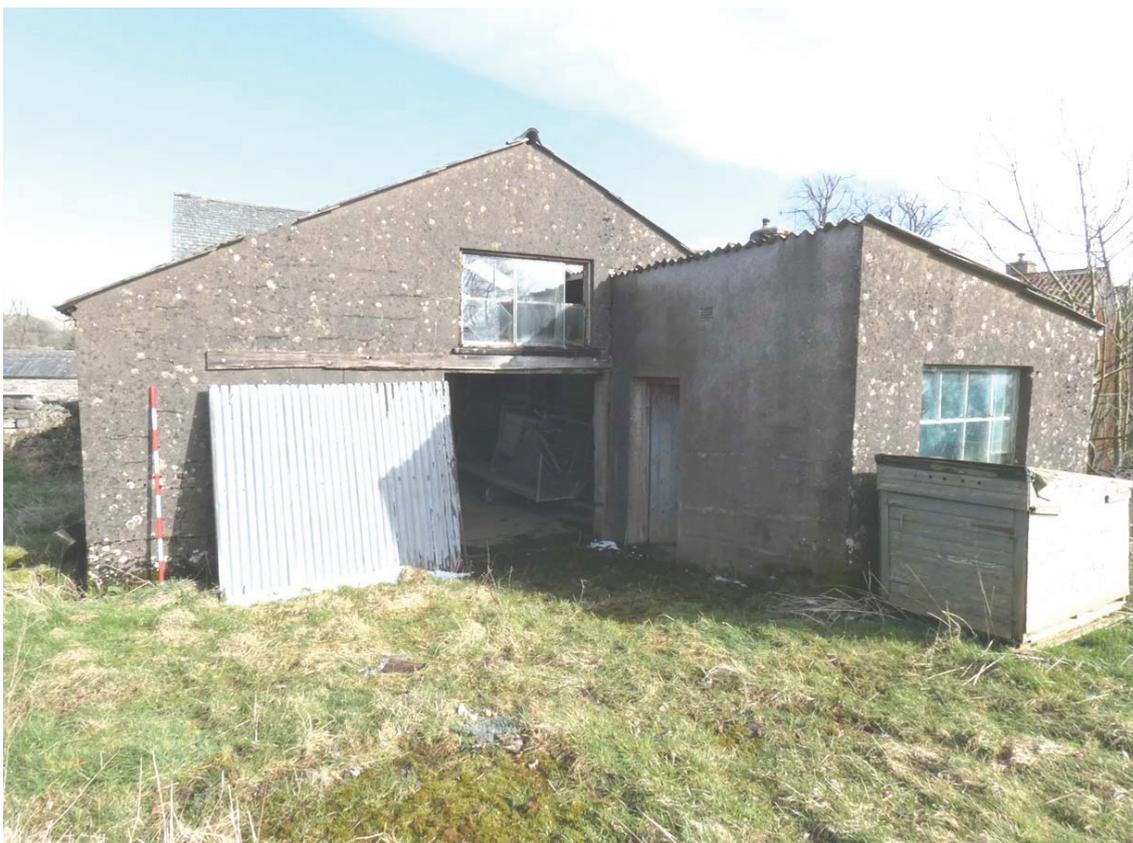
Plate 18 (right): The north end of the west external elevation showing the later extension, viewed from the north-west

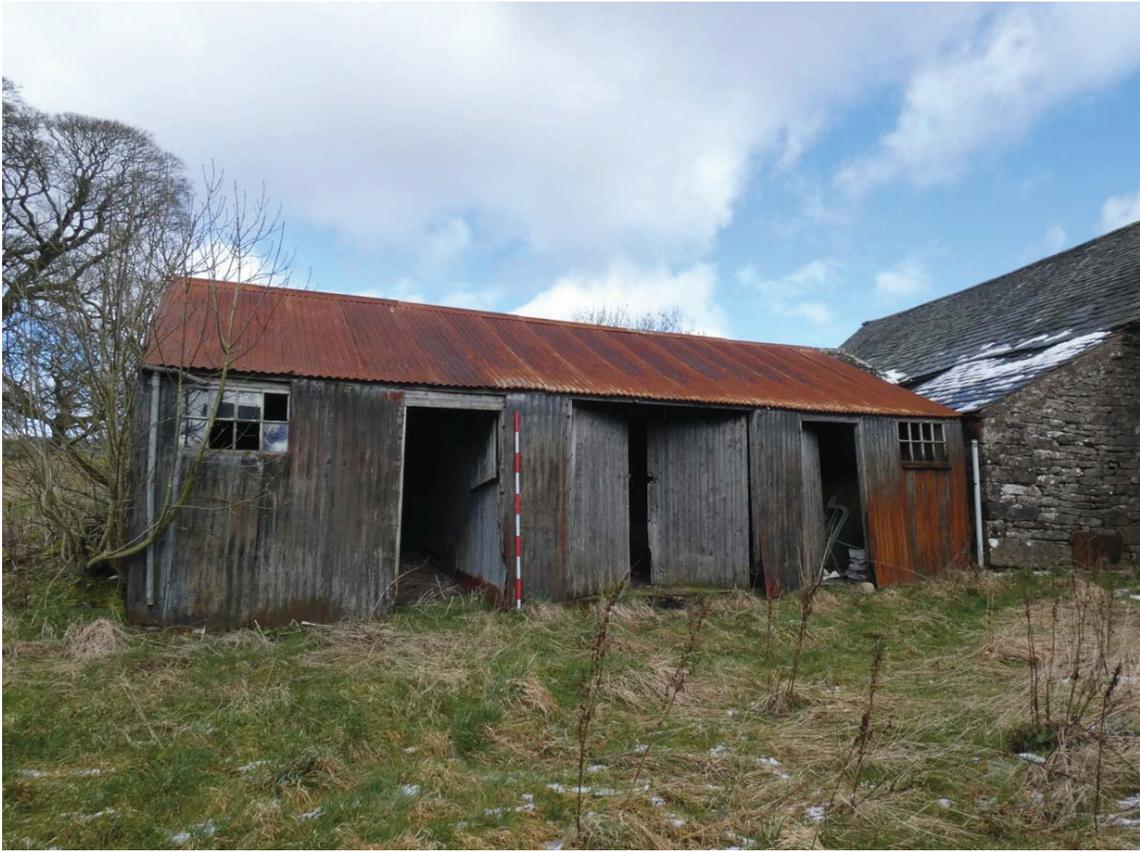
4.2.4 **Shed:** this is detached from the main building but part of the structure is in the space between the main barn and the outshut. It is of timber construction covered with corrugated iron sheeting. The north and east elevations are against other buildings. The south elevation has two small doorways and two windows, both eight-light, with a central large doorway with a plank and batten door (Plate 19). The west elevation is a plain gable (Plate 20).

Plate 19: The south elevation of the shed, viewed from the south

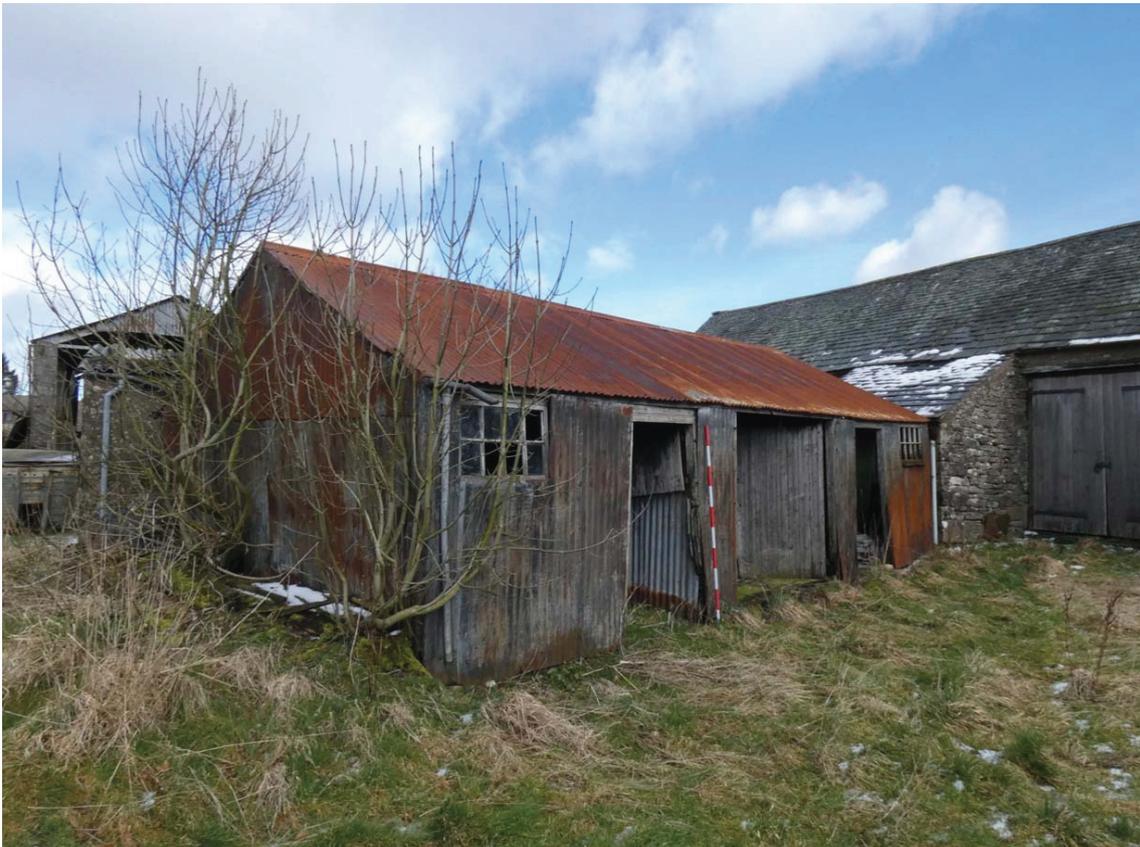
Plate 20: General view of the shed, from the south-west

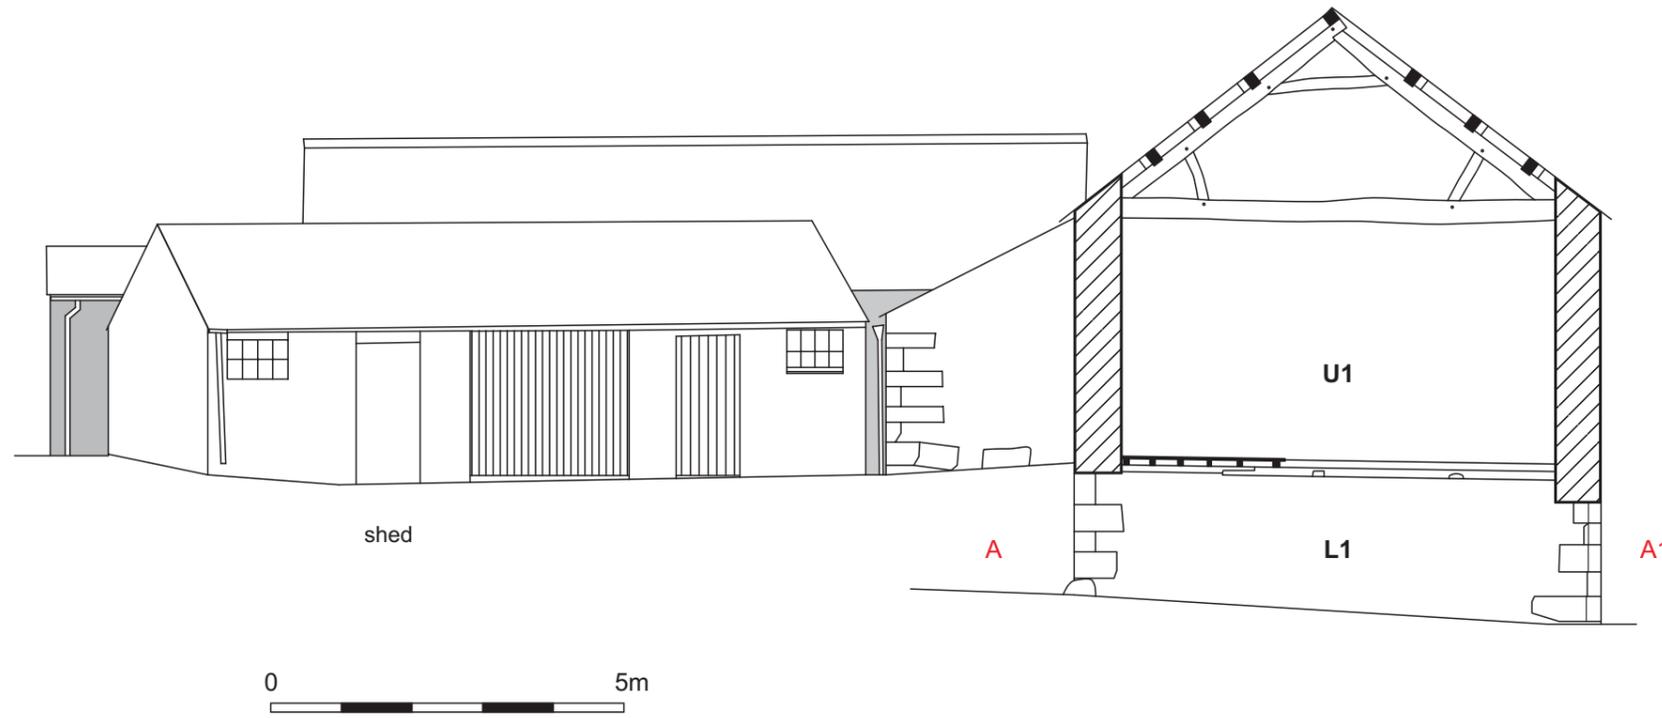
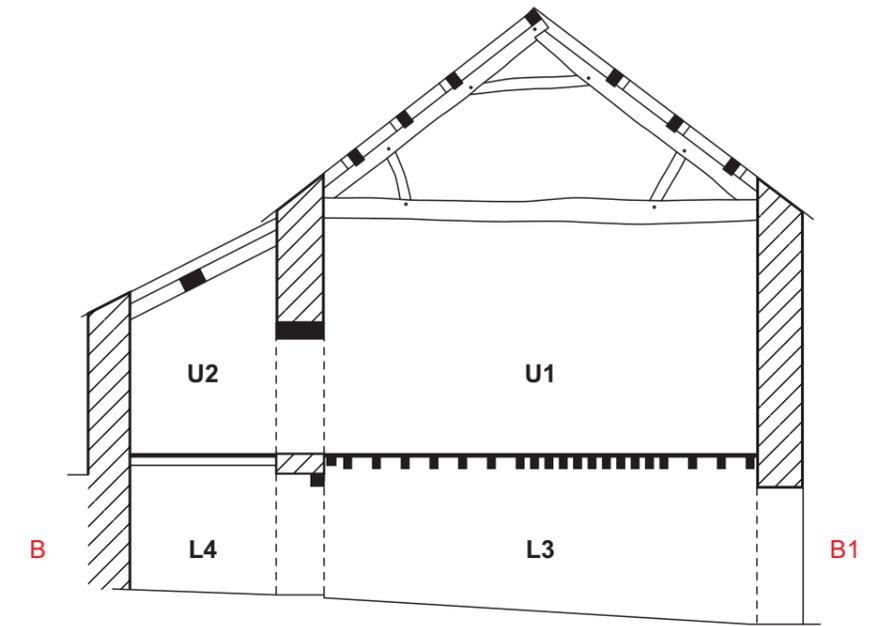
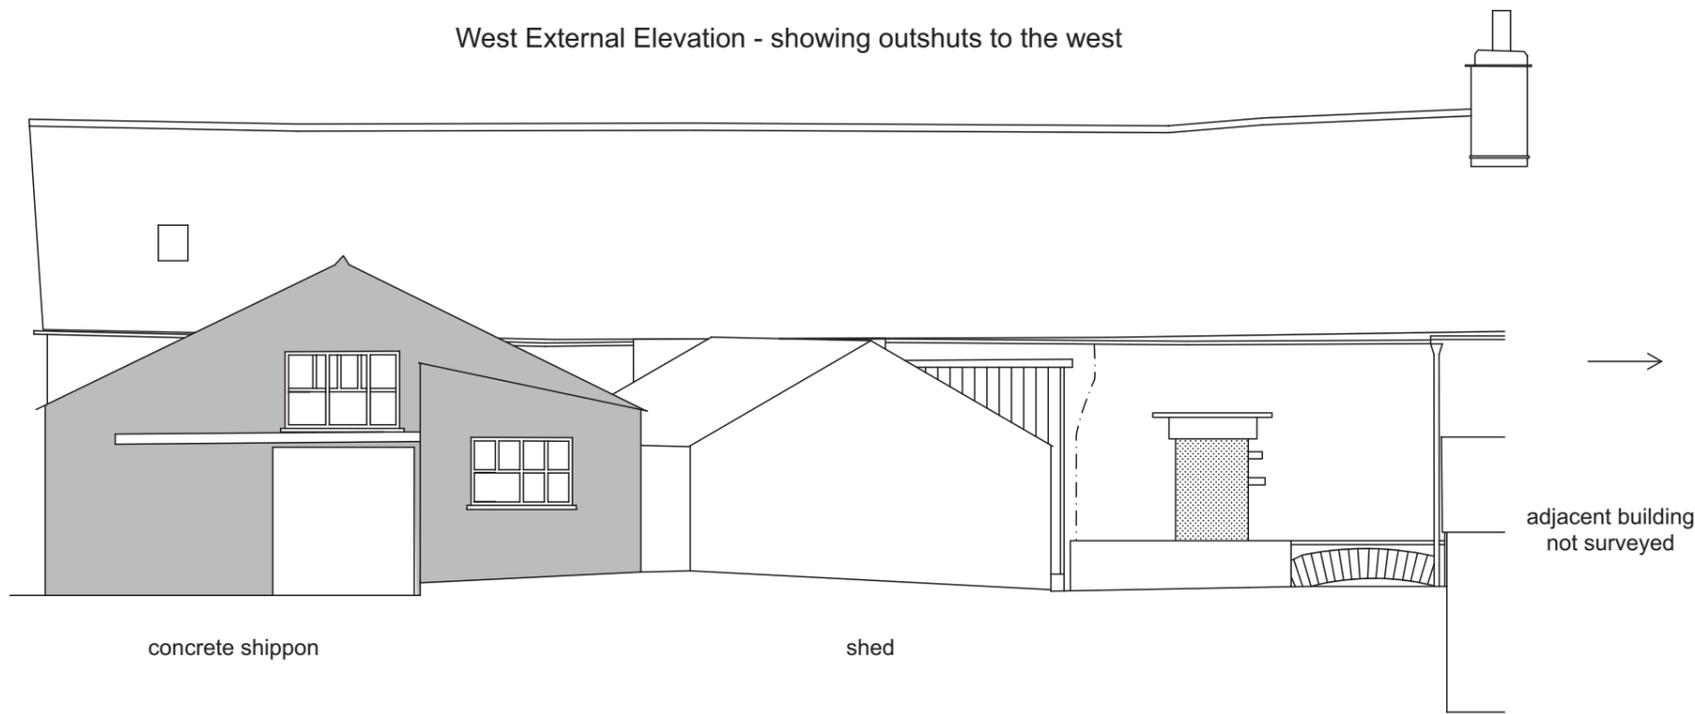
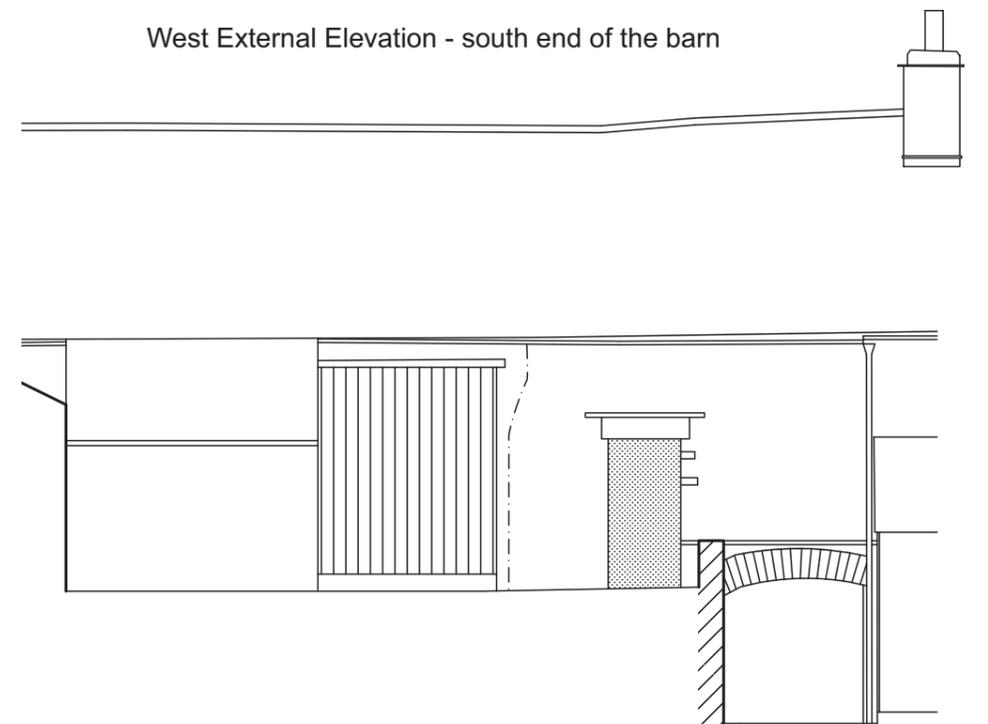
Figure 3: South and west external elevations and cross-sections A-A1 and B-B1

South External Elevation and Cross-section A-A1

Cross-section B-B1

West External Elevation - showing outshuts to the west

West External Elevation - south end of the barn

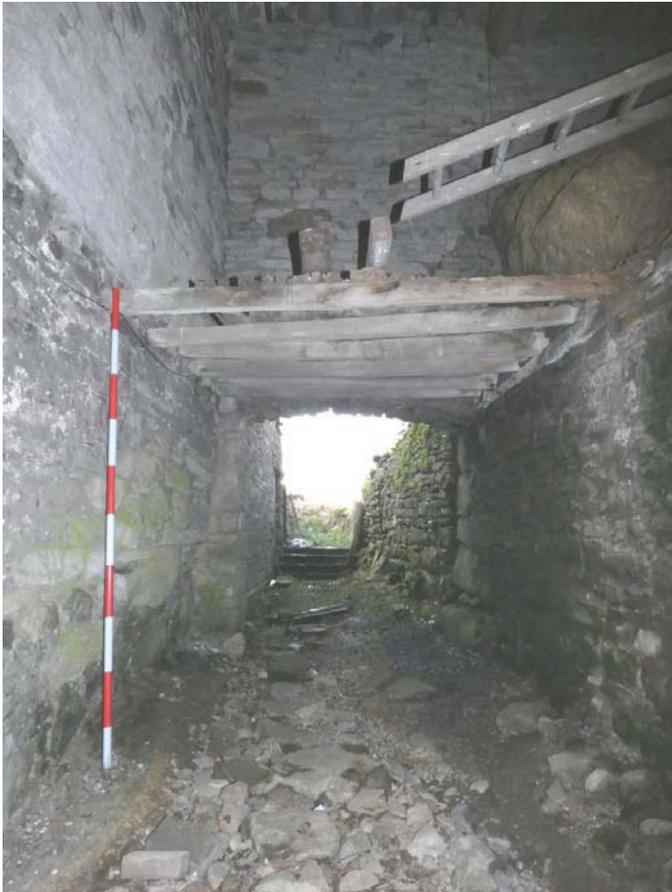
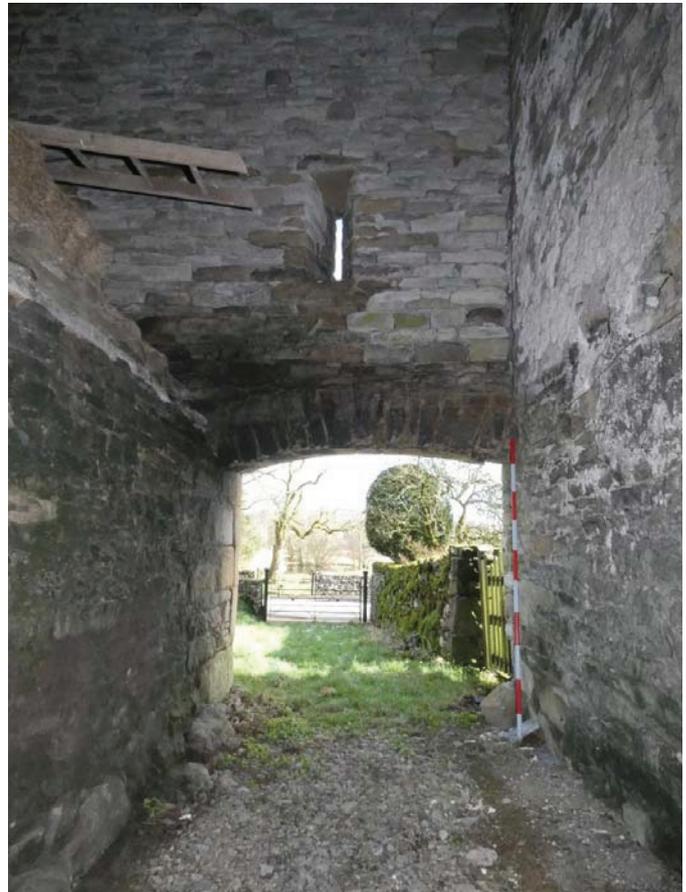
4.3.1 **Lower level floor Room 1 (L1):** this comprises a passageway running below the building from east to west. The floor was apparently originally concrete but this has largely worn through to rough stone and the room is mostly open to the floor above but the west end retains part of a floor made from sawn joists and floorboards (Plate 21). The walls are finished with rough render to the **north** and **south** and there is a timber wall plate at the top of the north elevation and joist holes to the south. The **east** and **west** ends of the room are open through arched openings with voussoir stones (Plate 22).

Plate 21 (left): Room L1 showing the remaining floor of the room above, viewed from the east

Plate 22 (right): Room L1, showing the arched opening to the east, viewed from the west

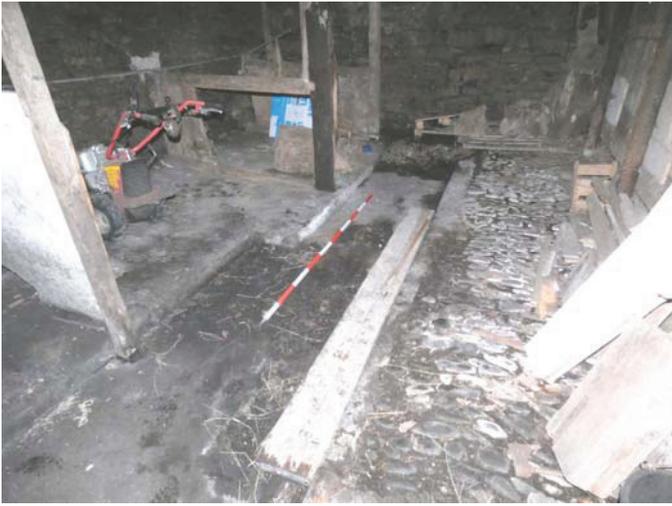
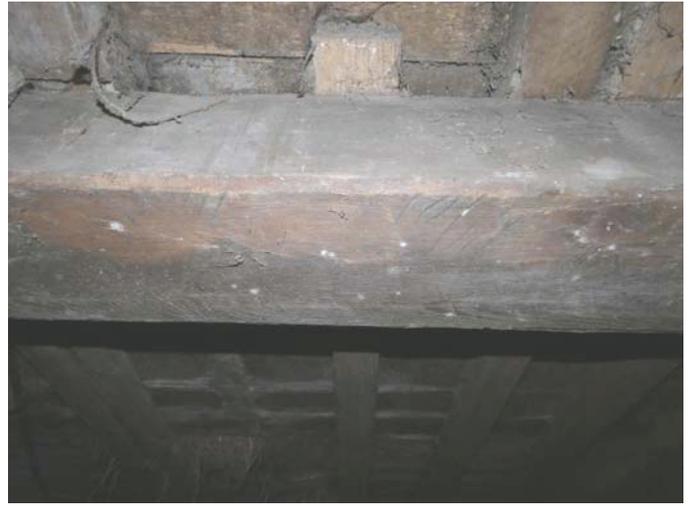
4.3.2 **Lower level floor Room 2 (L2):** this room has a concrete dung channel east/west through the centre and a concrete step up on the south side but cobbles to the north (Plate 23). The ceiling is supported by two east/west beams. The south beam has Baltic timber marks (Plate 24) and the north one is reused. The south one is supported by posts for three timber stalls against the south wall, which are very basic and hand-finished (Plate 25 and Plate 26). The north beam is supported by three iron columns with flat plates on the top. The east, west and south walls are exposed stone. The **north elevation** comprises a plank and batten timber partition against the iron posts (Plate 27). The **east elevation** has a doorway with a stone lintel and rebate for the plank and batten door (Plate 28). The small two-light casement window to the south has a stone lintel and thin stone sill. The **south elevation** is plain with a wall plate at the top and pipes for the drinking troughs labelled 'FORDHAM | PAT N^o. 452755'. The **west elevation** has a small alcove on the north side with a stone lintel.

Plate 23 (left): Floor in Room L2, viewed from the east

Plate 24 (right): Baltic marks on the southern beam, Room L2, viewed from the south

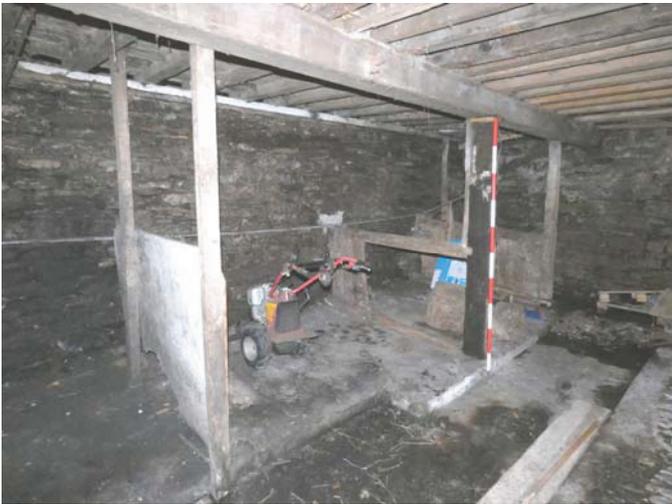
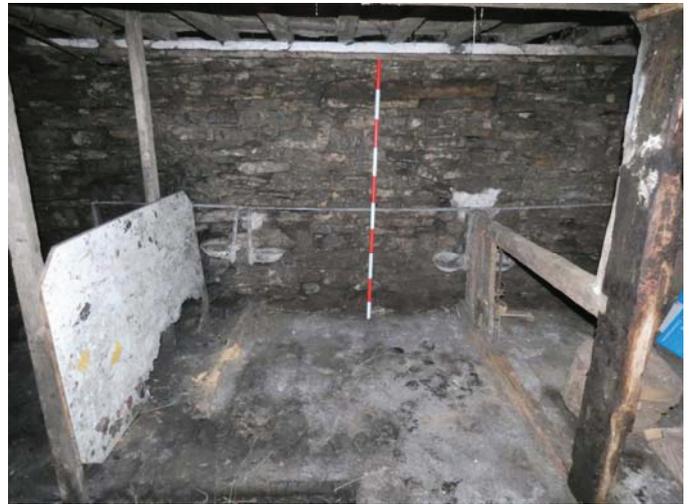
Plate 25 (left): Stalls on the south side of Room L2, viewed from the north-east

Plate 26 (right): Stall detail on south side of Room L2, viewed from the north

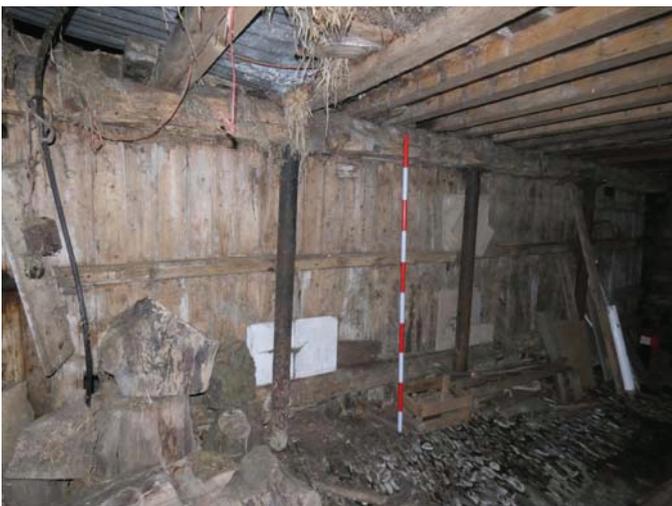
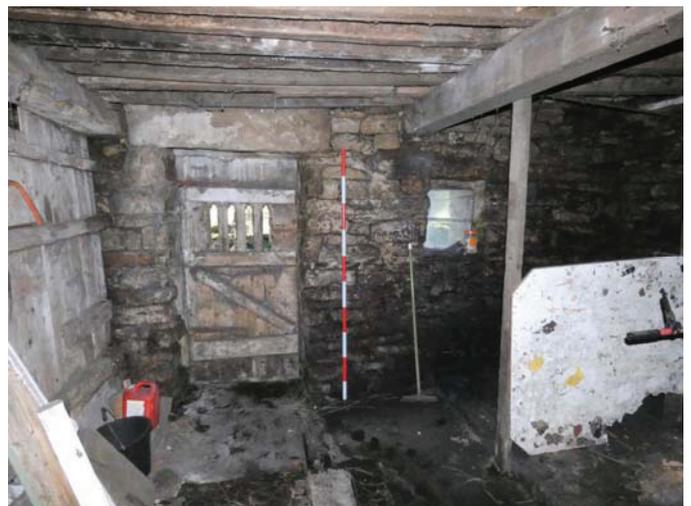
Plate 27 (left): The north elevation in Room L2, viewed from the south-west

Plate 28 (right): Doorway in the east elevation, Room L2, viewed from the west

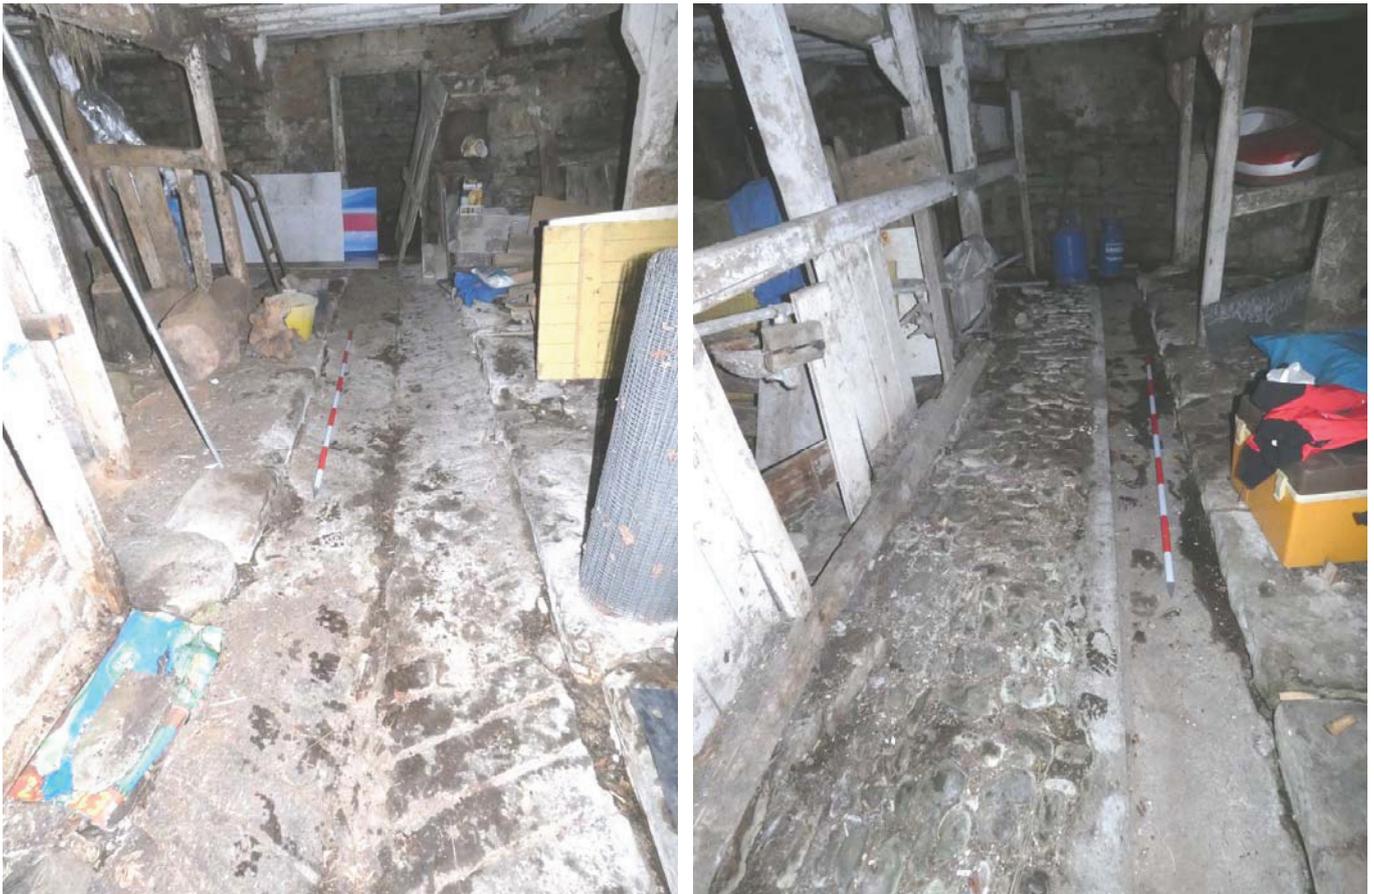
4.3.3 **Lower level floor Room 3 (L3):** there is a double row of stalls with two concrete lined dung channels east/west with raised areas either side with stone edging and cobbled floors (Plate 29 and Plate 30). There are stalls against the south elevation and in the central area and to the north side, mostly of hand-finished timber construction connected to the hand-finished supporting beams for the ceiling (Plate 31 and Plate 32). The stalls to the north side of the room have stone slab construction (Plate 33) and there is a manger in the south-east corner (Plate 34). The joists are a mix of hand-finished and later replacements. The originals are whitewashed. There are metal troughs at the stalls like in L2. The walls are finished with whitewash. The **north elevation** is plain apart from the doorway on the west side. The **east elevation** has two doorways with stone lintels and a very decayed timber one rebated for the plank and batten doors (Plate 35). The **south elevation** comprises a plank and batten timber partition. The doorway to the south side of the **west elevation** has a plain timber surround and early plank and batten door on strap hinges (Plate 36) with a timber lintel and an alcove to the north with a stone lintel. To the north of this there is a further possible opening blocked with stone.

Plate 29 (left): Dung channel in the floor on the south side of Room L3, viewed from the east

Plate 30 (right): Dung channel in the floor on the north side of Room L3, viewed from the east

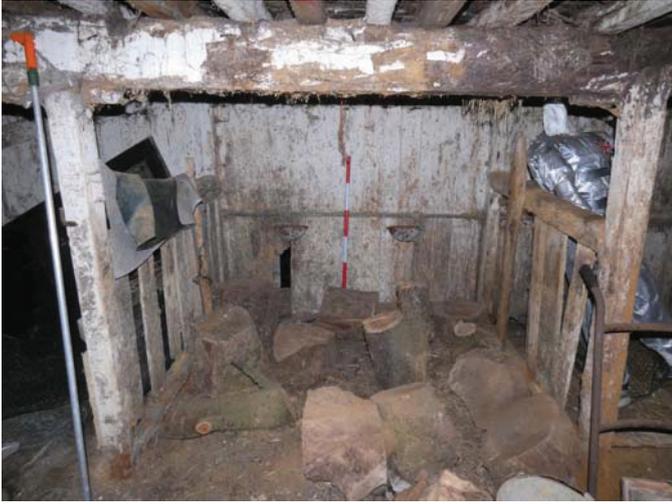
Plate 31 (left): Stall detail on the south side of Room L3, viewed from the north

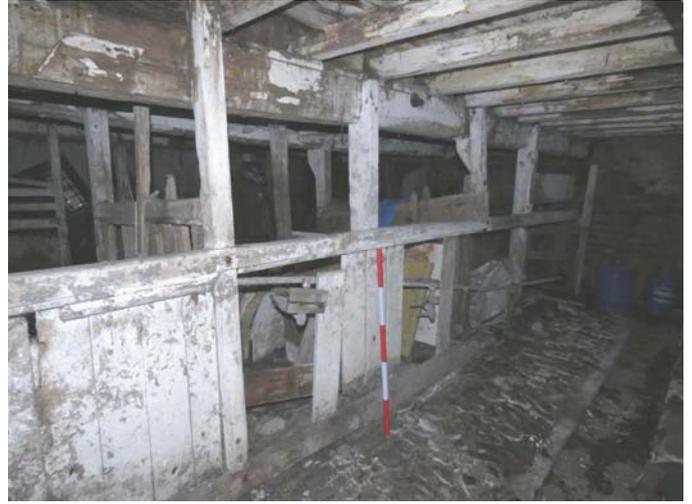
Plate 32 (right): Stalls in the centre of Room L3, viewed from the north-east

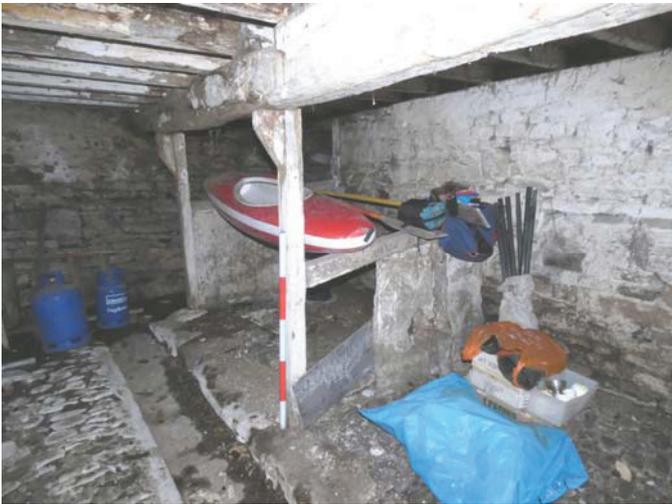
Plate 33 (left): Stalls on the north side of Room L3, viewed from the south-east

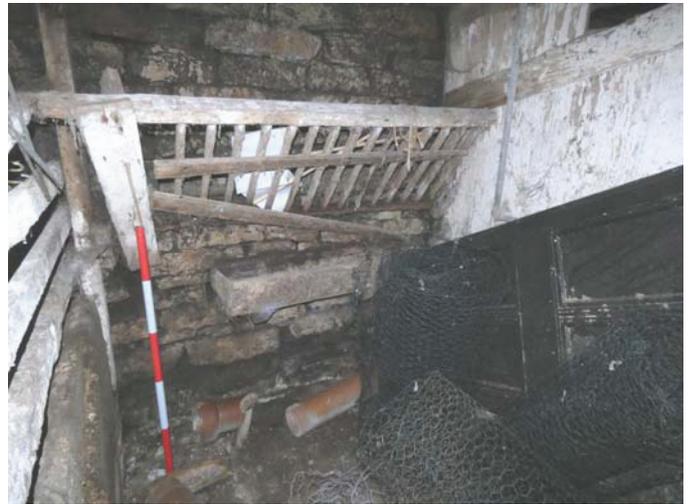
Plate 34 (right): Manager in the south-east corner of Room L3, viewed from the west
