PETTY HALL BARN, ORTON, CUMBRIA

Heritage Statement

April 2019

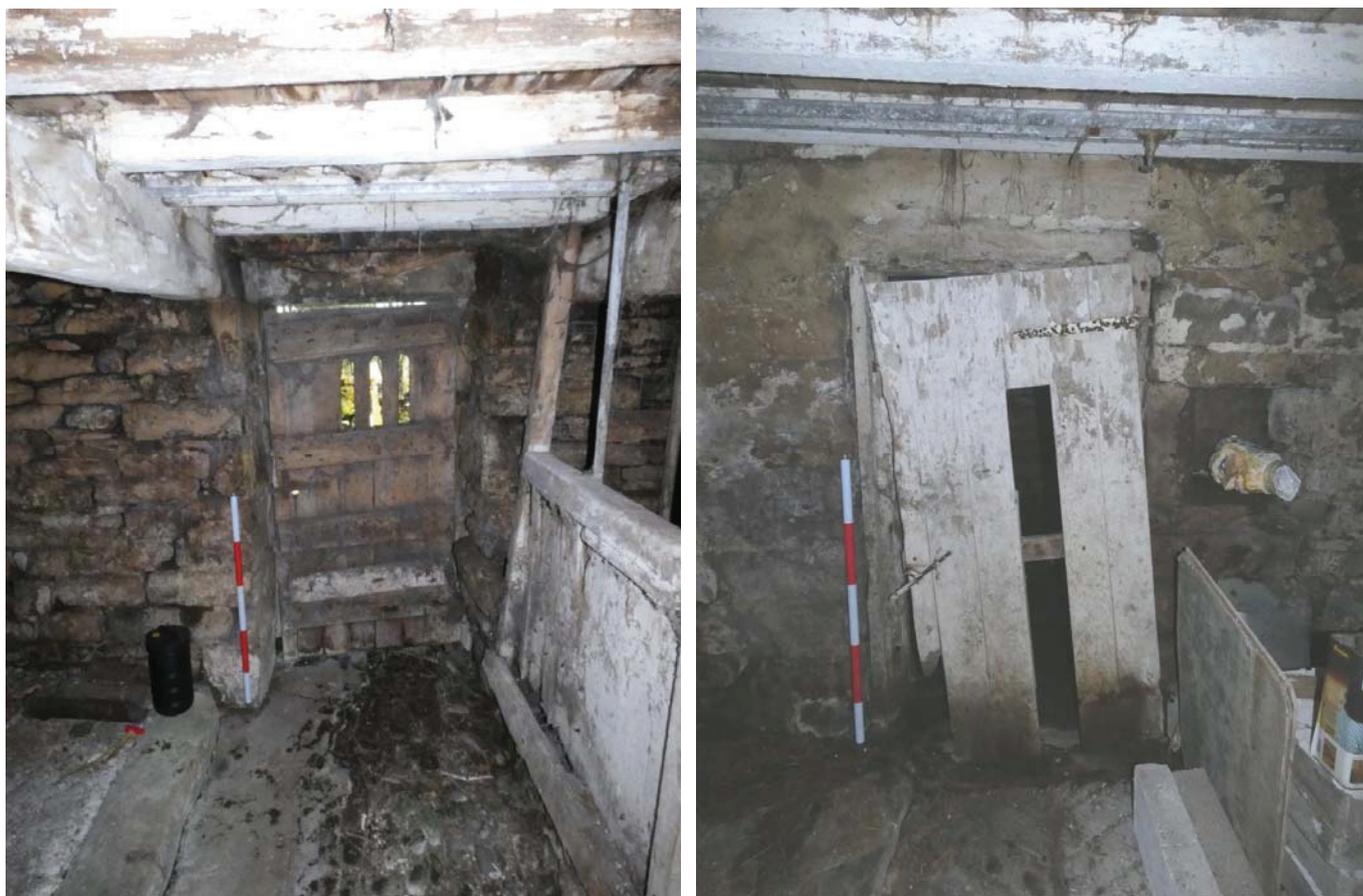
Plate 35 (left): Door in the north side of the east elevation of Room L3, viewed from the west

Plate 36 (right): Door in the west elevation of Room L3, viewed from the east

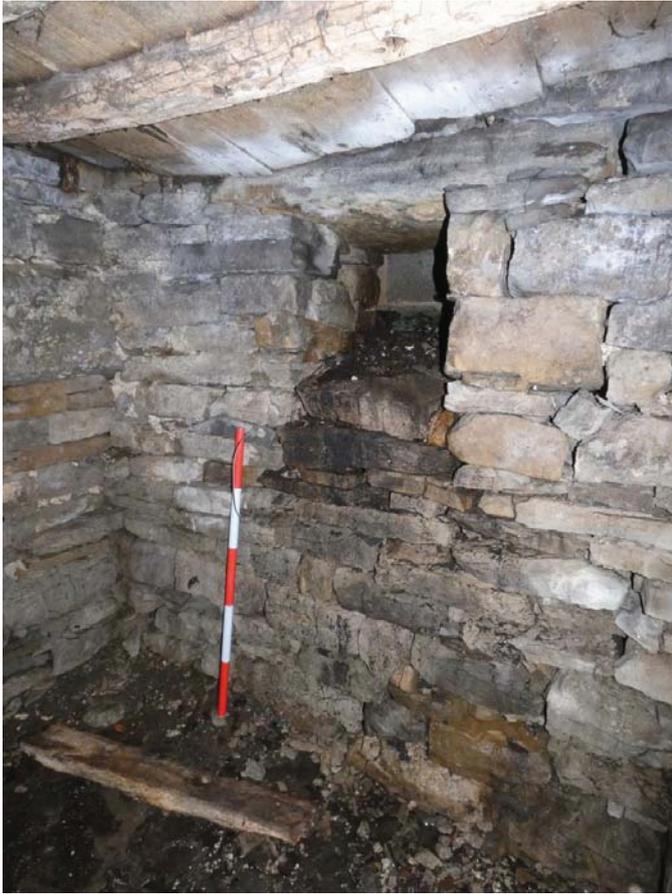
4.3.4 **Lower level floor Room 4 (L4):** this room has an 'earth' floor possibly with cobbles below and heavy hand-finished joists support the boards for the ceiling. The walls are unfinished stone. The **north elevation** has an aperture/chute with a sloping sill and a rough timber lintel (Plate 37). The doorway in the **east elevation** has a timber lintel and plain surround (Plate 38). The **south elevation** has a rough hole knocked through and the **west elevation** is plain.

Plate 37 (left): Chute in the north elevation of Room L4, viewed from the south-east

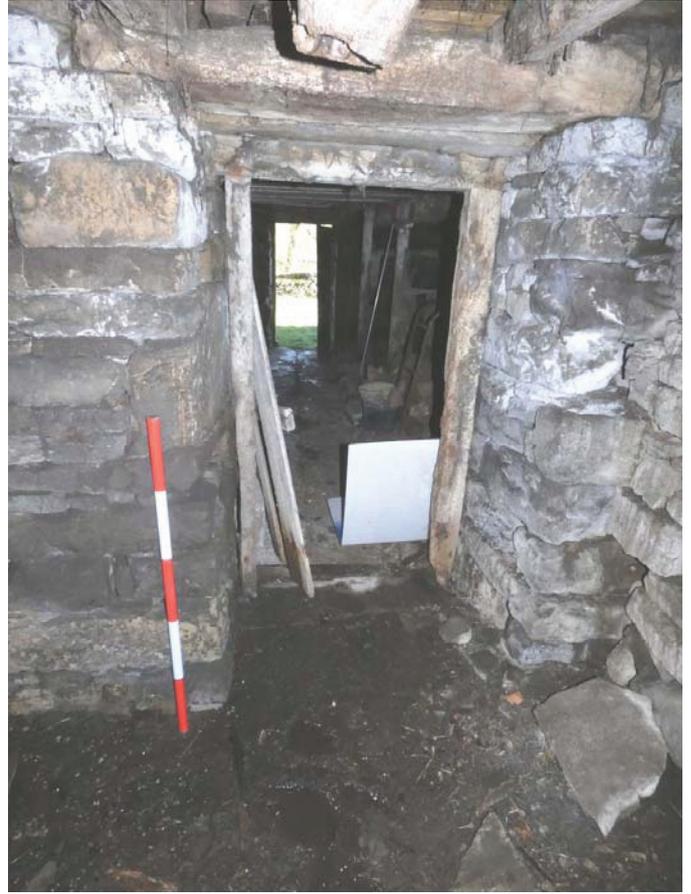
Plate 38 (right): Doorway in the east elevation of Room L4, viewed from the west

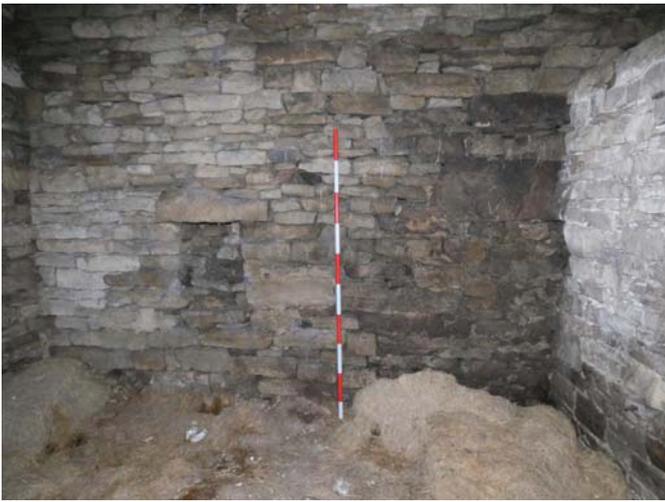
4.3.5 **Lower level floor Room 5 (L5):** the 'earth' floor in this room is obscured. The room is open to the floor above and all the walls are exposed stone. The **north elevation** is plain. There is a blocked opening to the north side of the **east elevation** leaving an alcove with a stone lintel and sill and there is a second blocked feature to the south side of the same elevation with a stone lintel possibly butted by the south elevation (Plate 39). The **south elevation** is only up to the height of the next floor and topped with large slabs. It is keyed into east wall at the bottom but the upper part is butts it. The doorway to the west side has a hand-finished timber lintel with a square door surround (Plate 40), which butts the west elevation. The **west elevation** is plain.

Plate 39 (left): The east elevation of Room L5, viewed from the west

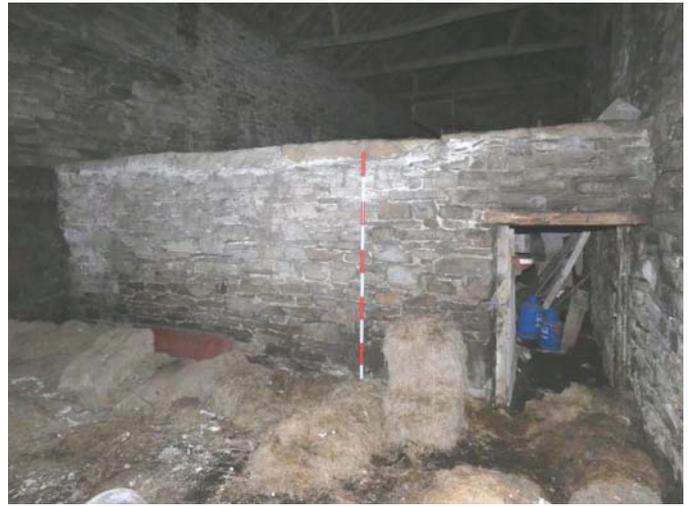
Plate 40 (right): The south elevation of Room L5, viewed from the north

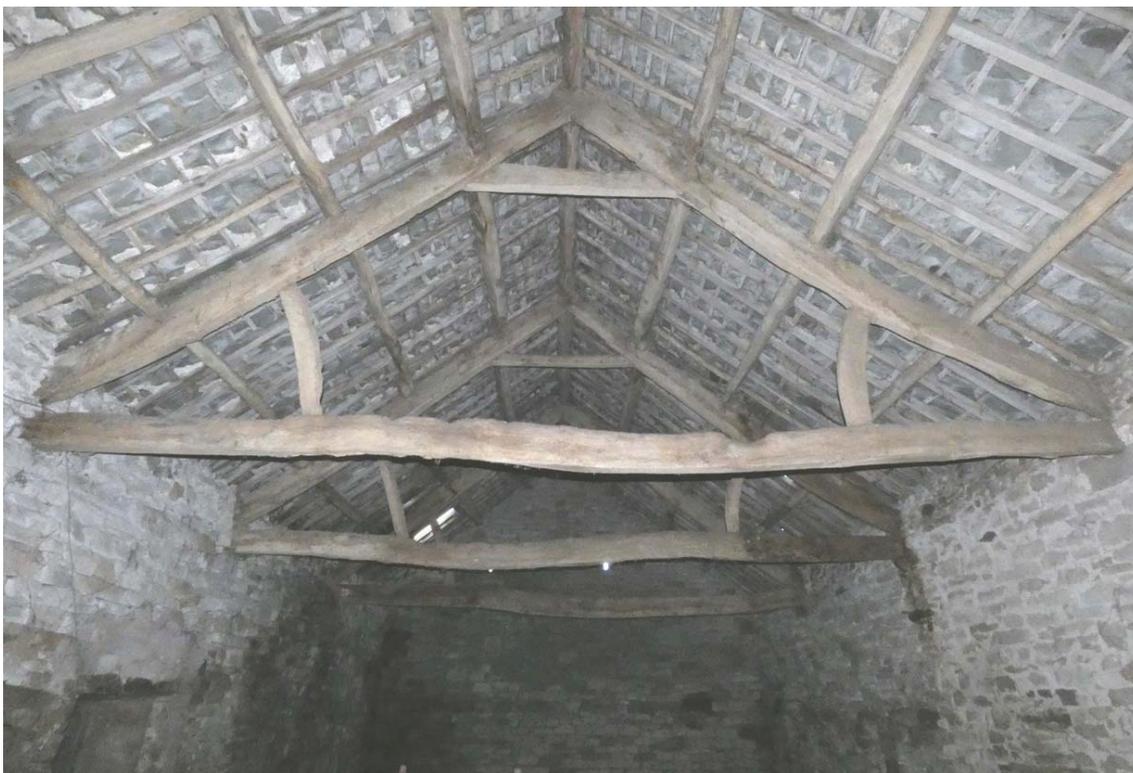
4.3.6 **Upper level floor Room 1 (U1):** this is in the main part of the barn. The floor is timber boards but is obscured by straw and other items. It is open to the roof – there are six trusses, all fairly basic tie beam type each supported by a pair of angled braces (Plate 41). There is a diagonal ridge and three purlins per pitch. The timber is all hand-finished and lots of it is clearly reused, evidently from cruck blades. There is no floor at the north end where the dividing wall comes through the floor level and it is open to the room below. The walls are all bare stone, and are much more irregular compared to the exterior, and there is no sign of mortar or whitewash at the north end of the west elevation but the rest has traces. The **north elevation** is a gable end, and has two square holes at the top corresponding with the dovecote and two slot vents below (Plate 42). In the **east elevation** the first two bays have no whitewash or mortar but the rest have mortar. There is a row of six slot vents (Plate 43) and to the south of the centre there is a winnowing door (Plate 44). It has a large lintel and a plank and batten door with large strap hinges. The last bay and a half at the south end also has no mortar. The **south elevation** is a plain gable with remnants of roughcast render and continues to the lower floor with arrow of joist holes just below this floor level, although part of the floor remains on the west side (Plate 45). The east and west elevations clearly butt against the south and there is a window blocked with stone high on the east side. The **west elevation** has a blocked doorway on the south side with a timber lintel and wagon door to the north of that, with a timber lintel in a recess. The south jamb of the wagon doorway have been rebuilt. There is possibly a blocked window high on the east side. The doorway to the north of that to U2 has a rough timber lintel and timber surround and was evidently not inserted. There is a further doorway with rebuilt jambs to the north. This was evidently inserted and has a timber lintel and plank and batten door with diagonal battens. There is another vent slot on this side of the room at the north end.

Plate 41: Trusses in Room U1, viewed from the north

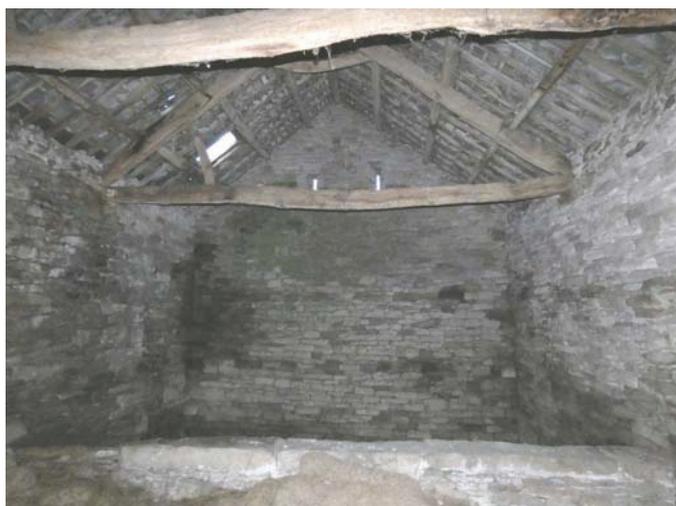
Plate 42 (left): The north elevation in Room U1, viewed from the south

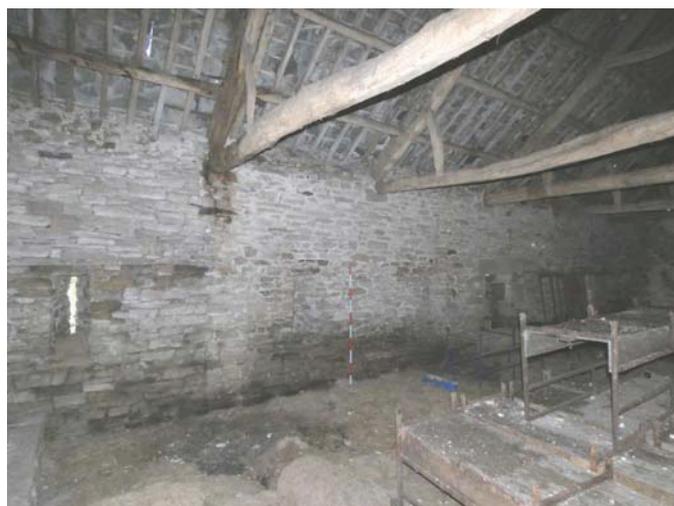
Plate 43 (right): The east elevation in Room U1, viewed from the north-west

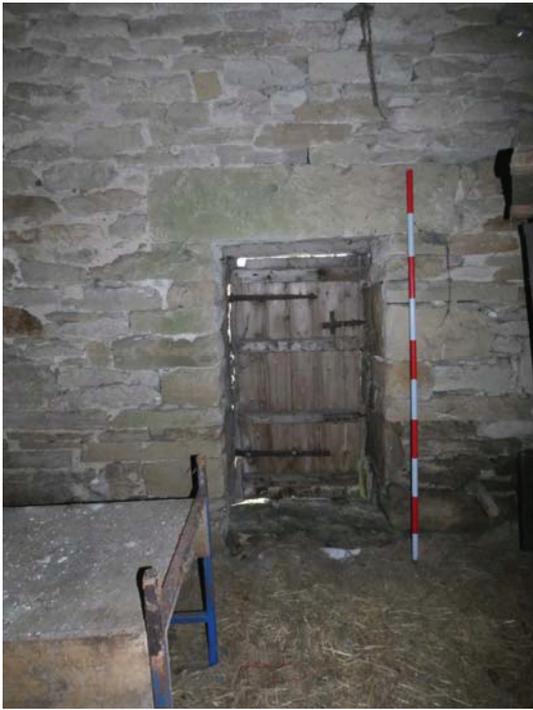
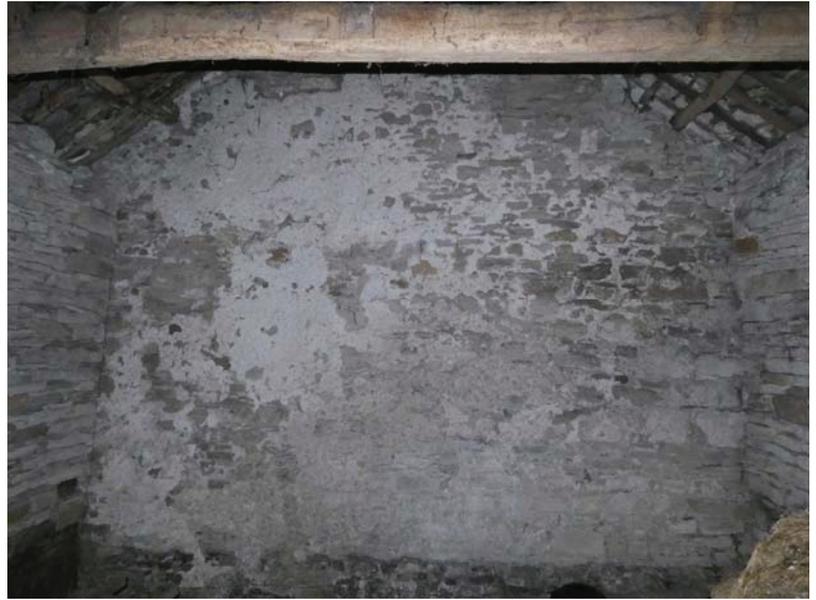
Plate 44 (left): Doorway in the east elevation of Room U1, viewed from the west

Plate 45 (right): The south elevation of Room U1, viewed from the north

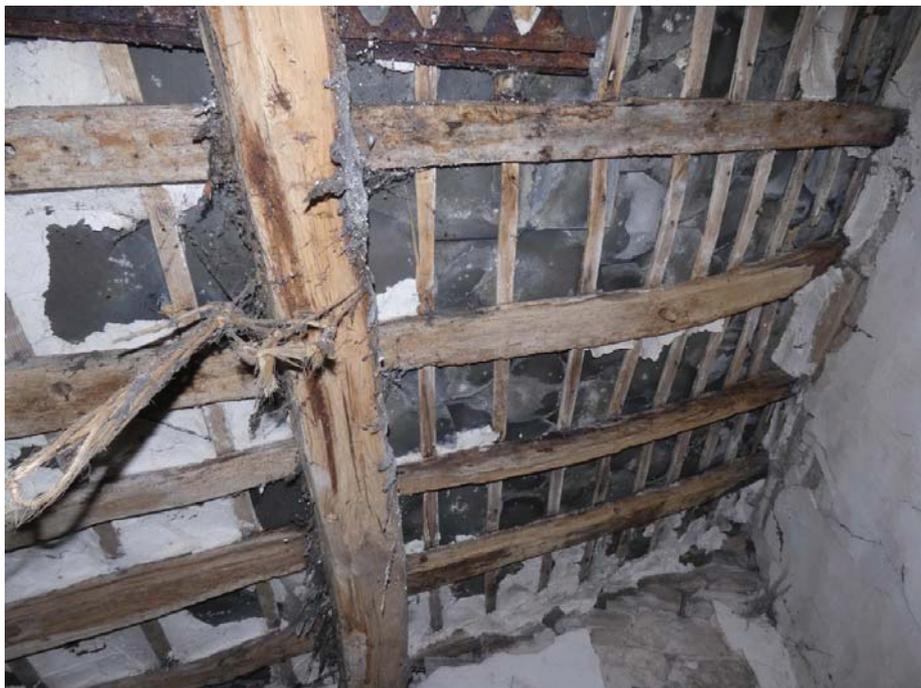
4.3.7 Upper level floor Room 2 (U2): the floor in this room is obscured. The room is open to the roof where the hand-finished east/west joists are visible and the slates are torched with lime (Plate 46). The walls are finished with remnants of whitewashed lime plaster. The **south and west elevations** are plain. The south elevation might butt the wall to the east and there is a small window on the **north elevation** with a rough timber lintel and stone sill and there are tally marks drawn onto the plaster to the east (Plate 47). The doorway in the **east elevation** to U1 has a rough timber lintel and timber surround with further tally marks to the north side (Plate 48). The **south elevation** has a low aperture to the outside, possibly broken through the wall, which also leads to the floor below.

Plate 46: The roof in Room U2, viewed from the south

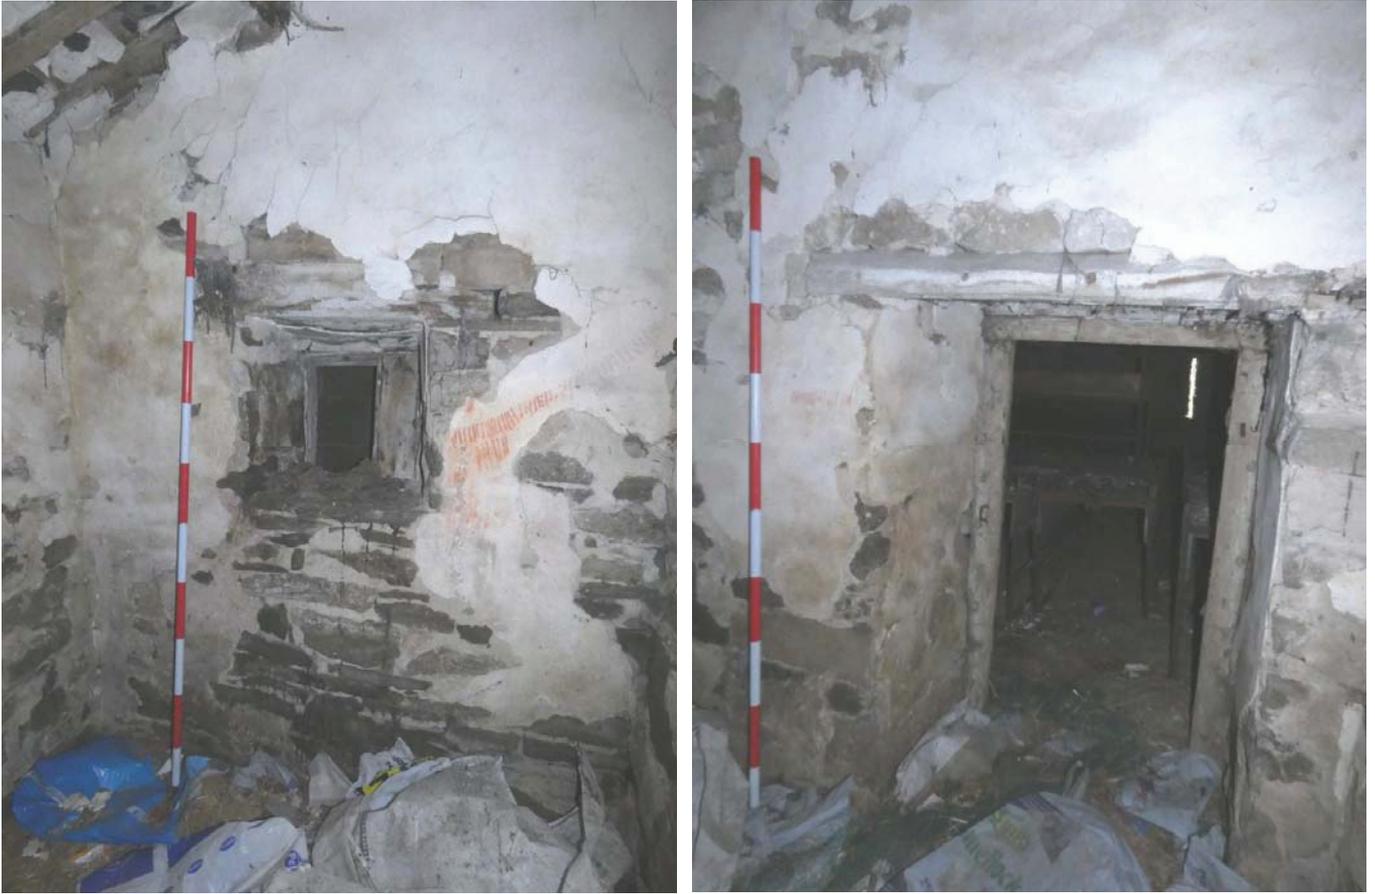
Plate 47 (left): Window and tally marks in the north elevation of Room U2, viewed from the south-east

Plate 48 (right): Doorway in the east elevation of Room U2, viewed from the west

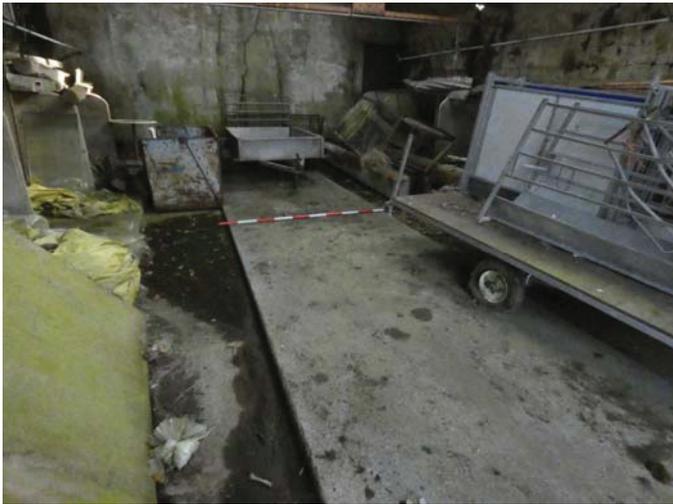
4.3.8 **Upper level floor Room 3 (U3):** this room has a concrete floor, which is raised in the centre, with dung channels either side (Plate 49). There are concrete stalls to the north and south on raised floors, four to the north and five to the five to the south, with iron tether posts between and pipes attached to the walls for water troughs, marked 'DICKIE' (Plate 50). The walls are finished with concrete skim. The corrugated sheet roof is supported by two L-beam steel trusses with three skylights per pitch (Plate 51 and Plate 52). The **north and south elevations** are plain with just the pipes, troughs, stalls and ceramic vents. The doorway on the south side of the **east elevation** is a tongue and groove plank and batten door. The **west elevation** has a wide doorway with a concrete lintel with a window over. There is a water tank fixed to the wall to the south.

Plate 49 (left): The floor in Room U3, viewed from the west

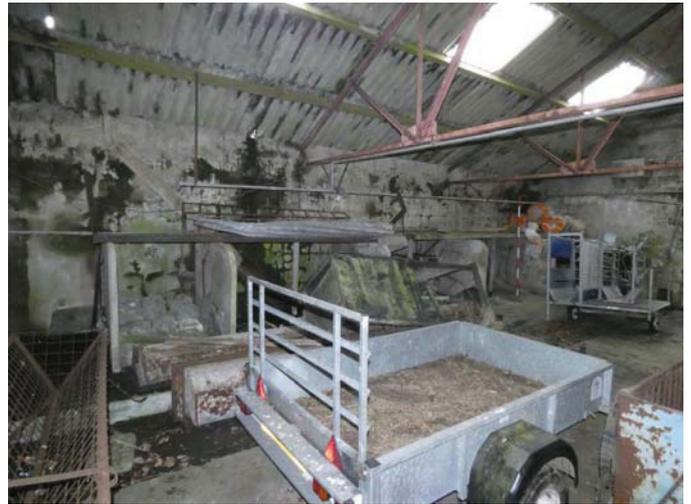
Plate 50 (right): The stalls against the south side of Room U3, viewed from the north-east

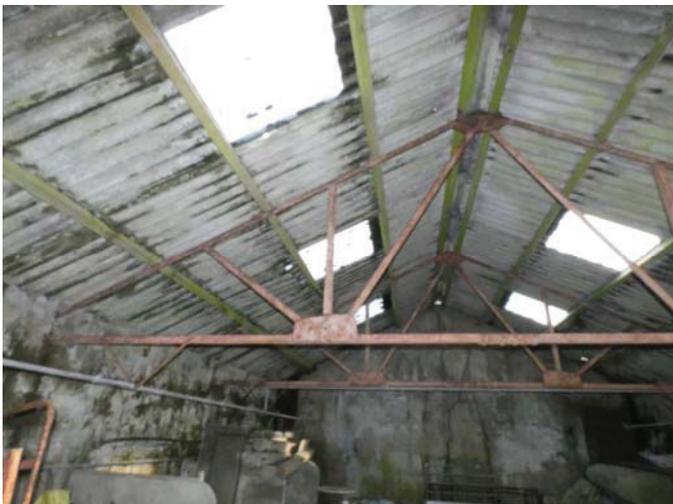
Plate 51 (left): North side of trusses in Room U3, viewed from the west

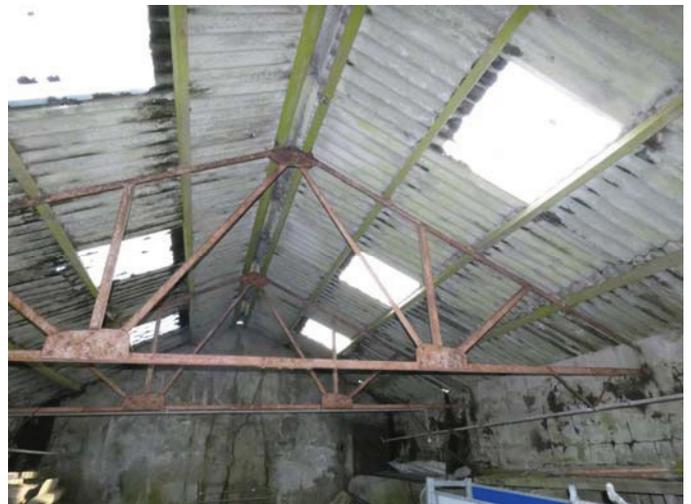
Plate 52 (right): South side of trusses in Room U3, viewed from the west

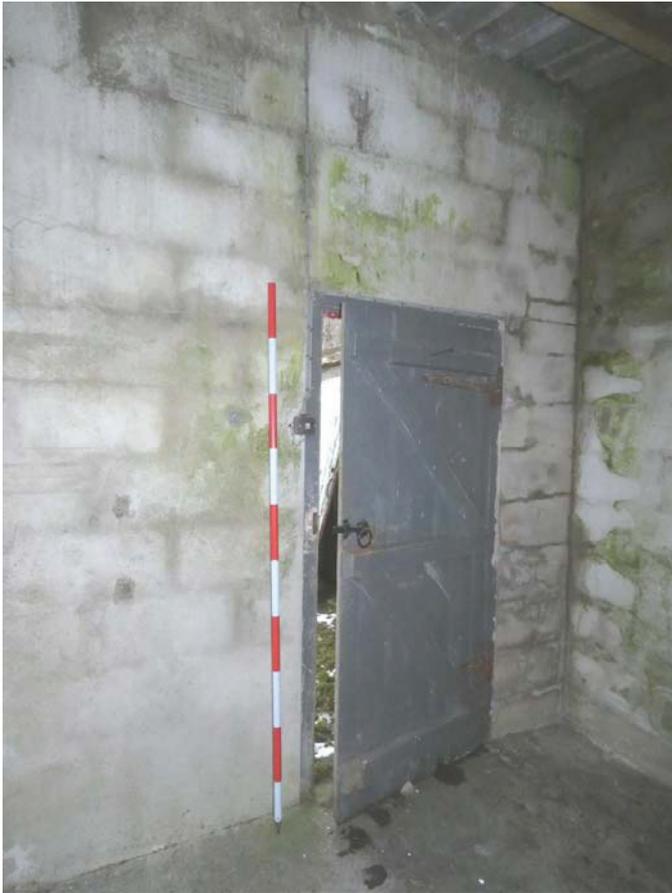
4.3.9 **Upper level floor Room 4 (U4):** this room has a concrete floor and corrugated sheet roof with two machine-cut timber joists. The **south** and **east elevations** are plain apart from pipes and electrics. The **north elevation** has a plank and batten door on the east side with a machine-cut surround (Plate 53) and vent to the west. The window in the **west elevation** is an eight-light casement (Plate 54).

Plate 53 (left): Doorway in the north elevation of Room U4, viewed from the south

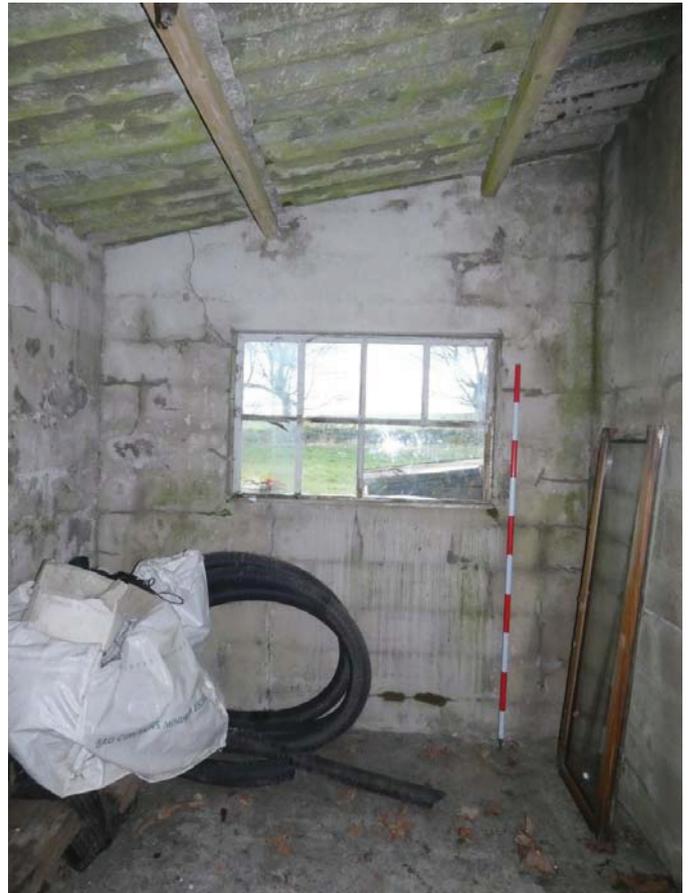
Plate 54 (right): Window in the west elevation of Room U4, viewed from the east

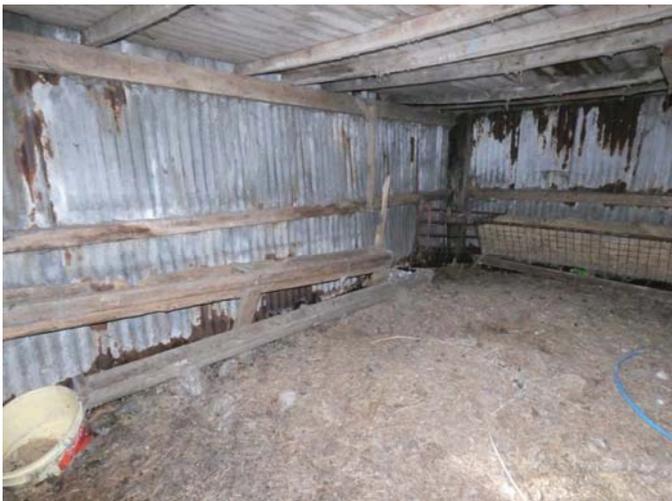
4.3.10 **Shed:** the shed is divided into three sections with a manger in the one to the west end (Plate 55) and it has concrete floors throughout. It has a flat ceiling at the west end but the two trusses are otherwise simple tie-beam type with two purlins at the ridge and one per pitch (Plate 56). The sheets are marked 'TRADEMARK STANLEY'.

Plate 55 (left): General view of the west end of the shed, viewed from the south-east

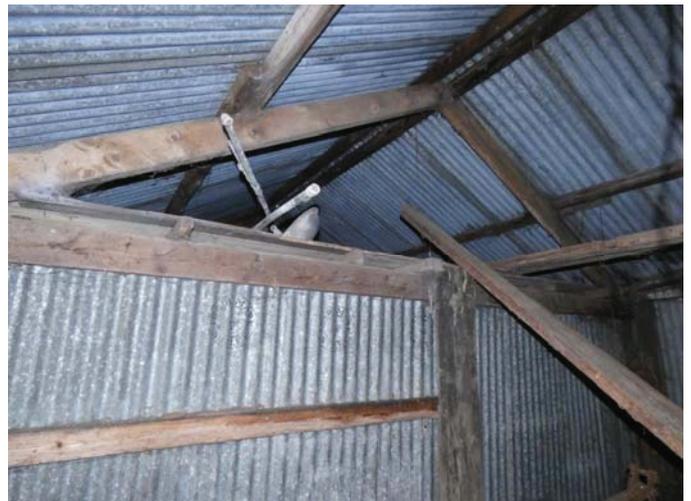
Plate 56 (right): A typical truss within the shed, viewed from the south-east
