FAIR VIEW, DALTONGATE, ULVERSTON, CUMBRIA

Archaeological Building Recording

Client: Storey Sharp

April 2019

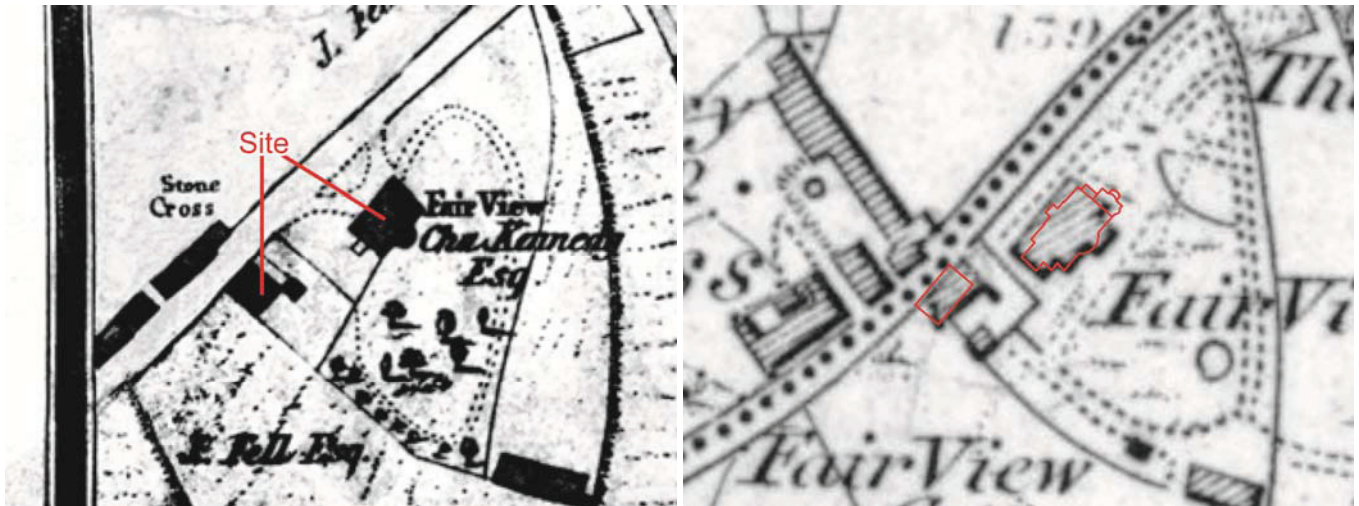
Plate 1 (left): Extract from Wood's map of Ulverston, 1832

Plate 2 (right): Extract from Ordnance Survey map, 1850

3.1.1 **Wood's map, 1832:** Fair View and its coach house are shown on this map, owned by Charles Kennedy esquire. A double driveway is shown leading to the front of the building, with a gap in the boundary wall, displaying the whole of the front façade from Daltongate.

3.1.2 **Ordnance Survey, 1850:** this is the first edition six inch scale Ordnance Survey map, and it again shows Fair View and its coach house, but with a different arrangement of driveways to that shown previously, and apparently a complete front boundary wall. A small structure has been built to the south-east of the coach house.

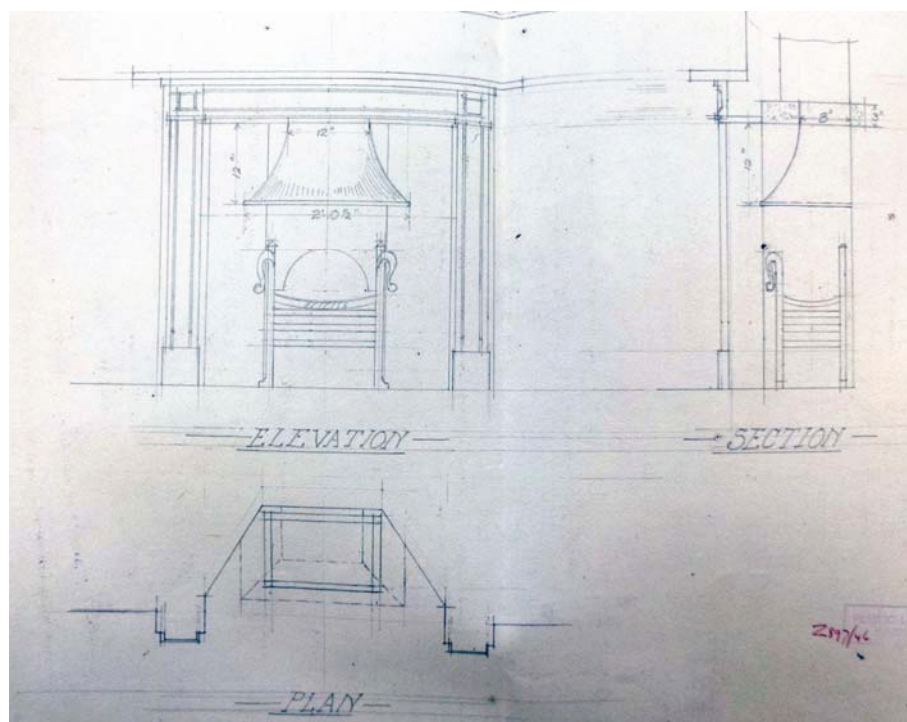
3.1.11 **Plans and elevations, 1936:** plans showing the positions of flues and a proposed fireplace were produced by JW Grundy and Son, architect and surveyor, on 17th November 1936 for Colonel Kennedy, the then owner of Fair View (CAC(B) Z/897/46 1936). They show the building much as it was in the detailed plans of 1893 (Plate 32 to Plate 34) with the addition of a proposed fireplace design (Plate 35).

Plate 35: Elevation, section, and plan of proposed fireplace canopy, 1936

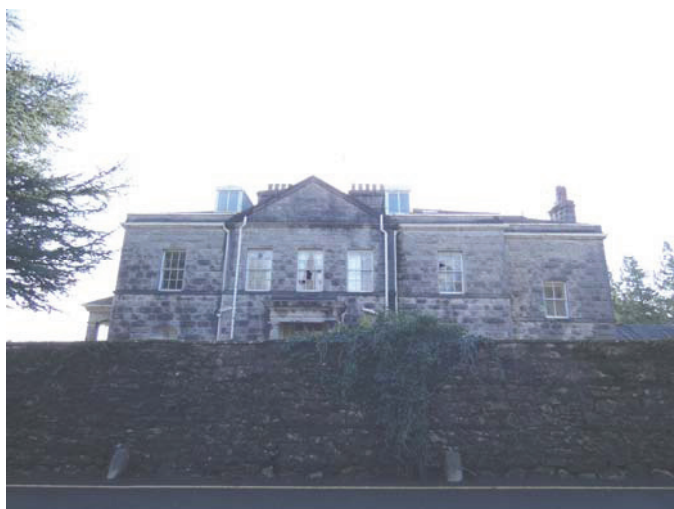
Plate 37 (left): The front (north-west) elevation viewed from the north-west from Daltongate showing the boundary wall

4.1.1 **Arrangement:** the main part of the site (the mansion) comprises a single linear range orientated north-east/south-west, with a projecting porch on the north-west side and the remains of a glasshouse to the north-east. The front (north-west elevation) looks onto Daltongate over a tall boundary wall (Plate 37), while the rear (south-east) is raised over a terrace and looks over gardens that run down to the A590 (Plate 38). The mansion is two storeys high plus extensive basement and attic rooms. The south-east end of the original building has been extended by a range of modern buildings that were not recorded in detail, in part due to their unsafe condition. These form a dog-leg to the south-west connecting the mansion to a former coach house, which was originally a separate building. The coach house is also two storeys, but built into the slope in the style of a bank barn.

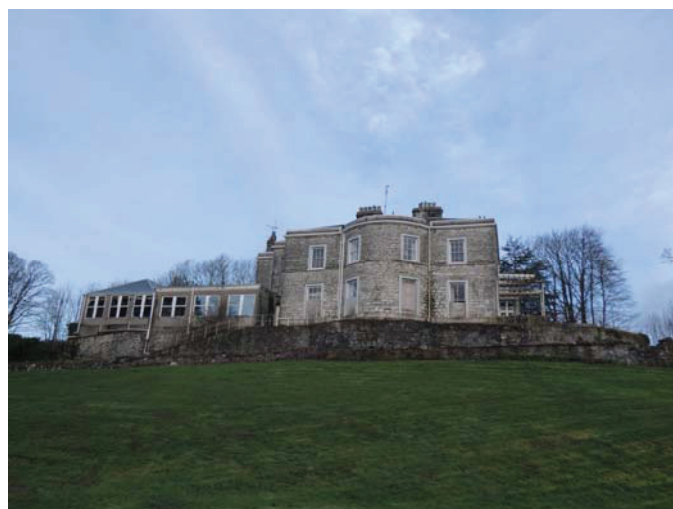
Plate 38 (right): The rear (south-east) elevation viewed from south-east from the gardens

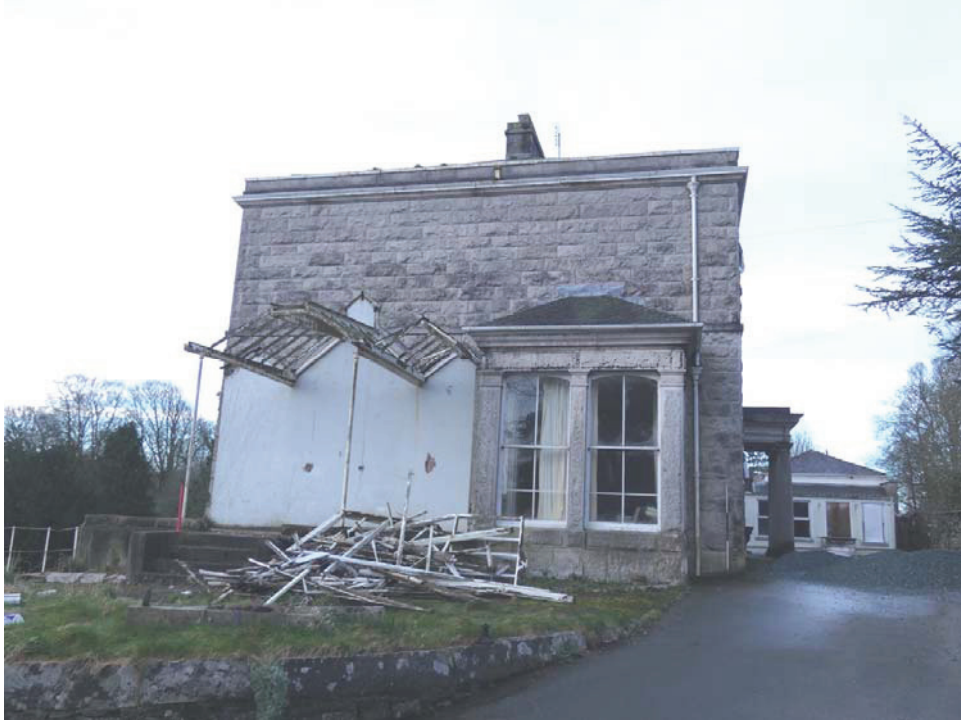
Plate 39: The north-east elevation of the mansion, viewed from the north-east

survives (Plate 41). Within this area the wall is finished with plaster and paint and as brickwork visible apparently denoting the presence of a large doorway or some form of recess. The former conservatory was sat on a raised area formed by a low retaining wall of ashlar blocks and accessed by a flight of stone steps in the centre of the north-east side. Within what would have been the interior of the conservatory the floor is largely finished with decorative tiles laid in a geometric pattern (Plate 42). There is also a doorway in the return on the south-west side of the bay window with a double door, each part of which has a single light and a single moulded panel and two further lights over.

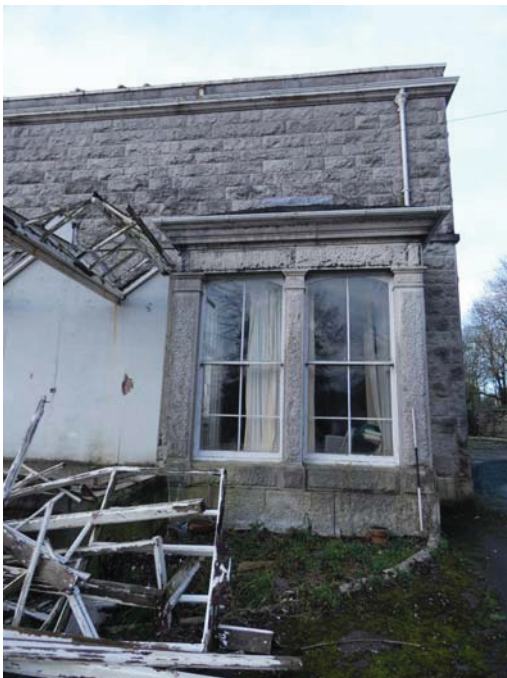
Plate 40 (left): The bay window on the north-west side of the north-east elevation of the mansion, viewed from the north-east

4.2.1 **North-east external elevation – mansion:** this is the gable end of the building and has a hipped roof with a band of ashlar stone along the top of the wall forming a low parapet with a moulded band below supporting the moulded iron gutter (Plate 39). There is a projecting square bay window on the north-west side, which also has a hipped roof with a moulded band below and has two windows with four-light sash casements (with no horns) between engaged pilasters (Plate 40). To the south-east of this is the remains of a glazed conservatory of timber construction but supported on iron posts and I-beams; the roof evidently originally had three pitches, the central one with a raised top, but very little now

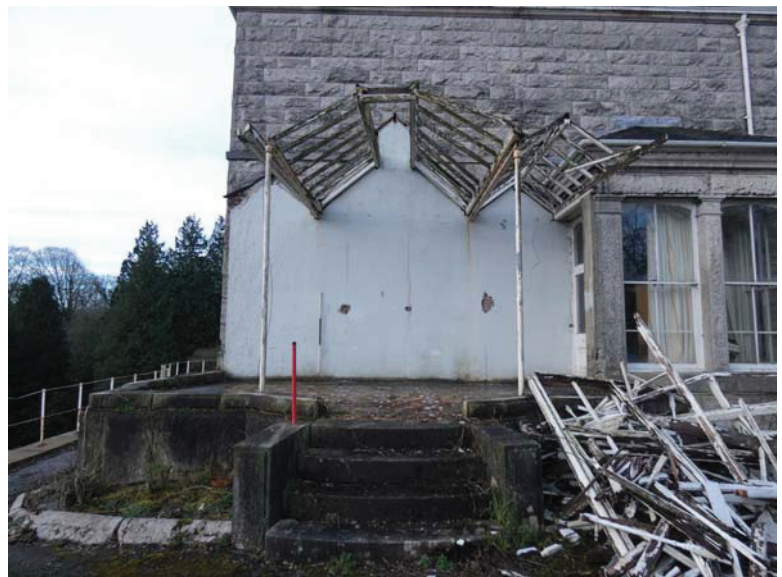
Plate 41 (right): The remains of the conservatory on the south-east side of the north-east elevation of the mansion, viewed from the north-east

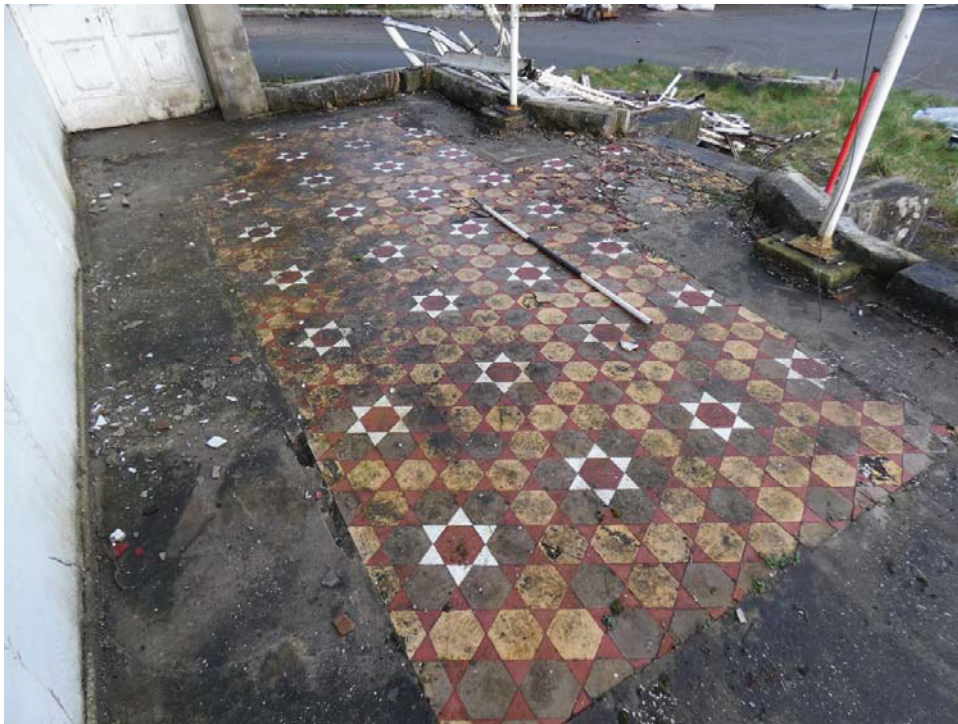
Plate 42: The tiled floor of the former conservatory attached to the north-east elevation of the mansion, viewed from the south-east

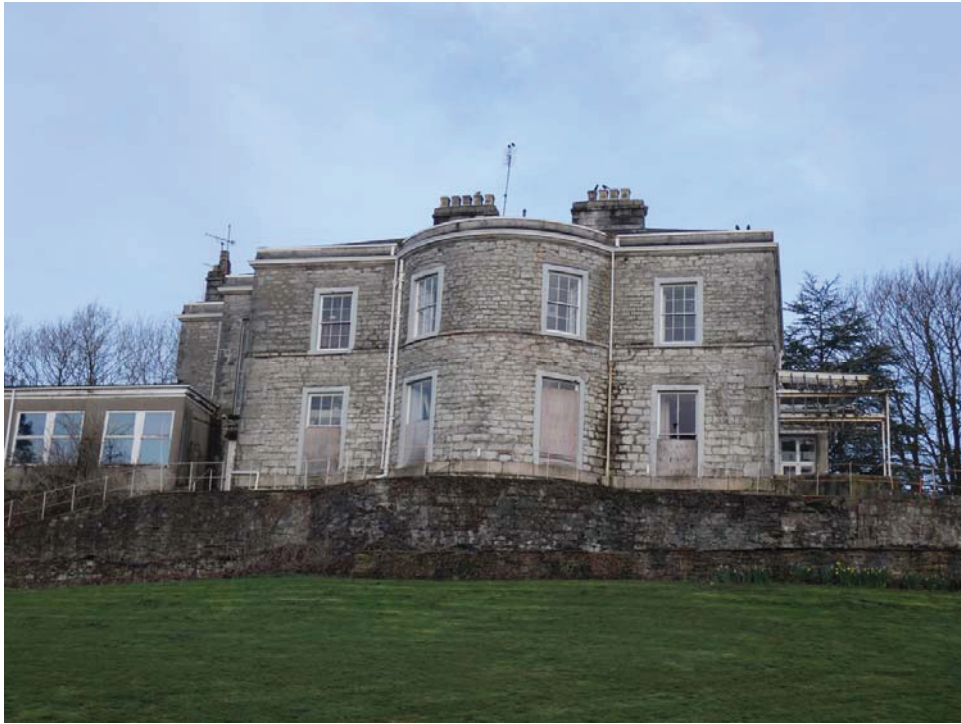
4.2.2 South-east external elevation – mansion: this comprises a very long essentially symmetrical façade based around a semi-circular central section all of which extends to two storeys; it is typically more roughly finished limestone blocks but with an ashlar band at the top forming a parapet and a moulded band below supporting the gutter (Plate 43). It is flanked by pairs of windows (one on each floor), typically comprising 12-light sash casements with no horns, although those on the ground floor on the north-east side have four-light sash casements with no horns (Plate 44), and there is a cellar light on the north-east side with an eight-light sideways sliding sash casement behind iron bars. The central section has four windows in the same style as the rest, two per floor, plus a small cellar light with a single-light casement behind iron bars (Plate 45). There is also a large sill in the centre at first floor, perhaps representing the position of a third window at that level. A thin stone string band forms the sills of all of the first floor windows while an ashlar plinth forms the sill of the ground floor ones, with the surrounds of the windows comprising square render bands. At the south-west end the elevation steps back and is finished with rock-faced ashlar blocks as per the front, although the same moulded band for the gutter is also present. The ground floor has two steps up to a doorway the quoined jambs and lintel of which have rilled edges while the door is a relatively modern six-panel door (Plate 46). At first floor level there is a window with geometric glazing in a similar surround and with a square sill. This section is butted on the south-west side by the modern extension although this sits on an earlier rough stone wall (Plate 47). This addition obscures a further return in the main wall, although this has a window at first floor level with a four-light sash casement and rendered band surround. The wall is again in rougher stone at this point although the quoins have rilled edges. Within the modern extension the south-west end of the original south-east external elevation is visible; it is finished with plaster or render and has a single window on the north-east side (now boarded over) with square rendered surrounds and a stone sill (Plate 48). The south-west corner was evidently originally rounded although this was extended by later concrete blocks.

Plate 43: The south-east elevation of the mansion, viewed from the south-east

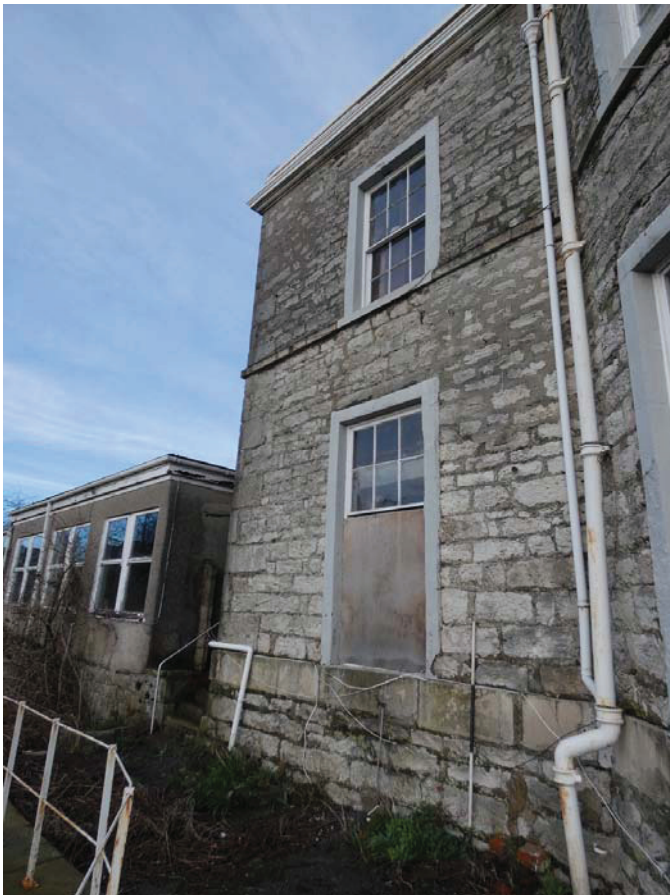
Plate 44 (left): Windows on the south-west side of the south-east elevation of the mansion, viewed from the east

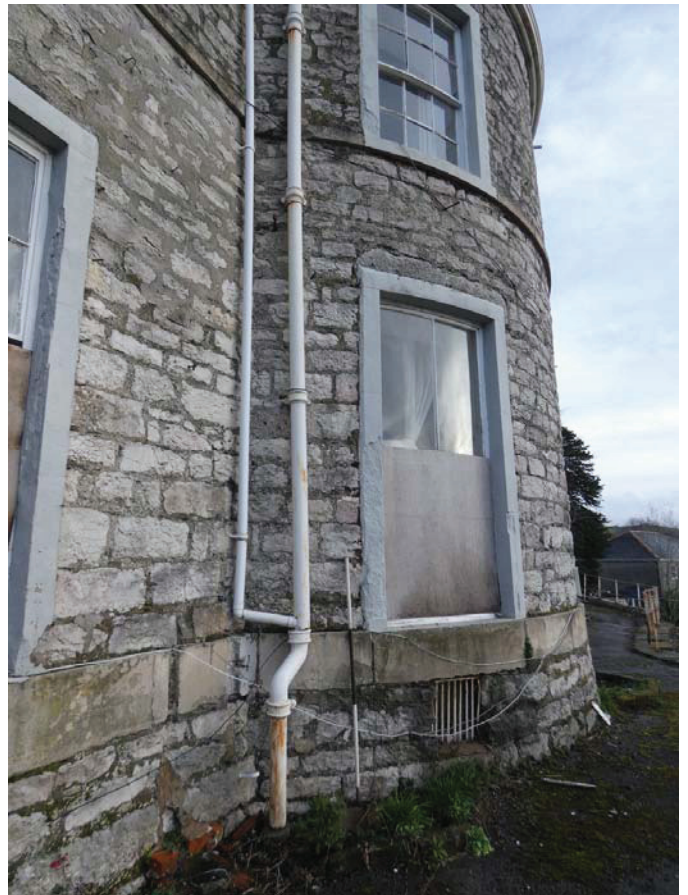
Plate 45 (right): Windows on the south-west side of the central part of the south-east elevation of the mansion, viewed from the south

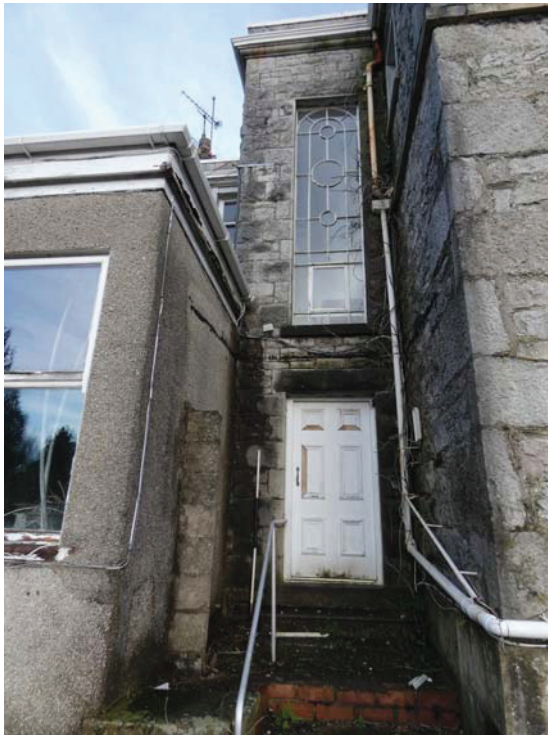
Plate 46 (left): Doorway and window at the south-west end of the north-east external elevation of the mansion, viewed from the south-east

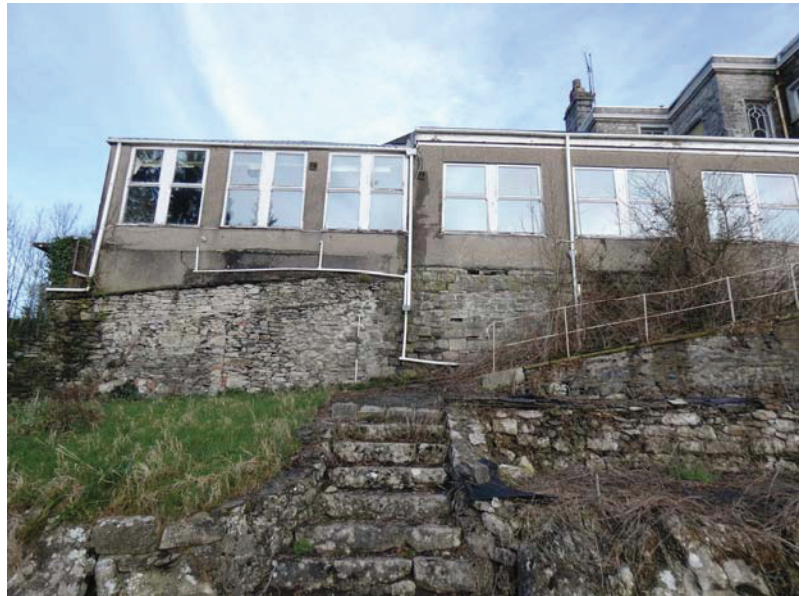
Plate 47 (right): Modern extension at the south-west end of the north-east external elevation of the mansion, viewed from the south-east

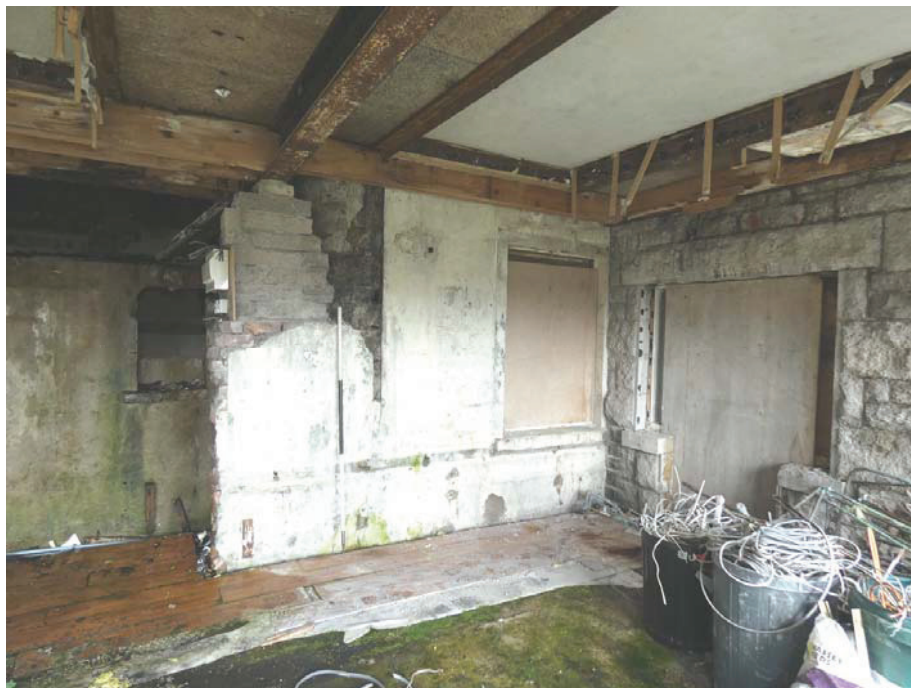
Plate 48: The south-west end of the original south-east external elevation visible within the later extension, viewed from the east

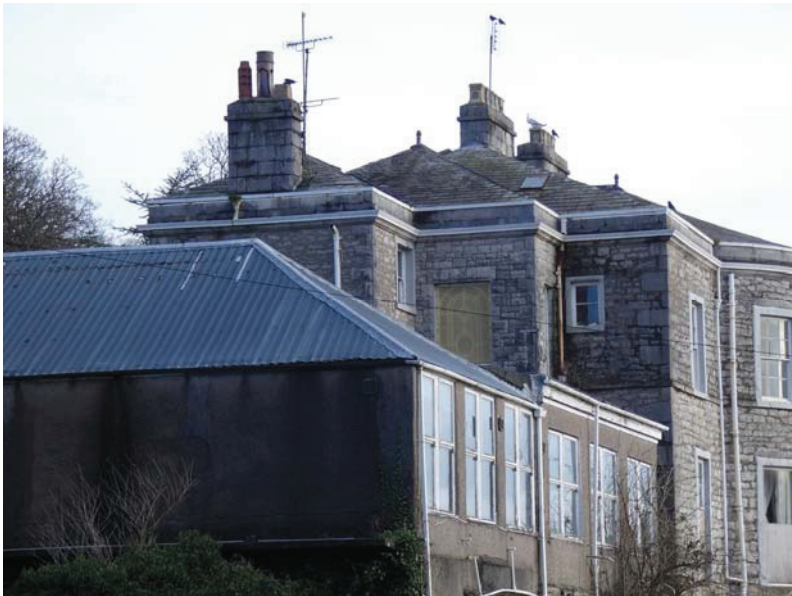
Plate 49 (left): The south-west external elevation of the mansion, viewed from the south-west

4.2.3 **South-west external elevation – mansion:** this is largely obscured by the later extension but above this it forms a range of sections topped with hipped roofs with one chimney. There is a small window on the south-east side with a rendered surround and two lights, plus a long window near the centre with elaborate painted glass although this was largely hidden by attached plastic sheeting (Plate 49). On the north-west side the elevation is partially visible and essentially plain, although the build is of

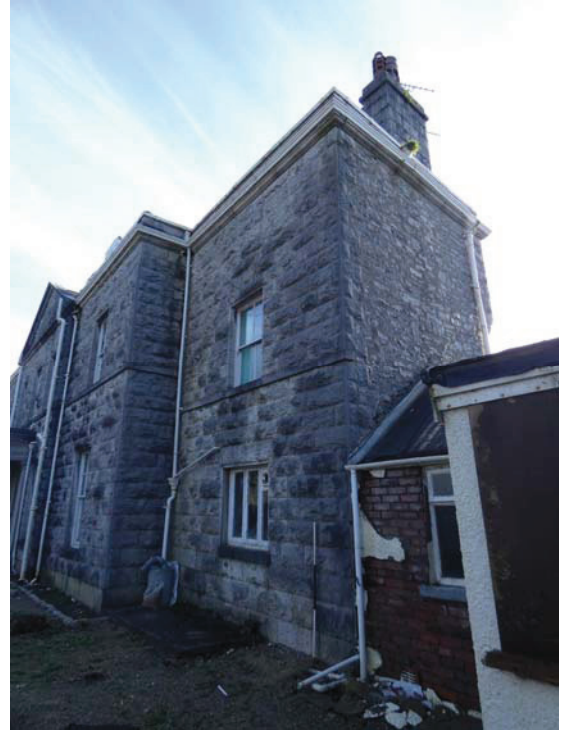
Plate 50 (right): The north-west side of the south-west external elevation of the mansion, viewed from the west

rough stone unlike the north-west elevation (Plate 50). At the south-west end of the modern extension, within a section of rendered wall, there is an early doorway at basement level next to the coach house, with a plank and batten door. Within the later extension part of the original south-west external elevation was exposed; this had a doorway with single light flanking windows (all now boarded over) sharing a single long rock faced stone lintel (Plate 51). The wall was finished with rock-faced stone in irregular courses, extended by concrete blocks forming part of the modern extension on the south-east side.

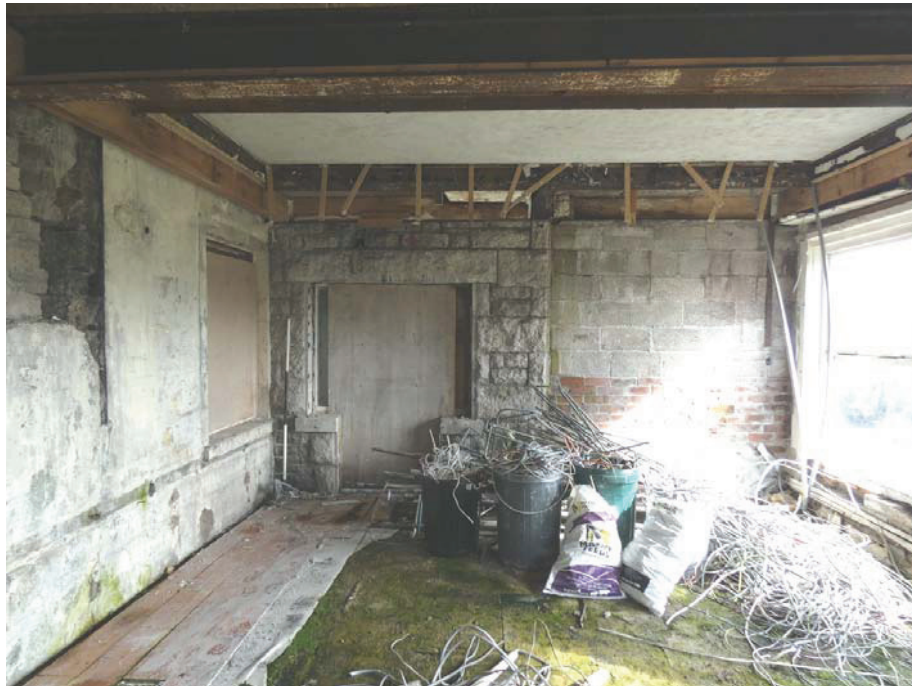
Plate 51: Part of the original south-west external elevation visible within the later extension, viewed from the south-west

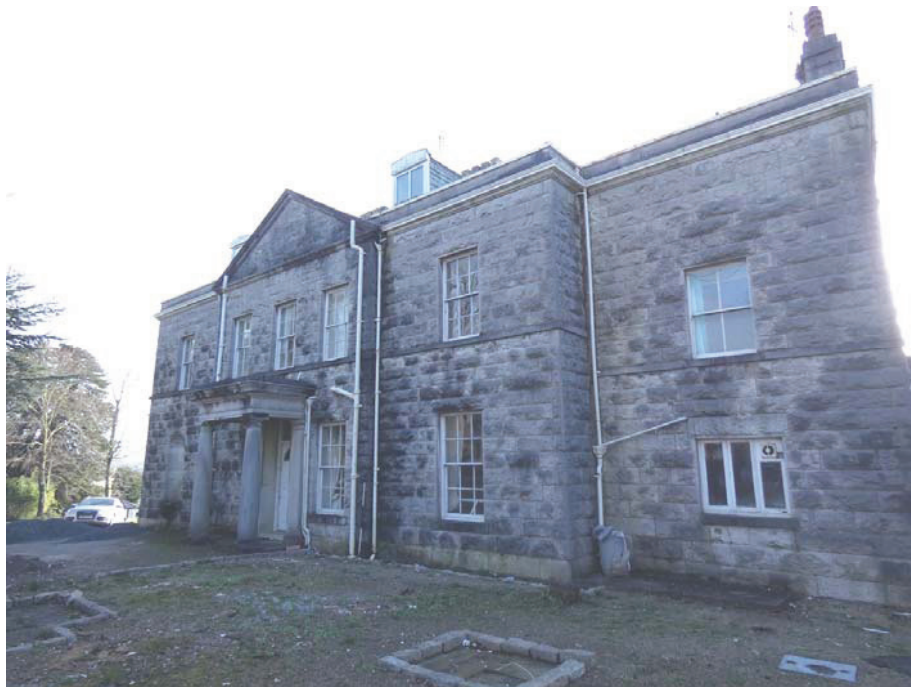
4.2.4 North-west external elevation – mansion: this is broadly symmetrical except at the south-west end (Plate 52 to Plate 55). It is extended at the north-east end by the side of the projecting bay window, which has a pair of engaged pilasters either side of a window with four-light sash casement. The main elevation is built around a central projecting section with a pedimented gabled on top with moulded stonework. This has three windows at first floor level, each with 12-light sash casements with no horns and sharing a dressed string band that forms the sill. The quoins are rock faced with rilled edges. Below is a projecting porch with a moulded entablature supported by a pair of Doric columns with engaged pilasters behind between which is the front doorway, which has a wide door with six raised and fielded panels and a semi-circular fan overhead and a plainer overhead above. To the south-west of this is a single window with a 12-light sash casement. There is a single bay either side of the central part of the elevation, the north-east with a first floor window as per the rest, below which is a semi-circular niche in ashlar stone with fan decoration in the top and a projecting rounded base. The southern bay has a pair of windows, one per floor, with 12-light sash casements and beyond this the elevation steps back again. This seems to be a later addition that is not quite properly attached to the main part, and it contains a first floor window with a four-light sash casement with horns and a string course for the sill, albeit at a lower level to that to the north-east, and a further window at ground floor level with a relatively modern three-light casement with a square sill and thick lintel. The elevation is continued to the south-west by the later extensions, although the first part of these is of red brick construction (Plate 56).

Plate 52: General view of the north-west external elevation of the mansion, from the west

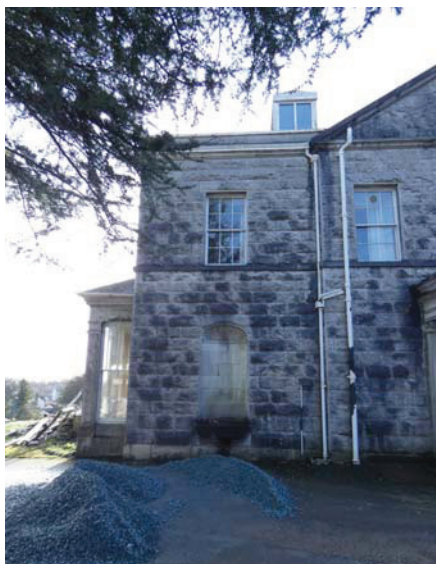
Plate 53 (left): North-east end of the north-west external elevation, viewed from the north-west

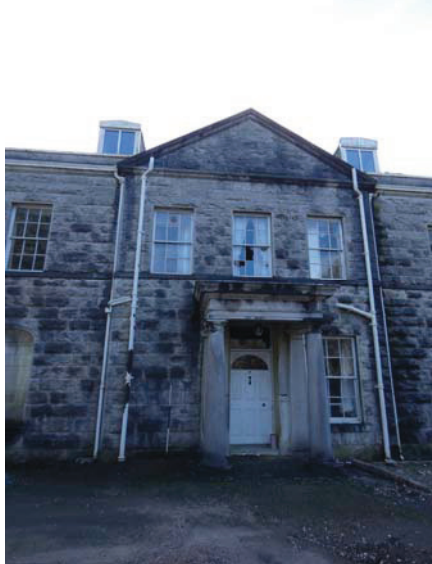
Plate 54 (centre): Centre of the north-west external elevation, viewed from the north-west

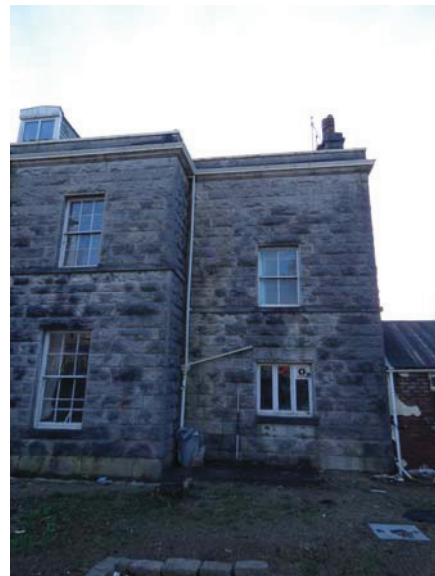
Plate 55 (right): South-west end of the north-west external elevation, viewed from the north-west

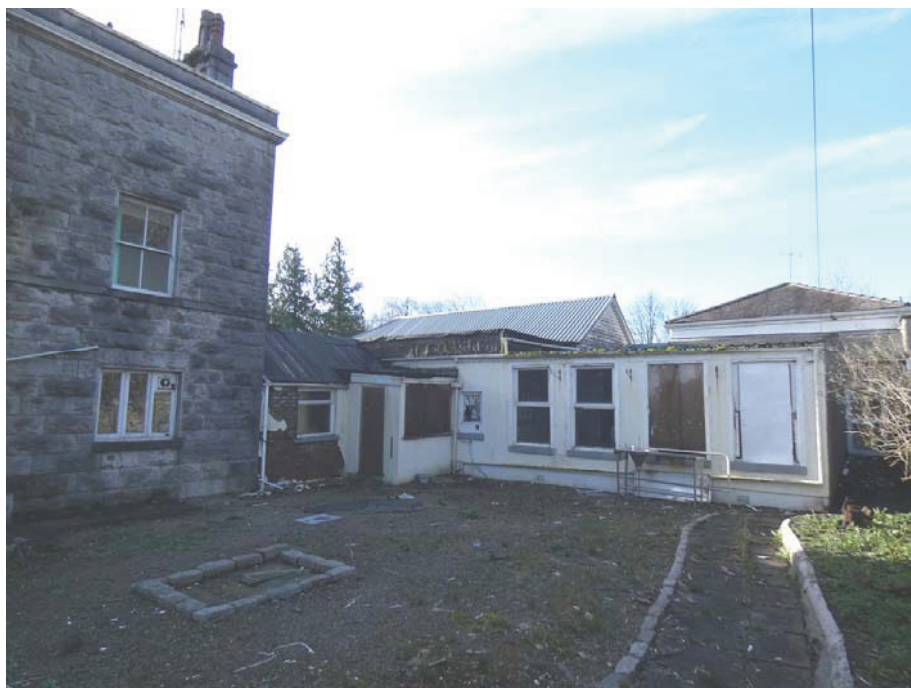
Plate 56: The modern extension at the south-west end of the north-west external elevation of the mansion, viewed from the north

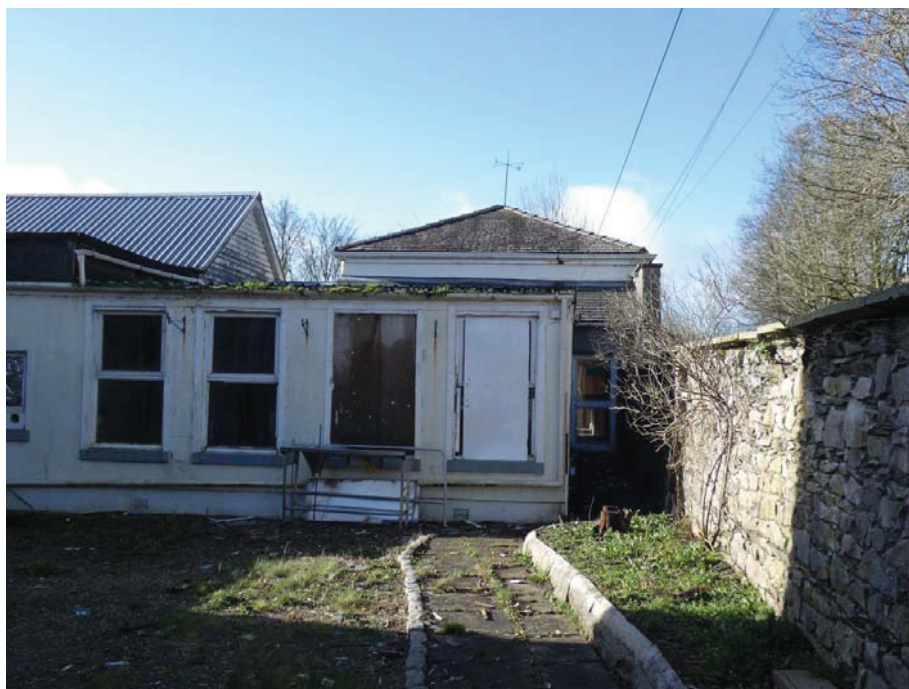
4.2.5 **North-east external elevation – coach house:** this is mostly obscured by the later additions but an earlier monopitch outshut set at right angles to the main elevation is visible on the north-west side (Plate 57). This has a doorway on the north-west side although this now houses a modern door with two lights. The main wall of the coach house above this addition is otherwise quite plain and has a hipped roof with a plain timber barge board below.

Plate 57: The north-east external elevation of the coach house, viewed from the north-east

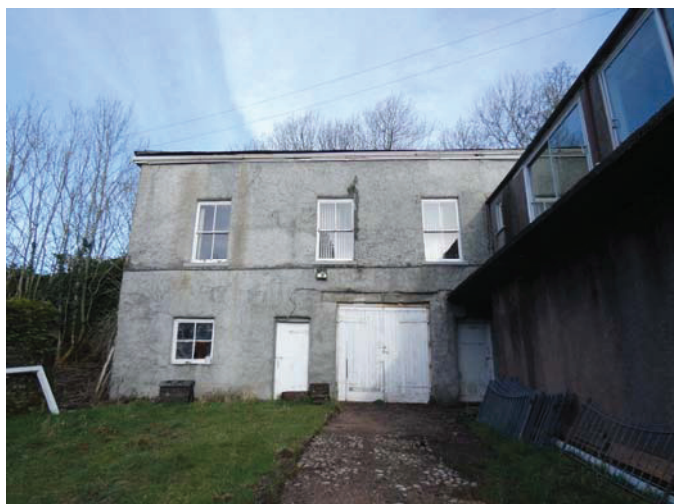
Plate 58 (left): The south-east external elevation of the coach house, viewed from the south-east

4.2.6 South-east external elevation – coach house: the upper floor has a row of three windows, all with four-light sash casements with no horns and square stone sills (Plate 58). The lower floor has a wide wagon doorway on the north-east side with a plank and batten double door and timber lintel covered by attached slates. There is a further small doorway either side, both with plank and batten doors and the north-east with a shallow stone voussoir head. The south-west is hung on long strap hinges and to the south-west of it there is a window with a four light casement and a thin slate sill. At the top there is a moulded iron gutter attached to a plain timber barge board. Within the later extension the north-east end of the original south-east external elevation of the coach house was visible. This comprised a small gable end of what was evidently a later extension added to the north-east side of the coach house, constructed from brick and finished with concrete render. It has a doorway on the north-east side, perhaps inserted, the north-east jamb of which is formed by a pillar of stone walling, and the purlin ends of the roof project above (Plate 59).

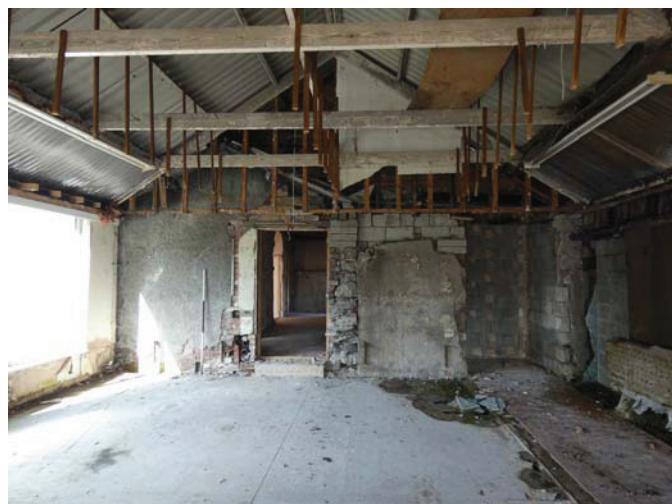
Plate 59 (right): The north-east end of the original south-east external elevation of the coach house visible within the later extension, viewed from the south-east

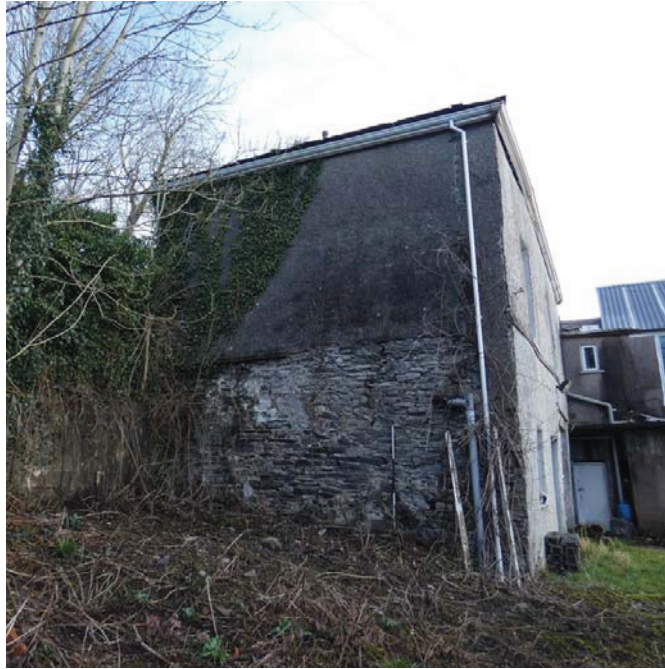
4.2.7 **South-west external elevation – coach house:** this is a plain gable topped by a hipped roof with a moulded iron gutter below, with roughcast concrete render over the upper part but not the lower, which is exposed stone with the scar for what was presumably an attached outshut visible (Plate 60).

Plate 60: The south-west external elevation of the coach house, viewed from the south-west

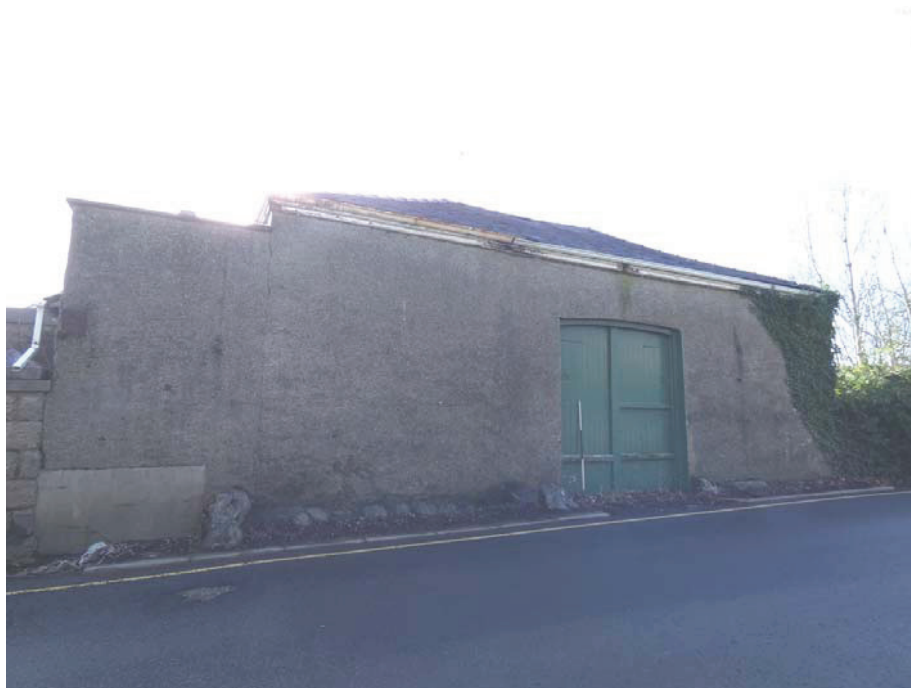
4.2.8 **North-west external elevation – coach house:** this faces directly onto Daltongate, is finished with rough cast concrete render, and has been extended on the north-east side by a raised wall that denotes the location of an attached outshut (Plate 61). It has a hipped roof with a moulded iron gutter below attached to a timber barge board and a central wagon doorway with a plank and batten double door, with the battens on the external face, and a slightly rounded top. Edge-set slate flags are positioned against the foundations, presumably covering a drain or other void.

Plate 61 (left): The north-west external elevation of the coach house, viewed from the north-west

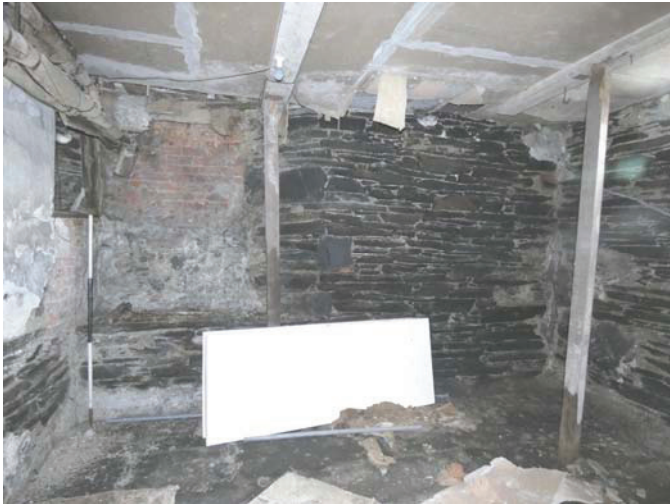
Plate 62 (left): The north-east elevation of Room B1, viewed from the south-west

4.3.1 **Mansion – Basement Room 1 (B1)**: this has a stone flag floor and modern plaster ceiling, with two sawn beams orientated north-east/south west supported by later inserted timber posts. The walls are all exposed stone although with the remnants of plaster remaining. The **north-east elevation** has an aperture on the north-west side with a splayed south-east jamb, the top half of which is blocked with brick and so was presumably originally a window (Plate 62). The **south-east elevation** has high level window near the centre with brick in the jambs and an eight-light horizontally sliding sash casement (Plate 63). The **south-west elevation** has more plaster remaining and there is an opening essentially in the centre running through the wall into the adjoining room to the south-west. This was presumably originally a fireplace that has been broken right through the wall; there is brick in the south-east jamb where it has presumably been partially blocked and an iron lintel, which projects slightly (Plate 64). A further small hole has been inserted above presumably to allow access to the flue. On the floor in front of the large opening there is a block constructed from fire bricks that presumably originally housed a stove or boiler. On the north-west side of the elevation there is a doorway with a plank and batten door on strap hinges. The **north-west elevation** is mostly plain, again with slightly more plaster remaining, and there is brick blocking the opening continuing from the north-east elevation at the north-east end, although this is partially open at the top and has a timber surround and plank infill.

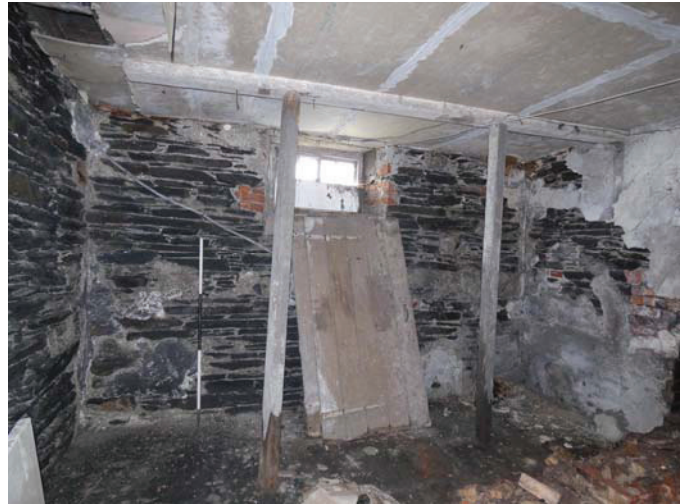
Plate 63 (right): The south-east elevation of Room B1, viewed from the north-west

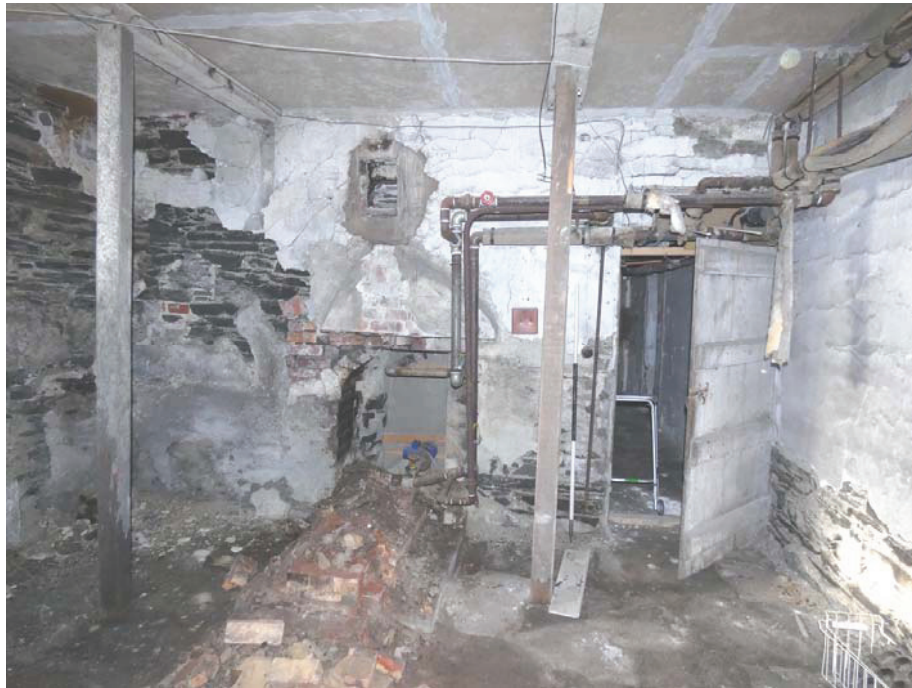
Plate 64: The south-west elevation of Room B1, viewed from the north-east

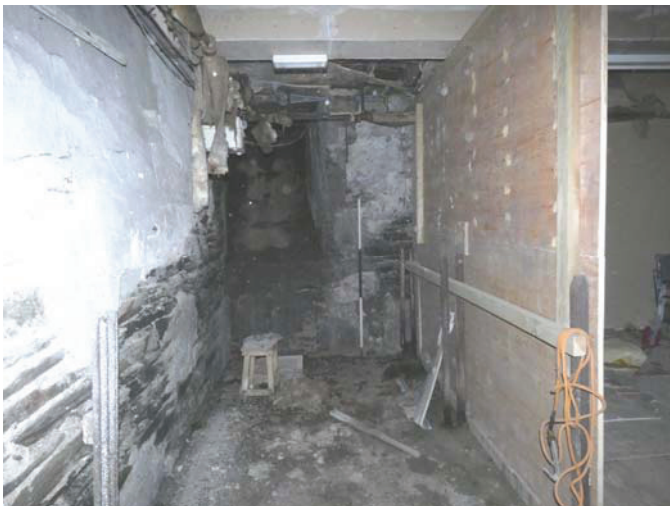
Plate 65 (left): The plywood partition across the south-west side of Room B2 and the chute in the north-west elevation, viewed from the south-east

4.3.2 **Mansion – Basement Room 2 (B2)**: this has a concrete floor, raised on plywood on the north-east side. It has a modern plasterboard ceiling, with boxed in beams. The walls are mostly modern plasterboard, except at the south-west end, where they are exposed stone. There is a plywood partition at the stop in the floor supported by iron uprights to the south-west side, corresponding with the raised floor (Plate 65). The **north-east elevation** is plain, with modern shelves attached (Plate 66). The **south-east elevation** has a doorway at the south-west end, with a plain surround and a modern panel door. The **south-west elevation** is plain. The **north-west elevation** is mostly plain, with a chute on the south-west side, concrete lined, and with iron I-beam lintels.

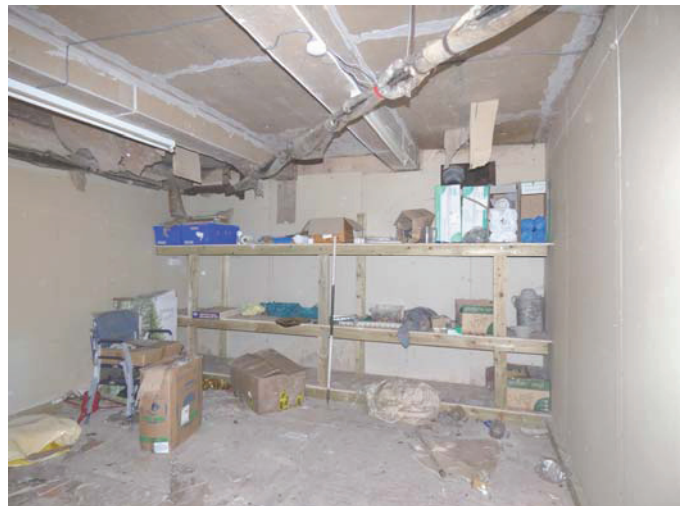
Plate 66 (right): The north-east elevation, Room B2, viewed from the south

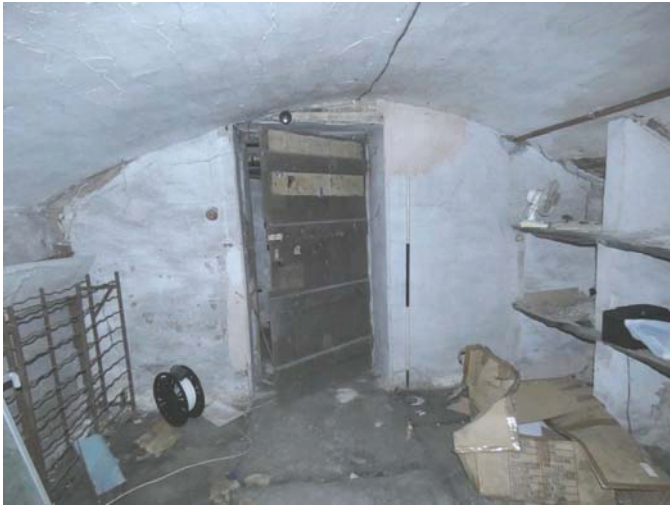
Plate 67 (left): The south-east elevation of Room B3, showing the vaulted ceiling, viewed from the north-west

4.3.3 **Mansion – Basement Room 3 (B3)**: this has a flag floor, a stone vaulted ceiling (Plate 67), and walls of rough plaster over stone, with thin slate courses. The **north-east** and **north-west elevations** are plain. The **south-east elevation** has a doorway with a plank and batten door on long strap hinges with an early lock (Plate 67). The **south-west elevation** has stone slab on brick pillar shelves over three levels (Plate 68).

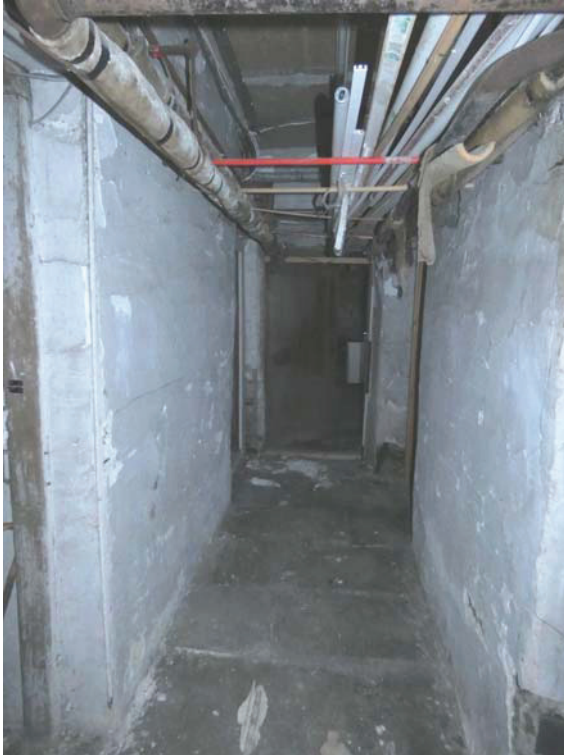
Plate 69 (left): Doorway at the north-east end of Room B3, viewed from the south-west

4.3.4 **Mansion – Basement Room 4 (B4):** this comprises a long corridor running north-east/south-west, with a flag floor and a plasterboard ceiling. There is a door in the **north-east elevation**, which is plank and batten on long strap hinges, with a plain surround. There are three doors in the **south-east elevation**, which are plank and batten where they survive, one modern, with plain surrounds, and there is also a slate bench with brick pillars on the north-east side. There are two more doorway in the **north-west elevation**. The **south-west elevation** just comprises a doorway at end of the corridor that blocked by modern boards, presumably this originally led outside. There is a staircase on the north-west side constructed from plain timber, with a square newel and handrail, boxed in with plasterboard. There is a dividing door midway along, which has plank and batten door, which is very thick, on strap hinges.

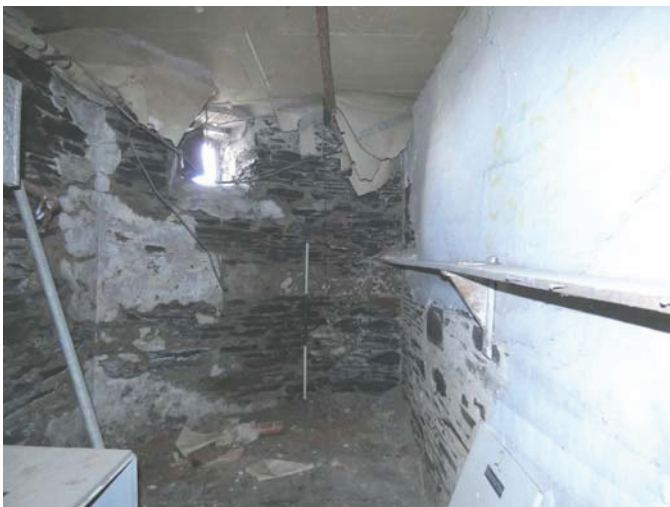
Plate 73 (left): The south-east and south-west elevations, Room B5, viewed from the north-west

4.3.5 **Mansion – Basement Room 5 (B5):** this has a flag floor, a modern plasterboard ceiling, and the walls are exposed stone with the remains of plaster. There are modern boilers on the north-west side. The **north-east** and **south-west elevations** are plain apart from boxing on the north-west side of the north-east round the hole formed around the broken through fireplace in Room B1. The **south-east elevation** is curved, with a small opening with iron bars high up. The **south-west elevation** has a long shelf on a bracket with 'John 8/3/79' sprayed on. The **north-west elevation** has a doorway on the north-east side, with modern graffiti to the south-west 'Deborah Wilkes is a nut' 'John 4/10/76' 'Norma Wilkes 1976' etc. There are shelves fixed high on the south-west side.

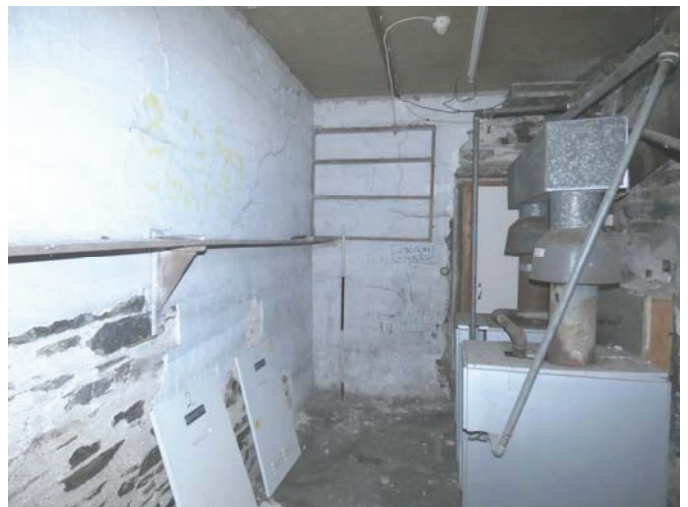
Plate 74 (right): The south-west and north-west elevations, Room B5, viewed from the south-east
