FAIR VIEW, DALTONGATE, ULVERSTON, CUMBRIA

Archaeological Building Recording

Client: Storey Sharp

April 2019

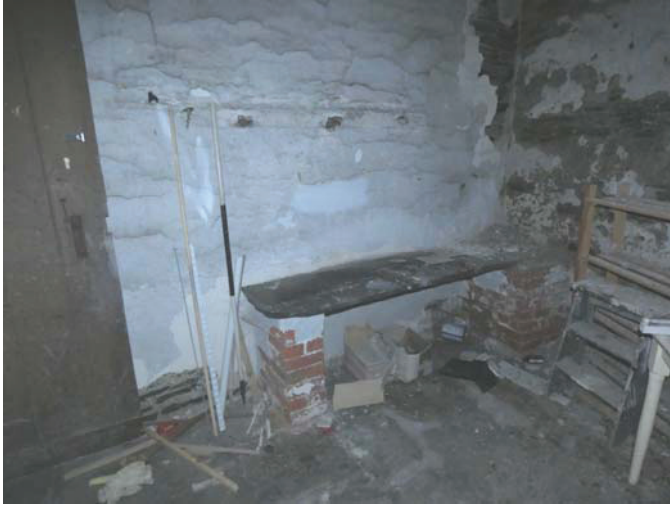
Plate 75 (left): Slate bench on the north-east side of Room B6, viewed from the west

4.3.6 **Mansion – Basement Room 6 (B6)**: this has a flag floor, and a modern plasterboard ceiling. The walls have the remains of lime plaster. The **north-east** and **south-west elevations** are relatively plain, although there is a stone flag bench on the north-east on brick pillars (Plate 75) and shelves fixed to the south-west, which curve round from the south-east (Plate 76). The **south-east elevation** has a small high-level window with the remnants of a timber shutter (Plate 76). The **north-west elevation** has a doorway with a plank and batten door in a plain surround.

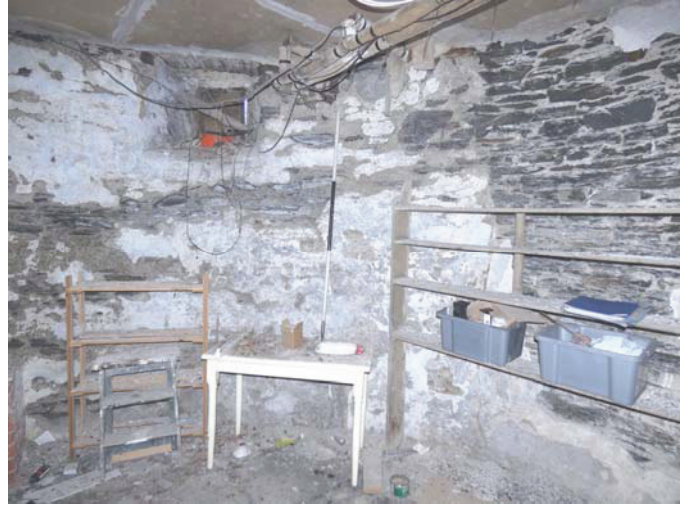
Plate 76 (right): South-east and south-west elevations, Room B6, viewed from the west

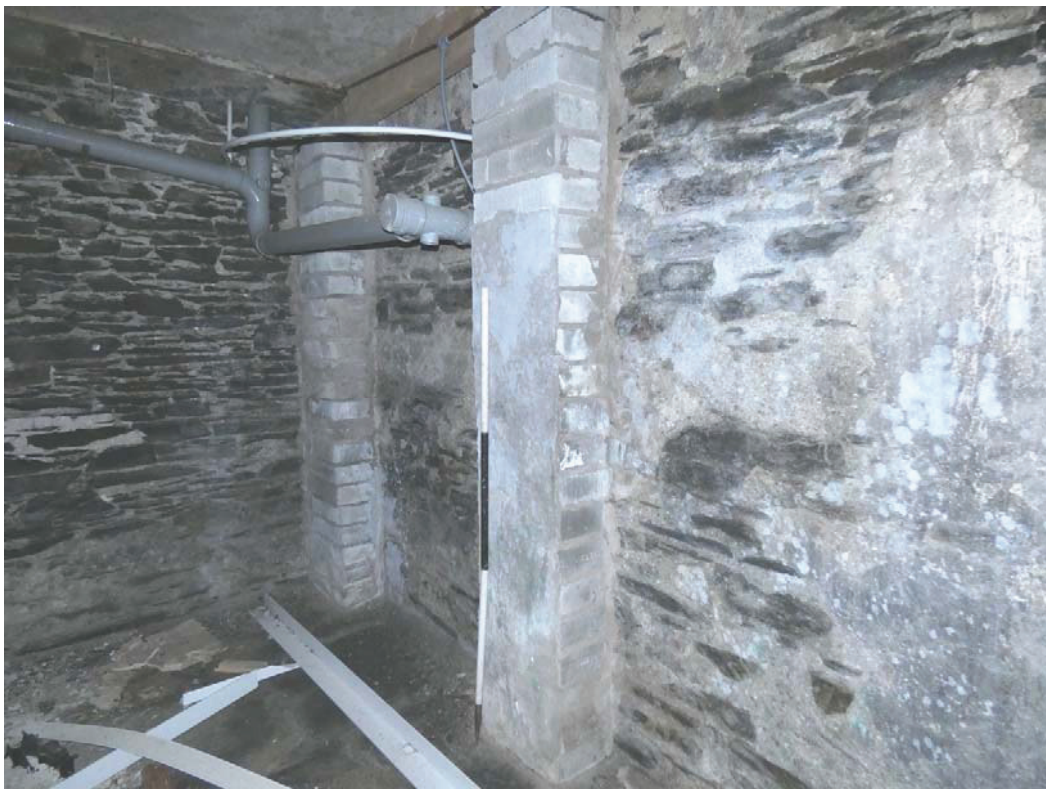
4.3.7 **Mansion – Basement Room 7 (B7)**: this has a flag floor, a plasterboard ceiling, and the walls are largely exposed stone. The **north-east** and **south-west elevations** are plain. The **south-east elevation** has three buttresses in concrete block added against it (Plate 77) and a hole knocked through for a pipe. The **north-west elevation** has a doorway near the centre, with a plain surround, and a very thin timber lintel.

Plate 77: Concrete pillars against the south-east elevation, Room B7, viewed from the west

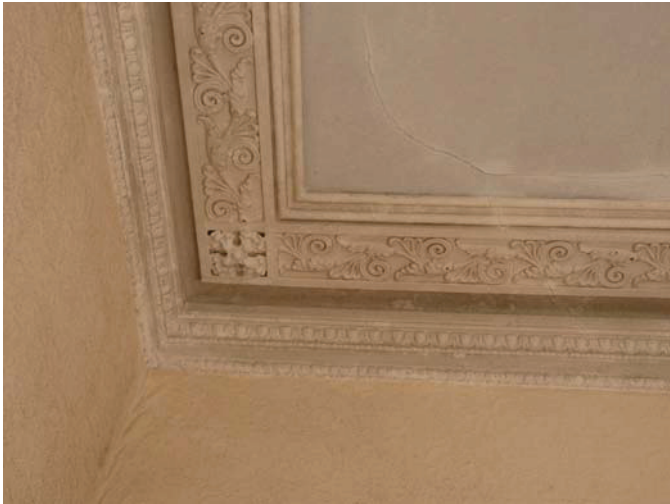
Plate 78 (left): Detail of the cornice in Room G1

4.3.8 Mansion – Ground floor Room 1 (G1): the floor is finished with carpet over floorboards and the ceiling is plaster with a decorative cornice with floral designs and egg and dart (Plate 78). The walls are finished with plaster and textured wallpaper. The north-east elevation has a central fireplace with a fairly plain but moulded stone surround (Plate 79). The south-east elevation has a window with splayed jambs extending to the floor finished by moulded shutters and a four-light sash casement. There is an alcove on the south-west side with a panelled back designed to accommodate the folding door in the south-west elevation (Plate 80). The south-west elevation is dominated on the south-east side by this folding door which comprises two curving panelled sections set within a wide moulded surround. To the north-west is a pedestrian doorway with moulded six panel door and surround. The north-west elevation has a large central alcove with a reeded surround supporting a round headed arch with floral medallions below which is a flat moulded band that has a recessed area behind it (Plate 81).

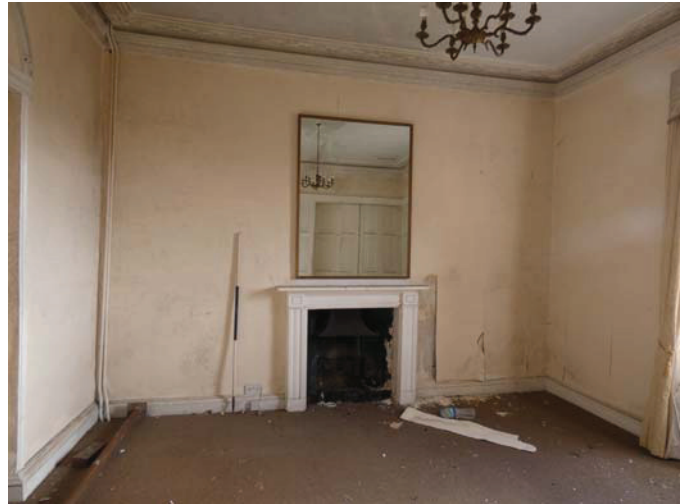
Plate 79 (right): The north-east elevation in Room G1, viewed from the south-west

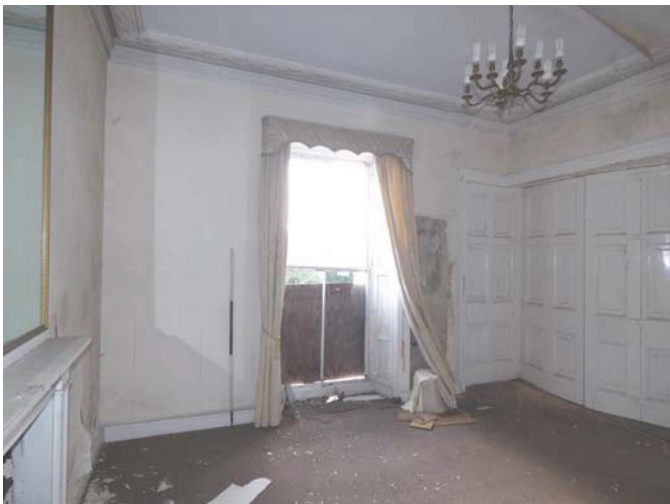
Plate 80 (left): The south-east elevation in Room G1, viewed from the north-west

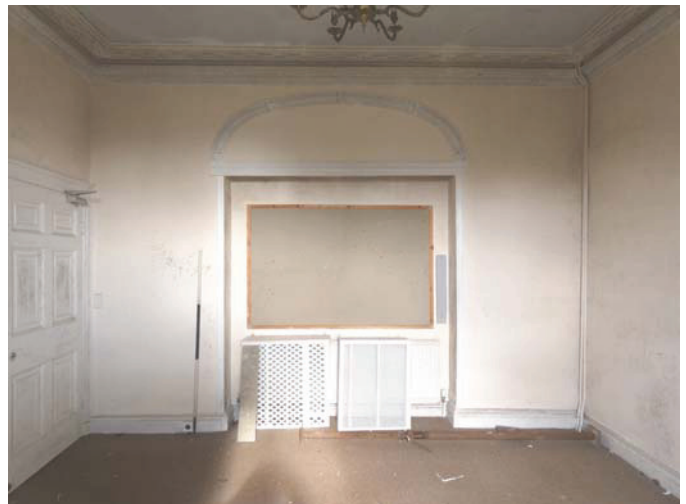
Plate 81 (right): The north-west elevation in Room G1, viewed from the south-east

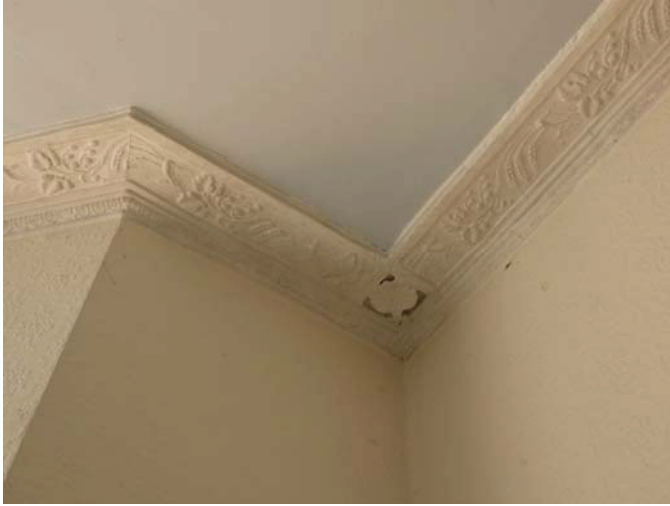
Plate 82 (left): Cornice in Room G2

4.3.9 Mansion – Ground floor Room 2 (G2): the floor is finished with carpet over floor boards and the ceiling plaster with a moulded floral cornice, although very shallow. The walls are finished with plaster and textured wallpaper. The north-east elevation is dominated by a bay window on the south-east side with two four-light sash casements in the main part and one on the north-west side (Plate 83). There is also a doorway to the south-east with a double door each with a single panel and light and with two lights above. The south-east elevation is plain while the south-west has a doorway on the north-west and south-east sides both with moulded six panel doors and surrounds (Plate 84); the south-east also has

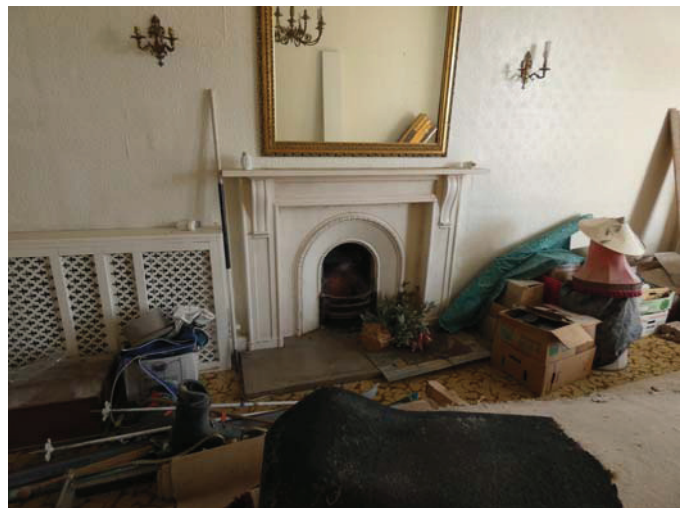
Plate 85 (right): Fireplace in the north-west elevation of Room G2, viewed from the south-east

panelled jambs while the north-west provides access to a small cupboard with shelves. Between them is a central alcove with a decorative arch with ram's head corbels and acanthus leaves, flowers and beads. Inside is a plaster fan with leaves and a floral border. The alcove sides are straight apart from curved sections that have been cut out of the lower part. The north-west elevation is largely plain apart from a central fireplace with a fairly plain moulded stone surround with scrolled corbels, iron insert with floral decoration and marble hearth (Plate 85).

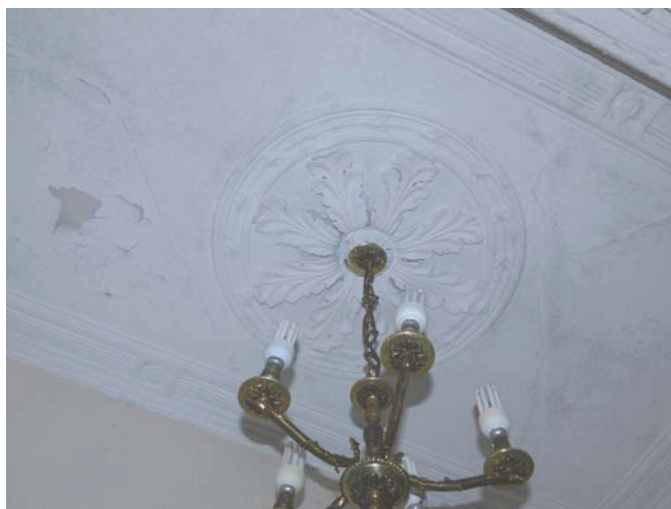
Plate 87 (right): Ceiling rose in Room G3

4.3.10 Mansion – Ground floor Room 3 (G3): this comprises an essentially L-shaped corridor, with the long axis running north-east/south-west down the centre of the building and the short axis north-west/south-east to the front door. It is finished with carpet throughout over timber boards with a plaster ceiling with a reeded cornice with floral bosses (Plate 86) and acanthus leaf ceiling rose (Plate 87). The north-west/south-east arm has a door in the north-east elevation with panelled jambs and there is a dividing arch to the south-east that is also panelled while the arch is beaded (Plate 88). There is a further smaller arch to the south-east at a further short north-east/south-west section which also has a panelled door in a moulded surround, to the north-west of which is an alcove with a beaded surround on acanthus leaf corbels, the front of which has been filled with a modern plain door (Plate 89). Opposite this, in the south-west elevation, there is another full height doorway, with no door, leading into a cupboard with a curved back following the line of Room G4 (Plate 90). To the south-west of this is a further doorway, into Room G4, which an elaborate moulded surround of criss-cross pattern with floral medallions and an

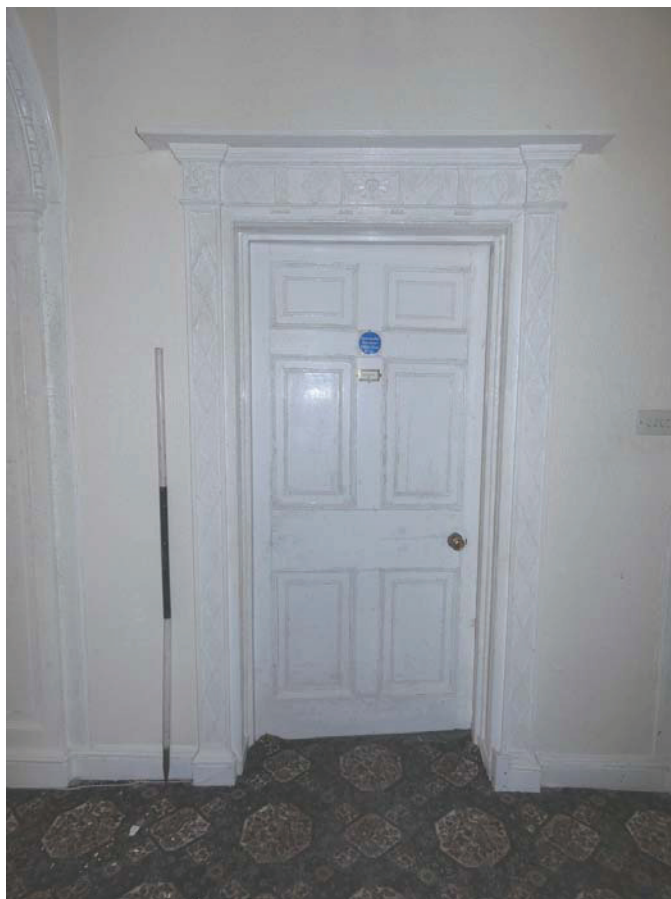
Plate 91 (right): Doorway in the south-east elevation of Room G3, viewed from the north-west

entablature (Plate 91). The south-west elevation has a doorway on the south-east side with a rounded top with bead decoration into which a later door has been inserted with a single panel and overlight. There is a further doorway to the north-west of this with a moulded surround and six panel door. The north-west end is dominated by the large front door, which has six panels, two overlights and a moulded surround. The north-east/south-west section is plainer and links to the main staircase. There are doorways to the south-east with panelled and moulded surrounds. There is a doorway at the south-west end with flanking single light windows and a later door and an inserted timber hand rail below the staircase. The staircase itself has a fairly plain handrail coming to a turned end, thin square section balusters and decorative bracketing below the steps.

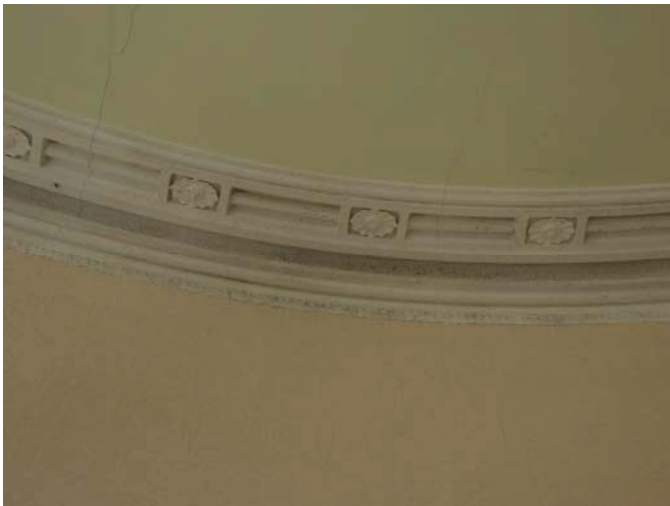
Plate 94 (left): Cornice in Room G4

4.3.11 Mansion – Ground floor Room 4 (G4): this is oval in plan, with a carpet floor over boards and a plaster ceiling with a moulded cornice decorated with fan modillions and egg and dart (Plate 94) and there is a central plaster ceiling rose in a Gothic/floral design (Plate 95). The walls are finished with plaster and textured wallpaper and a tall moulded skirting board. The north-east elevation is dominated by a large doorway with a folding panelled timber door in three parts set in a moulded surround (Plate 96). The south-east elevation has a pair of windows in moulded surrounds and with panelled splayed jambs (perhaps shutters?) and a four light sash casement. These are set either side of a fireplace with a marble surround with decorative corbels, tiled hearth and iron and brass insert with floral decoration (Plate 97). The south-west elevation is plain, while the north-west has a central doorway with a moulded surround and six panels.

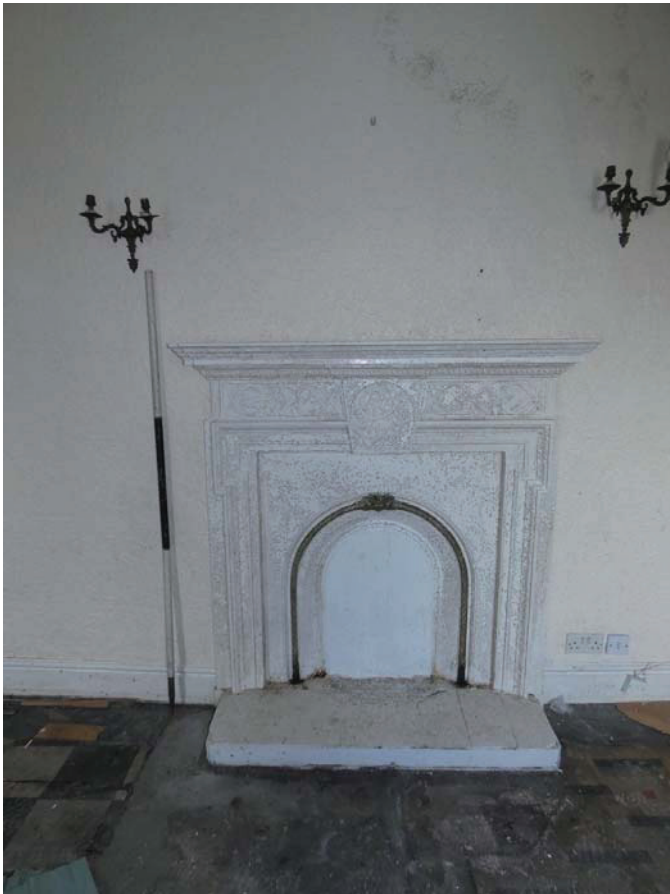
Plate 98 (left): Fireplace on the south-east side of Room G5, viewed from the north-west

4.3.12 Mansion – Ground floor Room 5 (G5): this has a vinyl floor covering over concrete or perhaps stone flags and a plaster ceiling with a relatively simple moulded cornice and a fan ceiling rose. The walls are finished with plaster and textured wallpaper and there is a simple moulded skirting board. The north-east elevation has doorway on the south-east side with a deep moulded surround and six panel moulded door. The south-east elevation is relatively plain apart from a central fireplace with an elaborate stone surround with a lugged top with denticulate and decoration and an armorial crest in the centre (Plate 98). It has an iron and brass insert and stone hearth but the opening itself is blocked. The south-west elevation has a doorway on the south-east side with a moulded surround and six panel door. The north-west elevation has a pair of tall windows with splayed jambs extending to the floor with moulded panels (or shutters) and 12-light sash casements (Plate 99). There are tongue and groove boards beneath the north-east one.

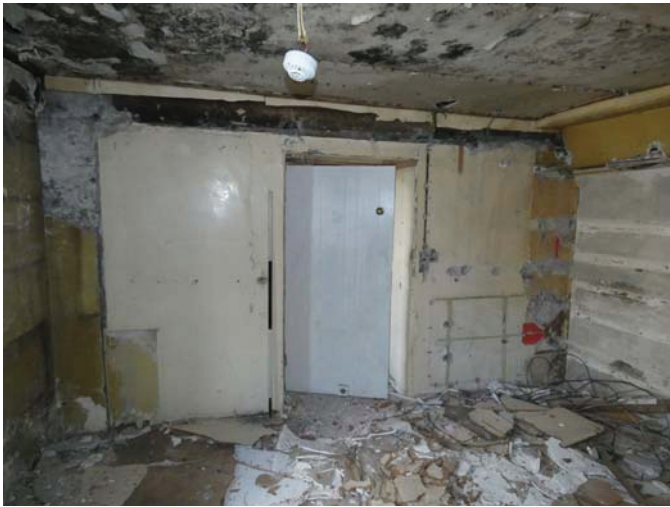
Plate 100 (left): The north-east elevation in Room G6, viewed from the south-west

4.3.13 Mansion – Ground floor Room 6 (G6): the floor is obscured by debris from the collapsed ceiling and wall coverings, but what is left of the ceiling is plaster and boards, while the walls are finished with plaster and some tiles in a poor condition and evidently previously covered by some form of cladding. The north-east elevation has a central doorway with a beaded plank and batten door (Plate 100). The south-east elevation has an alcove on the north-east side that originally had shelves. To the south-west is a window with splayed jambs, some brick in the north-east, and the remains of a sash casement. The wall is tiled to the south-west and there is a moulded batten attached (Plate 101). The south-west elevation has a large alcove in the centre with an iron I-beam lintel and machine made brick in the south-east jamb and brick and concrete block in the north-west (Plate 102). The back of the alcove is a mixture of brick, stone and concrete block and is partially tiled and the gap above the lintel has been filled with roof slate. North-west of this opening is a doorway with a round arched head in brick below which has been slightly infilled with brick above a stone lintel, and there are the remains of a timber surround still in

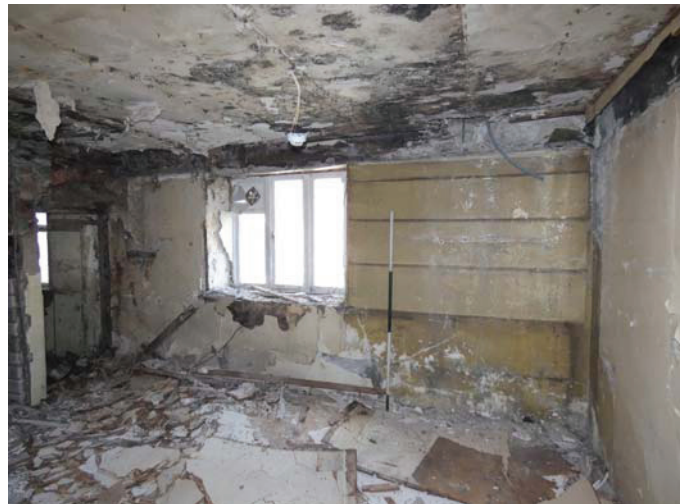
Plate 103 (right): The north-west elevation in Room G6, viewed from the south-east

situ. The north-west elevation has a central window with a hinged three-light casement incorporating a vent and with slightly splayed jambs (Plate 103).

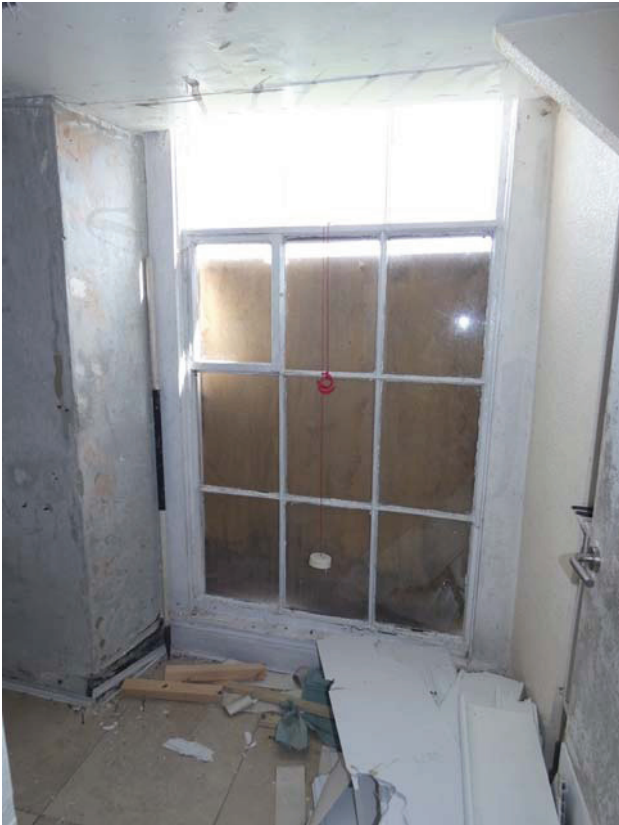
Plate 104 (left): Window in the south-east elevation of the bathroom (Room G7), viewed from the north-west

4.3.14 Mansion – Ground floor Room 7 (G7): this is a bathroom and is subdivided into three rooms, with a back stair to the south-west. The bathroom has a tiled floor and a modern plaster ceiling. The end of what is presumably the principal rafter is projecting through in the south corner. The ceiling is lowered, the walls finished with modern plaster, and there are internal stud partitions, finished with plastic cladding or textured wall paper. There are toilet/sink fittings throughout. There is a window to the south-east, which is a tall 12-light sash, but is cut by the ceiling. The door to the north-west has a moulded surround. The back stair is very narrow and the stair case is finished with carpet and the walls are finished with plaster and wall paper, with a plain handrail on the north-east side leading up to square balusters at the landing between floors, with further holes for balusters on the south-east side. There is a timber batten with coat hooks on the south-west wall and a small cupboard in the east corner at the landing, and the top three lights of the window in the bathroom below are visible to the south-east. There is a further tall window above continuing to the floor above. The cupboard is partly finished with tongue-and-groove boards, and has a door to the south-west, with four panels.

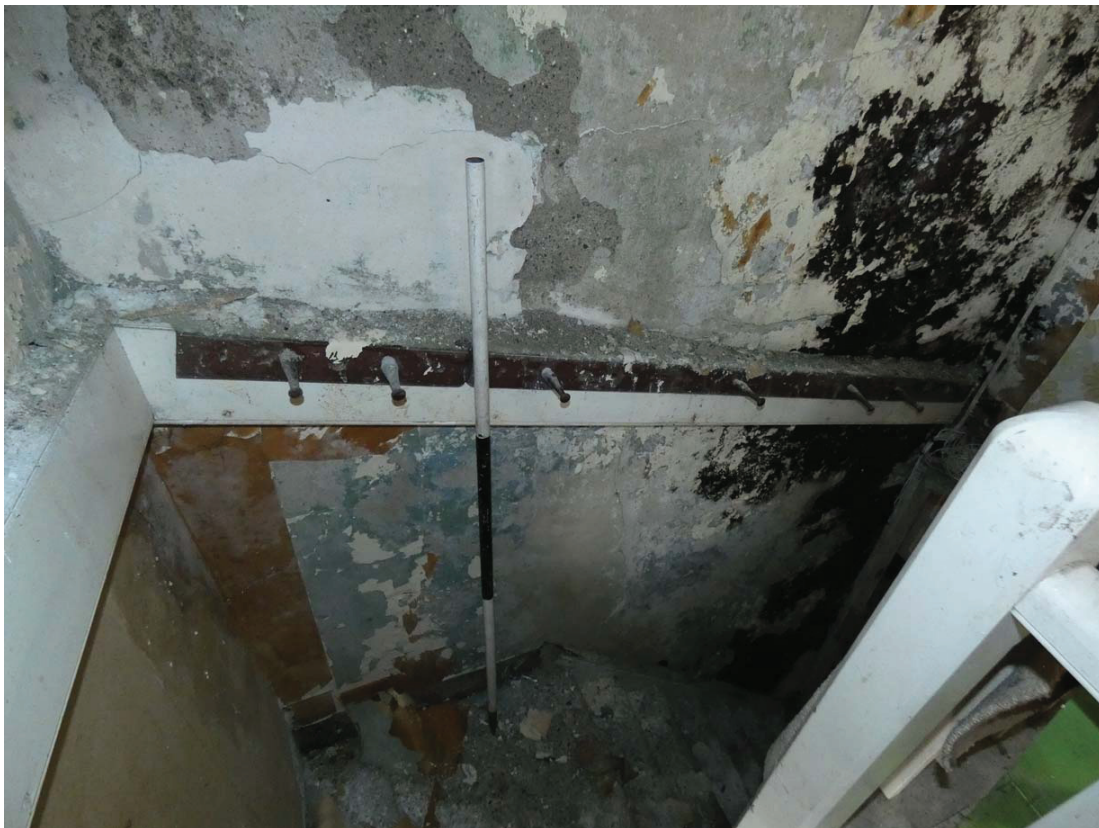
Plate 106: Batten and coat hooks attached to the south-west elevation in the back stair (Room G7), viewed from the north-east

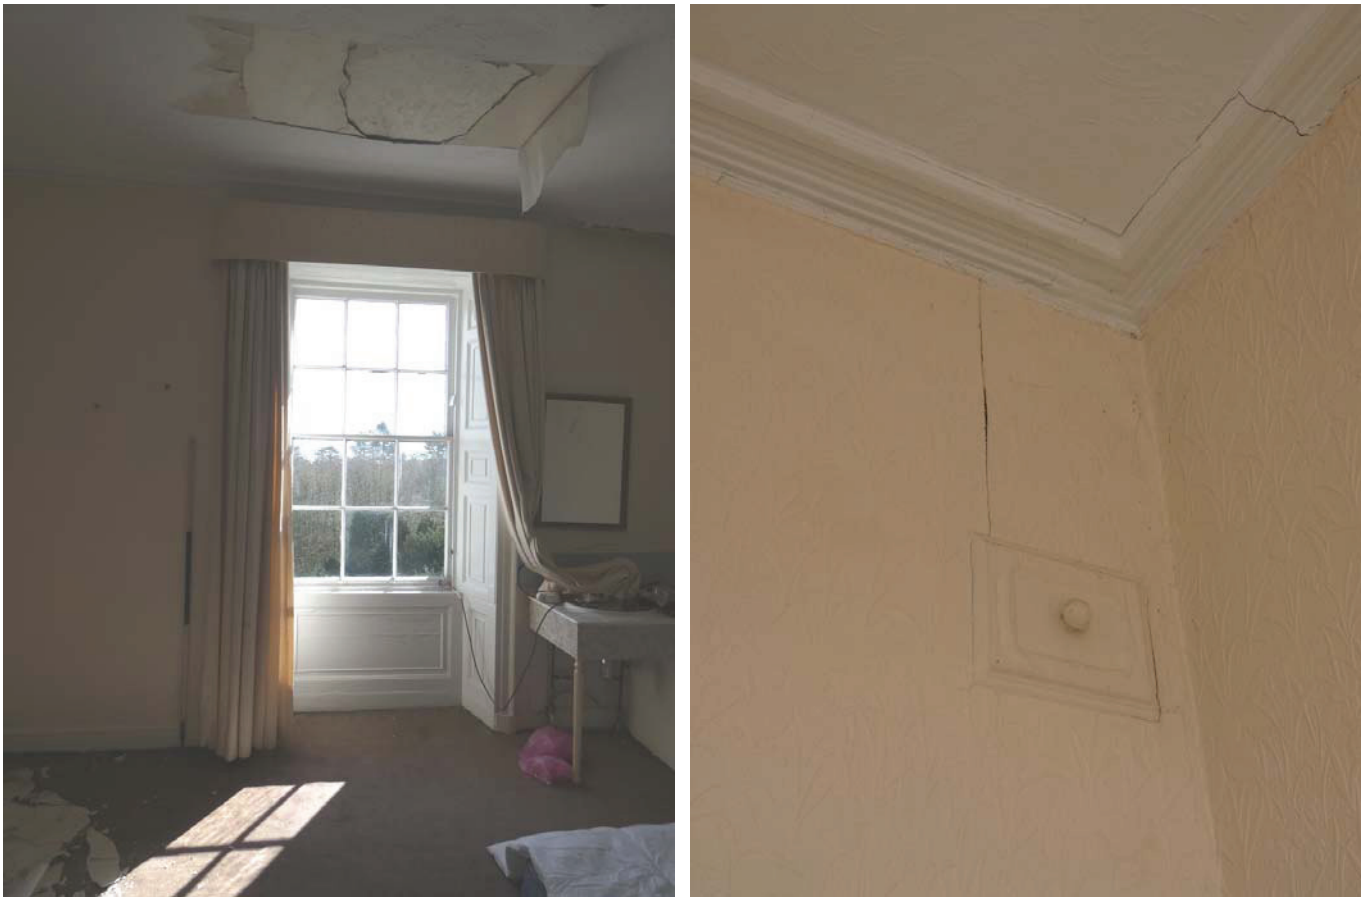
4.3.15 Mansion – First floor Room 1 (F1): the floor is finished with carpet over floorboards and the ceiling plaster with a shallow moulded cornice. The walls are finished with plaster and textured wallpaper and a skirting board. The north-east elevation is plain with a gap in the skirting board denoting the location of a fireplace. The south-east elevation has a window with splayed jambs extending to the floor with moulded panels and a surround. The south-west elevation has numerous cracks on the south-east side and a doorway on the north-west with a moulded surround but plain door (although this is clearly a panel attached to an earlier door). The north-west elevation is largely plain, but with a small aperture with an iron door high on the north-east side, presumably access to a flue or vent.

Plate 107 (left): The window in the south-east elevation of Room F1, viewed from the north-west

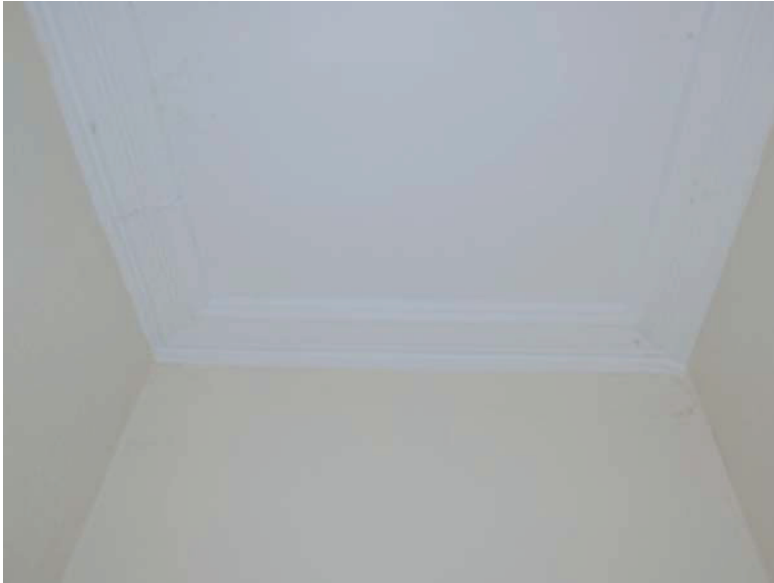
Plate 109 (left): Cornice in Room F2

4.3.16 Mansion – First floor Room 2 (F2): the floor is finished with carpet over floor boards and the ceiling is plaster with a moulded cornice (Plate 109) and a north-west/south-east orientated beam along the north-east side with a beaded edge. The walls are finished with plaster and textured wallpaper and there is a tall skirting board with a beaded edge although this looks more recent on the north-east side. The north-east elevation has later cladding fixed against the wall proper and is plain and the south-east elevation is also plain. The south-west elevation has a doorway on the south-east side with a moulded surround and plain single panel door (fixed over the original). The wall returns to the north-east on the north-west side as a stud wall and there is a sink attached on the north-west end. The north-west elevation has a window with splayed jambs extending to the floor finished with panelled shutters and with a 12-light sliding sash casement (Plate 110).

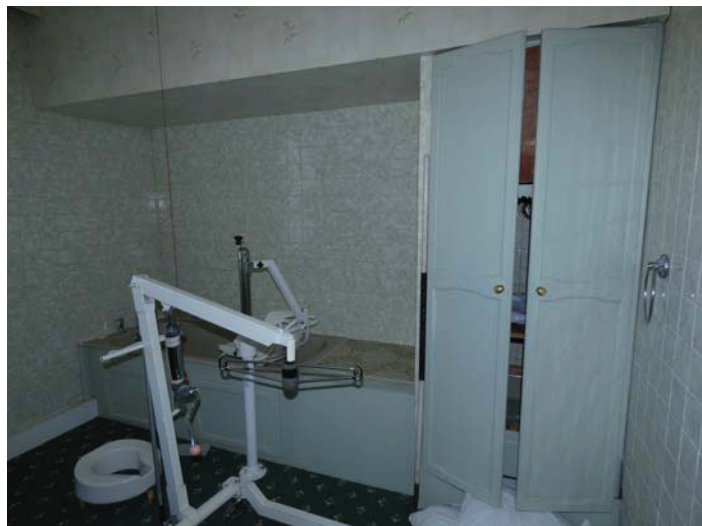
Plate 111 (left): The north-east elevation in Room F3, viewed from the south-west

4.3.17 **Mansion – First floor Room 3 (F3)**: the floor is carpet over floor boards, and the ceiling is plaster finished with textured wall paper, tiled and lowered on the north-east side. The walls are tiled. The **north-east elevation** is stepped down in the ceiling over the bath with a built-in cupboard on the south-east side (Plate 111). The **south-east elevation** has a door on the south-west side with a moulded surround and a panel over the earlier door – this leads to a small lobby with further doors to the south-east and north-east. There is a six-panelled door to the north-east and panelled jambs to the south-east. The **south-west elevation** is plain and tiled with a sink unit attached. The **north-west elevation** has a window on the south-west side, partly following the line of the wall, with panelled jambs, a tiled sill (possibly inserted), and a 12-light sash casement (Plate 112).

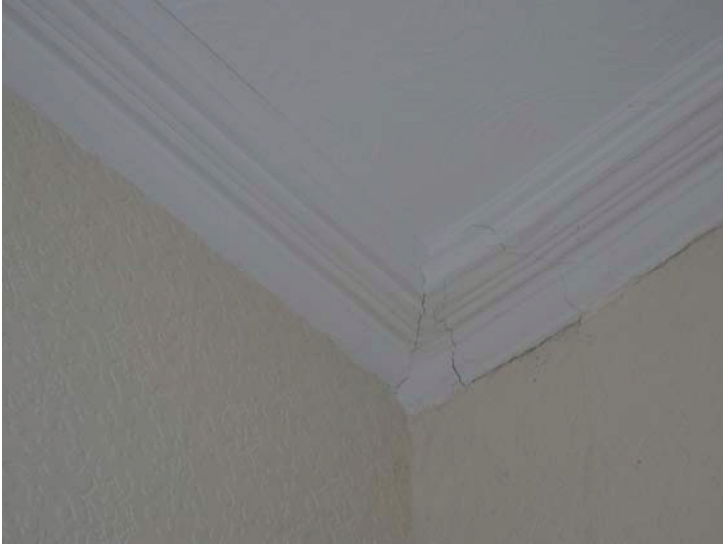
4.3.18 *Mansion – First floor Room 4 (F4)*: the floor is carpet over floor boards, and the flat plaster ceiling is finished with wallpaper and has a deep moulded cornice throughout (Plate 113). The walls are finished with textured wall paper and a beaded skirting board, which appears to be newer on the south-west side. The **north-east elevation** is plain, with lots of cracks. The **south-east elevation** has a window, with panelled shutters over jambs and a window seat, and a 12-light sash casement (Plate 114). The **south-west elevation** is plain, with a stud wall and an attached sink. The **north-west elevation** has a door on the north-east side, with a moulded surround, and a panel over the original door.

Plate 113 (left): Cornice detail in Room F4

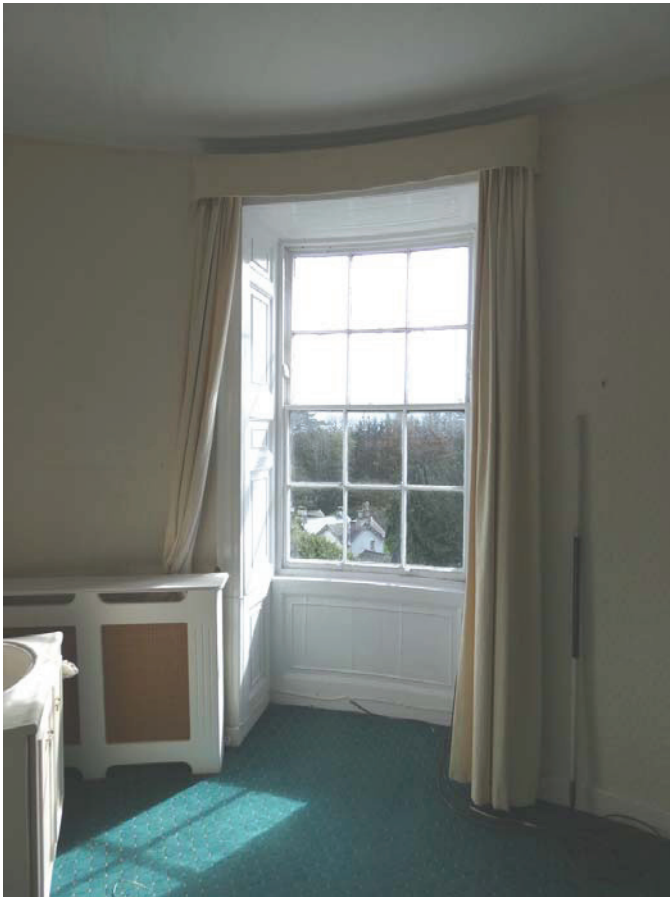
Plate 115 (left): Window in the south-east elevation of Room F5, viewed from the north-west

4.3.19 **Mansion – First floor Room 5 (F5)**: there is carpet on the floor, and the plaster ceiling is finished with textured wall paper and there is a moulded cornice on all sides. The walls are finished with textured wall paper and beaded skirting boards. The **north-east** and **south-west elevations** are plain. The **south-east elevation** has a window with splayed jambs to the floor, panelled shutters, and a panel below. The window is a 12-light sash casement. The **north-west elevation** has a door on the south-west side, with a moulded surround and a plain single panel over the original door.

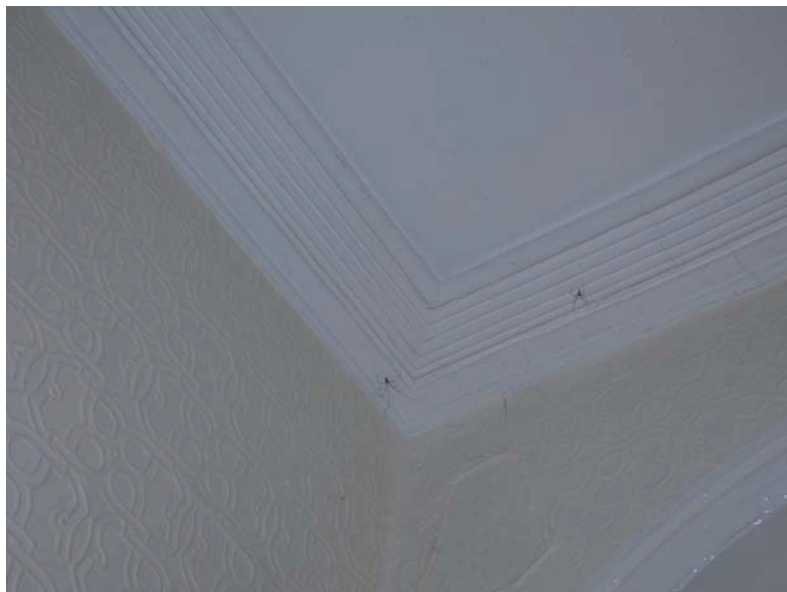
Plate 117 (left): Cornice in Room F6

4.3.20 **Mansion – First floor Room 6 (F6)**: this comprises is a corridor running north-east/south-west linking the rooms on the first floor with the stairs at the south-west end. The north-east end is a plain corridor with carpet floor and a plaster ceiling finished with textured wall paper and with a fluted cornice (Plate 117). There is a door at the north-east end, two doors to the south-east, and three to the north-west, all six-panel, with moulded surrounds, although the north-east on the north-west elevation has no door and panelled jambs. The door dividing the corridor from the stairs at the south-west end is a modern insertion below a round-headed arch (Plate 118). There are panelled jambs to the south-west door too and boxing has been added against the jambs in the east corner over the surrounds. The south-west end of the room opens into a wider space at the top of the main staircase. This space is again carpeted and with a plaster ceiling with a fluted cornice. The walls are finished with textured wall paper and beaded skirting boards. The stair hand rail has collapsed at the upper level but decorative end panels are still present. The **north-east elevation** has a pair of arched openings with moulded surrounds meeting at the central engaged pilaster, and to the south-east is an alcove with a moulded band (Plate 119). The **south-east elevation** has a doorway to the back stair with a moulded surround, and the door is missing, beyond which the remains of the staircase are present, although the hand rail and balusters have been pulled over (Plate 119). There is a window low on the south-west side with geometric lights and an inserted hinged light. The **south-west elevation** is dominated by a large window with a geometric light and an added iron frame with painted glass – classical floral patterns and a heraldic coat of arms (Plate 120). There are panelled jambs and a moulded surround. The **north-west elevation** has a doorway on the south-west side, possibly inserted and very plain, leading to two steps, with a moulded surround. There is a further door at the landing, with panelled jambs.

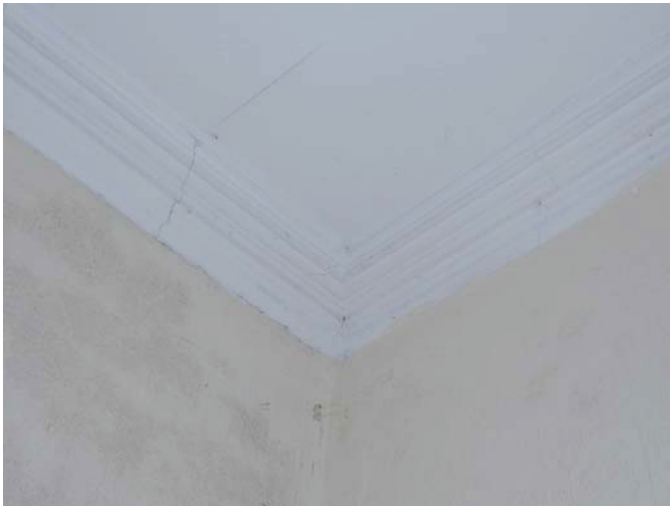
Plate 121 (left): Cornice in Room F7

4.3.21 **Mansion – First floor Room 7 (F7)**: there is carpet on the floor, and the plaster ceiling is finished with flock wall paper and there is a moulded cornice on all sides. The walls are finished with textured wall paper and beaded skirting board. The **north-east elevation** is plain. The **south-east elevation** has a door on the south-west side, with a moulded surround, and a plain panel over the original door. The **south-west elevation** has two doorways, both with six-panel moulded doors and moulded surrounds. The south-east doorway leads into a cupboard, and there is a sink attached between the two doorways. The **north-west elevation** has a window on the north-east side, with splayed jambs to the floor. There are panelled shutters and 12-light sash casements.

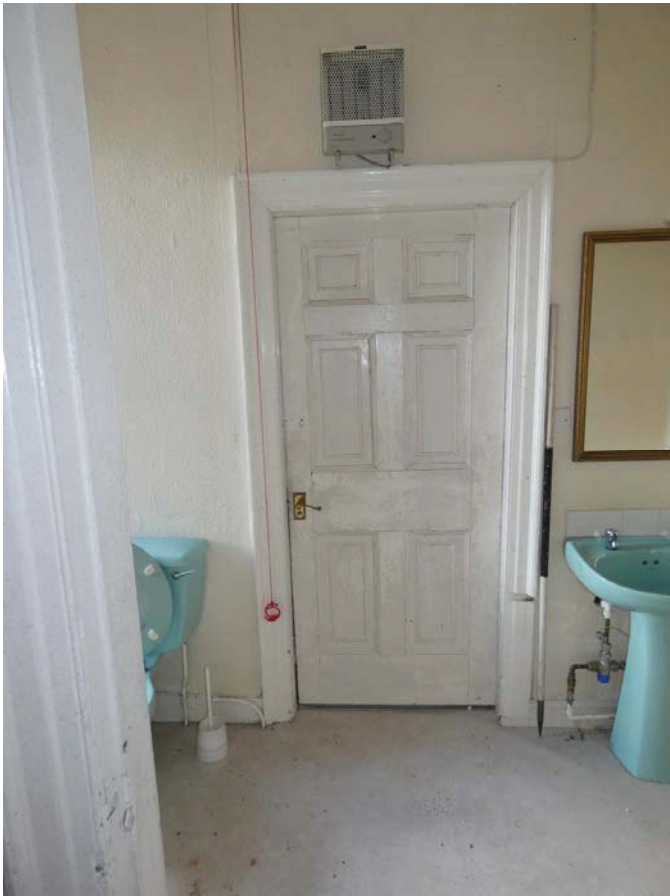
Plate 123 (left): Doorway to north-east, Room F8, viewed from the south-west

4.3.22 **Mansion – First floor Room 8 (F8)**: this is a small bathroom between rooms F7 and F9. It has a vinyl floor, with a plaster ceiling finished with textured wall paper. The **north-east** and **south-west walls** are stud partitions each with a doorway, with a moulded surround and a six-panel door (Plate 123). There is a toilet and sink on the north-east. There is a window to the north-west – half hidden by the north-east wall, but it is a 12-light sash with splayed jambs, plaster, a moulded surround, and a plain sill, possibly inserted, with a blocked alcove below (Plate 124).

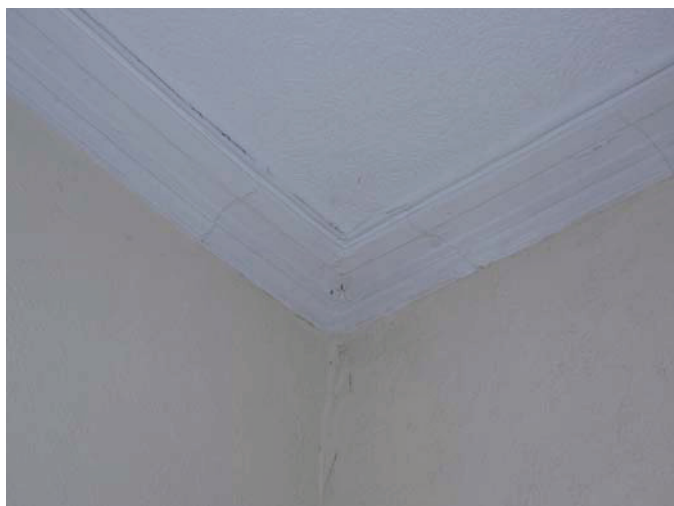
Plate 125 (left): Cornice in Room F9

4.3.23 **Mansion – First floor Room 9 (F9)**: there is carpet on the floor, and the plaster ceiling is finished with textured wall paper and with a simple cornice throughout (Plate 125), although there is a section in the south corner that is not present as the projecting base of the stairs come through walls finished with textured wall paper and beaded skirting. The **north-east elevation** has a door in the centre with a moulded surround and a six-panel door. There is a sink unit to the north-west and a smaller door to the south-east, with a plain surround and a three-panel door into a cupboard (Plate 126). The **south-east elevation** has a door on the north-east side, with a moulded surround and a plain panel over the door. The **south-west elevation** is plain apart from a scar in the skirting for a fireplace. The **north-west elevation** has a window with splayed jambs, which are panelled and have panelled shutters and 12-light sash casements.

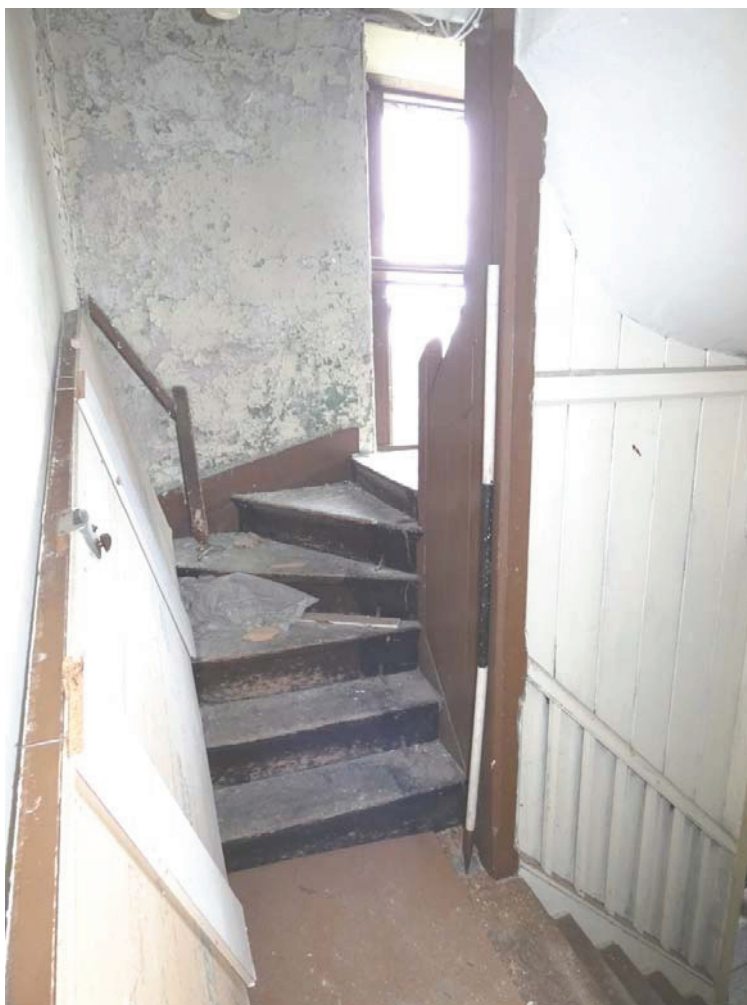
Plate 127: Top of the stairs in Room F10

4.3.24 *Mansion – First floor Room 10 (F10)*: this is the top of the back stair. It has the same timber stops, no carpet, and a plain handrail and balusters, and a stop-chamfered newel. The back of the cupboard on the floor below is finished with tongue-and-groove boards. There is a window in the south-east elevation which is partly covered by a cupboard built into the room at mid-level (Room F/S1).

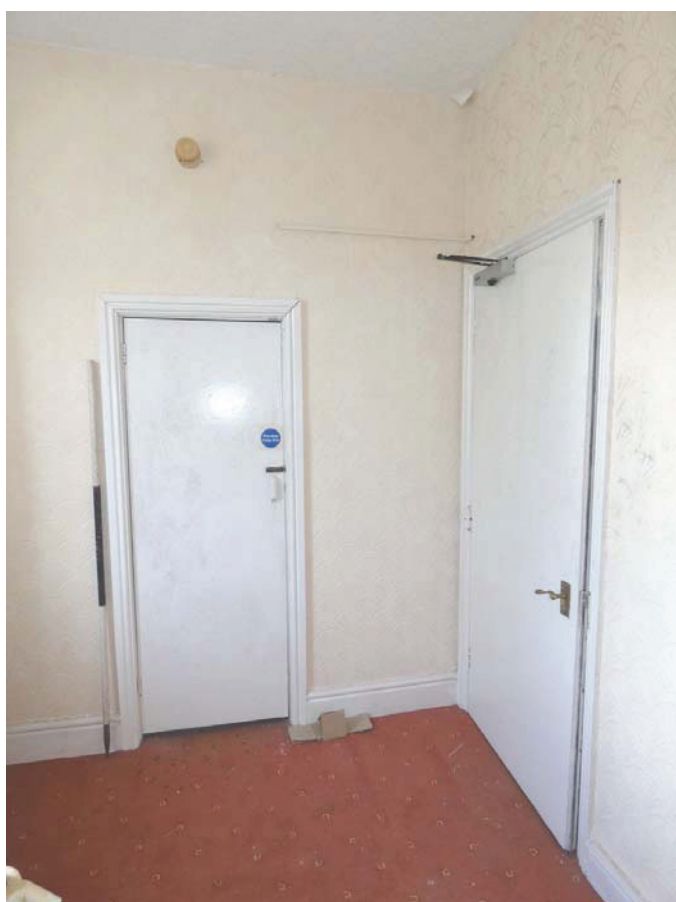
Plate 128 (left): Doorways in the north-east and south-east elevations of the bathroom (Room F11), viewed from the south-west

4.3.25 **Mansion – First floor Room 11 (F11)**: this is split into two rooms, a bathroom to the west and toilet to the south-east, plus the stairs along the north-east side. The main room has a carpet floor and a plaster ceiling finished with textured wall paper. The walls are also finished with textured wall paper and a fairly plain skirting. The **north-east elevation** has a doorway with a modern plain surround and door into a cupboard below the stairs (Plate 128), and the back of the stairs is finished with modern plaster board. There is a water tank on the north-west side. The **south-east elevation** has a doorway on the north-east side with a moulded surround and plain door (Plate 128). The **south-west elevation** is plain. The **north-west elevation** has a window with splayed jambs with panelling and a four-light sash (Plate 129). The wall is built out with boxing on either side. The stairs to the north-east are bare timber with a modern handrail to the south-west (Plate 130). The south-east rooms comprise a small lobby at the foot of the stairs, linking the different sections and a toilet to the south-west. There is carpet on the floor and the plaster ceiling is finished with textured wall paper. The walls are finished with textured wall paper. There is a doorway to the stairs, which is modern. The door to the toilet is six-panel, moulded, and with a moulded surround (Plate 131). The doorway to room F6 has a moulded surround, down two steps, and has no door. The toilet has a window in the south-east elevation, with splayed jambs, which are panelled, a timber sill, and a four-light sash.

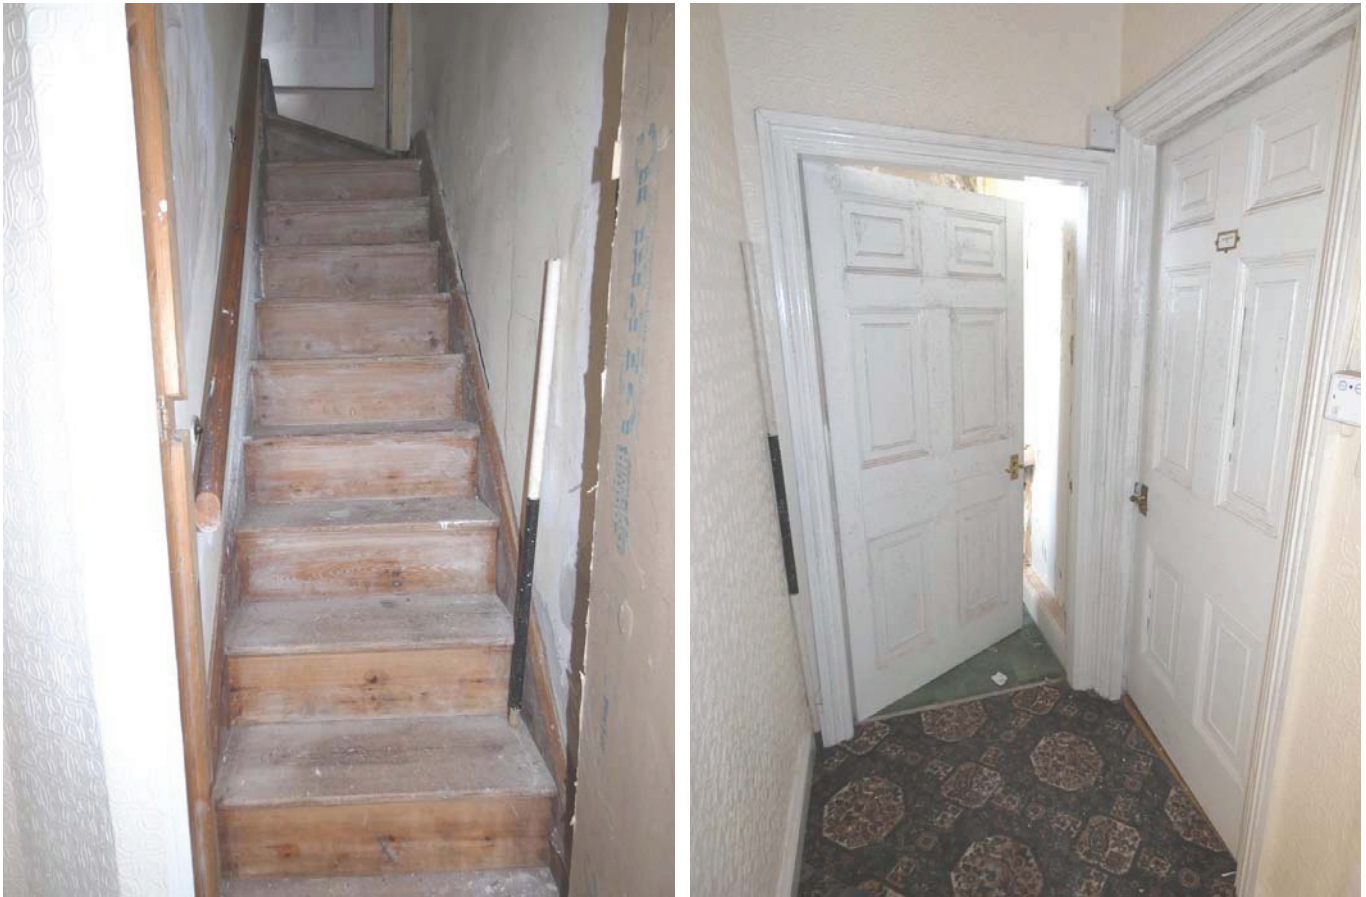
Plate 130 (left): Stairs along the north-east side of Room F11, viewed from the south-east

Plate 131 (right): Doorways within the lobby (Room F11), viewed from the north-east

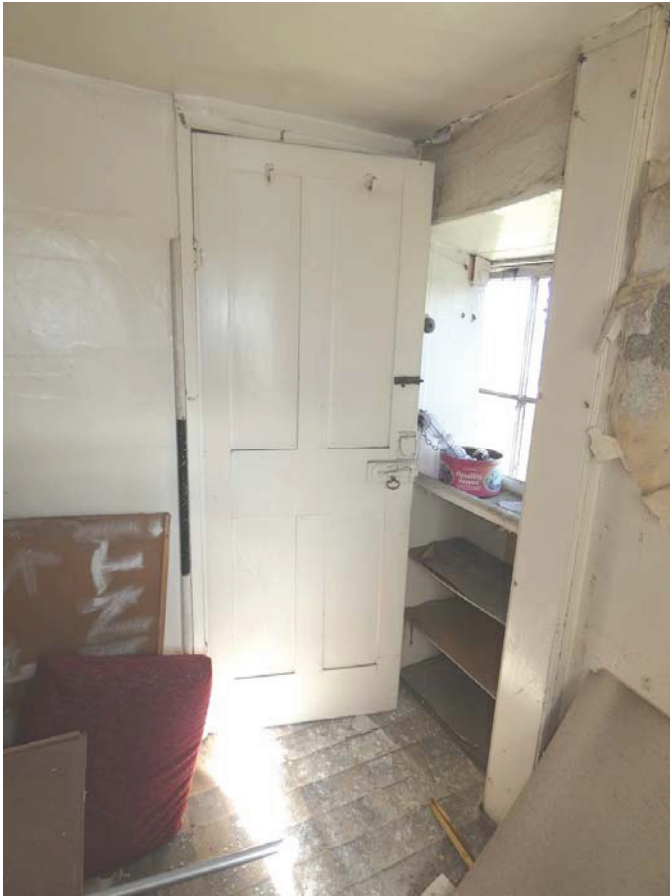
Plate 132 (left): The north-west side of Room F/S 1, viewed from the south-west

4.3.26 **Mansion – First/Second floor Room 1 (F/S1)**: this is a small bathroom off the south-west side of the back stair. It has a vinyl tiled floor over boards. The walls are rough plaster and have the remains of wall paper, with exposed thin courses of slate on the south-east side. There is a doorway in the **north-east elevation** in the stud wall, with four plain panels, moulded on the other side with an early sprung latch and a loop handle (Plate 132). There is a tall window continuing in the **south-east elevation** from the stair but shelves built into the alcove are partly blocking it. There is a small window in the **south-west elevation** with splayed jambs, which are plain, and a timber sill. It has a two-light hinged casement (Plate 133).
