FAIR VIEW, DALTONGATE, ULVERSTON, CUMBRIA

Archaeological Building Recording

Client: Storey Sharp

April 2019

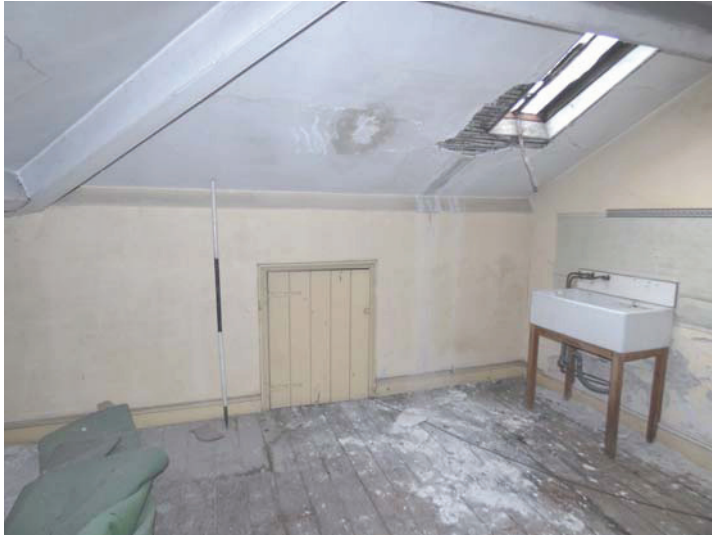
Plate 134 (left): The stud walling against the south-east elevation of Room S1, viewed from the north-west

4.3.27 **Mansion – Second floor Room 1 (S1)**: this has a board floor, with fairly narrow boards, running north-west/south-east. It is open to the roof, with two iron skylights, and the roof is plastered and has purlins on the north-east side and a principal from the east corner, all plastered and with beaded corners. There is a stud wall on the south-east side separating off the lower roof space area, with a small doorway with a moulded surround and a plank and batten door (Plate 134). There is a beaded skirting throughout and the walls are finished with plaster and paint, but the north-east wall has some exposed stone, with very thin slate courses, otherwise plain. The **north-east elevation** is plain. The **south-east elevation** has the end of a truss in the east corner, which comprises a post and angled brace with horizontal bar above (Plate 135) supporting the principal and a further small skylight to the south-west. It is otherwise plain, with a pipe driven through to the south-west for cables. The **south-west elevation** has an attached Belfast sink on a stand, a doorway on the north-west side, with moulded surround and a six-panel door, which is plain on this side (Plate 136). There is a metal hatch for a vent/flue above. The **north-west elevation** has two metal vent/flue hatches on the south-west side and is otherwise plain.

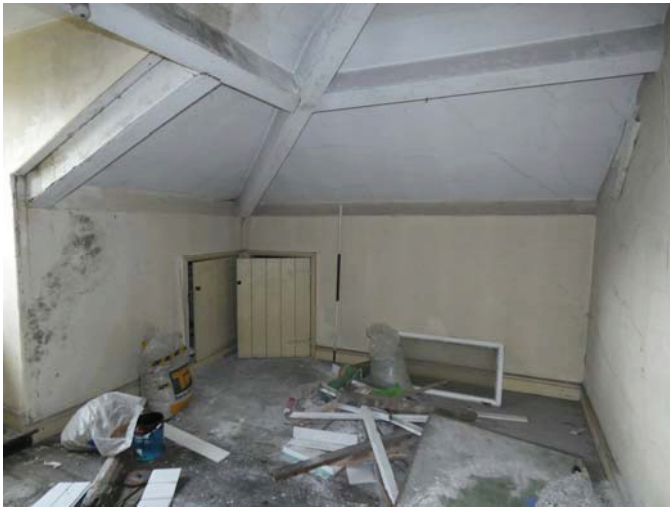
Plate 137 (left): The stud walls against north-east side of Room S2, viewed from the south-west

4.3.28 **Mansion – Second floor Room 2 (S2)**: this has a tongue-and groove floor with the boards running north-west/south-east, and it is open to the roof which is plastered and has exposed purlins/trusses which are finished with plaster and with beaded edges. The walls are finished with plaster and paint, and with stud walls along the north-east and north-west hiding the walls proper (Plate 137), which are exposed stone behind; thin slate courses with ends of trusses as per Room S1. There is beaded skirting throughout in the room proper. The **north-east elevation** hall proper is plain and not covered with later boarding. The stud wall has a door on the north-west side, with a moulded surround and a plank and batten door. The **south-east elevation** is plain. The **south-west elevation** has a doorway on the south-east side, with a moulded surround and a four-panel door, plain on this side (Plate 138). The majority of the **north-west elevation** proper is hidden by later boxing and has remnants of early limewash present. There is lath and plaster boxing around the window in the centre, which has a modern two-light casement and a built-in cupboard below with two drawers and two doors (Plate 139). In the stud wall there are low access doorways to the space behind, both with moulded surrounds and plank and batten doors.

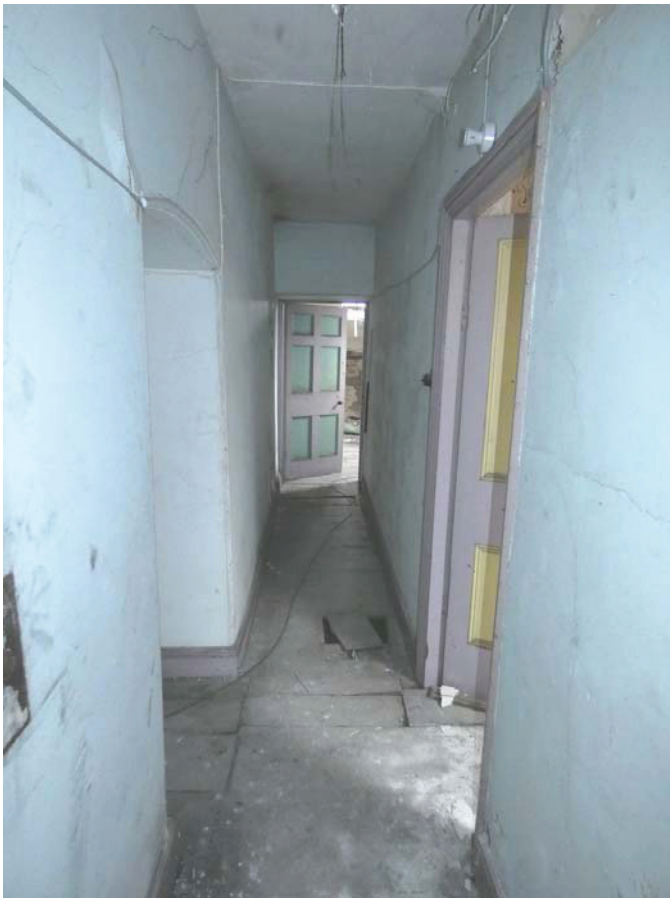
Plate 140 (left): The north-east end of Room S3, viewed from the south-west

4.3.29 Mansion – Second floor Room 3 (S3): this is a corridor running north-east/south-west with a short spur to the north-west. It has a wide board floor, a flat plaster ceiling with ends of trusses visible near the centre, which are plastered and beaded. The walls are plaster and paint with beaded skirting. The **north-east elevation** has a single doorway with a plain surround and a moulded six-panel door. The **south-east elevation** has a central doorway, with a four moulded panel door and a moulded surround (Plate 140). At the south-west end it opens to the back stair, with the same simple handrail and thin balusters. The **south-west elevation** has a doorway with a simple moulded surround and a plank and batten door, with tongue-and-groove boards (Plate 141). The **north-west elevation** is plain but with a central opening to the spur and two metal plates covering flue access hatches, the north-east one labelled 'main boiler flue from cellar. The north-west spur has doors to the north-east and south-west, which are moulded four-panels and surrounds. There is another flue access point on the south-east side and above the north-east door. There is a dividing door at the south-west end of the main section, which has a single panel and two lights and an angled top (Plate 141).

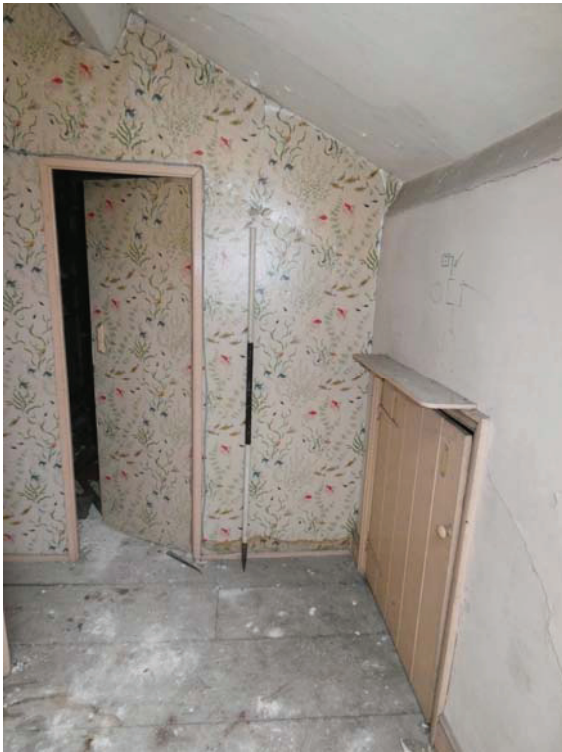
Plate 142 (left): The stud walls dividing Room S4, viewed from the south-west

4.3.30 Mansion – Second floor Room 4 (S4): this has a wide board floor with the boards running north-west/south-east. There is a plaster ceiling, with a purlin running north-east/south-west on the south-east side, which is plastered with a beaded edge. There are stud walls to the north-east and south-east forming the second room and boxing out the roof space (Plate 142), inside which is a complex base of a truss, with a post met by radiating beams and principal rafters (Plate 143). The walls are finished with plaster and paint or wall paper. The **north-east elevation** is plain, with exposed stone in the roof space to the south-east with some rough plaster. The **south-east elevation** is plain, with a curving wall of exposed stone. The **south-west elevation** is plain, with a sink and a bath attached (Plate 144). The **north-west elevation** has a door on the south-west side with a moulded surround and a plain four-panel door. There is attached timber for a water tank cupboard. The dividing wall is a modern stud

and has a narrow doorway with a plain surround and a plain panel door. There is a stud to the south-east which has a small doorway with a moulded surround and a plank and batten door.

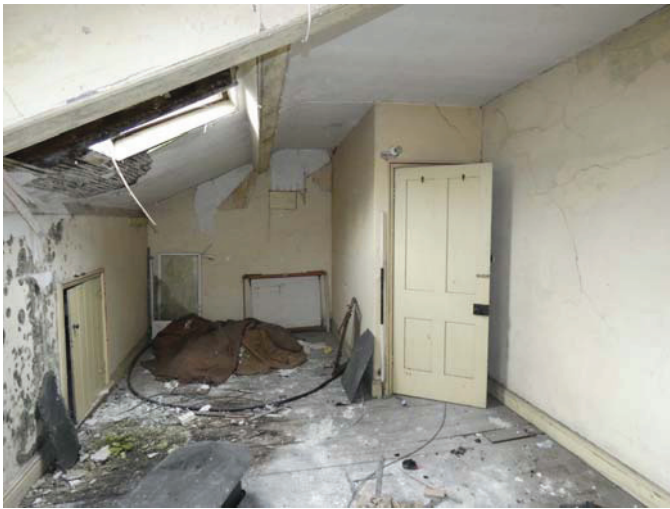
Plate 145 (left): The north-east end of Room S5, viewed from the south-west

4.3.31 **Mansion – Second floor Room 5 (S5)**: this has a fairly wide board floor with the boards running north-west/south-east, and the plaster ceiling has exposed purlins and principals, which are plastered and beaded. There are two iron skylights on the north-west side. The walls are finished with plaster and paint and with stud walls along the north-west side and on the south-west boxing in the roof space, and there is a stud wall in the east corner forming an angle around the stairs, probably a later addition (Plate 146), with a beaded skirting. The **north-east elevation** is plain on the north-west side before returning to the south-west, where it is a stud wall with a doorway with a moulded surround and a plain four-panel door (Plate 145). The **south-east elevation** is plain, apart from a return at the east corner. It continues into the roof space with a one-light window to the stairs. The **south-west elevation** is stone with limewash behind a stud wall, which has a small door with a moulded surround and a plank and batten door (Plate 146). The **north-west elevation** has a central dormer window, with two modern uPVC lights, with a built-in cupboard below, with two drawers and two doors (Plate 147). There are lath and plaster flanking walls and two doors into the roof space, with moulded surrounds and plank and batten doors.

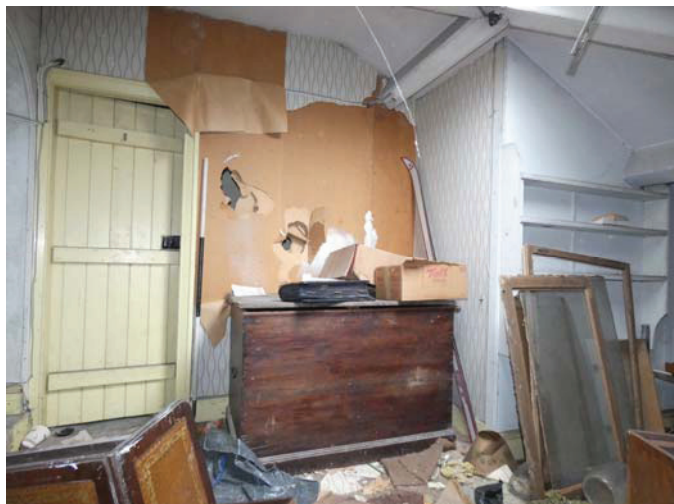
Plate 148 (left): The north-east elevation in Room S6, viewed from the south-west

4.3.32 **Mansion – Second floor Room 6 (S6)**: this has a wide board floor, and a plaster ceiling with purlins and principals plastered and with beaded edges. The walls are finished with plaster and pain or wall paper. The **north-east elevation** is a modern stud wall on the north-west side, with a doorway with a plain surround and a plank and batten door (Plate 148). There is a return at the south-east end to an earlier stud wall with attached early shelves. The **south-east elevation** is plain. The **south-west elevation** is covered by a stud wall, which has a small door with a moulded surround and a plank and batten door (Plate 150), and inside is a small roof space, with rough plaster over stone. The **north-west elevation** is plain. There is a doorway on the north-east side with a beaded surround and a round-headed arch (Plate 150), leading to a small L-shaped corridor with narrow floor boards, and a plaster ceiling with principals. There is a window in the stud wall to the north-west and the room drops down a flight of stairs on the south-west side to a doorway with a four-panel moulded door and moulded surround (Plate 151).

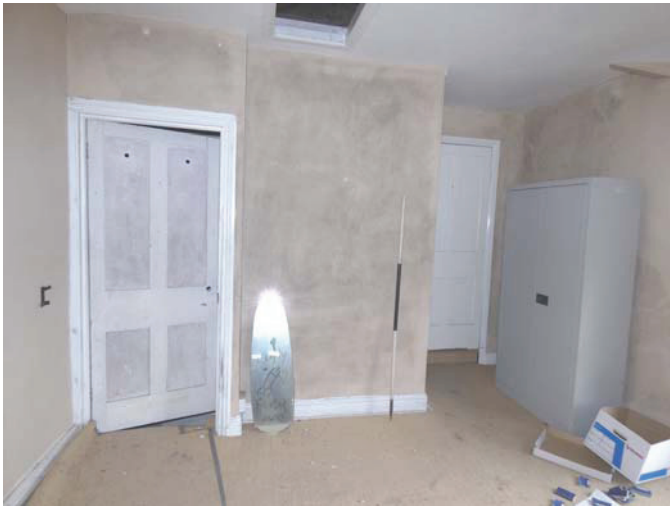
Plate 152 (left): The north-east elevation of Room S7, viewed from the south-west

4.3.33 **Mansion – Second floor Room 7 (S7)**: this has a carpet floor, and a flat plaster ceiling with ends of principals, which are plastered and beaded, and a roof hatch on the north-east side. The walls are finished with plaster and paint with moulded skirting. The **south-west** and **north-west elevations** are plain. The **north-east elevation** has a door on the north-west side, with a moulded surround and a plain four-panel door (Plate 152). There is a door to the south-east, which is the same. There is a stud wall with a cupboard in the return at the south-east side. The **south-east elevation** has a window with splayed jambs, which are plain, and a four-light sash casement (Plate 153). Inside the roof space above is a king post truss (Plate 154), and the walls to the north-east and south-west have rough plaster.

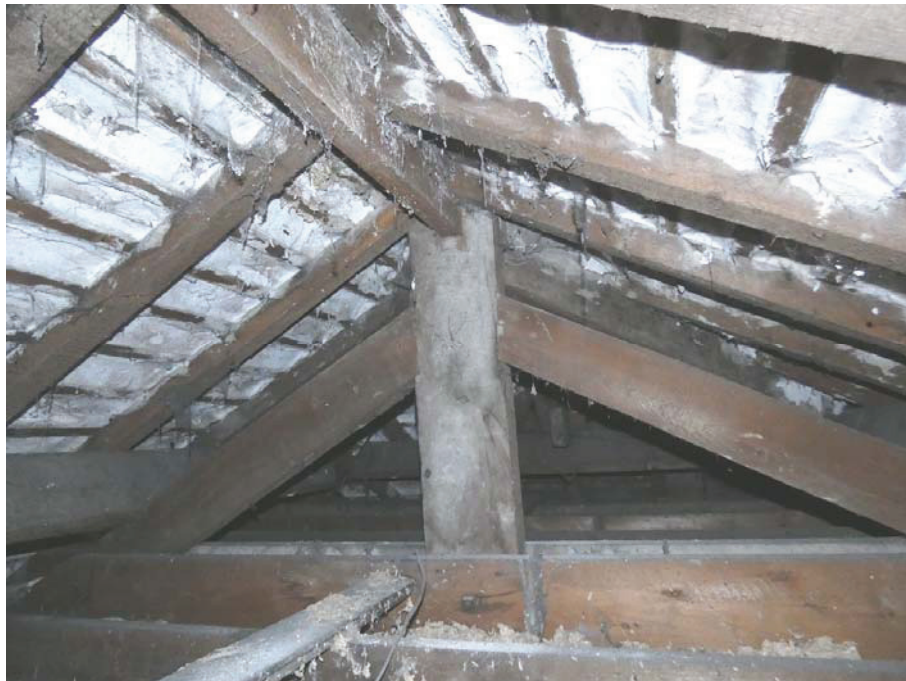
Plate 154: Truss in the roof space above Room S7, viewed from the north-east

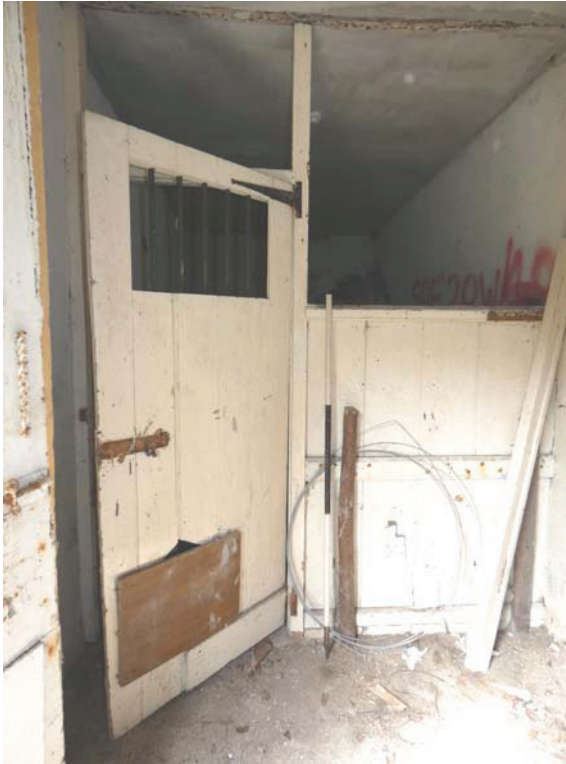
Plate 155 (left): Partition on the south-east side of Room G1, viewed from the south-east

4.3.34 **Coach House – Ground floor Room 1 (G1)**: this has a cobbled floor on the north-west side, with flags on the south-east, either side of a timber partition, not extending to the ceiling, with a plank and batten door on the south-west side with a grilled opening (Plate 155). It has a flat plaster ceiling and the walls are finished with plaster or render scored as ashlar blocks except for the flower part within the north-west section which is finished with tongue-and-groove planks (Plate 156). The **north-east elevation** is plain. The **south-east elevation** has a doorway on the south-west side, with a plank and

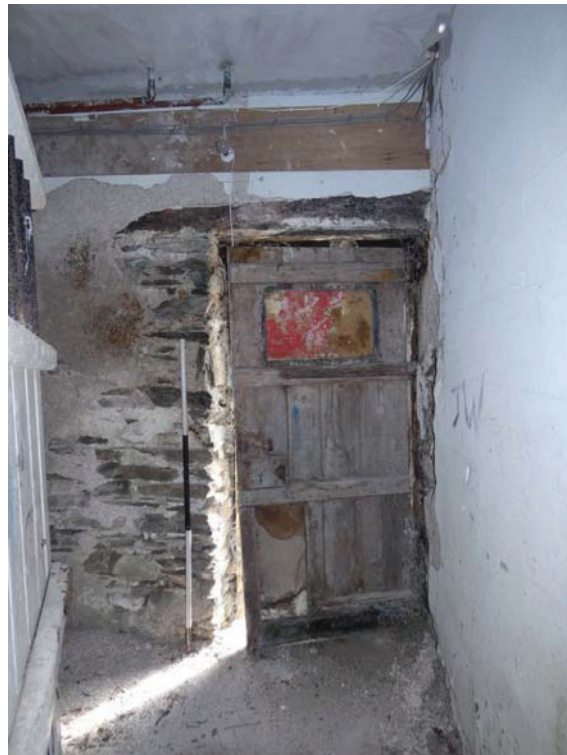
Plate 157: The doorway in the south-east elevation of Room G1, viewed from the north-west

batten door on long strap hinges, and a rough timber lintel (Plate 157). The **south-west** and **north-west elevations** are plain.

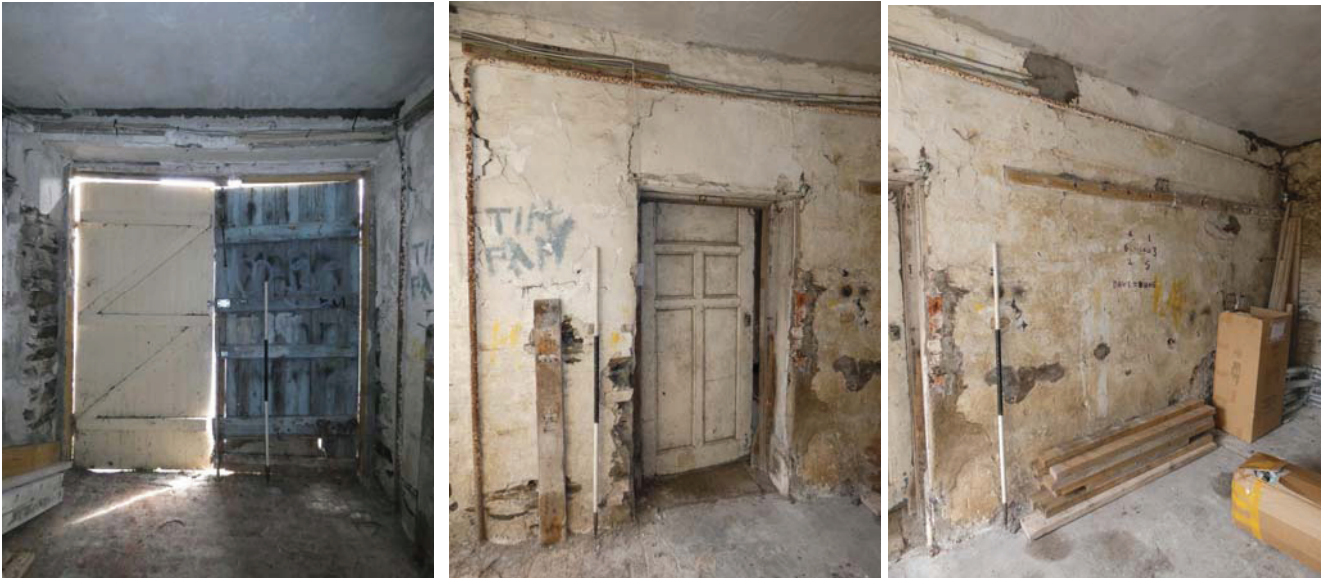
where there is exposed stone in thin courses of slate. The **north-east elevation** has an attached batten on the north-west side with hooks, and a central alcove with timber shelves inserted. The **south-east elevation** has a wagon door with a timber lintel plastered over and double plank and batten doors (Plate 158). The **south-west elevation** has a doorway on the south-east side with a five panel reused door (Plate 159), a horizontal timber batten attached with holes for pegs and which is beaded on the south-east side (Plate 160), and graffiti spray painted in various places. There is a further long timber batten to the north-west of two parts, the north-west end much rougher, with holes for pegs. There is a doorway on the south-east side, with a reused five-light door in a plain surround. The **north-west elevation** is plain apart from a blocked up alcove/aperture high on the north-east side.

Plate 158 (left): Double doorway in the south-east elevation of Room G2, viewed from the north-west

Plate 159 (centre): Doorway in the south-west elevation of Room G2, viewed from the north-east

Plate 160 (right): Batten attached to the south-west elevation of Room G2, viewed from the north-east

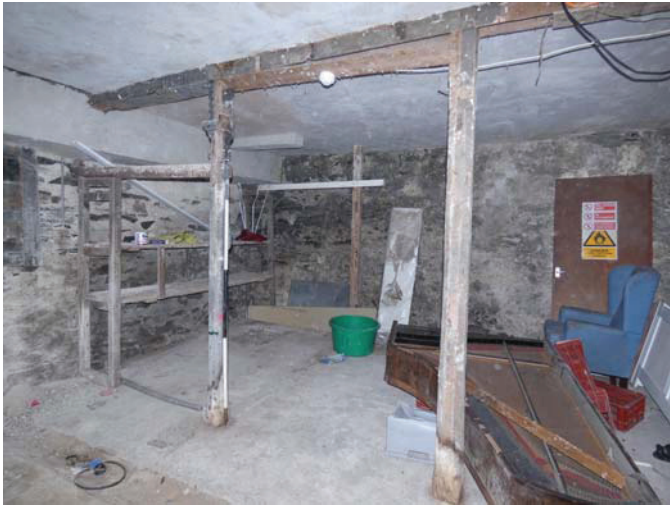
Plate 161 (left): Stall posts within Room G3, viewed from the south-east

4.3.36 **Coach House – Ground floor Room 3 (G3)**: this has a flag floor on the south-east side, with concrete to the north-west, either side of a stone gulley running north-east/south-west. There are two stop-chamfered stall posts across the centre below a beam boxed in with timber (Plate 161) and a further post to the north-west, with raised bricks between in the floor. The walls are mostly now exposed stone, with the north-east scored render. The **north-east elevation** has the side of a stall with a curving rail and further stop-chamfered posts, with tongue-and-groove planks below (Plate 162). To the south-east is a doorway with a reused five-panel door, with a small tall cupboard to the north-west with two timber shelves remaining. The **south-east elevation** has a doorway on the north-east side with a plank and batten door with strap hinges externally and an early lock (Plate 163). There is a batten with a row of thick hooks to the south-west, and a window beyond with a rough timber lintel, reused timbers and an inserted timber shelf on iron legs below, with splayed jambs and a four-light fixed casement. The **south-west elevation** has attached planking on the south-east side, below modern boxing for pipes, which continues round the south-east elevation (Plate 164). There are attached timber shelves to the north-west. The **north-west elevation** is plain.

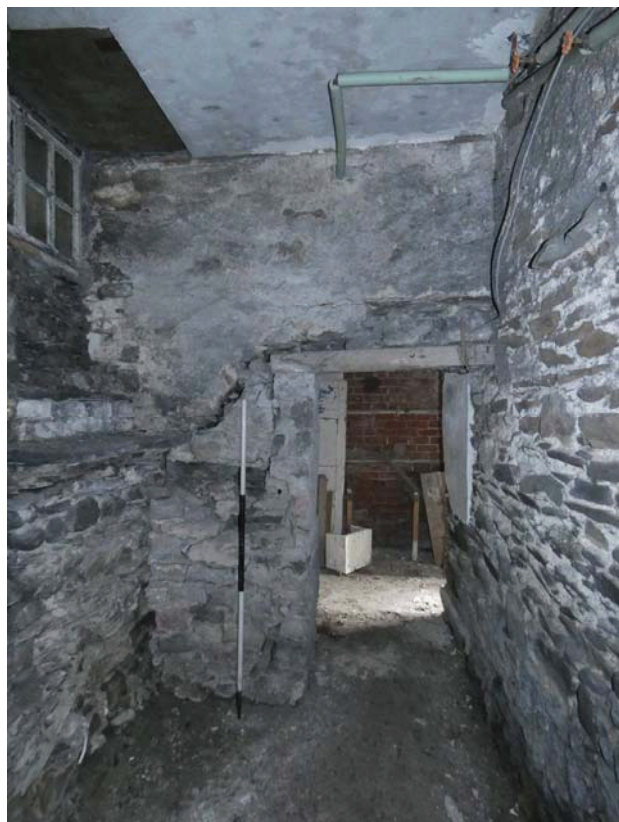
Plate 165 (left): Dividing wall within Room G4, viewed from the north-west

4.3.37 **Coach House – Ground floor Room 4 (G4)**: this is an L-shaped room off the north-east end, with a concrete floor in the south-east end at least, divided in two by a stone wall with a low doorway with a timber lintel (Plate 165). It has a plaster ceiling, and the walls are exposed stone but with brick at the south-east end. There are two beams running north-east/south-west in the main part and one running north-west/south-east in the south-east end. The **north-east elevation** is plain up to the opening at the south-east end, and the lower part is blocked with stone and with an eight-light fixed casement in the top and a stone sill, with brick below above a bigger stone sill projecting below (Plate 166). There is a dividing wall at the south-east butting north-east on the lower level. Beyond is an angled corner with a very simple fireplace with a stone lintel, with a section cut out (Plate 167). There is a timber batten with hooks below and an in-filled section with concrete blocks and brick. The **south-east elevation** is red handmade bricks in stretcher bond with timber inserts (Plate 168). There is a timber batten near the top with pegs, some rebuild in concrete block on the south-west side. The **south-west elevation** has a small window on the south-east side, with a stone lintel, partially blocked with concrete, and a blocked door to the north-west, with a timber lintel and a plank and batten door. The elevation returns to the north-east towards the dividing wall, with a doorway with a sawn timber lintel, then plain. The **north-west elevation** has a chute high on the north-east side.

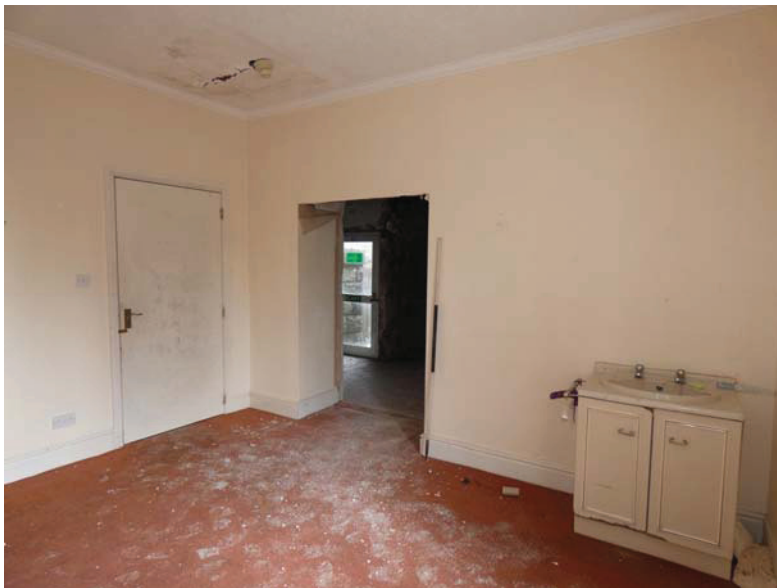
Plate 169 (left): The north-east and north-west elevations, Room F1, viewed from the south

4.3.38 **Coach House – First floor Room 1 (F1)**: this has carpet on the floor, and a flat plaster ceiling finished with textured wall paper and fairly plain coving. It has been totally modernised throughout, and the walls are finished with textured wall paper and beaded skirting. The **north-east elevation** has a large opening near the centre, originally blocked on the north-east side, now broken through, with boarding over the wall proper (Plate 169). There is a round-headed brick arch behind the boarding at the top, and a sink to the south-east. The **south-east elevation** has a window, with splayed jambs and a timber seat, and a four-light sash (Plate 170). The **south-west elevation** is a plain stud wall or boarded over. The **north-west elevation** is a stud wall, with a door on the north-east side, and a modern moulded surround and a plain panel door.

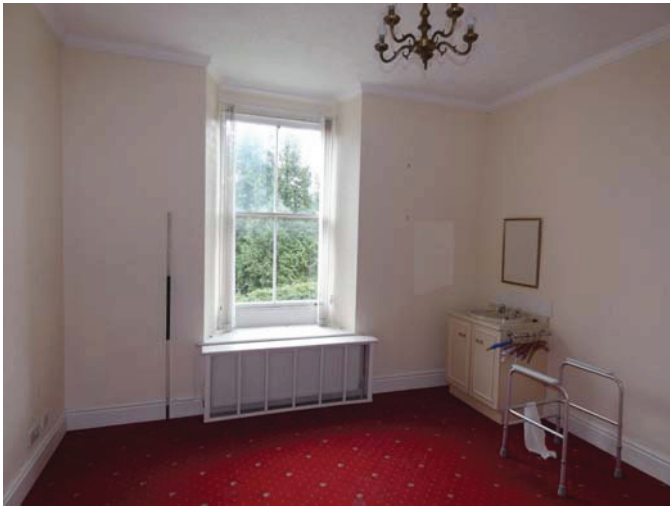
Plate 171 (left): The window in the south-east elevation of Room F2, viewed from the north-west

4.3.39 **Coach House – First floor Room 2 (F2)**: this room has a carpet floor, and the flat ceiling is finished with textured wall paper and modern coving. The walls have been totally modernised and finished with textured wall paper and beaded skirting. The **north-east** and **south-west elevations** are plain stud walls with a sink on the south-west. The **south-east elevation** has a window with splayed jambs, with a timber seat and a four-light sash (Plate 171). The **north-west elevation** is a stud wall, with a doorway on the north-east side, with a modern moulded surround and a plain door (Plate 172).

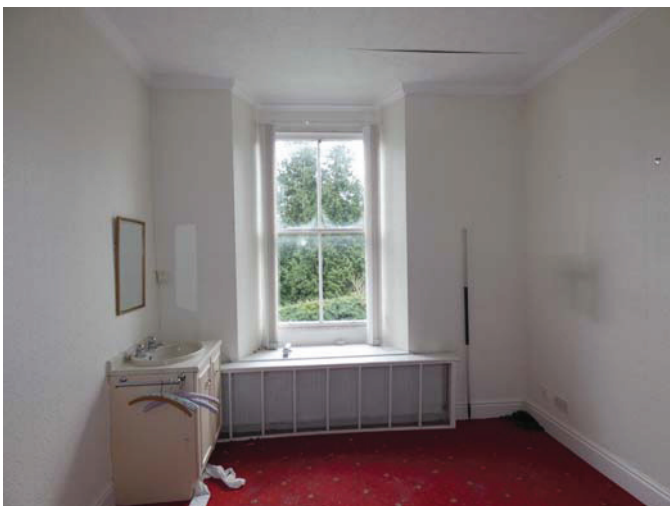
Plate 173 (left): The south-east elevation of Room F3, viewed from the north-west

3.3.40 **Coach House – First floor Room 3 (F3)**: this has carpet on the floor, and the flat plaster ceiling is finished with textured wallpaper and coving. The walls have been modernised and finished with textured wallpaper and beaded skirting. The **north-east** and **south-west elevations** are plain, the north-east is a stud wall with a sink attached. The **south-east elevation** has a window with splayed jambs, a timber seat and a four-light sash casement (Plate 173). The **north-west elevation** is a stud wall, with a door on the north-east side, with a modern moulded surround and a plain door (Plate 174).

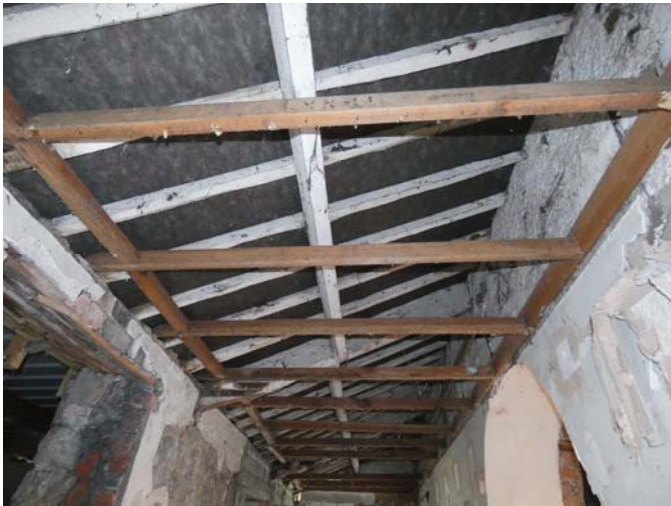
Plate 177 (left): The roof over Room F5, viewed from the north-west

3.3.42 **Coach House – First floor Room 5 (F5)**: this is a mixture of materials but the core is clearly an early extension to the coach house. It is L-shaped, with a laminate or vinyl floor, exposed to a monopitch roof, with sawn rafters and two principals and the remains of an inserted horizontal suspended ceiling below (Plate 177). The walls are rough plaster or exposed brick and concrete block. The **north-east elevation** has a doorway on the north-west side in the brick section, with a modern two-light emergency door, then large openings either side of the stone section and another at the south-east end (Plate 178). The **south-east elevation** has a wide doorway, the north-east jamb masonry, with brick to the south-west. The **south-west elevation** has an opening at the south-east end into a small room, which is plastered and continues the roof from the north-east (Plate 179). There is a small window to the south-west. There is a large opening in the south-west elevation proper, with a round head and a doorway at the north-west end (Plate 180). The **north-west elevation** is plain, with a step in the wall at mid-height.

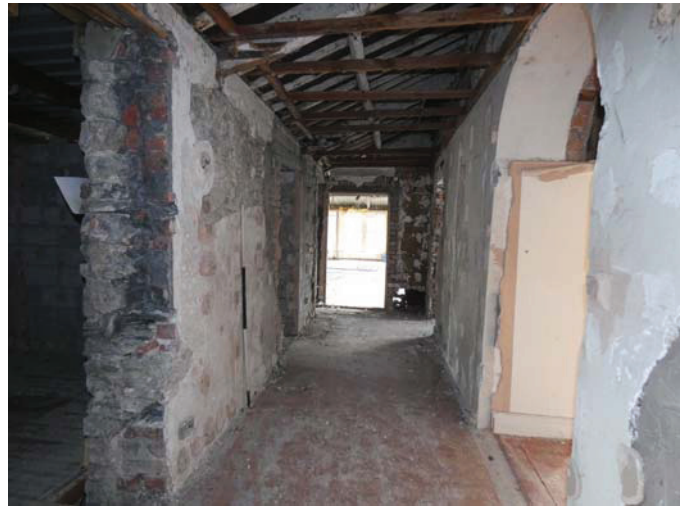
Plate 178 (right): The south-east end of Room F5, viewed from the north-west

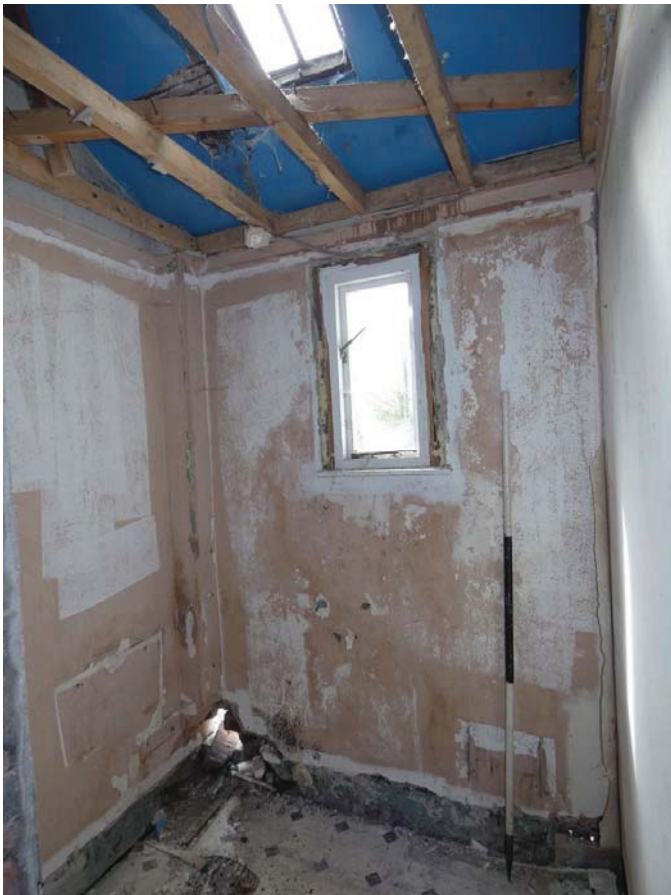
Plate 179 (left): The small room off the south-east side of the south-west elevation of Room F5, viewed from the north-east

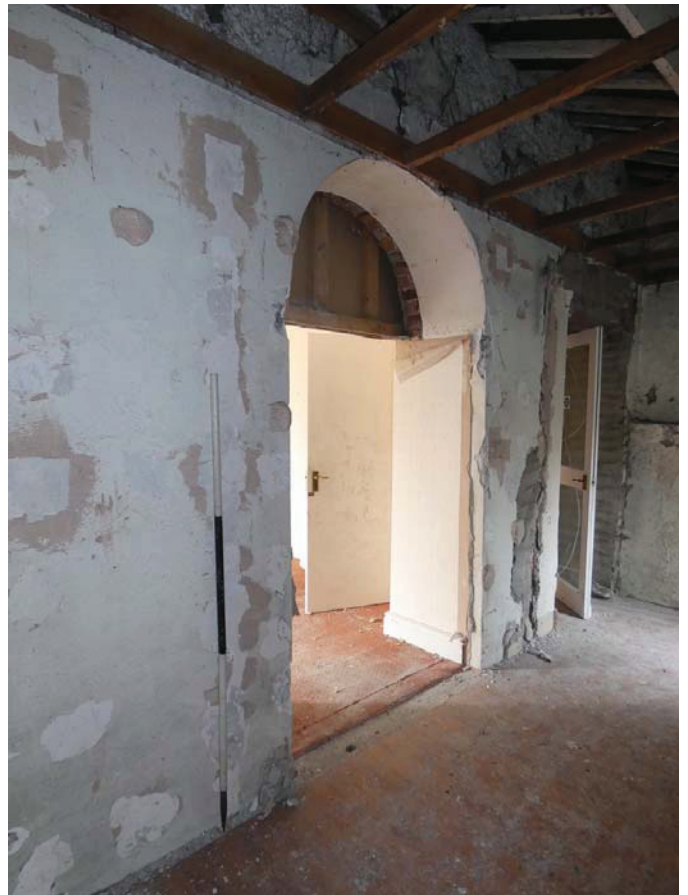
Plate 180 (right): The wide doorway in the south-west elevation of Room F5, viewed from the east

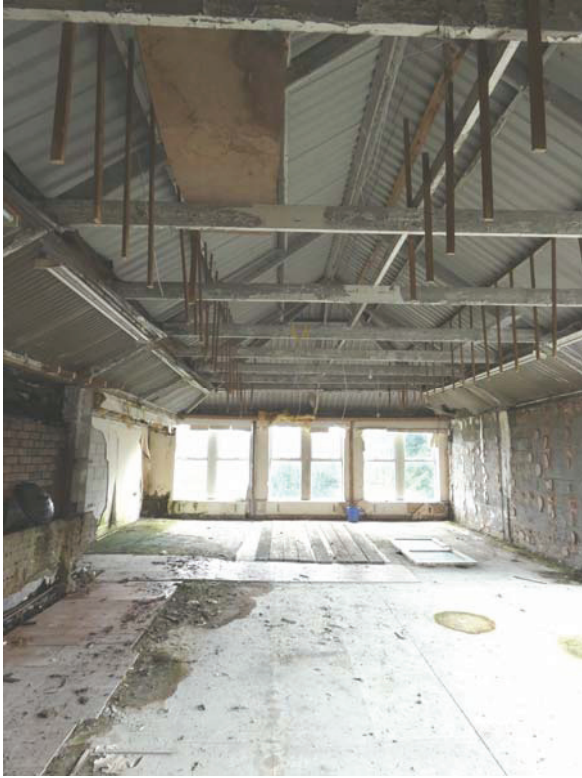
Plate 181 (left): General view of the large room comprising the south-west end of the modern extension, viewed from the north-west

3.3.44 **Modern extension:** this was not examined in detail, in part because of its age but also because of the poor condition of the floor, which had a large drop beneath parts of it. The main part, to the south-east and south-west, is a concrete block construction with numerous large windows and simple tie beam trusses supporting a corrugated metal roof (Plate 181). However, there are some smaller rooms on the north-east side in the area adjoining the mansion, one of which is clearly has at its core an earlier structure of brick construction, with a king post roof with angled braces (Plate 182 to Plate 184).

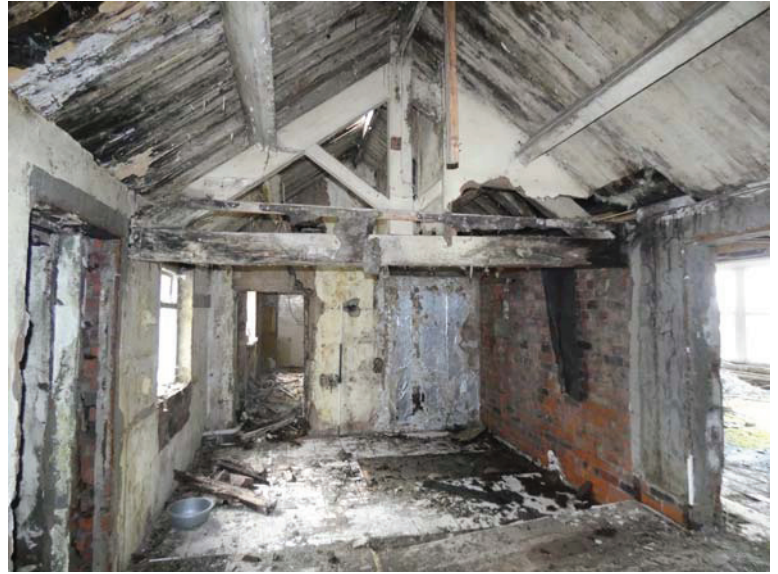
Plate 182 (right): General view of the brick built section within the modern extension, viewed from the south-west

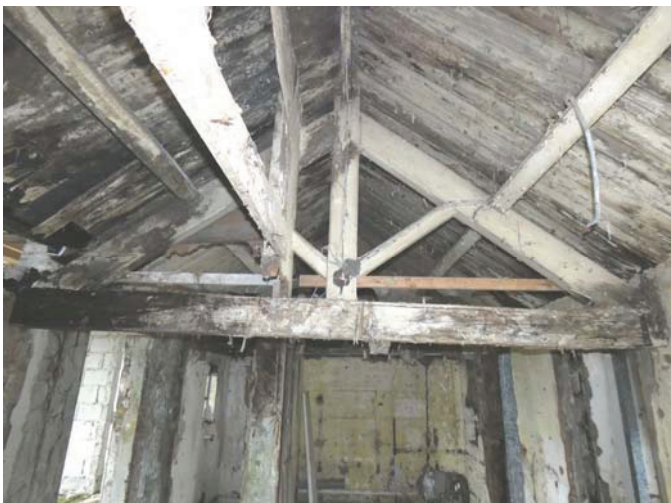
Plate 183 (left): Detail of the truss of the brick section within the modern extension, viewed from the north-east

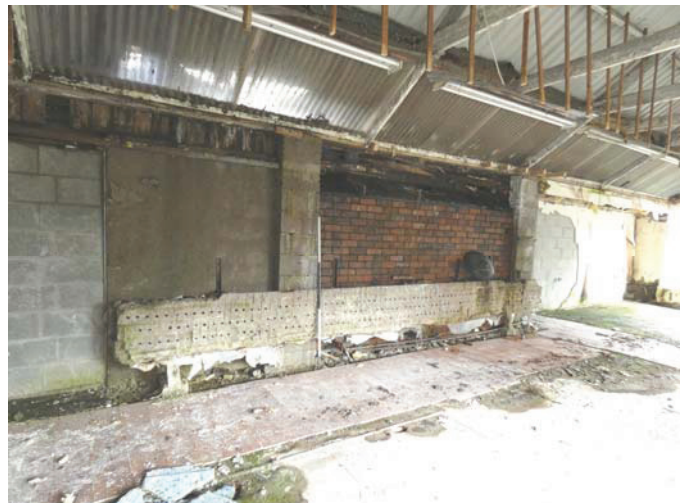
Plate 184 (right): The rear of the brick section within the modern extension viewed from the west
