THE GATEHOUSE, CALDER BRIDGE, SEASCALE, CUMBRIA

Archaeological Watching Brief

June 2019

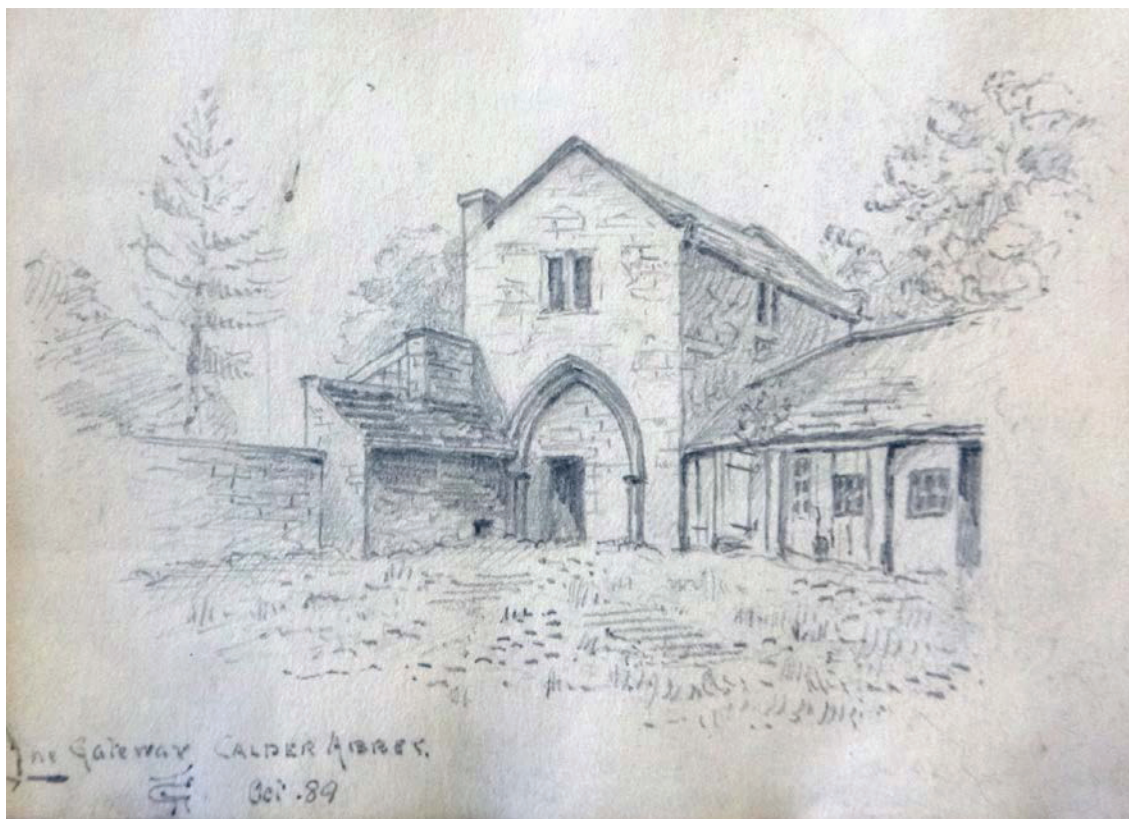
Plate 5: Sketch of the gatehouse dated 1889 (CAC(C) DX 2114/1 c1892-1894)

3.2.7 **Sketch, 1889:** a pencil sketch by an unknown artist dated October 1889 is present in the archives in Carlisle (CAC(C) DX 2114/1 c1892-1894). Again there are some inaccuracies in the drawing, which has made the building appear taller and thinner than it actually is, but this drawing otherwise shows a number of features of interest. While it is apparent that the building has changed relatively little since the previous sketch was produced it does show that the original arched gateway on the east side was still mostly blocked leaving a smaller doorway (Plate 5). In addition, the slope of an outshut on the south side of the gatehouse is just visible, confirming the presence of an adjoining building, as shown on the early plans.

3.2.6 **Sketch, 1886:** a sketch of the gatehouse, apparently signed 'JRL' accompanies Loftie's second account of the remains of Calder Abbey (Loftie 1886) (Plate 4). There are clearly some discrepancies in terms of the dimensions of the building compared to later views (see Plate 5 and Plate 8) but some important details are apparent. Firstly, the arched opening on the east side has clearly been largely blocked by this date leaving a smaller doorway. Secondly, the chimney on the south-east corner is shorter than it is now and as it is depicted in later images, while the building attached to the north side was clearly a stable or animal housing. The building otherwise appears much as it does today.

3.2.10 **Photograph, c1920s:** a photograph held in the Cumbria Image Bank shows the gatehouse from the east in what is thought to be the 1920s (Cumbria Image Bank 2018; ref ct12356). It is remarkable how little the building has apparently changed since the production of the earlier sketch (Plate 8; cf. Plate

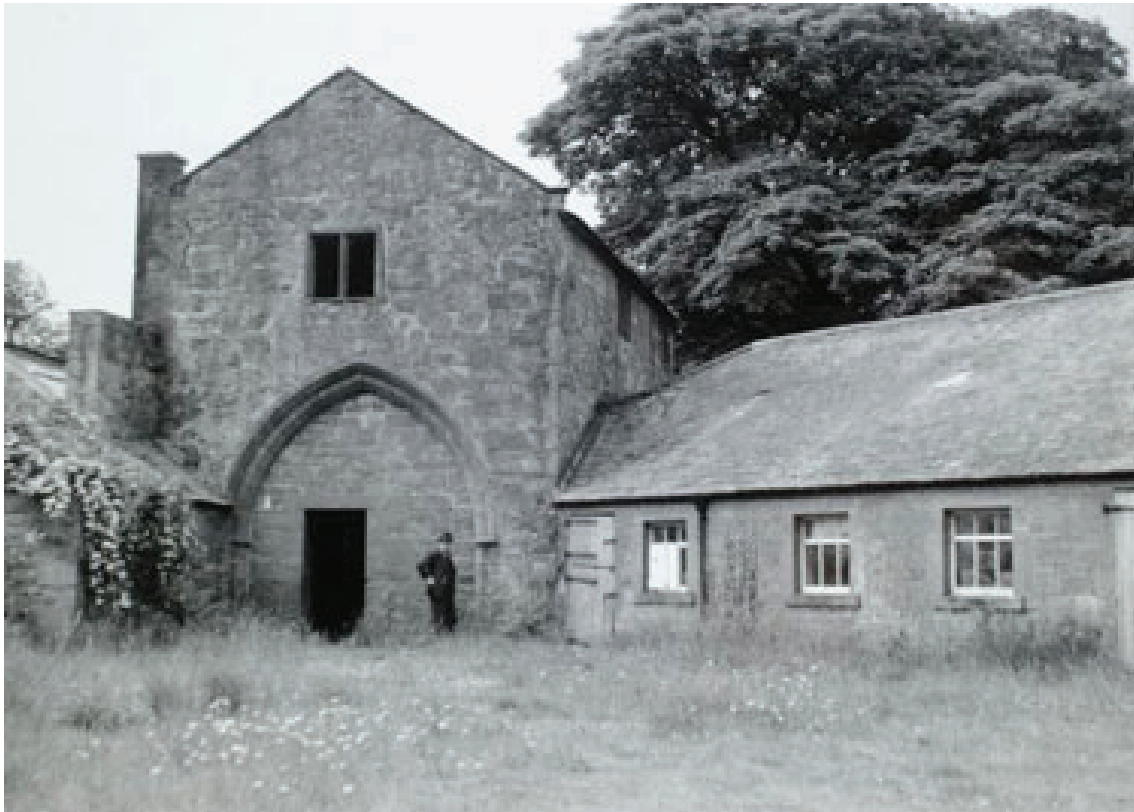
Plate 8: Photograph of the gatehouse from the 1920s (Cumbria Image Bank 2018)

5), although it is apparent that the site was somewhat neglected by this date as the adjoining yard is very overgrown.

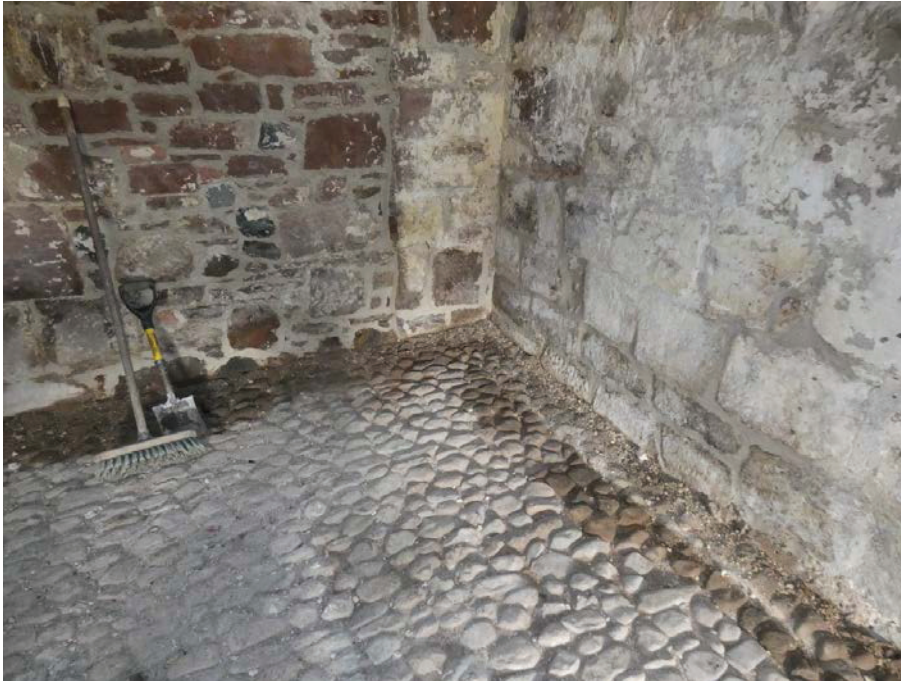
Plate 9: Pre-excitation view of the cobbles in the area of Pit 4, taken from the south-east

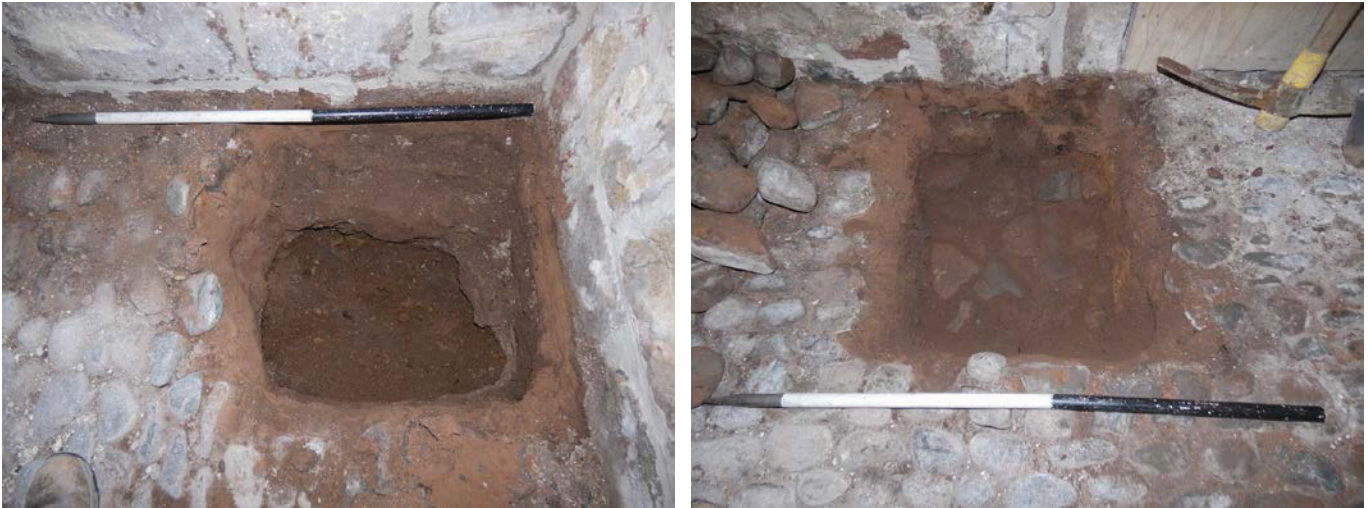
4.2.1 **Pit 1:** the cobbles of the current floor (**100**) were removed and were found to be 0.1m thick. They were set in a very loose dark reddish orange sand (**101**), with 10% rounded gravel, which was c0.1m thick. Below this was a more compacted dark reddish slightly grey deposit with lots of lime, some mussel shell and occasional rounded/sub-angular cobbles (**102**), c0.3m thick. Below this was a firm orange gritty clay natural with rounded cobbles (**103**). Along the south side was a possible plinth of the wall, which was 0.2m wide, and 0.2m tall (Plate 10).

4.2.2 **Pit 2:** the cobbles (**200**) were set on top of loose orange sand (**201**), with a more compacted layer beneath, which was 0.1m thick, and contained lime, brick, and fine-grained slate fragments in sandy clay 0.1m thick (**202**). There was an earlier cobbled surface below this (**203**), which comprised larger flatter cobbles but was again little more than 0.1m thick (Plate 11). Below this was a layer containing lots of loose lime mortar (**204**), 0.1m-0.15m thick. This lay over the natural mid orange gravelly clay (**205**) (Plate 12). There was a pad stone for the door jamb in the west wall in the north-west corner of the pit, below deposit **201**.

Plate 10 (left): Pit 1 fully excavated showing the plinth below the south wall, viewed from the north

Plate 11 (right): The earlier cobble surface (203) in Pit 2, viewed from the north

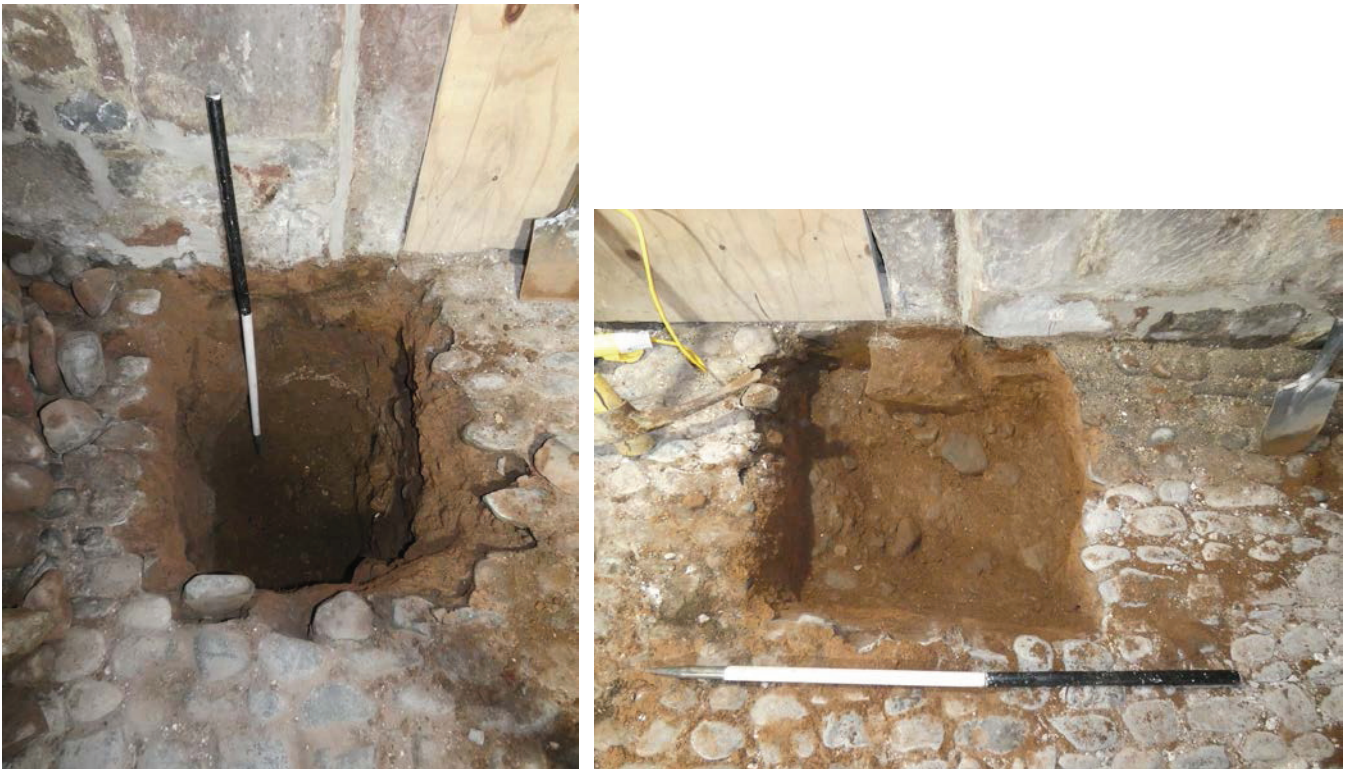
Plate 12 (left): Pit 2 fully excavated, viewed from the east

Plate 13 (right): Cobble floor 302 and plinth in Pit 3, viewed from the north

4.2.3 **Pit 3:** the cobbles (300) lay on top of loose orange sand (301), beneath which was a compacted dark red sandy clay with some mortar and rounded cobbles (302) and parts of a cobbled floor 0.1m – 0.2m thick (Plate 13). There is a possible plinth or footing for the door jamb on the north side. Below this was a more definite layer of cobbles (303), 0.2m thick (Plate 14), over a layer of loose lime with roofing slate (very fine grained grey material) (304) 0.15m thick, with natural dark orange gravelly clay below (305) (Plate 15).

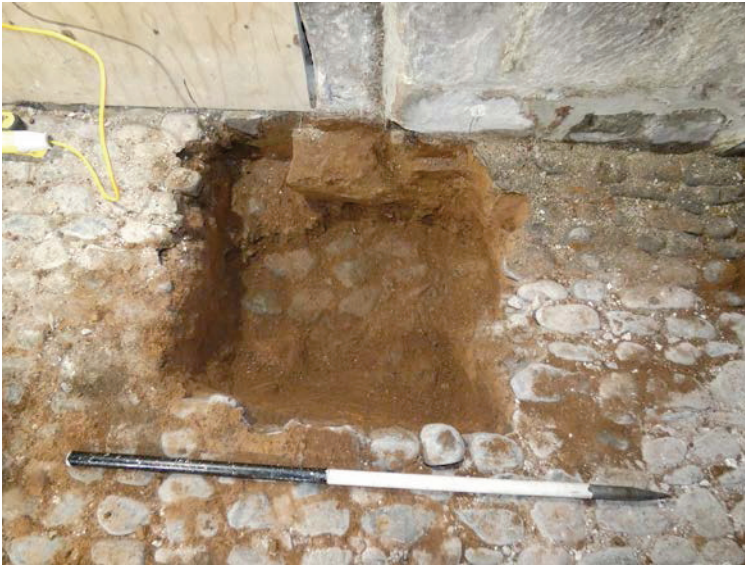
Plate 14 (left): Cobbled surface 303 and plinth in Pit 3, viewed from the north

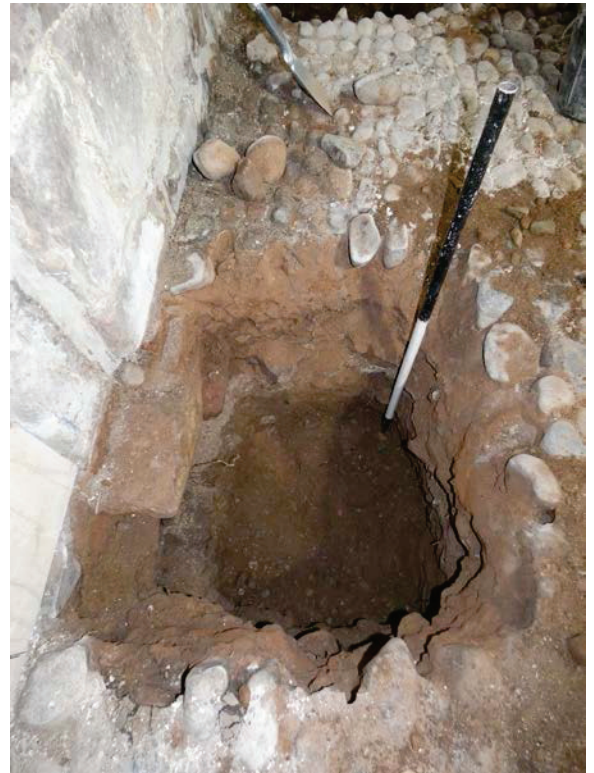
Plate 15 (right): Pit 3 fully excavated, viewed from the south

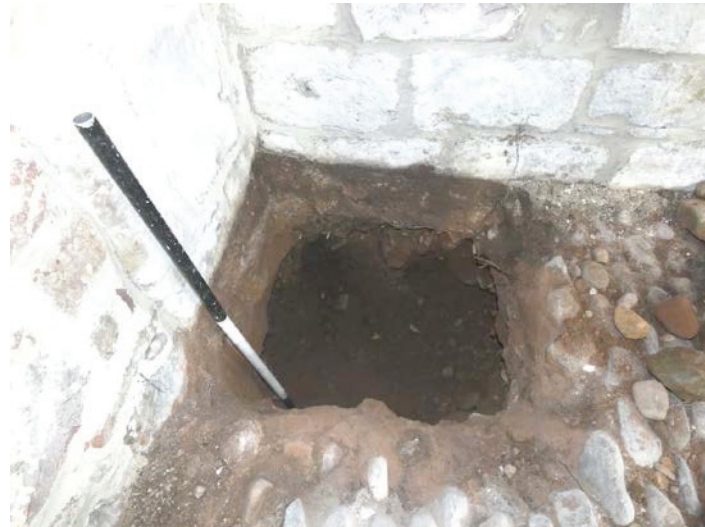
4.2.4 **Pit 4:** the cobbles (400) lay on loose orange sand (401) c0.1m thick. Below this was a more compacted greyish brown layer with lots of lime, with 20% cobbles and 0.2m thick (402). Below that was the natural firm mid orange gritty clay (403) (Plate 16). The footings for the north wall were seen to be 0.25m below the floor surface.

Plate 16: Pit 4 fully excavated, viewed from the south

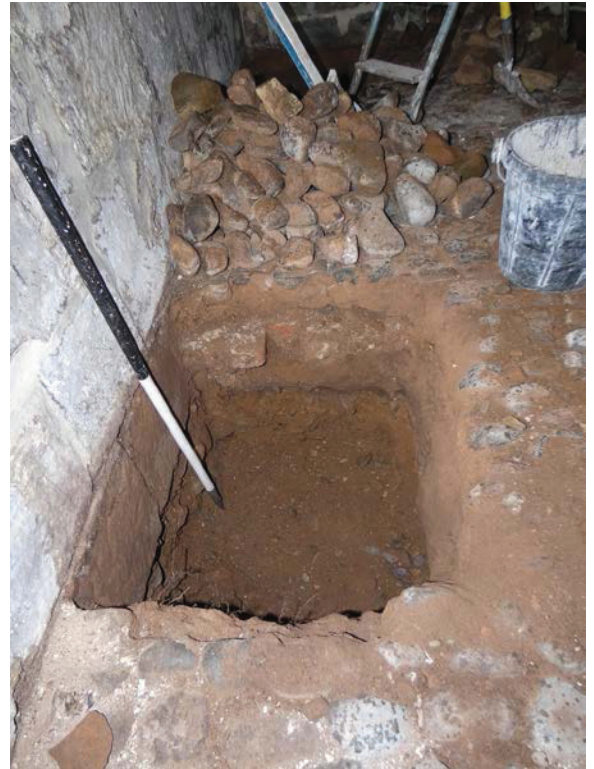
4.2.5 **Pit 5:** the cobbles (**500**) lay on top of a loose fine orange sand (**501**), within which was a lump of bitumen. On the west side, below **501**, was a layer of handmade bricks (**502**) extending out of the side of the trench (Plate 17), presumably part of a small area of flooring. These were laid on a layer of loose orange sandy clay containing lots of lime (**503**), with some very fine-grained roofing slate, as in **Pit 2**. The dressed blocks in the wall extend to the base of the footing were 0.3m below the floor surface (Plate 17). Layer **503** was on top of the natural mid-dark orange gravelly clayey sand (**504**) (Plate 18).

Plate 18 (right): Pit 5 fully excavated, showing brick layer 502 in section, viewed from the east

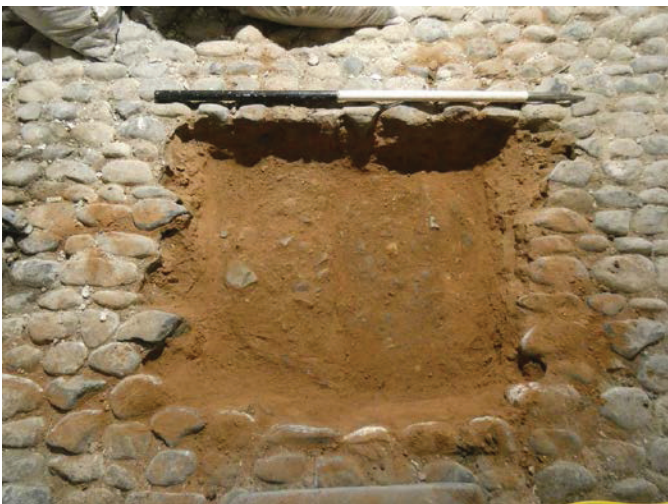
4.2.6 **Pit 6:** the cobbles (**600**) lay on top of loose orange sand (**601**) which was 0.1m thick, which in turn lay on top of a compacted layer of darker orangey brown rounded gravel, becoming darker with depth (**602**) (Plate 19). It was less than 0.1m thick, and lay on a layer of lime-rich gravelly clay (**603**), with rounded gravels, 0.1m thick. On the north side of the trench was a deposit of soft sand with 2% rounded cobbles (**605**), which was actually the backfill of a linear cut with a narrow bore iron pipe in the bottom

Plate 19 (left): Deposit 602 in Pit 6, viewed from the south

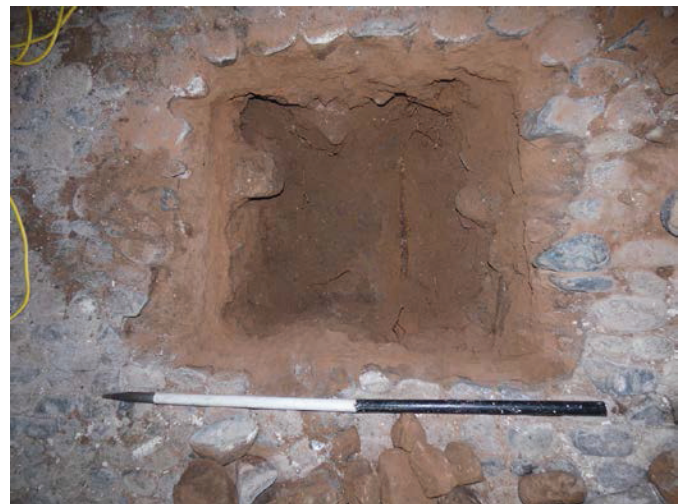
[604] (Plate 20). Cut **604** was broadly U-shaped, at least 0.4m wide at the top and 0.4m deep. It cut through a compacted lime- and cobble-rich deposit (**606**), which was dark greyish orange and 0.3m-0.4m thick. This lay on top of the natural dark brownish orange sandy rounded gravel (**607**) (Plate 21).

Plate 20 (right): Pipe cut 604 and deposit 606 following excavation in Pit 6, viewed from the north

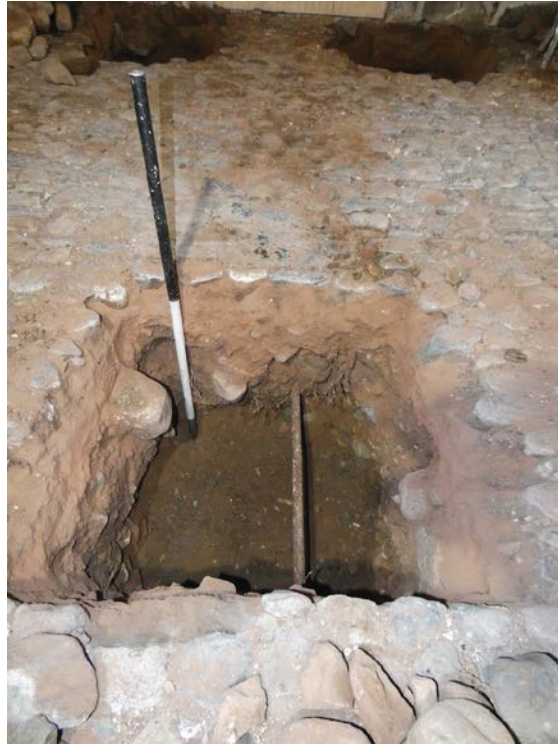
Plate 21: Pit 6 fully excavated, showing pipe within pipe cut 604, viewed from the east

5.1.5 **Phase 4 – late post-medieval:** in **Pit 6** the earlier deposits had been cut through for the insertion of an iron pipe [**604**] the cut of which was filled by loose sand (**605**), which had then been overlain by a compacted deposit (**602**). This is presumably late 19th or early 20th century.

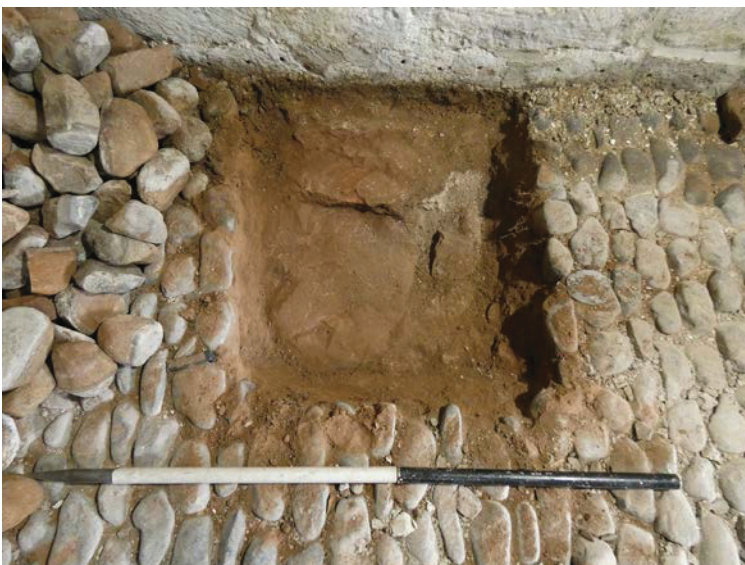
4.2.7 **Pit 7:** the cobbles (700) were set in loose sand (701) containing pieces of polystyrene and timber, c0.1m thick. Below this was deposit 702, a layer comprising large sandstone blocks and lime mortar, 0.2m-0.3m thick (Plate 22). One of the blocks in deposit 702 extended below the footing of the wall to the north, at a depth of 0.25m below the floor surface (Plate 23). Deposit 702 lay on top of natural mid-orange gravelly clay and pebbles (703) (Plate 23).

Plate 22 (left): Deposit 702 in Pit 7, viewed from the south

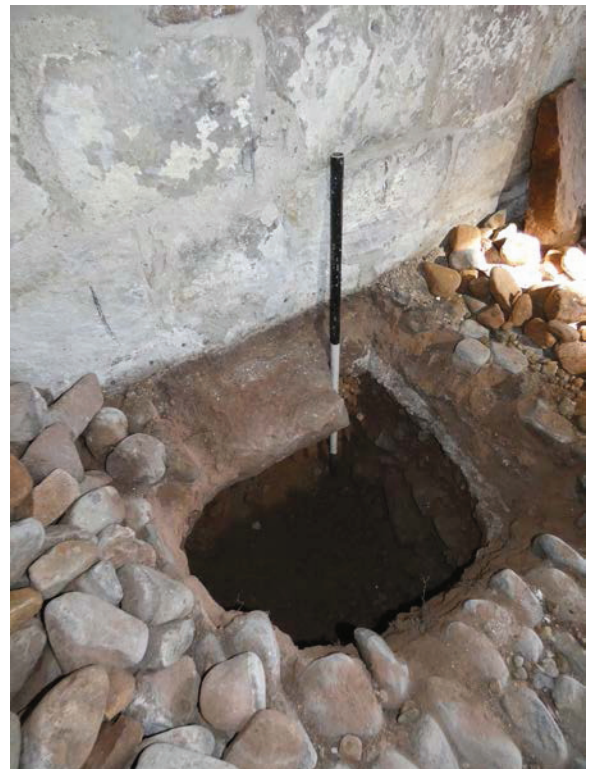
Plate 23 (right): Pit 7 fully excavated, viewed from the south-west

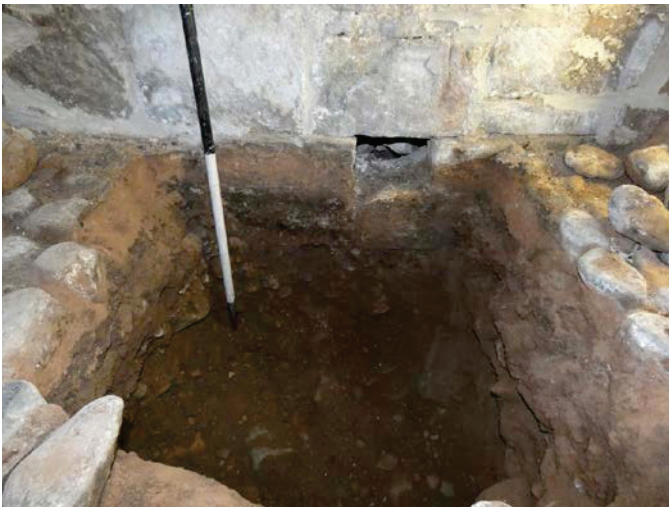
4.2.8 **Pit 8:** the cobbles (**800**) were removed, and below them was a loose soft orange sand (**801**) less than 0.1m thick. This in turn lay on top of a layer of slightly firmer and darker gritty sand (**802**) with fragments of grey fine-grained slate, potash, dressed red sandstone, and iron concretions/slag, c0.3m thick. This lay on top of a natural dark brown loose gravel (**803**). The dressed blocks of the wall extended approximately 0.3m below the floor surface and there was an approximately 0.2m square hole cut into one of them that extended back 0.3m into the wall (Plate 24).

Plate 24 (left): Pit 8 fully excavated, showing the hole in the wall, viewed from the north

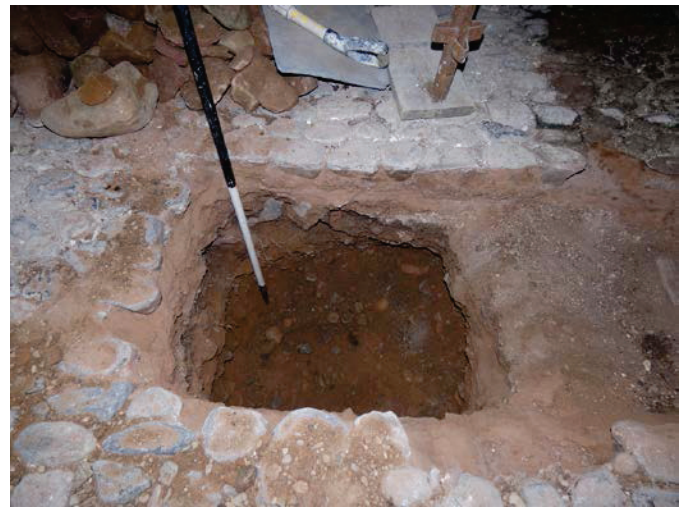
4.2.9 **Pit 9:** the cobbles (**900**) lay on a deposit of loose soft sand (**901**), less than 0.1m thick. Below this was a compacted dark greyish red deposit with lots of gravel and lime (**902**) and lumps of dressed red sandstone. This pit was initially dug to close to the north wall and so was extended to the south. Layer **902** also had some of the fine-grained slate within it and was 0.1m thick. Below this was a looser darker greyish brown deposit, c0.1m-0.15m thick, with lime and charcoal (**903**) and post-medieval pottery. Below this was another layer of concreted mid orange sandy clay with 30% rounded cobbles and gravel (**904**) and some dressed sandstone fragments. This deposit was 0.1m-0.15m thick, and lay on top of the natural mid orange sandy rounded gravel (**905**), with a patch of mid brown silt on the north side (Plate 25).

Plate 25 (right): Pit 9 fully excavated, viewed from the east

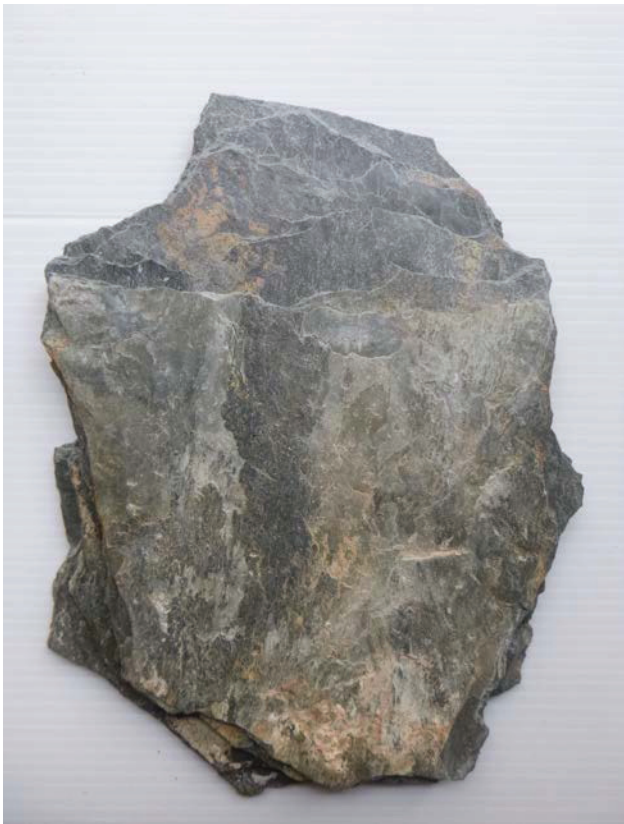
4.3.6 **Stone:** six fragments of roof slate were recovered from three contexts (**202**, **503** and **903**; see examples in Plate 26 and Plate 27). A visual inspection of the slate indicated that it was all of a similar material, most closely resembling that extracted from the Highland Boundary quarries in Central Scotland, which stretch from Arran in the West to Dunkeld in the east. Three samples of the slate were examined using X-ray Diffraction (XRD) and compared to material from Bute. This revealed that the samples from Calder Abbey are not exactly the same as those from Bute and so, while they are still likely to be from the Highland Boundary group, it is not possible to more accurately identify where without further analysis.

Plate 26 (left): Slate recovered from context 203

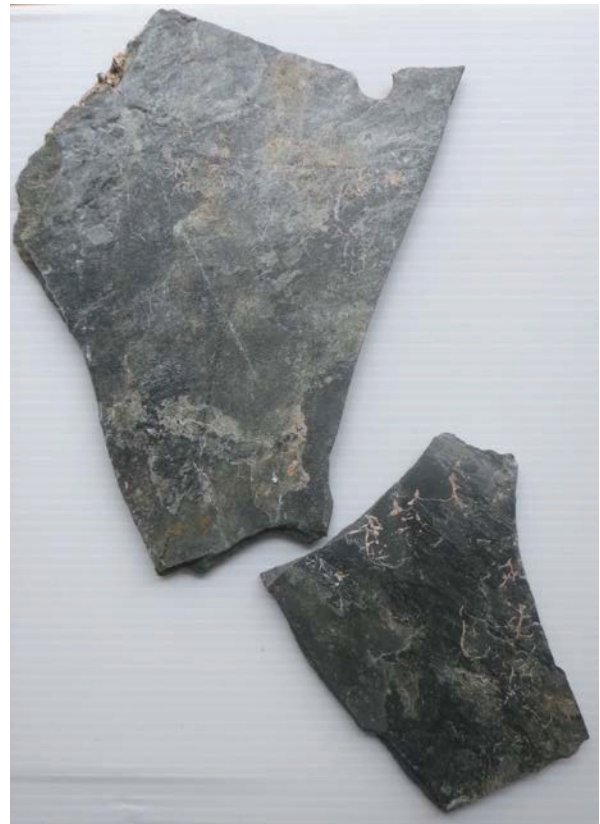
Plate 27 (right): Slate fragments recovered from context 503, including piece with peg hole
