# 30 WINCKLEY SQUARE, PRESTON, LANCASHIRE

## Archaeological Building Recording

March 2023

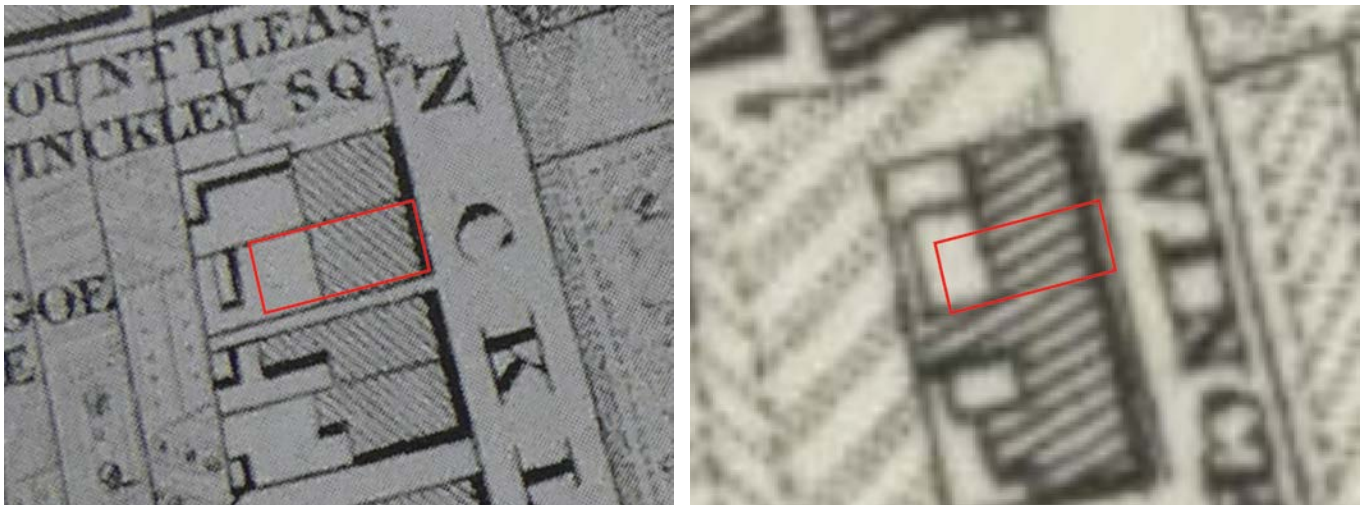
3.1.2 **Myers, 1836:** this is the earliest map of the area detailed enough to accurately show individual buildings (Plate 1). It clearly shows the site as a simple rectangular block with a detached outshut to the rear.

3.1.3 **Ordnance Survey, 1849:** this is the less detailed 1: 10,560 scale map, but it shows essentially the same detail as the earlier map (Plate 2).

Plate 1: Extract from Myers Map of 1836

Plate 2 (right): Extract from the Ordnance Survey map of 1849

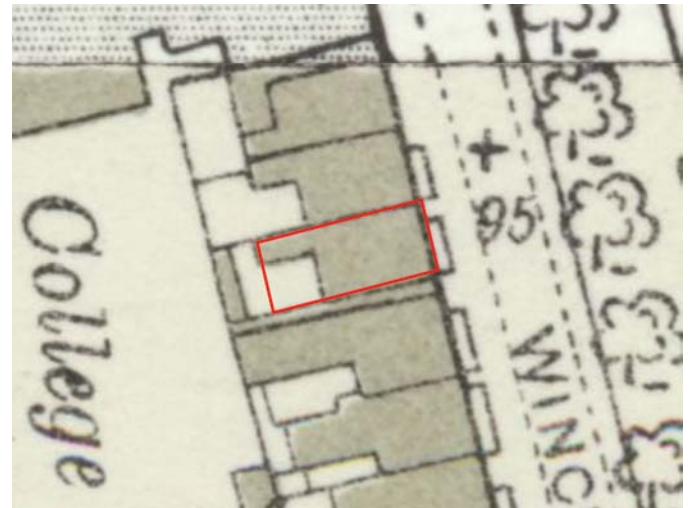
3.1.8 **Ordnance Survey, 1931:** this shows a similar arrangement to the previous, although a new detached outbuilding has been constructed to the west (Plate 7). 'College' is again marked nearby to the west.

Plate 7 (right): Extract from the Ordnance Survey map of 1931

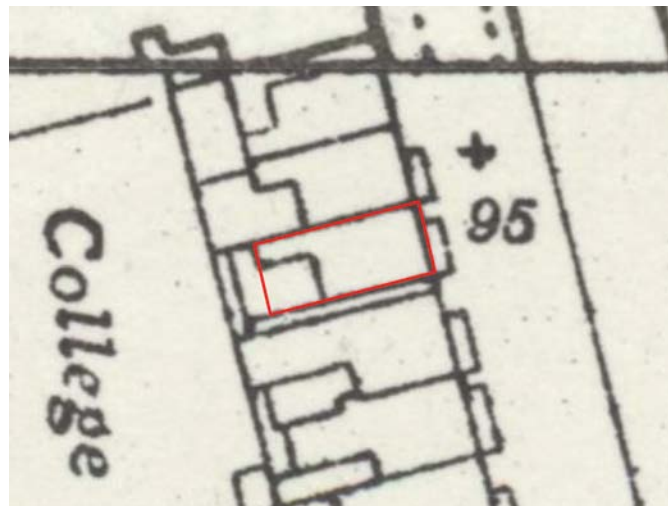
3.1.9 **Ordnance Survey, 1946:** this shows essentially the same arrangement as the earlier map.

Plate 8: Extract from the Ordnance Survey map of 1946

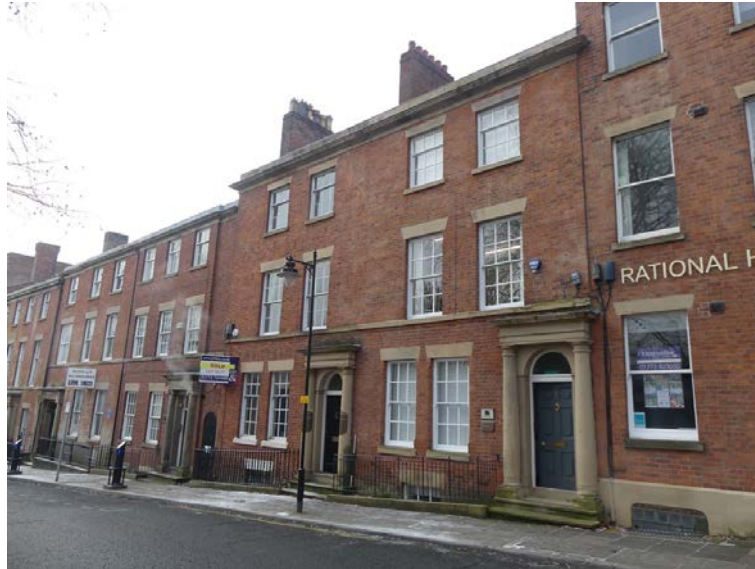
4.1.1 **Arrangement:** the building faces east/west, the front onto Winckley Square to the east, the rear, which has been extended, facing onto a small yard adjoining a larger yard associated with neighbouring buildings. It is evident from the front elevation that it was originally one of a pair of buildings; the other half being to the north (No. 31; Plate 9). There is a passageway along the south side, shared with the adjoining property, which allows access to the lower part of the south external elevation, but there are otherwise no north and south external elevations.

**Plate 9: Front (east) external elevation showing the location of the property relative to the rest of the street, viewed from the north-east**

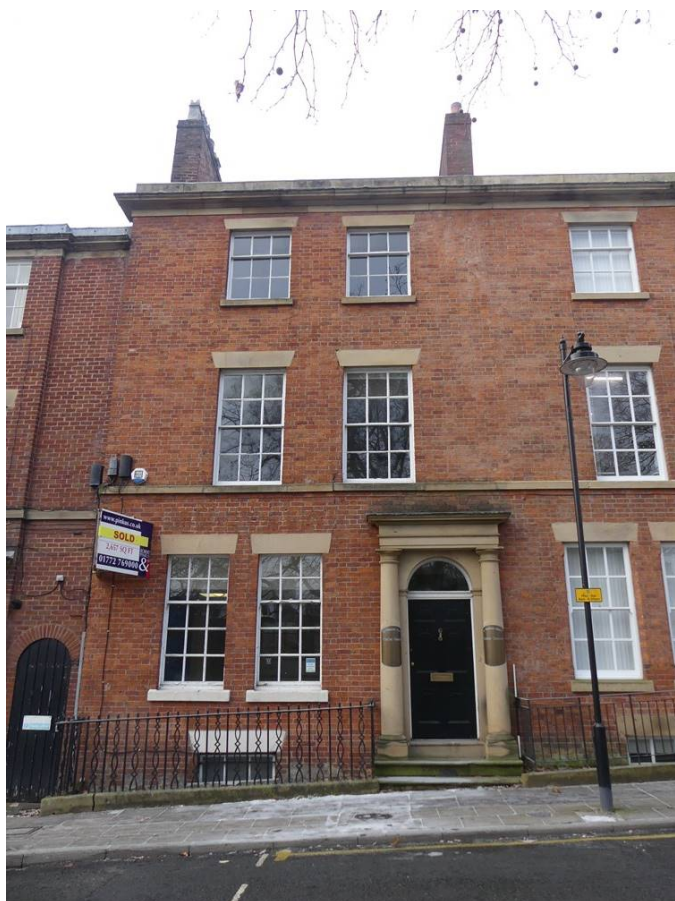
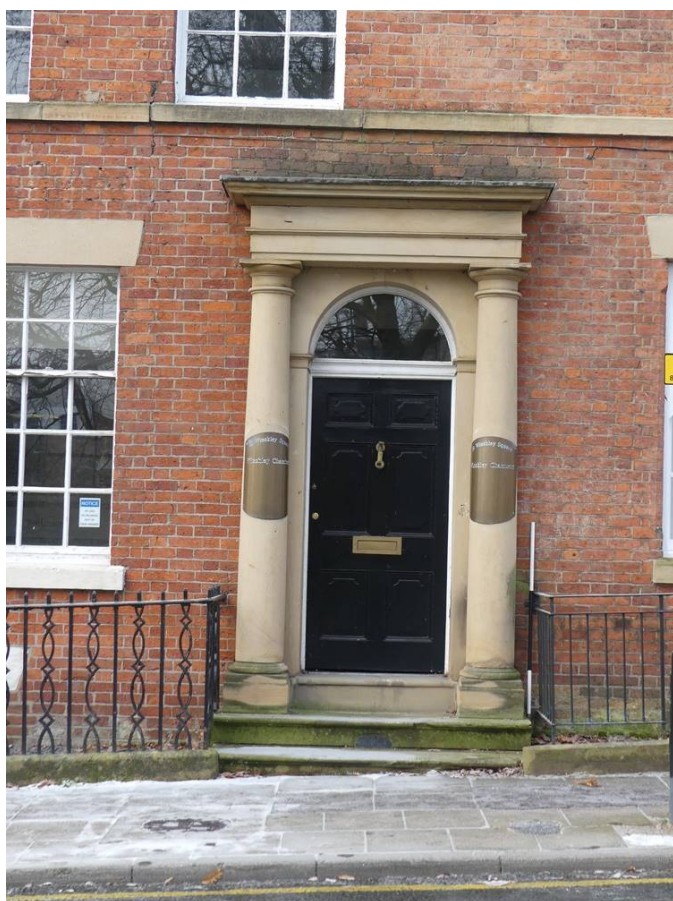
4.2.1 **East external elevation:** at the front elevation of the building, the brick work is laid in Flemish bond, with the front door up two stone steps; the surround comprises a pair of pale-yellow sandstone engaged Tuscan columns. The columns support a plain frieze and moulded cornice with a six-panel door with semi-circular fanlight above (Plate 10 and Plate 11). The columns have metal signage attached reading "30 Winckley Square Winckley Chambers". There is a pair of windows to the south, both with 15-light (six over nine) sash casements and splayed pale sandstone lintels. A string course runs above these, forming the sill for two further windows above, both of which have 12-light sash casements (six over six), also with splayed stone lintels. Above these are two further windows with nine-light sash casements (three over six) and sandstone sills. The original railings remain at pavement level with alternating curvilinear and stick balusters in a low stone plinth (Plate 12) and there the splayed lintel (which has been painted white) of the basement level window visible above the ground level, although the cellar light is covered. There is a pierced circular iron plate covering a coal hole in the pavement outside (Plate 13) and a slight step back at the adjoining structure to the south. The roof is topped by two chimneys at either end of the main ridge, with a moulded stone gutter parapet along this face.

Plate 10 (left): The east external elevation, viewed from the east

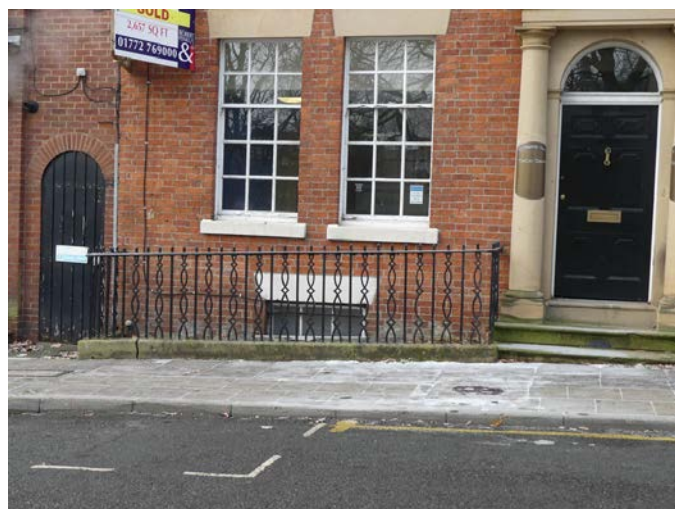
Plate 12 (left): Railings outside the east external elevation, viewed from the east

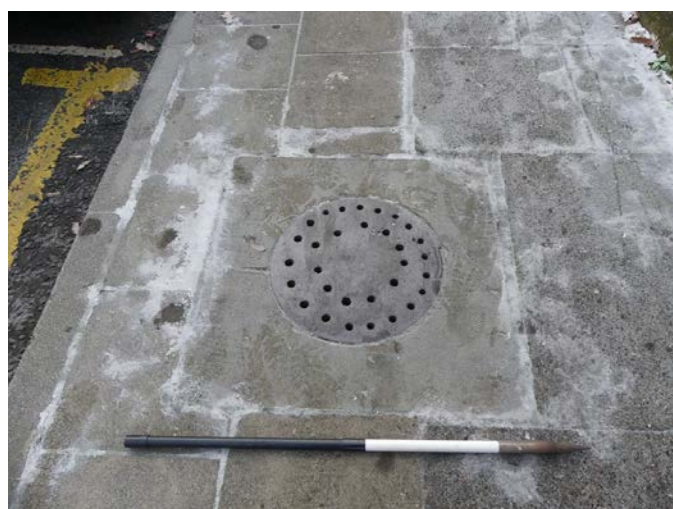
Plate 13 (right): Coal hole outside the east external elevation, viewed from the north

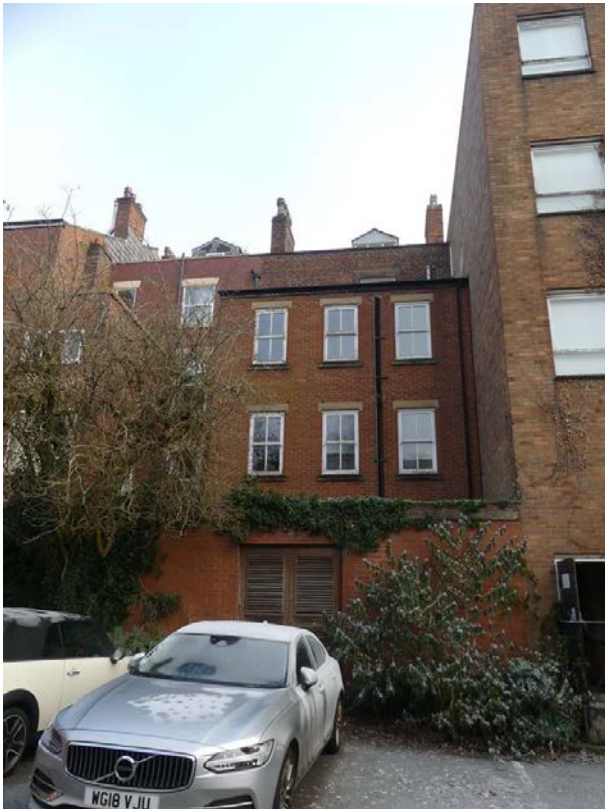
**Plate 14 (left):** General view of the west external elevation from the adjoining yard, from the west

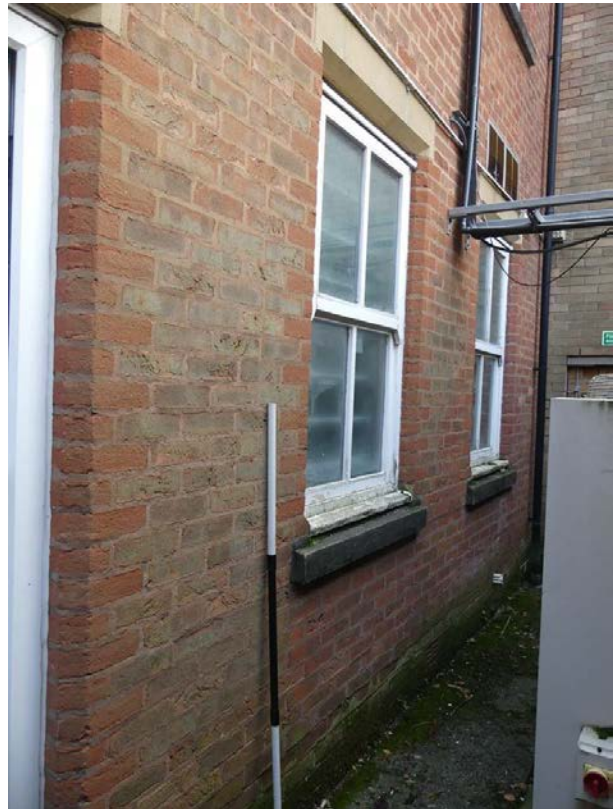
**Plate 15 (right):** Ground floor windows in the west external elevation, viewed from the north-west

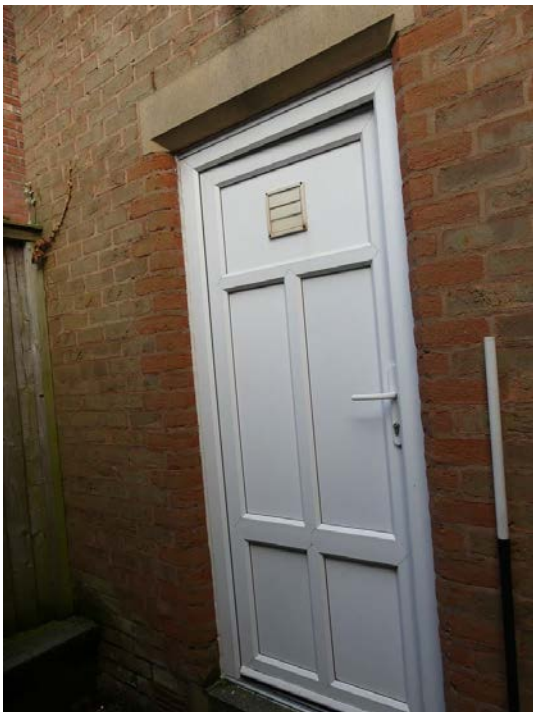
**Plate 16:** Ground floor doorway in the west external elevation, viewed from the south-west

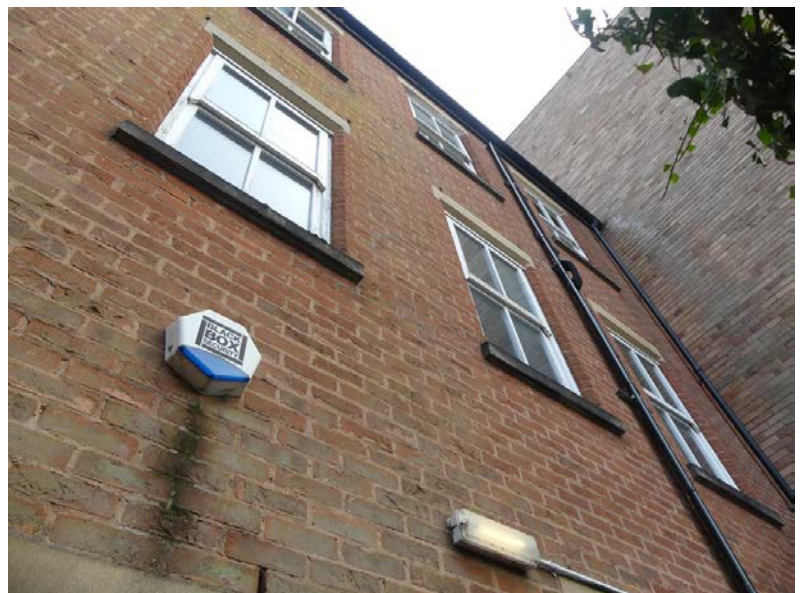
light casement (Plate 17). There is a further dormer window, with a three-light casement, at the attic level and a further two chimneys on this side.

**Plate 17:** Upper-level windows in the west external elevation, viewed from the west

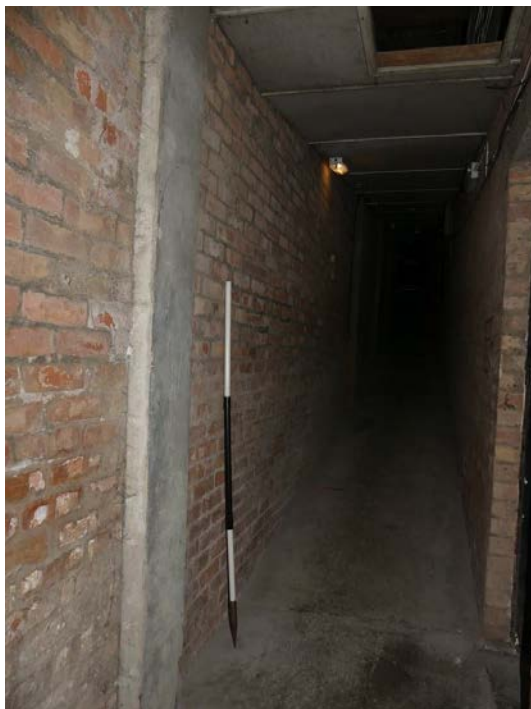
4.2.3 **South external elevation:** this is only visible inside the passageway along the south side, shared with the adjoining building. It is brick, laid in stretcher bond, with four or five concrete buttresses (Plate 18). The floor of the passage is concrete and slopes up to the east.

Plate 18: The south external elevation, inside the passageway, viewed from the west

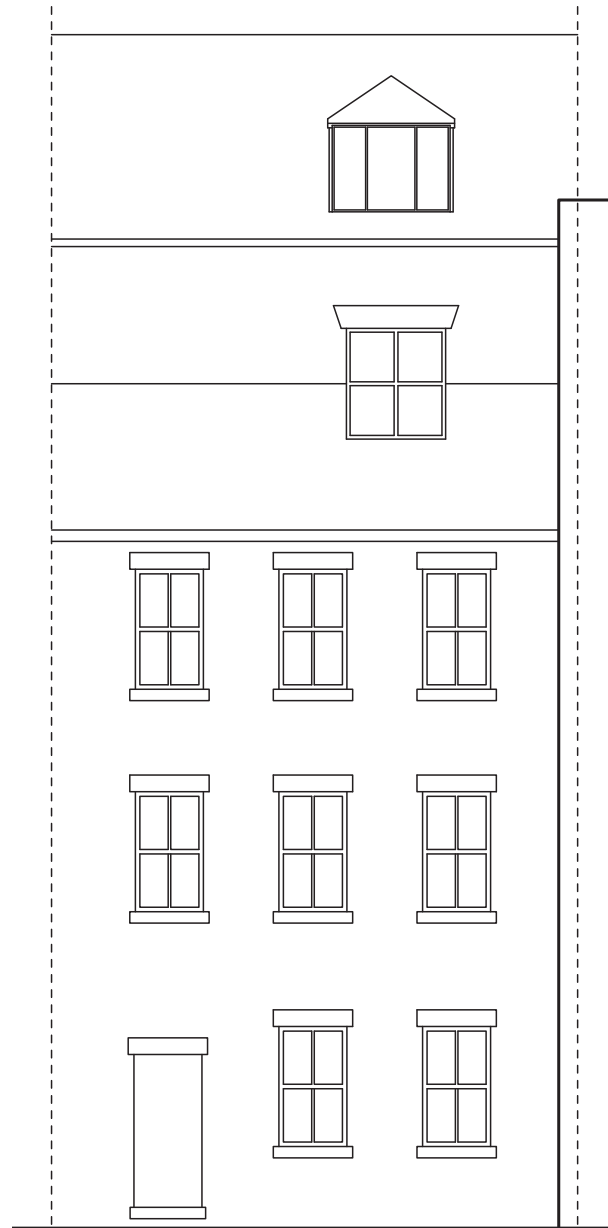
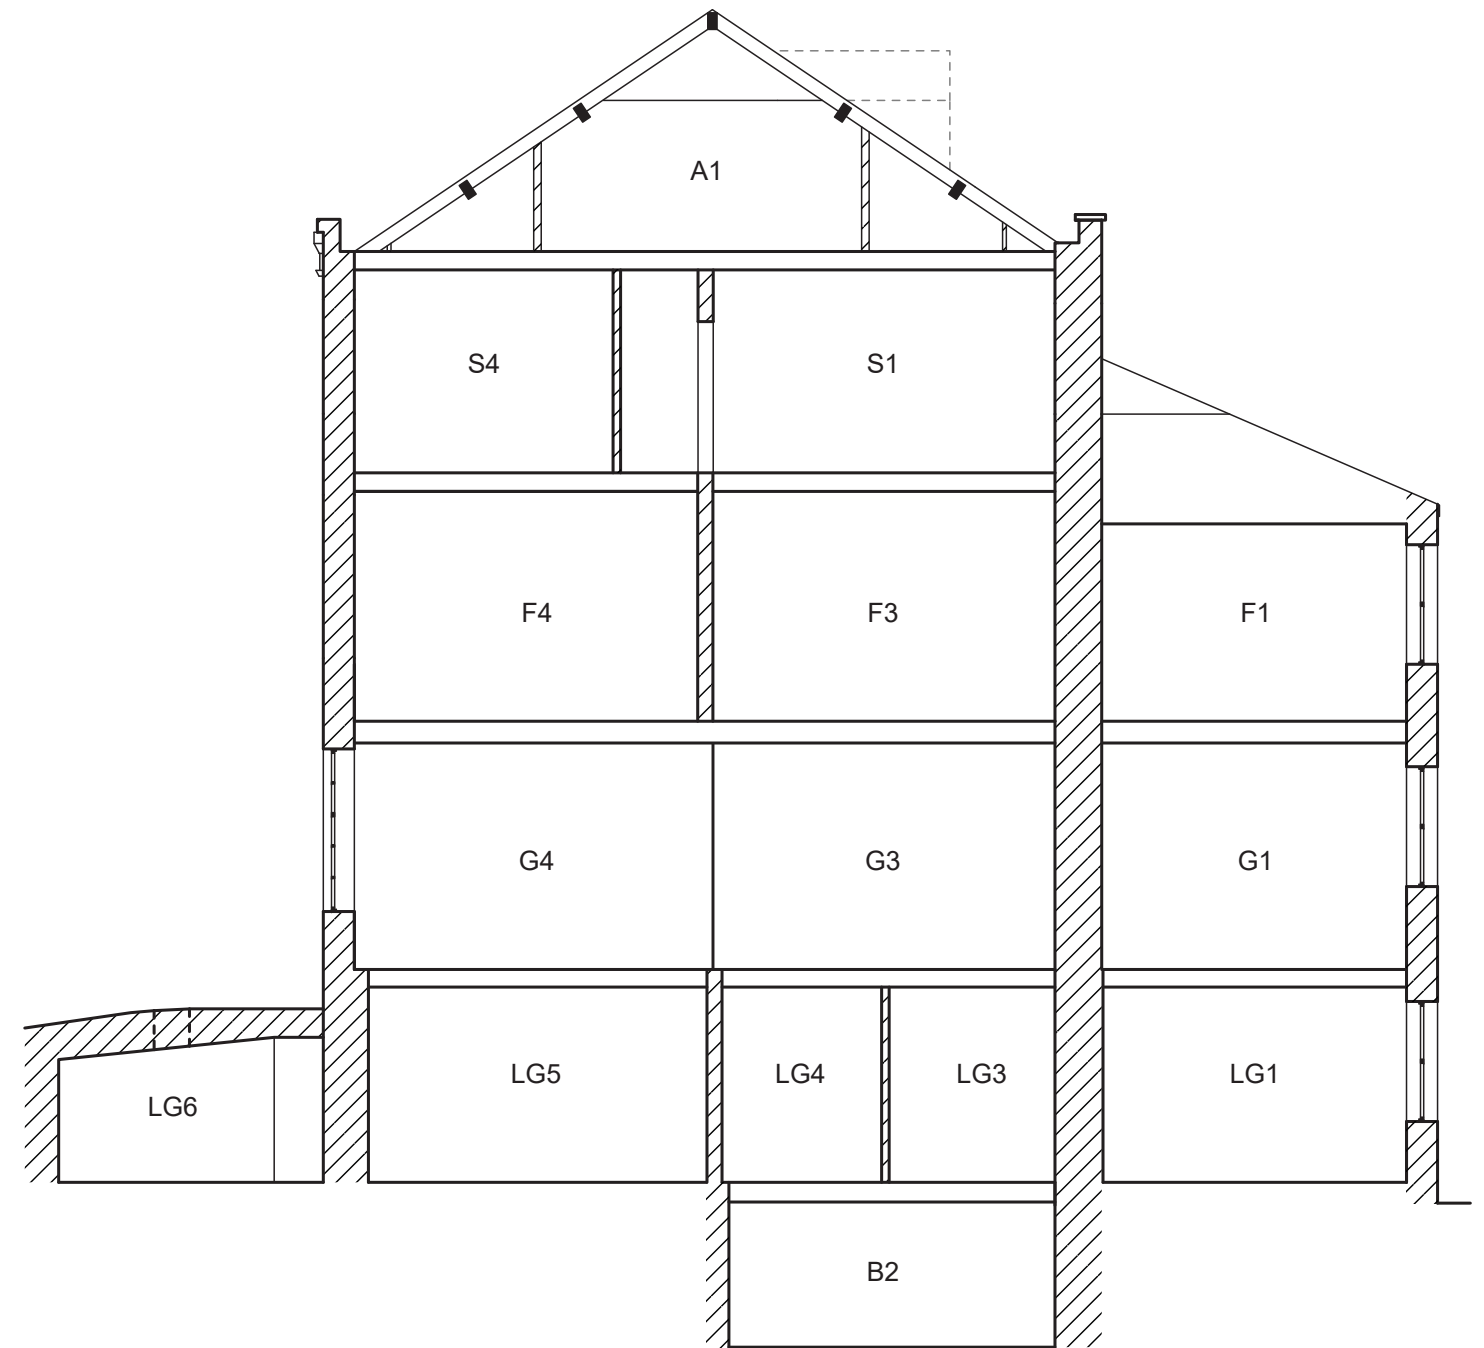
Figure 2: External elevations and cross-section

EAST EXTERNAL ELEVATION

WEST EXTERNAL ELEVATION

CROSS-SECTION A-A1

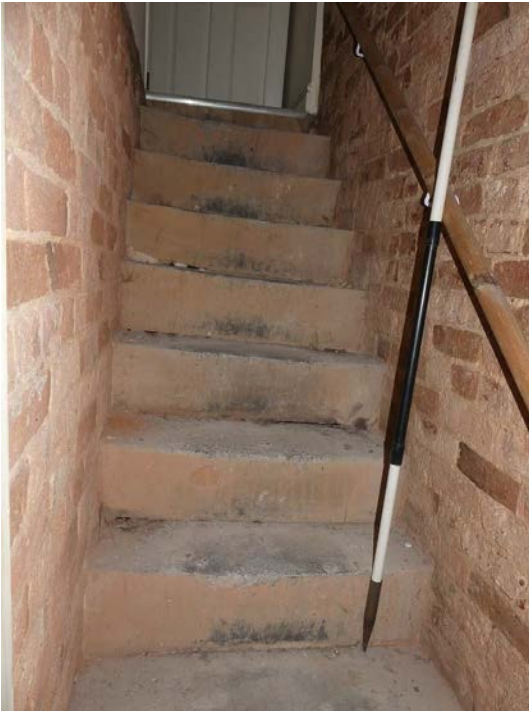
4.3.1 **Basement Room 1 (B1)**: this has a concrete floor, with concrete steps along the north side leading up to the west. There is a modern six-panel door to the south at the top of these and a modern timber hand rail attached to the north wall (Plate 19). Within the room the bricks are red and handmade, typically 23.5cm long, 11.5cm wide, and 8.5cm thick laid in English garden wall bond at a ratio of 3:1, but the walls have evidently been sand blasted. At the bottom of the stairs there is a doorway to the south with a modern door and round brick arch.

Plate 19 (left): Stairs along in Room B1, viewed from the east

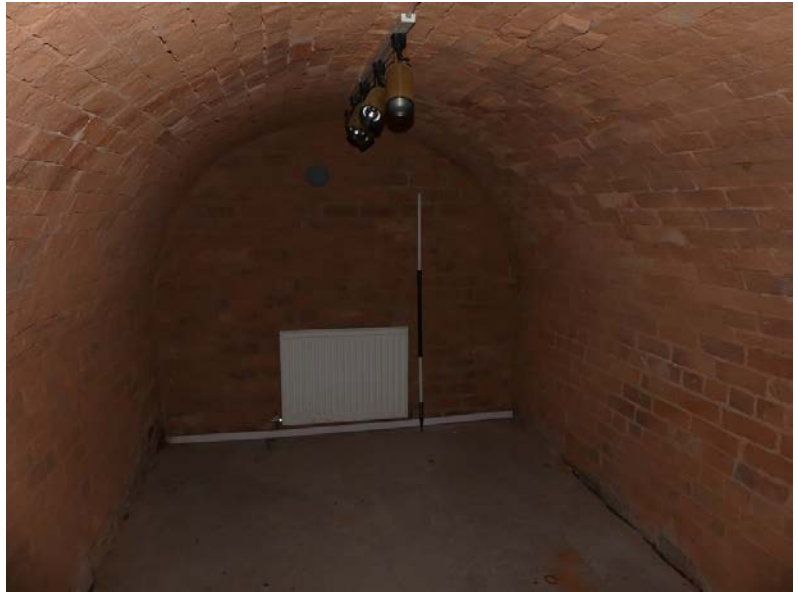
Plate 20 (right): General view of the west end of Room B2, from the east

4.3.2 **Basement Room 2 (B2)**: this has a concrete floor, vaulted brick ceiling and exposed brick walls in English garden bond, laid at a ratio of 5:1 (Plate 20). The bricks are slightly smaller than to the north, being 22.5cm long and 7.5cm thick. There are doorways to the north and south with round brick arches.

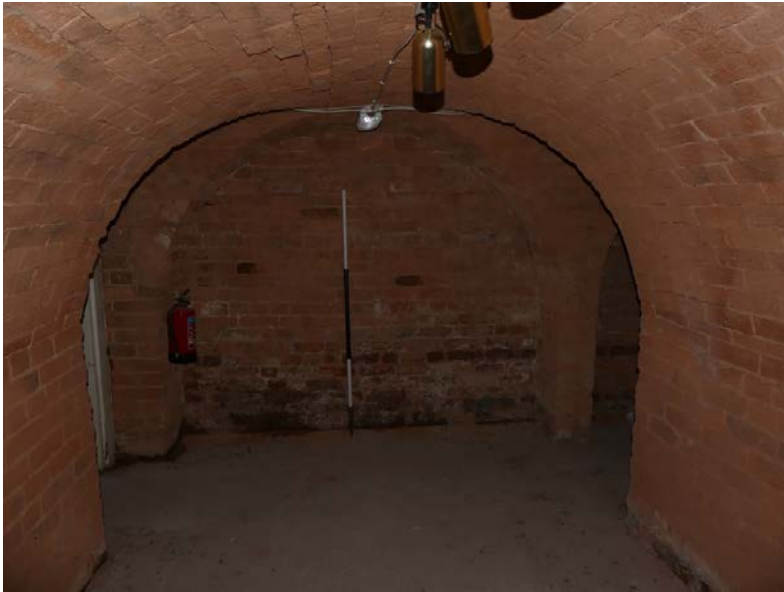
**Plate 21 (left): General view of the east end of Room B2, from the west**

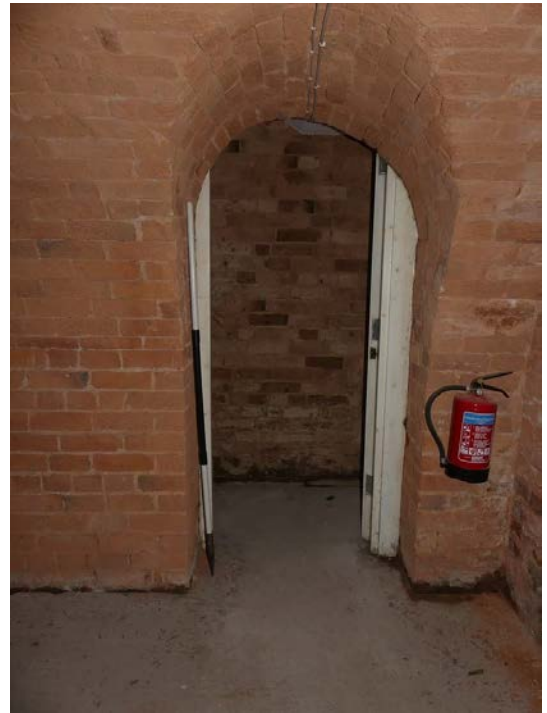
**Plate 22 (right): Doorway in the north side of Room B2, viewed from the south**

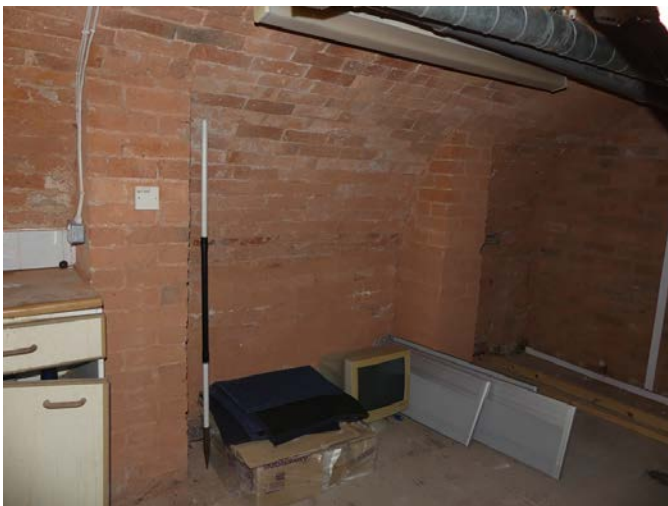
4.3.3 **Basement Room 3 (B3):** this also has a concrete floor and vaulted brick ceiling with modern piping attached. The walls are exposed brick as per those to the north in the same bond. There is a kitchen unit to the east, a pair of brick buttresses to the south, two lower brick plinths to the west, and a doorway to the north with a rounded arch.

**Plate 23 (left): Buttresses on the south side of Room B3, viewed from the north-east**

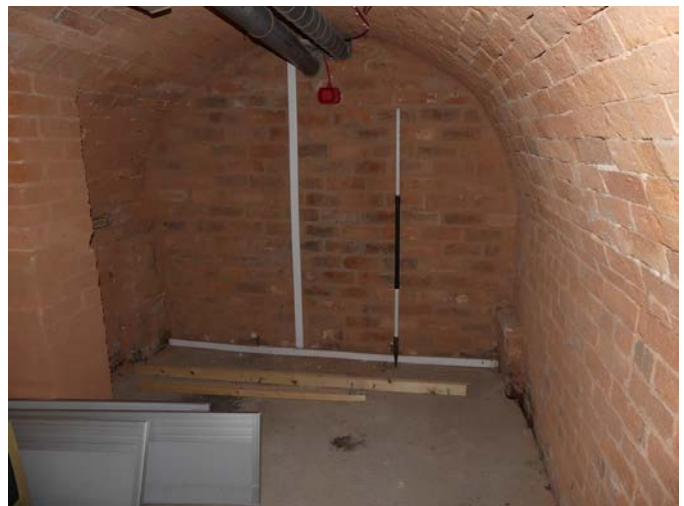
**Plate 24 (right): The west side of Room B3, showing plinths**

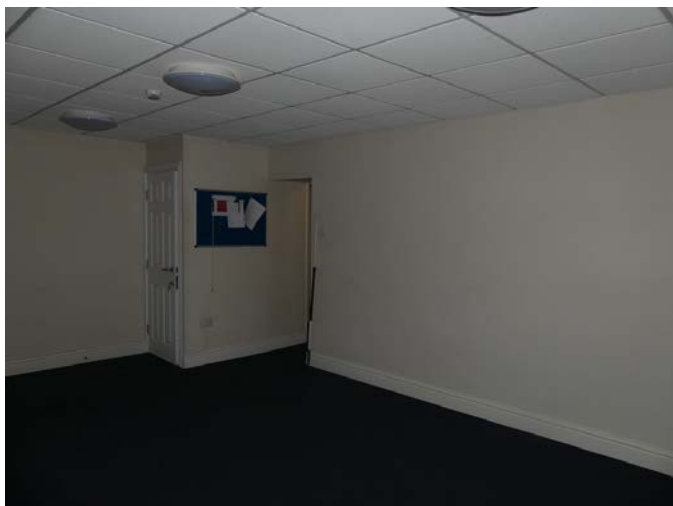
4.3.4 **Lower Ground Floor Room 1 (LG1):** this has partitions in the north-east corner for a small cupboard, with a doorway with a modern six-panel door to the west (Plate 25). There are two windows to the west with square jambs, a timber sill and modern iron bars over. There is a doorway to the north with a modern five-panel UPVC door (Plate 26). The walls are otherwise plain, apart from a doorway to the east with no door.

**Plate 25 (left):** General view of Room LG1 showing the cupboard in the north-east corner, from the south-west

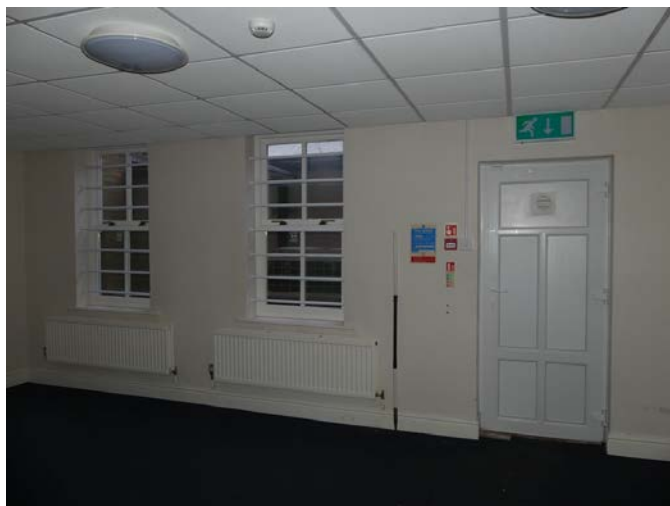
**Plate 26 (right):** The west elevation of Room LG1, viewed from the east

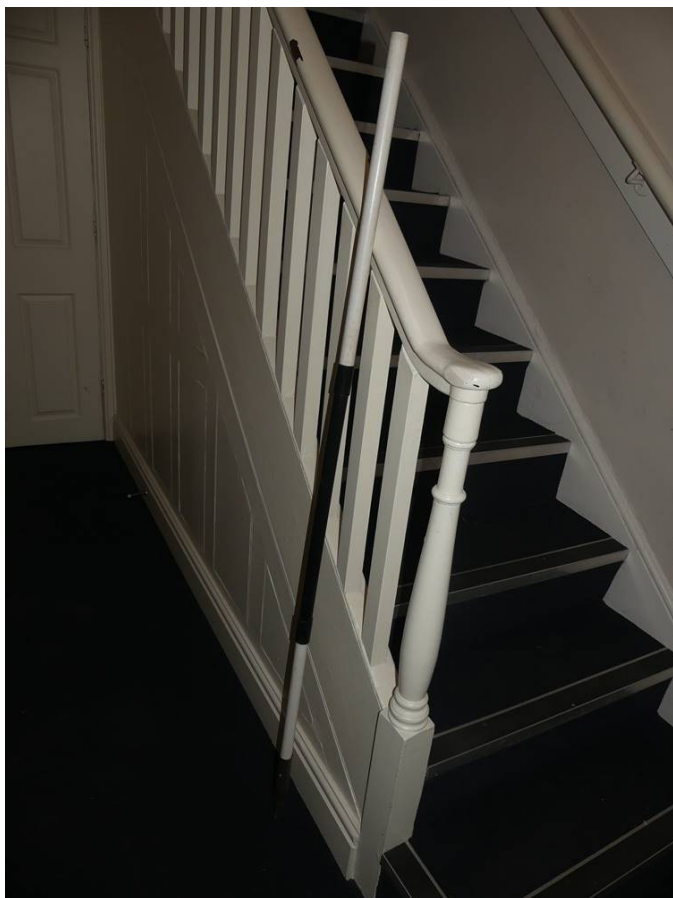
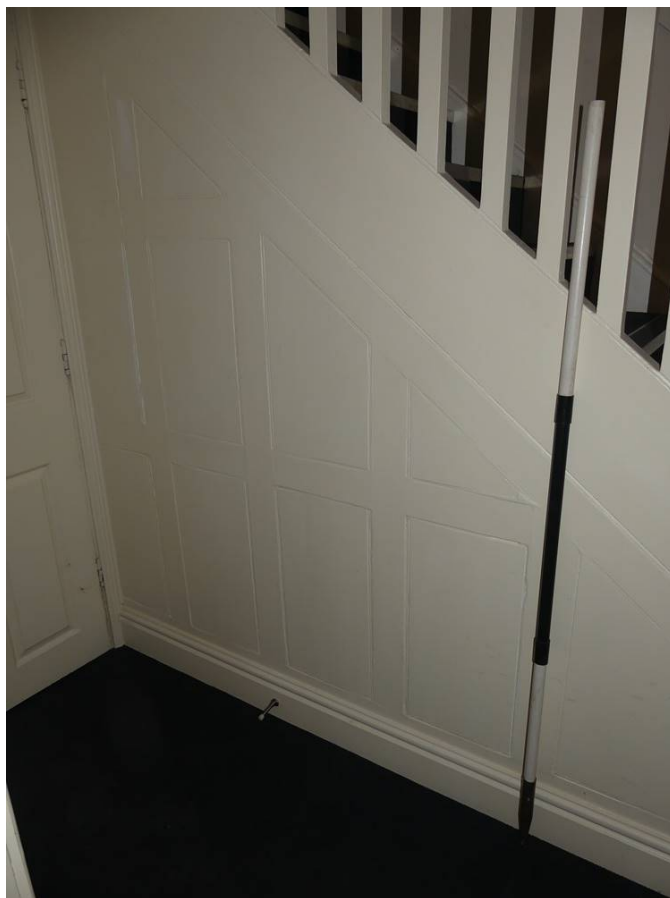
**4.3.5 Lower Ground Floor Room 2 (LG2):** this comprises a corridor linking to the stairs. The stairs are along the north wall have an original turned newel post and hand rail but very substantial rectangular-section balusters (Plate 27). The side panelling is fairly plain but the sections have beaded edges (Plate 28). The walls are otherwise plain and with a doorway with a modern plain door to the east in an area of partial infill. There are two doorways to the south with modern six-panel doors and another in the dividing wall and to the stairs.

**Plate 27 (left):** Detail of the staircase in Room LG2, viewed from the south-east

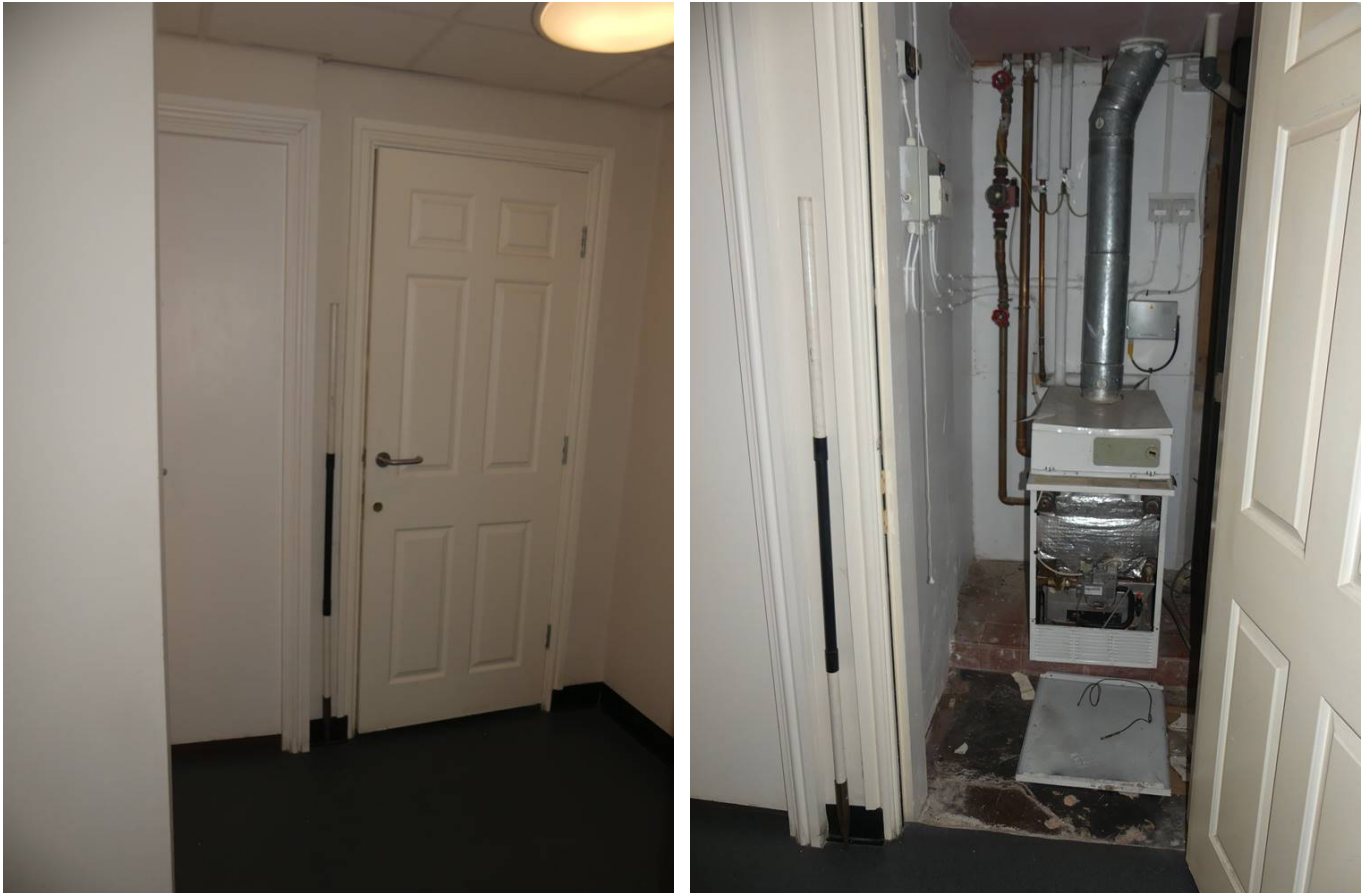
4.3.6 **Lower Ground Floor Room 3 (LG3)**: this comprises a modern toilet and shower and the floor is finished with vinyl, which extends to form a simple skirting. It is divided inside with doorways to the south with a six-panel and plain door into the toilet and boiler room respectively (Plate 29). The latter has a concrete floor, stepped up and tiled on the south side to house the boiler (Plate 30).

Plate 29 (left): Doorways to the south in Room LG3, viewed from the north

Plate 30 (right): The boiler cupboard in Room LG3, viewed from the north

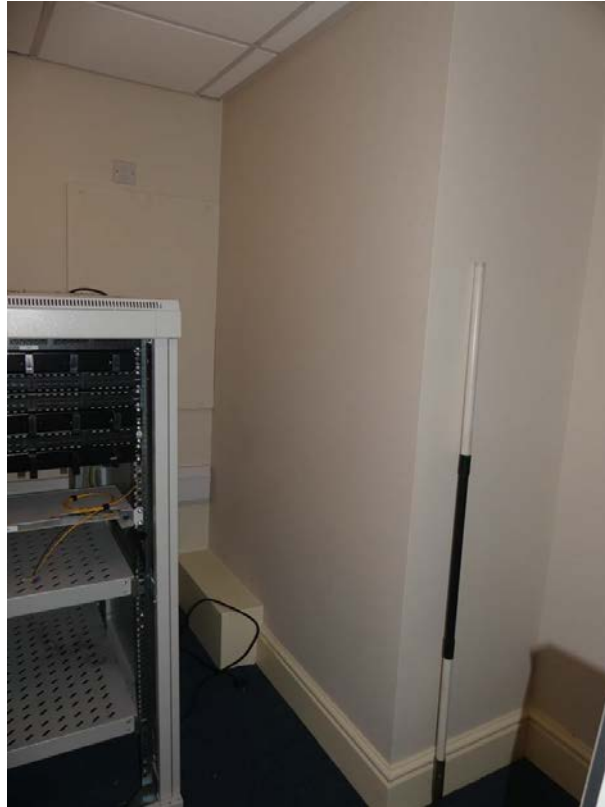
4.3.7 **Lower Ground Floor Room 4 (LG4)**: this comprises a server room and is largely plain, but stepped out in the south-west corner. There is boxing low to the east of this plus a panel fixed to the south wall, presumably over a small opening, i.e. the wall is probably boxed over.

**Plate 31: General view of Room LG4, from the north-east**

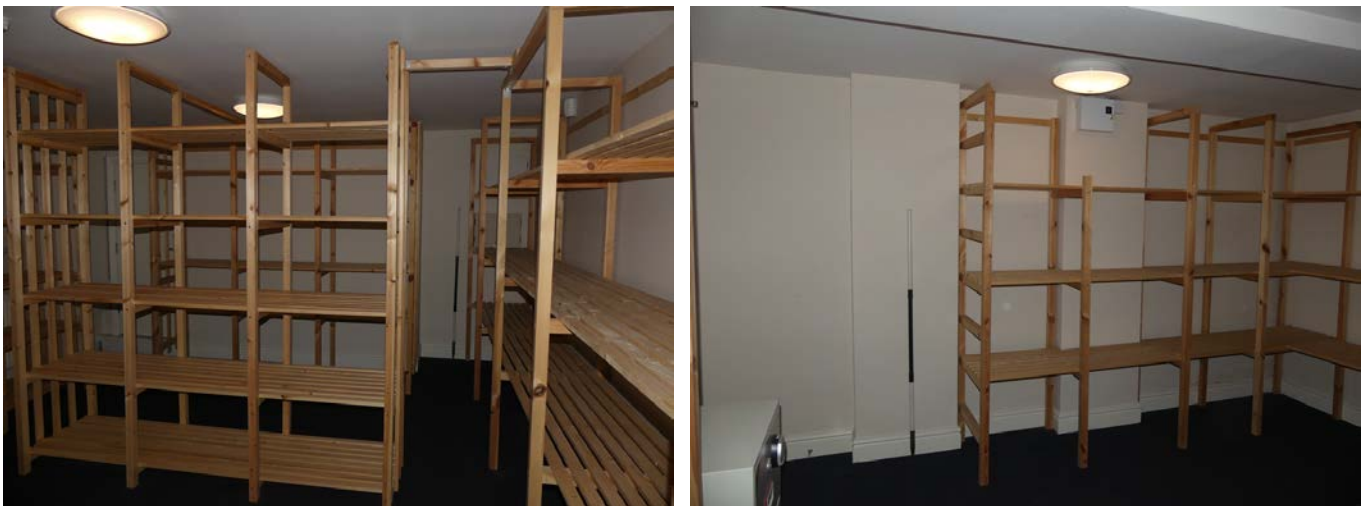
**4.3.8 Lower Ground Floor Room 5 (LG5):** this has modern timber shelving against all of the walls (Plate 32) and there is a single wide boxed beam east/west supporting the ceiling. There are plain single-panel doors to the east, west and south. The latter door leads into a cupboard which was built in an alcove, i.e. the space to the side of a central chimney breast, with a step back to the west. There is a pair of buttresses on the north side, but apparently only boxing for cables (Plate 33).

**Plate 32 (left): General view of Room LG5, from the north**

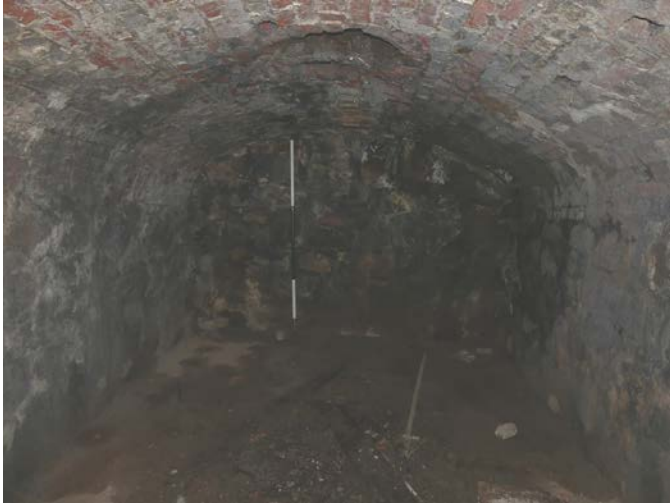
**4.3.9 Lower Ground Floor Room 6 (LG6):** this comprises a cellar extending out below the pavement to the east of the building (Plate 34). It has a concrete floor and vaulted brick ceiling, with a circular coal hole in the centre covered externally by a perforated iron plate. There is a recess on the south-west side forming the cellar light from the street, but covered by a corrugated sheet apparently on timber battens. The walls are exposed stone to the north and south and brick to the west, with the remnants of

**Plate 34 (left): The east end of Room LG6, viewed from the west**

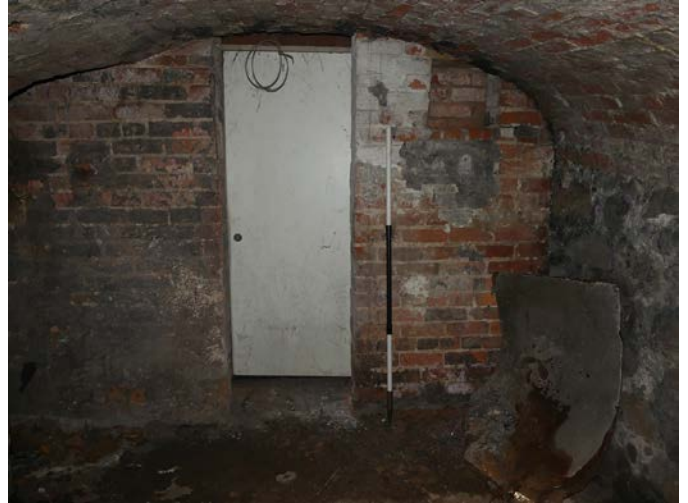
limewash; the bricks are typically 23.5cm long and 7cm thick and laid in English garden wall bond at a ratio of 5:1. There is a window to the south with a six-light casement (Plate 36) with a hinged top and a doorway to the north with a flat brick arch with a boxed iron beam behind. To the north is a small alcove, perhaps originally a small aperture and now blocked (Plate 36).

**Plate 35 (right): The west end of Room LG6, viewed from the east**

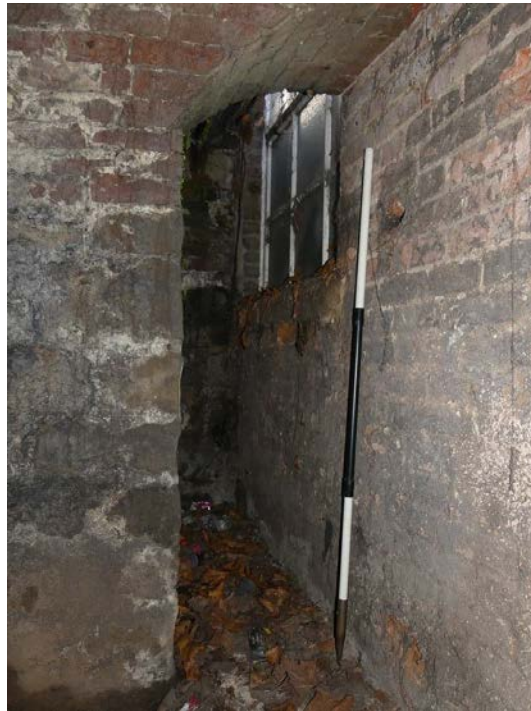
**Plate 36: The window on the south side of the west elevation of Room LG6, viewed from the north**

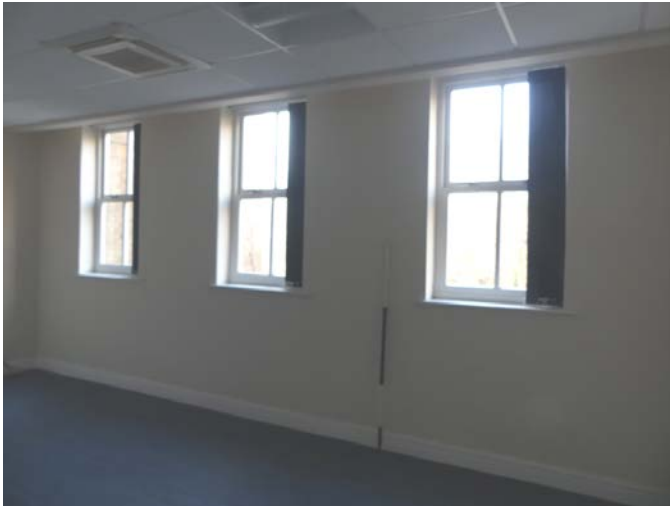
4.3.10 **Ground Floor Room 1 (G1):** there are three windows to the west, all with four-light hinged timber casements, square jambs and timber sills. There is an area in the south-east corner, boxed out with modern partitions but with a deep alcove on the north side with glass shelves. There is a wide alcove in the east elevation and a doorway to the north with a modern six-panel door.

**Plate 37 (left): Windows in the west elevation of Room G1, viewed from the north-east**

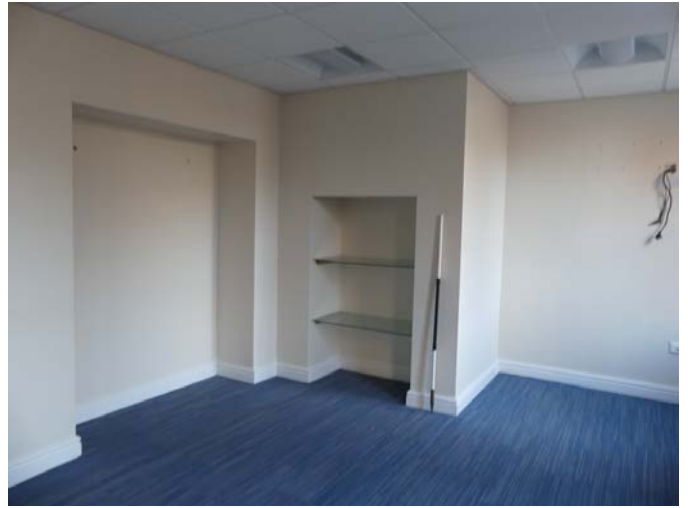
**Plate 38 (right): Built out walls and alcove in the south-east corner of Room G1, viewed from the north-west**

4.4.4 **Room G1:** the stud boxing in the south-east corner had been removed revealing a further section of suspended boxing, which had been broken through (Plate 75). This revealed that this boxing was around a window in the adjoining property to the south, continuing to the floor above to provide a borrowed light from a skylight in the roof above. The suspended ceiling has also been removed to reveal a boxed in beam orientated north/south, but otherwise plain (Plate 76).

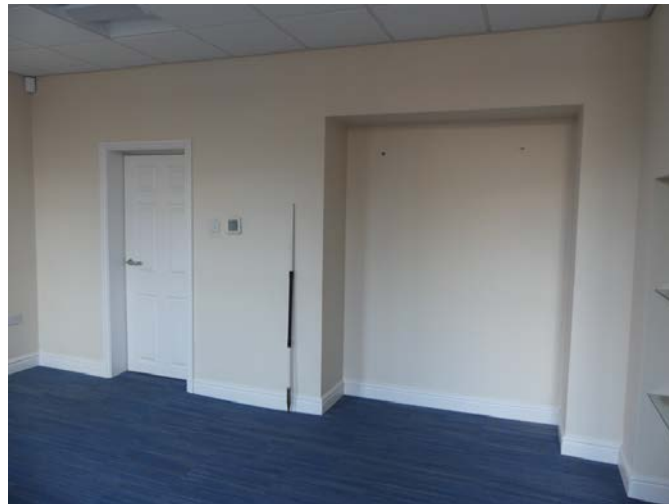
**Plate 39: Alcove and doorway in the east elevation of Room G1, viewed from the west**

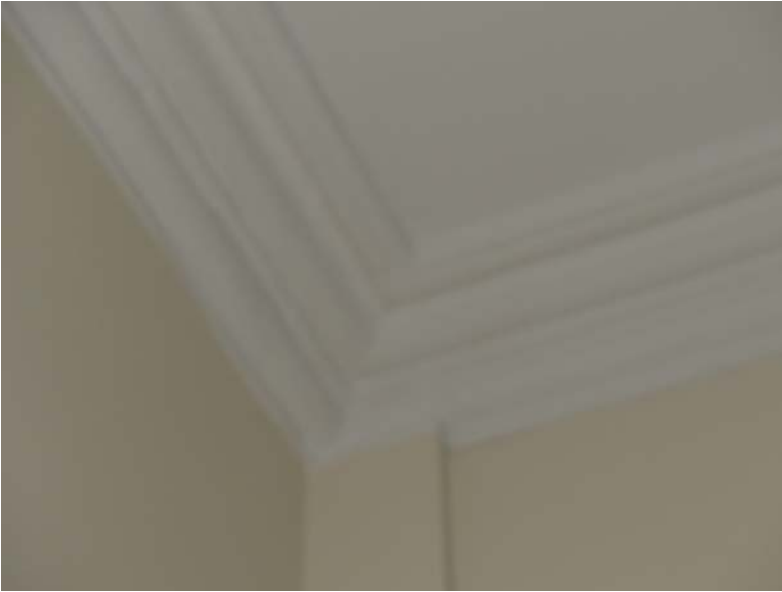
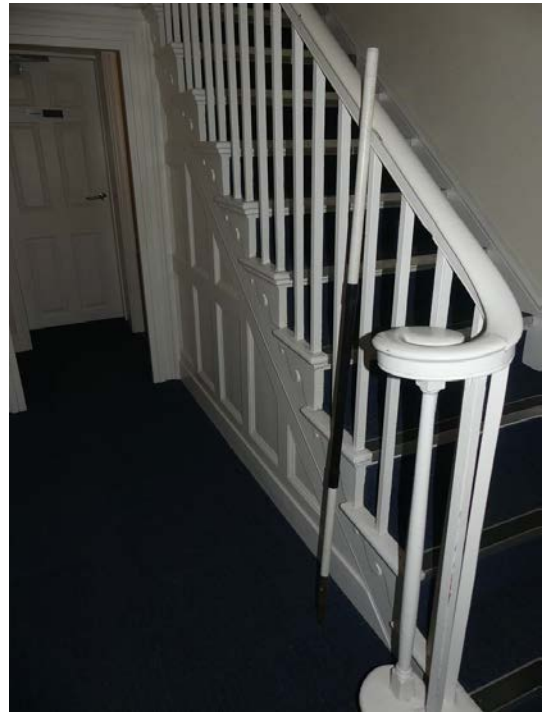
4.3.11 **Ground Floor Room 2 (G2)**: this has a plaster ceiling, sloping to the underside of stairs on the north side with a moulded plaster cornice (Plate 40). The stairs have a handrail ending in a spiral, a slender turned newel post and thin square balusters (Plate 41). The sides are decorated with double scrolled brackets to the outer string and moulded panels to the west (Plate 42). The room is otherwise plain with a modern six-panel door to the west and to the stairs down to the floor below, where there is an original moulded surround. There is a modern glass door to the south and to the east a glazed division with an overlight (Plate 43).

**Plate 40 (left): Moulded cornice in Room G2, viewed from the north-west**

**Plate 41 (right): Staircase in Room G2, viewed from the south-east**

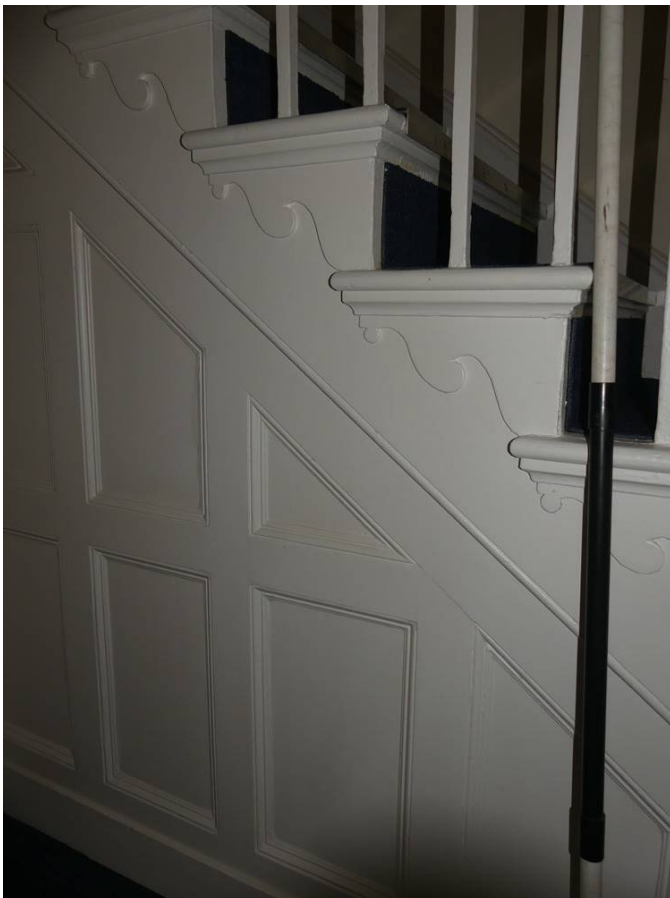
**Plate 42 (left): Side of the staircase in Room G2, viewed from the south**

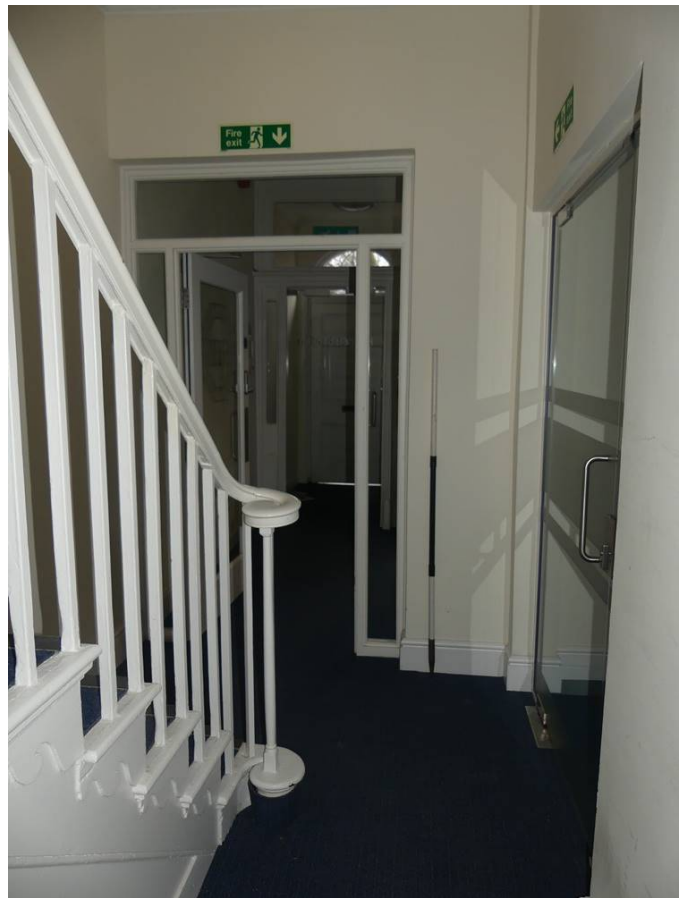
**Plate 43 (right): The east end of Room G2, viewed from the west**
