# 30 WINCKLEY SQUARE, PRESTON, LANCASHIRE

## Archaeological Building Recording

March 2023

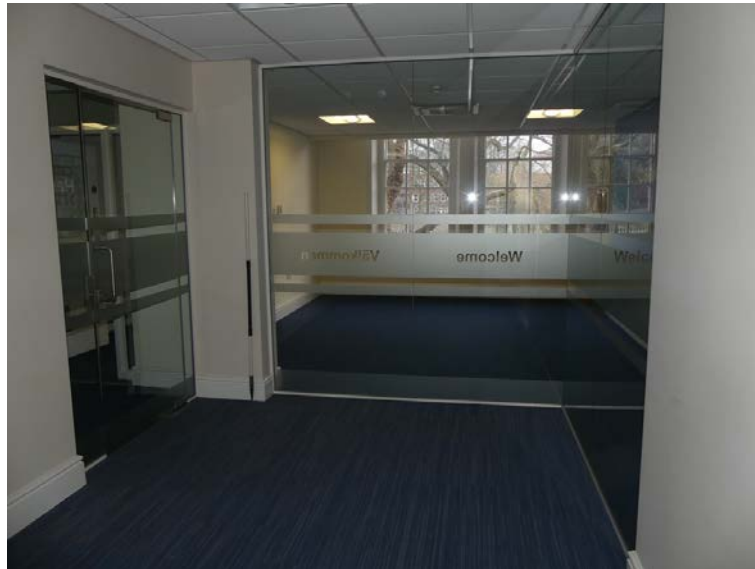
4.3.12 **Ground Floor Room 3 (G3)**: is has been created within a larger room, with glazed walls to the east and south with a glazed door to the north, but it is otherwise plain.

**Plate 44: General view of Room G3, from the west**

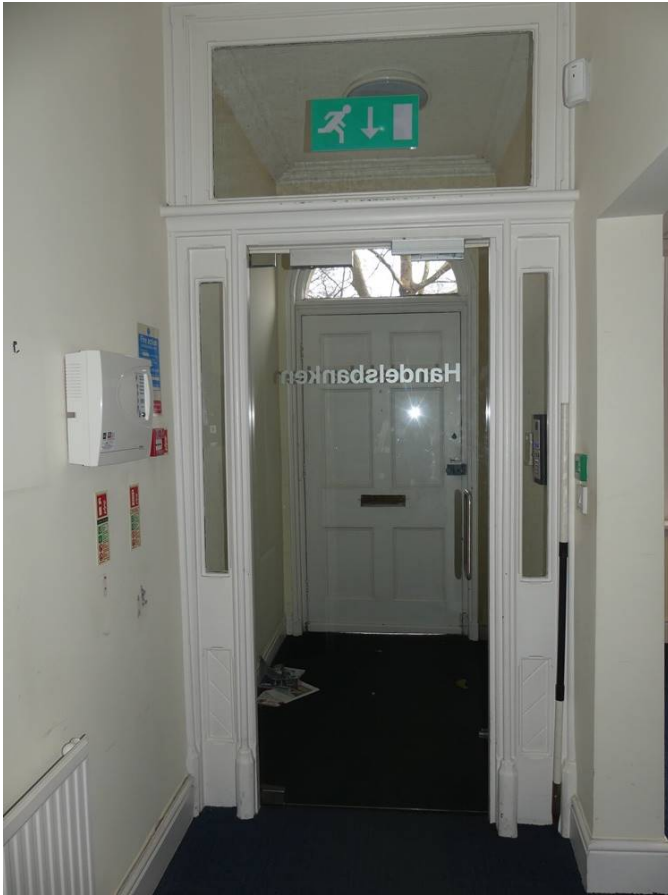
4.3.13 **Ground Floor Room 4 (G4)**: this is glazed on the west side, with a passage leading to modern stud walls forming a toilet with a modern door to the east. The north side is open to the entry lobby, with a glazed door to the porch in an original dividing wall with slender engaged columns on octagonal bases (Plate 45). The panels either side are panelled with stop chamfer decoration and a roll-moulded lintel and rectangular overlight. The east elevation has a doorway within the porch with a six-panel door with a moulded surround and semi-circular fanlight (Plate 47) and there is a moulded cornice inside the porch and extending out of it to the west. To the south of this are two windows, both with 15-light sash casements with horns, splayed jambs, moulded surrounds and timber sills (Plate 48). The south elevation has a projecting central section, presumably an original chimney breast and boxing either side, with a small modern door on the west side (Plate 49). There is a glass door on the west side, with an etched sign reading "Svenska Handelsbanken 1871" (Plate 50).

**Plate 45 (left): The partition door to the porch in the north-east corner of Room G4, viewed from the west**

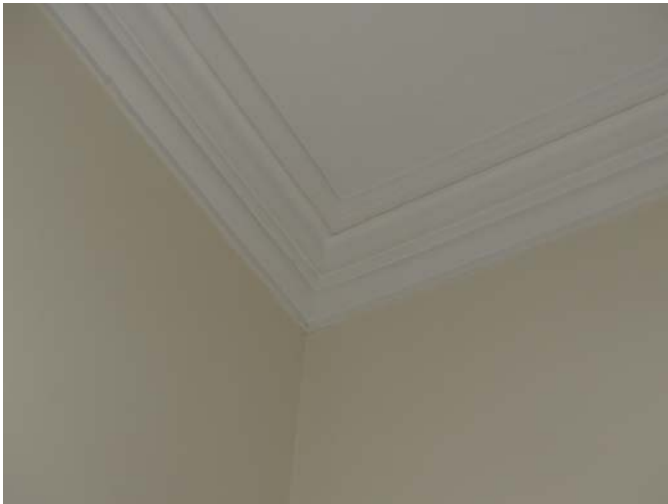
**Plate 47 (left): Moulded cornice in the porch in Room G4, viewed from the north-east**

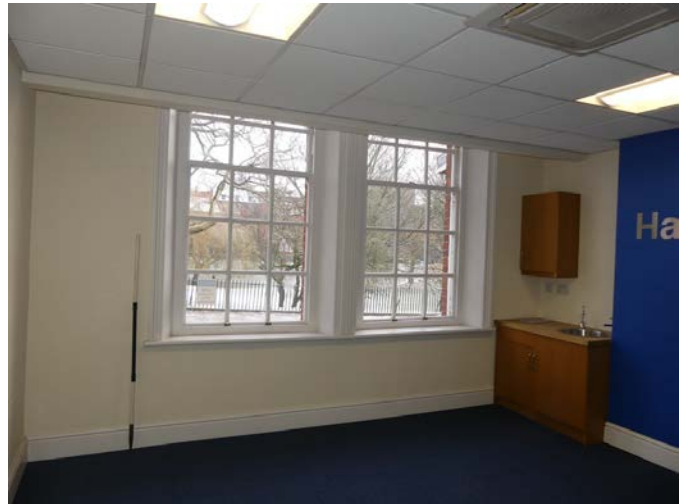
**Plate 48 (right): Windows in the east elevation of Room G4, viewed from the west**

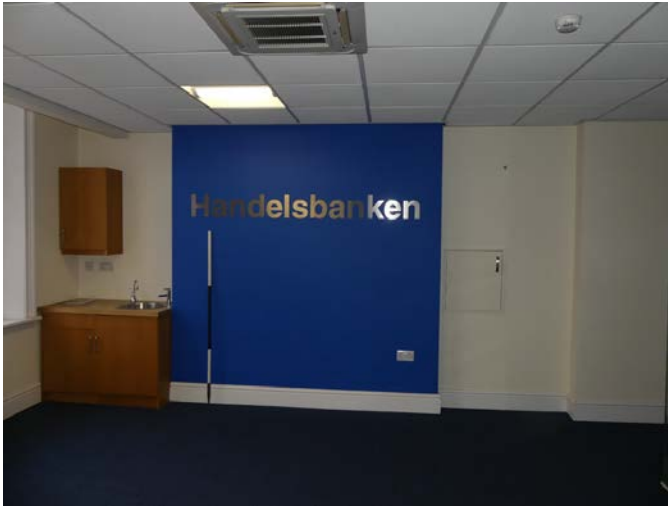
**Plate 49 (left): The south elevation of Room G4, viewed from the north**

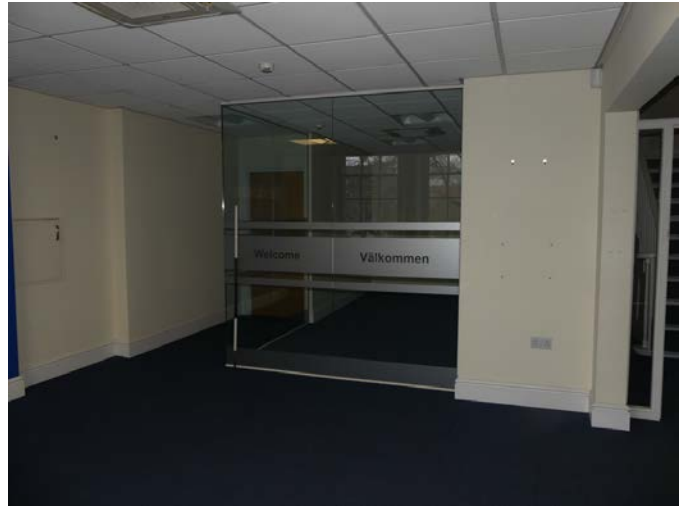
**Plate 50 (right): The west elevation of Room G4, viewed from the east**

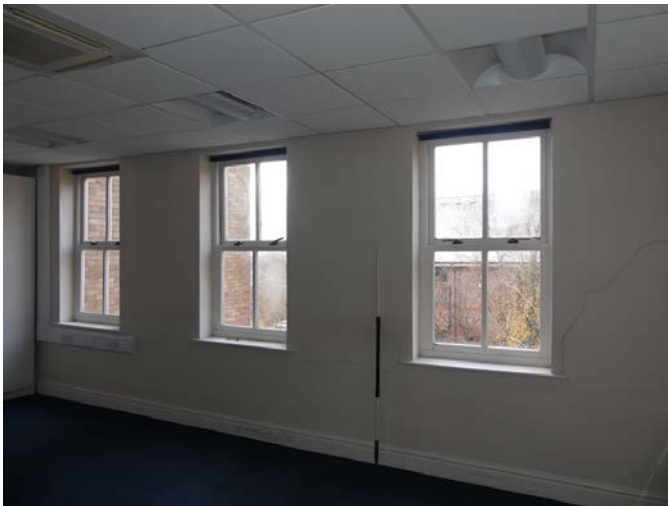
4.3.14 **First Floor Room 1 (F1)**: this is plain to the north, with three windows to the west with square jambs, timber sills and four-light hinged timber casements (Plate 51). The south-east corner is built out, apparently with solid masonry walls, but it is inaccessible (Plate 52). There is a large opening in the east elevation.

**Plate 51 (left): The west elevation of Room F1, viewed from the north-east**

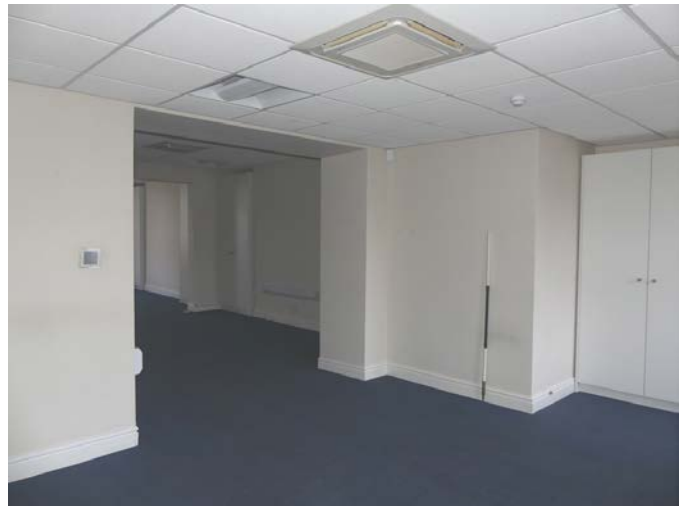
**Plate 52 (right): The east elevation of Room F1, viewed from the north-west**

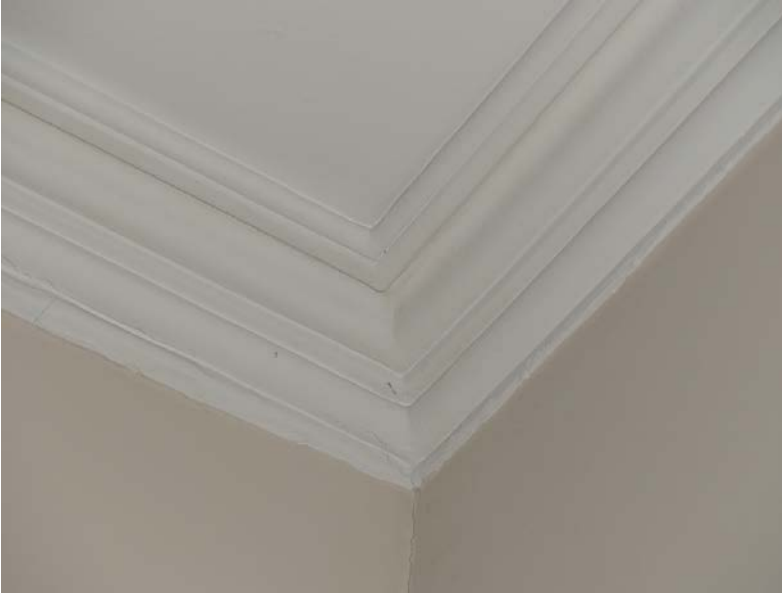
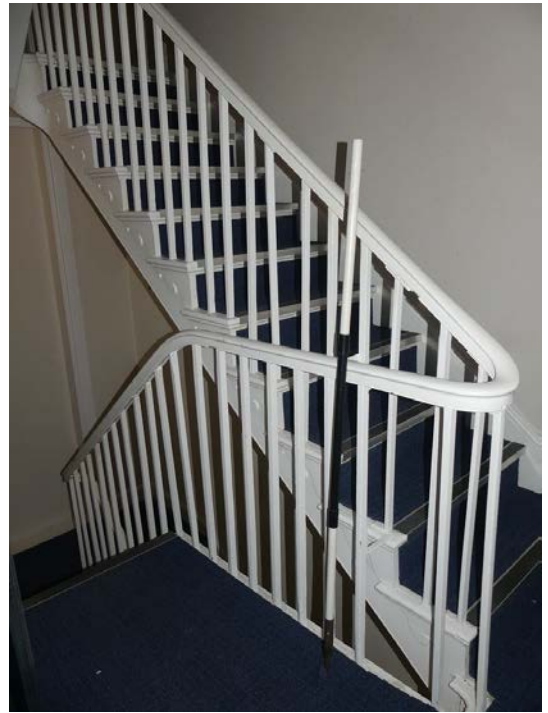
4.3.15 **First Floor Room 2 (F2)**: this comprises the stair well, with a plaster ceiling following the slope of the stairs above, and a moulded cornice (Plate 53). The stairs, against the north side, have a curving handrail, plain square balusters and double scrolled brackets to the outer string (Plate 54). The landing has a tall window to the west, now a blocked leaving a large alcove with a roll-moulded surround (Plate 55). The original moulded skirting board survives throughout.

**Plate 53 (left): Moulded cornice in Room F2, viewed from the south-west**

**Plate 54 (right): Stairs in Room F2, viewed from the south-east**

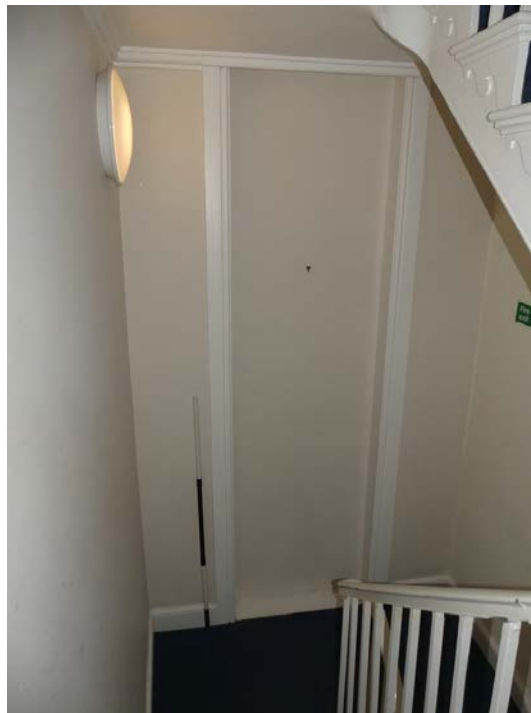
**Plate 55: Former window in the west elevation of Room F2, viewed from the east**

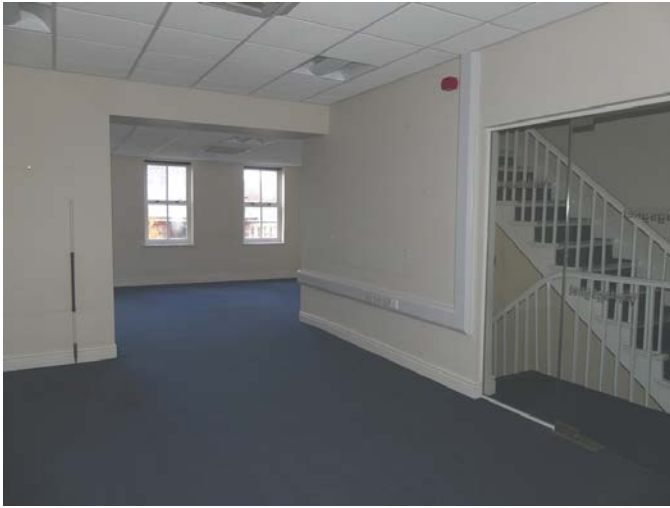
4.3.16 **First Floor Room 3 (F3)**: this comprises a space between Rooms 1 and 4 on this floor. There are large openings to the east and west and a glazed door to the north (Plate 56 and Plate 57). The room is otherwise plain, with a return on the south side now housing a cupboard.

**Plate 56 (left): General view of Room F3, from the south-west**

4.4.8 **Room F3:** the removal of the suspended ceiling (Plate 86 and Plate 87) revealed a cavetto moulded cornice (Plate 88), again with some damage to it caused by later pipes and cables, and shows that the east wall is brick. The space to the west of the south chimney breast is also blocked with stud walling, but interestingly the cornice continues across the top of this, suggesting that it was originally filled in some way.

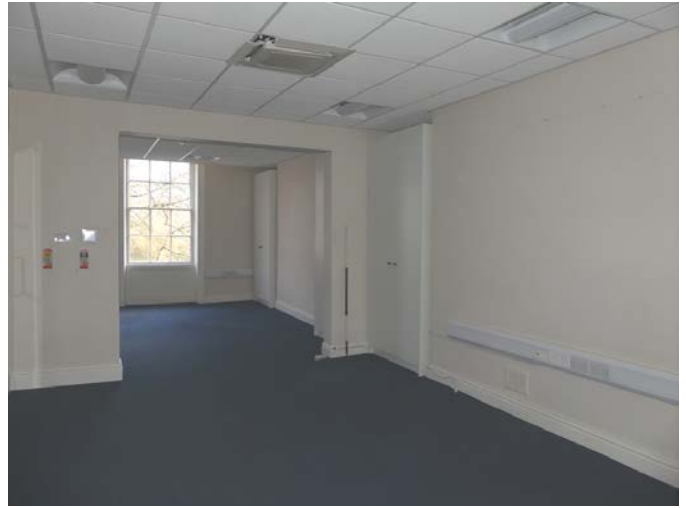
**Plate 57 (right): General view of Room F3, from the north-east**

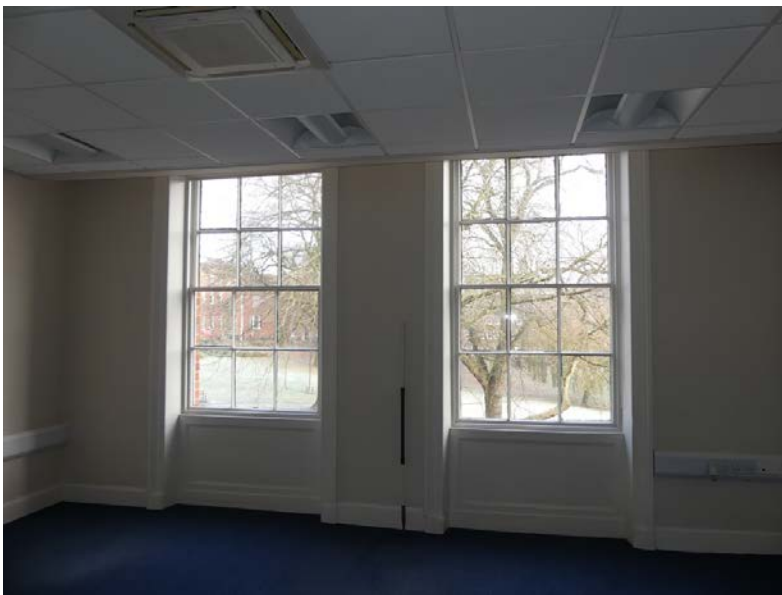
4.3.17 **First Floor Room 4 (F4)**: the north elevation is plain, there are two windows to the east, both with 12 light (six over six) sash casements with no horns, splayed jambs and moulded surrounds and a single moulded panel below (Plate 58 and Plate 59). The south elevation has an alcove either side of a large projecting central section (presumably originally a chimney breast) (Plate 60), and a large opening to the west (Plate 61).

**Plate 58 (left): Windows in the east elevation of Room F4, viewed from the west**

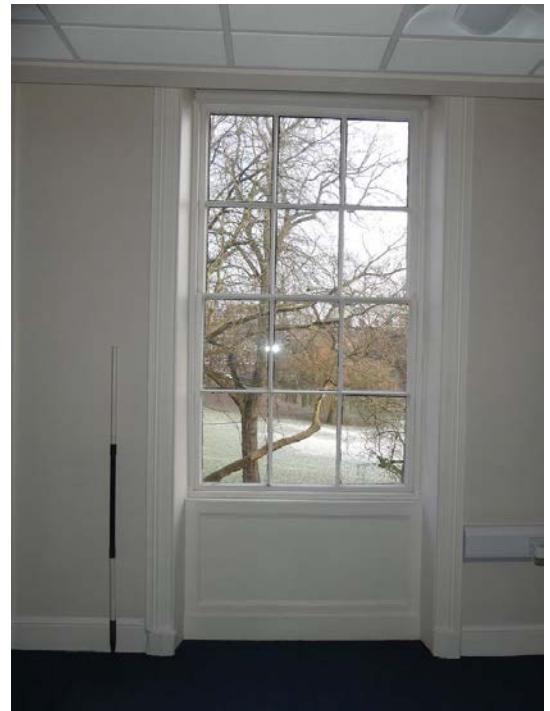
**Plate 59 (right): Detail of window in the east elevation of Room F4, viewed from the west**

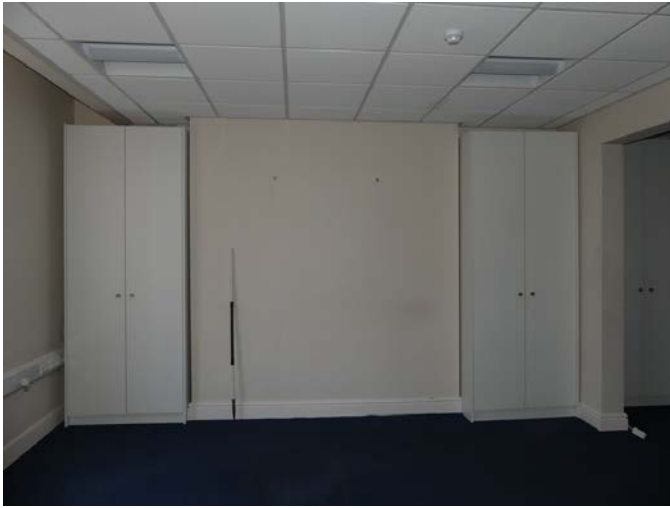
**Plate 60 (left): South elevation of Room F4, viewed from the north**

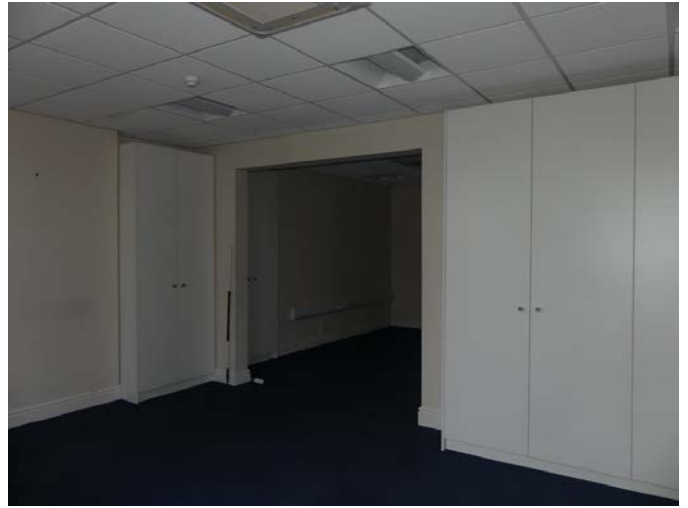
**Plate 61 (right): West elevation of Room F4, viewed from the north-east**

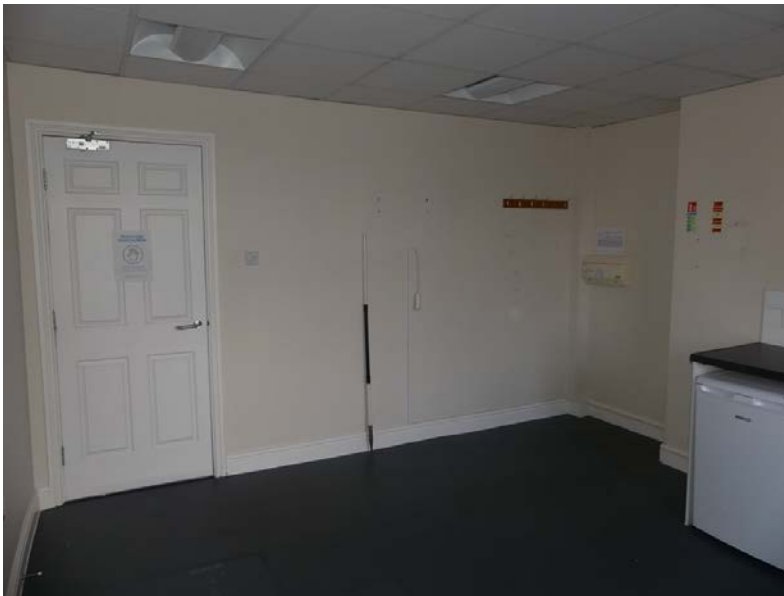
4.3.18 **Second Floor Room 1 (S1)**: this currently comprises a kitchen, whose floor is finished with vinyl and has been fitted with a tiled ceiling and kitchen units on the south side, as well as modern skirting. The north elevation is plain whilst the east elevation has a doorway on the north side with a modern six-panel door. The south elevation is plain apart from a step back on the east side. The west elevation has a single large window with a modern four-light timber sash casement with horns, splayed jambs, moulded surrounds and a single moulded panel below.

**Plate 62 (left): The east elevation of Room S1, viewed from the west**

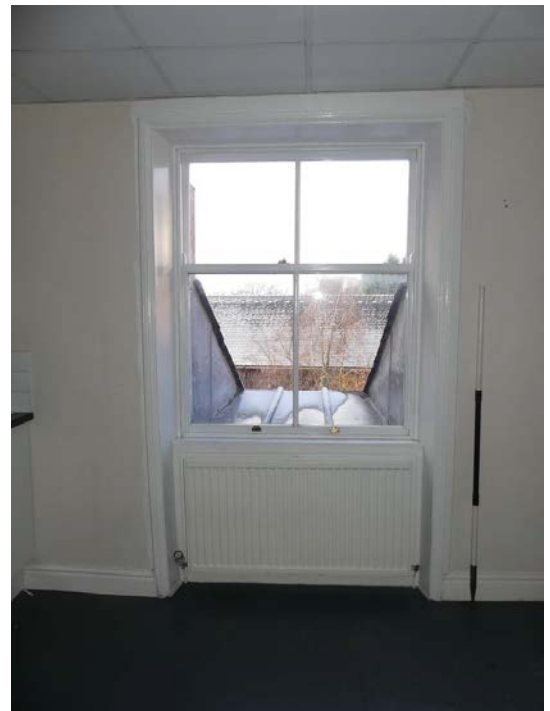
**Plate 63 (right): Window in the west elevation of Room S1, viewed from the east**

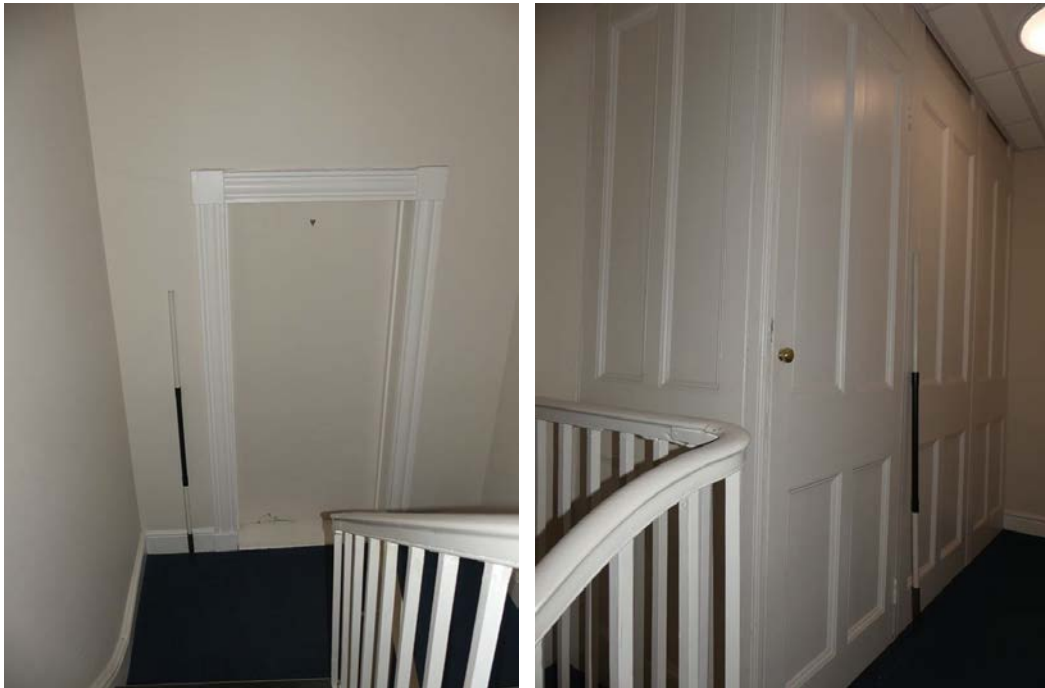
4.3.19 **Second Floor Room 2 (S2)**: this comprises the top of the main staircase, with a handrail and square balusters. There is a blocked former stair window at the landing level on the west side now forming a large alcove with moulded surround and blank roundels at the corners. In the north-east corner there is timber panelling made up of moulded sections and with a doorway on the south side with a four moulded panel door, covered on the interior with a modern (fire retardant?) sheet. The stairs up to the

attic floor within this boxed section comprise plain timber steps with a modern hand rail attached to the wall. There is a doorway to the south-east with a modern six-panel door.

**Plate 64 (left): Former window in the west elevation of Room S2, viewed from the east**

**Plate 65 (right): Timber panelling around the stairs in the north-east corner of Room S2, viewed from the south-west**

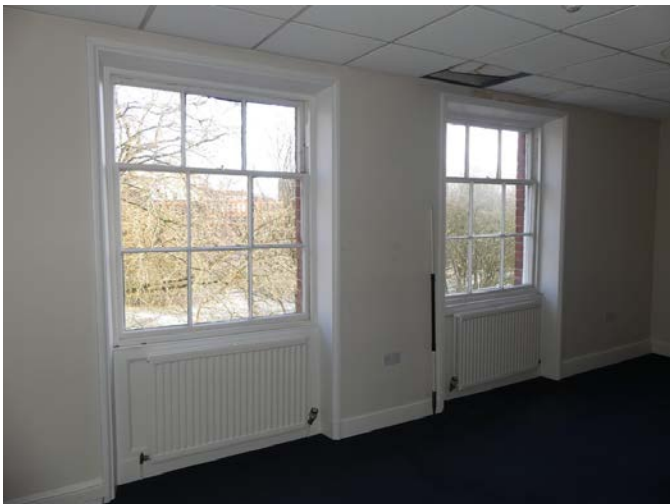
4.3.21 **Second Floor Room 4 (S4):** the north elevation is plain whilst the east has two windows. Both elevations have nine-light (three over six) sash casements without horns in splayed jambs and with moulded surrounds and a single moulded panel below, mostly hidden by a radiator (Plate 66). There is a fireplace to the south with a stone surround in fine-grained grey stone and iron hob grate insert with geometric and floral decoration (Plate 67). The west elevation has a doorway with a modern door and a recess to the north forming an open cupboard below the stairs (Plate 68).

**Plate 66 (left): Windows in the east elevation of Room S4, viewed from the west**

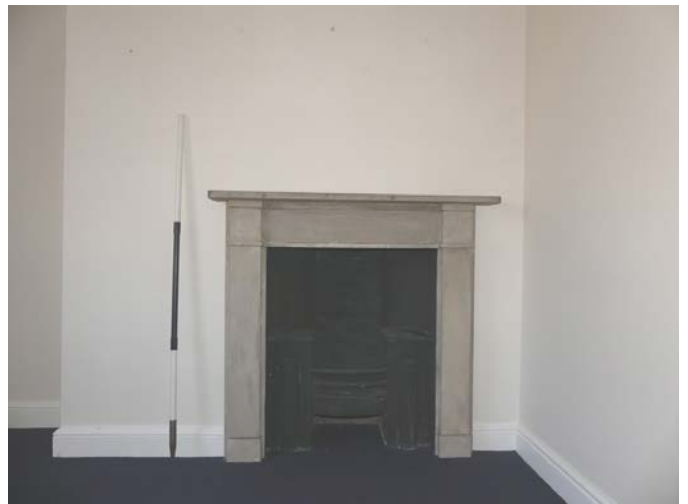
**Plate 67 (right): Fireplace in the south elevation of Room S4, viewed from the north**

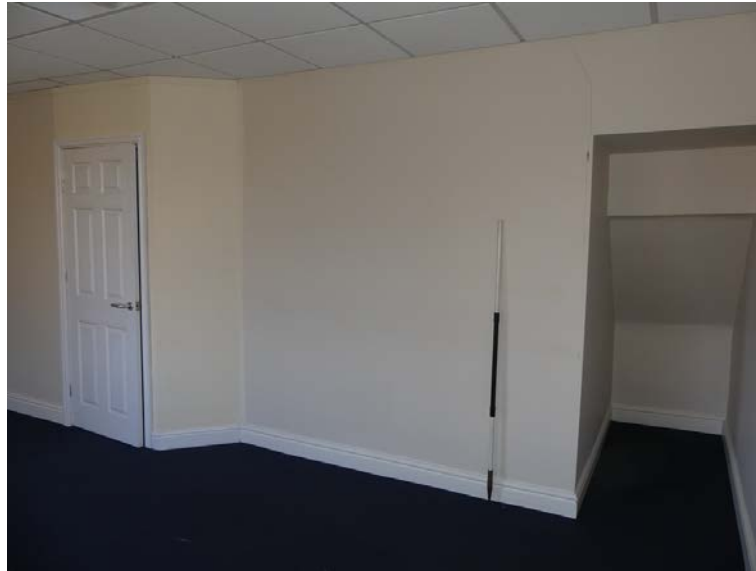
**Plate 68: West side of Room S4, viewed from the north-east**

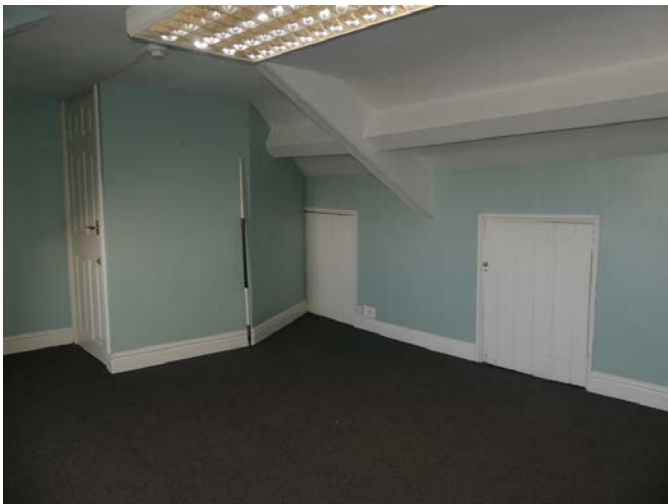
**4.3.22 Attic Floor Room 1 (A1):** this comprises the majority of the floor. It has a carpet floor and plaster ceiling, sloping down to the east and west, with the lower part boxed off into roof spaces by stud partitions, each with two small beaded plank and batten doors (Plate 69). The roof is supported by a single tie beam truss largely covered by plaster, with just the principal rafters visible, although these are largely boxed over with the exception of the east and west ends. The west side also forms part of the side of the dormer window. There is a single purlin per pitch and large corbels supporting them at the ends (Plate 70). There are stud walls on the north-east side around the top of the stairs (Plate 69 and Plate 71). Within the west roof space there is a second purlin, evidently truncated by the dormer window and supported by a brick wall. The brick of the main wall is just exposed to the south, with a slight step in the wall, and there is further lathe and plaster boxing off the wall to the west. The original wide floorboards are exposed within this area. The northern side of the west roof space also has the sawn end of the purlin on this side, with the end of the principal rafter visible and the brick wall to the north. The eastern roof space has the end of the principal rafter and purlin, all in sawn red pine. The exposed brick walls are visible to the north and south, with further lathe and plaster obscuring the east. One of the upright timbers in the stud wall to the west has Baltic timber marks. The main walls otherwise have a vent to the south a dormer window to the west with a three-light hinged casement (Plate 71).

**Plate 69 (left): East elevation of Room A1, viewed from the south-west**

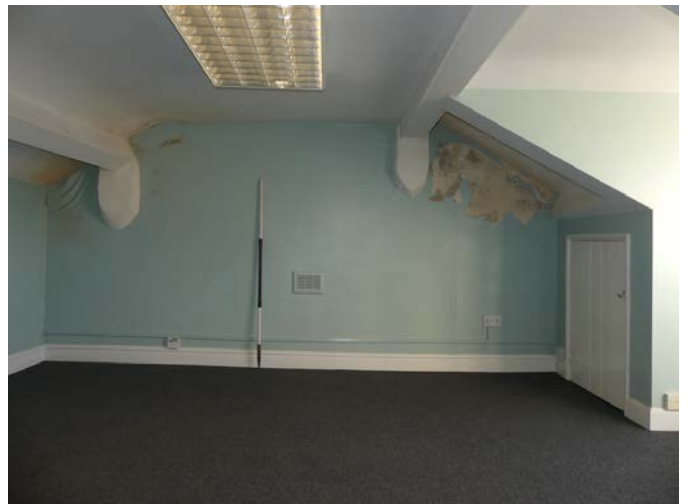
**Plate 70 (right): South elevation of Room A1, viewed from the north**

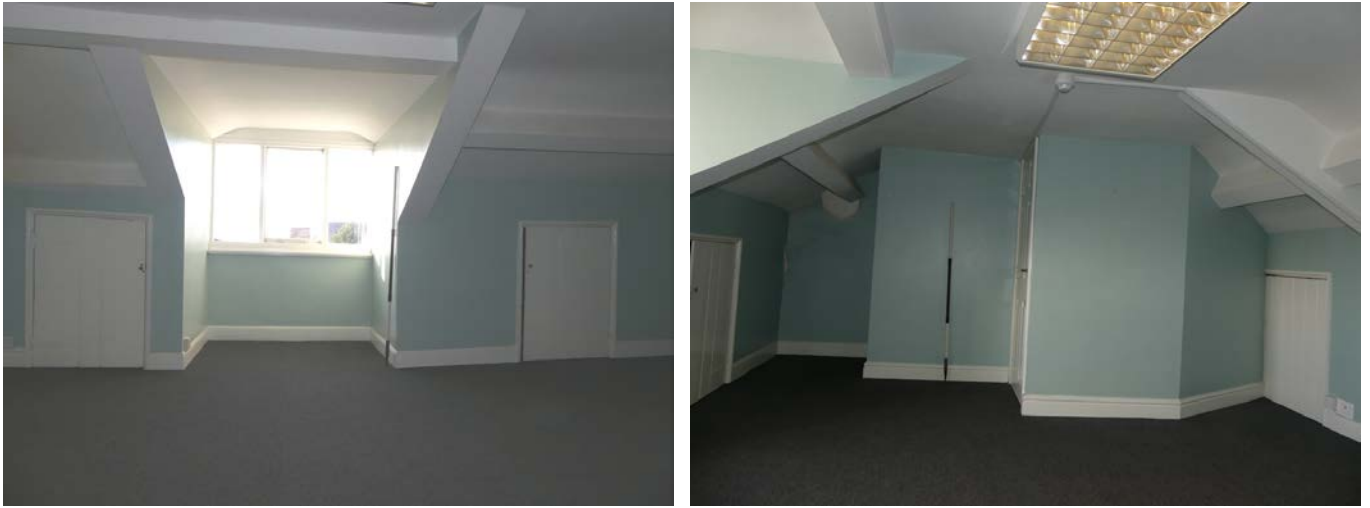
**Plate 71 (left): West elevation of Room A1, viewed from the east**

**Plate 72 (right): North elevation of Room A1, viewed from the south**

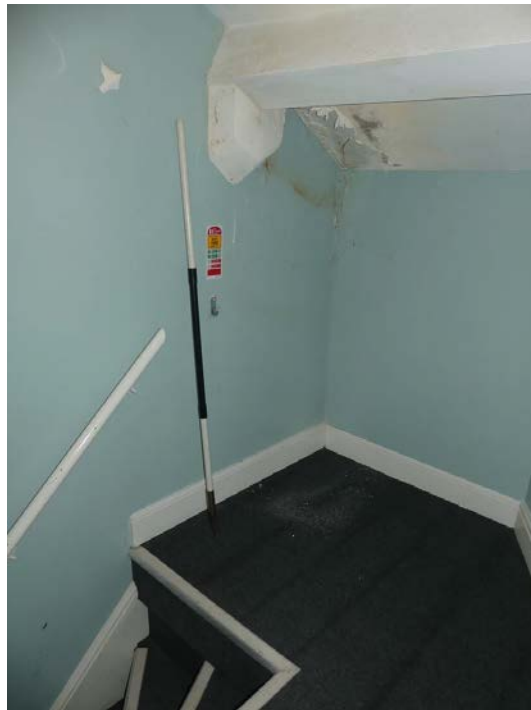
4.3.23 **Attic Floor Room 2 (A2)**: this comprises a small lobby at the top of the stairs and is very plain with modern handrail on the north side. The end of a purlin extends on the north-east side with a corbel below (Plate 73).

**Plate 73: The north-east corner of Room A2, showing the end of the purlin**

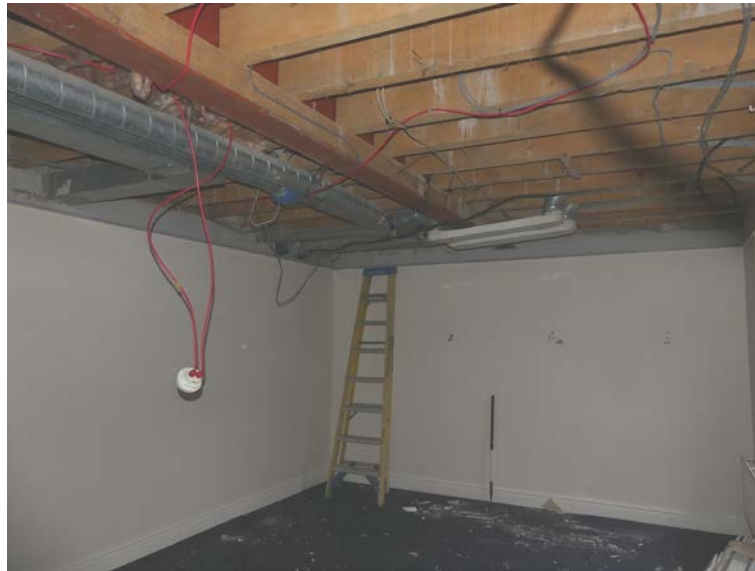
4.4.1 **Room LG1**: the removal of the suspended ceiling had revealed a large modern iron I-beam orientated north/south and sawn timber joists (Plate 74). The modern concrete block build of the walls was also exposed to the north, south and west.

**Plate 74: View of Room LG1 following soft stripping, viewed from the north-east**

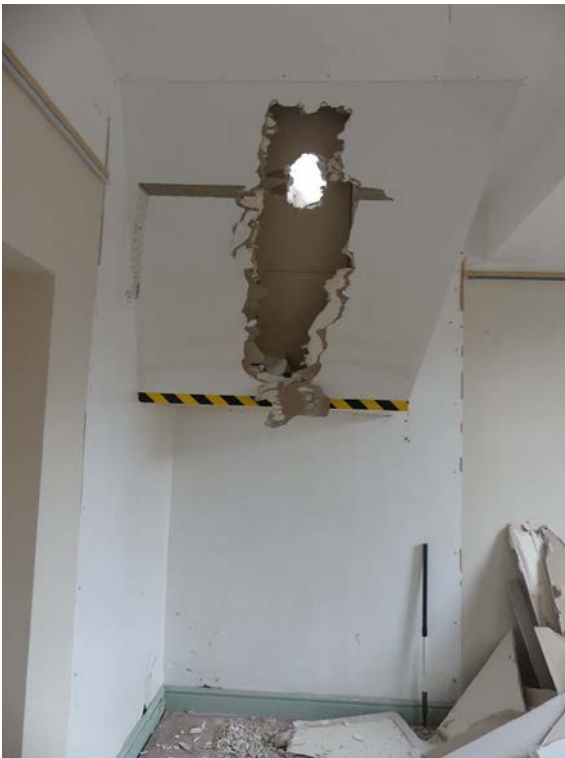
4.4.4 **Room G1:** the stud boxing in the south-east corner had been removed revealing a further section of suspended boxing, which had been broken through (Plate 75). This revealed that this boxing was around a window in the adjoining property to the south, continuing to the floor above to provide a borrowed light from a skylight in the roof above. The suspended ceiling has also been removed to reveal a boxed in beam orientated north/south, but otherwise plain (Plate 76).

**Plate 75 (left): Boxing removed in the south-east corner of Room G1, after soft stripping**

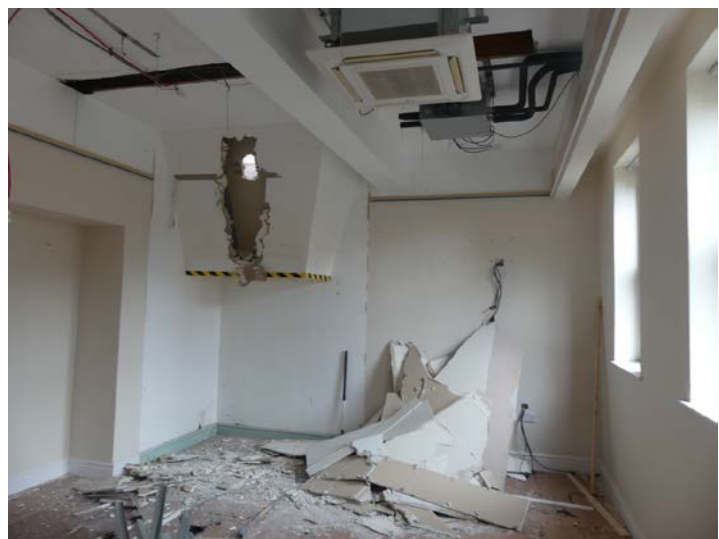
**Plate 76 (right): Room G1 after soft stripping, viewed from the north-west**

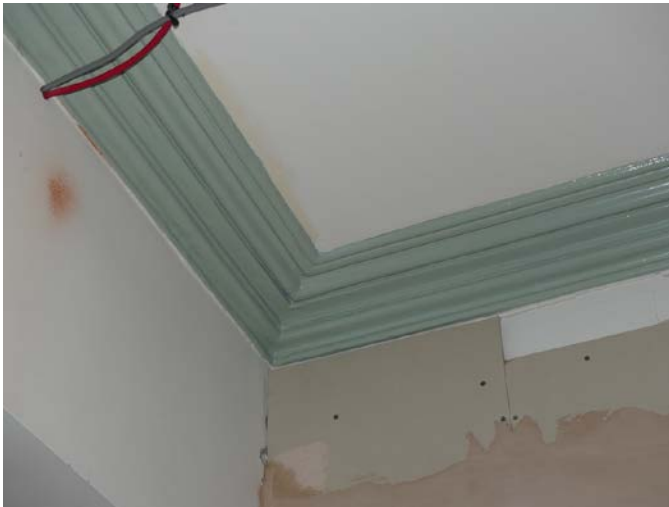
**Plate 77 (left): Cornice exposed in Room G3, viewed from the north-west**

4.4.5 **Room G3:** the removal of the suspended ceiling revealed a moulded cornice throughout (Plate 77), with modern stud wall forming the toilet in the south-west corner (Plate 78).

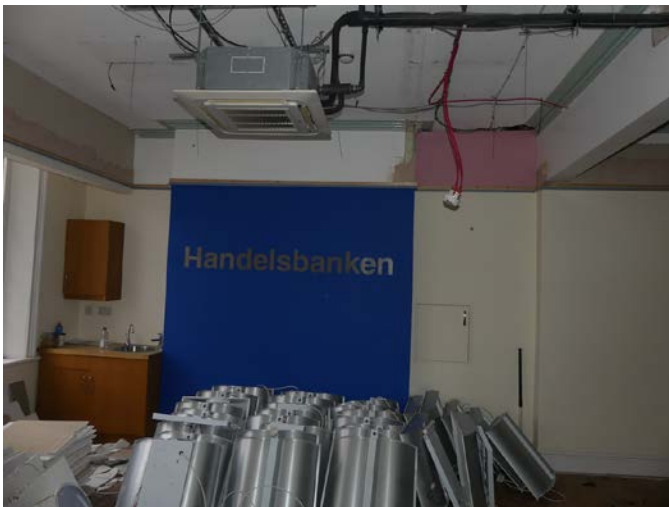
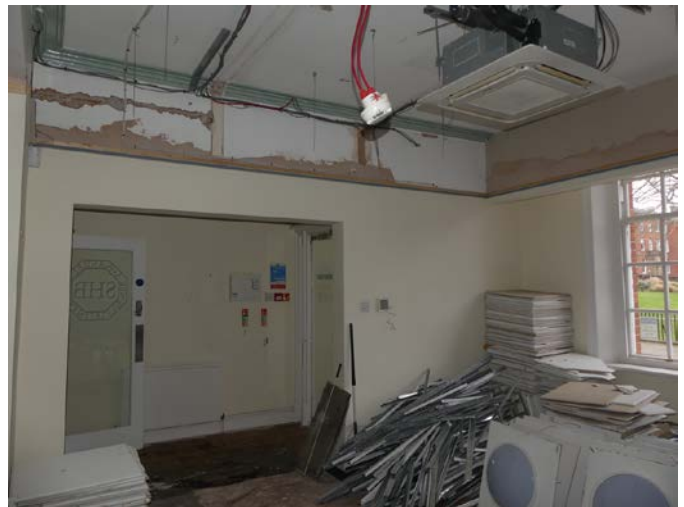
4.4.6 **Room G4:** the removal of the suspended ceiling (Plate 79 and Plate 80) revealed a moulded cornice (Plate 81) with lowered stud walling for the suspended ceiling across the windows on the east side and stud boxing out the area to the west of the chimneybreast on the south side. The cornice is damaged in several places by the insertion of cables and pipes and there are scars for an earlier stud wall projecting from the west side of the chimneybreast to the south (Plate 82), with a corresponding scar on the north elevation (Plate 83).

**Plate 79 (left): General view of Room G4 following soft stripping, viewed from the north**

**Plate 80 (right): General view of Room G4 following soft stripping, viewed from the south-west**

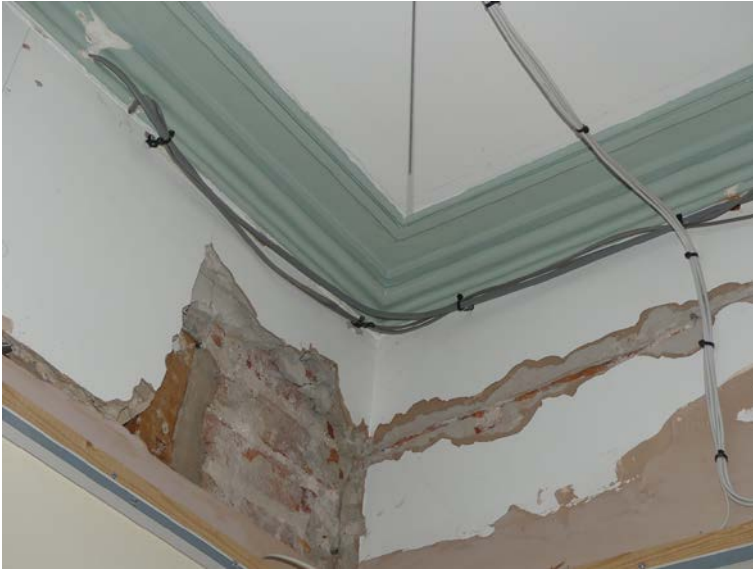
**Plate 81 (left): Cornice exposed in Room G4, viewed from the south-east**

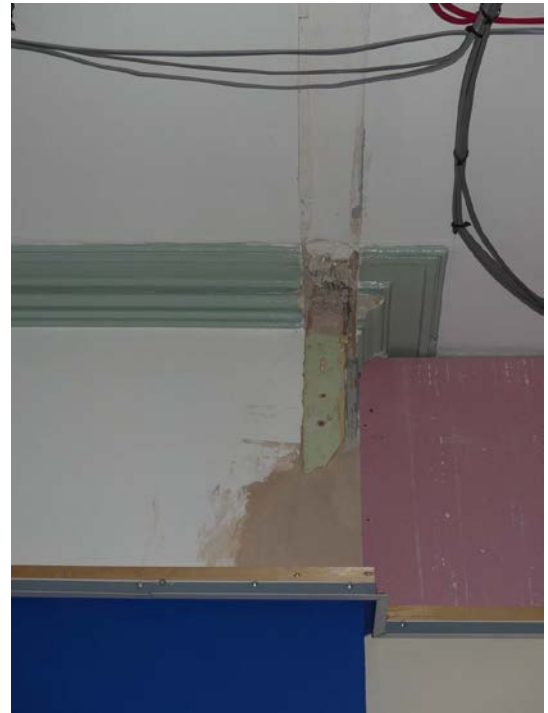
**Plate 82 (right): Earlier stud partition scar exposed on the south elevation, viewed from the north**

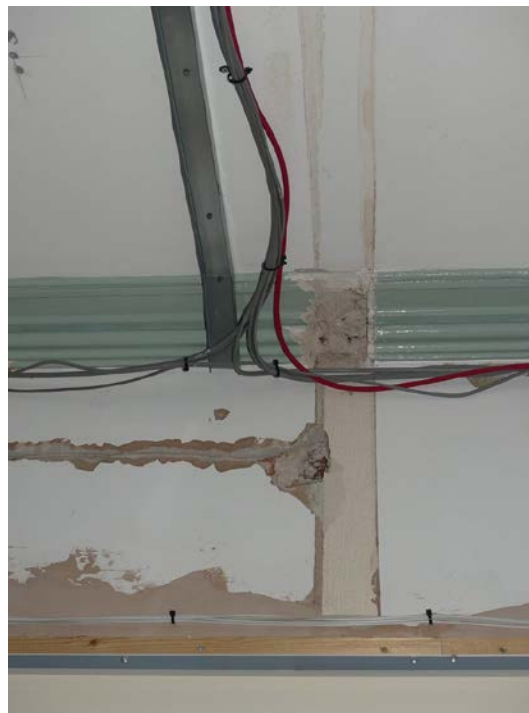
**Plate 83: Earlier stud partition scar exposed on the north elevation, viewed from the south**

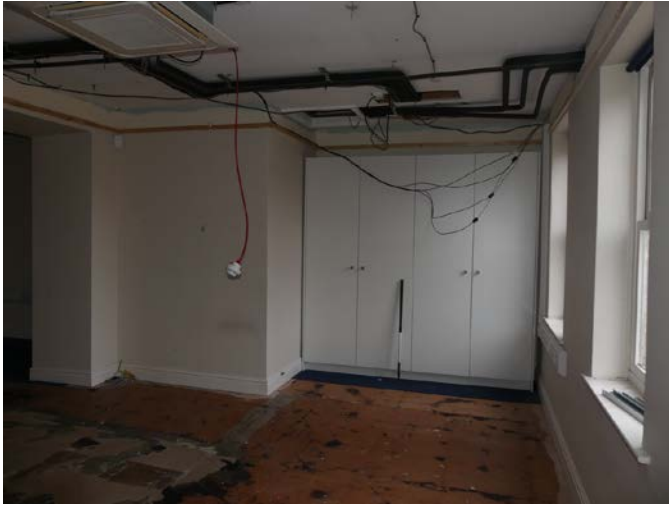
**Plate 84 (left): General view of Room F1 following soft stripping, from the north-west**

4.4.7 **Room F1:** the removal of the suspended ceiling (Plate 84) revealed a plasterboard ceiling above with an access hatch into the sloping roof above in the south-east corner. This also reveals that the built-out section in the south-east corner is constructed from concrete blocks with a timber purlin(?) on top supporting the roof (Plate 85).

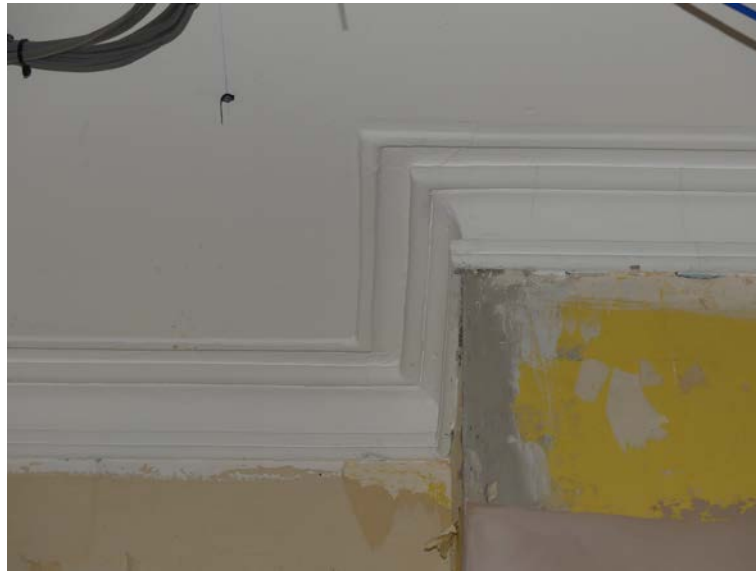
**Plate 88: Cornice exposed in Room F3, viewed from the north**

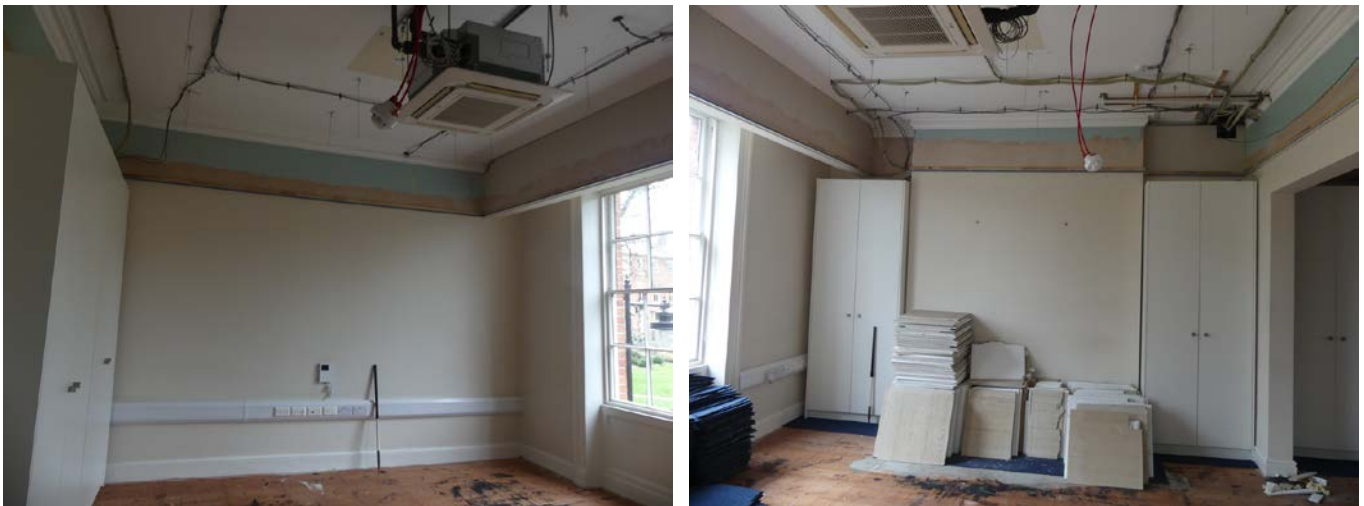
4.4.9 **Room F4:** again, the removal of the suspended ceiling (Plate 89 and Plate 90) revealed a deep cavetto moulded cornice (Plate 91), with some damage from cables and pipes, and a suspended section of stud walling on the east side over the tops of the windows. Additional boxing is also evident to the west of the southern chimney breast, with the cornice continuing behind (Plate 92).

**Plate 89 (left): General view of Room F4 following soft stripping, viewed from the south**

**Plate 90 (right): General view of Room F4 following soft stripping, viewed from the north**

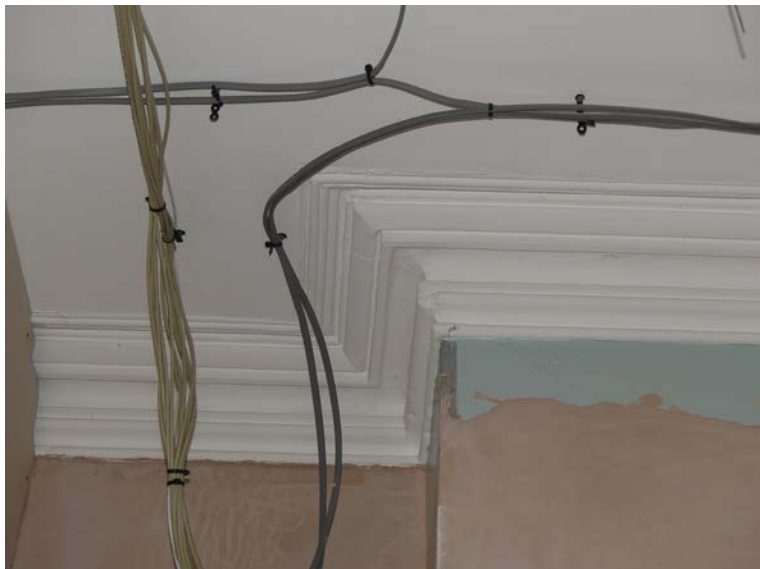
**Plate 91 (left): Cornice exposed in Room F4, viewed from the north**

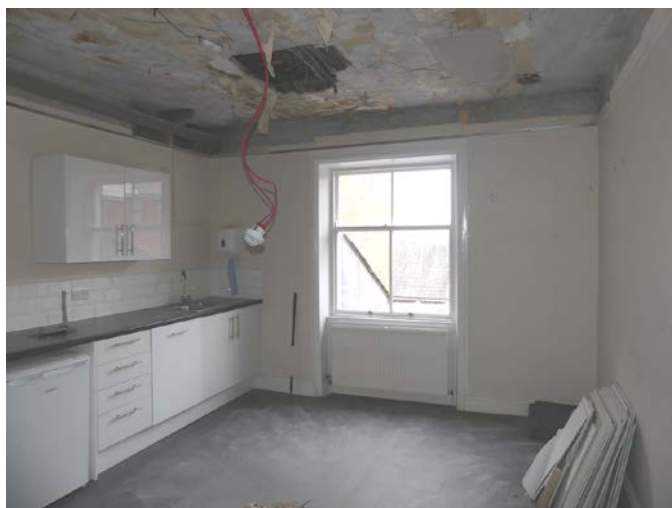
**Plate 93 (left): General view of Room S1 following soft stripping, from the north-east**

4.4.10 **Room S1:** the removal of the suspended ceiling (Plate 93 and Plate 94) revealed a plain lathe and plaster ceiling on sawn timber joists and the boards of the floor above exposed in places where this was damaged (Plate 95). There were no other features although the return for the chimney breast on the west side was evident (Plate 96).

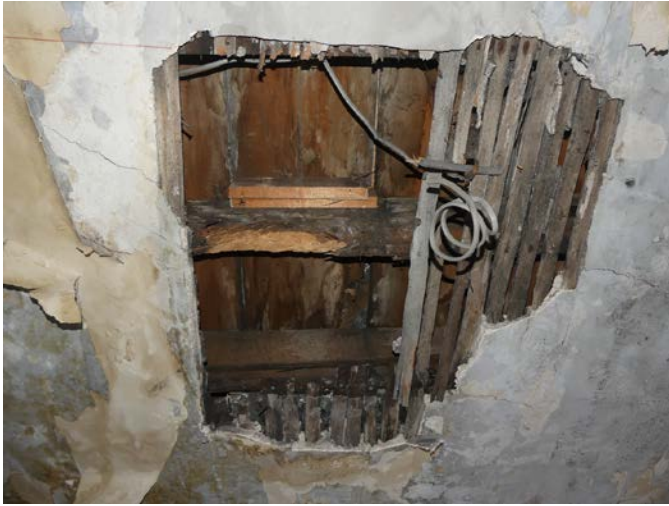
**Plate 95 (left) Exposed joists and boards behind the lathe and plaster exposed in Room S1, viewed from the west**

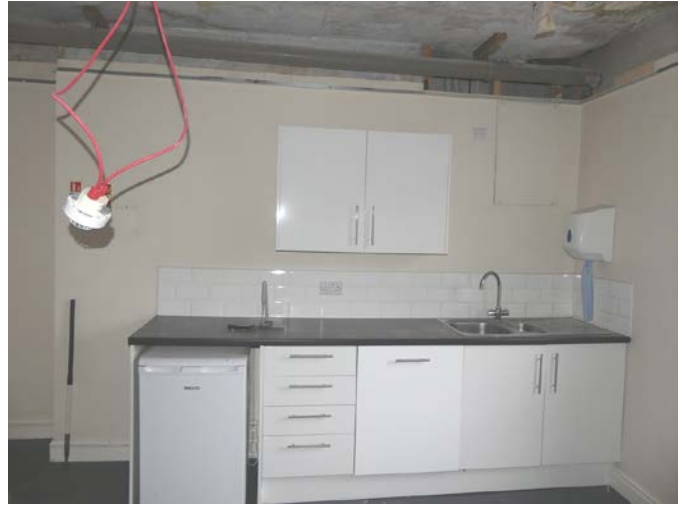
**Plate 96 (right): Chimney breast exposed on the south side of Room S1, viewed from the north**

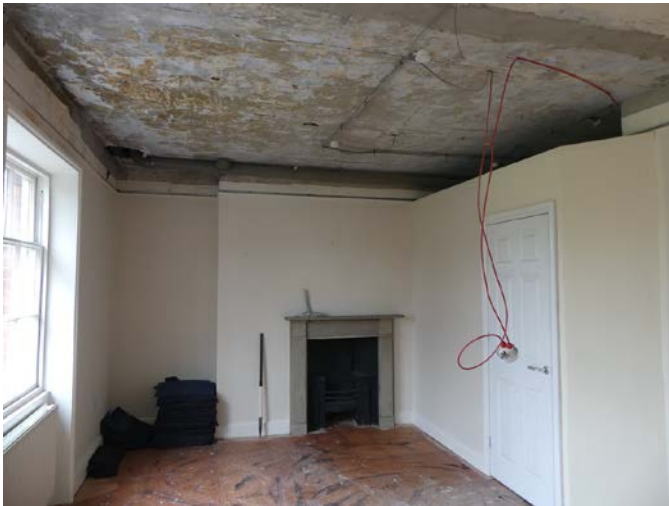
**Plate 97 (left): General view of Room S4 following soft stripping, from the north**

4.4.11 **Rooms S3 and S4:** the removal of the suspended ceiling revealed the original lathe and plaster and that the dividing walls between Rooms S3 and S4 are concrete block (Plate 97 and Plate 98). A plastic water pipe was also hidden against the south side behind the suspended ceiling.
